CAIRNS SHIPPING DEVELOPMENT PROJECT

APPENDIX AE: Condition Assessment Report: Wharf 6, Wharf Street Cairns

CONDITION ASSESSMENT REPORT

Wharf 6, Wharf Street, Cairns

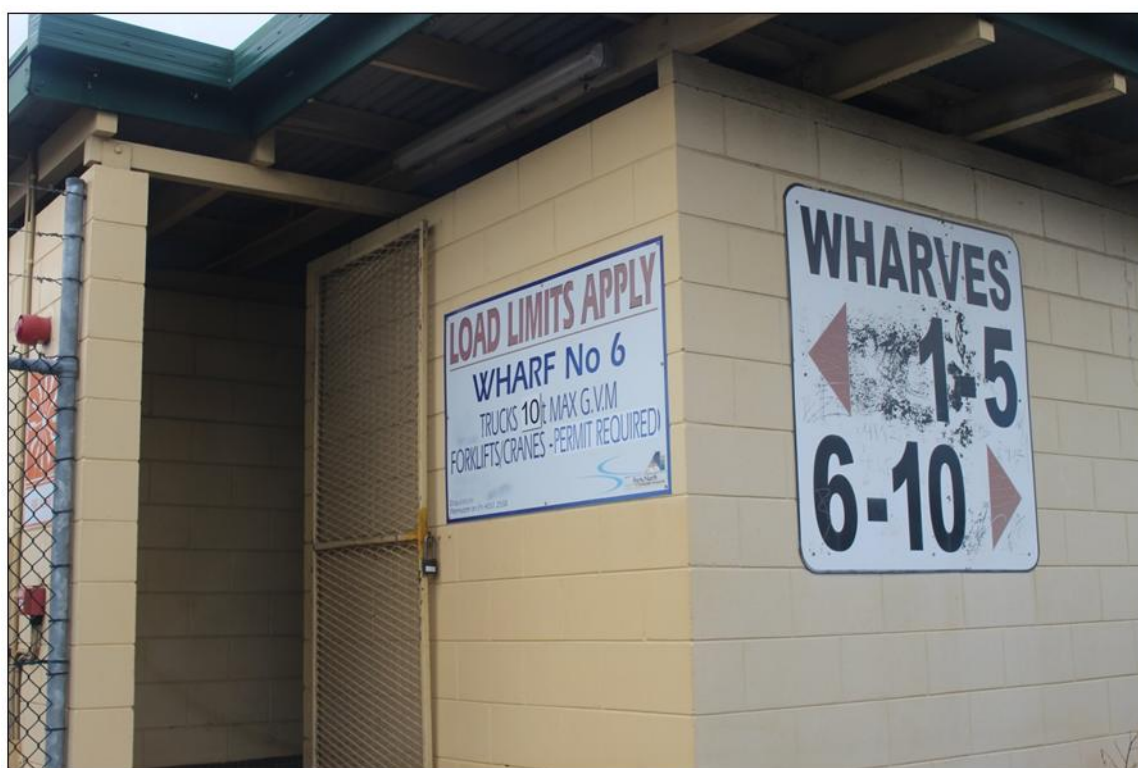
Current load limit to Wharf 6.

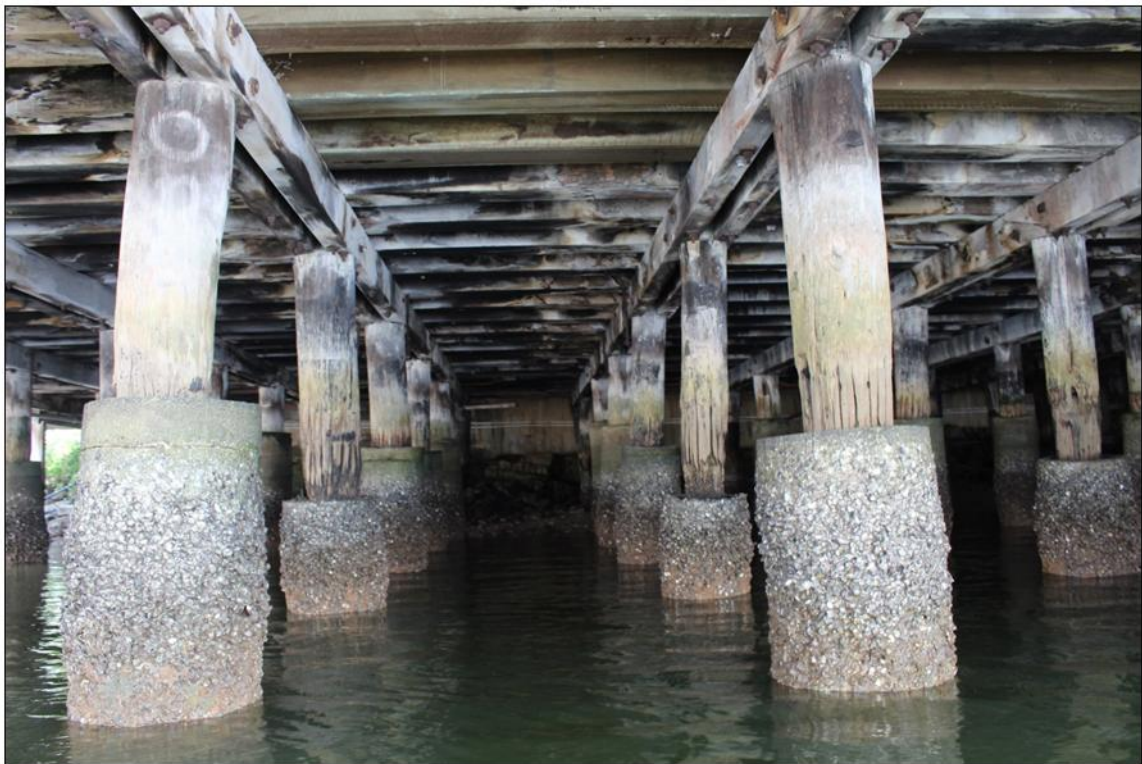
Degraded and decayed portion of piles visible above the concrete sleeves. Variable height of concrete sleeves.

The timber piles are in poor condition with varying degrees of section loss and damage throughout the wharf. Several piles were completely missing and others were cracked, crooked and close to collapse. The condition of the piles within the concrete sleeves and below the water could not be observed, however loss of capacity could be inferred from the sleeve movements.

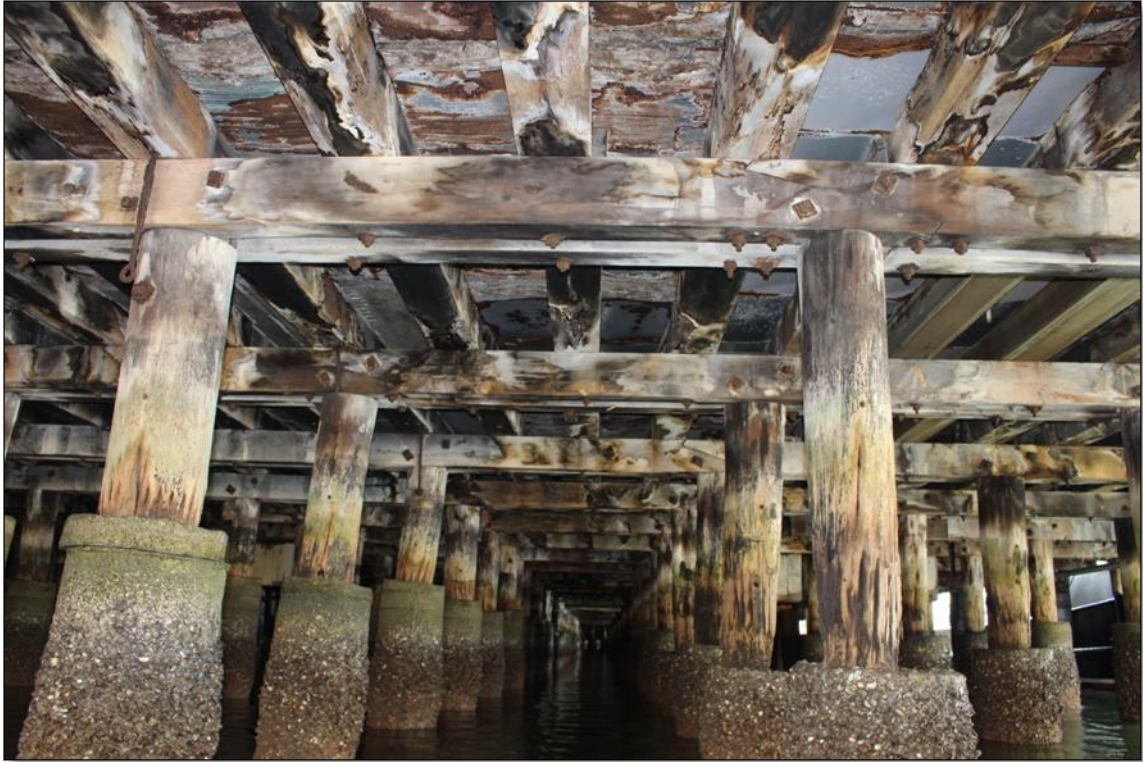
The height of the concrete sleeves was observed to vary in level. It is understood that progressive settlement into the soft underlying sediments, tidal or vessel generated scour, and potential effects of periodic dredging of the adjacent wharf berth pocket, has undermined the base of the sleeves (and potentially the piles) resulting in the sleeves dropping in level over time. The variability of the sleeve height is concerning as it indicates that the pile embedment level and the current support conditions are drastically different to that when the wharf was originally constructed and designed. The sleeve movement has reduced the durability of the piles and could be resulting in additional 'drawdown' forces on the piles reducing their capacity.

Degraded and decayed portion of piles visible above the concrete sleeves. Variable height of concrete sleeves.

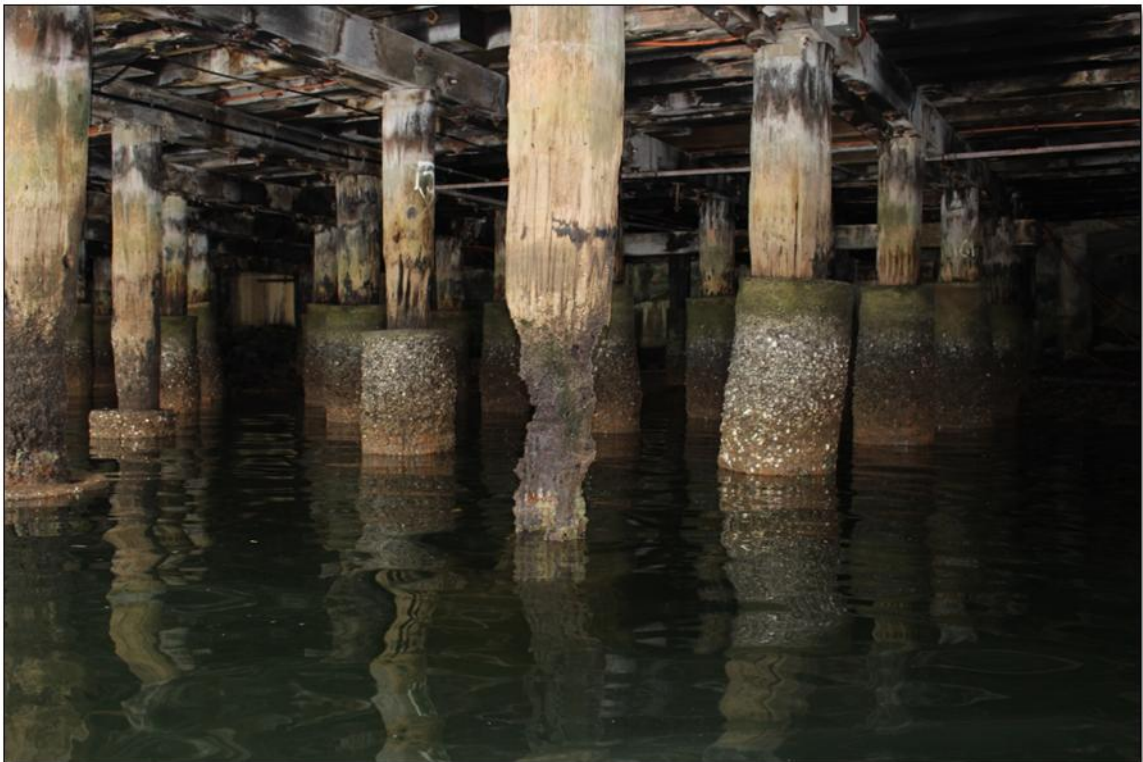
Advance degradation and decay of pile. Severe reduction in section dimension of pile.

The damaged piles represent a high risk to the safety of deck users, their equipment and adjacent boat users. Failure of a compression member of this nature would result in catastrophic failure of the section of deck supported by the pile. Structural failure of the pile would be sudden and could occur with little warning.

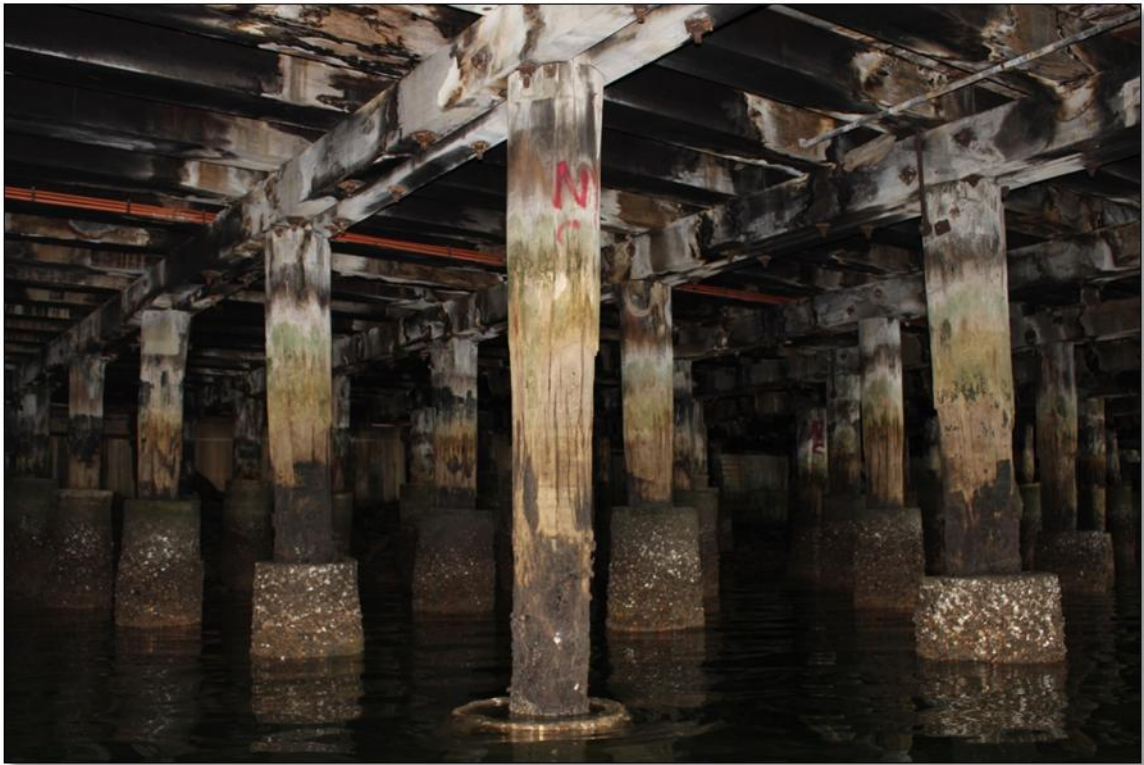
Top portion of concrete sleeve at same height of water level.

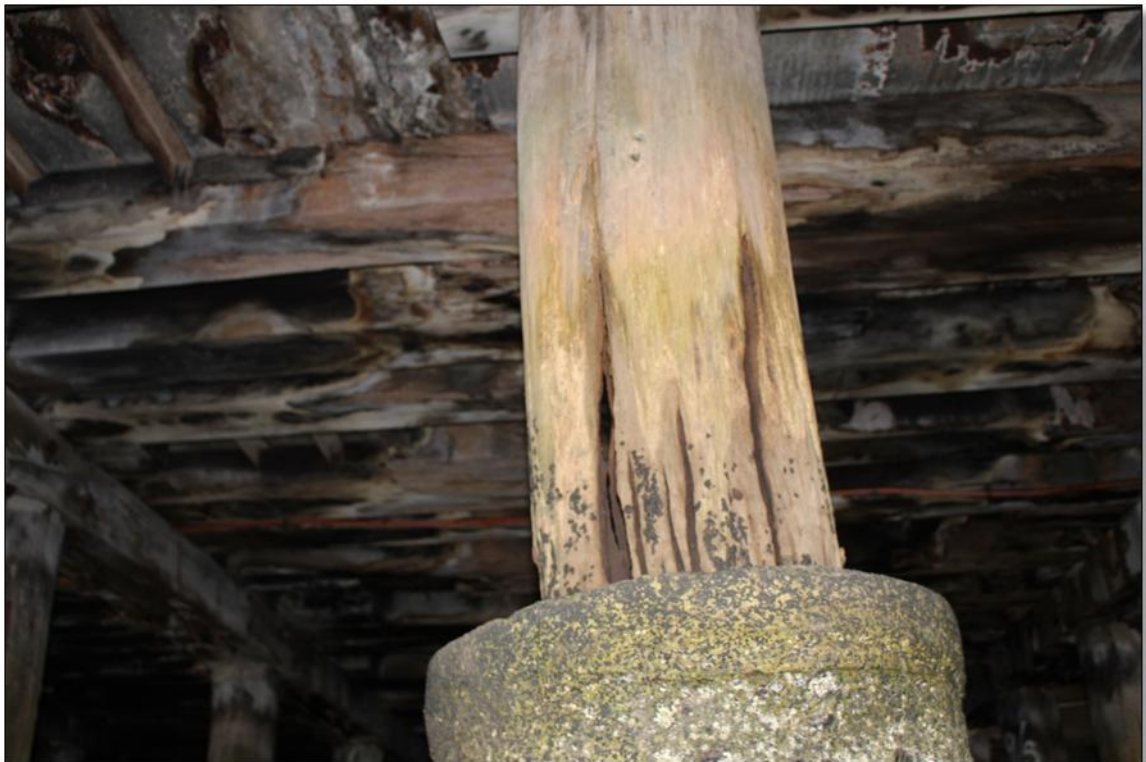
Splitting of pile.

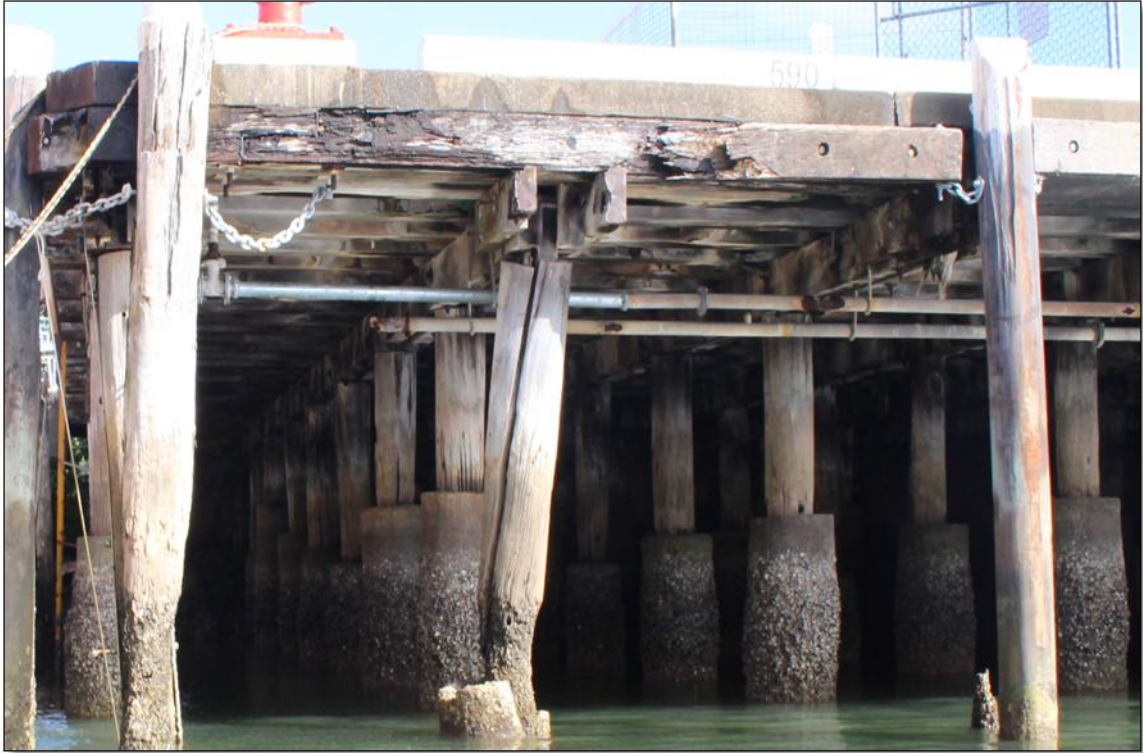
Splitting of pile and damage to concrete sleeve.

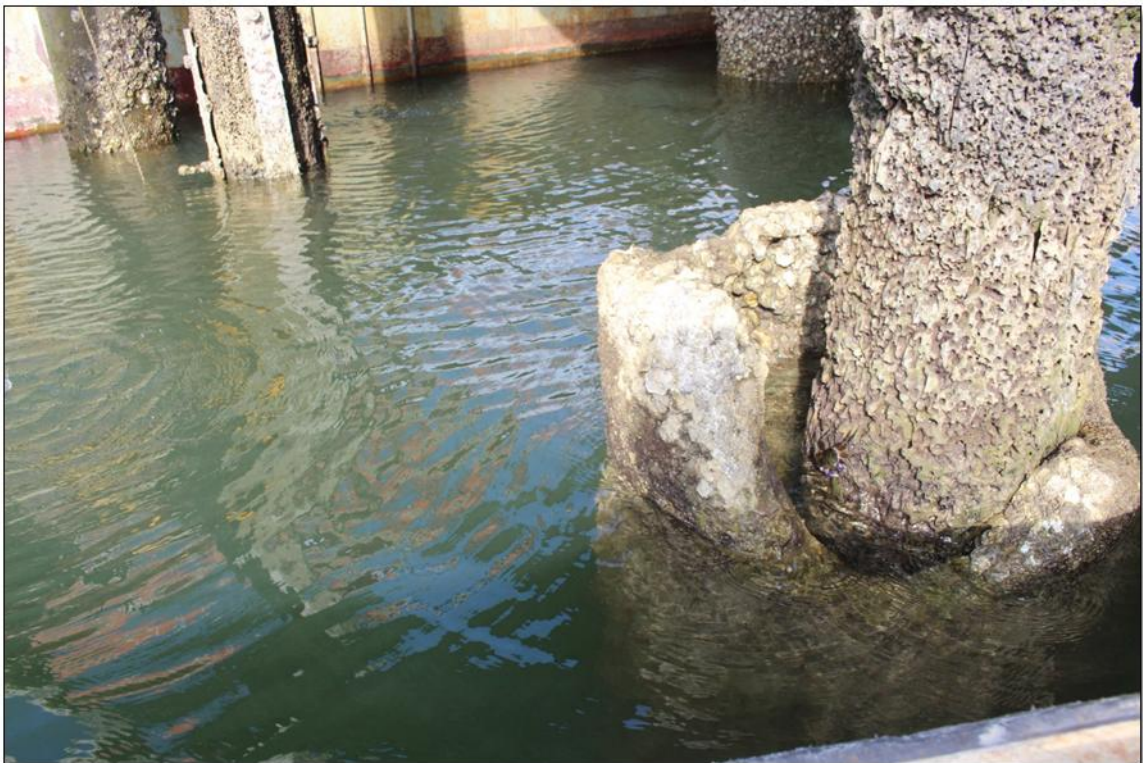
- Damage to the concrete sleeves was evident at different locations.

Damage to concrete sleeve.

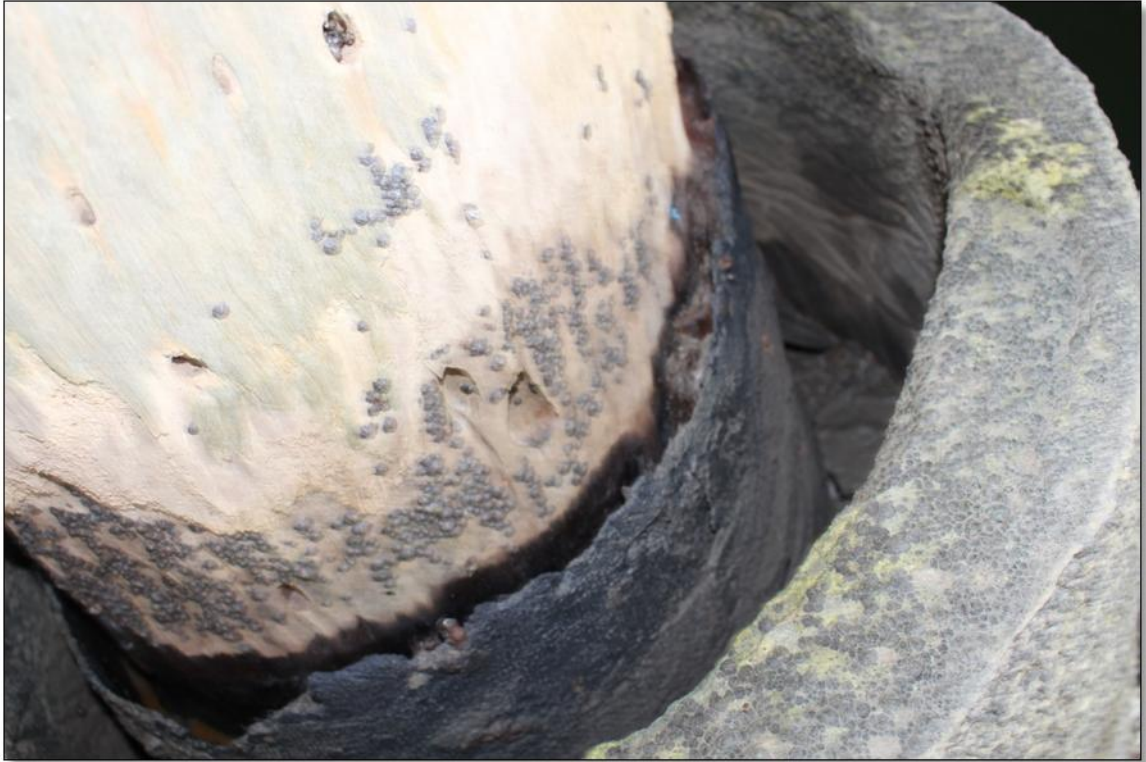
Void between the pile and the concrete sleeve.

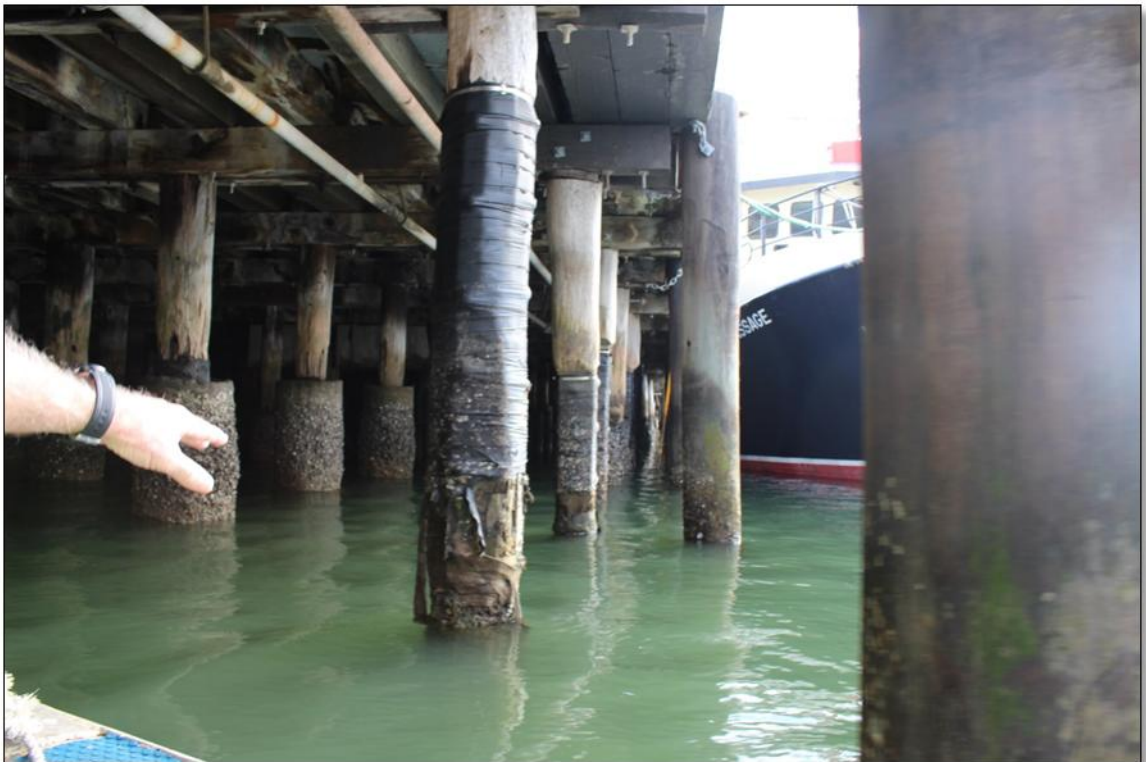
Wrapped pile with tape.

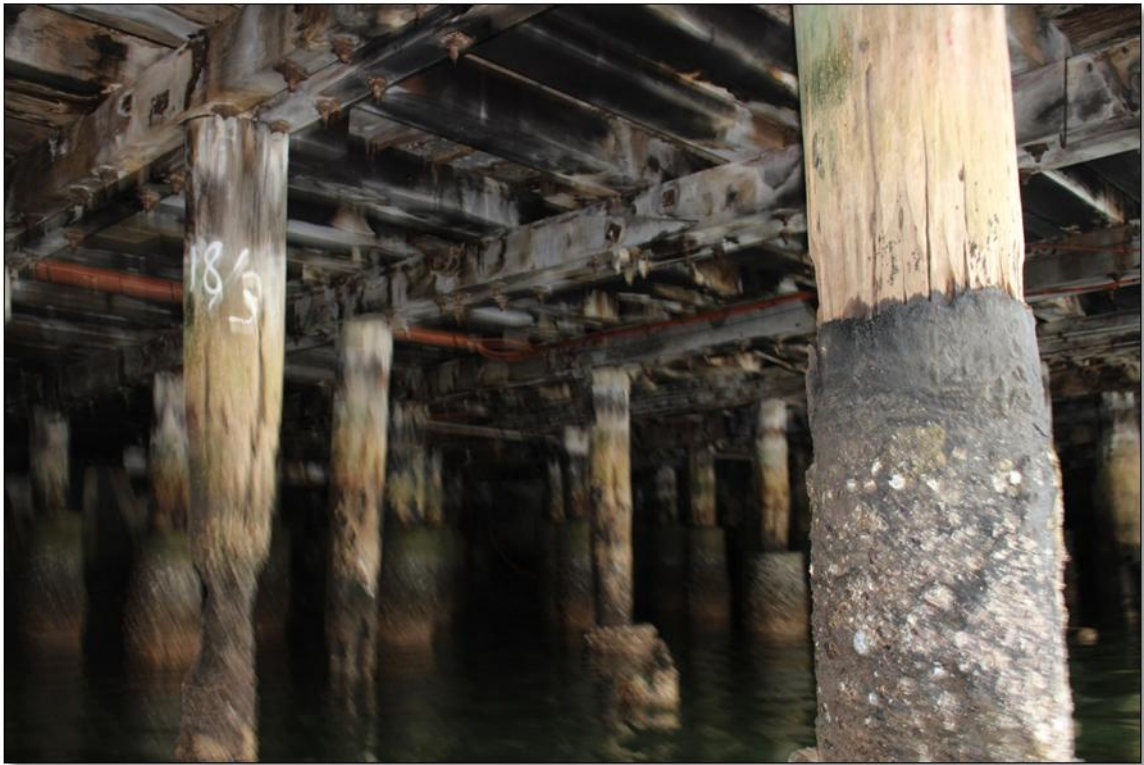
Pile wrapped with epoxy coating.

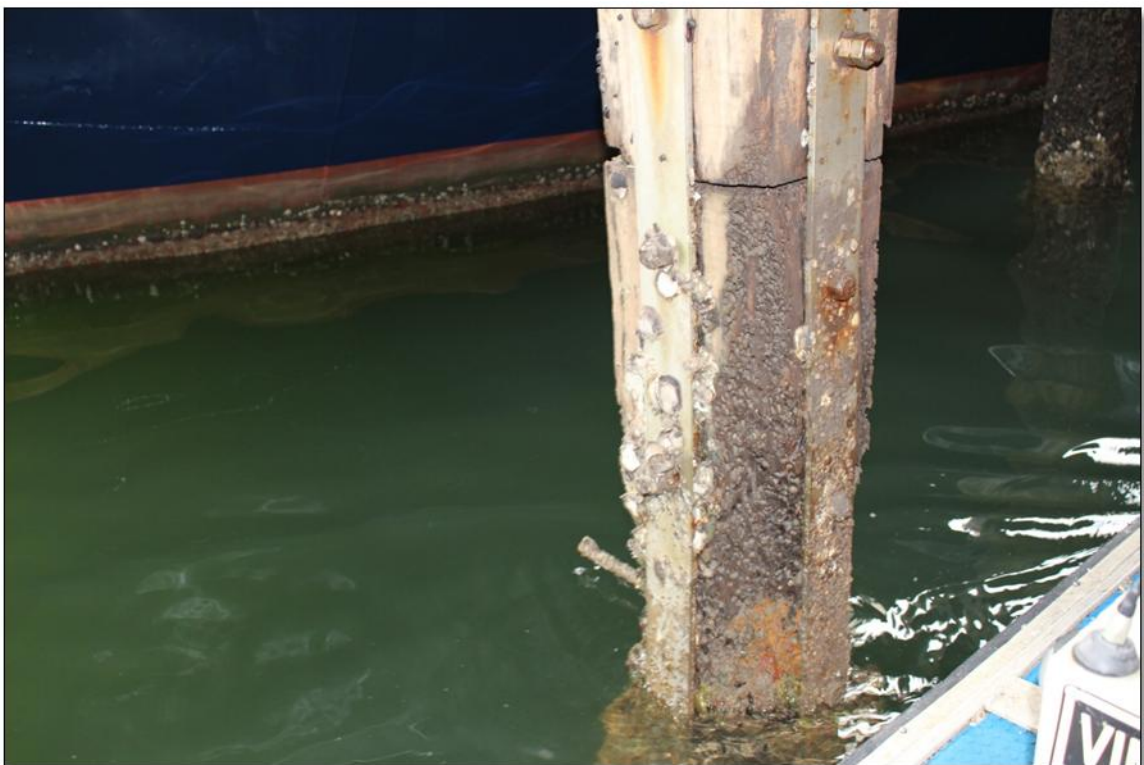
Spliced piles connected with steel plates bolted around the perimeter of the pile

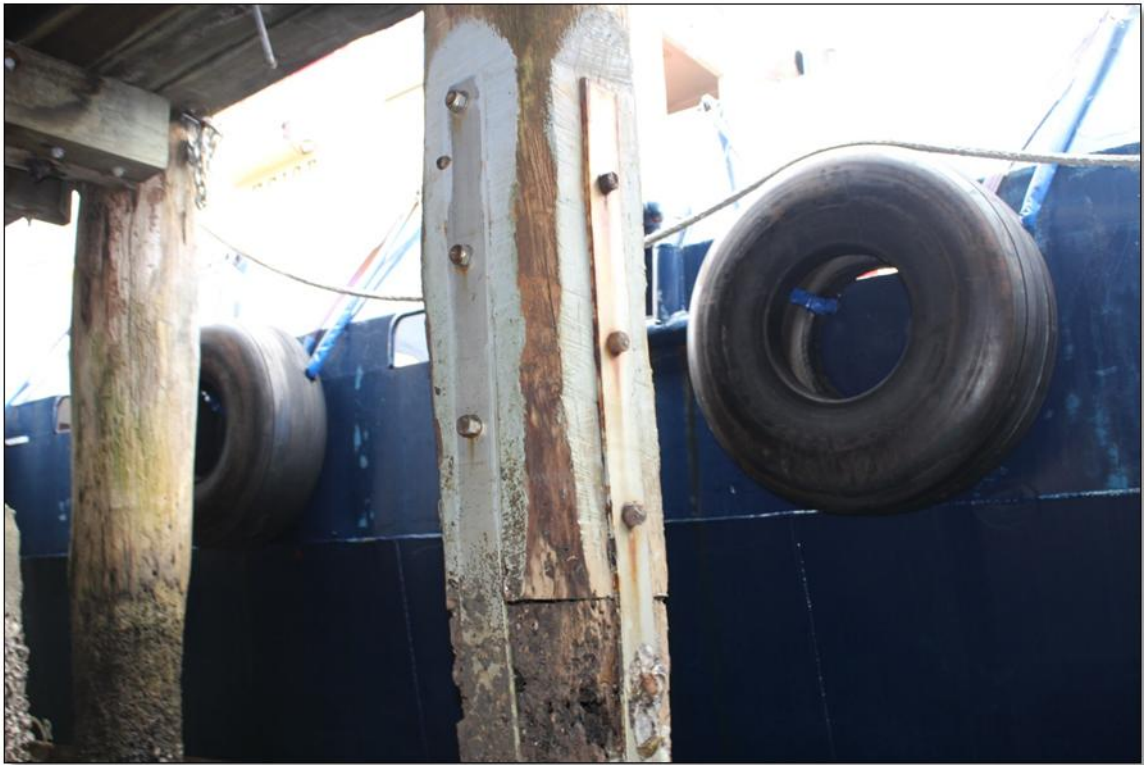
Spliced piles connected with steel plates bolted around the perimeter of the pile

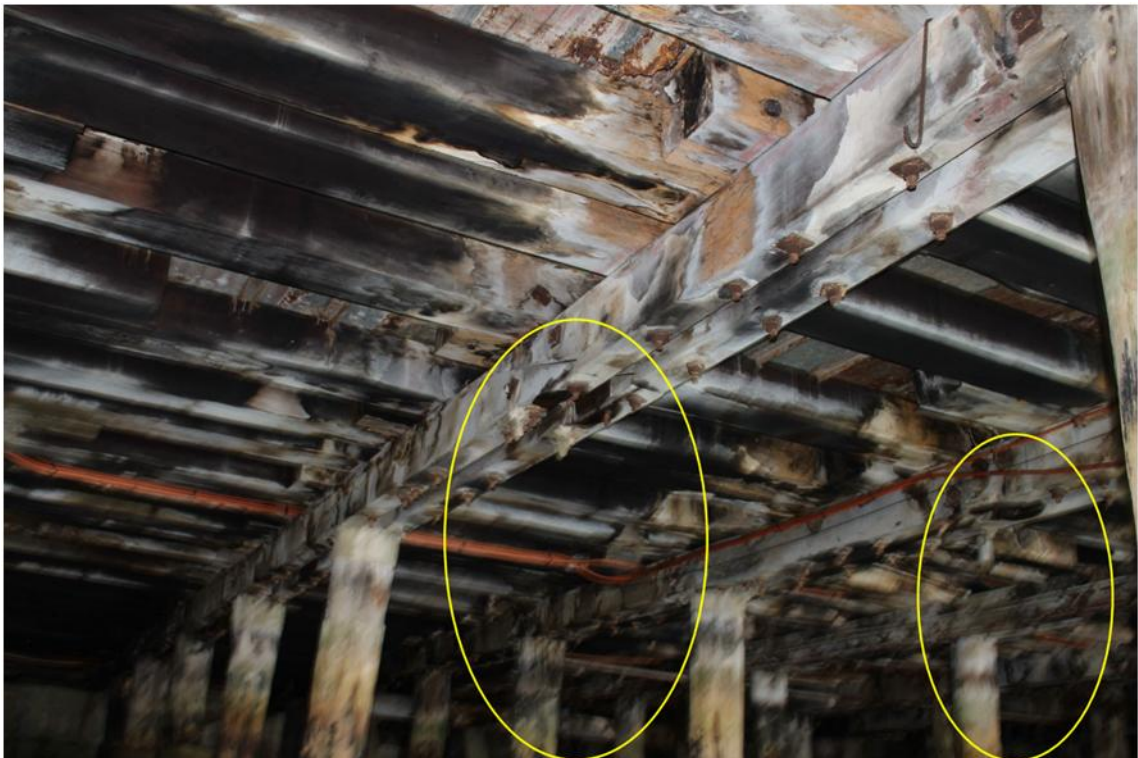
Various attempts have been made to fix and protect problem piles throughout the wharf. Several piles were observed to be wrapped, coated and in places spliced with varying degrees of success. It was observed that two piles were completely missing, leaving a section of the deck unsupported (this zone has been fenced off).

Missing piles

Ports North have cordoned off the worst sections of the wharf (where piles are completely missing) and have attempted to put load restrictions on the remaining areas of the wharf. This approach is extremely difficult to monitor and maintain due to the variability in vehicle wheel loading, mass and configuration (particularly for frannas cranes) and operator awareness and knowledge. Given the structural defects and the nature of failure described in sections 6.1 – 6.3, consideration should be given to further restrictions or closure of the wharf.

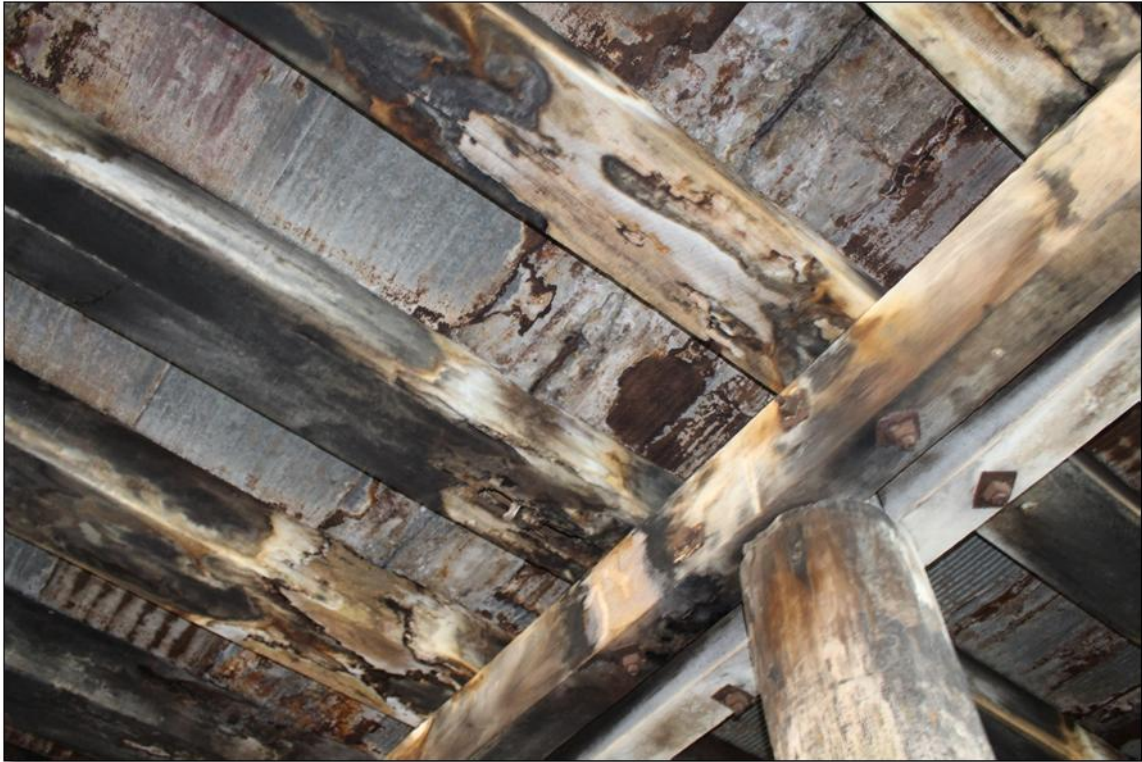
Staining and fungal decay was evident in the timber headstocks and girders. Significant section loss has resulted from water leakage through cracks in the concrete deck.

Staining and damage to timber

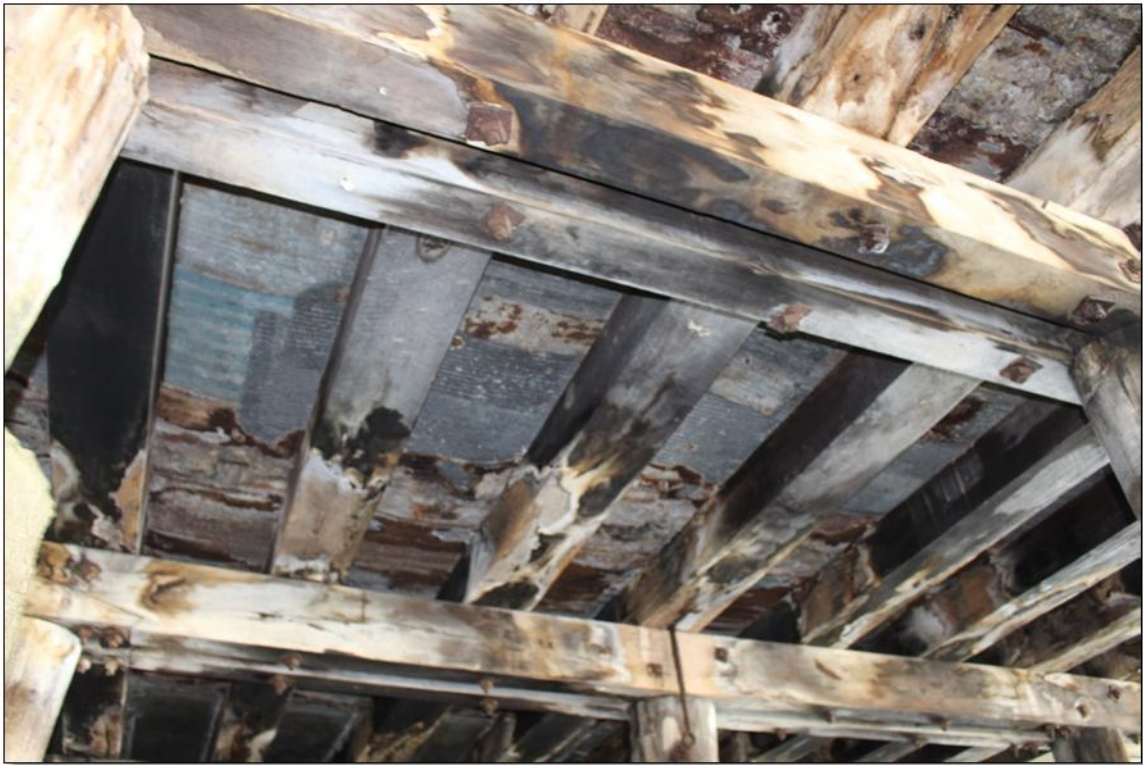
Staining on headstock surface.

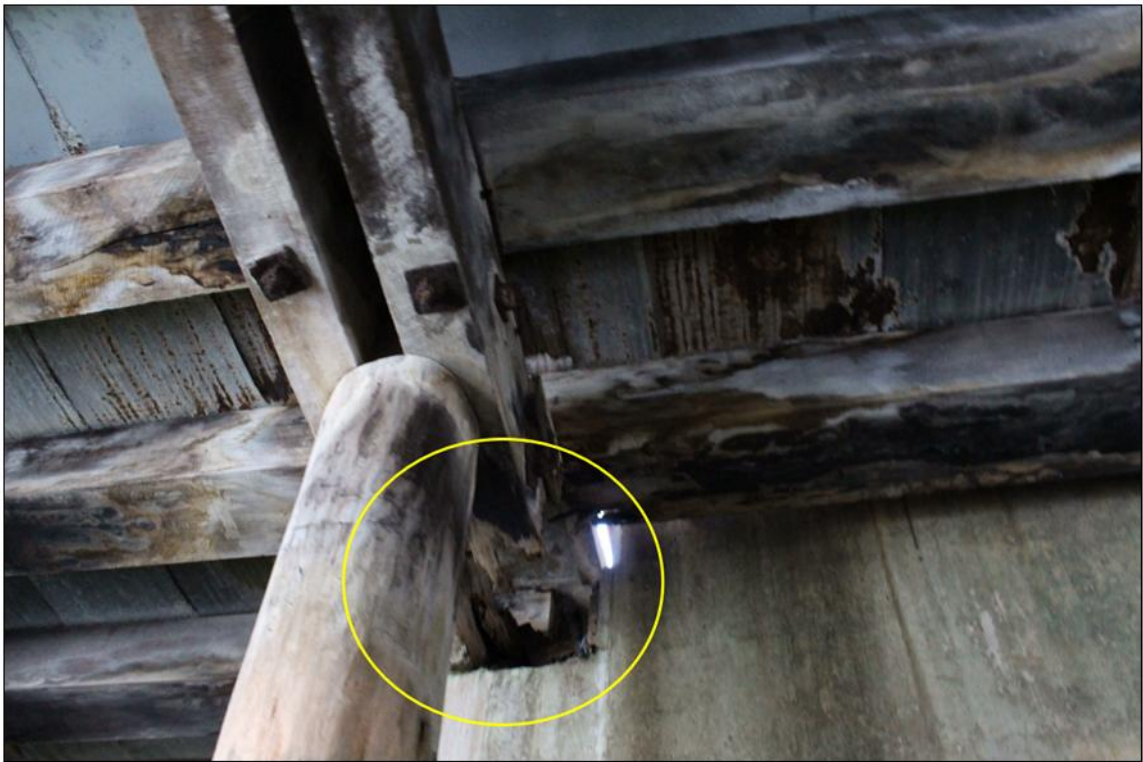
Localised damage to headstock.

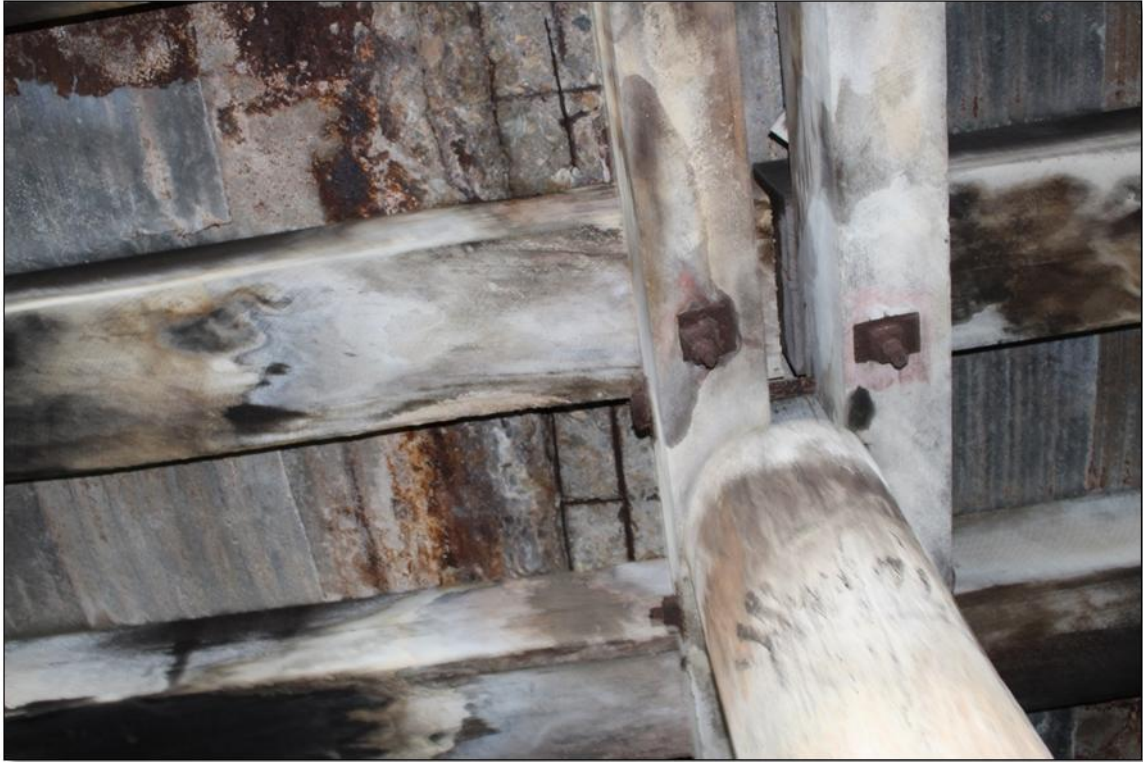
All bolted connections have experienced a degree of corrosion and section loss.

Corrosion to steel rods, nuts and washers.

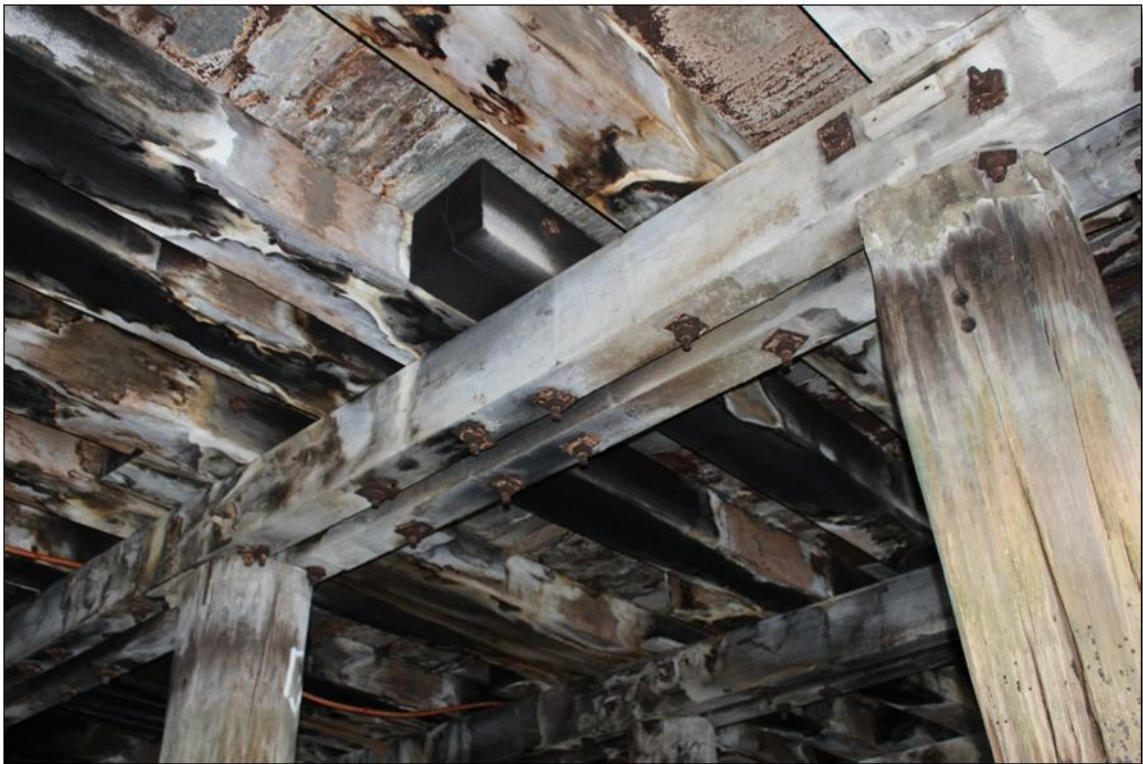
Corrosion to steel rods, nuts and washers.

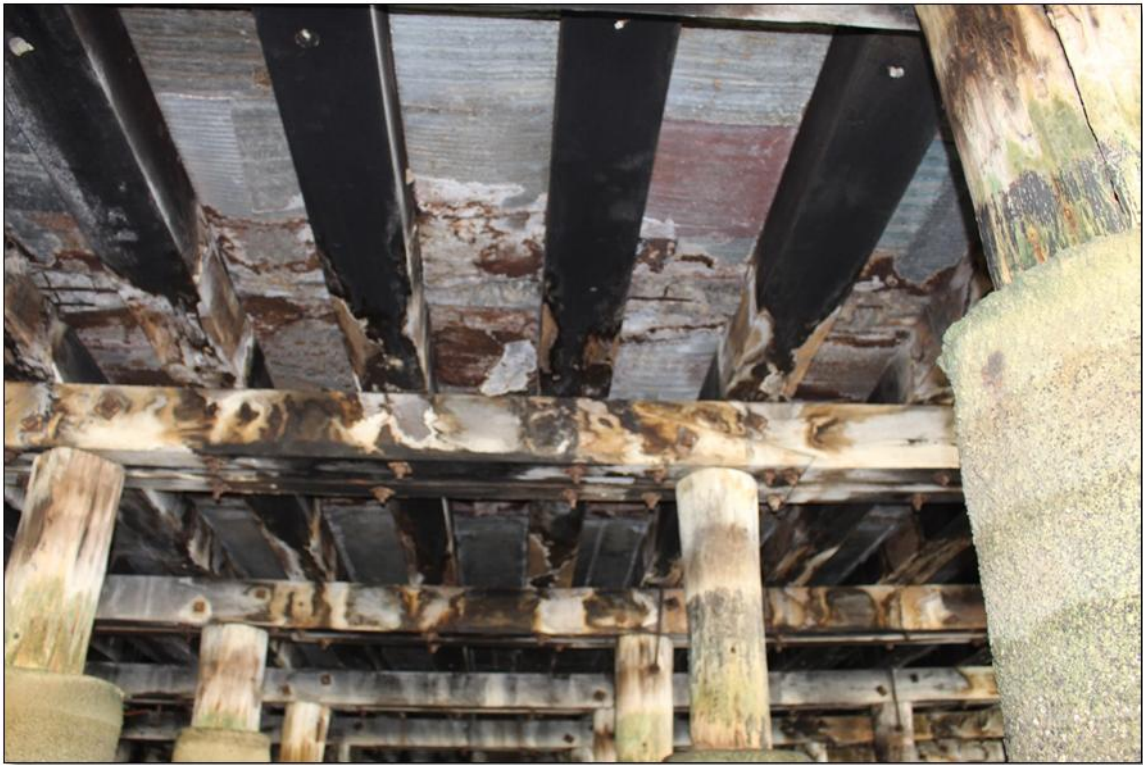
Staining to timber girders.

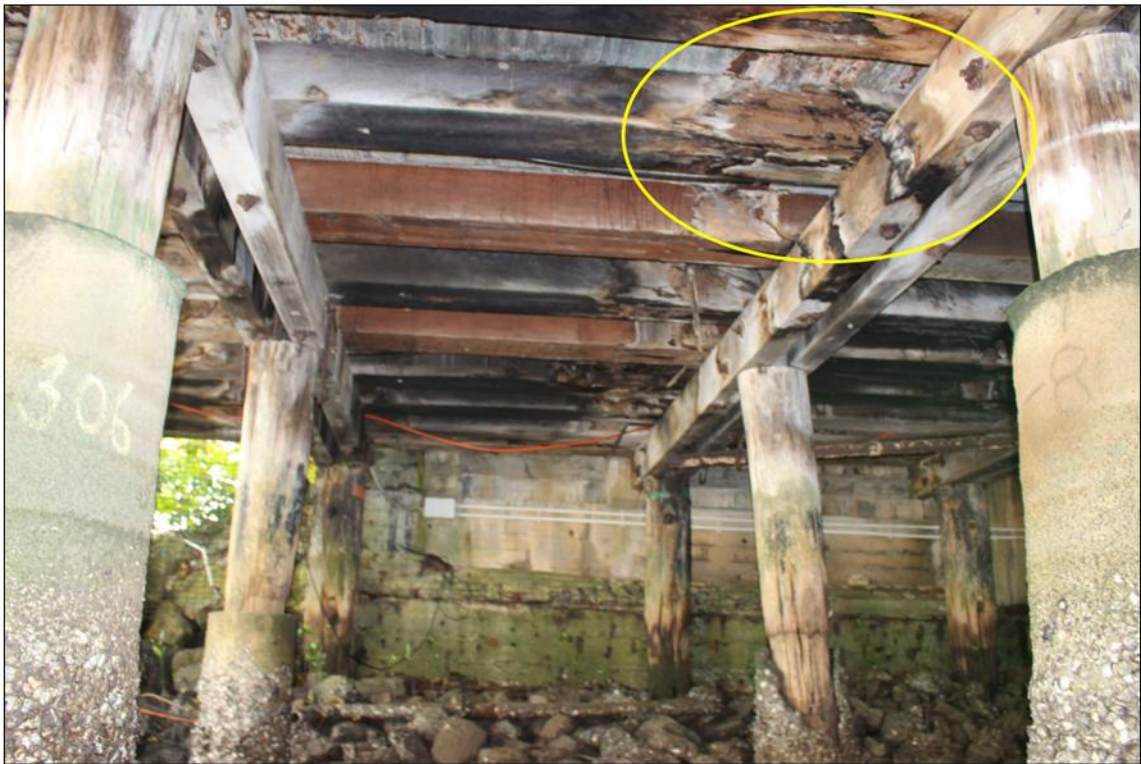
Advance degradation and decay to timber girders.

The damaged headstocks and girders represent a high risk to the safety of deck users, their equipment and adjacent boat users. The rot and section loss where water ingress has occurred could result in localised crushing or shear failure of these members and sudden deck collapse.

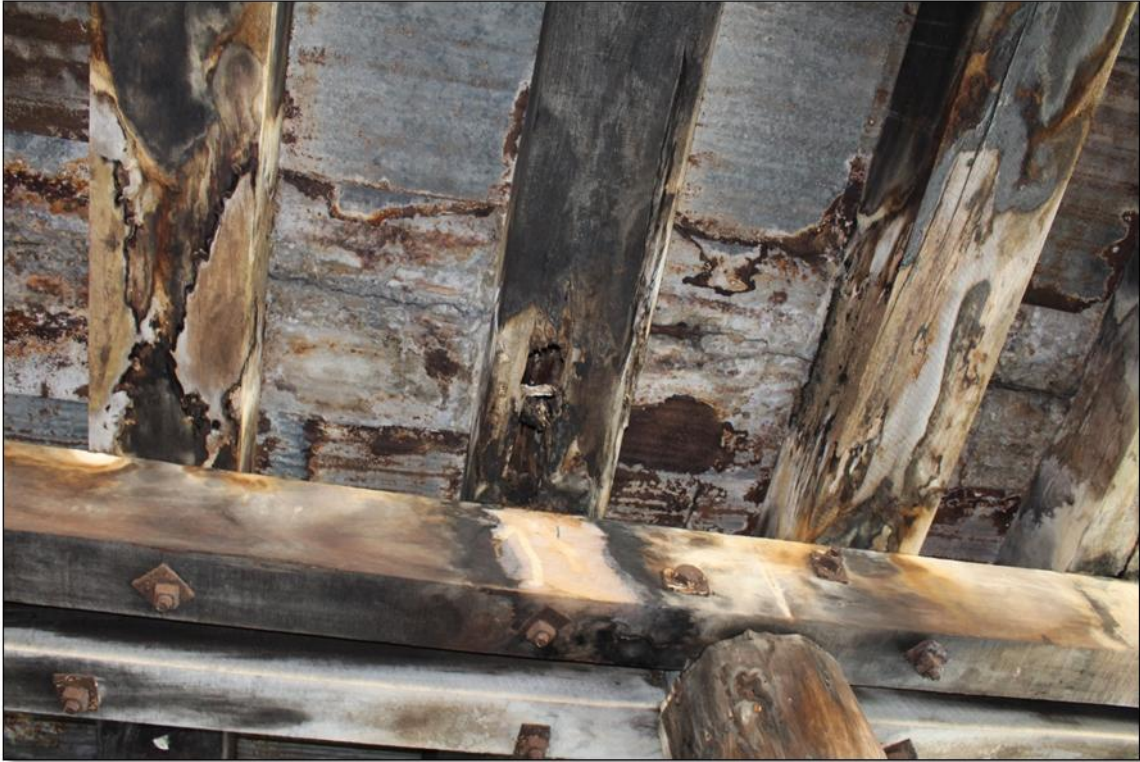
Advance degradation and decay to timber girders.

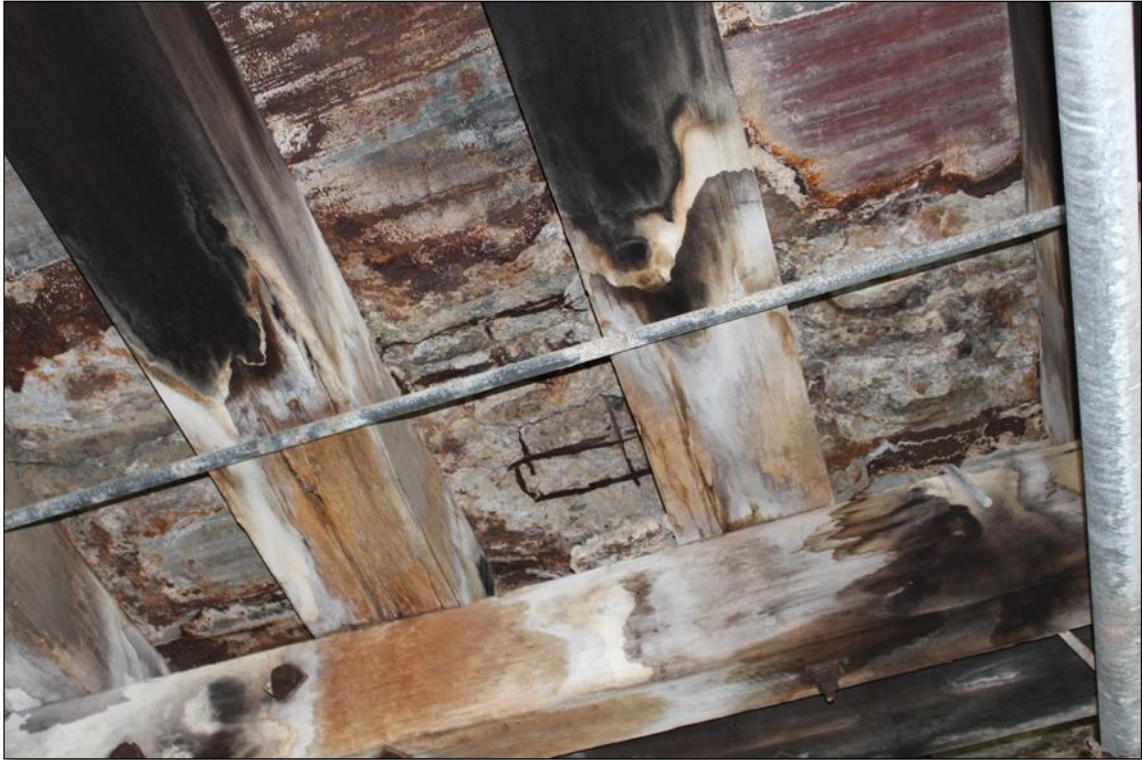
The concrete deck is supported by the timber girders and only spans a short distance between these members. The concrete deck has been poured in various sections with (potentially) sacrificial soffit formwork. Where it still remains, this formwork is in very poor condition. Spalling of concrete (due to corroded reinforcing) is evident throughout the structural indicating an accelerating decline of the deck.

Corrosion to iron steel. Portions of the sheeting had completely rusted away.

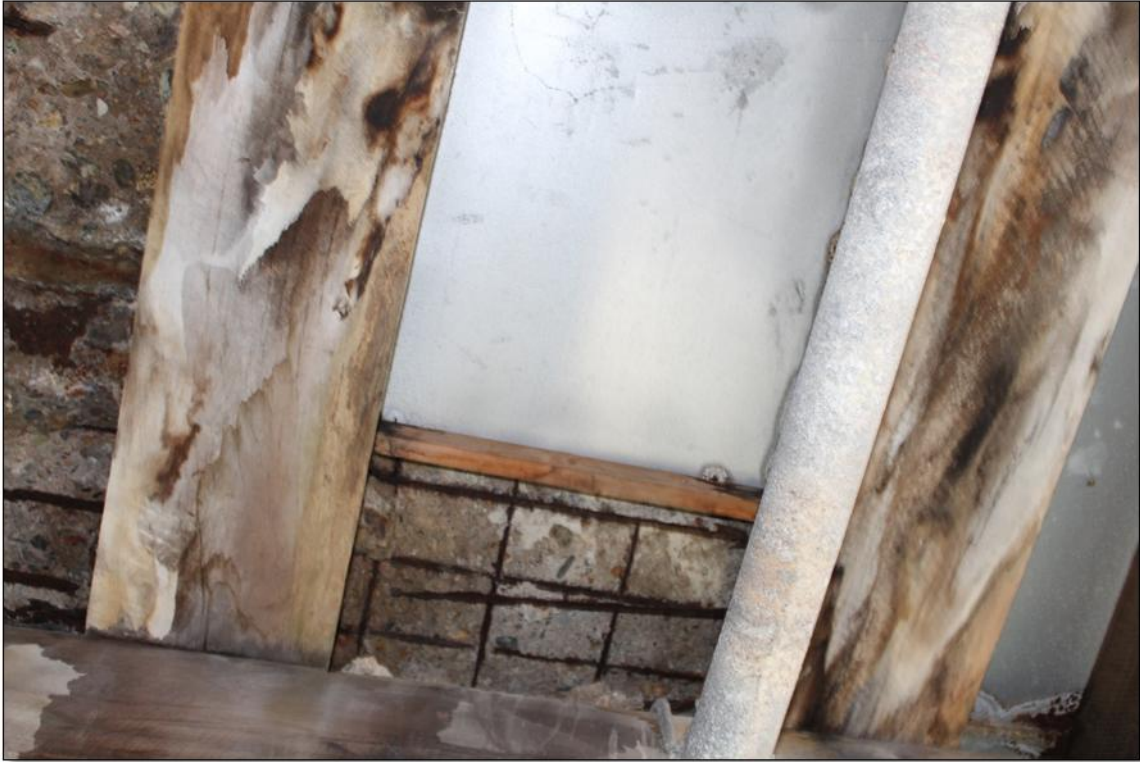
Severe corrosion to bottom reinforcement. Steel sheeting to underside of deck has completely rusted away.

- Varied in thickness and construction technique
- Is constructed from poorly compacted concrete with a high void content
- Has low concrete strength and density
- Is severely carbonated beyond the depth of the reinforcing
- Has a high rate of corrosion
- Has cracked as a result of prior overload

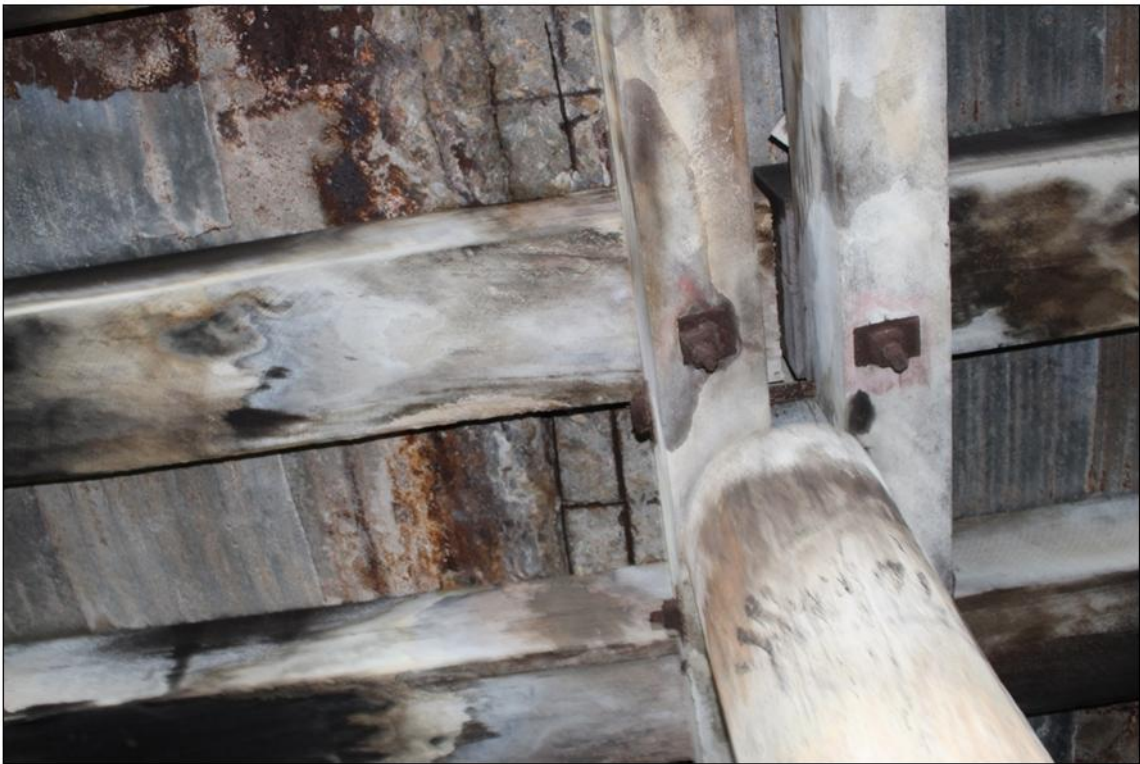
Severe corrosion of bottom reinforcement. Steel sheeting to underside of deck has completely rusted away.
