**GOLD COAST QUARRY
ADDITIONAL INFORMATION TO THE ENVIRONMENTAL IMPACT STATEMENT**

Gold Coast Quarry

ROAD SAFETY REVIEW

Old Coach Road, Reedy Creek

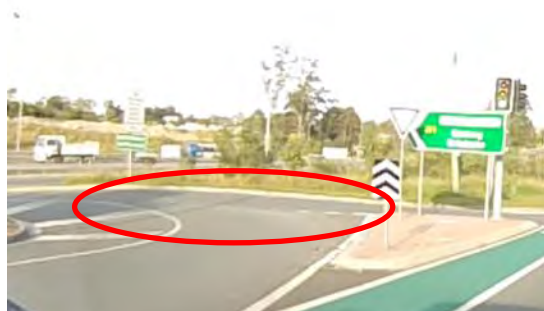
Issue 1

Location	Old Coach Road (northern approach) left turn slip lane to the northbound Pacific Motorway on-ramp, at the Old Coach Road/Bridgman Drive/On-ramp intersection		
Deficiency	Give Way line faded		
Risk	Vehicles may not perceive the need to give way at this location, with failure to give way potentially causing conflict with other vehicle movements.		
Recommendation	Repaint the Give Way line or consider using a thermoplastic material to reduce maintenance frequencies		
Priority	Low	Boral Presence	No

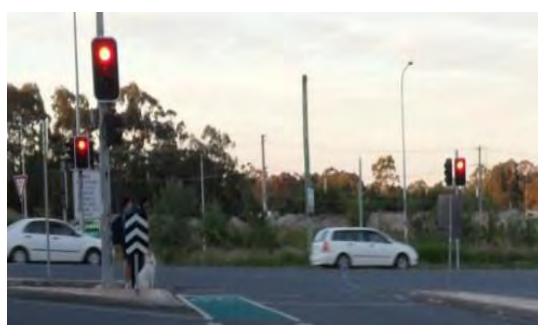
Issue 2

Location	Bridgman Drive approaching the Old Coach Road/Bridgman Drive/ On-ramp intersection		
Deficiency	Only three signal lanterns are provided for the through and right turn movements on the northbound approach		
Risk	May not provide a sufficient level of redundancy for the northbound movement		
Recommendation	Consider providing one additional lantern for the northbound approach signal group		
Priority	Low	Boral Presence	No

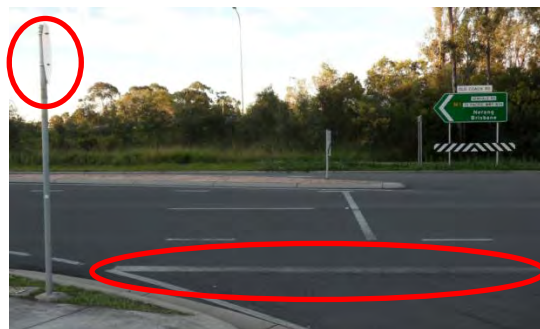
Issue 3

Location	Woodland Drive approaching the Old Coach Road/Woodland Drive intersection		
Deficiency	Stop sign rotated and Stop line faded		
Risk	Risk that vehicle may not detect the presence of the intersection or may not pay sufficient attention (as it may be considered as a Give Way controlled intersection)		
Recommendation	Re-orientate the Stop sign and repaint the Stop line (give consideration to using a thermoplastic material)		
Priority	Medium	Boral Presence	No

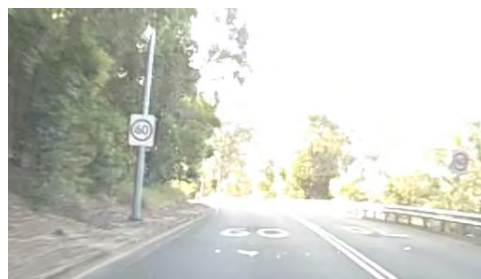
Issue 4

Location	Old Coach Road (northbound approach) to Old Coach Road/Kingsmore Boulevard/Off-ramp roundabout (approximately 150m in advance of the roundabout)		
Deficiency	Reduction in speed from 70km/h to 60km/h occurs on a curve and in close proximity to the reverse curves on the approach to roundabout		
Risk	Drivers may not have sufficient time to respond to the change in speed limit prior to negotiating the curves on approach to the roundabout		
Recommendation	Considering relocating the speed limit signage and pavement markings upstream to the straight section of Old Coach Road immediately prior to curve		
Priority	Low	Boral Presence	Yes

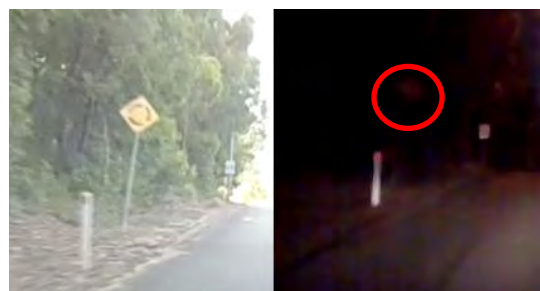
Issue 5

Location	Old Coach Road (northbound approach) to Old Coach Road/Kingsmore Boulevard/Off-ramp roundabout (approximately 150m in advance of the roundabout)		
Deficiency	Roundabout advisory sign is faded and offers a poor level of retro-reflectivity		
Risk	Drivers may not see the advisory sign at night or under adverse weather conditions and fail to anticipate the approach curves to the roundabout		
Recommendation	Replace sign		
Priority	Medium	Boral Presence	Yes

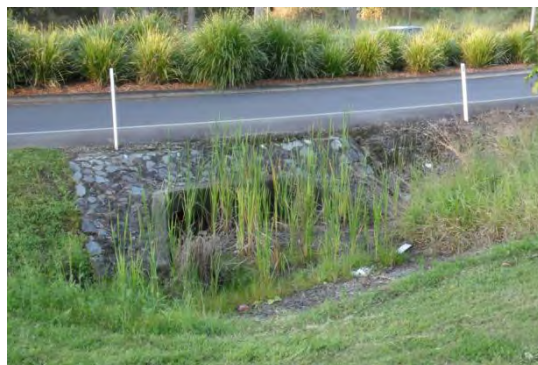
Issue 6

Location	Left hand side of Old Coach Road (northbound approach) to Old Coach Road/Kingsmore Boulevard/Off-ramp roundabout (approximately 20m prior to roundabout)		
Deficiency	Sharp drop off and unprotected culvert headwall located immediately outside the shoulder (within the clear zone)		
Risk	If an errant vehicle left the road at this location, there is a risk of loss of vehicle control		
Recommendation	Consider installing guardrail to shield the hazard		
Priority	Medium	Boral Presence	Yes

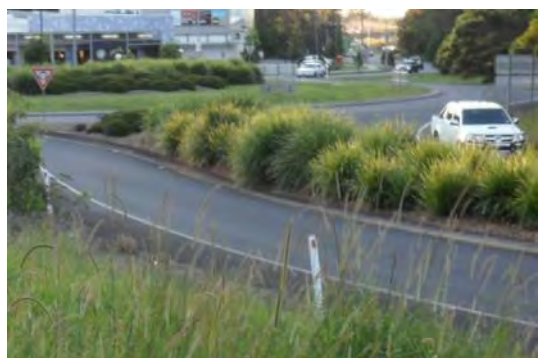
Issue 7

Location	Old Coach Road (northbound approach) to Old Coach Road/Kingsmore Boulevard/Off-ramp roundabout		
Deficiency	Median vegetation has grown to a height where it obscures the approach view of circulating traffic on the roundabout for approaching light/passenger vehicles		
Risk	Northbound vehicles may fail to observe/give way to circulating traffic on the roundabout, resulting in conflict/collision		
Recommendation	Trim the vegetation to a maximum height of 800mm above the road surface so that northbound drivers (in light vehicles) can observe circulating vehicles and their turn signals. Regularly maintain the vegetation to ensure that it does not grow high enough to obscure sight lights.		
Priority	Medium	Boral Presence	No

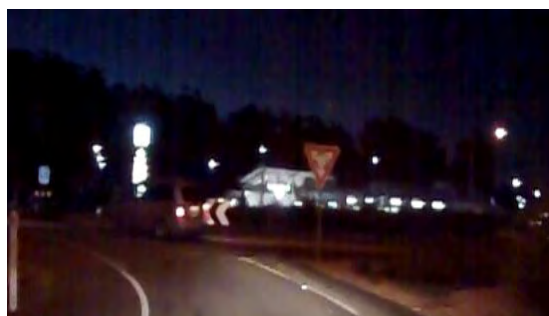
Issue 8

Location	Old Coach Road/Kingsmore Boulevard/Off-ramp roundabout		
Deficiency	Street lights in the middle of roundabout were not working		
Risk	Driver perception of the roundabout may be reduced at night time, increasing the potential for vehicles to fail to reduce approach speed or give way as required		
Recommendation	Repair street light		
Priority	Medium	Boral Presence	Yes

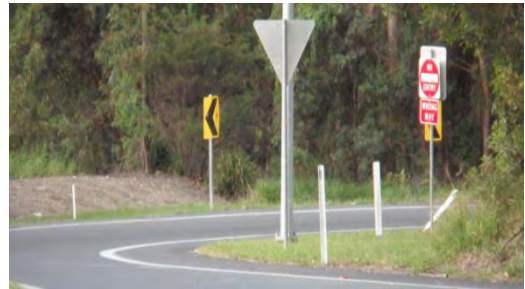
Issue 9

Location	Pacific Motorway northbound off-ramp (Exit 85)		
Deficiency	No guardrail present at the hairpin turn from the off-ramp (Exit 85)		
Risk	If an errant vehicle left the road on the hairpin, there is a risk of loss of control of vehicle or collision with the vegetation on the outside of the curve. It is likely that the existing vegetation will continue to grow and greater trunk diameters will pose an increased risk in the event of collision		
Recommendation	Consider installing guardrail along the outside of the hairpin curve		
Priority	Med	Boral Presence	Yes
