Coopers Gap Wind Farm AGL Energy Ltd 15-Feb-2017

TC01-D Route Analysis

Wind Turbine Blade Transport

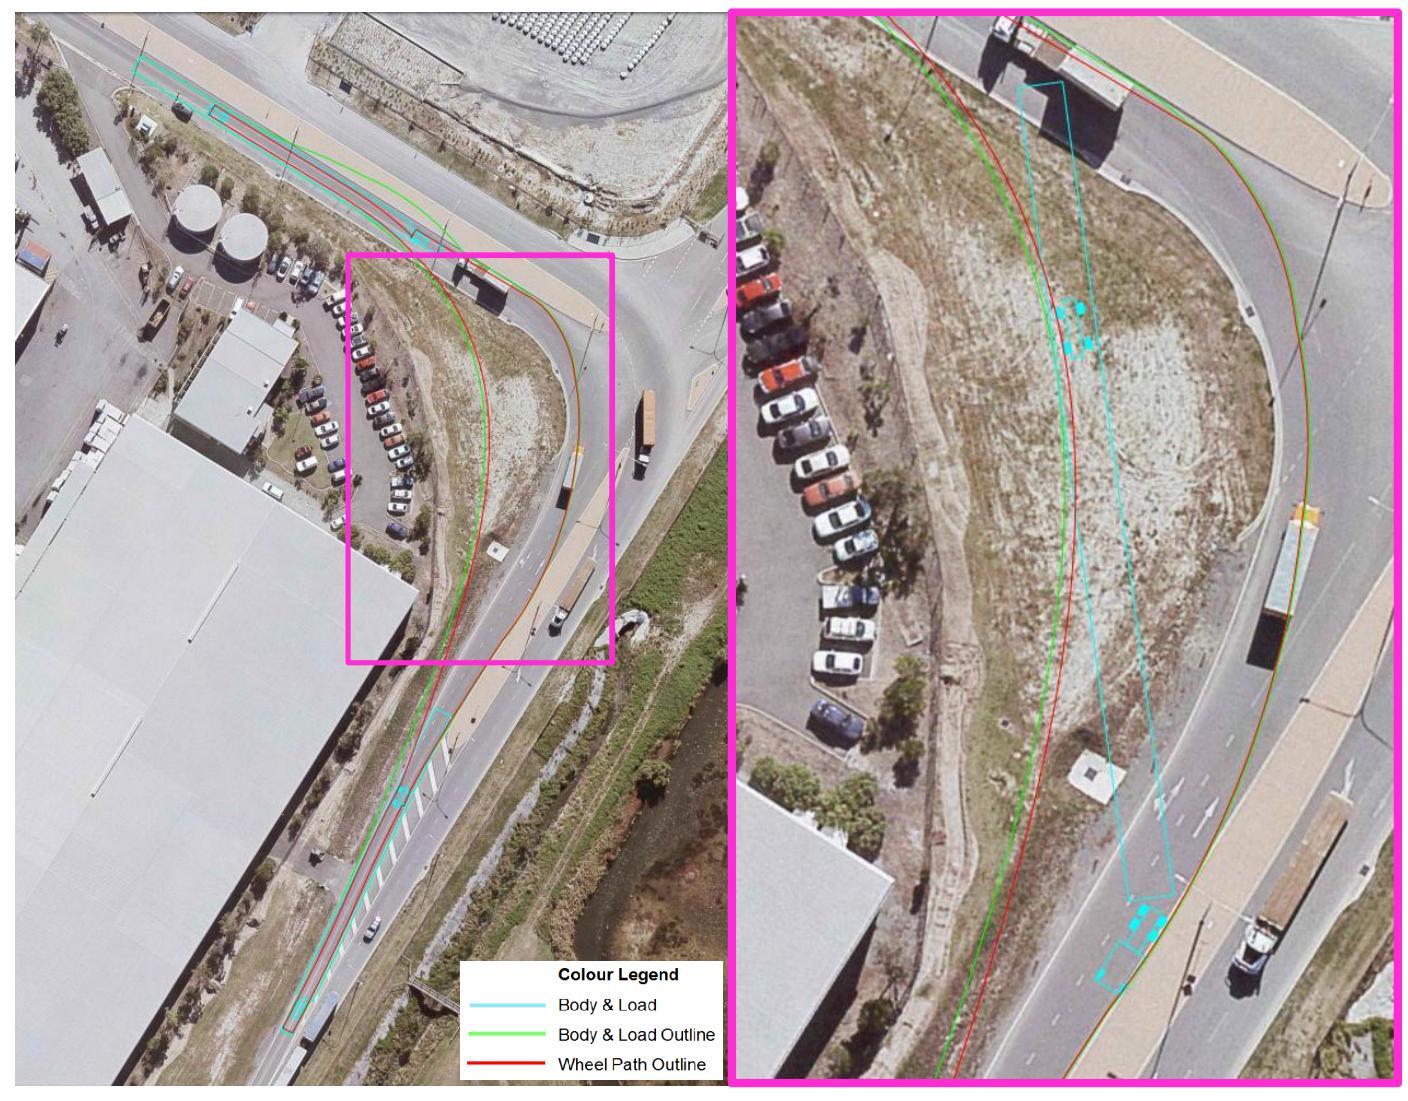
Figure 7 Swept Path for Location 1, Option 1

The conflicts for Option 1 include approximately 7 x guide posts, 1 x street sign, 1 x drainage ditch, the kerb as the truck enters the adjacent ground and the ground itself (most likely unsuitable for heavy loads over 342 trips). Mitigation steps would include the temporary removal of the signs & posts and new pavement to create suitable ground conditions. The viability for the rear wheels to use land adjacent to the intersection would also need to be confirmed with the relevant stakeholder / authority, as well who would be responsible for the new pavement.

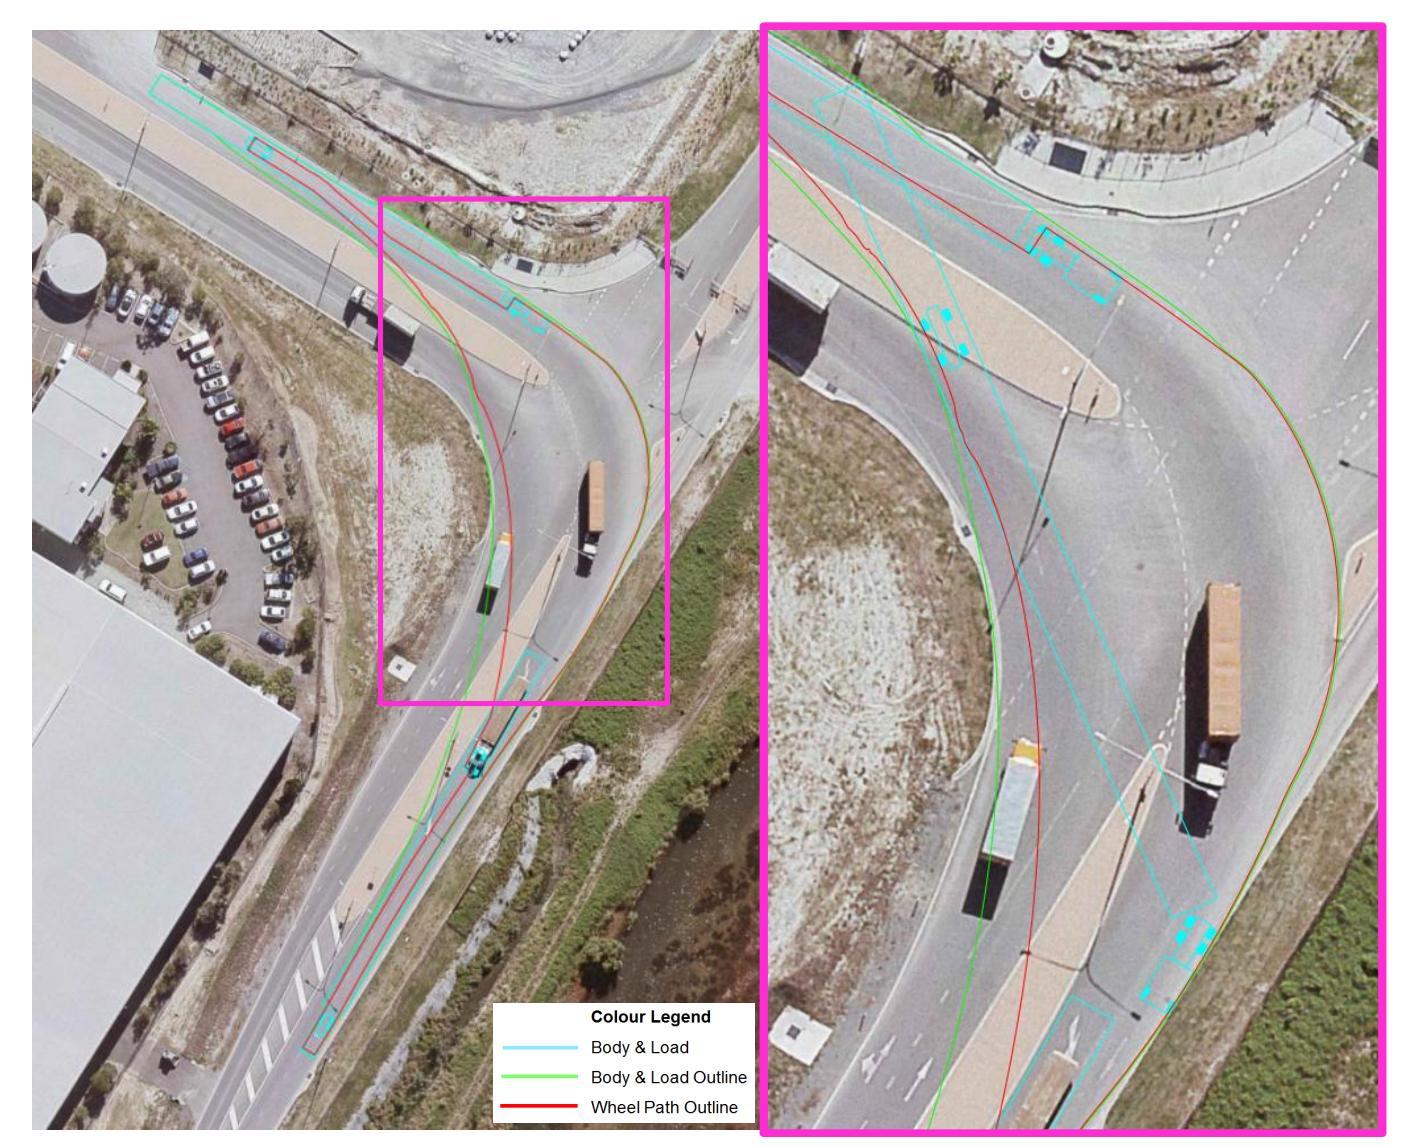
Figure 8 Swept Path for Location 1, Option 2

The conflicts for Option 2 include $4 \times$ street lighting poles and $2 \times$ road signs. Mitigation steps consist of installing temporary lighting or relocation of the existing ones, as well as temporarily relocating the signs.

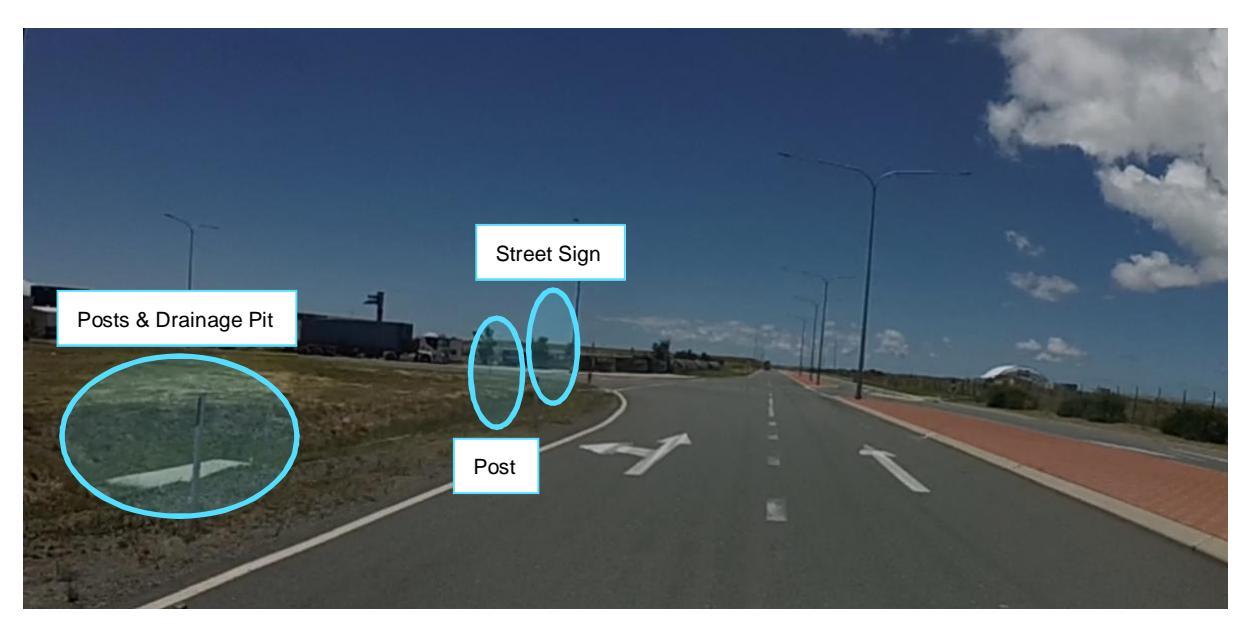
Figure 9 Path Option 1 Clashes (Driving Towards Bishop Drive)

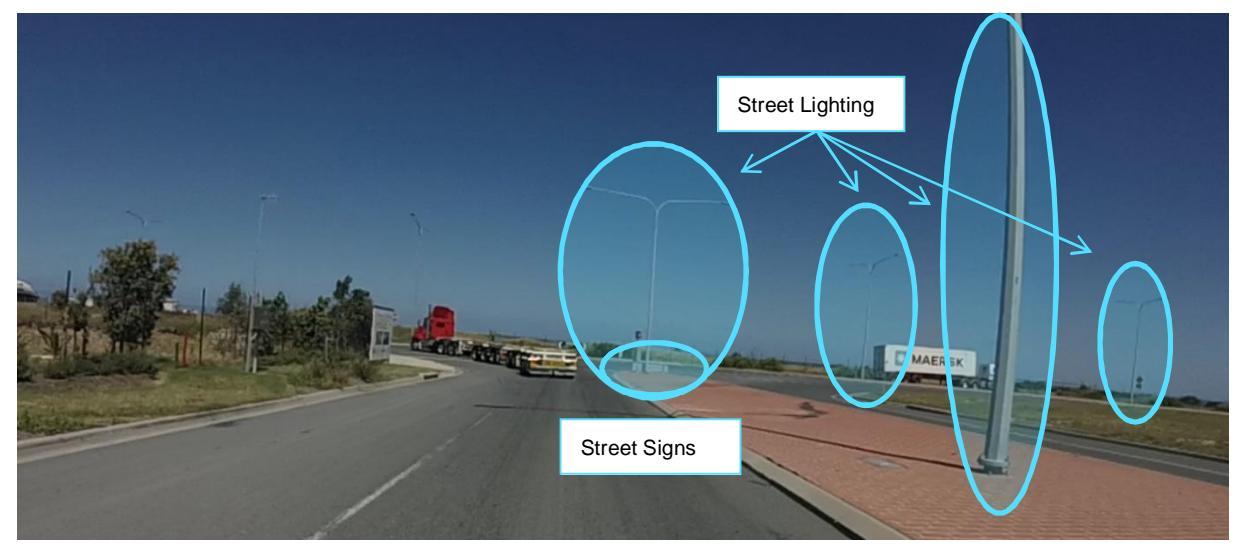
Figure 10 Path Option 2 Clashes (Driving Towards Lucinda Drive)

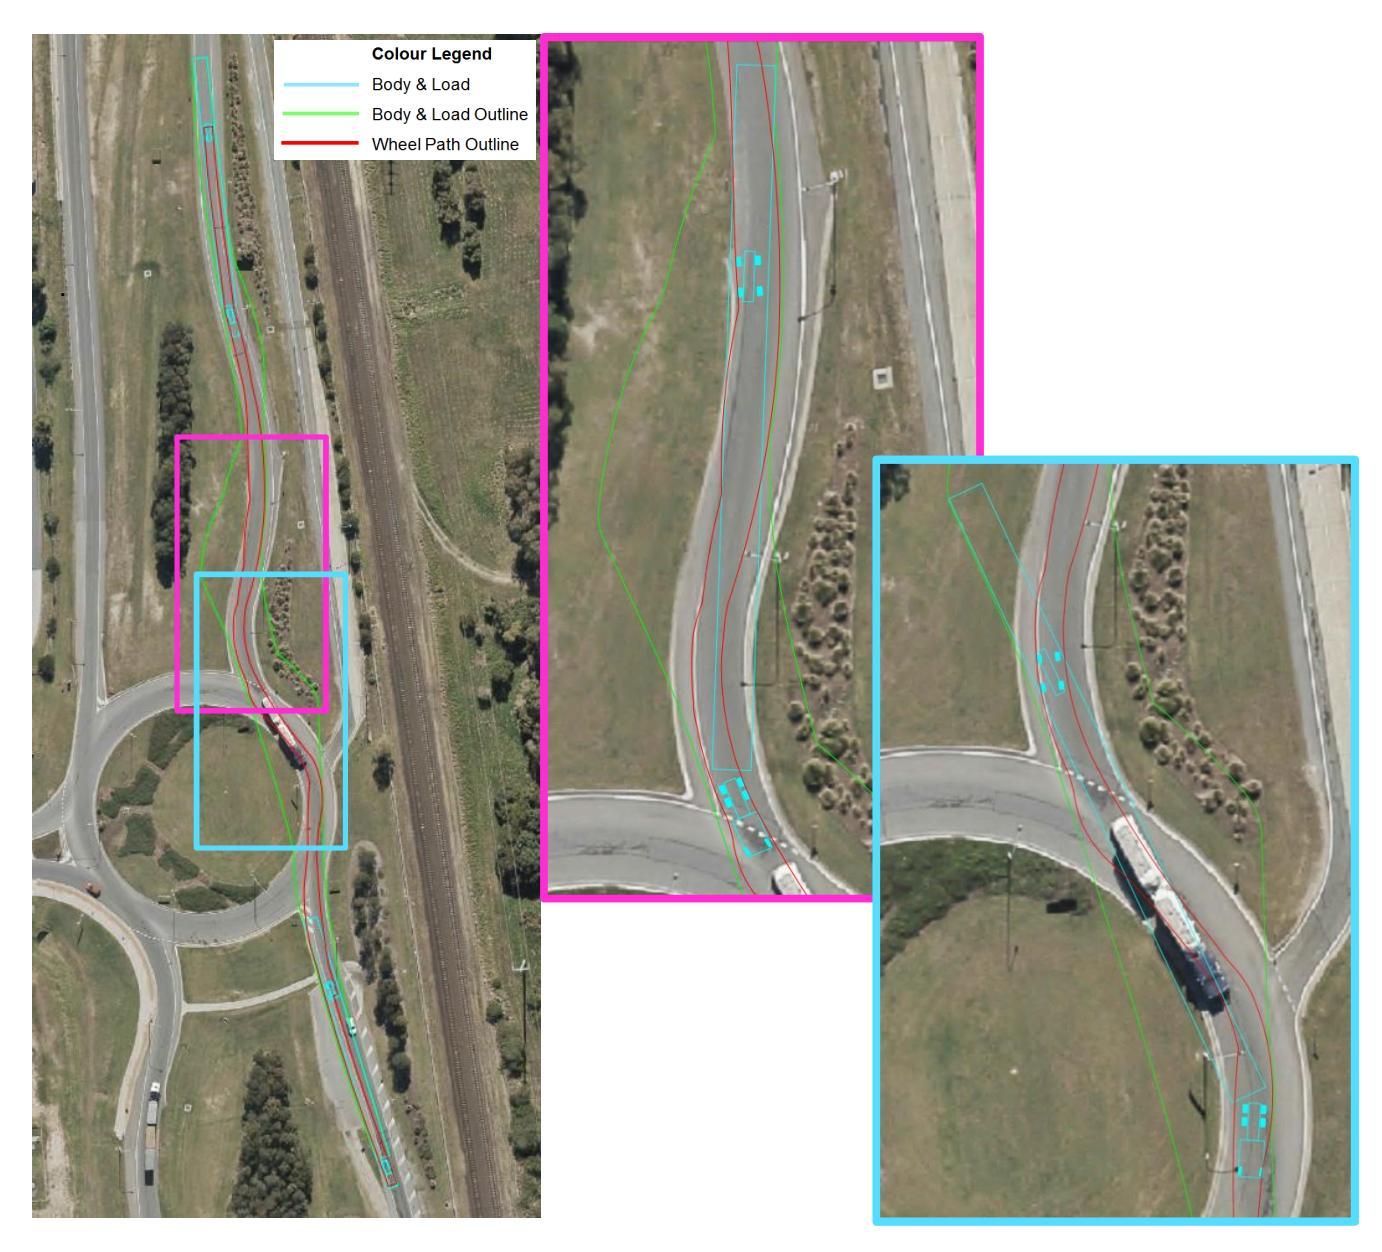
Figure 12 Swept Path for Location 3

The roundabout exiting Fisherman's Island requires the truck to perform a number of turns in quick succession. As a result, as shown in **Figure 12**, the end of the wing swings outs both sides of the road. The wheels however do not go over the kerb at any point.

Mitigation measures required based on high level assessment include temporary relocation of 1 x street light and 3 x road signs, as shown in **Figure 13** and **Figure 14**.

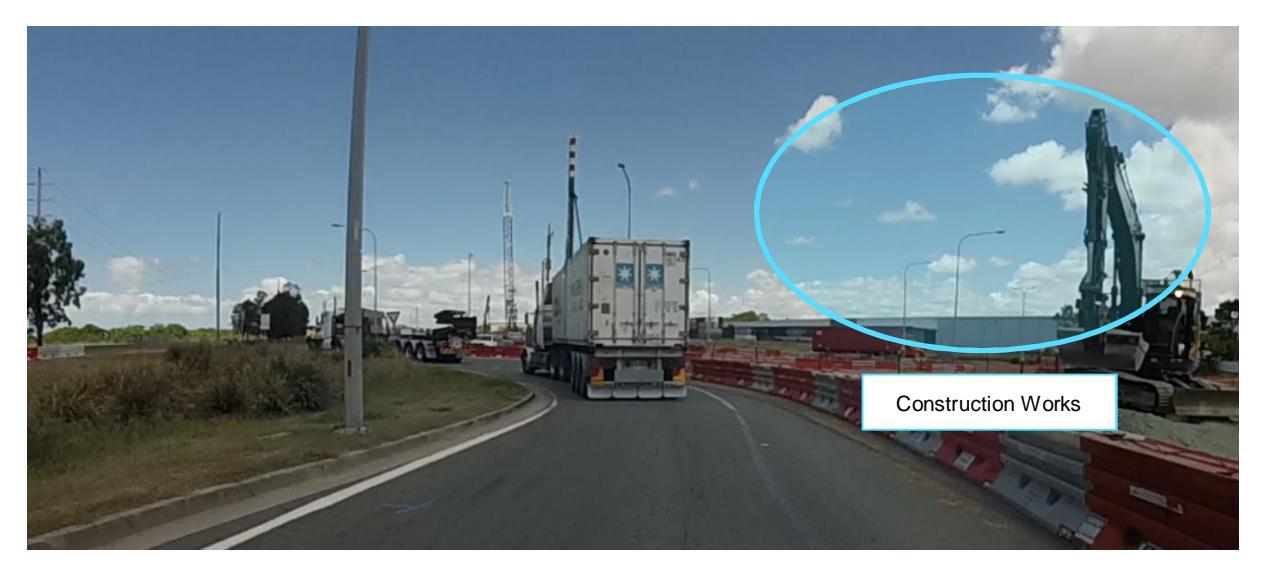
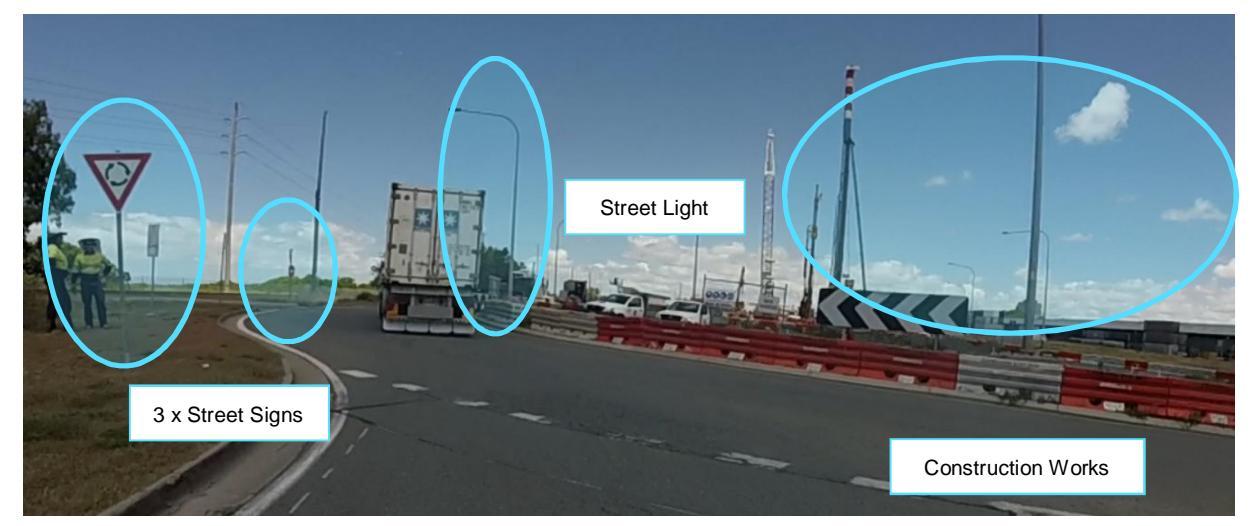
Figure 13 Video Drive Through Capture for Location 3 (Before Roundabout)

Figure 14 Video Drive Through Capture for Location 3 (At Roundabout)

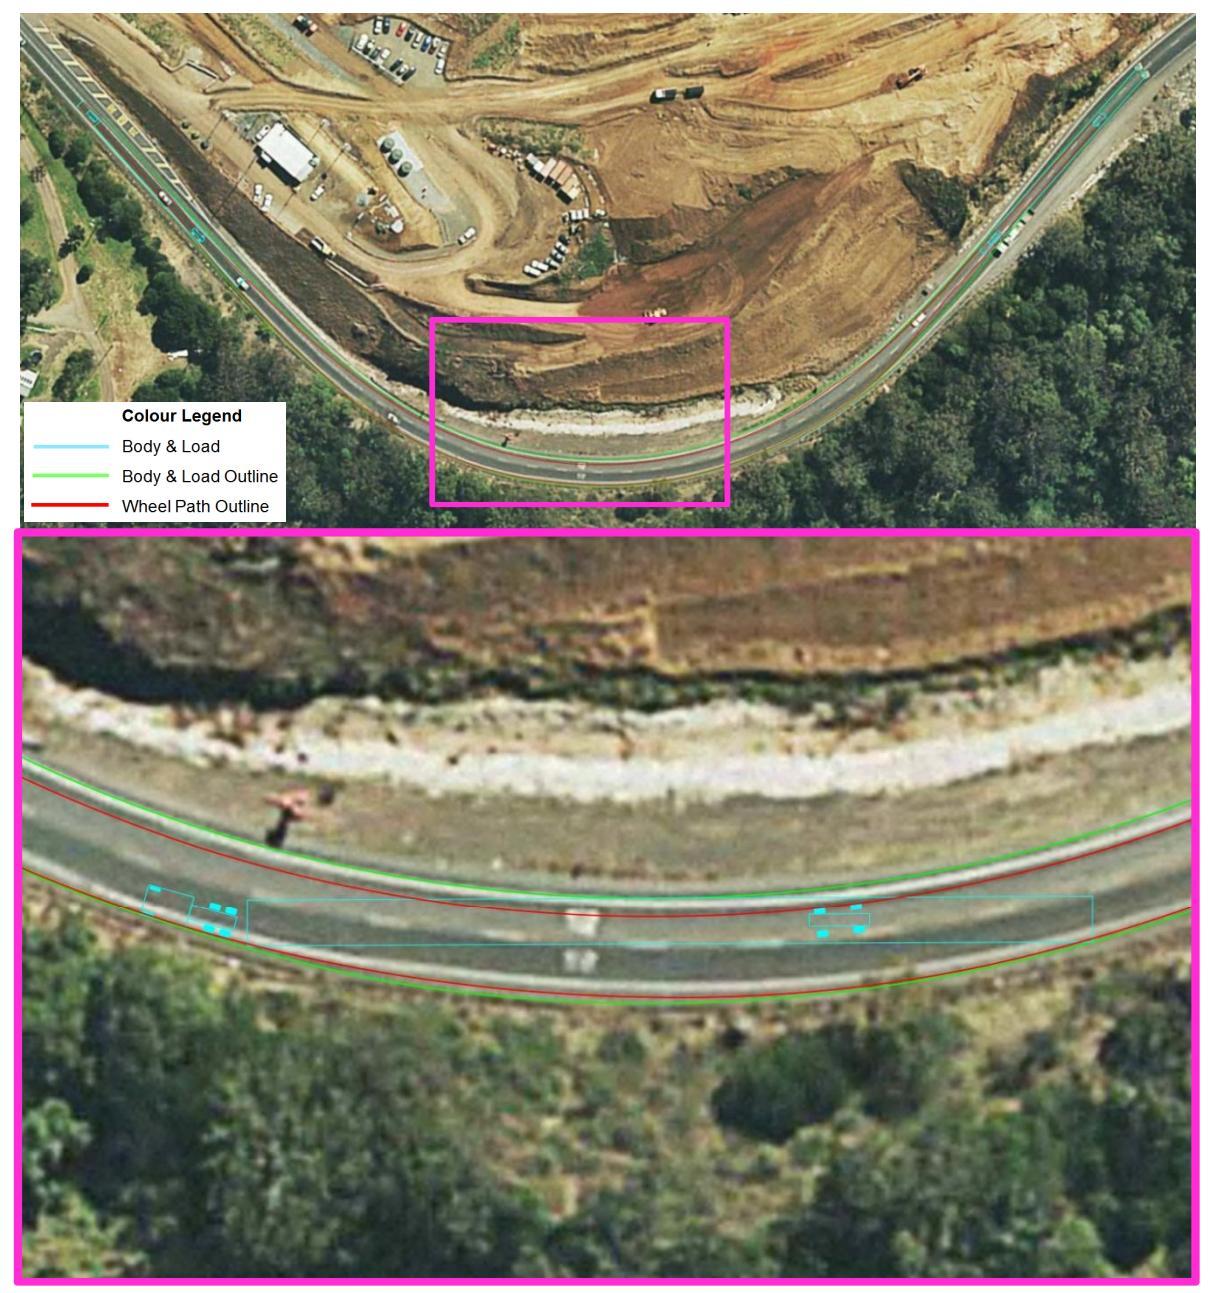
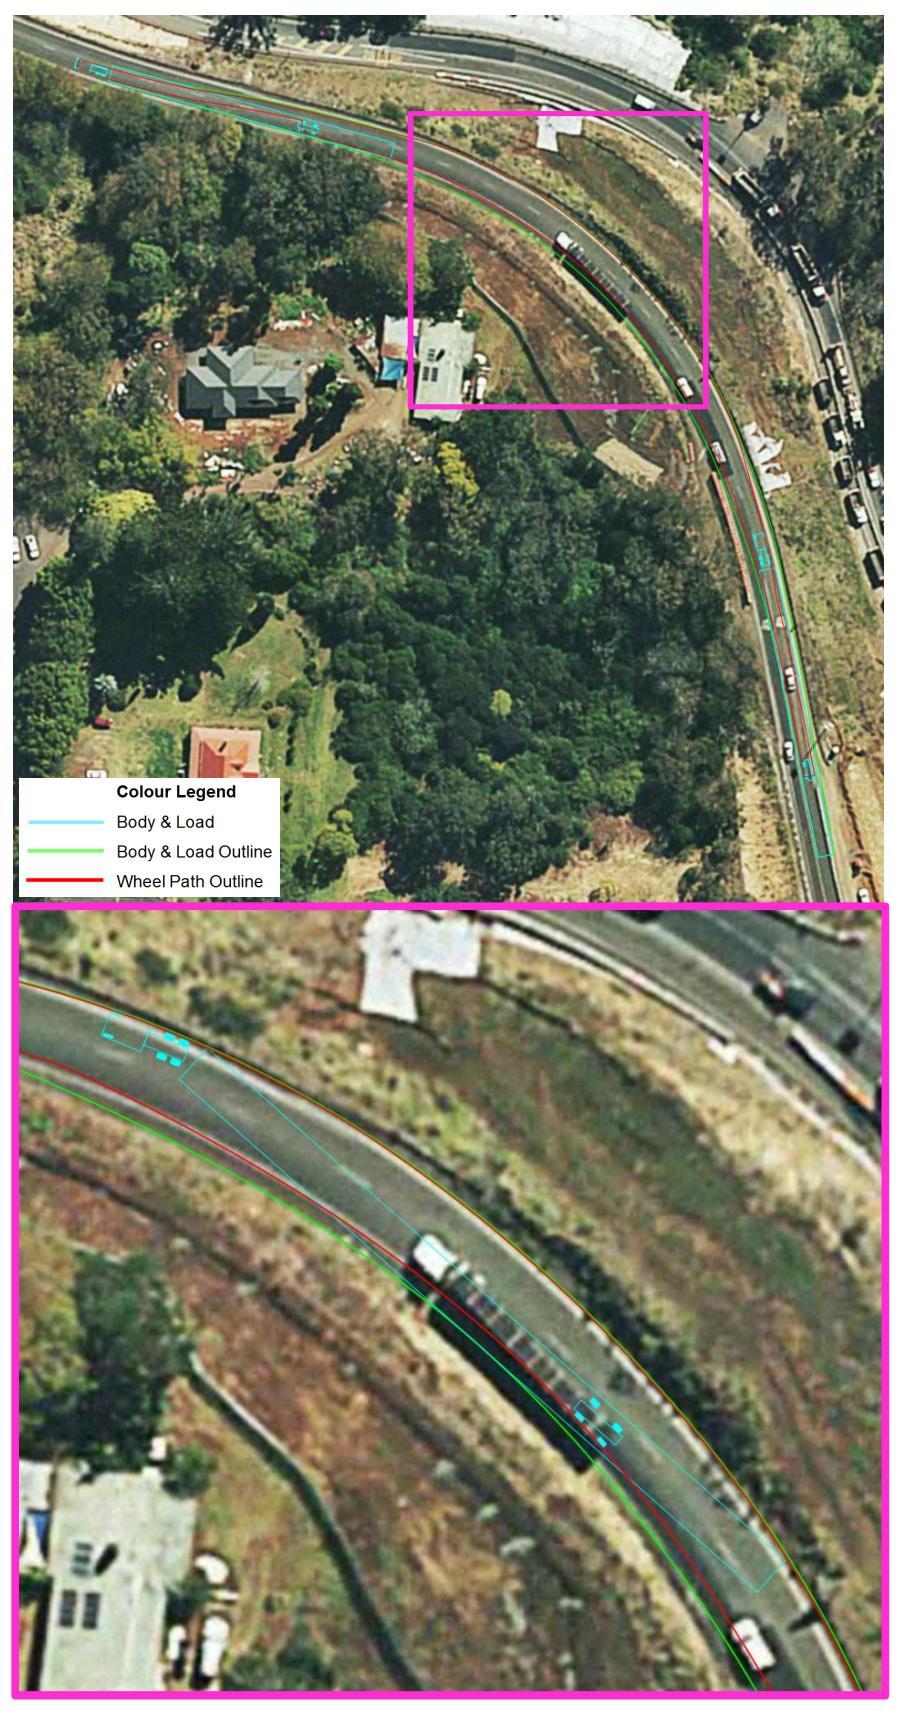
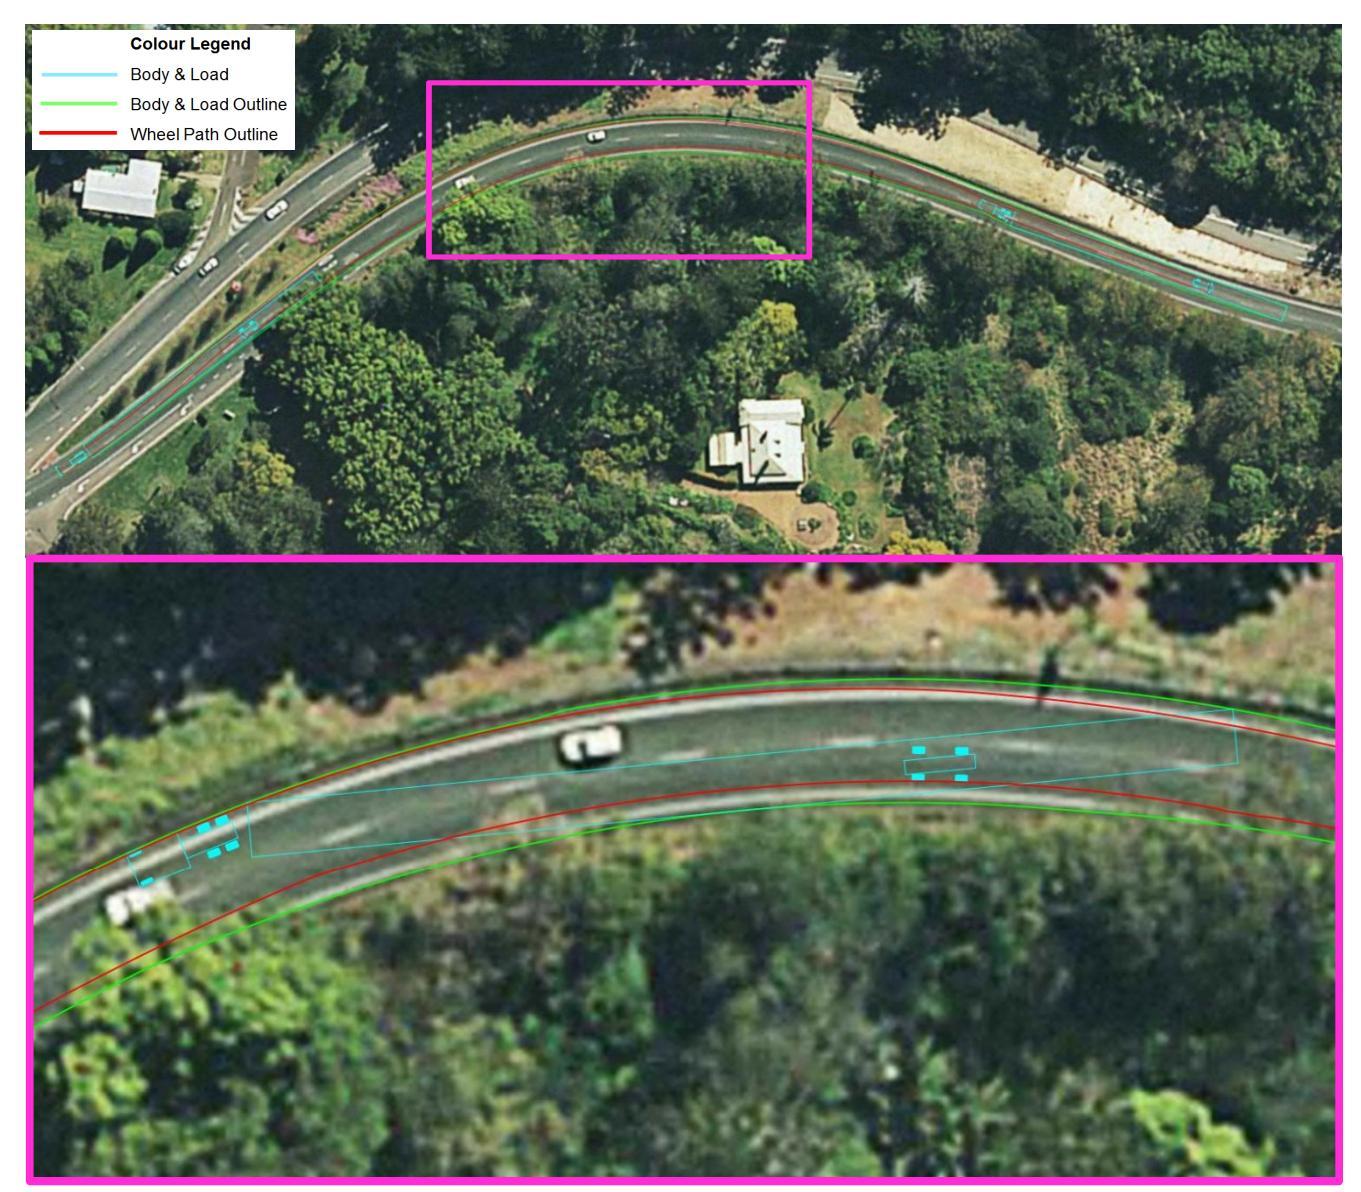
Swept paths were run on the Toowoomba Range westbound and eastbound carriageways to review possible conflicts, as shown in **Figure 19** through to **Figure 21**. From review of the aerial photography and swept paths it appears as through the vehicle can manoeuvre through both carriageways. The location of safety barriers cannot be accurately determined using the aerial photography and therefore needs to be assessed in detail once the design vehicle has been determined.

It is to be noted that through this section of the Toowoomba Range, the grade is at its steepest (10%+ grade). This may not only increase the difficulty of these manoeuvres, but since a design vehicle has not been determined, the maximum grade that the truck is capable of achieving these maneuverers cannot be determined.

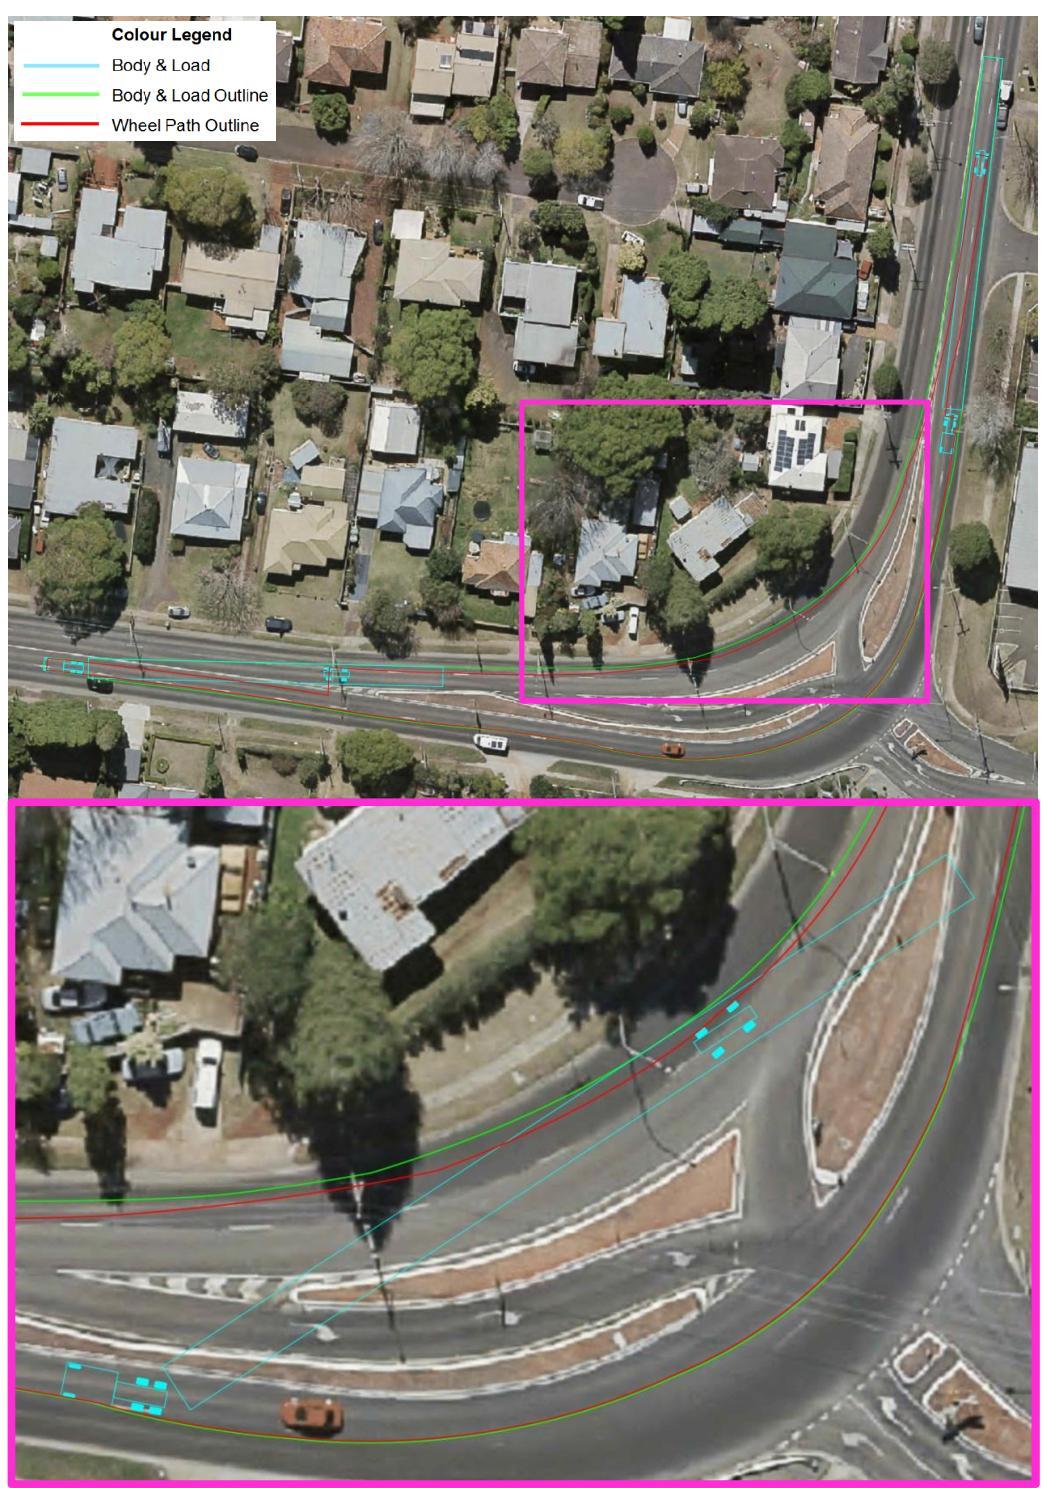
Figure 25 Swept Path for Location 10

The optimal path for the truck for the Warrego Highway / James Street corner is for the truck itself to be on the westbound carriageway and for the rear bogie to be on the eastbound carriageway, as shown in **Figure 25**. This path does not conflict with the street lighting as other paths do; however it does require the signage (6 x corner hazard signs, 1 x 'Give Way' sign, 1 x directional sign) on the median to be temporarily removed / relocated, as shown in **Figure 26** and **Figure 27**.

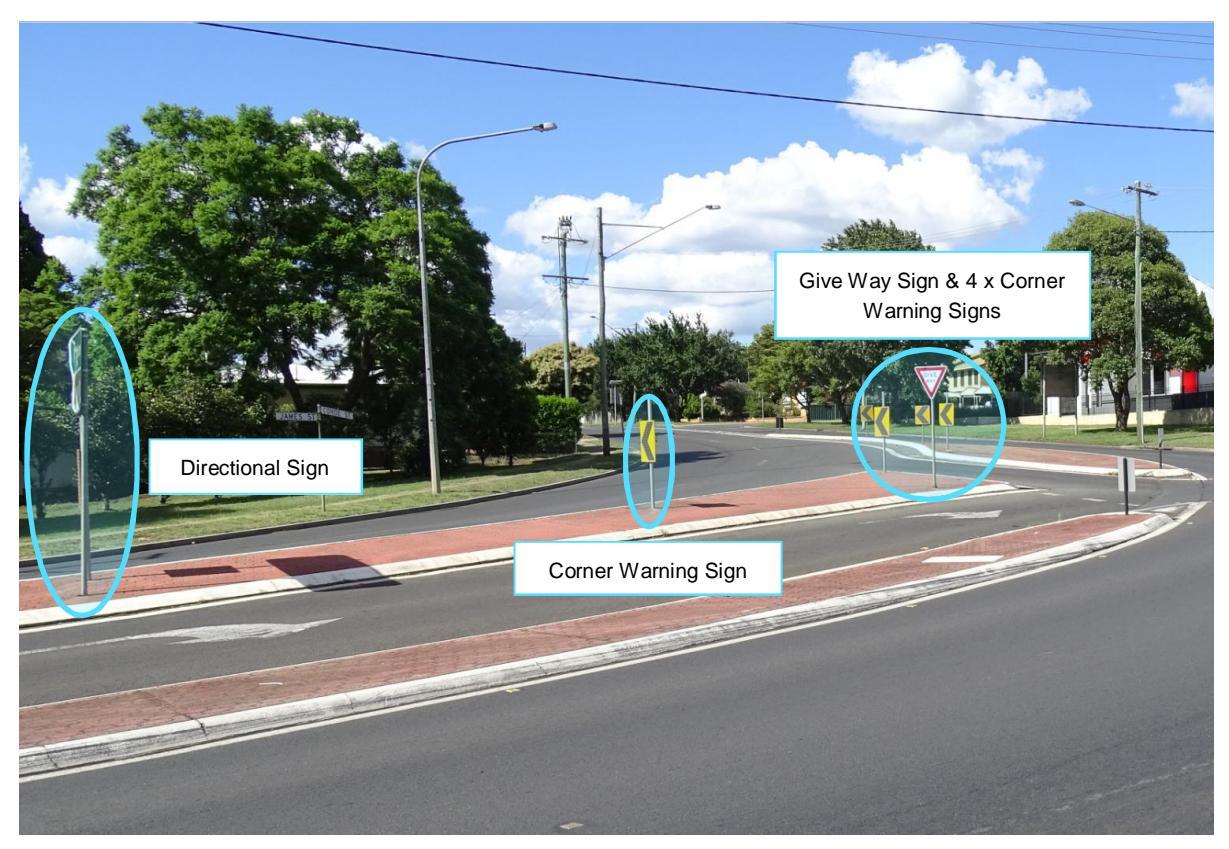
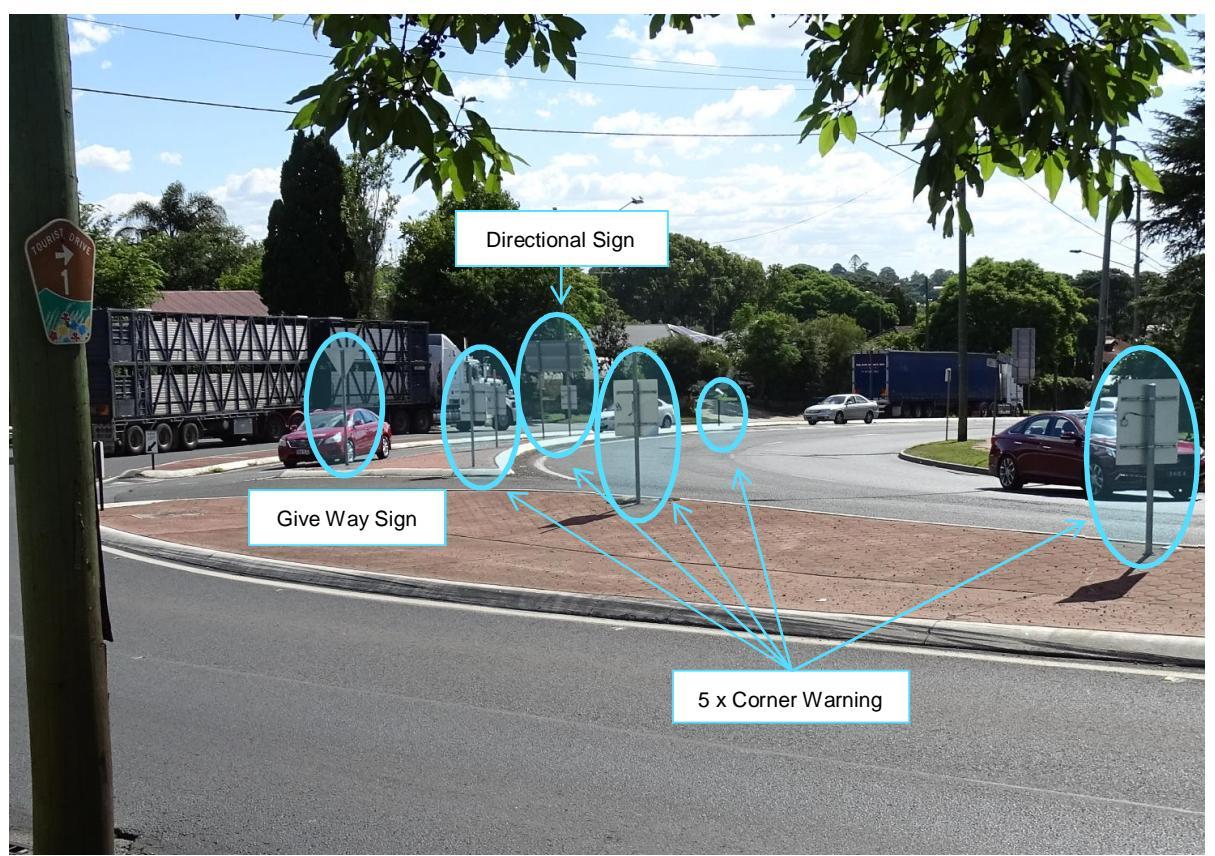
Figure 26 Site Visit Photograph for Location 10 (Looking towards the Range)

Figure 27 Site Visit Photograph for Location 10 (Looking towards Toowoomba)

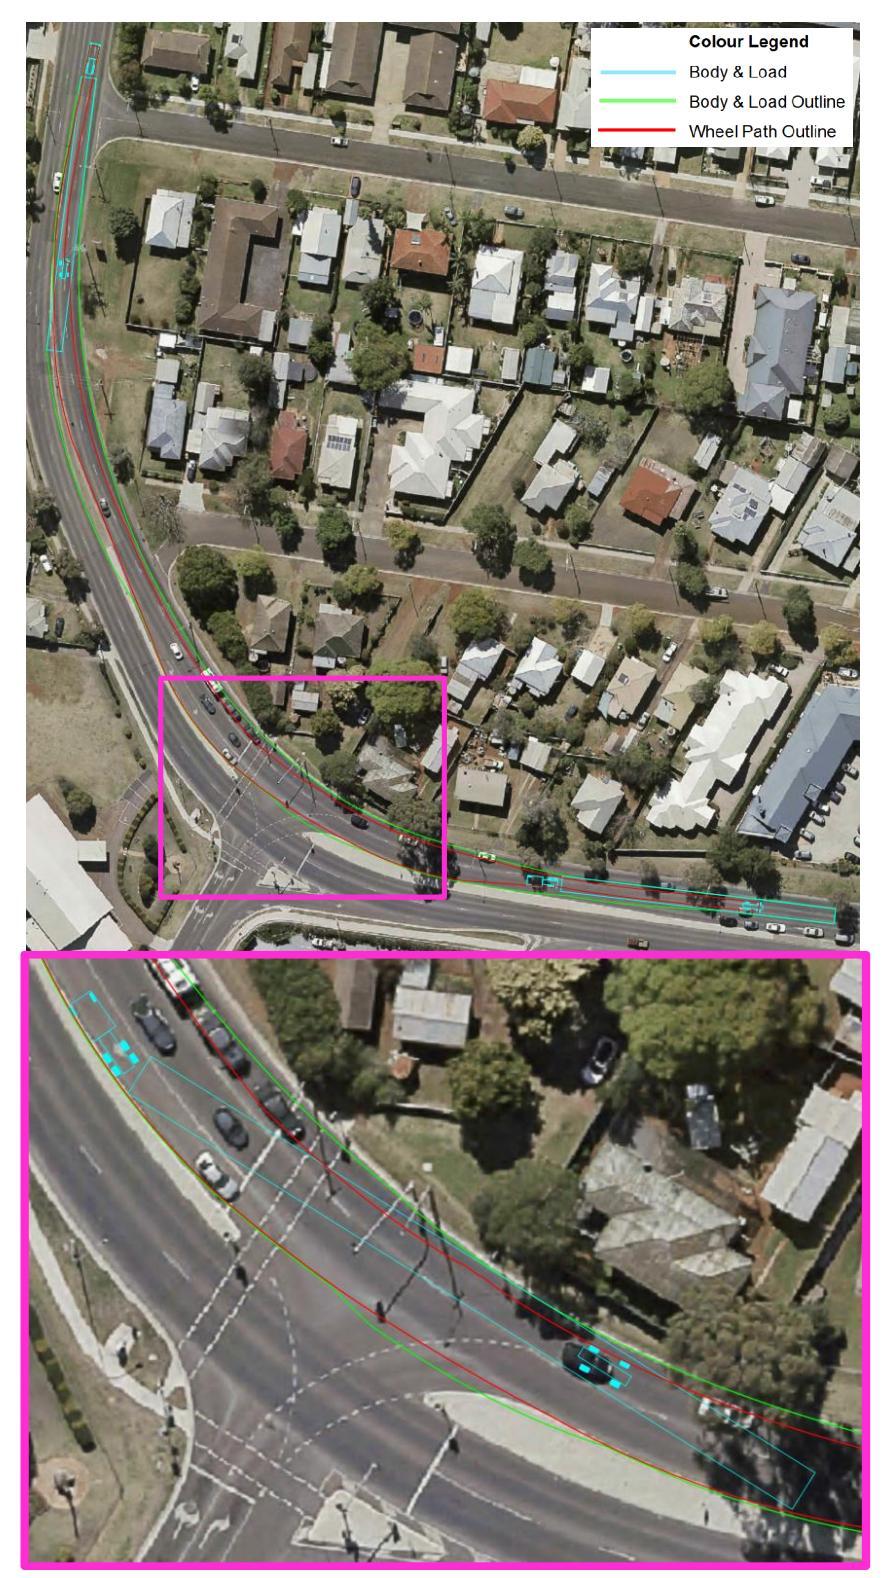
Figure 28 Swept Path for Location 11

Truck and load clears with only one conflict, as shown in **Figure 28**. This conflict with a sign towards occurs towards the end of the turn path, as shown in **Figure 29**.

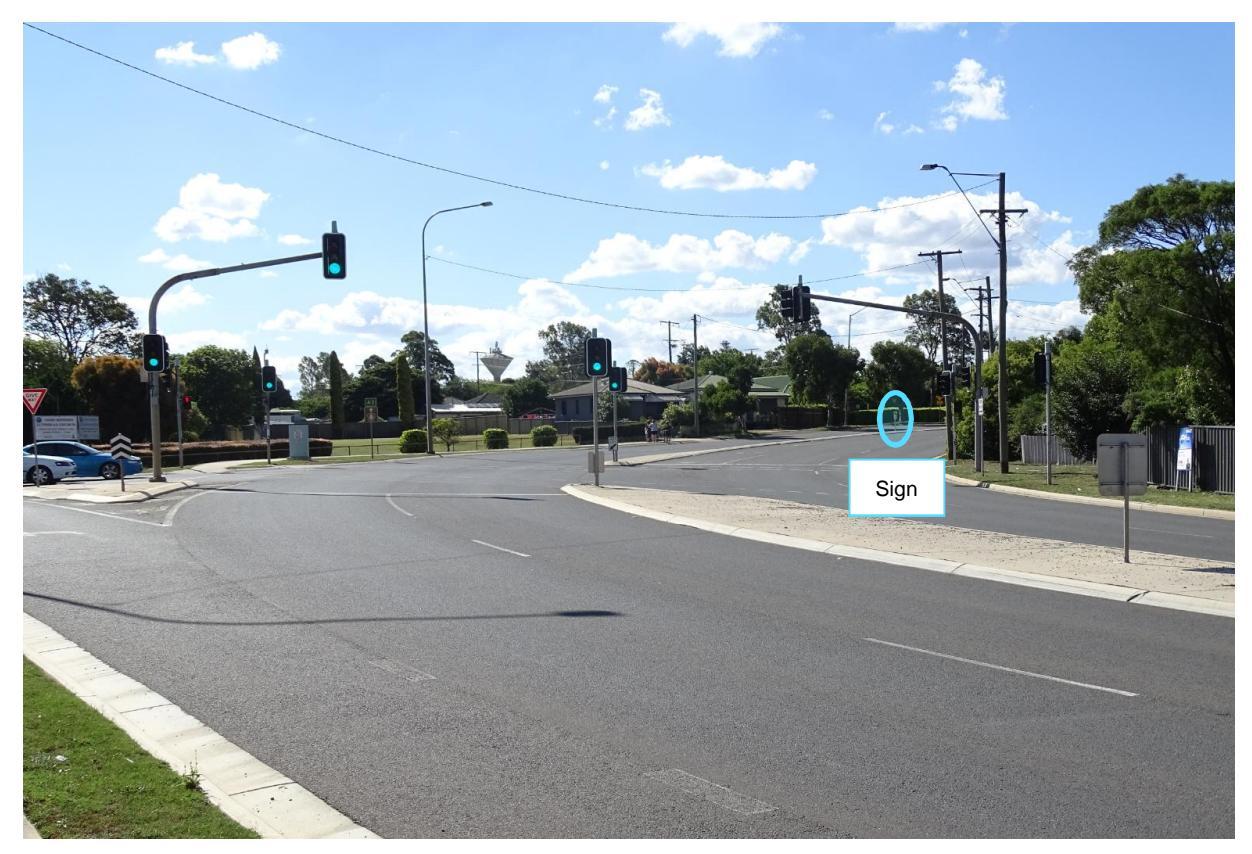
Figure 29 Site Visit Photograph for Location 11 (Looking towards Dalby)

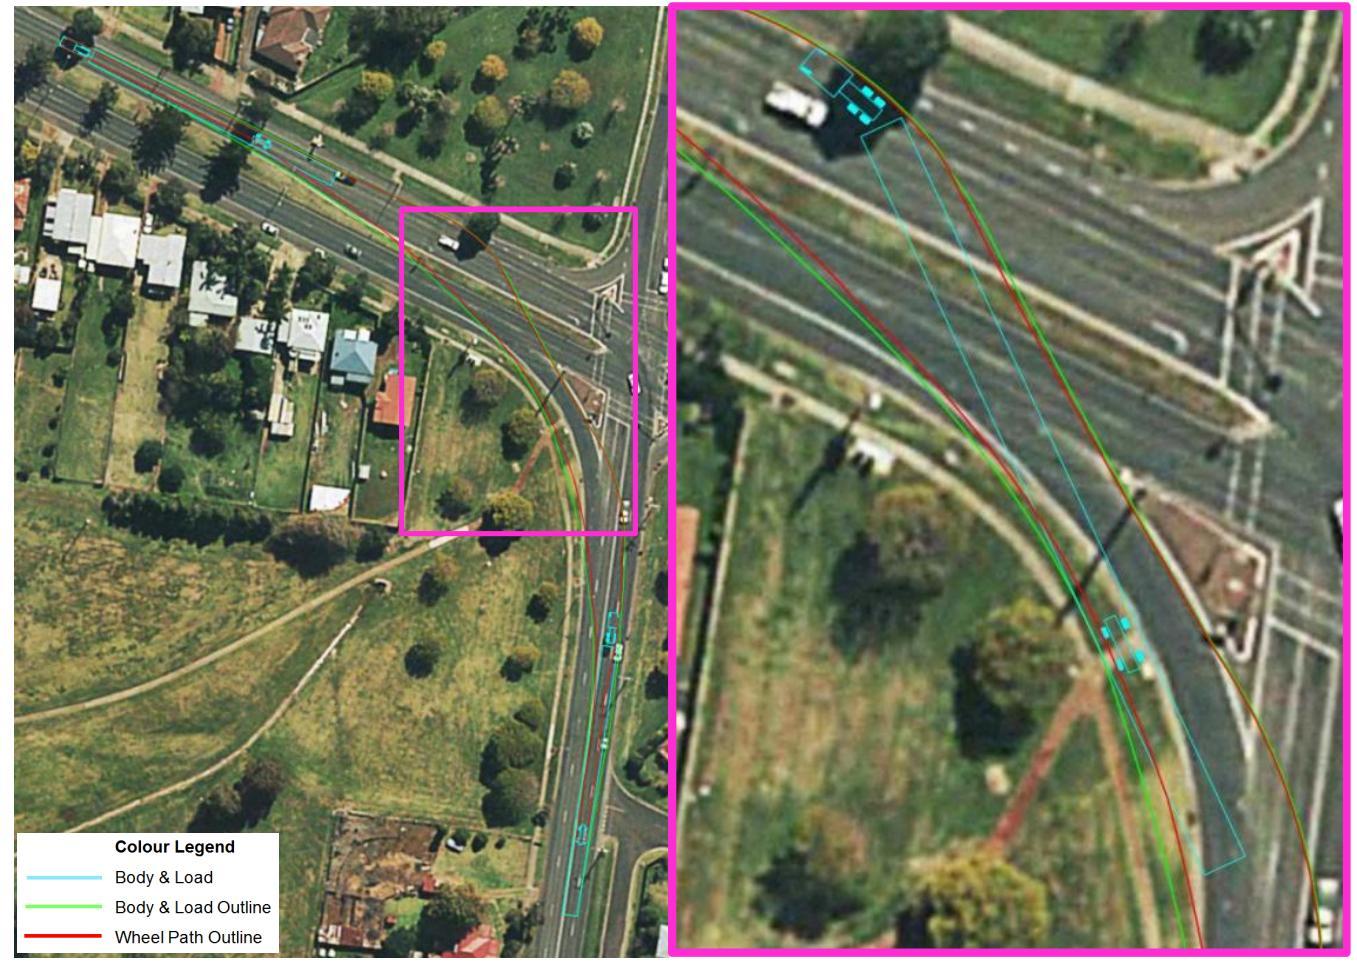
Figure 31 Swept Path for Location 12, Option 1

Option 1 shows the vehicle using the land adjacent to the left turn slip lane, and crossing the centre median. Mitigation works for this path would include the temporary relocation of 2 x street signs, protecting an existing drain, pavement widening where traversing over ground and creating a mountable kerb around the left slip lane, as shown in purple **Figure 33**. **Figure 34** shows the kerb for the centre median is already semi-mountable, however given the number of trips required, further mitigation works to strengthen this kerb or repair it will need to assessed in further detail.

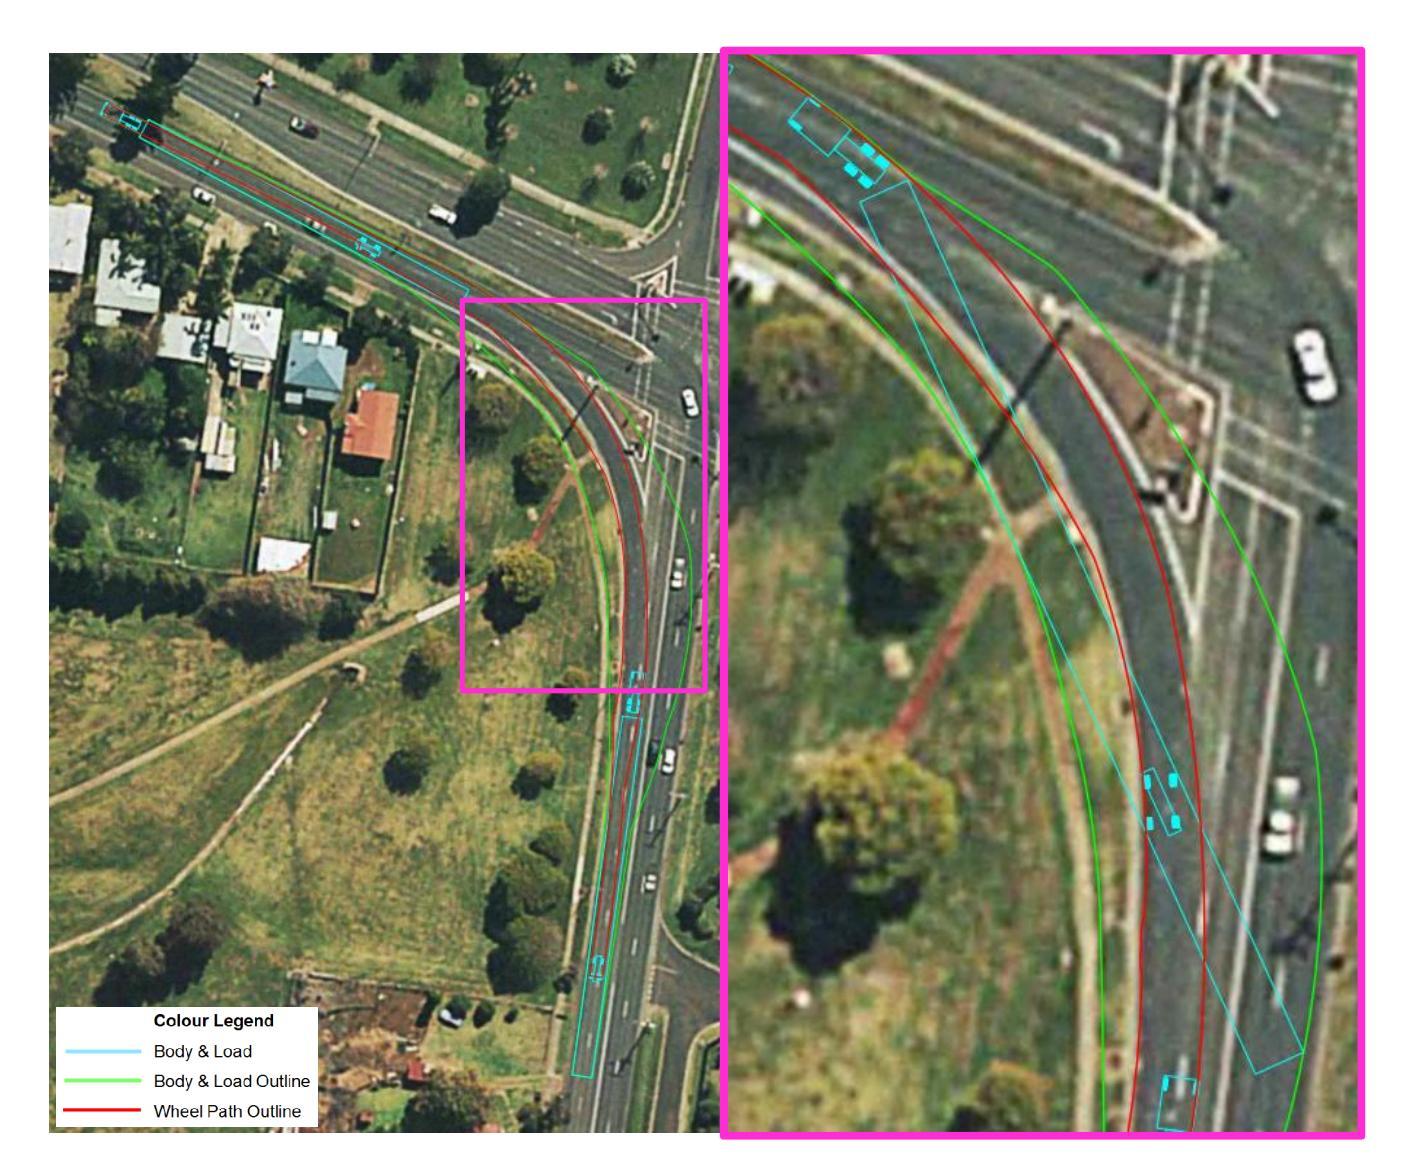
Figure 32 Swept Path for Location 12, Option 2

Option 2 also takes the left slip lane, however does not cross the centre median or encroach onto the footpath. As a result the load swings further into the intersection, conflicting with 1 x power pole and 2 x traffic signal poles, shown in blue in **Figure 34**.
