Coopers Gap Wind Farm AGL Energy Ltd 15-Feb-2017

TC01-D Route Analysis

Wind Turbine Blade Transport

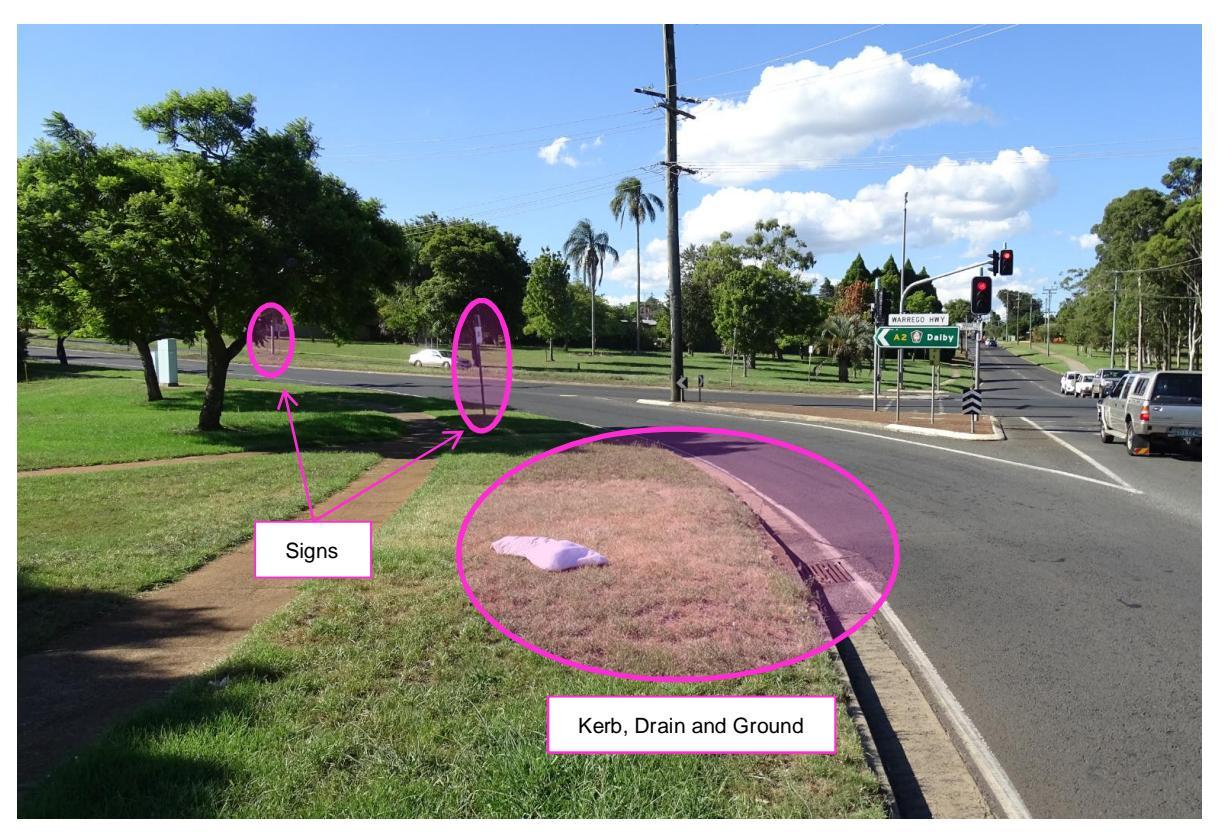
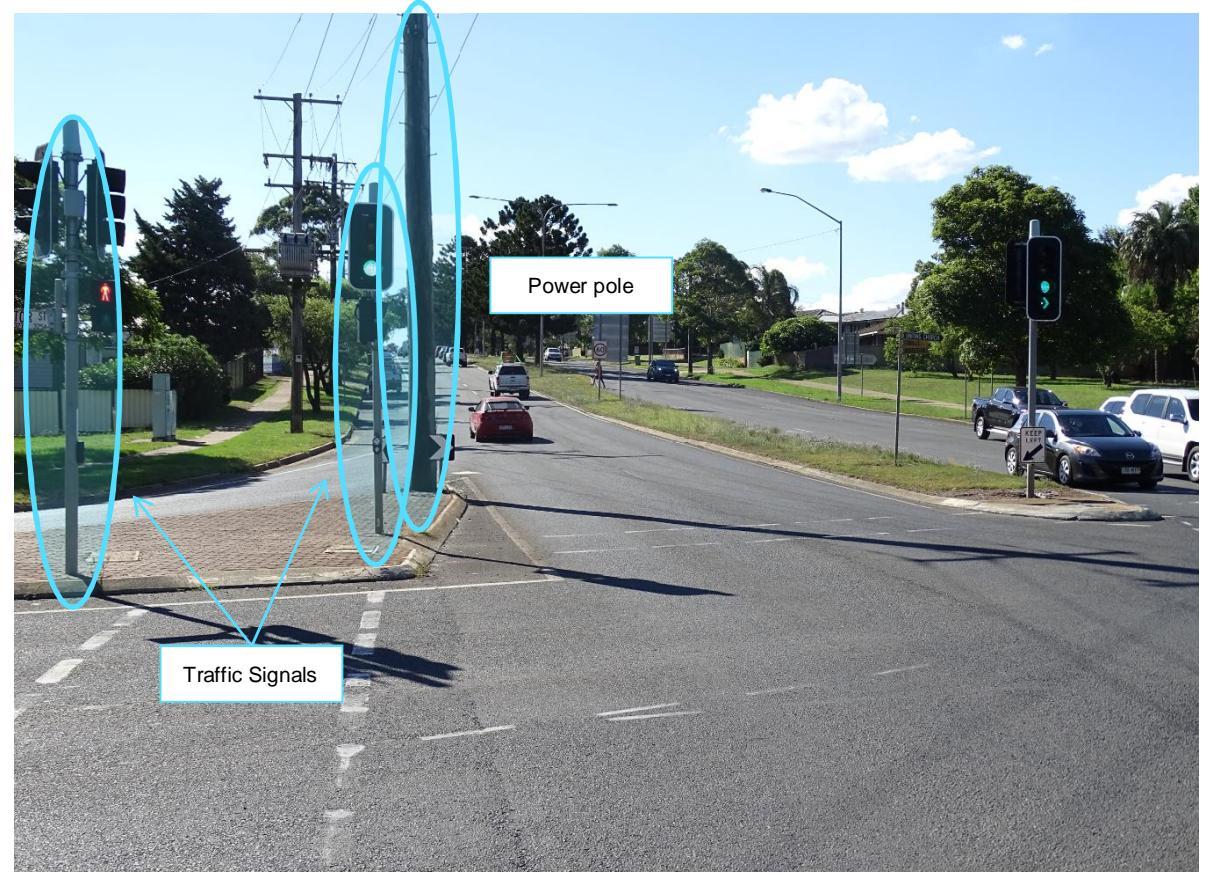
Option 2 also takes the left slip lane, however does not cross the centre median or encroach onto the footpath. As a result the load swings further into the intersection, conflicting with 1 x power pole and 2 x traffic signal poles, shown in blue in **Figure 34**.

Figure 33 Site Visit Photograph for Location 12 (Looking towards Bridge Street)

Figure 34 Site Visit Photograph for Location 12 (Looking towards Dalby)

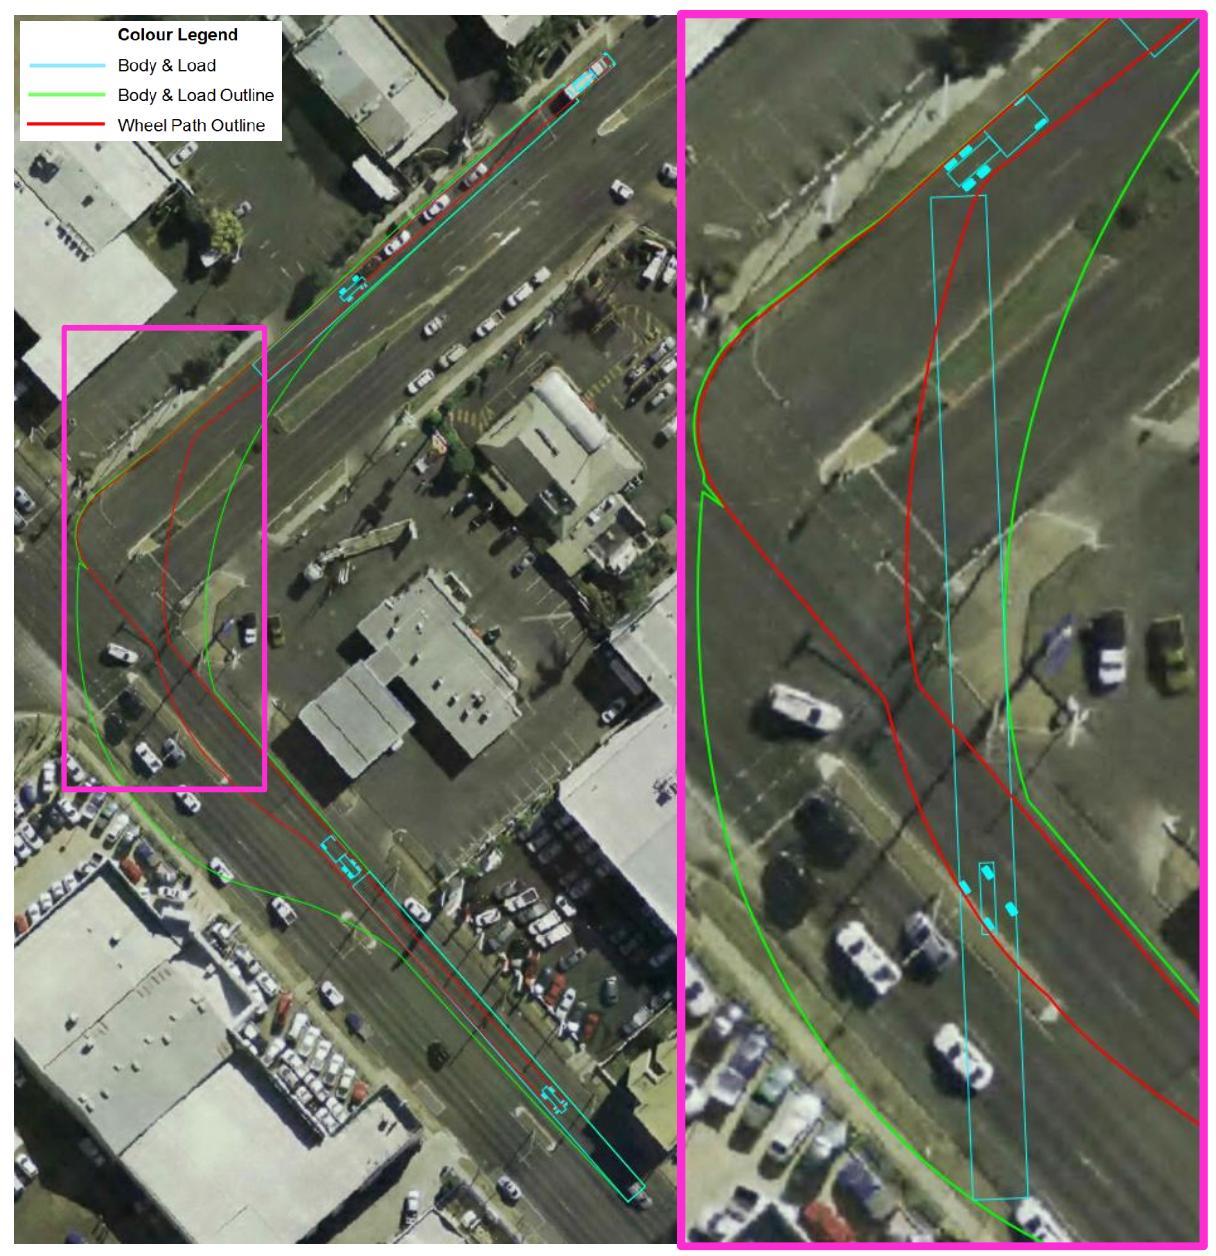
Figure 36 Swept Path for Location 14, Option 1

Option 1 conflicts with 1 x street light, 1 x road sign, 2 x power poles, 4 x traffic signals and vegetation within the median along the Bunya Highway exit. Multiple kerbs are crossed; and while all appear to be mountable / traversable, the viability to withstand numerous heaving loads will need to be assessed in further detail. These conflicts are shown in purple in **Figure 38** through to **Figure 40**.

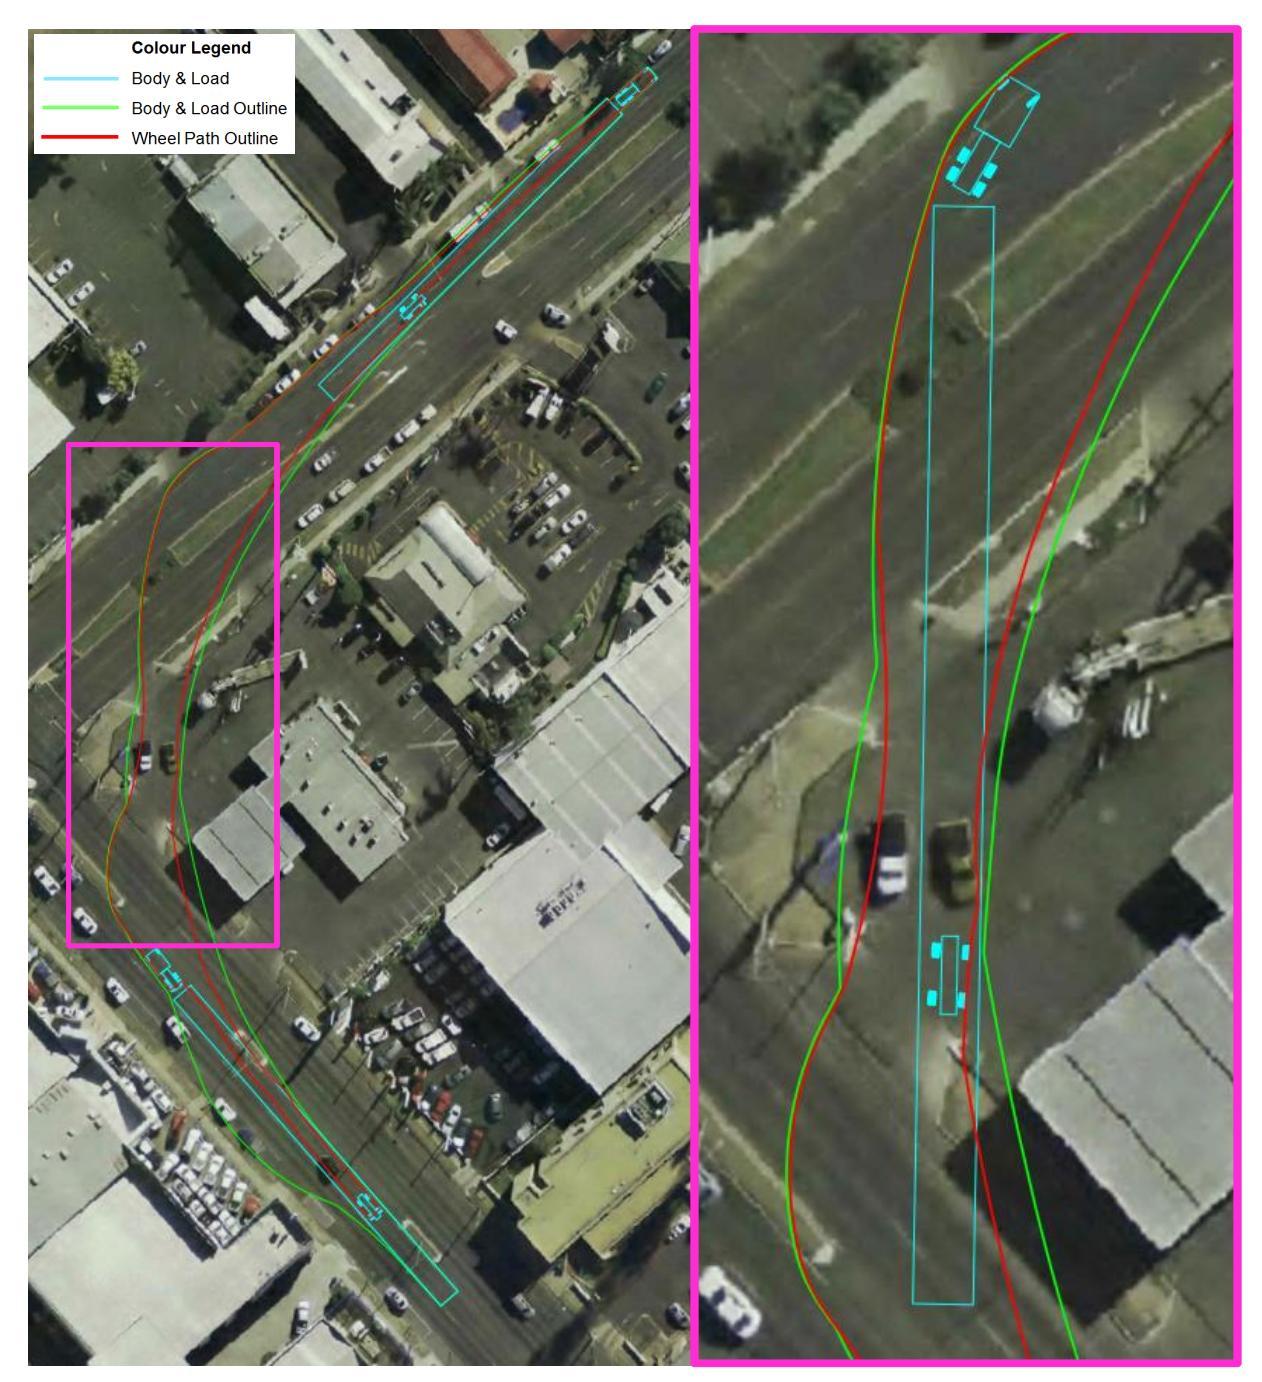
Figure 37 Swept Path for Location 14, Option 2

Option 2 conflicts with less infrastructure overall, consisting of 1 x street light, vegetation within the median and kerb on the path entry. However the path goes through a United petrol station (private property), conflicting with the petrol price sign. These conflicts are shown in blue in **Figure 38** and **Figure 39**.

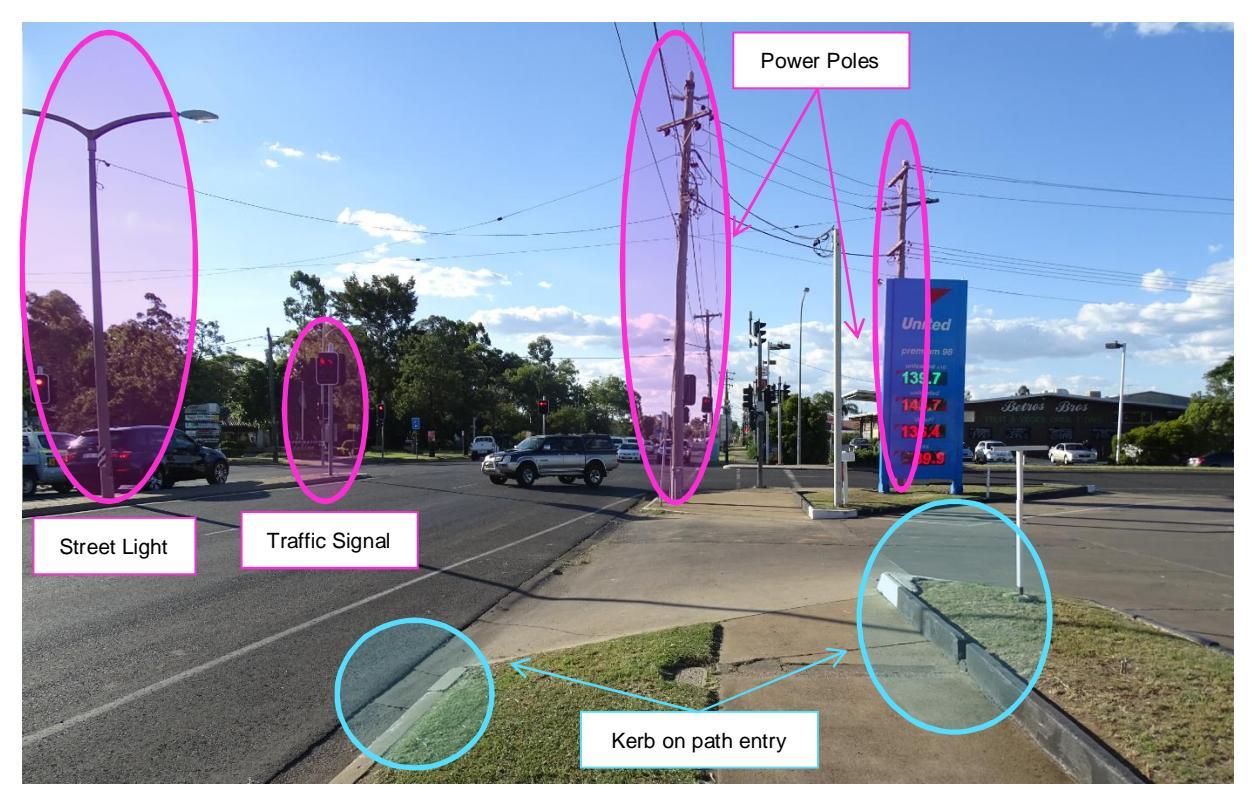
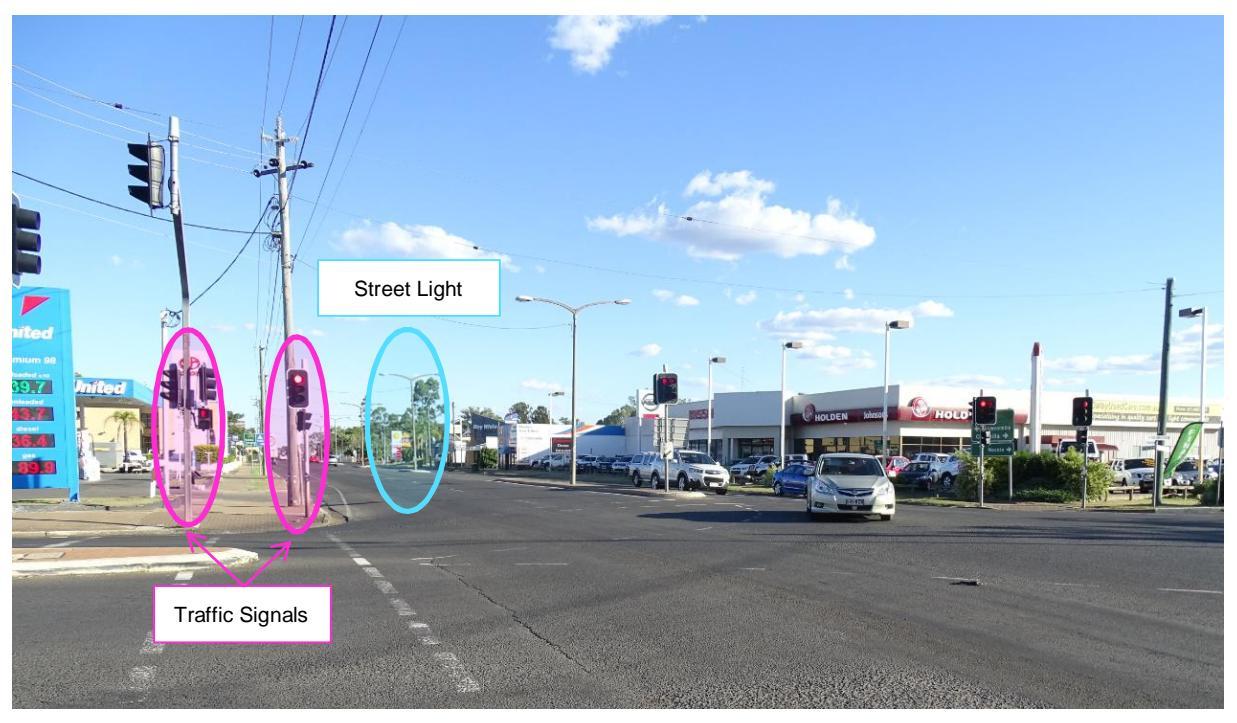
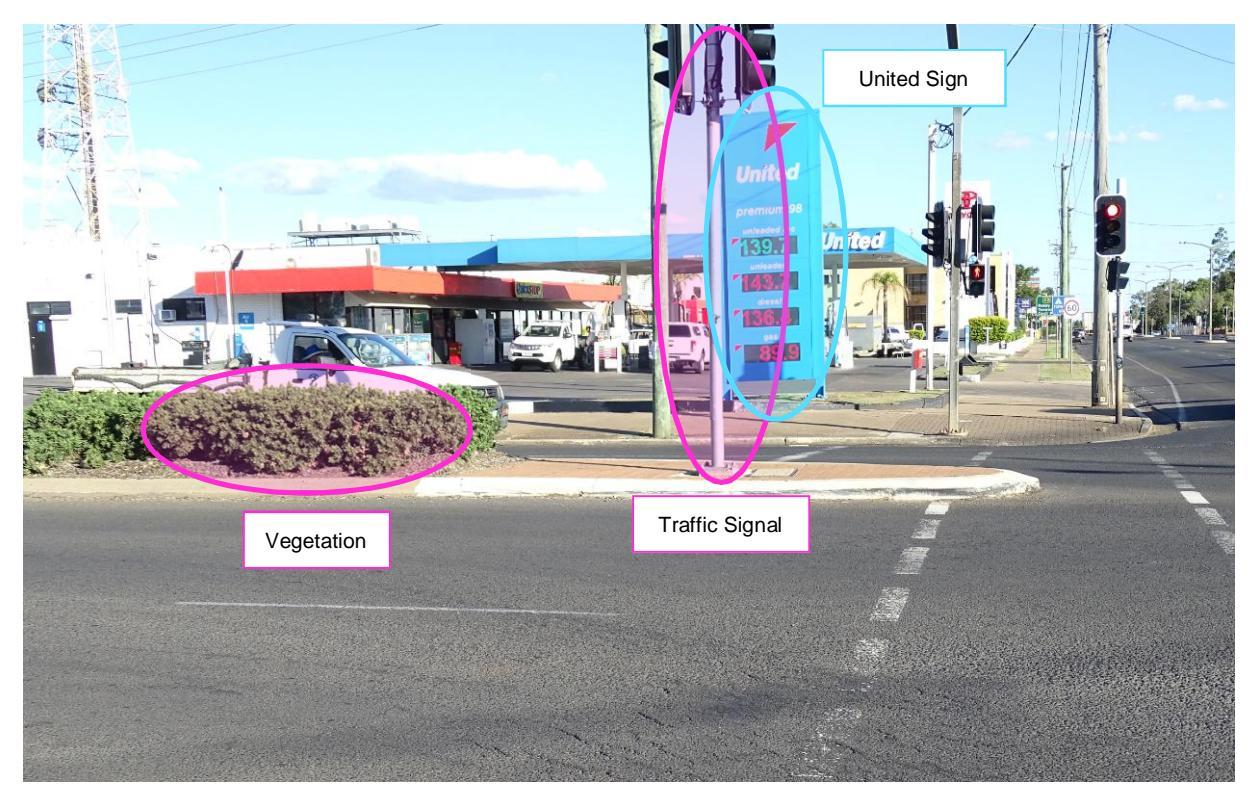
Figure 38 Site Visit Photograph for Location 14 (Looking West)

Figure 39 Site Visit Photograph for Location 14 (Looking toward Toowoomba)

Figure 40 Site Visit Photograph for Location 14 (Looking towards Toowoomba 2)

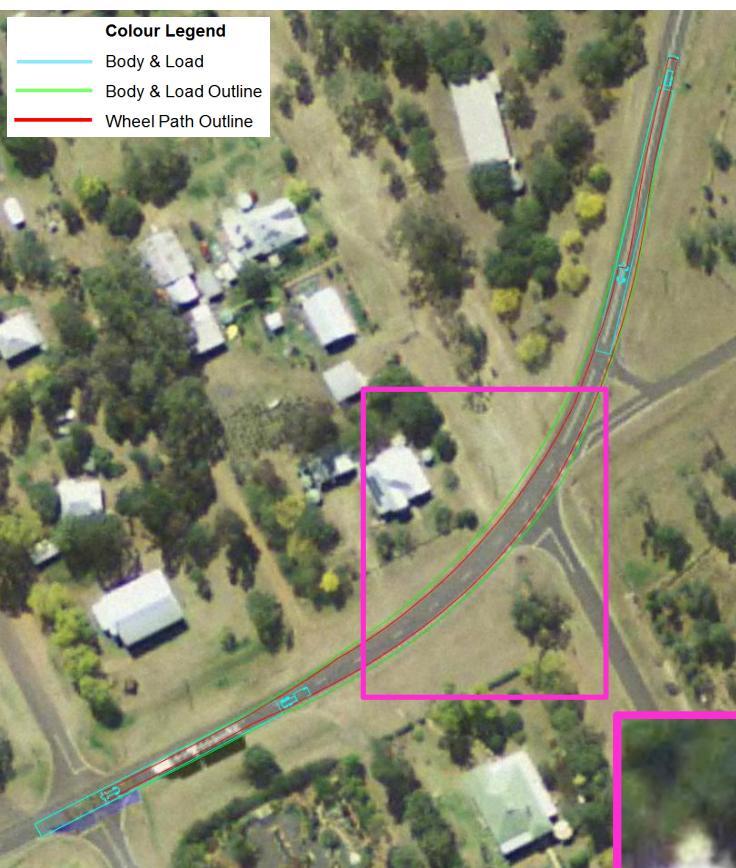
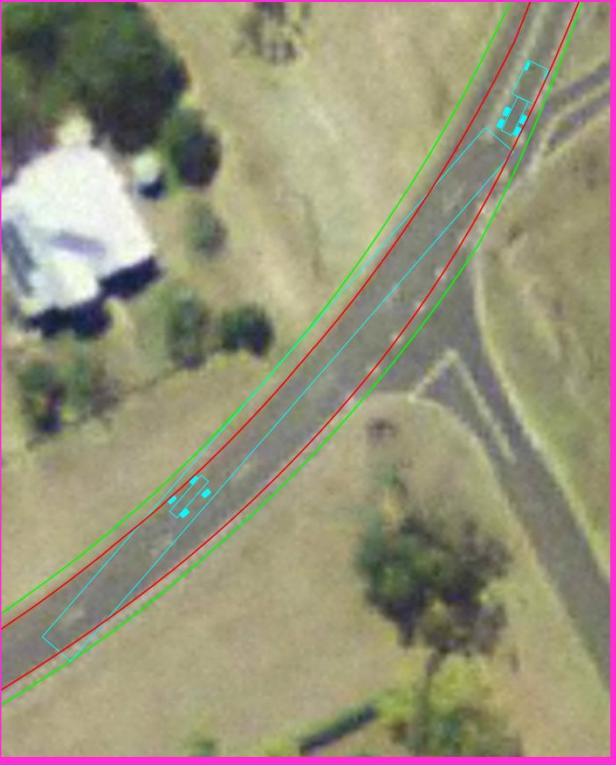
Figure 41 Swept Path for Location 15

The turn path for the Bunya Highway and Crawshay intersection is shown in **Figure 41**. The only conflict which is seen is the how the wheels path is to edge of the pavement, which towards the edge may not be full depth pavement and therefore not of sufficient strength to withstand multiple heavy loads. Further investigation is needed to determine if road widening is required.

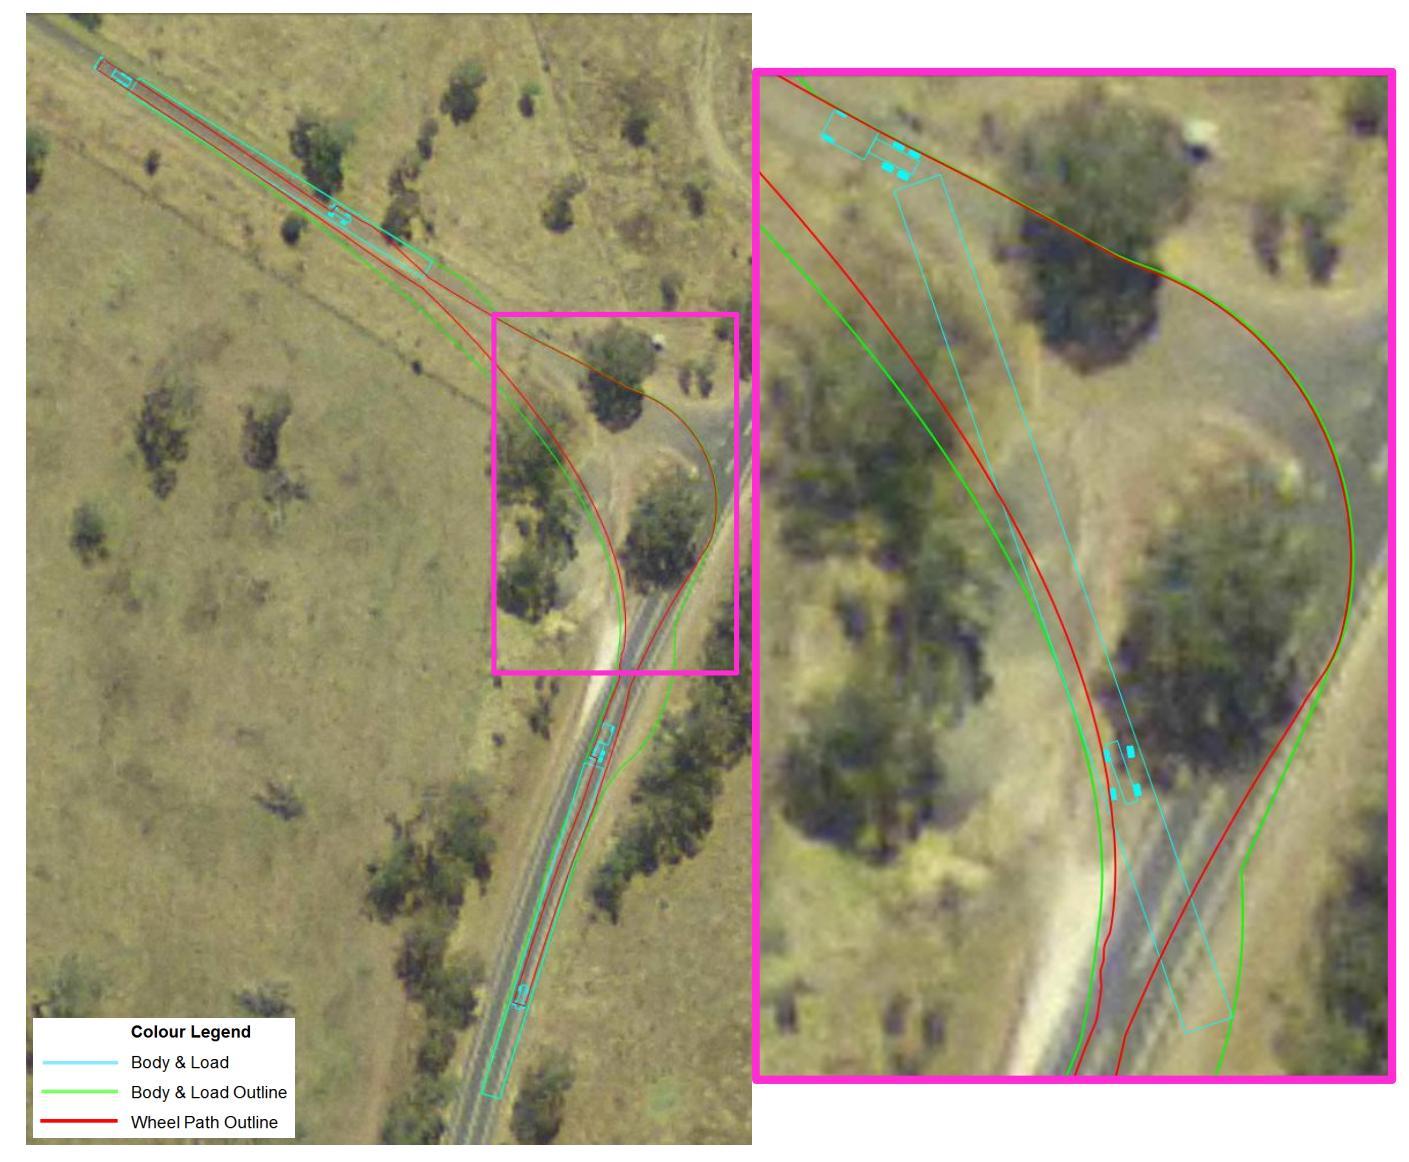
Figure 42 Swept Path for Location 16

The turn path for the truck entering Niagara Road is shown in **Figure 42**. The path conflicts with a large amount of vegetation, trees, a gated fence entry, ground with no pavement and a culvert structure. These conflicts are shown in **Figure 43** and **Figure 44**.

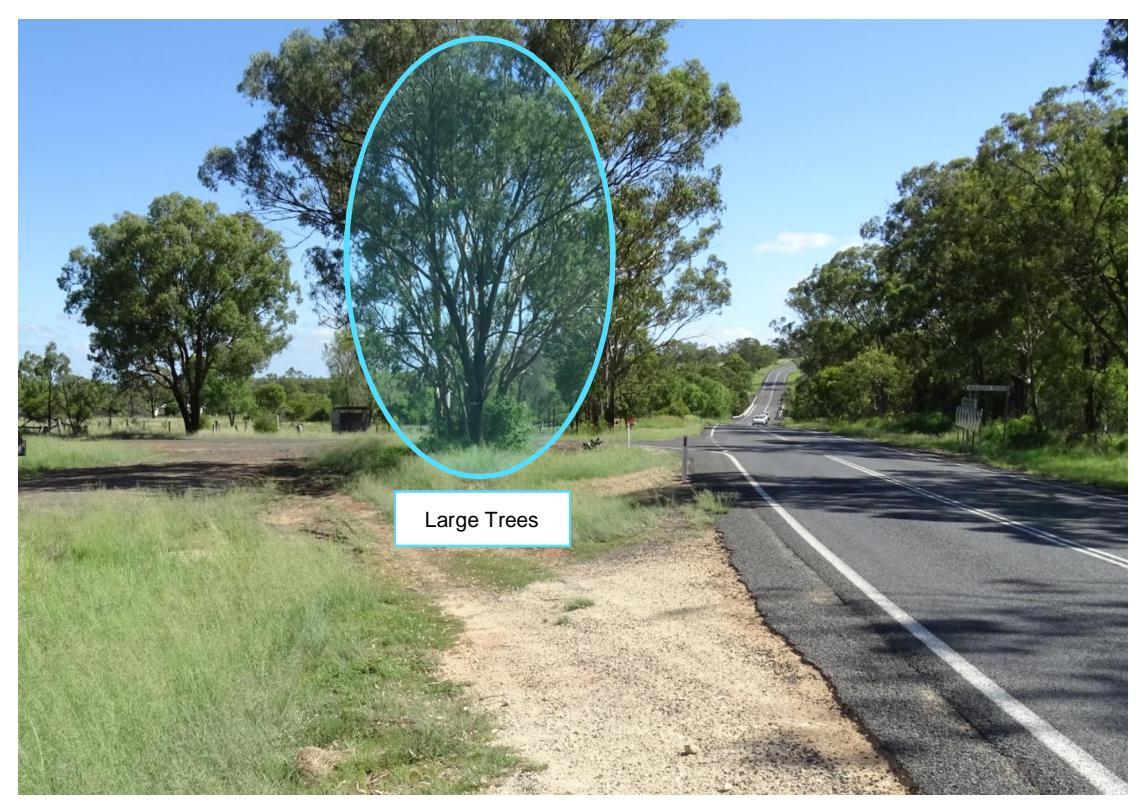
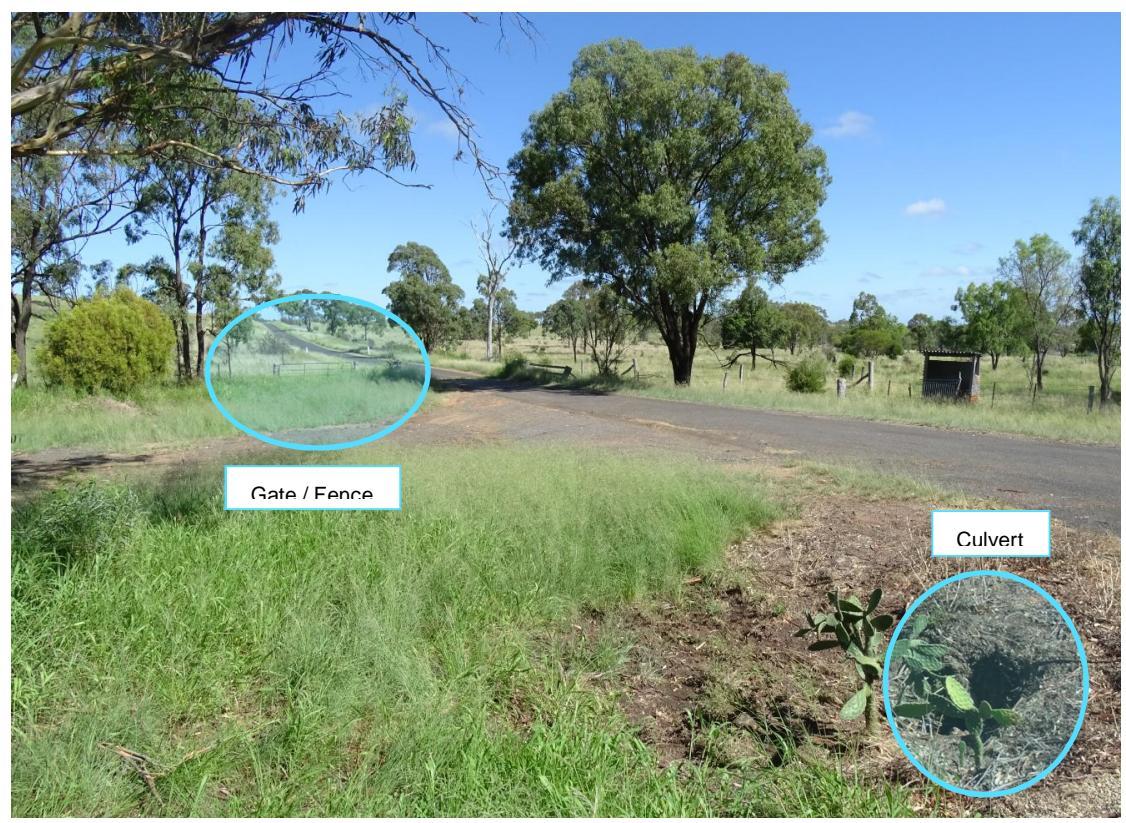
Figure 43 Site Visit Photograph for Location 16 (Looking towards Kingaroy)

Figure 44 Site Visit Photograph for Location 16 (Looking down Niagara Road)
