Project title	Brisbane Temporary Coach Terminal	Job number	262710
cc	Project Team and CRRDA	File reference	
Prepared by		Date	09 August 2018
Subject	Technical Advice Note: Traffic Signal at Parkland Boulevard and Parkland Crescent Intersection

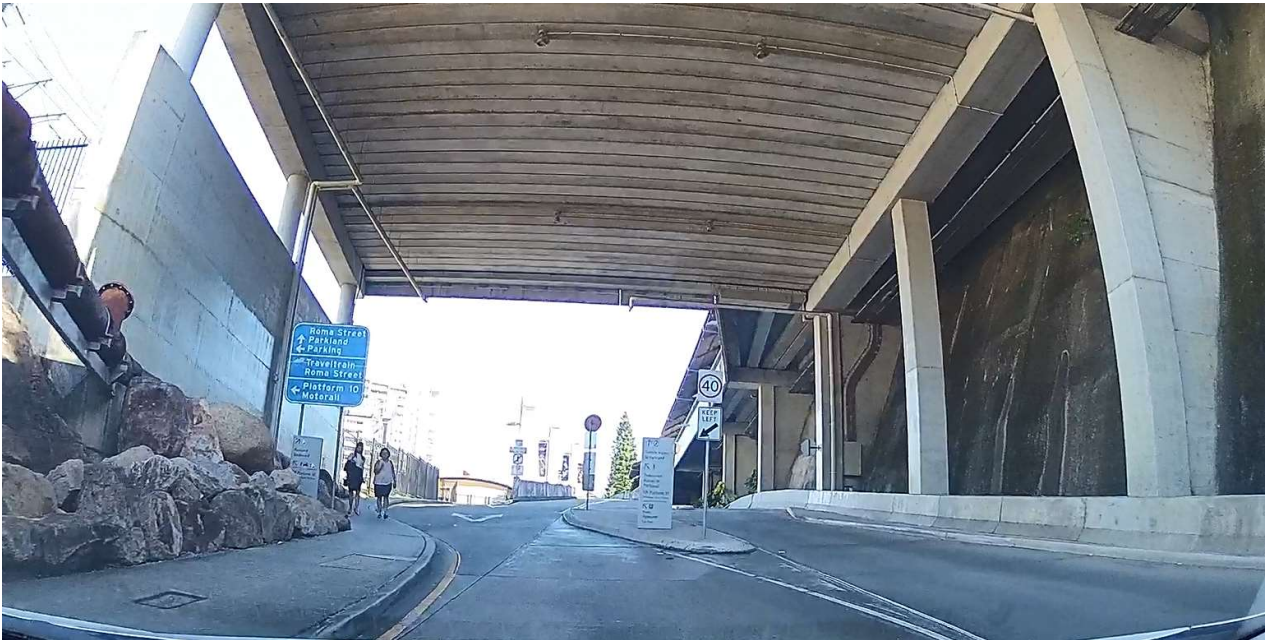
The existing intersection is confined by a retaining wall on one side and the rail corridor on the other. As a result, there is limited width to carry out intersection geometry improvements. This is particularly constraining in implementing a compliant design.

Figure 1.1: Approach to intersection from rail underpass.

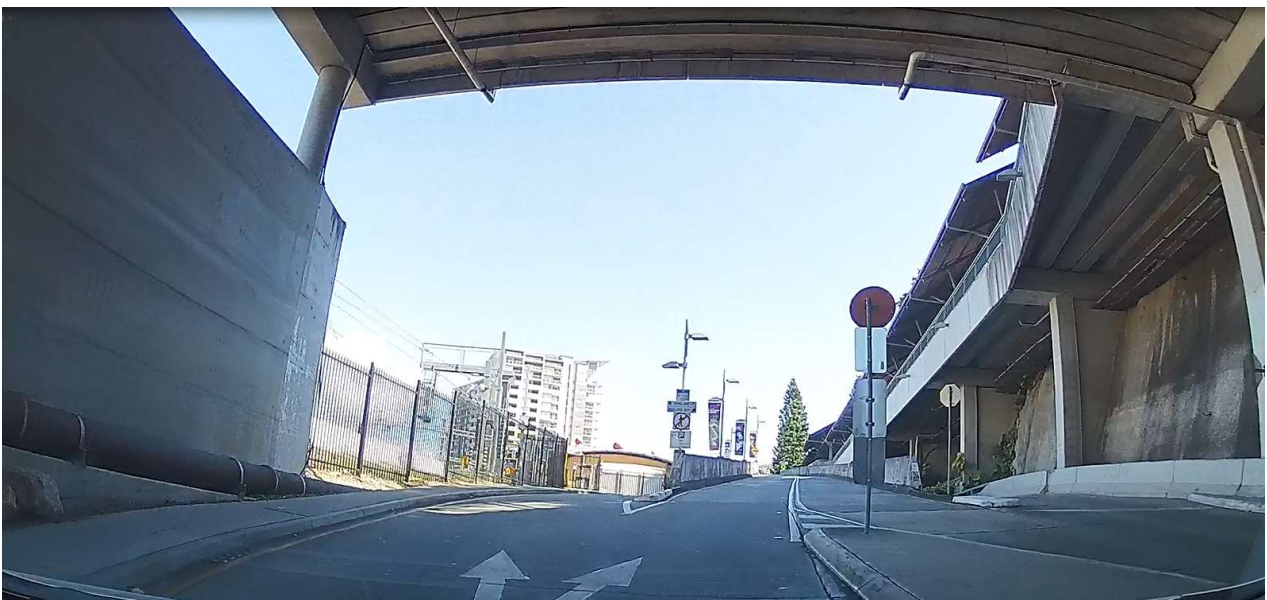
A key design issue identified was the safety of the existing Parkland Boulevard / Parkland Crescent (South) intersection, it was noted that it is currently a priority-controlled (stop sign) intersection. The sight lines at this intersection are limited due to the configuration of the ramp and concrete barriers. Due to the relocation of the coach terminal to Parkland Crescent, the volume of vehicles traversing this intersection is expected to increase, thus leading to an increased risk of collision.

Figure 1.2: View of ramp up Parkland Boulevard

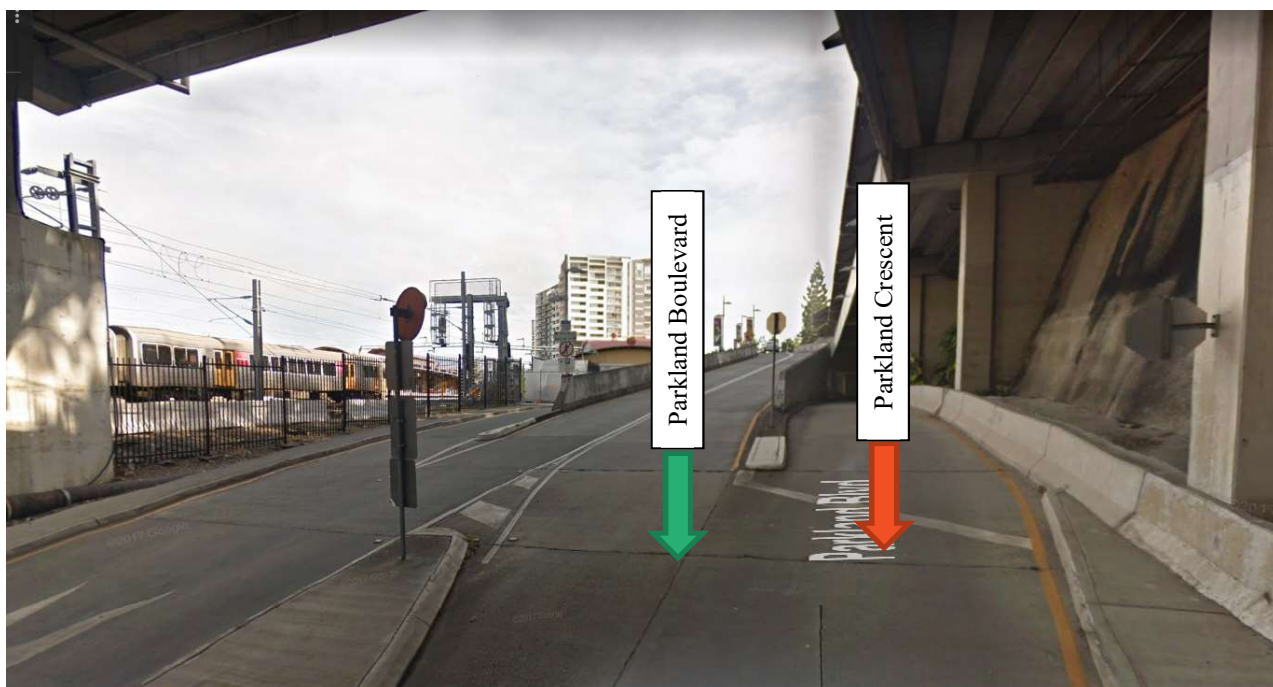
The proposed intersection has an unusual arrangement. The primary entering movements that need to be separated by signalisation to manage conflicts are the ramp down from Parkland Boulevard and Parkland Crescent. Both signalised directions of travel are in the same direction and in close proximity to each other horizontally. As viewed in the figure below.

With standard stop line arrangements, vehicles can see the exact same traffic signals lanterns for each movement at their respective stop lines. This creates issues with controlling these movements separately as the both vehicles desire to move in the same direction.

Given this, the placement of standard secondary and tertiary lanterns is ineffective at controlling the driver's movements, and would likely result in significant driver confusion. These posts have been omitted to avoid this issue.

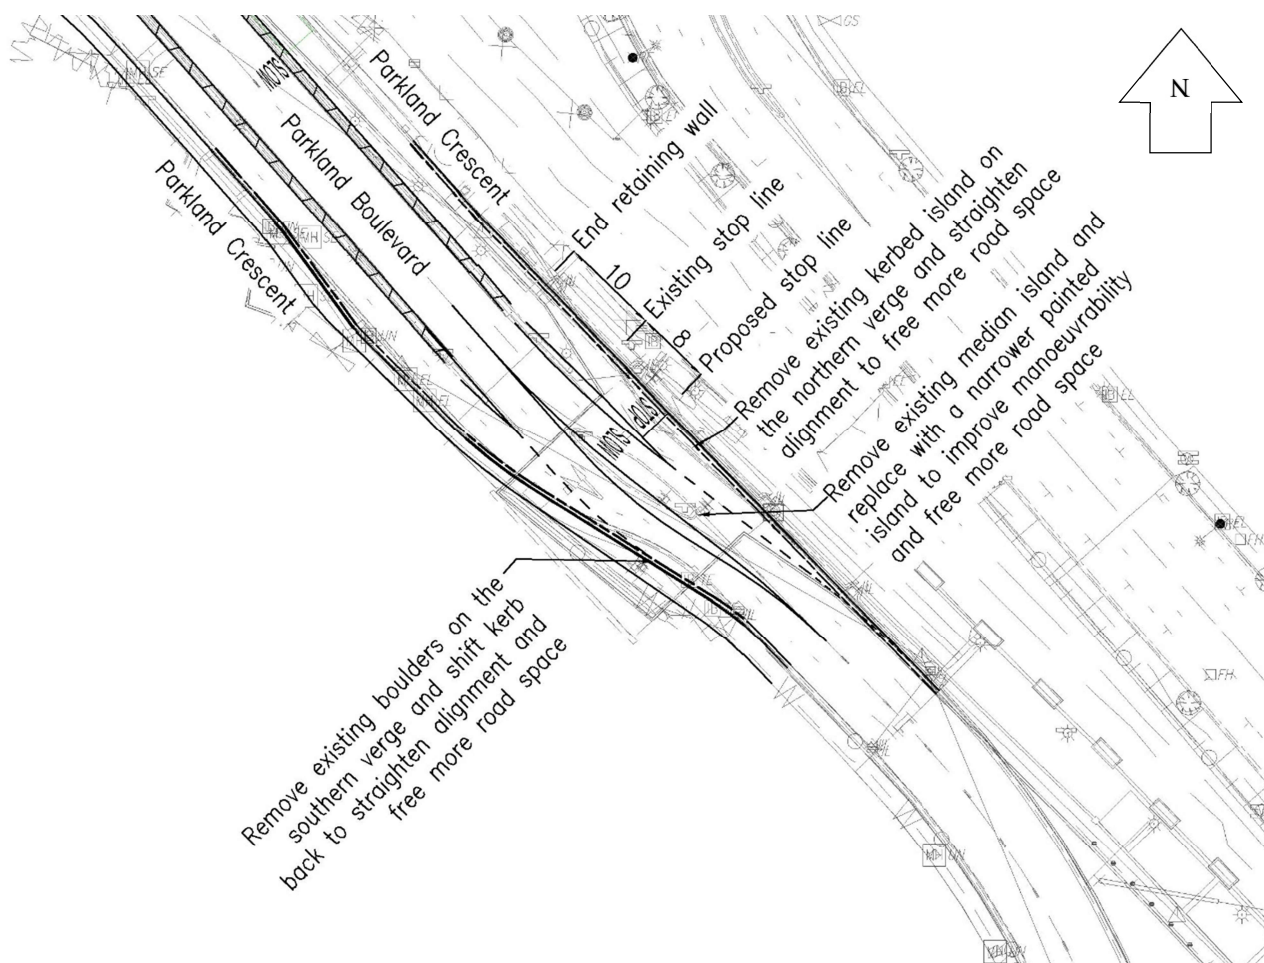
Where it has been mentioned previously, the location of the intersection is constrained which limits the improvement options available. Traffic signals will not be compliant within applicable design standards but minor geometric improvements may improve safety by increasing visibility of vehicles in the intersection giving more time to react to possible conflicts.

Figure 4.1: Proposed Geometric Improvements

The figure below shows a compliant improved layout that should increase vehicle visibility and improve coach manoeuvrability. The improvements include:

- Remove existing kerbed island on the northern verge and straighten alignment to free more road space;
- Remove existing boulders on the southern verge and shift kerb back to straighten alignment and free more road space;
- Remove existing median island and replace with a narrower painted island to improve manoeuvrability and free more road space; and
- Move the existing stop line forward approximately 8m to give a clear length of approximately 18m to the retaining wall to improve vehicle visibility.
