M0001 Waterway Locations and Assessments

M0001 – September 2020

Client: CuString 2.0
Reference: J0105

Title:	Waterway Locations and Assessment for M0001 – September 2020
Address:	
Job Number:	J0105
Client:	CuString 2.0

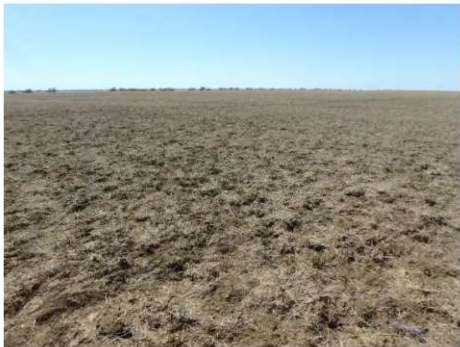
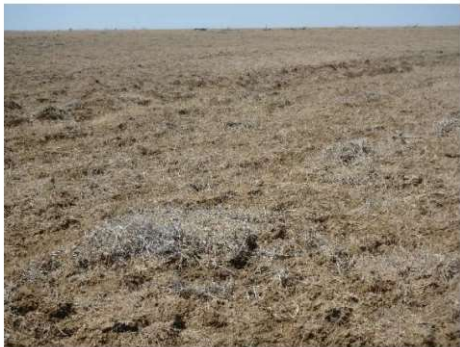
1.1 Unnamed Watercourse W1-1

Desktop Mapping	Comment / Description
Vegetation Management Watercourse / Drainage (Vegetation Management Act, 1999)	
Stream Order	1
Waterway (Fisheries Act, 1994)	
Waterway	High impact (red)
Watercourse Identification (Water Act, 2000)	
Watercourse / Drainage Feature / Unknown	The watercourse location fits the definition of an unmapped Watercourse.
Other Comments	
<p>Creek bed characteristics and vegetation characteristics: Area slightly undulating providing shallow depression for channelling water after rainfall. No riparian vegetation was observed in association with the watercourse.</p> <p>Weed risk: weed species not observed.</p> <p>Current Aquatic Values: nil</p> <p>Vehicle / Construction access requirements: A crossing within the alignment is absent. Dry weather farm access track composed of clay is located to the west of the alignment. This track is accessed via Richmond Winton Road 10km to the west. An extension of this track to the alignment could be completed largely without the removal of vegetation. A crossing of this watercourse would not require any earthworks.</p>

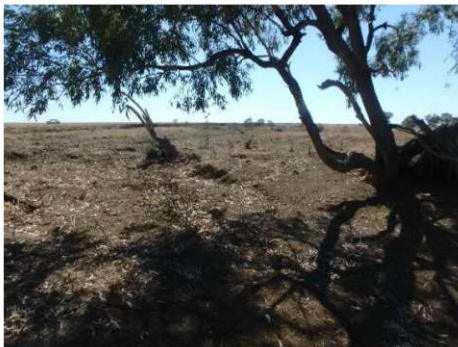
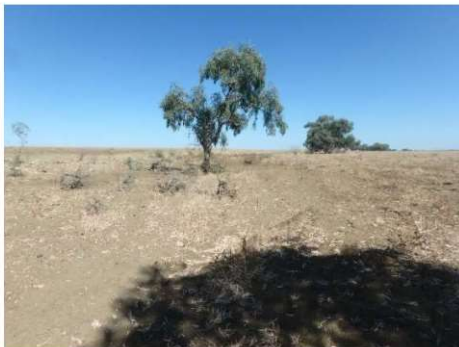
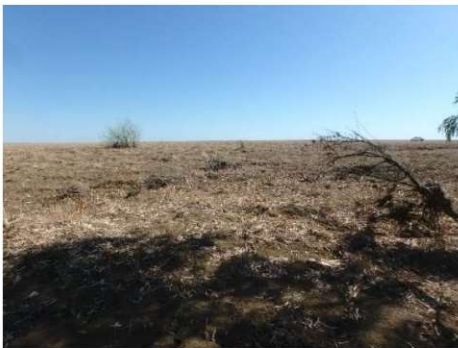
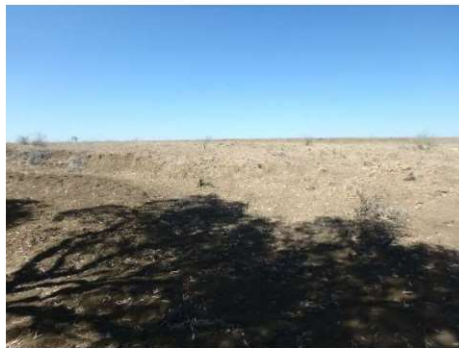
1.2 Unnamed Watercourse W1-2

Desktop Mapping	Comment / Description
Vegetation Management Watercourse / Drainage (Vegetation Management Act, 1999)	
Stream Order	4
Waterway (Fisheries Act, 1994)	
Waterway	Moderate impact (amber)
Watercourse Identification (Water Act, 2000)	
Watercourse / Drainage Feature / Unknown	The watercourse location fits the definition of an unmapped Watercourse
Other Comments	
<p>Creek bed characteristics and vegetation characteristics: Area slightly undulating providing shallow depression for channelling water after rainfall. No riparian vegetation was observed in association with the watercourse. Severe erosion of watercourse banks from cattle grazing was observed.</p> <p>Weed risk: weed species not observed.</p> <p>Current Aquatic Values: nil</p> <p>Vehicle / Construction access requirements: A crossing within the alignment is absent. Dry weather farm access track composed of clay is located to the west of the alignment. This track is accessed via Richmond Winton Road 9.5 km to the west. An extension of this track to the alignment could be completed largely without the removal of vegetation. Crossing of this watercourse would require minimal modification to the banks to be trafficable.</p>

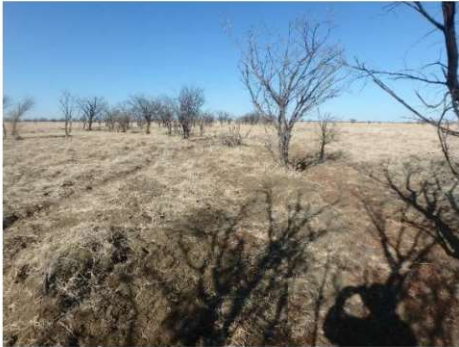
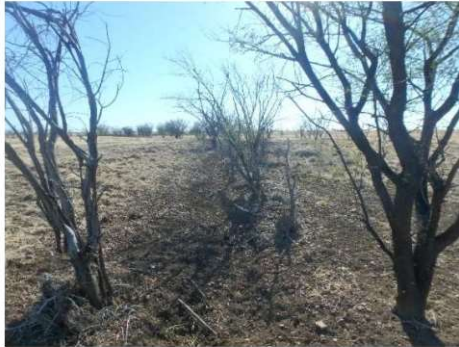
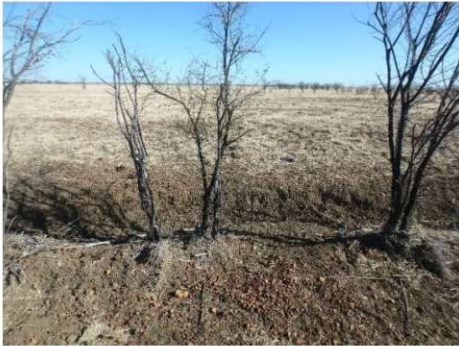
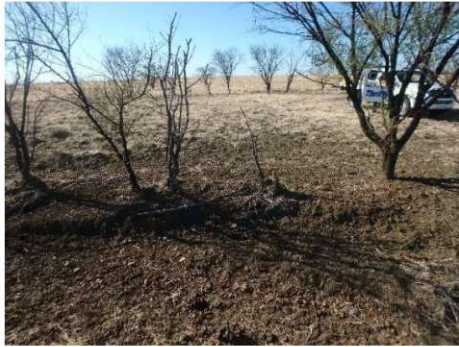
1.3 Unnamed Watercourse W1-3

Desktop Mapping	Comment / Description
Vegetation Management Watercourse / Drainage (Vegetation Management Act, 1999)	
Stream Order	2
Waterway (Fisheries Act, 1994)	
Waterway	Absent
Watercourse Identification (Water Act, 2000)	
Watercourse / Drainage Feature / Unknown	The watercourse location fits the definition of an unmapped Watercourse
Other Comments	
<p>Creek bed characteristics and vegetation characteristics: Area slightly undulating providing shallow depression for channelling water after rainfall. No riparian vegetation was observed in association with the watercourse. Severe erosion from cattle grazing was observed in the watercourse.</p> <p>Weed risk: <i>Vachellia nilotica</i>* dispersed along watercourse edge.</p> <p>Current Aquatic Values: nil</p> <p>Vehicle / Construction access requirements: A crossing within the alignment is absent. Dry weather farm access track composed of clay is located to the south of the alignment. This track is accessed via Richmond Winton Road 10 km to the east. An extension of this track to the alignment could be completed largely without the removal of vegetation. Crossing of this watercourse would require minimal modification to the banks to be trafficable.</p>

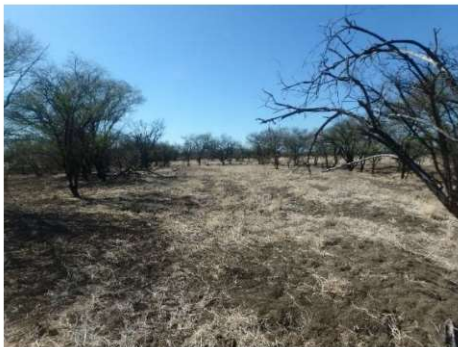
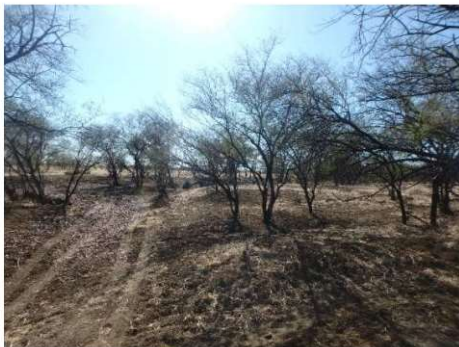
1.4 Unnamed Watercourse W1-4

Desktop Mapping	Comment / Description
Vegetation Management Watercourse / Drainage (Vegetation Management Act, 1999)	
Stream Order	1
Waterway (Fisheries Act, 1994)	
Waterway	Absent
Watercourse Identification (Water Act, 2000)	
Watercourse / Drainage Feature / Unmapped	The watercourse location fits the definition of an unmapped Watercourse
Other Comments	
<p>Creek bed characteristics and vegetation characteristics: Area slightly undulating providing shallow depression for channelling water after rainfall. No riparian vegetation was observed in association with the watercourse. Severe erosion from cattle grazing was observed in the watercourse.</p> <p>Weed risk: <i>Vachellia nilotica</i>.*</p> <p>Current Aquatic Values: nil</p> <p>Vehicle / Construction access requirements: A crossing within the alignment is absent. Dry weather farm access track composed of clay is located to the south of the alignment. This track is accessed via Richmond Winton Road 15 km to the east. An extension of this track to the alignment could be completed largely without the removal of vegetation. Crossing of this watercourse would require minimal modification to the banks to be trafficable.</p>

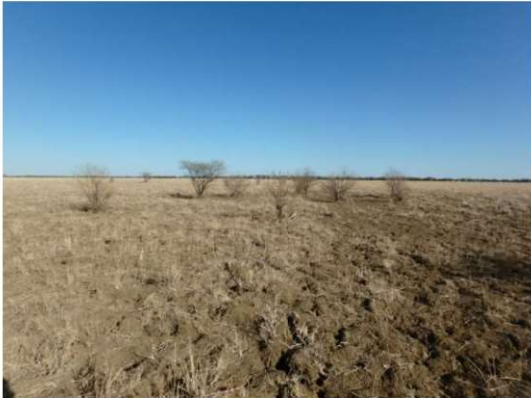
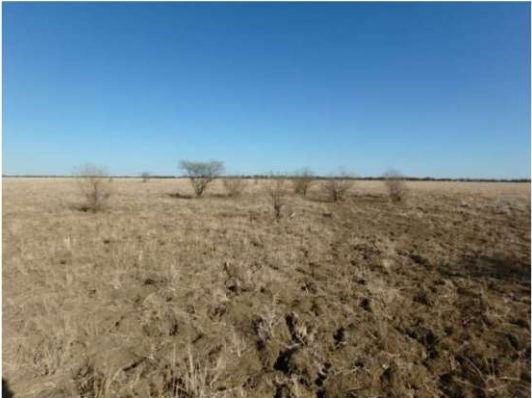
1.6 Unnamed Watercourse W1-6

Desktop Mapping	Comment / Description
Vegetation Management Watercourse / Drainage (Vegetation Management Act, 1999)	
Stream Order	2
Waterway (Fisheries Act, 1994)	
Waterway	Low impact (green)
Watercourse Identification (Water Act, 2000)	
Watercourse / Drainage Feature / Unknown	The watercourse location fits the definition of an unmapped Watercourse
Other Comments	
<p>Creek bed characteristics and vegetation characteristics: Potential drainage feature. Area slightly undulating providing shallow depression for channelling water after rainfall. No riparian vegetation was observed in association with this feature.</p> <p>Weed risk: <i>Vachellia nilotica</i>.*</p> <p>Current Aquatic Values: nil</p> <p>Vehicle / Construction access requirements: A crossing within the alignment is absent. Dry weather farm access track composed of clay is located to the south of the alignment. This track is accessed via Richmond Winton Road 26.5 km to the east. An extension of this track to the alignment could be completed largely without the removal of vegetation. Crossing of this watercourse would require minimal modification to the banks to be trafficable.</p>

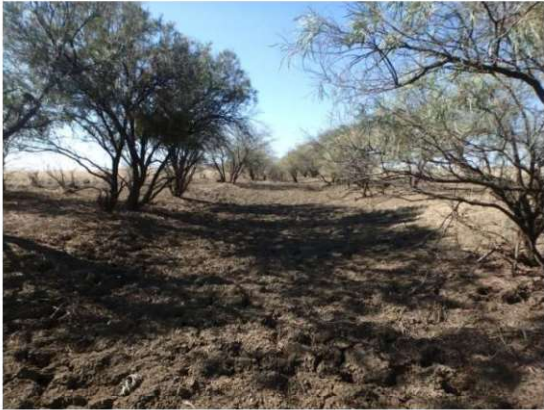
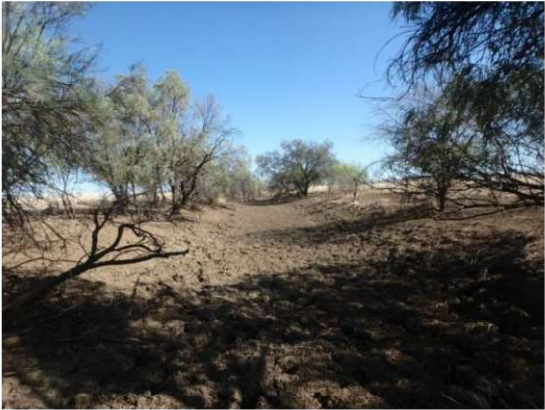
1.8 Alick Creek W1-8

Desktop Mapping	Comment / Description
Vegetation Management Watercourse / Drainage (Vegetation Management Act, 1999)	
Stream Order	6
Waterway (Fisheries Act, 1994)	
Waterway	Major impact (purple)
Watercourse Identification (Water Act, 2000)	
Watercourse / Drainage Feature / Unknown	The watercourse location is defined as a mapped Watercourse
Other Comments	
<p>Creek bed characteristics and vegetation characteristics: Watercourse feature approximately 12m wide. Riparian vegetation includes <i>Alectryon oleifolius</i> and weed species. Watercourse feature heavily grazed by cattle and infested with <i>Vachellia nilotica</i> and <i>Parkinsonia aculeata</i>*</p> <p>Weed risk: <i>Vachellia nilotica</i>* and <i>Parkinsonia aculeata</i>*</p> <p>Current Aquatic Values: nil</p> <p>Vehicle / Construction access requirements: A crossing within the alignment is absent. Dry weather farm access track composed of clay is located to the southeast and southwest of the alignment. These tracks lead to the property boundaries. An extension of this track to the alignment could be completed largely without the removal of vegetation. Crossing of this watercourse would require minimal modification to the banks to be trafficable.</p>

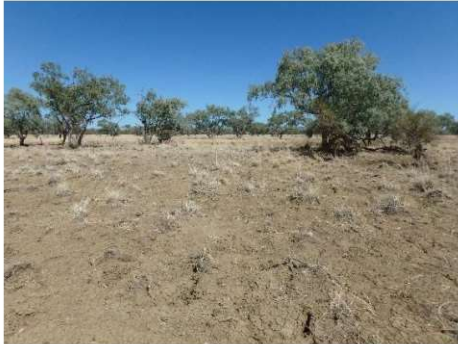
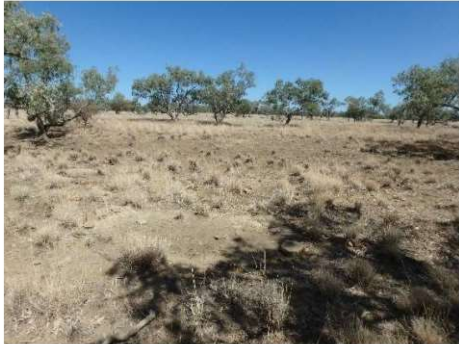
1.11 Unnamed Watercourse W1-11

Desktop Mapping	Comment / Description
Vegetation Management Watercourse / Drainage (Vegetation Management Act, 1999)	
Stream Order	None
Waterway (Fisheries Act, 1994)	
Waterway	Absent
Watercourse Identification (Water Act, 2000)	
Watercourse / Drainage Feature / Unknown	The watercourse location is not defined.
Other Comments	
<p>Creek bed characteristics and vegetation characteristics: Potential drainage feature. Area slightly undulating providing shallow depression for channelling water after rainfall. No riparian vegetation was observed in association with this feature.</p> <p>Weed risk: nil</p> <p>Current Aquatic Values: nil</p> <p>Vehicle / Construction access requirements: Currently, a crossing within the alignment is absent. Dry weather farm access track composed of clay is located to the north of the alignment. This track is accessed via Mt Isa Road 12 km to the north. An extension of this track to the alignment could be completed largely without the removal of vegetation. Crossing of this watercourse would require minimal modification to the banks to be trafficable.</p>

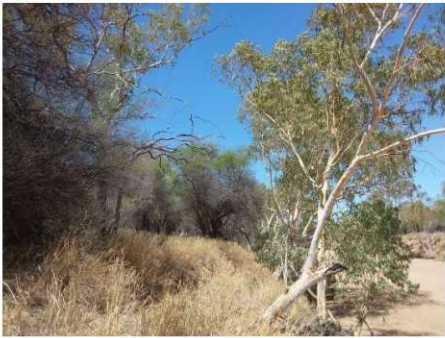
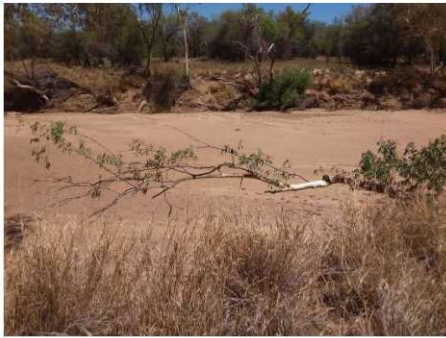
1.3 Porcupine Creek - Watercourse W3-3

Desktop Mapping	Comment / Description
Vegetation Management Watercourse / Drainage (Vegetation Management Act, 1999)	
Stream Order	6
Waterway (Fisheries Act, 1994)	
Waterway	High impact (red)
Watercourse Identification (Water Act, 2000)	
Watercourse / Drainage Feature / Unknown	The watercourse location fits the definition of a Watercourse.
Other Comments	
<p>Creek bed characteristics and vegetation characteristics: Steep sided watercourse with 38m wide sandy gravel channel bed containing minimal modification by cattle grazing. Riparian canopy vegetation dominated by <i>Eucalyptus camaldulensis</i> with a dense coverage of exotic tall shrubs.</p> <p>Weed risk: <i>Prosopis sp.*</i> and <i>Vachellia nilotica*</i> at top of bank.</p> <p>Current Aquatic Values: nil</p> <p>Vehicle / Construction assess requirements – Major modifications would be required to span this waterway. Steep sided banks would require bank works to reduce gradient. No major access tracks cross this waterway within the vicinity of the alignment. Accessing the southern bank could be accomplished by utilising the access track associated with the previous waterway assessment (W3-2) which passes within 50m. The northern bank would be accessed via properties along Canterbury Plains Road.</p>

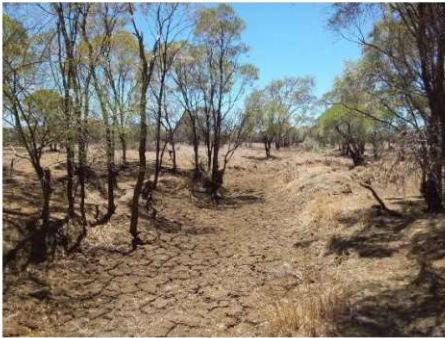
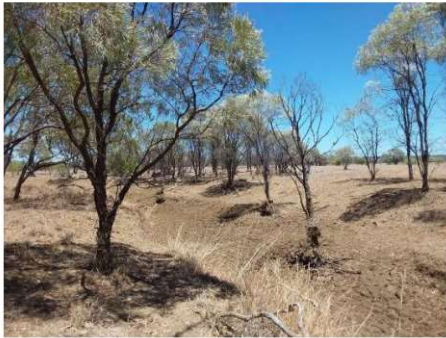
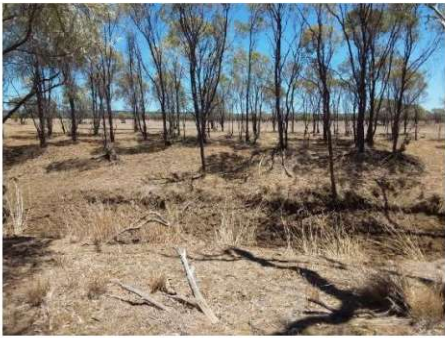
1.4 Coolibah Creek - Watercourse W3-4

Desktop Mapping	Comment / Description
Vegetation Management Watercourse / Drainage (Vegetation Management Act, 1999)	
Stream Order	4
Waterway (Fisheries Act, 1994)	
Waterway	Low impact (green)
Watercourse Identification (Water Act, 2000)	
Watercourse / Drainage Feature / Unknown	The watercourse location fits the definition of an unmapped Watercourse.
Other Comments	
<p>Creek bed characteristics and vegetation characteristics: A watercourse with 3m wide cracking clay channel bed containing banks modified by cattle grazing. Adjacent vegetation dominated by <i>Acacia tephрина</i>. Very scattered <i>Eucalyptus coolabah</i> downstream from the alignment.</p> <p>Weed risk: weed species not observed.</p> <p>Current Aquatic Values: nil</p> <p>Vehicle / Construction assess requirements: A crossing within the alignment is absent. The channel is on average 1m in depth. Minor modifications to bank gradients and approaches would enable small vehicular access in the dry season. Minimal removal of vegetation would be required. Nearest vehicular access is off Torver Valley Road.</p>

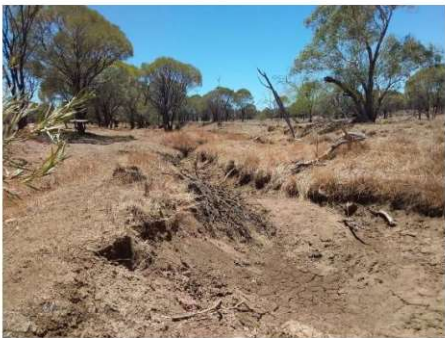
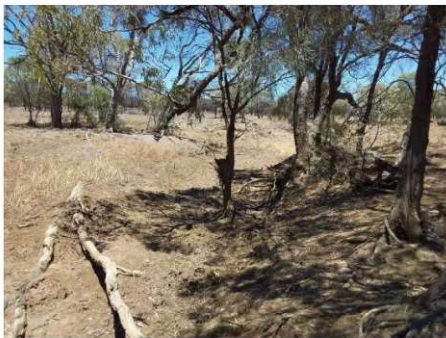
1.5 Coolibah Creek - Watercourse W3-5

Desktop Mapping	Comment / Description
Vegetation Management Watercourse / Drainage (Vegetation Management Act, 1999)	
Stream Order	3
Waterway (Fisheries Act, 1994)	
Waterway	Low impact (green)
Watercourse Identification (Water Act, 2000)	
Watercourse / Drainage Feature / Unknown	The watercourse location fits the definition of an unmapped Watercourse.
Other Comments	
<p>Creek bed characteristics and vegetation characteristics: Watercourse with 3m wide cracking clay channel bed. Seasonal pools up and downstream. Contains banks modified by cattle grazing. Adjacent vegetation dominated by <i>Acacia tephрина</i> and very scattered <i>Eucalyptus coolibah</i>.</p> <p>Weed risk: <i>Parkinsonia aculeata</i> observed nearby.</p> <p>Current Aquatic Values: nil</p> <p>Vehicle / Construction assess requirements: A crossing within the alignment is absent. This channel is on average 1m in depth. Minor modifications to bank gradients and approaches would enable small vehicular access in the dry season. Minimal removal of vegetation would be required. Nearest vehicular access is off Torver Valley Road.</p>

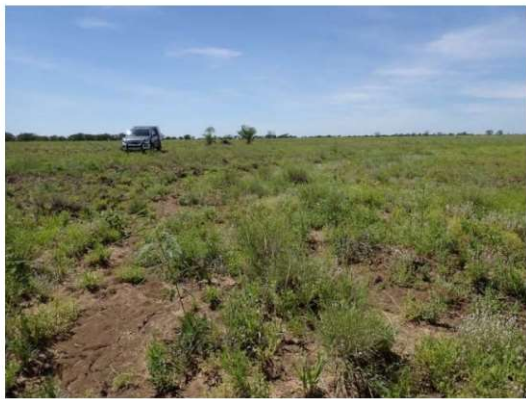
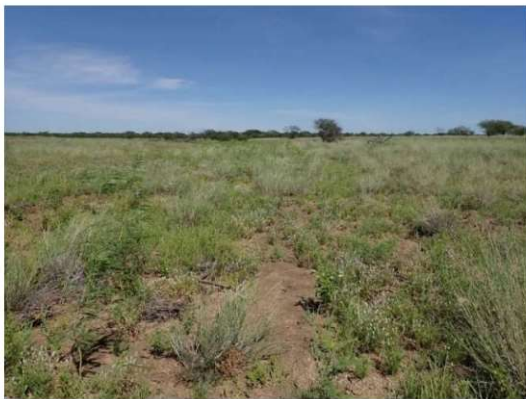
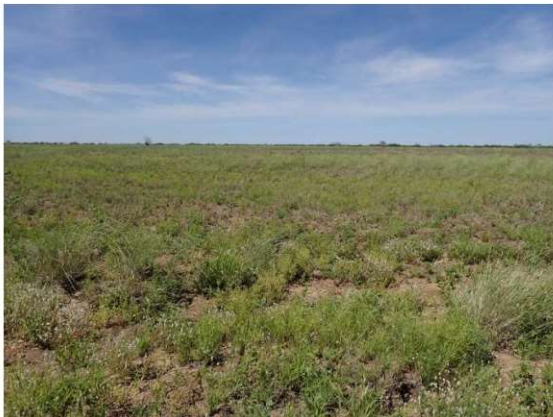
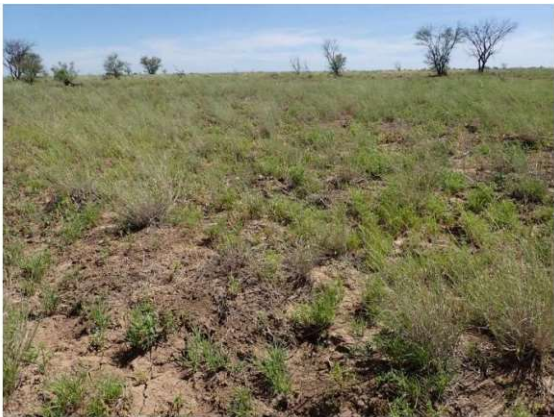
1.2 Alick Creek- Watercourse W6-2

Desktop Mapping	Comment / Description
Vegetation Management Watercourse / Drainage (<i>Vegetation Management Act, 1999</i>)	
Stream Order	6
Waterway (<i>Fisheries Act, 1994</i>)	
Waterway	Major impact (purple)
Watercourse Identification (<i>Water Act, 2000</i>)	
Watercourse / Drainage Feature / Unknown	The watercourse location fits the definition of a mapped Watercourse.
Other Comments	
<p>Creek bed characteristics and vegetation characteristics: Ephemeral watercourse 2m wide with a 0.5m deep silt / clay dry channel. Wetland species absent. Banks covered in <i>Astrebla spp.</i>, <i>Sesbania spp.</i>, exotic and native grasses.</p> <p>Weed risk: <i>Vachellia nilotica</i> observed.</p> <p>Current Aquatic Values: nil</p> <p>Vehicle / Construction access requirements: A crossing within the alignment is absent. Very limited modifications required for access. Dry weather only.</p>	
Upstream	Downstream

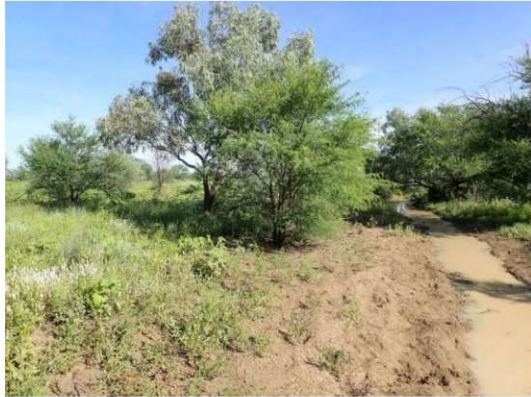
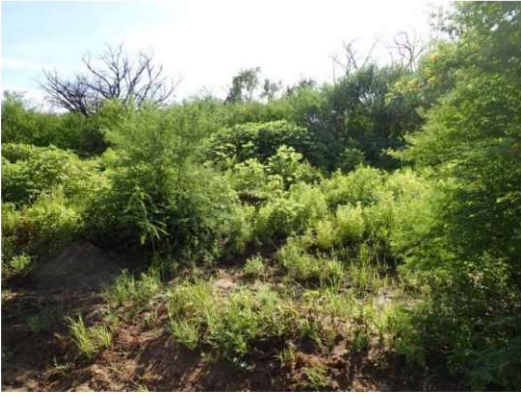
1.3 Alick Creek- Watercourse W6-3

Desktop Mapping	Comment / Description
Vegetation Management Watercourse / Drainage (<i>Vegetation Management Act, 1999</i>)	
Stream Order	6
Waterway (<i>Fisheries Act, 1994</i>)	
Waterway	Major impact (purple)
Watercourse Identification (<i>Water Act, 2000</i>)	
Watercourse / Drainage Feature / Unknown	The watercourse location fits the definition of a mapped Watercourse.
Other Comments	
<p>Creek bed characteristics and vegetation characteristics: Ephemeral watercourse 10.5m wide with 1.5m narrow low flow channel. Riparian vegetation on silt / clay banks. Scattered <i>Eucalyptus coolabah</i> dominates canopy layer to 5m in height, with <i>Cyperus spp.</i> ground cover.</p> <p>Weed risk: <i>Vachellia nilotica</i> observed.</p> <p>Current Aquatic Values: Aquatic flora, algae and macrophyte absent.</p> <p>Vehicle / Construction access requirements: A crossing within the alignment is absent. A shallow channel with shallow bank slopes. Minor modifications to bank slopes and approaches would enable vehicular access during the dry season. Removal of riparian vegetation would be required. Existing unsealed access track 700m to the west and 400m to the east.</p>

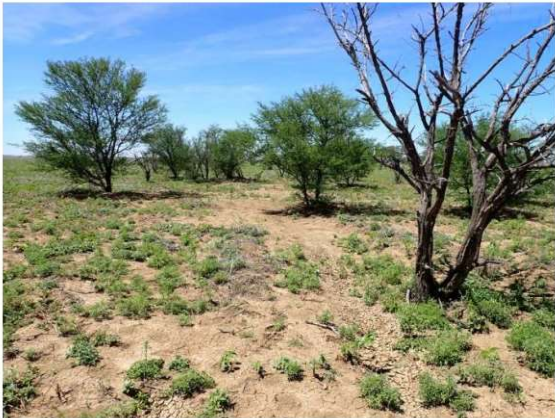
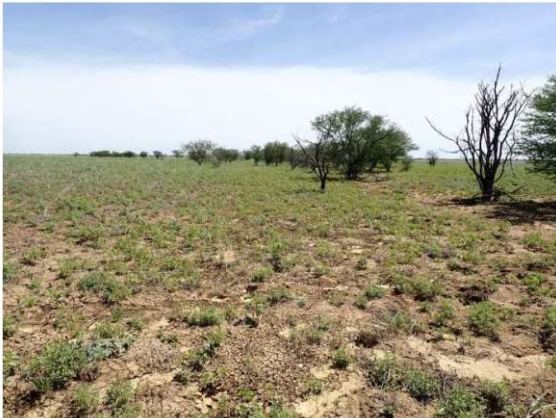
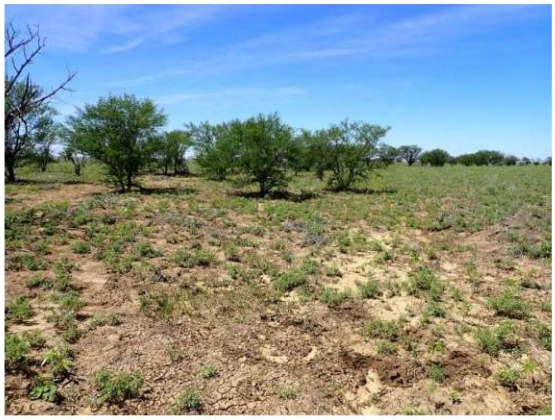
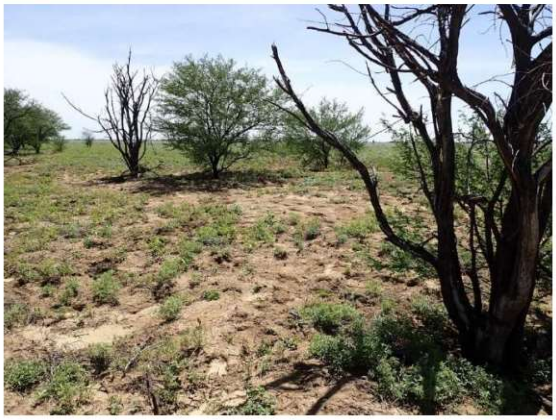
1.6 Watercourse W6-6

Desktop Mapping	Comment / Description
Vegetation Management Watercourse / Drainage (<i>Vegetation Management Act, 1999</i>)	
Stream Order	4
Waterway (<i>Fisheries Act, 1994</i>)	
Waterway	Low impact (green)
Watercourse Identification (<i>Water Act, 2000</i>)	
Watercourse / Drainage Feature / Unknown	The watercourse location fits the definition of an unmapped Watercourse.
Other Comments	
<p>Creek bed characteristics and vegetation characteristics: Ephemeral watercourse 3m wide with a narrow 0.3m deep dry channel. Silt / clay banks covered in native forbs and scattered grasses. Evidence of heavy grazing showing little ground layer.</p> <p>Weed risk: <i>Vachellia nilotica</i> observed.</p> <p>Current Aquatic Values: nil</p> <p>Vehicle / Construction access requirements: A crossing within the alignment is absent. Very limited modifications required for access. Dry weather only.</p>	
Upstream	Downstream

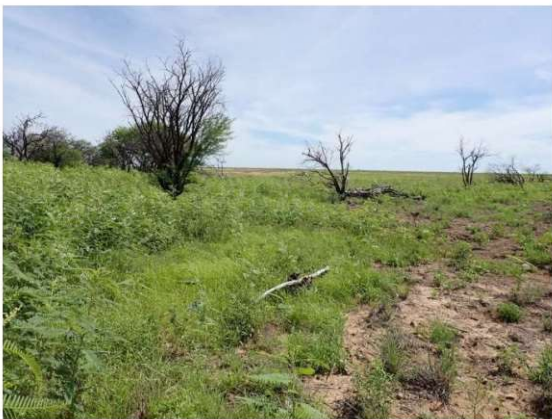
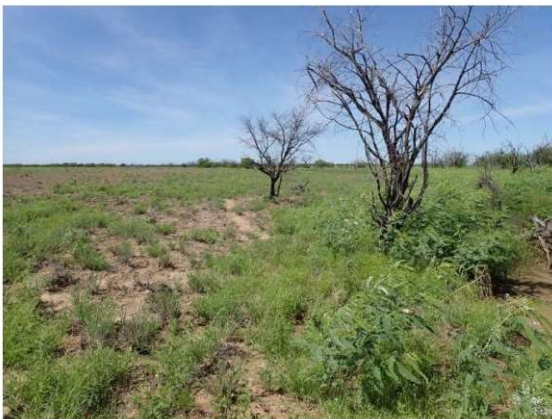
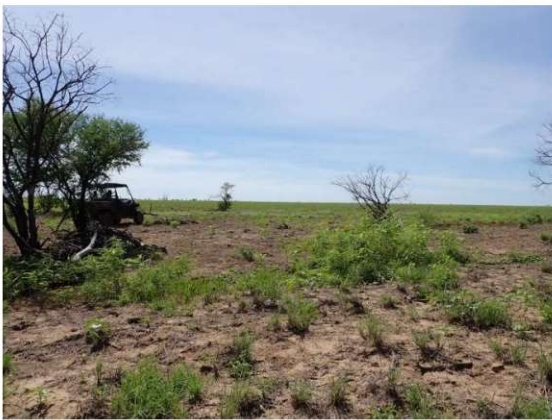
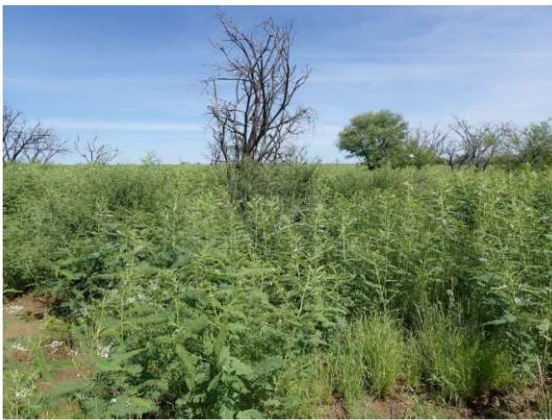
1.7 Watercourse W6-7

Desktop Mapping	Comment / Description
Vegetation Management Watercourse / Drainage (<i>Vegetation Management Act, 1999</i>)	
Stream Order	3
Waterway (<i>Fisheries Act, 1994</i>)	
Waterway	Low impact (green)
Watercourse Identification (<i>Water Act, 2000</i>)	
Watercourse / Drainage Feature / Unknown	The watercourse location fits the definition of an unmapped Watercourse.
Other Comments	
<p>Creek bed characteristics and vegetation characteristics: Ephemeral watercourse 10m wide with a narrow 2m dry channel. Silt / clay banks with slight traces of pebble covered in <i>Iseilema spp.</i>, <i>Cyperus spp.</i>, and <i>Sesbania spp.</i> up to 1.4m in height.</p> <p>Weed risk: <i>Vachellia nilotica</i>, <i>Xanthium pungens</i> observed.</p> <p>Current Aquatic Values: nil</p> <p>Vehicle / Construction access requirements: A crossing within the alignment is absent. Very limited modifications required for access. Dry weather only.</p>

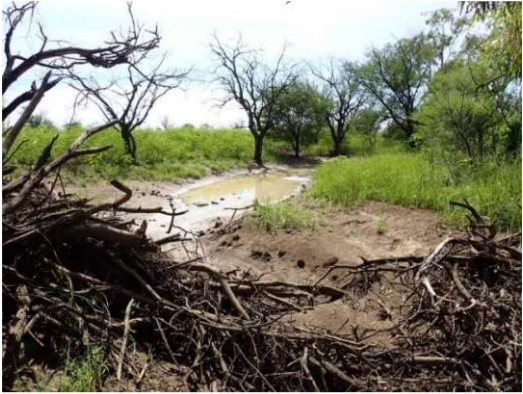
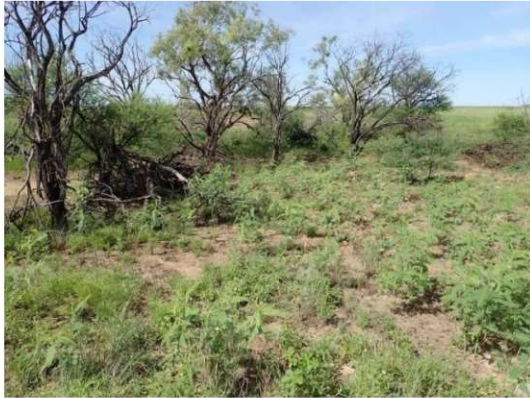
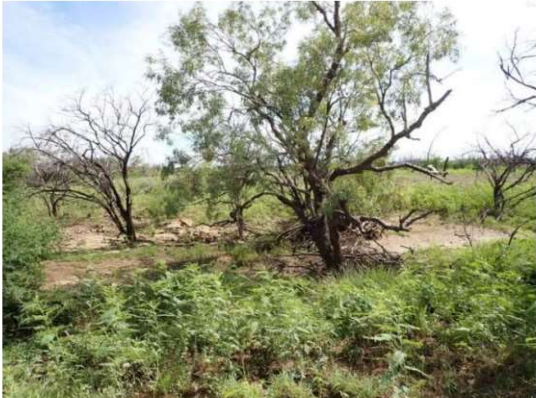
1.8 Watercourse W6-8

Desktop Mapping	Comment / Description
Vegetation Management Watercourse / Drainage (<i>Vegetation Management Act, 1999</i>)	
Stream Order	5
Waterway (<i>Fisheries Act, 1994</i>)	
Waterway	High impact (red)
Watercourse Identification (<i>Water Act, 2000</i>)	
Watercourse / Drainage Feature / Unknown	The watercourse location fits the definition of an unmapped Watercourse.
Other Comments	
<p>Creek bed characteristics and vegetation characteristics: Ephemeral watercourse 25m wide with narrow 4m isolated flow channel. Fringing riparian vegetation on banks. Scattered <i>Eucalyptus coolabah</i> up to 4-6m in height dominates canopy layer. <i>Cyperus spp.</i> covers ground layer. Regional ecosystem described as 4.3.4f.</p> <p>Weed risk: <i>Vachellia nilotica</i> observed.</p> <p>Current Aquatic Values: Aquatic flora, algae and macrophyte absent.</p> <p>Vehicle / Construction access requirements: A crossing within the alignment is absent. A shallow channel with moderate sloped banks. Minor modifications to bank slopes and approaches would enable vehicular access during the dry season. Removal of minor sections riparian vegetation would be required. The nearest recorded access track is 800 m to the west.</p>

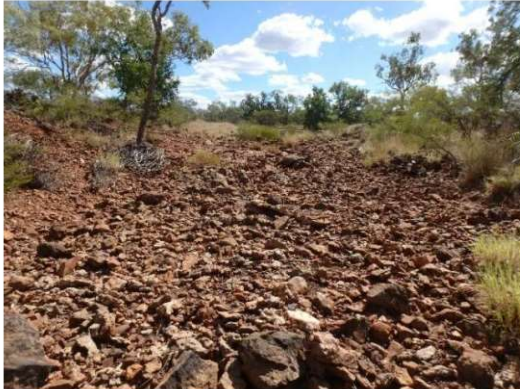
Desktop Mapping	Comment / Description
Vegetation Management Watercourse / Drainage (<i>Vegetation Management Act, 1999</i>)	
Stream Order	3
Waterway (<i>Fisheries Act, 1994</i>)	
Waterway	Low impact (green)
Watercourse Identification (<i>Water Act, 2000</i>)	
Watercourse / Drainage Feature / Unknown	The watercourse location fits the definition of an unmapped Watercourse.
Other Comments	
<p>Creek bed characteristics and vegetation characteristics: Ephemeral watercourse with banks and bed of laomy sand over clay, with surface rocks (pebbles, cobbles, and boulders). Banks lightly covered with a ground layer dominated by buffel grass (<i>Cenchrus ciliaris</i>). Riparian canopy extends to 12m high and is dominated by <i>Corymbia terminalis</i> and <i>Lysiphyllum carronii</i>.</p> <p>Weed risk: None recorded.</p> <p>Current Aquatic Values: None present.</p> <p>Vehicle / Construction access requirements: A crossing within the alignment is present as an access track parallel to the main road.</p>

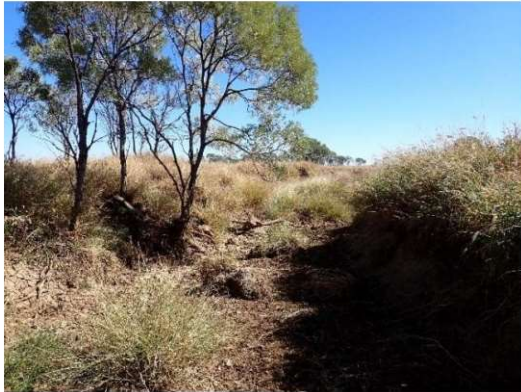
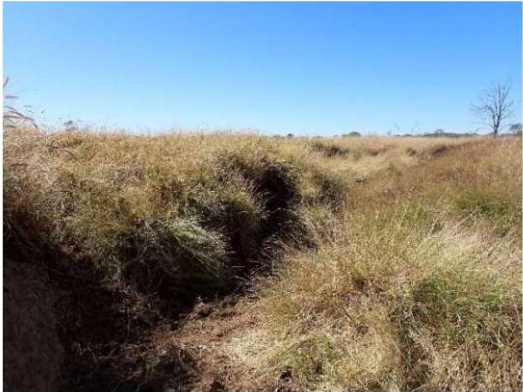
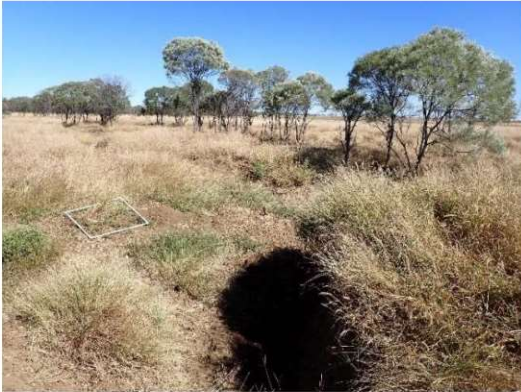
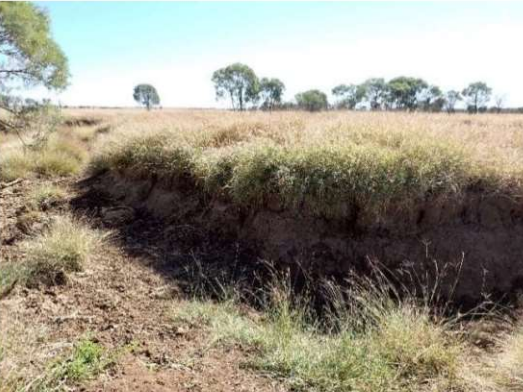
Desktop Mapping	Comment / Description
Vegetation Management Watercourse / Drainage (<i>Vegetation Management Act, 1999</i>)	
Stream Order	4
Waterway (<i>Fisheries Act, 1994</i>)	
Waterway	Low impact (green)
Watercourse Identification (<i>Water Act, 2000</i>)	
Watercourse / Drainage Feature / Unknown	The watercourse location fits the definition of a mapped Drainage Feature.
Other Comments	
<p>Creek bed characteristics and vegetation characteristics: Ephemeral watercourse 6m wide with 1.3m narrow low flow clay-based dry channel. Riparian vegetation on silt / clay banks. Scattered sparse <i>Acacia cambagei</i> dominates canopy layer to 5m in height, with <i>Cenchrus ciliaris</i> dominant and scattered <i>Bothriochloa sp.</i> ground cover.</p> <p>Weed risk: <i>Cenchrus ciliaris</i> and <i>Vachellia farnesiana</i> observed.</p> <p>Current Aquatic Values: nil</p> <p>Vehicle / Construction access requirements: A crossing within the alignment is absent. A shallow channel with steep slopes on banks. Minor modifications to bank slopes and approaches would enable vehicular access during the dry season. Removal of sparse riparian vegetation would be required. The nearest recorded access track is 100m to the south and main roads within 4000m to the west and east.</p>

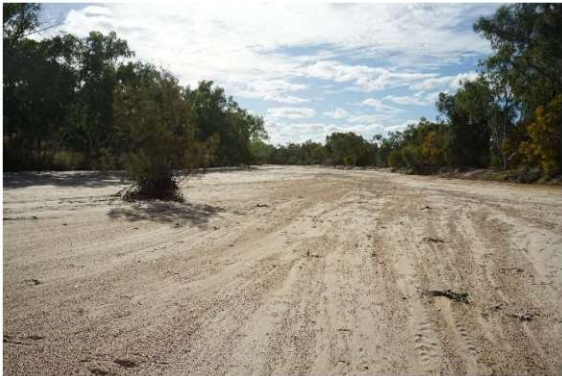
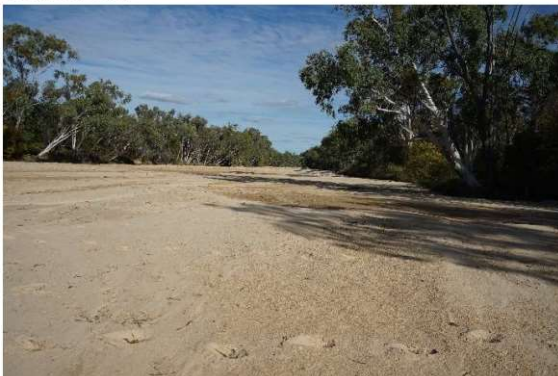
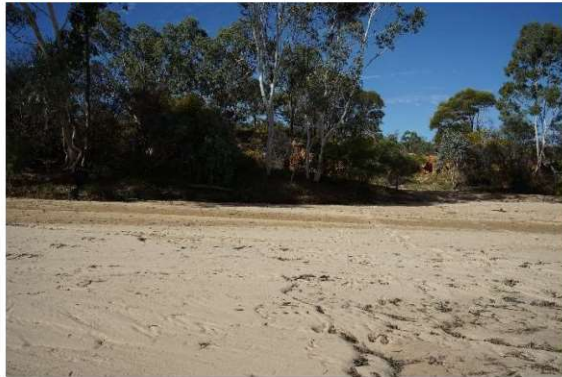
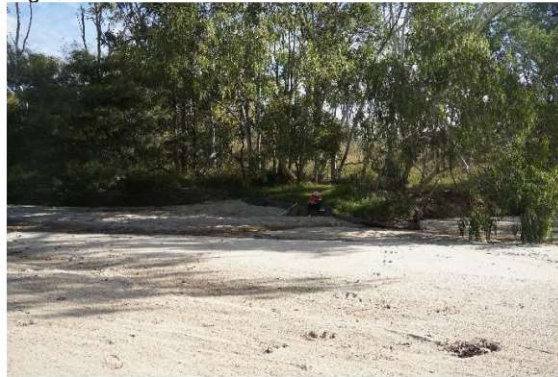
Desktop Mapping	Comment / Description
Vegetation Management Watercourse / Drainage (<i>Vegetation Management Act, 1999</i>)	
Stream Order	6
Waterway (<i>Fisheries Act, 1994</i>)	
Waterway	Major impact (purple)
Watercourse Identification (<i>Water Act, 2000</i>)	
Watercourse / Drainage Feature / Unknown	The watercourse location fits the definition of a mapped Watercourse.
Other Comments	
<p>Creek bed characteristics and vegetation characteristics: 83m wide watercourse containing an in-stream bar with riparian vegetation (10m wide). Riparian vegetation on banks. Steep, rocky eastern bank (8m tall) with sloped western bank (4m tall). <i>Eucalyptus camaldulensis</i> dominated canopy layer.</p> <p>Weed risk: None observed.</p> <p>Current Aquatic Values: Aquatic flora, algae and macrophyte absent.</p> <p>Vehicle / Construction access requirements: A crossing within the alignment is absent. Modifications to the eastern bank and approaches would enable vehicular access in the dry season, although would be difficult due to rocky ravines. Access may be possible further south or north beyond the reaches of the rocky structures. Removal of riparian vegetation may also be required.</p>

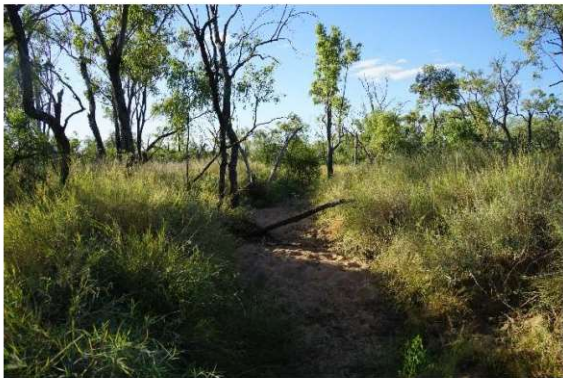
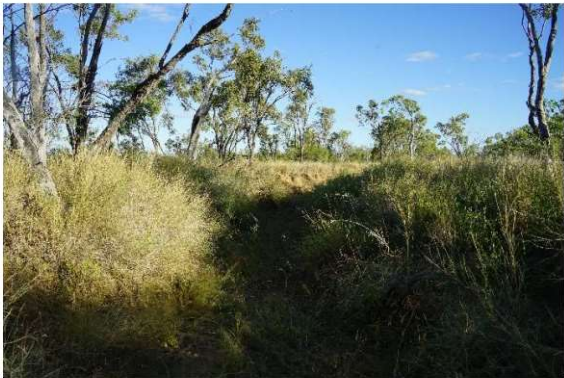
1.2 Prairie Creek - Watercourse W12-2

Desktop Mapping	Comment / Description
Vegetation Management Watercourse / Drainage (<i>Vegetation Management Act, 1999</i>)	
Stream Order	2
Waterway (<i>Fisheries Act, 1994</i>)	
Waterway	Low impact (green)
Watercourse Identification (<i>Water Act, 2000</i>)	
Watercourse / Drainage Feature / Unknown	The watercourse location fits the definition of a mapped Watercourse.
Other Comments	
<p>Creek bed characteristics and vegetation characteristics: Ephemeral watercourse 4m wide with a 1.2m deep dry sand channel. Wetland species absent. Banks covered in <i>E. coolabah</i> and <i>Carissa lanceolata</i>, and several grass species; <i>Aristida</i> sp., <i>Enneapogon</i> sp., <i>Eragrostis</i>., <i>Iseilema vaginiflorum</i>, <i>Eulalia aurea</i>, <i>Cenchrus</i> sp. and <i>Chloris pectinata</i>.</p> <p>Weed risk: <i>Vachellia farnesiana</i> observed.</p> <p>Current Aquatic Values: nil</p> <p>Vehicle / Construction access requirements: No crossing present within the alignment. Very limited modifications required for access. Dry weather only.</p>
