Waterway Barrier Works Technical Report

Waterway investigation and fish community survey in relation to the Scenic Rim Agricultural Industrial Precinct project.

Technical Report – April 2020

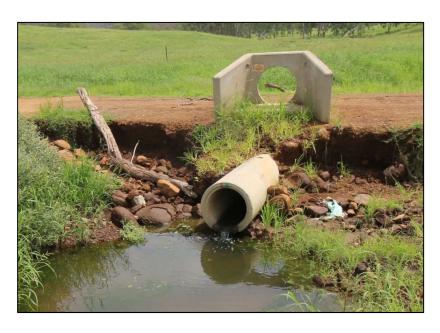
Despite fish colonisation into the site after recent rainfall, no fish were recorded within the middle to upper reaches of the amber waterway (site five and above). This is despite the middle reach having semi-permanent fish habitat within the site (Table 1; Appendix A). The most obvious reason for the lack of fish within this site was the presence of a downstream barrier, that is preventing fish from migrating upstream. The barrier to fish passage in this case was a narrow pipe culvert (reinforced concrete pipe 450mm diameter, 7.4m long) part of an internal road crossing at site four. It appears that the area below the culvert has eroded away and at the time of the site visit the outlet for the pipe was above the water level within the downstream pool (Figure 5).

Figure 5. The waterway crossing that is acting as a barrier to fish passage.

Many small bodied Australian native fish have relatively poor swimming speeds (Watson *et al.* 2020), do not jump to migrate upstream and are unlikely to have migrated through this pipe during higher water levels. Although fish may migrate past such a barrier, if there was enough

At the time of the field investigation there was a noticeable congregation of fish below this structure. For example, the catch per unit data from fish sampling indicates that there were over twice as many fish in this location, compared to the two sites located further downstream (sites 1 and 2). Waterway barriers often cause high congregations of fish and impact fish communities in many ways. Impacts include increase predation and disease, block access for recolonisation, spawning and feeding habitats. The impacts of barriers to fish migration are widely recognised in Australia (Mallen-Cooper, 1997; Walker, 1985; O'Connor *et al.*, 2006) and have been implicated in the decline of native fish in Australia over the previous 100 years (Mallen-Cooper, 1999).

Waterway crossings will be constructed in compliance with the relevant accepted development requirement (ADR) for operational work that is the construction or raising of waterway barrier works (DAF, 2018). The internal vehicle crossing, identified above as a barrier to fish passage, will be upgraded in compliance with the accepted development requirements for a replacement culvert crossing on a moderate risk (amber) waterway.

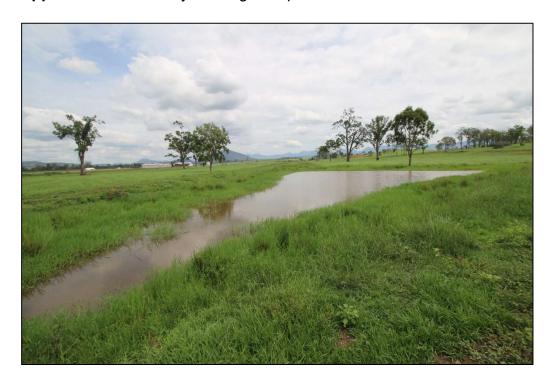
Site 1 – Shallow pool on diversion channel near north-eastern property boundary.

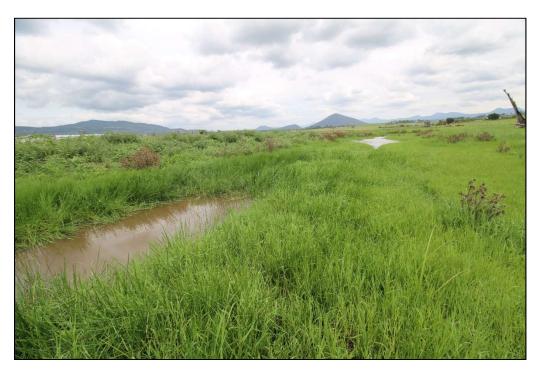
Site 2. Shallow pools within diversion channel next to levee bank.

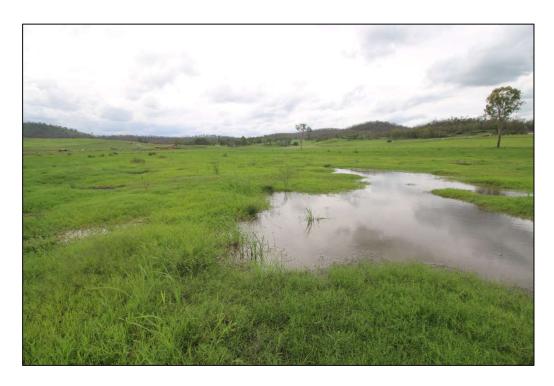
Site 3. Very shallow standing water (maximum depth 50mm) within water treatment wetland.

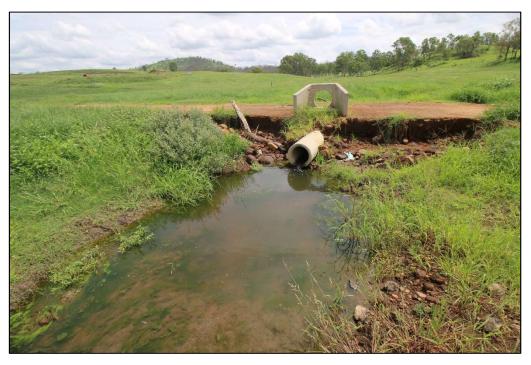
In the lower section of the amber waterway (between sites 2 and site 4) the waterway features became less defined. At site four a waterway crossing with a 450mm diameter pipe culvert concentrates flow creating waterway features including a downstream scour pool and defined bed and bank immediately below the crossing. Downstream of site four the amber waterway did not contain any waterway features and becomes very shallow without defined bed or banks (Table 1).

Site 4 - Small pool below culvert crossing contained fish. Culvert acting as barrier to fish passage.

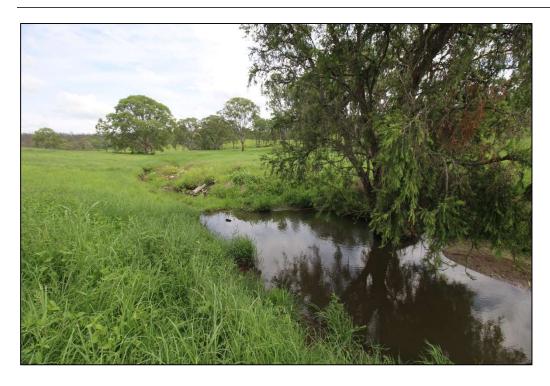
Site 5 - Pool habitat and dry channel upstream. No fish present.

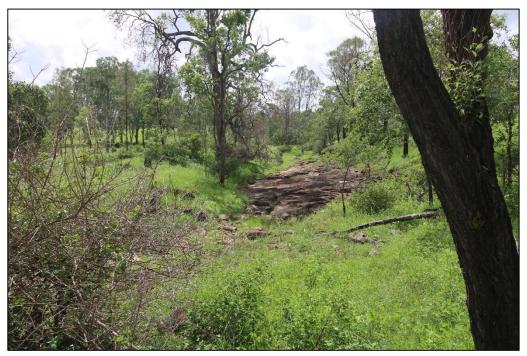
Site 6 - Dry channel

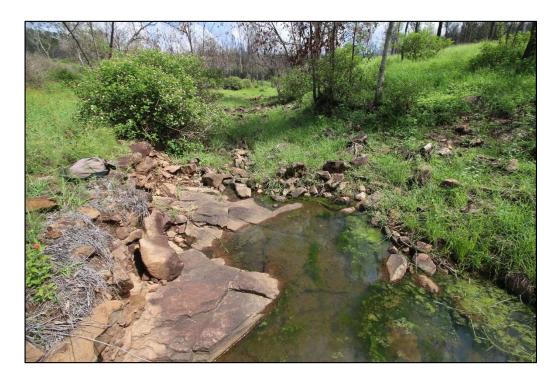
Site 7 – Isolated shallow pool and dry upstream channel.

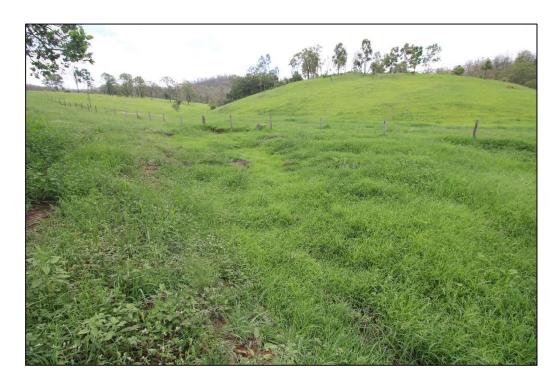
Site 8 – Dry gully with no waterway features.

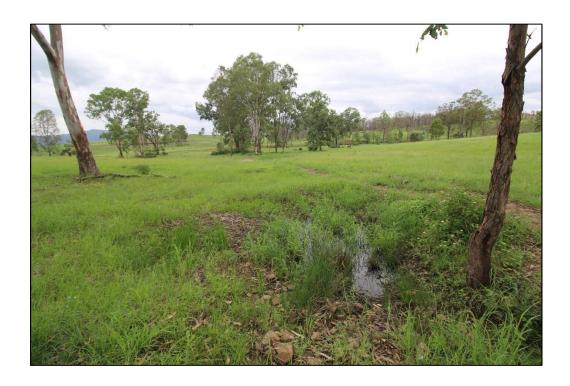
Site 9 - Gully with no waterway features.
