AQUIS RESORT AT THE GREAT BARRIER REEF PTY LTD

ENVIRONMENTAL IMPACT STATEMENT

CHAPTER 21 CULTURAL HERITAGE

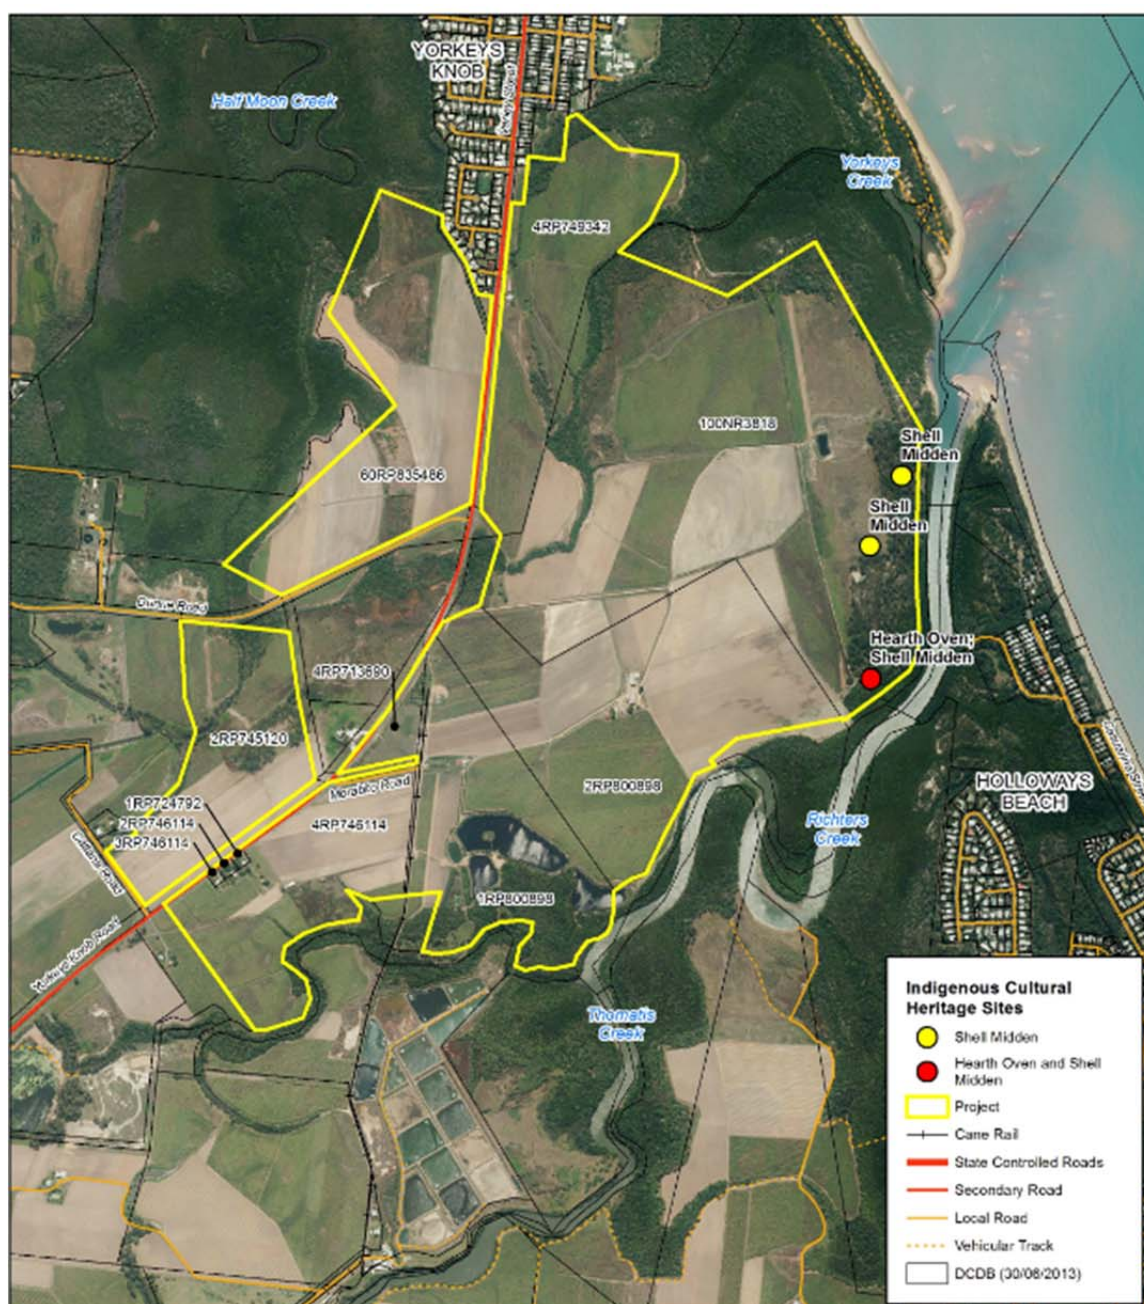
Figure 21-1 Indigenous cultural heritage sites.

AQUIS
GREAT BARRIER REEF RESORT
Aquis Resort Indigenous Cultural Heritage Review

Indigenous Cultural Heritage Sites

The general locations of these sites are shown on **Figure 21-2**.

Three indigenous cultural heritage (ICH) sites are registered. These consist of shell middens and a hearth oven and the sites are all located in natural vegetation along the eastern fringe of the Aquis Resort site. All sites are clear of the footprint of the development and do not present a constraint.

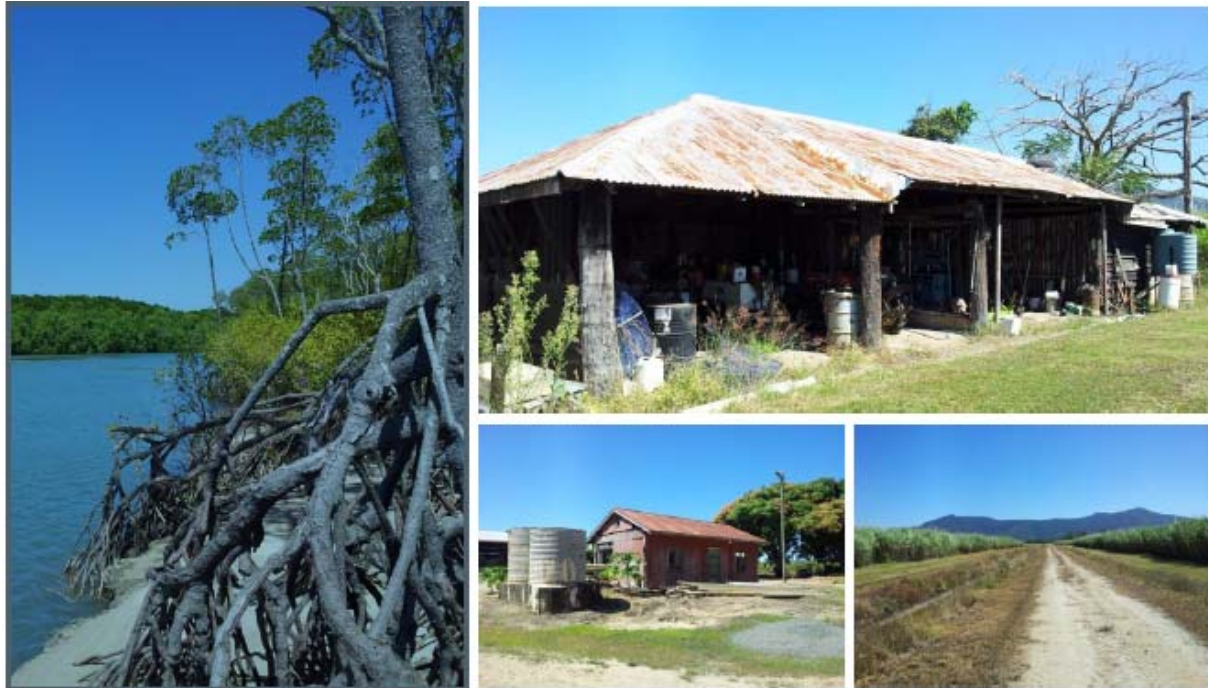
Photo 21-1 Mosaic of site images.

The current farm landscape reflects the works of the current owner to improve the flood immunity of the land and this is evidenced by the many drains and bunds that still exist, as well as the various structures on stumps or mounds. See photos over page.

Five hectares of ponds were constructed for the growing of barramundi but this use has now been abandoned.

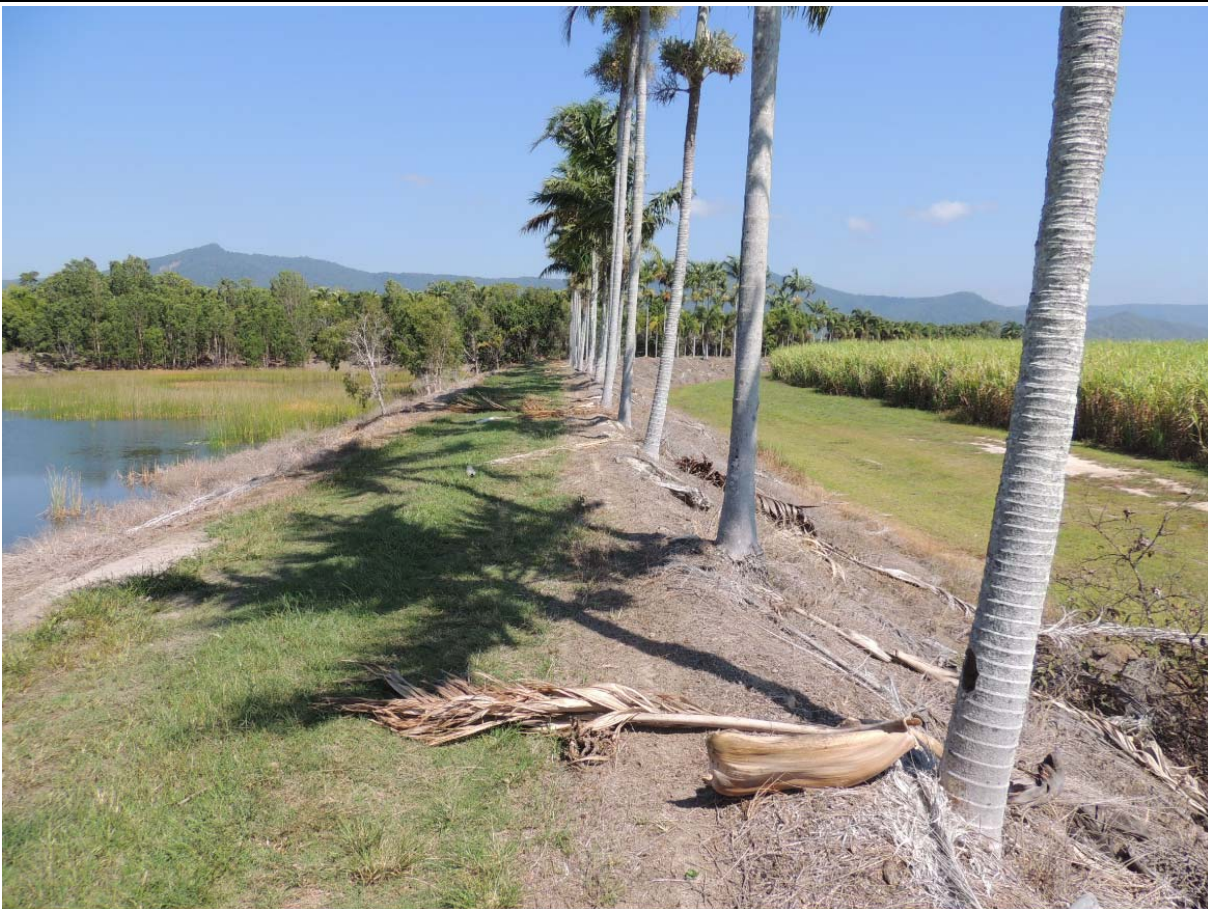
Photo 21-2 Bund separating cane land from one of the abandoned aquaculture ponds.
