# Airport Link

## Phase 2 – Detailed Feasibility Study

TECHNICAL PAPER NO. 3

CONTAMINATED LAND

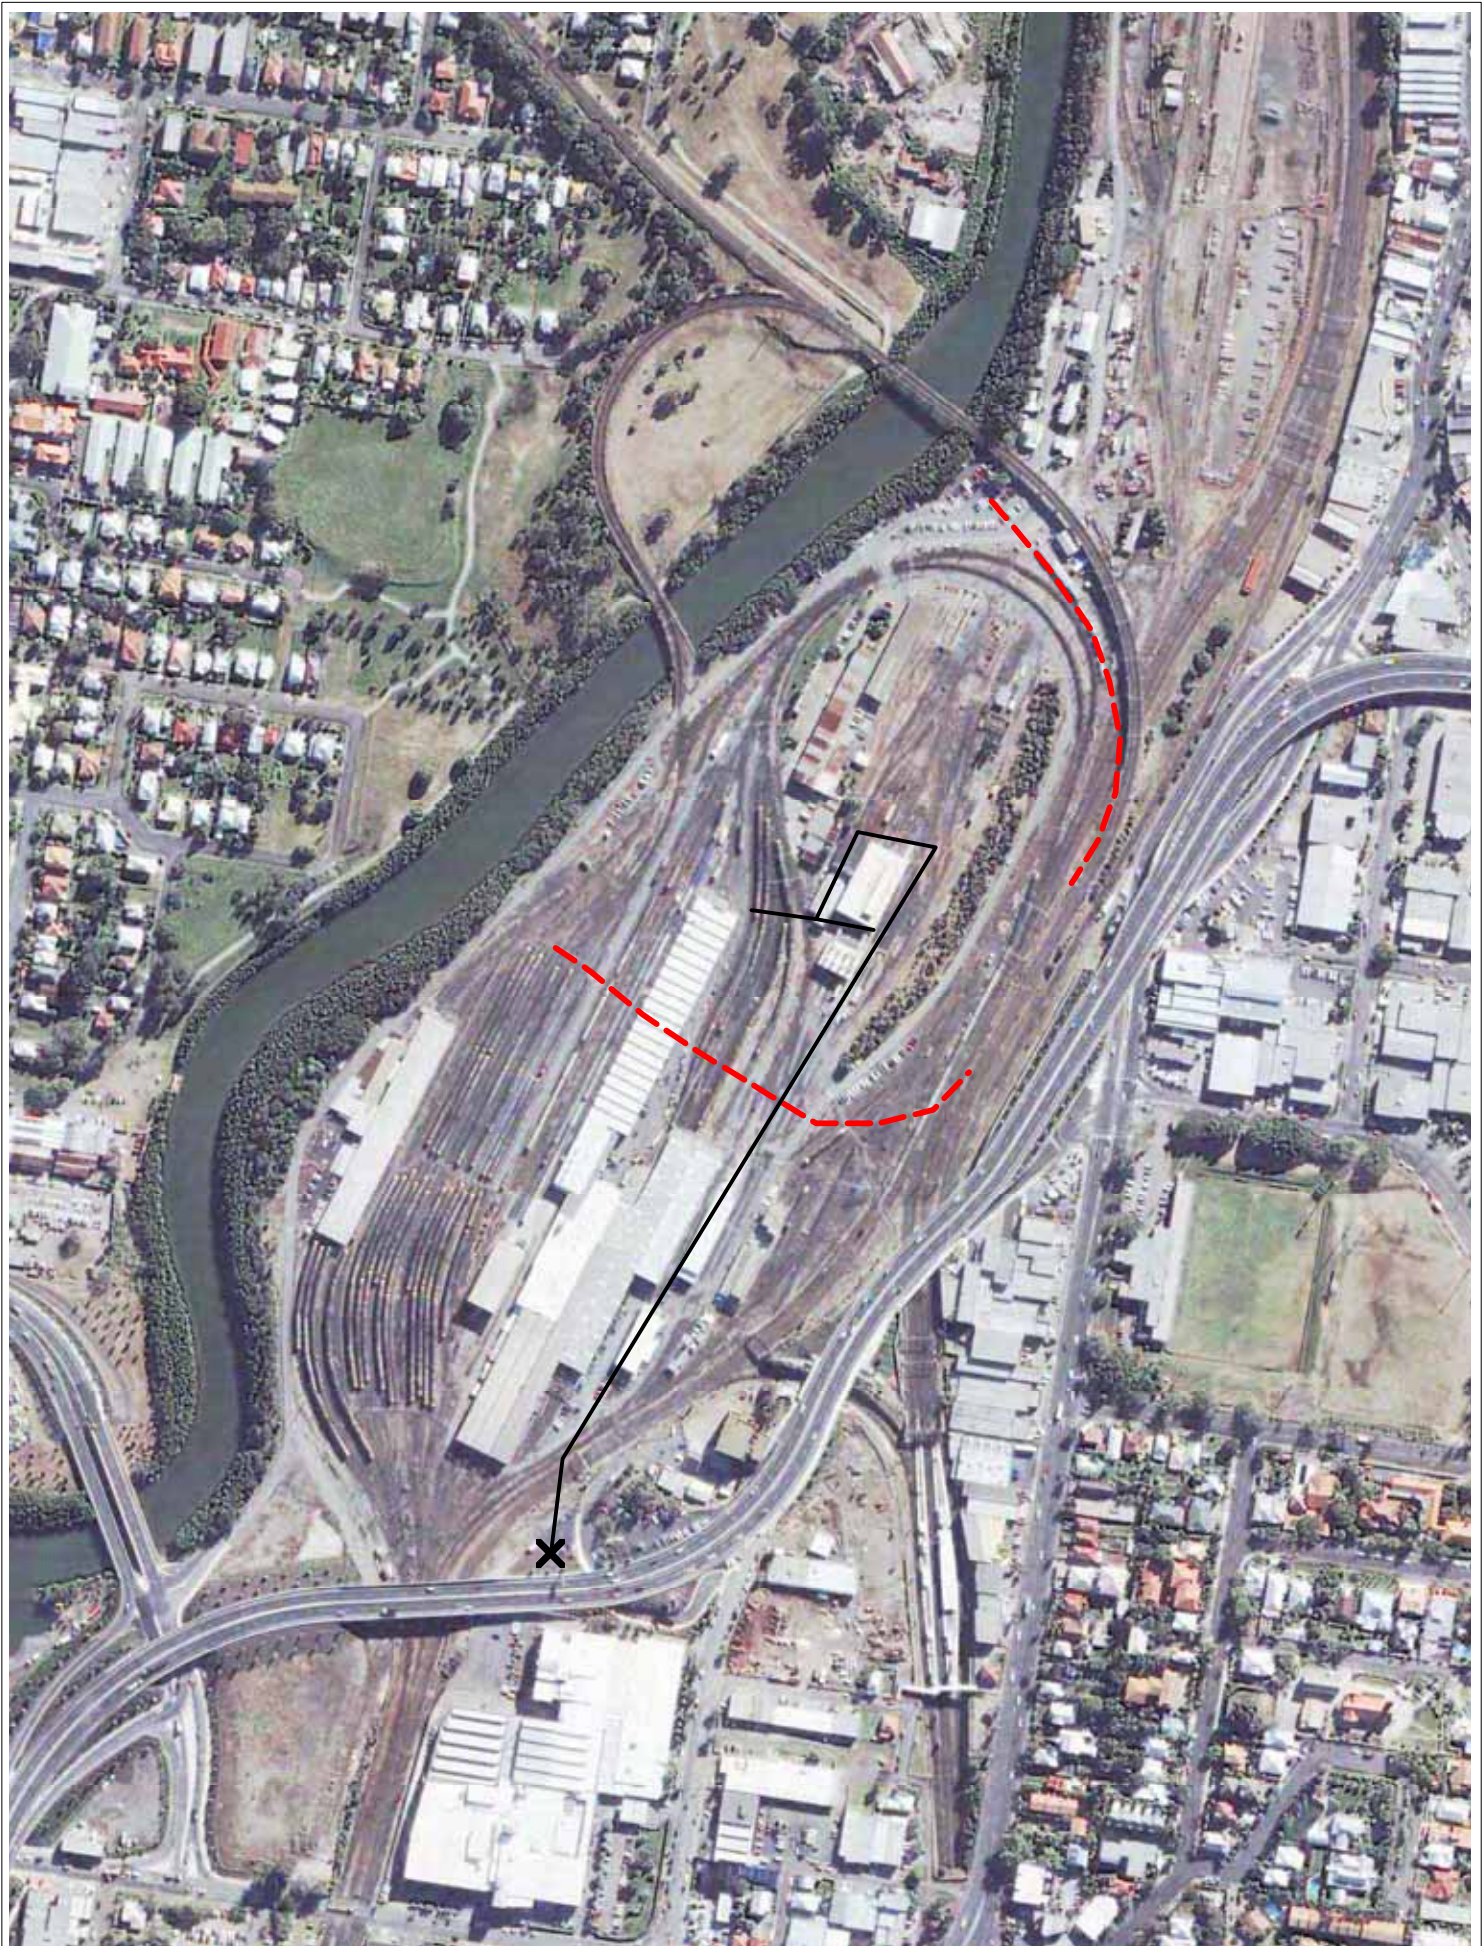
- Lot 2 on SP116599 Mayne Railway Yards. The Mayne Railway Yards have been used by QR for over 100 years. Hydrocarbon contamination exists on site. Free product was identified in late 1990s or early 2000s during site excavation activities (**Figure 2-1**). The source of contamination was identified from a leaking diesel reticulation line associated with two old 60,000 Litre (L) Aboveground Storage Tanks (ASTs) and related above ground handling. The USTs were removed during construction of the Inner City Bypass (ICB) and replaced with a 30,000 L AST located toward the centre of the southern yard. Inferred groundwater flow direction is to the northwest towards Enoggera Creek. A contamination risk assessment was conducted in the mid 1990s followed by a regular groundwater monitoring program. In recent years an extraction system was installed to remove free phase product.

- Observed Hydrogen Plume
- Diesel Reticulation Line
- X Previous Location of UST's

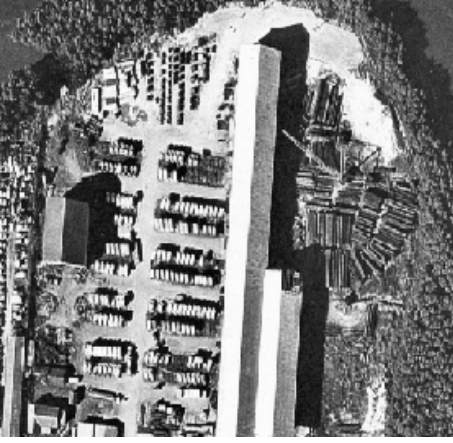
<p>1969</p>
		<p>By 1974 there have been extensions to the major buildings on the southern boundary. Timber stockpiles moved to the northern-central portion of the site. Riparian vegetation still intact.</p> <p>By 1994 the site had been demolished with buildings and stockpiles removed.</p>

Site Number	Real Property Description	Description of Site History	Historical Aerial photography
		<p>By 1969, two long, thin rectangular buildings have been constructed in the centre of the lot, covering the area otherwise covered by the dip.</p>

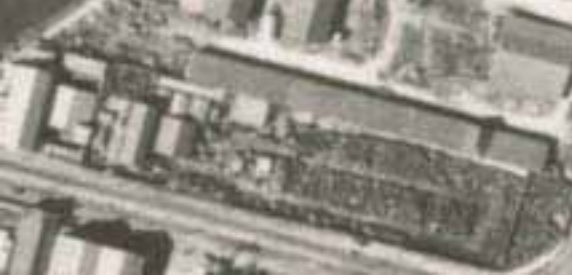
Site Number	Real Property Description	Description of Site History	Historical Aerial photography
D	<p>Lot 153 on RP861394 153-4 Campbell St. Bowen Hills, Lot 1 on RP152622 67 Bowen Bridge Rd. Bowen Hills, Lot 65 on RP861394 65-4 Bowen Bridge Rd. Bowen Hills, Lot 3 on RP207249 61-A Bowen Bridge Rd. Bowen Hills, Lot 2 on RP1526622 67-A Bowen Bridge Rd. Bowen Hills.</p> <p><b>Scrap Yard</b></p>	<p>BCC 1951 and 19565 A rectangular shaped building runs along the entire eastern boundary. The remainder of the central and southern portions of the lot consists of two and a half rows of scrap metal or tyres. There are a series of smaller square and rectangular shaped buildings on the northern portion of the lot.</p>

<p>The central and southern portions of the premises are tidier with an area segregated via a fence on the southern side. No materials stockpiled in that corner.</p>

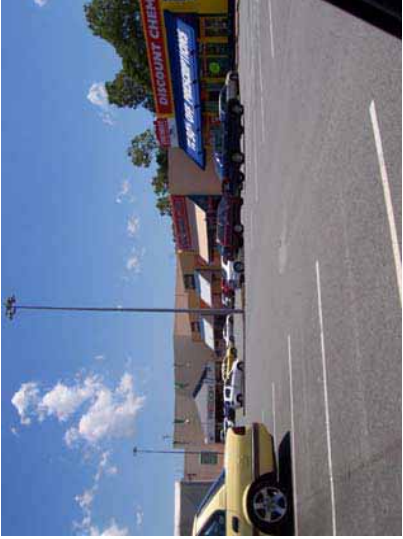
<p>2005</p>

<p>1994</p>
		<p>In 2005 the site contains the Freedom Furniture and Homemaker City retail and commercial precinct.</p>

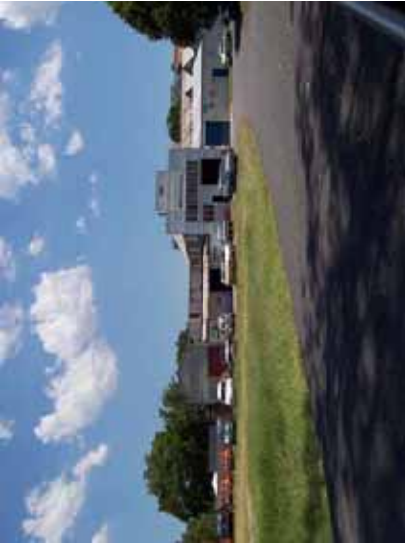
Site Number	Real Property Description	Description of Site History	Historical Aerial photography
<b>H</b>	Mechanical repairer 23-4 Earle Street, Windsor Lot 3 on RP52982	Industrial Historical use as industrial, potential risk of hazardous contaminants

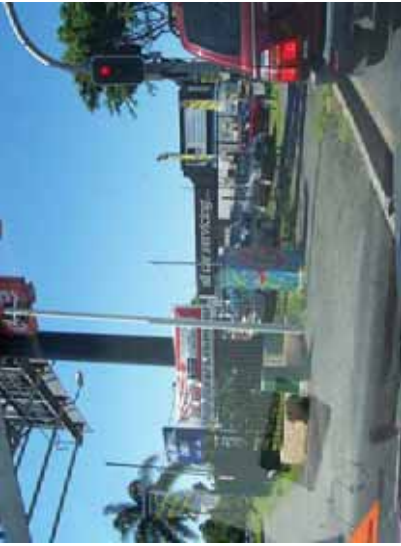
<b>I</b>	Auto Leaders 78 Lutwyche Road, Windsor Lot 53 on RP80002	Commercial

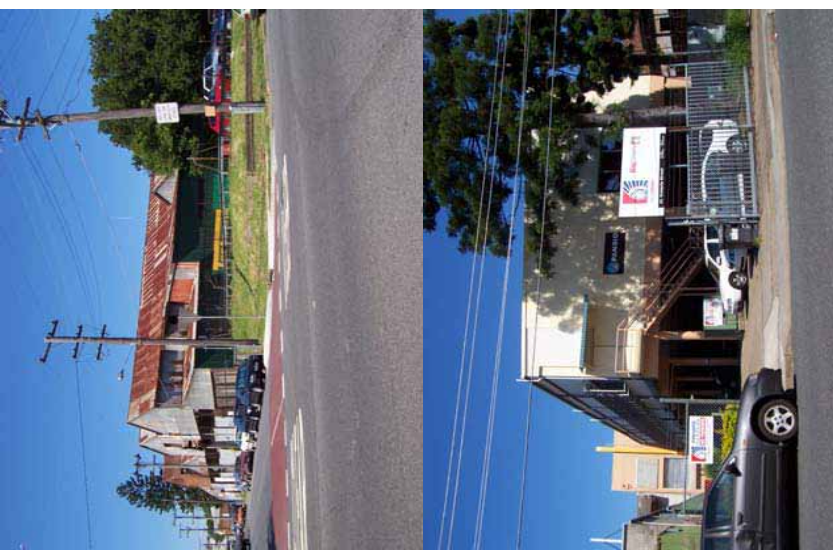
Site Number	Real Property Description	Description of Site History	Historical Aerial photography
J	<p>21-57 Rosemount Street</p> <p>Block between Nicholas &amp; Northey Streets</p> <p>Lots 61 to 69, 72 and 76 on RP18524 and Lot 77 on RP898070.</p> <p>Victoria St Windsor</p>	<p>Industrial</p> <p>Row of industrial sites, mixture of timber stores, car servicing, surgical storage and printer</p>

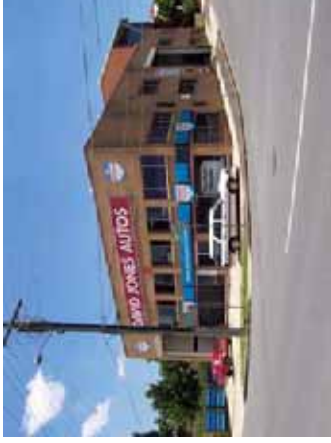
5	David Jones Auto Campbell Street, corner of Wren Street	Industrial Next to ICB Likely to have BCC licence as a Motor Vehicle Workshop.

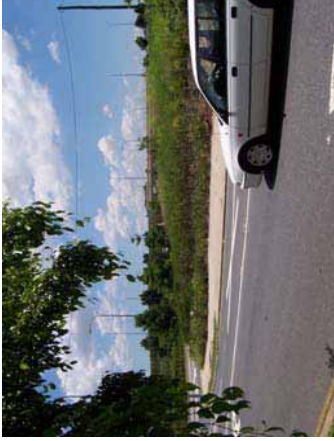
Site Number	Site Name and Address	Current Land Use	Photograph
7	Empty lot Corner Horace & Campbell Streets On EMR for Petroleum Product Storage	Reserve Disused site, no buildings, fill dumped on-site, some machinery on-site.

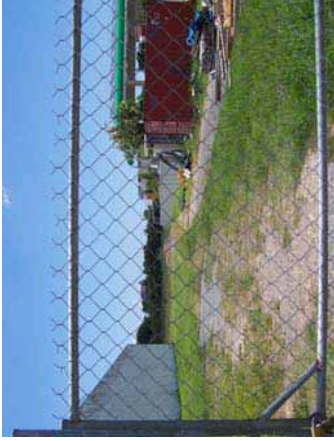
9 F	Vacant 1 Butterfield Street Lot 3 on RP9939	Reserve Next to BP, scrap on-site Unknown site use

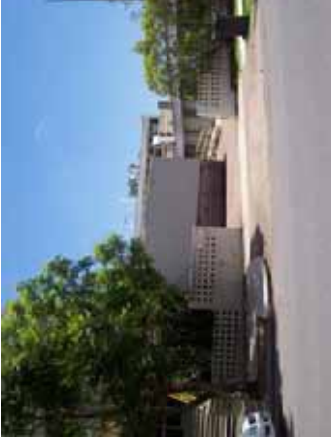
12	Yellow Cabs 35 Butterfield Street, Herston Lot 449 SL4244	Industrial On EMR Between Main Roads building and Auto Repairs. Refuelling, vehicle maintenance and air conditioner repairs.

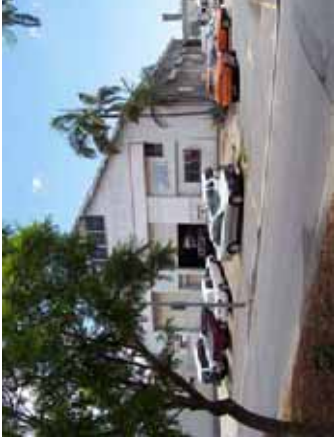
14	Boral Concrete Horace Street, Corner of Lutwyche Road	Industrial Known to have USTs on eastern portion of the block

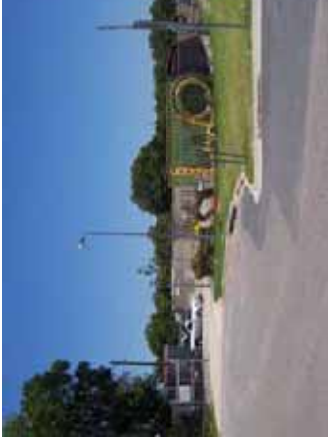
15	Car Yard Horace Street	Commercial	
16	Landscaping & Bitumen Supplies Corner Horace & Earle Streets (north of ICB exit)	Industrial Historical aerial photography search indicated former timber yard on this site

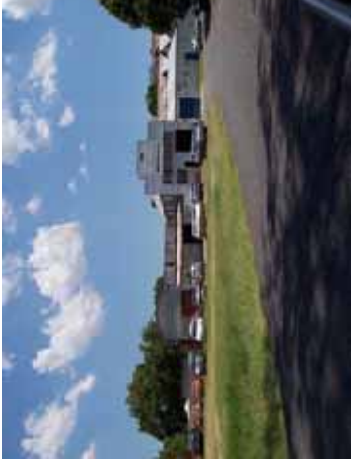
<b>Site Number</b>	<b>Site Name and Address</b>	<b>Current Land Use</b>	<b>Photograph</b>
20 <b>H</b>	Mechanical repairer Byrne Street	Industrial Historical use as industrial, potential risk of hazardous contaminants

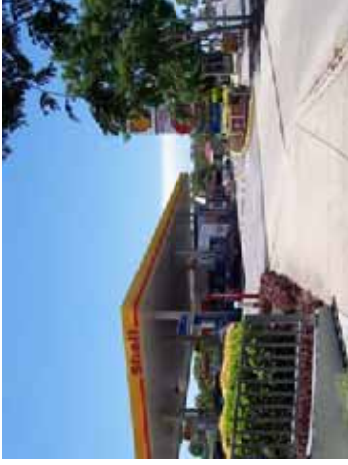
22 <b>G</b>	Freedom – Homemaker City 214 Lutwyche Road Lot 7 on RP223902	Commercial Location of former ASTs

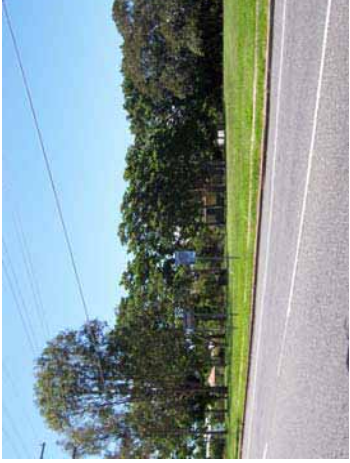
<b>Site Number</b>	<b>Site Name and Address</b>	<b>Current Land Use</b>	<b>Photograph</b>
27	Parkland Bradshaw Street	Reserve Located down slope from Lutwyche Road On EMR for Landfill

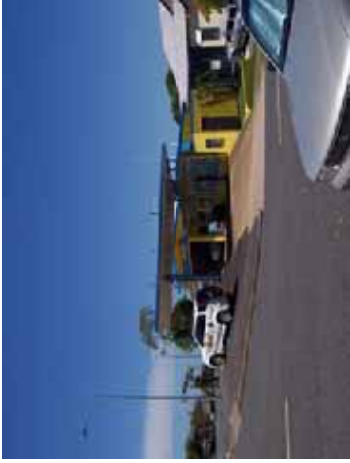
28	Denning Car Audio 607 Lutwyche Road Cnr Felix & Lutwyche Roads Lot 2 on RP19349	Commercial On EMR for service station No info from BCC

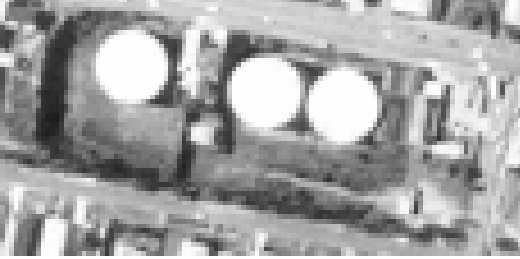
Year	Real Property Description	Description of Immediate Site	Description of Surrounding Area	Historical Aerial photography
1978		<p>staining or fill.</p> <p>The bunds surrounding both of the southern tanks have been reinforced and enlarged. The northern tank compound has been surrounded by a high fence, visual barrier for surrounding properties. A building has been constructed between the northern tank and the southern tanks to the right of the pre-existing building and it adjoins Lutwyche Road. This may be a loading gantry or canopy for a service station.</p>	No changes to the surrounding land uses

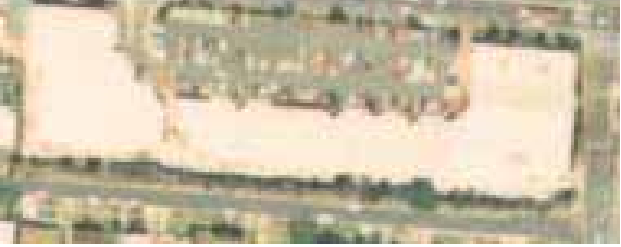
Year	Real Property Description	Description of Immediate Site	Description of Surrounding Area	Historical Aerial photography
1994		Site has been completely redeveloped to the Freedom Furniture complex consisting of an eastern facing U-shaped building which borders the western boundary with Rosemount Terrace. A bitumen surfaced car park exists on the central-eastern portion of the site bordering Lutwyche Road. The entire site is covered with a hard pavement.

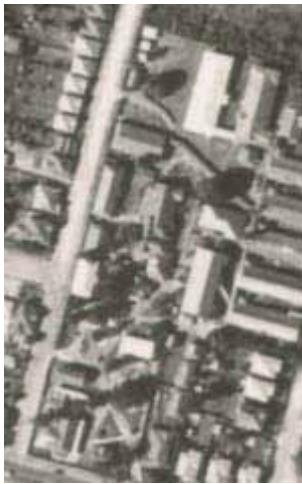
Year	Real Property Description	Description of Immediate Site	Description of Surrounding Area	Historical Aerial photography
1946	Lot 8 on RP72098 189 Lutwyche Road, Windsor  <b>Place of interest</b>	Compound of buildings is located opposite the petroleum product storage facility which is now Freedom furniture. The premises may have been a hospital, army barracks or nursing home. Potential for small scale petroleum product storage.

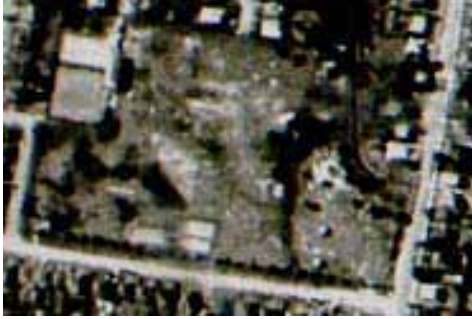
1946		Not on photo.		
1955	Lot 1 on RP19518 Melrose Park  <b>Landfill</b>	<p>Three areas of disturbance on the entire site. The boundary with Thorpe Street in the north eastern corner contains two (one square and one rectangular) tennis courts with a building on their southern border. The central portion of the western boundary with Roseleigh Street contains two buildings and an area of disturbance north of the buildings (most likely a car park). The south western corner of the site bordering on Rose Street contains the area of most disturbance consisting of bare pavement, potentially the landfill area.</p> <p>According to BCC records the site operated as a sanitary landfill between 13/3/1958 and 26/5/1958. Area of 47,849m2 depth of waste is approximately 2mbgs. No record of contents. Site not monitored by BCC.</p>	<p>North – Thorpe Street and low density residential</p> <p>East – Jimbour Street</p> <p>South – Rose Street and low density residential</p> <p>West – Roseleigh Street and low density residential</p>

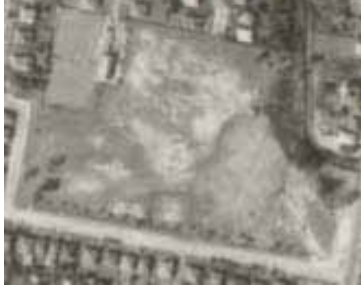
Year	Real Property Description	Description of Immediate Site	Description of Surrounding Area	Historical Aerial photography
1965		The amount of disturbance is not significantly greater than previous years. Two grass tennis courts on the north eastern corner of the site.	No significant changes

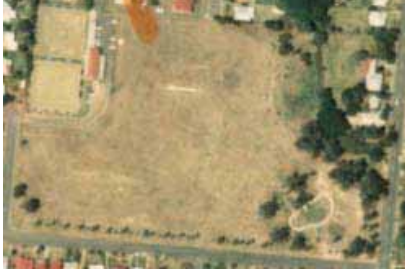
1969		The tennis courts still present on north eastern corner. There are isolated patches of scalding on the park, mainly over the cricket ground. Evidence of ground disturbance in south west corner of the site.		
1978		No significant changes		
1987		The tennis court complex in the north eastern corner appears to have been redeveloped and there is a roadway leading into the site.		
1994		No significant changes. Complete area is covered by open space and park.	No significant changes.

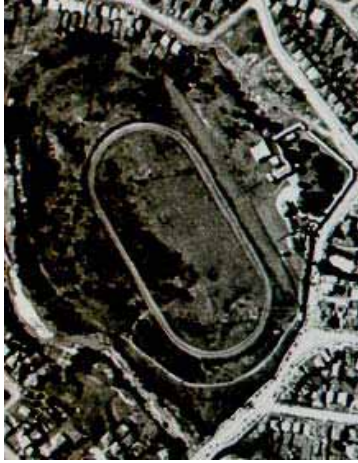
Year	Real Property Description	Description of Immediate Site	Description of Surrounding Area	Historical Aerial photography
1955	Lot 1182 on SL9293 (Emergency Services)  <b>Landfill</b>	The northern portion of the site contains a raceway. Raceway and buildings encircled with a fence/wall. Series of buildings in the south east corner, presumed to be amenities for the raceway. Significance ground disturbance in the south eastern corner, may be location of landfill.	North – Kedron Brook and residential. Large disturbed areas. East – Park Road and residential South – Junction of Lutwyche, Kedron and Park Roads West – Kedron Road and residential

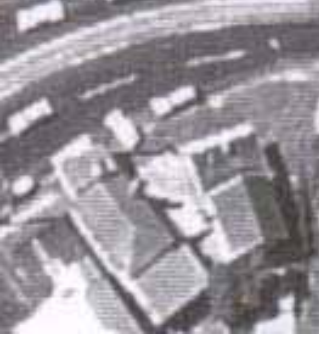
Year	Real Property Description	Description of Immediate Site	Description of Surrounding Area	Historical Aerial photography
1969		The lot contains a rectangular shaped building (northern portion of the site) that appears to have two canopies, one on the western side of the building and the other on the eastern side bordering onto intersection with Lutwyche, Kedron Park and Gympie Roads. The building has a chimney or stack and the building is separated from another building by a concrete pavement. The southern building consists of a smaller rectangular shaped building and a canopy on its eastern side.	No significant changes

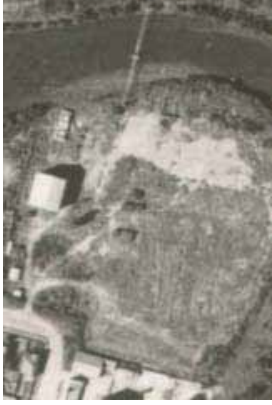
1946	<b>C</b>  Lot 2 on RP56087 7 Earle Street, Windsor  <b>Sawmill/Timber treatment</b>	Lot is generally vacant. There are two small buildings (likely to be sheds) on the north western corner of the site. On the central northern boundary there is a larger square building. There is minor surface land disturbance on the eastern boundary. A pipeline crosses Breakfast Creek and onto the property, pipeline is underground. North of the pipeline and directly east of the square building are two circular structures, likely to be fans.	North – northern boundary shared with a scrap yard. Commercial/industrial. East – Breakfast Creek, then vacant land (vegetated) and then railway yards. South – Breakfast Creek and general industry West – Horace Street and Lutwyche Road. Commercial/industrial.

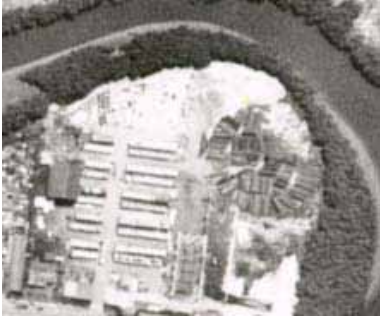
1955		Minor surface disturbance		
1960		Pipeline across the river has been removed. Significant site disturbance with the development of a timber treatment facility/sawmill. The southern portion of the site contains timber storage and there appears to be a thin depression (perhaps a dip) on the western side of the property. Vehicles are parked on the central/northern portion of the lot.	East – the opposite bank of Breakfast Creek has been developed into an extension of the rail yards.

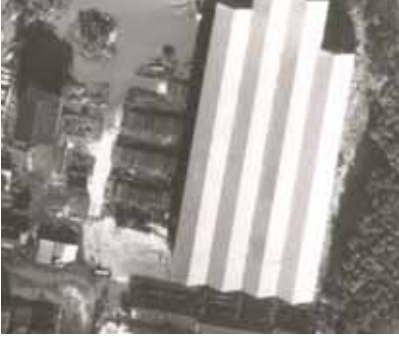
<p>QASCO Run 2A (1969)</p>
1974		Extensions to the major sawmill/treatment building on the southern boundary. Timber stockpiles moved to the northern-central portion of the site. Riparian vegetation still in tact.

<p>Brisbane Floods (1974)</p>
1978		Site has been demolished with buildings and stockpiles removed.

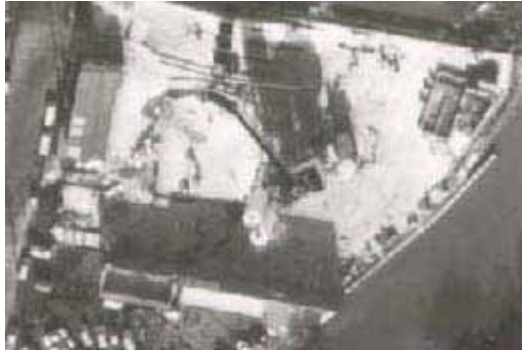
1960		No significant changes		
1974		Loss of riparian vegetation. BCC records indicate in 1971 1x4,500L UST filled with sand and 2 x 13,600L USTs installed and there location is recorded. Unknown location of sand filled tank.		
1978		No significant changes		
1987		No significant changes		
1995		Not on photograph

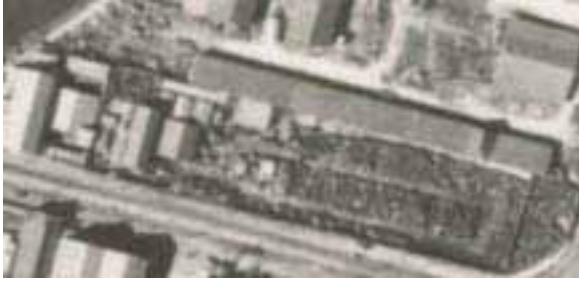
Year	Real Property Description	Description of Immediate Site	Description of Surrounding Area	Historical Aerial photography
1946	<p><b>D</b></p> <p>Lot 153 on RP861394, Lot 1 on RP152622, Lot 65 on RP861394, 61A-67 Lutwyche Road, Bowen Hills</p> <p><b>Scrap Yard</b></p>	<p>A rectangular shaped building runs along the entire eastern boundary. The remainder of the central and southern portions of the lot consists of two and a half rows of scrap metal or tyres. There are a series of smaller square and rectangular shaped buildings on the northern portion of the lot.</p>	<p>North – Breakfast Creek and concrete batching plant</p> <p>East – commercial/industrial</p> <p>South – Campbell Street and residential</p> <p>West – Lutwyche Road and industrial/commercial</p>

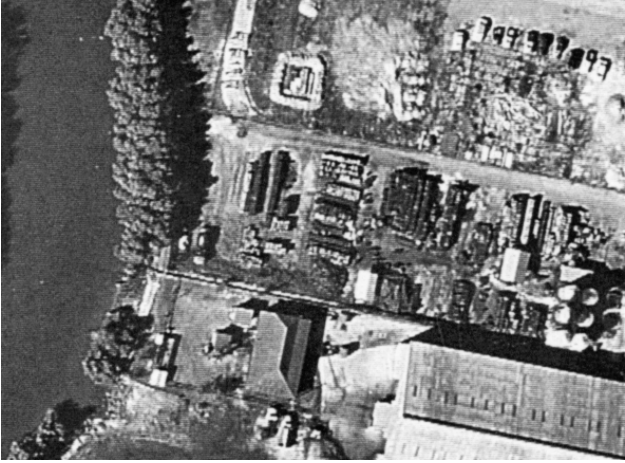
1974		<p>Slipway appears redundant. Six tall vessels still present in the central portion of the site. Possibly a batching plant or high pressurised vessels. Flood waters deem unable to assess whether wastes/materials are stored on the northern portion of the block.</p>

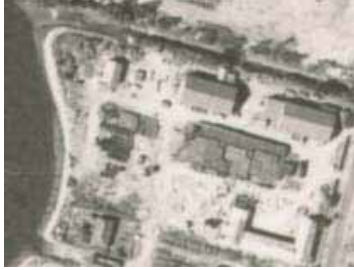
<b>Year</b>	<b>Real Property Description</b>	<b>Description of Immediate Site</b>	<b>Description of Surrounding Area</b>	<b>Historical Aerial photography</b>
1987		Tanks and materials stored have been removed.		
1994		Not on photograph		
1946	Lot 2 on RP92589 117 Campbell Street, Bowen Hills  <b>Hazardous Contaminants</b>	Materials stored on the northern portion of the premises closest to Breakfast Creek. A series of low-level buildings in the centre of the premises.	North – Breakfast Creek East – tidal inlet from Breakfast Creek and railway yards South – Campbell Street and residential uses. West - Commercial/Industrial

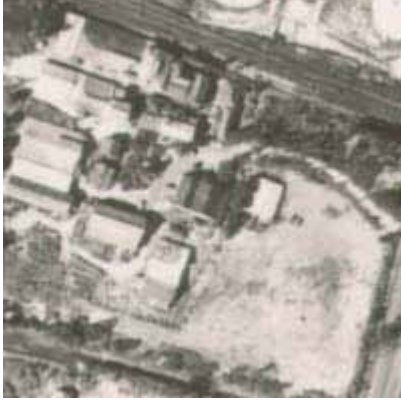
Year	Real Property Description	Description of Immediate Site	Description of Surrounding Area	Historical Aerial photography
1974	Lot 3 on RP890186 49-4 CAMPBELL ST BOWEN HILLS	Building complete. Flood water over the northern portion of the lot prevents identification of whether waste is still stored on the northern portion of the lot.	No significant change	
1987		No significant change	No significant change	
1994		Not on photograph		
1946		General industrial site. Materials stored on ground on north western corner.	North – Breakfast Creek and industrial uses East – Bulk tank storage (hydrocarbons perhaps)Railway yards/tracks South – Campbell Street and residential uses. West – Inlet of Breakfast creek//stormwater drain. Commercial/industrial.

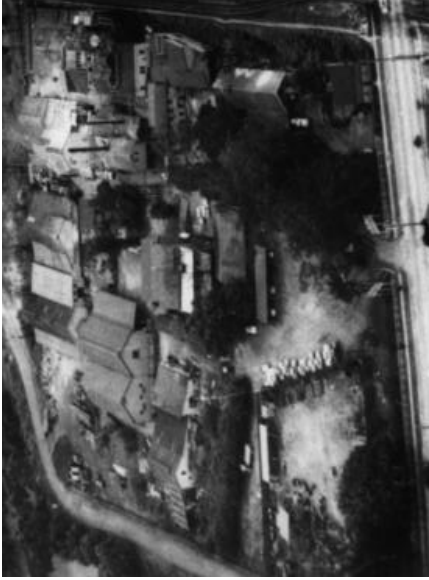
1955		No significant change	No significant change	
1960		Scrap yard or waste storage appears to have been developed on the south western corner bordering Campbell Street. There are stacks visible in the building on the eastern side of the premises suggesting that there may be a boiler or other device requiring a fuel source from underground fuel storages.	No significant change

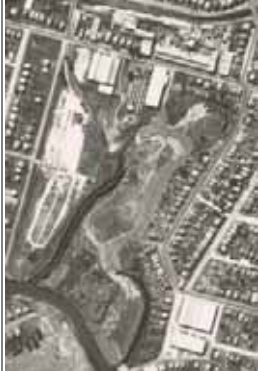
Real Property Description	Description	Historical Aerial Photo
Properties within and surrounding Downey Park in Windsor	Majority of land has been cleared and some roads are present. Site appears to be a landfill. Riparian vegetation is present around two existing drainage channels and some vegetation in the south-east of the site. The site contains both commercial/industrial and residential areas. The commercial/industrial areas are heavily developed with large buildings surrounding Newmarket Road and the railway line to the north of the site. Some residential areas throughout the site. A large building is separated from the rest of the commercial/industrial sites, by the residential areas.

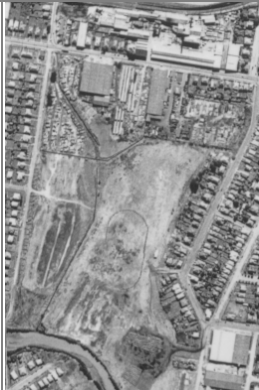
1946
	An increase in the density of commercial/industrial buildings since 1946 and more land has been cleared including pre-existing vegetation at the south-east of the site. Both drainage channels have been filled in and a minor trench has been put in place of the larger channel to the west. No further residential houses have been added to the site.

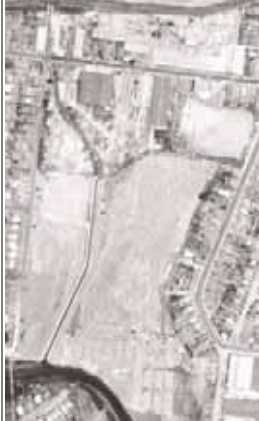
Majority of land now appears as cleared fields/parkland (Downey Park) with some playing fields at the south of the site. Some commercial/industrial works have been cleared to the south of Newmarket Road and carparking added whilst, work still continues to the north. No further residential houses have been added.

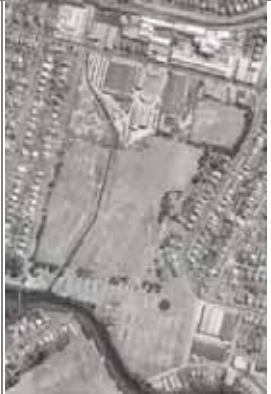
Real Property Description	Description	Historical Aerial Photo
	Buildings have been added to the south of Newmarket Road along with an increase in carparking spaces. The parkland appears to have matured with more trees around the perimeter.

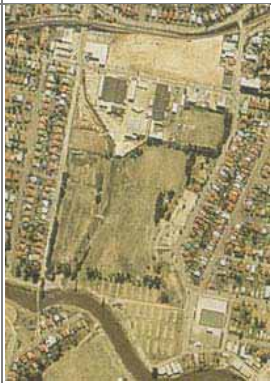
1969
	Commercial/industrial sites along with all residential lots have been cleared north of Newmarket Road. All residential lots, excluding one, have been cleared from the east of the site. Three paved tennis/netball courts are now in place of large building at the south-east of site.

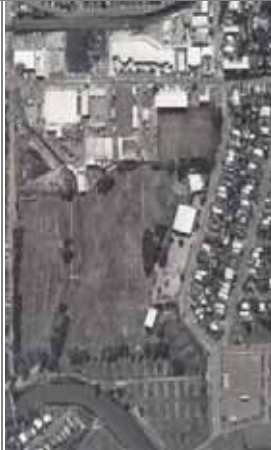
1978
	Playing fields are further developed including soccer and baseball fields. Buildings have been erected at the east of the site. More tennis/netball courts have been added to the paved site in the south-east corner of the site. A large commercial area has been added to the north of Newmarket Road with a large structure in place. The remaining residential lots to the north of Newmarket Road have been replaced with commercial properties. South of Newmarket Road, further commercial building have also been erected.

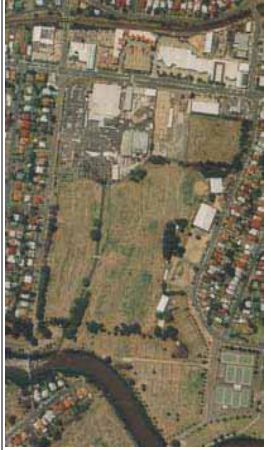
Real Property Description	Description	Historical Aerial Photo
	Commercial buildings have increased around Newmarket Road. Little change to Downey Park.

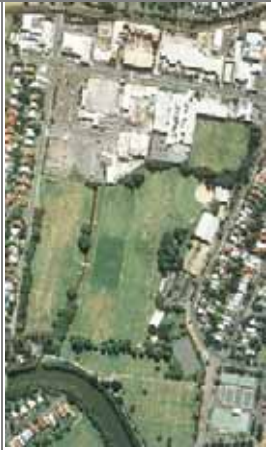
1994
	Commercial precinct further developed south of Newmarket Road since 1994. Downey Park relatively unchanged.

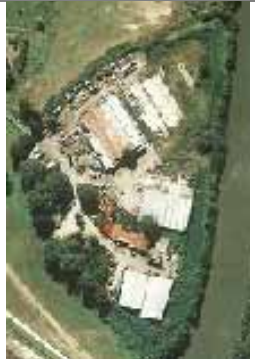
1994
	Much of the original buildings have been removed or appear abandoned. Surrounding vegetation has grown quite substantially.

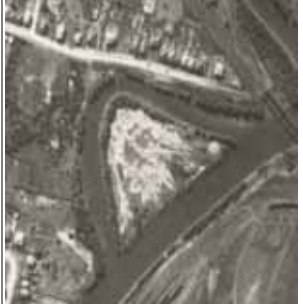
2001
Lot 23 on CP827248. 235-A Lutwyche Road Windsor	Meander bend in river has been previously shortcut to increase flow upstream, has resulted in the formation of an isolated piece of land with riparian vegetation especially on the 'older' western side of the 'island'. The surface of the 'island' appears disturbed possibly by plant traffic.

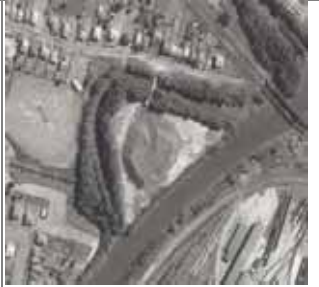
Real Property Description	Description	Historical Aerial Photo
	Further maturation of riparian vegetation. A bridge has been constructed on the northern side connecting the 'island' to the 'mainland'. A large pile of sediment has been transported to the island probably via the bridge.

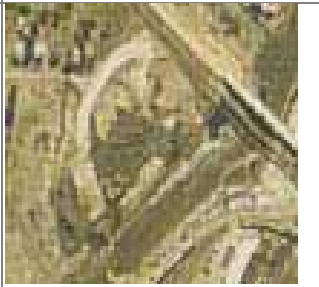
1969
	The island has been re-connected to the mainland by infilling the meander most likely with the sediment seen in previous photo. All vegetation appears to have been stripped from the site and houses to the north and west of the site have been removed.

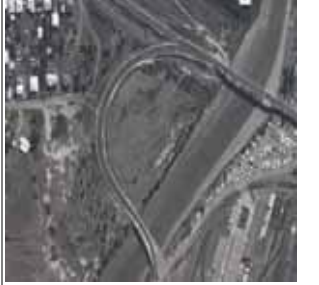
1978
	A railway line has been constructed around the previous meander. These tracks have been implemented to allow trains to turn around in the railway yards. Some riparian vegetation has regrown along the banks of the creek.

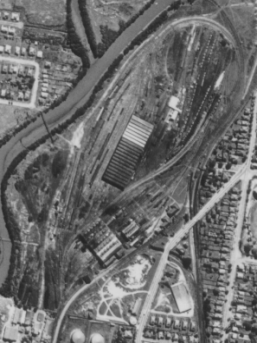
1946
	Little change to the layout of the yards. The southwest corner appears to have a couple of large stockpiles, likely to be coal or gravel. Riparian vegetation as grown and is more dominant than in 1946.

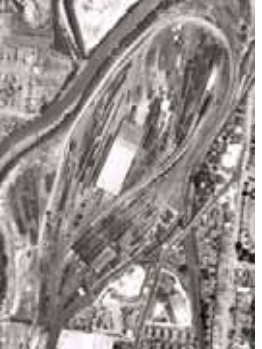
1955
	Some adjoining buildings have been constructed just northeast of the main train shed. Large stockpiles are now numerous in the yard. Riparian vegetation as further developed along the banks of the Enoggera Creek.
