Australia Pacific LNG Project

Volume 5: Attachments

Attachment 6: Geology, Topography, Geomorphology and Soils Assessment - Pipeline

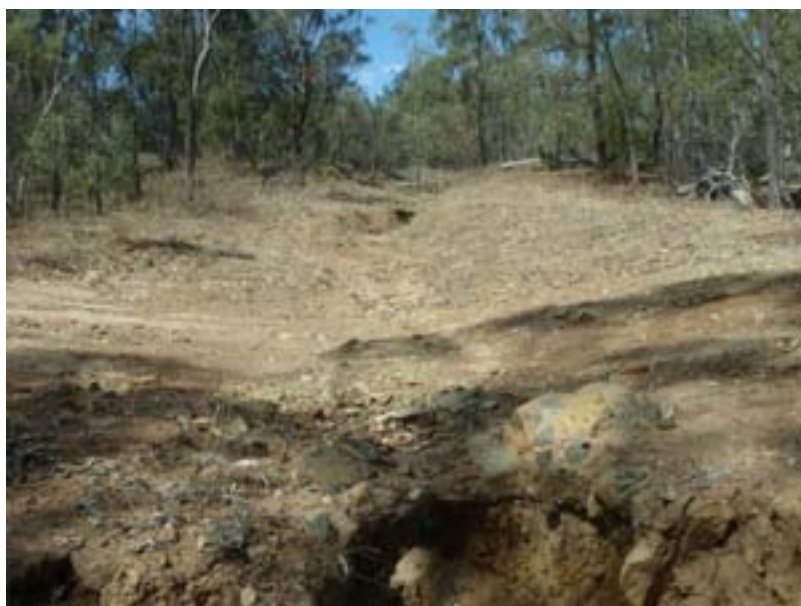
Plate 5.1 EROS001: Soil Group 2c

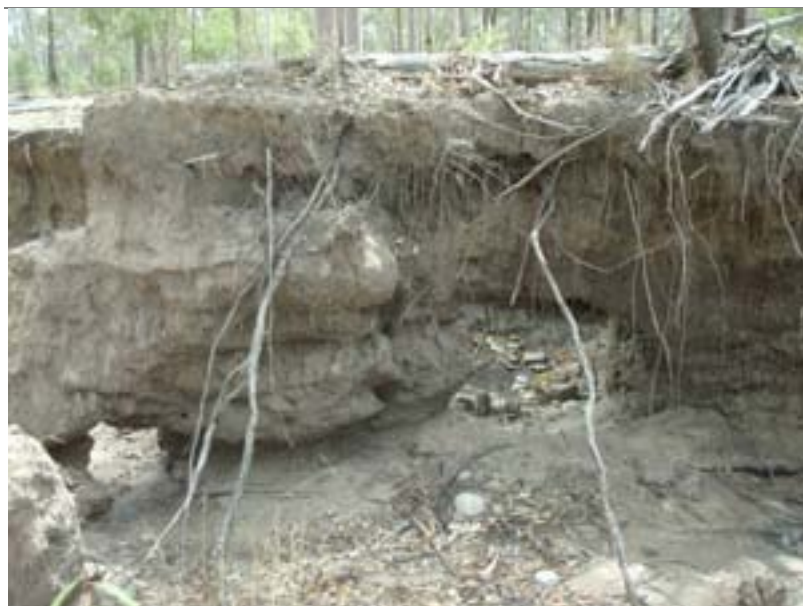
**Plate 5.7 EROS007: Soil Group 1b**
