Australia Pacific LNG Project

Attachment 9: Preliminary Site Investigation - Land Contamination Report - Pipeline

Executive summary

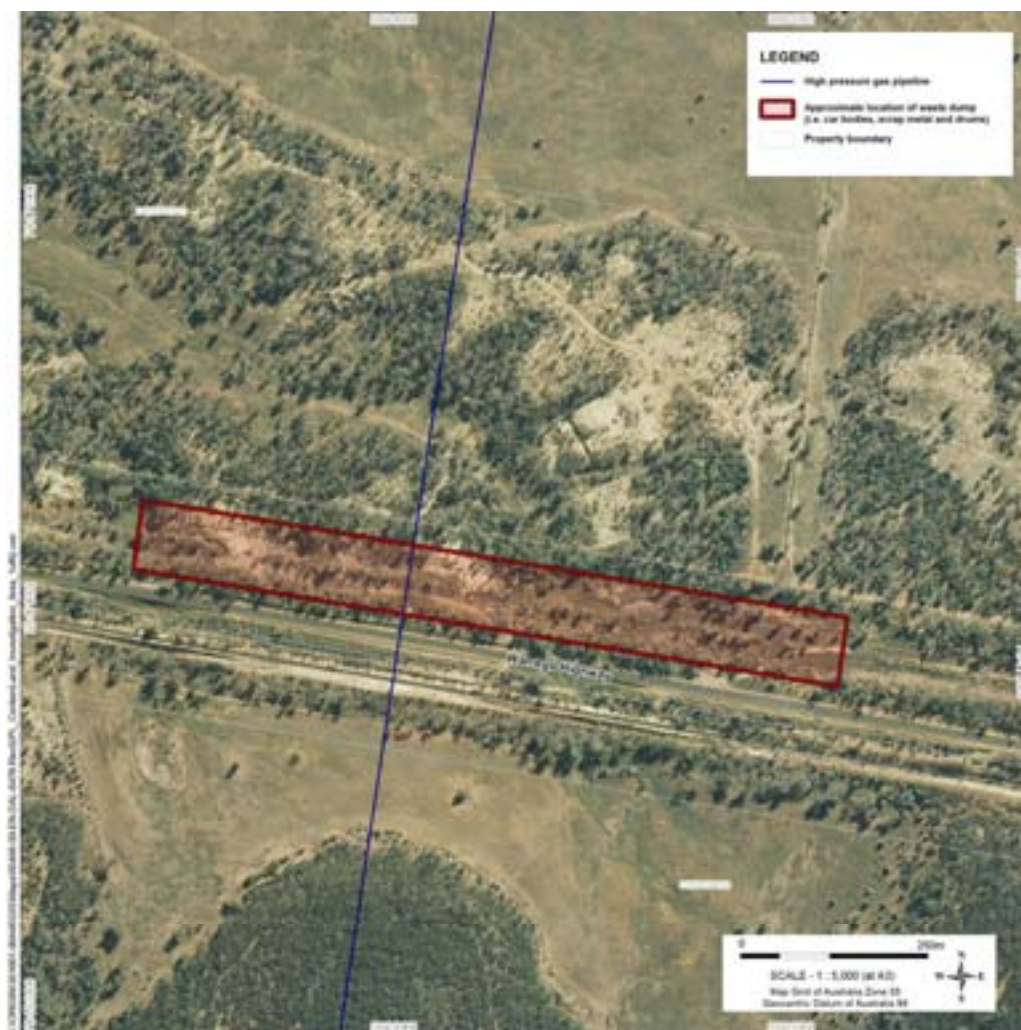
Plate 4.1 Waste dump located on road easement

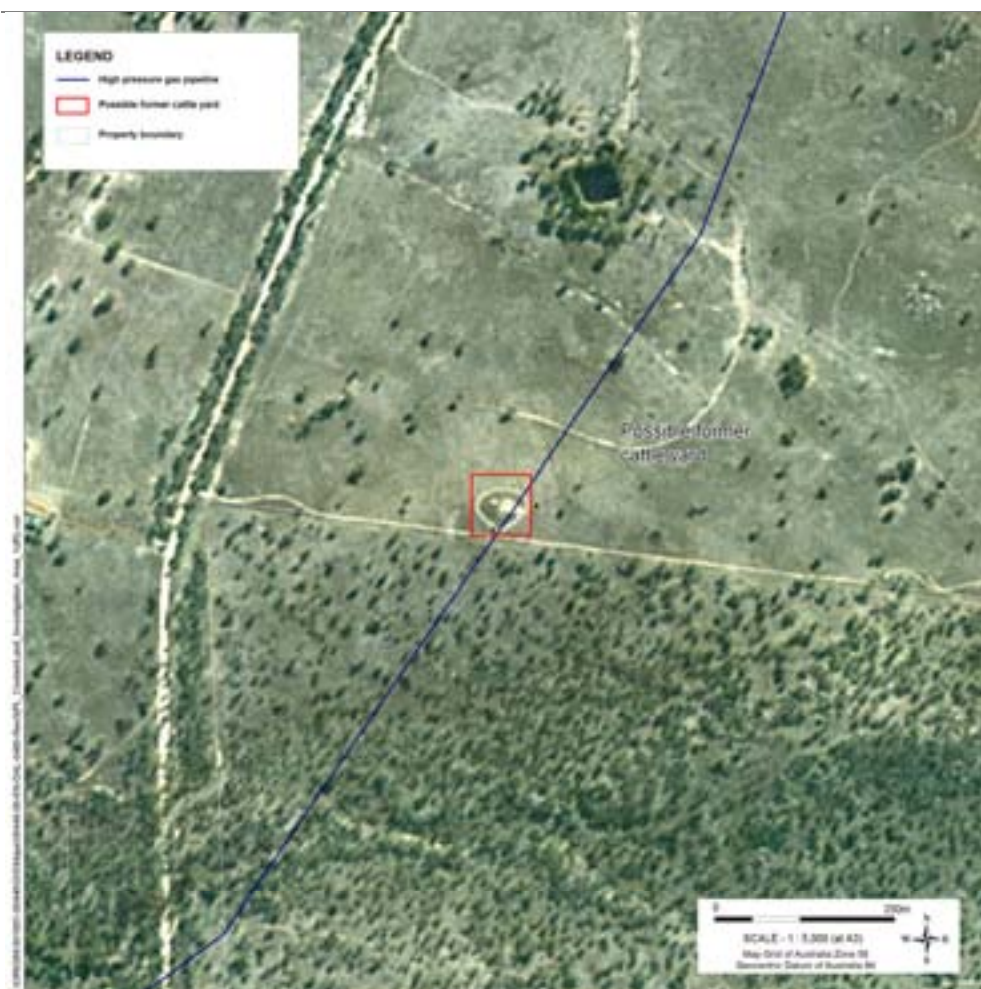
Plate 4.2 Possible former cattle yard (Lot 3 on DW464)

The satellite imagery identified a possible dam and evidence of land disturbance on Lot 3 DW464. As the reason for the land disturbance could not be confirmed visually, this area could not be discarded as a non-concern without further review of data, particularly as the area was in a tick-infested zone where dips and spray races were known to exist. The dam itself was considered to have a low possibility of containing hazardous contaminants, however if a cattle yard once existed, then there was the possibility that a dip or spray race were also present or that the pesticides were used to protect wood structures against termites.

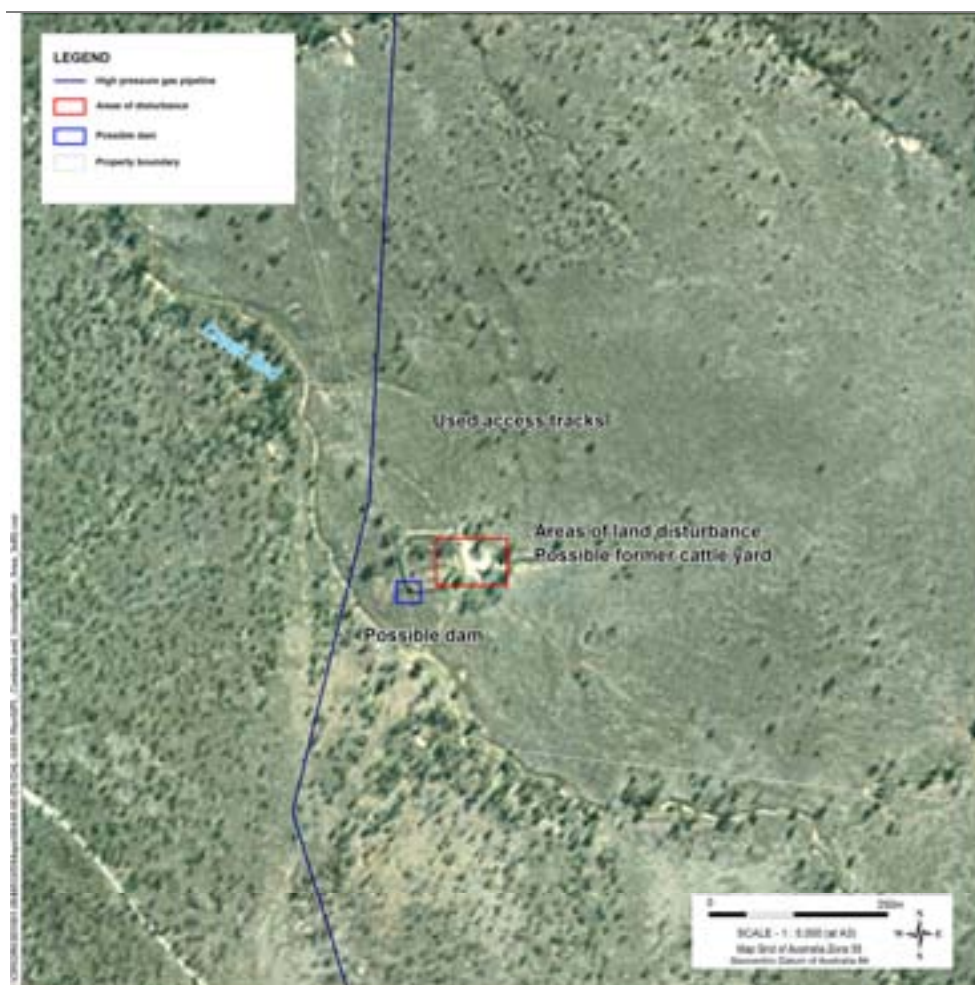
Plate 4.3 Disturbed land (possibly a former dam) [Lot 9 on DW19]

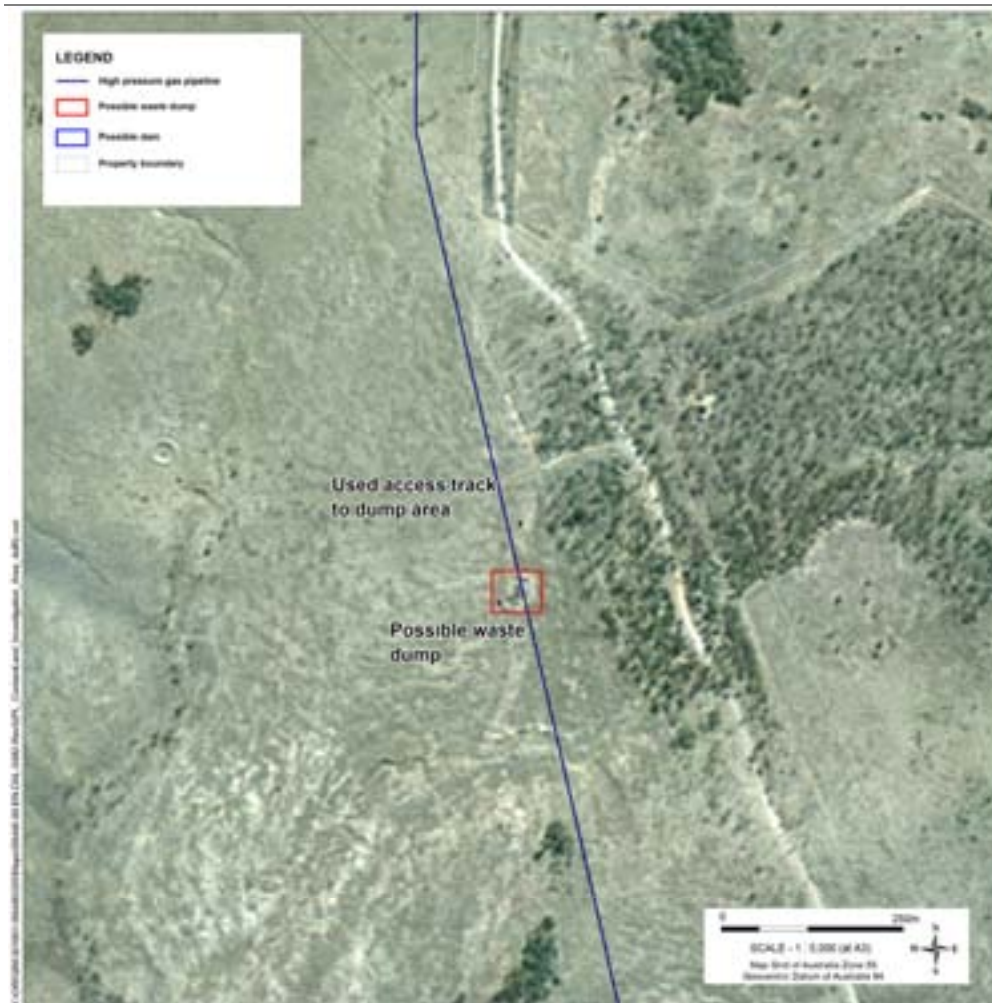
Plate 4.4 Possible waste dump (Lot 5 on DW390)

An Australia Pacific LNG interview conducted with the landholder of Lot 5 DW390 indicated that a cattle dip once operated at Lot 5 DW390. Cattle tick treatment still occurs on site, however the method of treatment has been converted into a more environmentally friendly method. The method of treatment was not elaborated on during the interview. The location of the dip and current treatment area was also not identified and will need to be located and, if found to be a separate area to the suspected cattle yard, then this area will also need to be investigated as part of a Stage 2 investigation prior to the construction of the proposed pipeline.

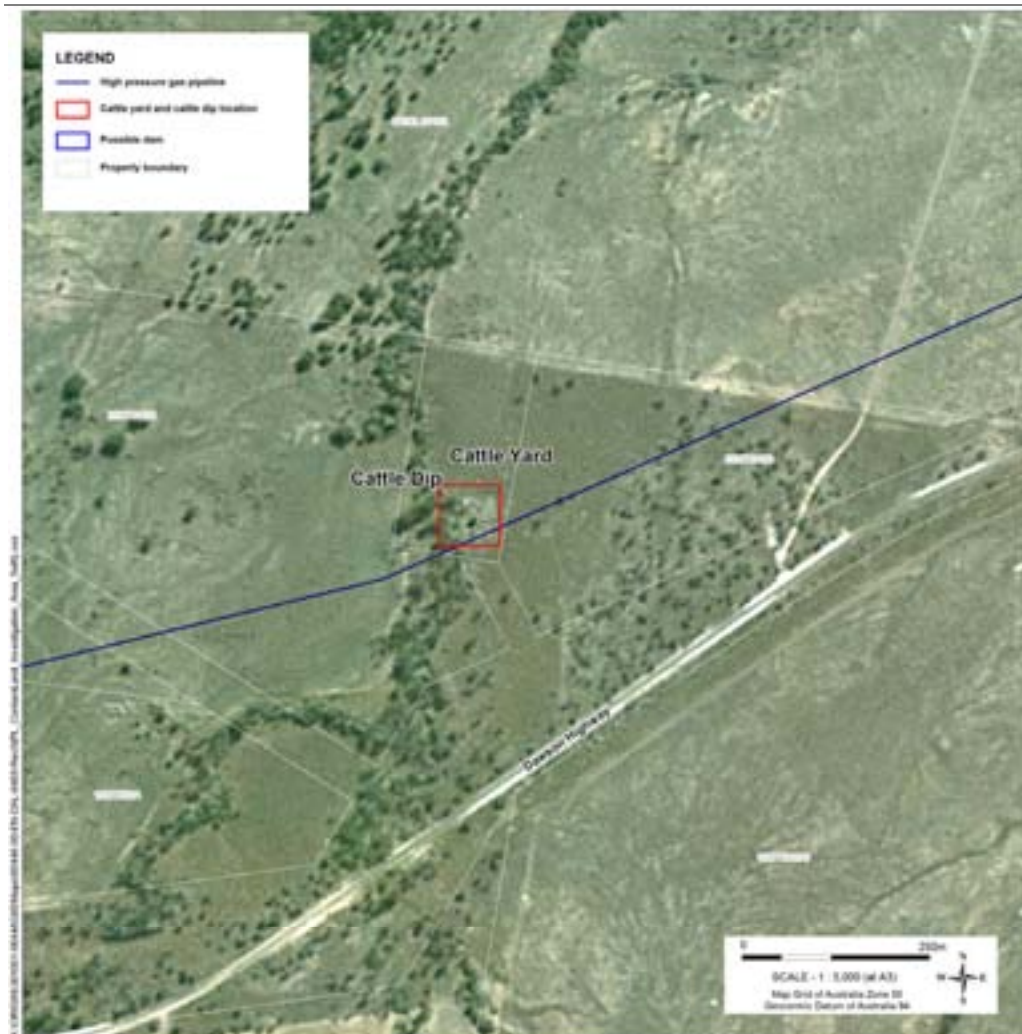
Plate 4.5 Cattle yard and dip (Lot 4 on CTN406)

As the cattle dip on Lot 4 on CTN406 was a notifiable activity, this lot was checked for a possible listing within the EMR/CLR and the result was negative. The road easement containing the dump was not a registered lot and subsequently no search for a possible listing within the EMR/CLR was possible.

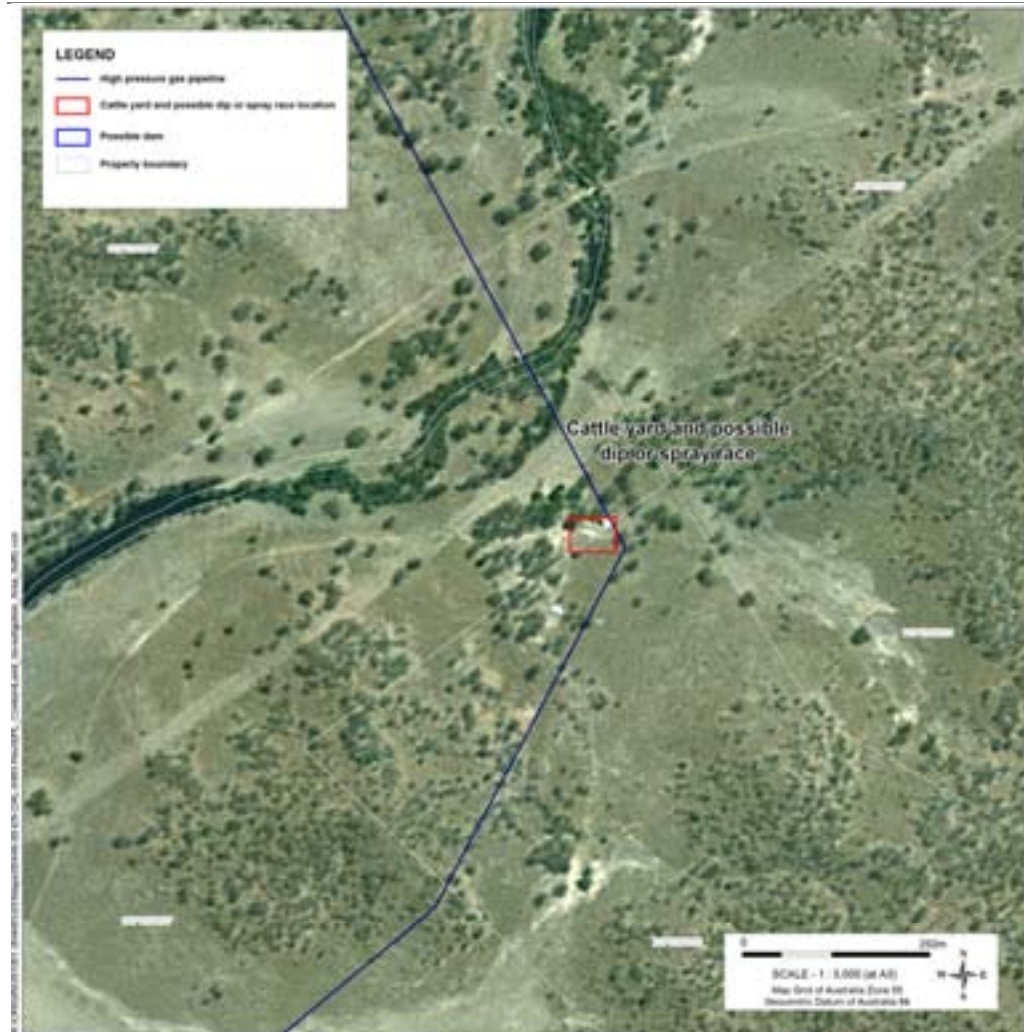
Plate 4.6 Cattle yard and possible dip or spray race (Lot 9 on SP200837)

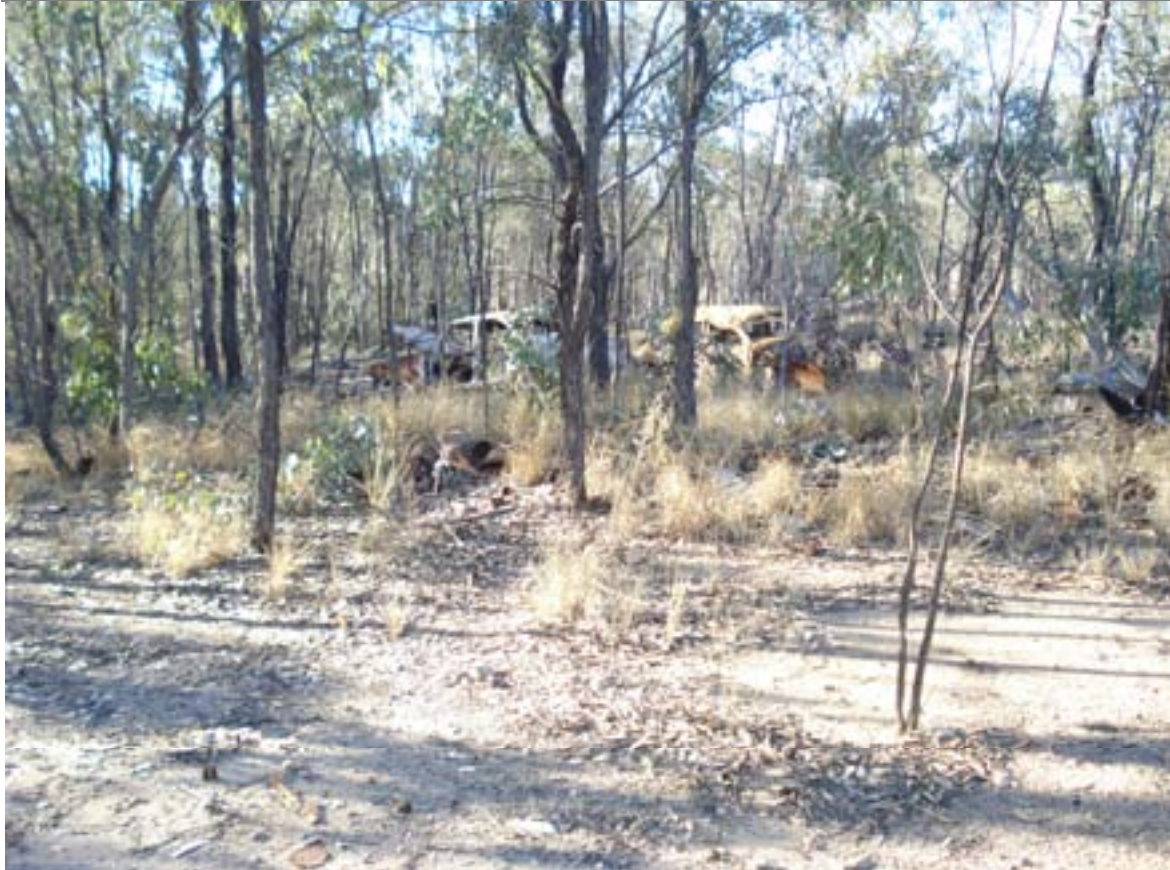
Plate 4.7 Waste dump located on Warrego Highway road easement

This photograph identifies abandoned cars, scrap metal and drums which were dumped within the road easement off Warrego Highway near Miles (refer Figure 3). The area may be traversed by the proposed pipeline. The dump may span over 100m in length, however further assessment is required to confirm the extent of the affected area. It is likely that this area may have been used as a dumping ground for several years. A satellite image of this area is provided in Section 4.1.

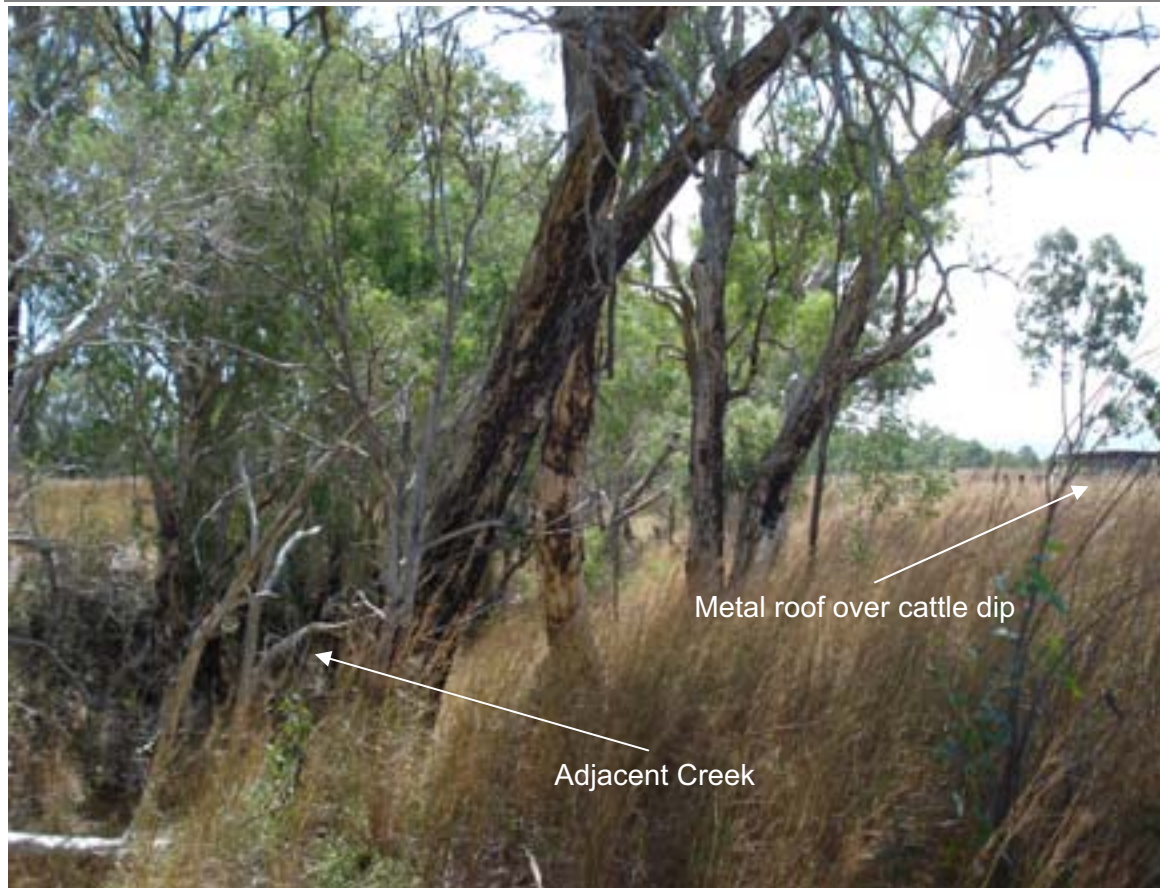
Plate 4.8 Suspected cattle dip, Lot 4 on CTN406

A suspected cattle dip was identified approximately 80m from the proposed gas pipeline, which was located within Lot 4 on CTN406 (refer Figure 6). Surrounding the dip was a cattle yard that contained several holding pens. A creek was also immediately south of the cattle yard. This would be the nearest receptor that could be affected by hazardous contaminants that are potentially present in and around the dip, such as arsenic and organochlorine pesticides. The dip was made of concrete and was filled with dark discoloured liquid and was sheltered by a rectangular roof. The dip did not appear to be in use. The brief site reconnaissance indicated there was no evidence of stressed vegetation beyond the dip.

The primary concern with cattle dips and spray races was the use of persistent toxic chemicals that have the potential to contaminate surrounding areas of soil and possibly groundwater and sediment of nearby waterways. The persistent toxic chemicals included arsenic and organochlorine pesticides. These treatment methods have the potential to cause serious environmental harm. The confirmed disused dip is located adjacent to a creek, therefore there is a potential for sediments and surface water to be impacted by this former treatment method. Arsenic and organochlorine pesticides would be the primary contaminants of concern at this location.

Arsenic would be the likely contaminant of concern for the earlier treatment facilities (i.e. pre-1950s), however cattle and sheep owners operating treatment facilities after the 1950s would have systematically replaced arsenic with other pesticides.

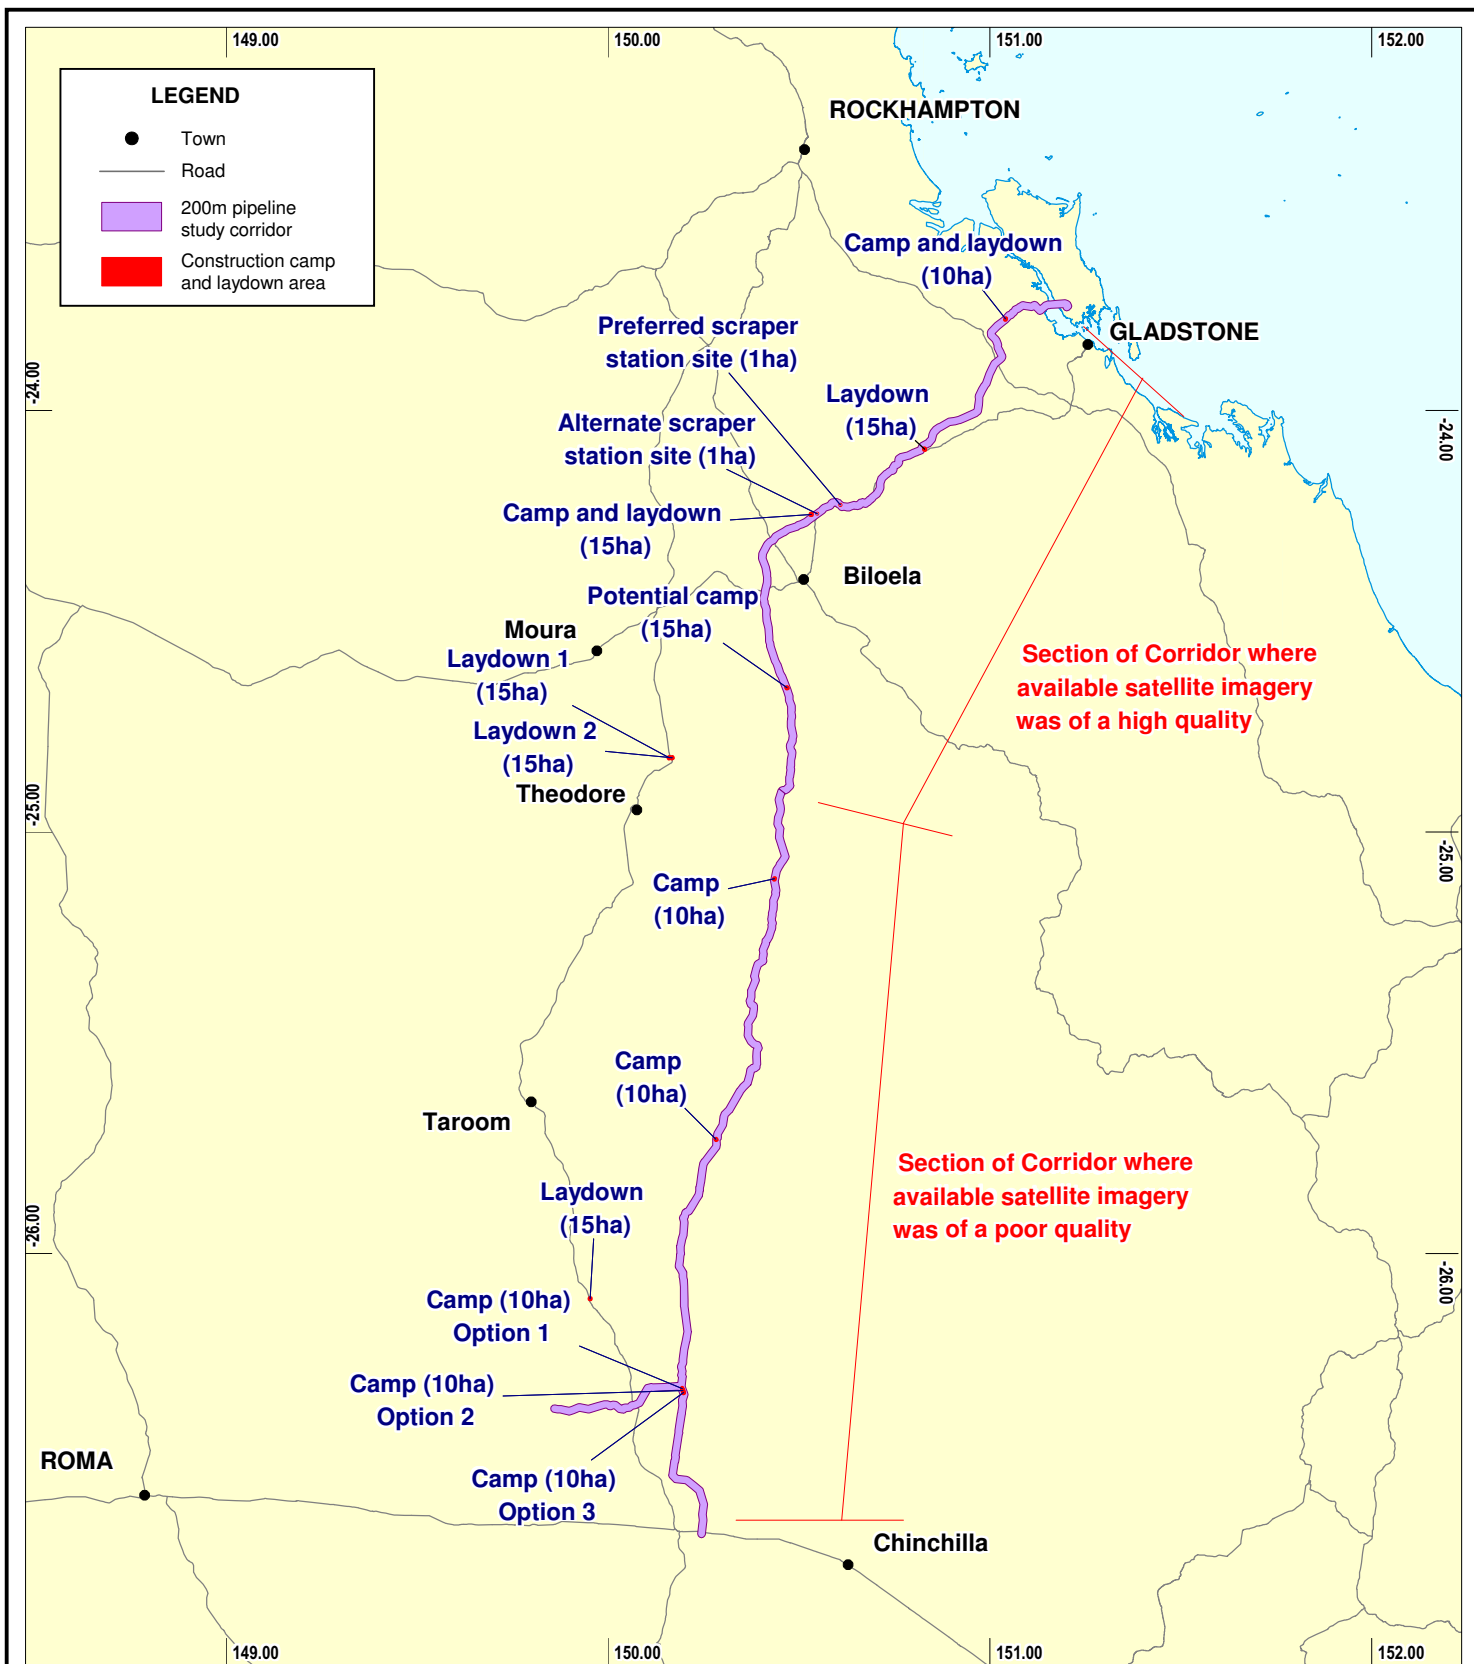
Figure: 00448-00-EN-DAL-00283

There was a section along the pipeline route where the satellite imagery was not clear, which made it difficult to assess land features. This was a 120km stretch that extended south from Taroom to Miles as shown on Figure 1. The limitation of not being able to obtain clear images in this area has been addressed in the recommendations provided in Section 7.2.

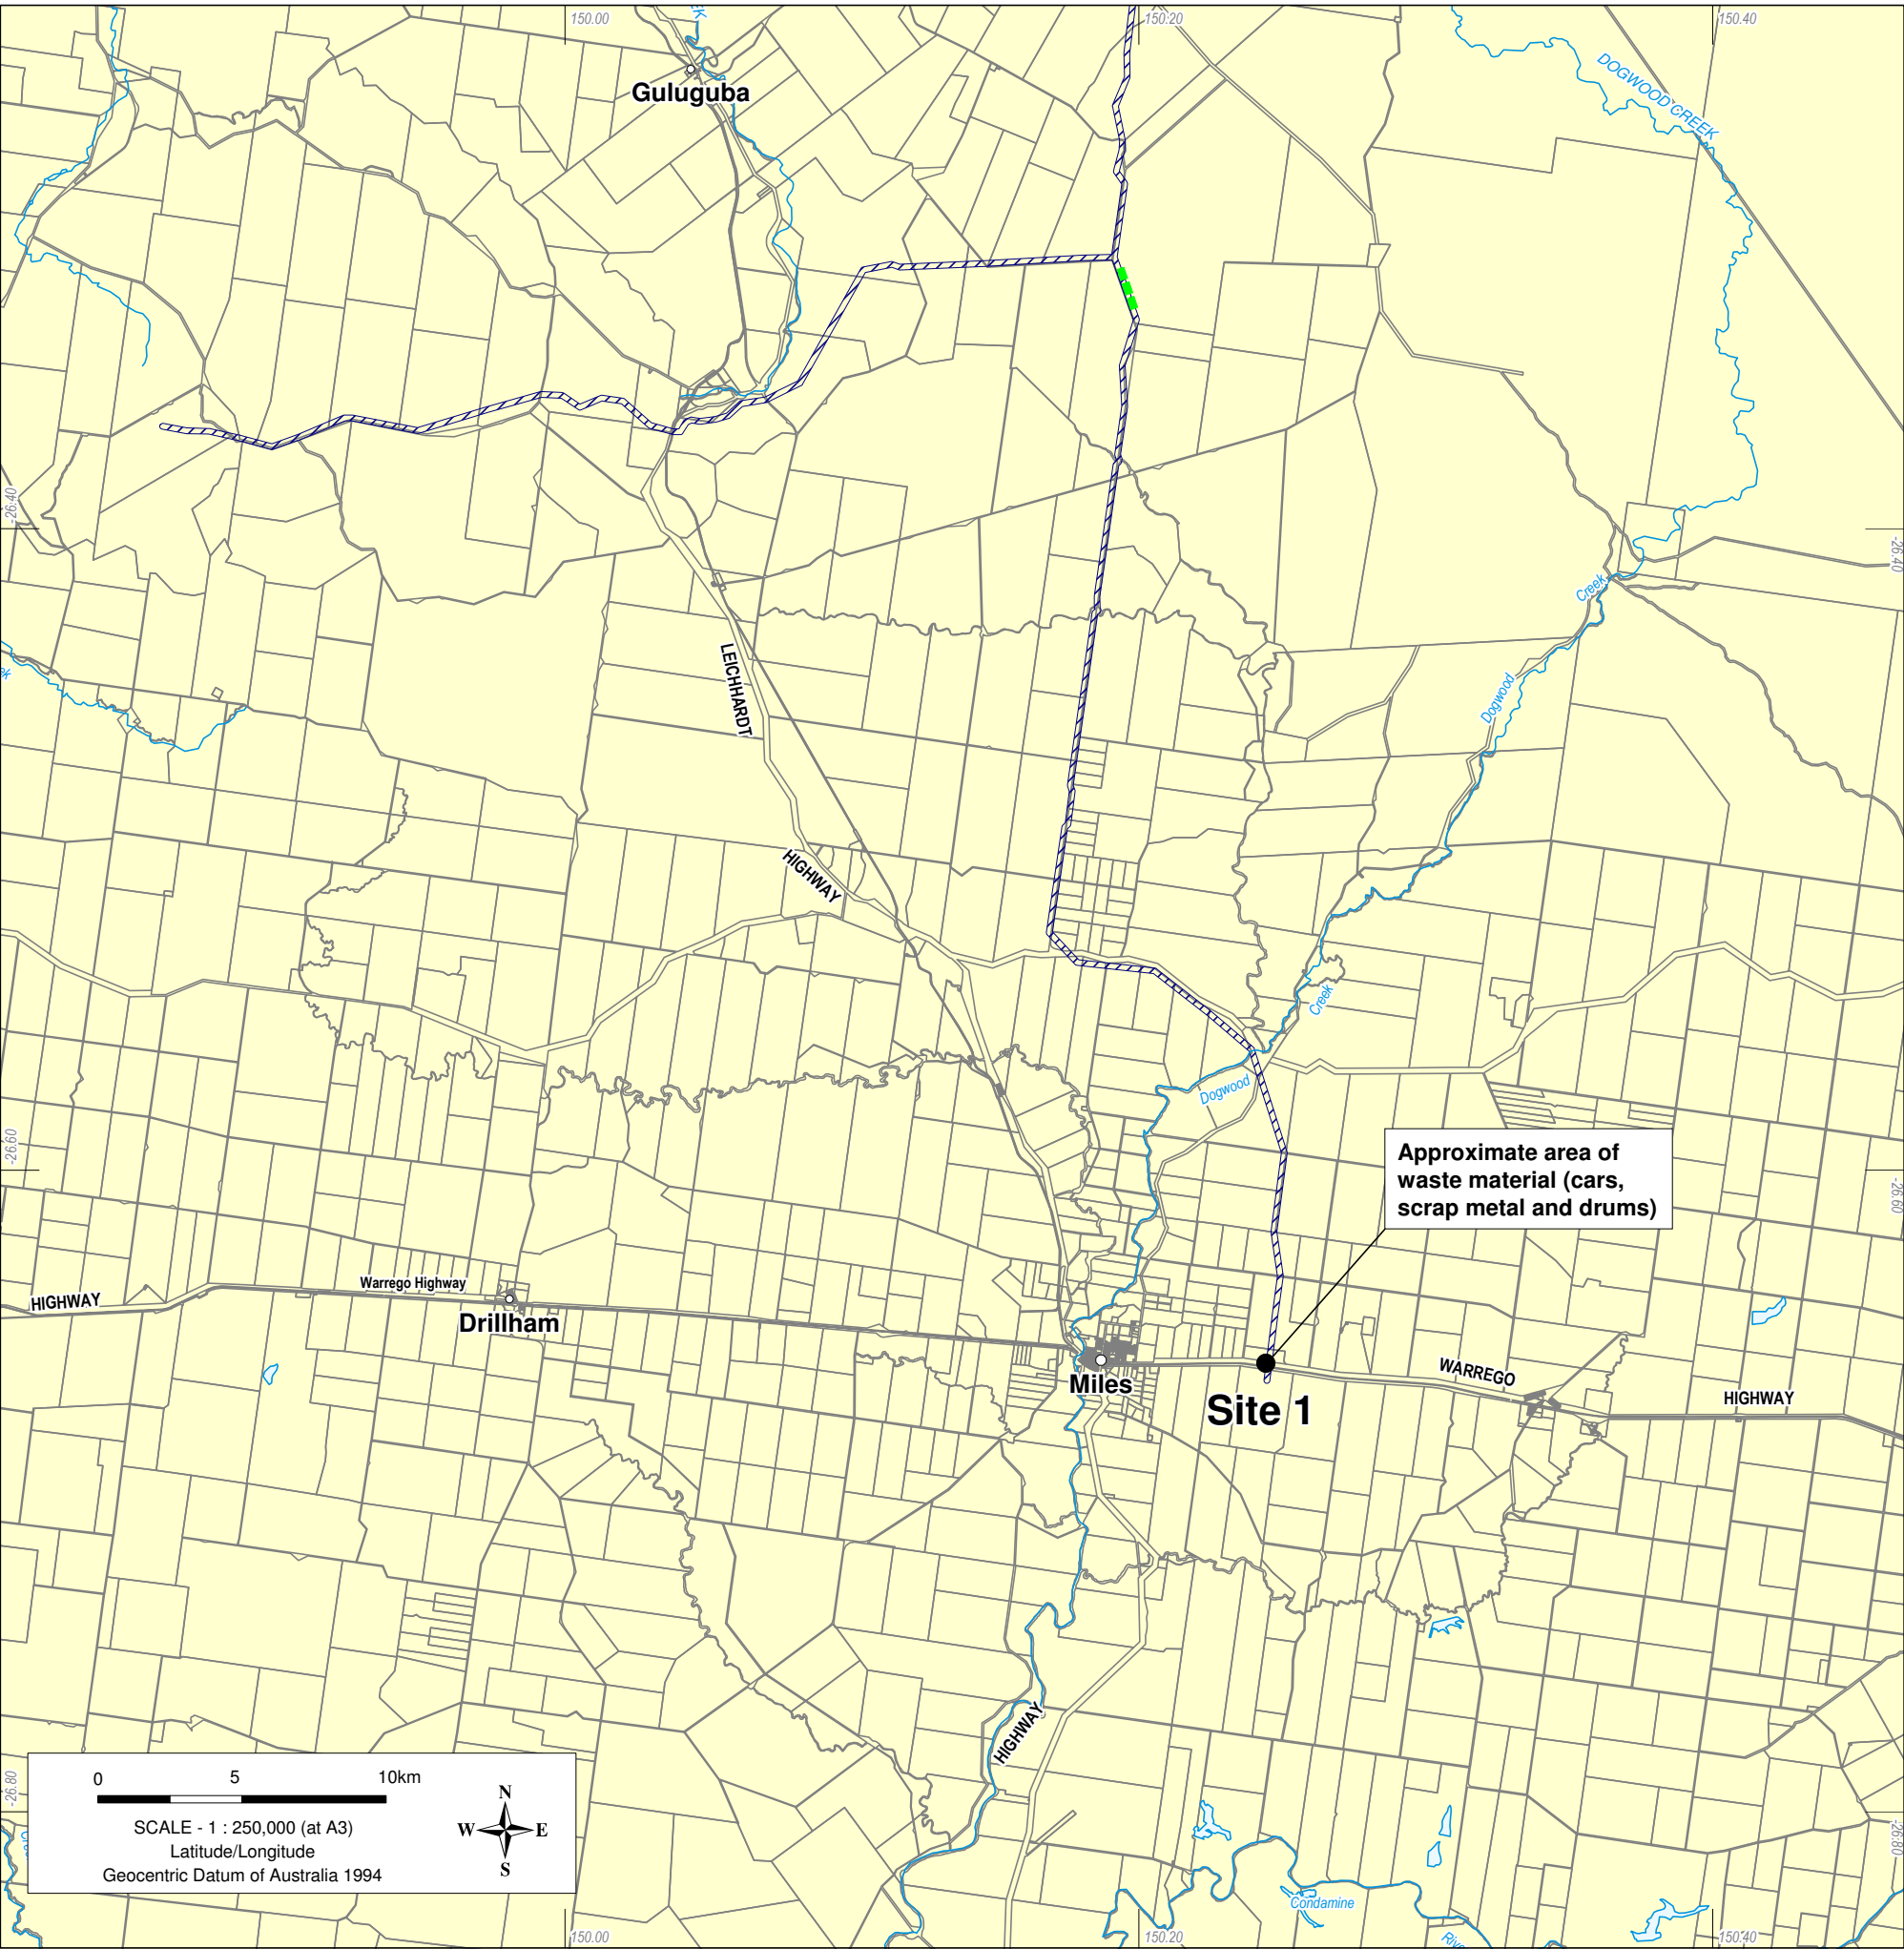
WorleyParsons resources & energy			 			
AUSTRALIA PACIFIC LNG PTY LIMITED						
AUSTRALIA PACIFIC LNG PROJECT EIS Figure 3 - Contaminated Land Investigation Areas (Map 1 of 5)						
Project No: 301001-00448			Figure: 00448-00-EN-DAL-0277			Rev: 0

The review of the satellite imagery identified six areas (i.e. Site 1 to Site 6) of potential concern which fell within the 200m wide pipeline corridor. These areas are identified on Figure 3 to Figure 7. The satellite images are also provided in Plates 3 to 8 below. The areas of potential concern included two potential waste dumps, three likely cattle yards with potential for cattle dips or spray races and one area of disturbed land, which appeared to be a former dam. The disturbed area could not be adequately assessed based upon satellite imagery and therefore could not be discarded as a non-concern without access to further data, particularly as the area was in a designated tick-infested zone where dips and spray races were known to exist. Five of these six locations, namely the waste dumps and the cattle dips/spray races are notifiable activities under the EP Act.

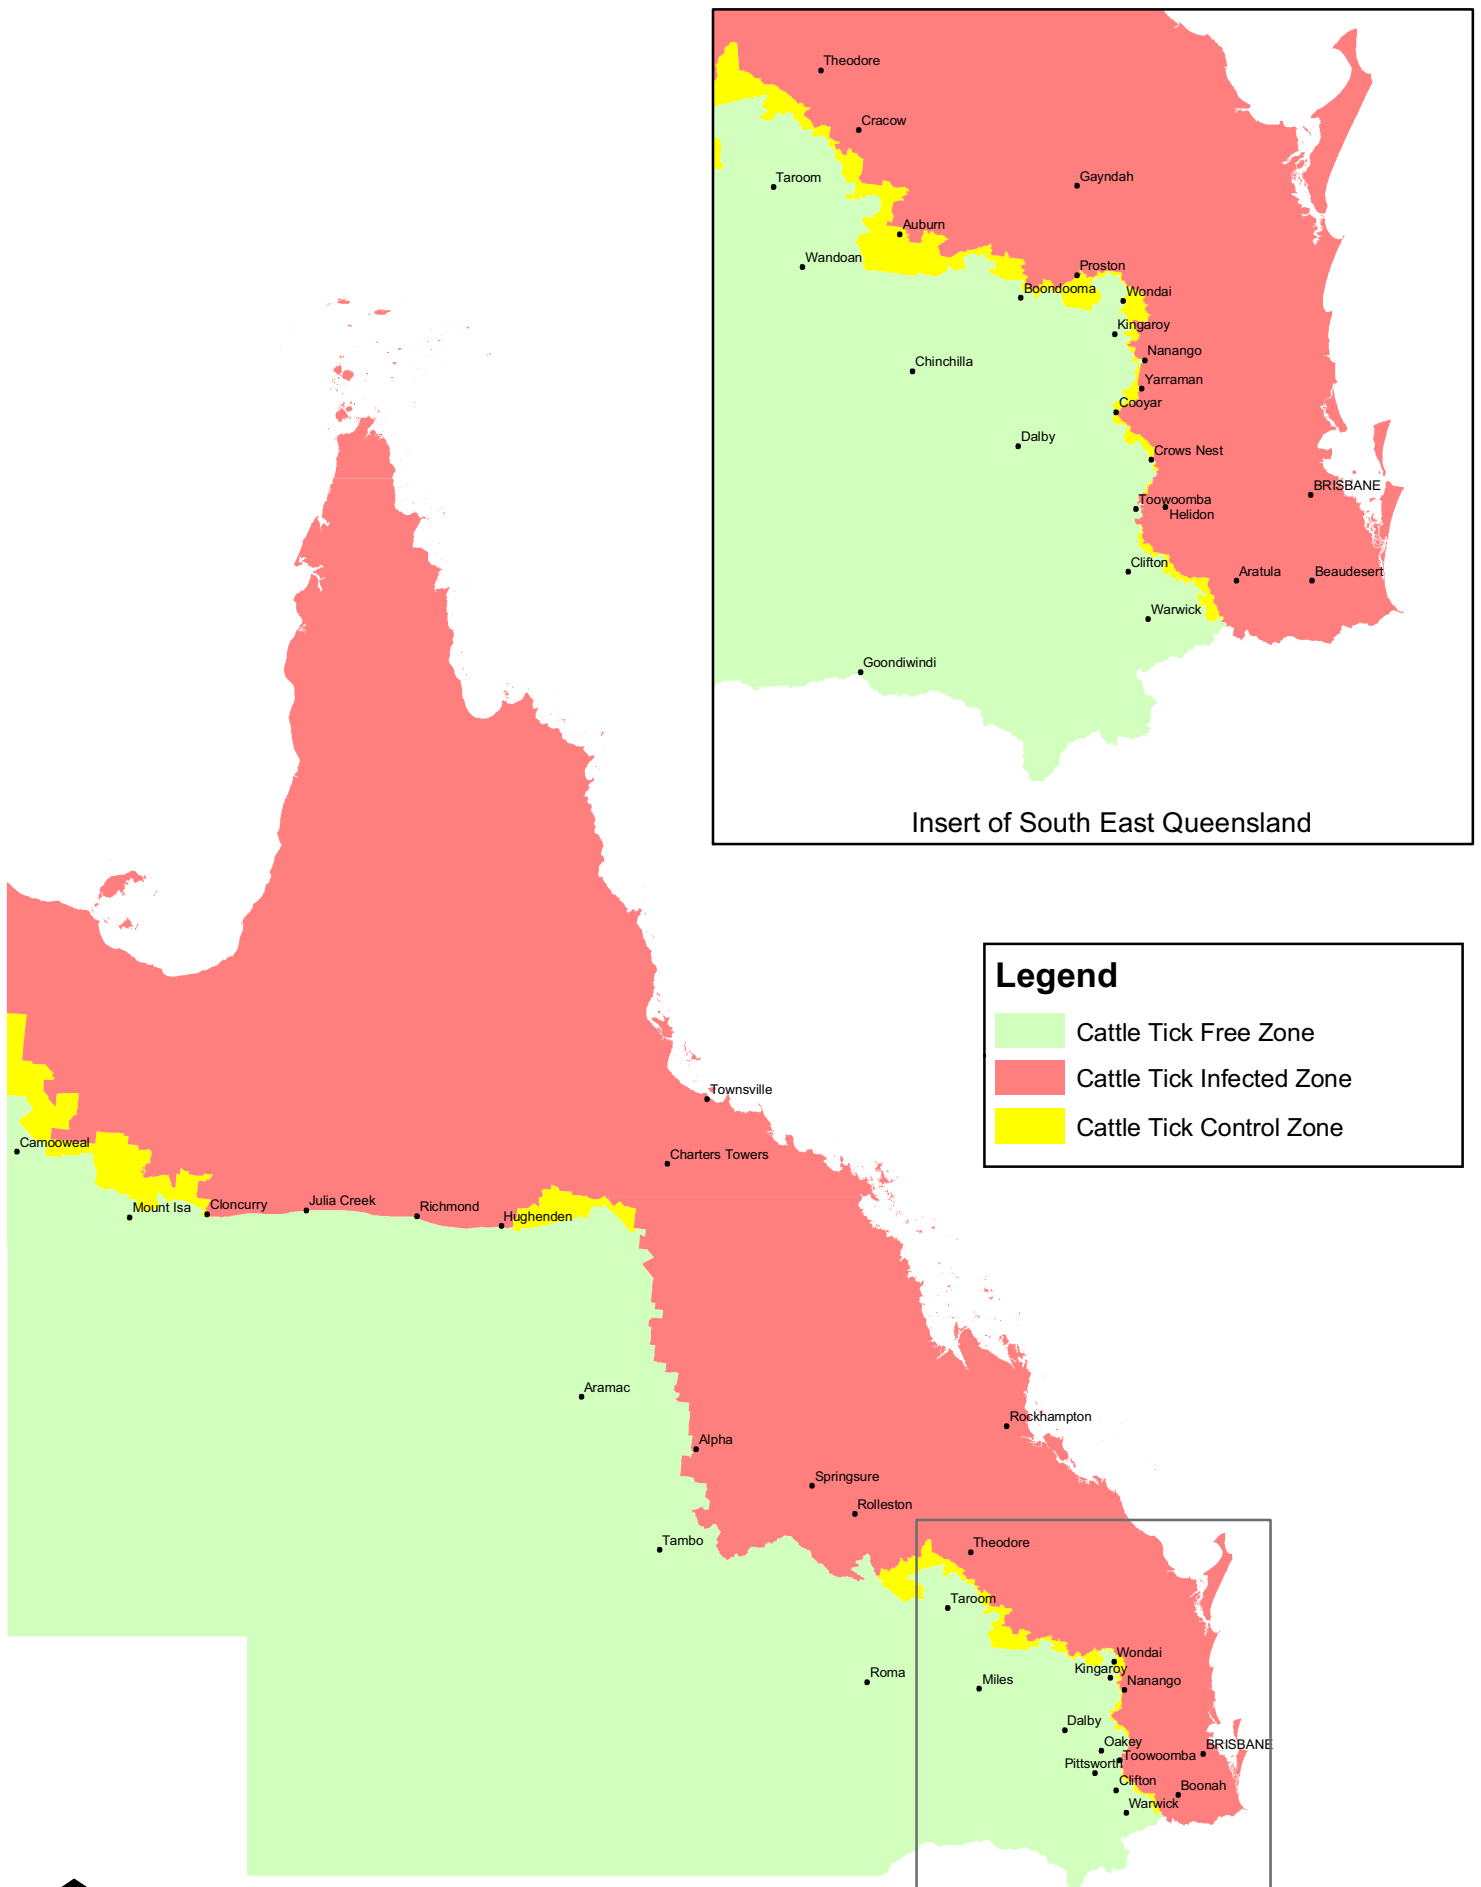
QUEENSLAND CATTLE TICK ZONES

DEEDI has created a map showing areas of cattle tick free zones, controlled zones and infested zones for Queensland. This map indicates that the majority of the study area is located in a designated tick-infested zone, which extends from Taroom to Gladstone. The tick-free zone extends from Taroom to Miles, which is at the southern most limit of the pipeline study area. The possible presence of cattle dips is in agreement with the findings from the interviews with landholders discussed in Section 3.2. The DEEDI map is provided in Appendix A. This map is also reproduced onto Figure 3 to Figure 7, which identify the locations of cattle yards and suspected cattle yards within the study area (based on satellite imagery).
