# **Australia Pacific LNG Project**

### **Attachment 17: Aquatic Ecology, Water Quality and Geomorphology Impact Assessment – Gas Fields**

## **Aquatic Ecology, Water Quality and Geomorphology Impact Assessment – Gas Fields**

**March 2010**

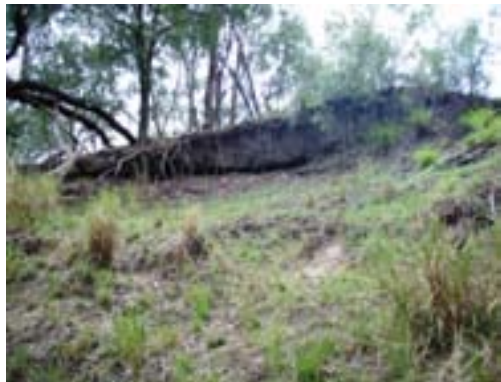
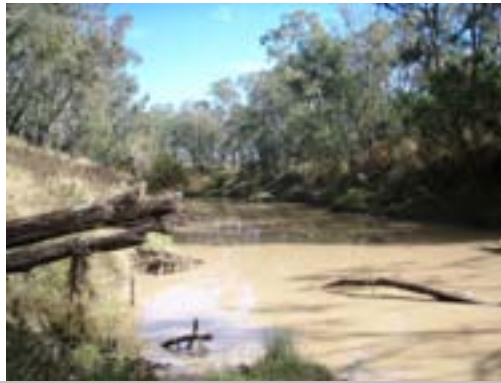
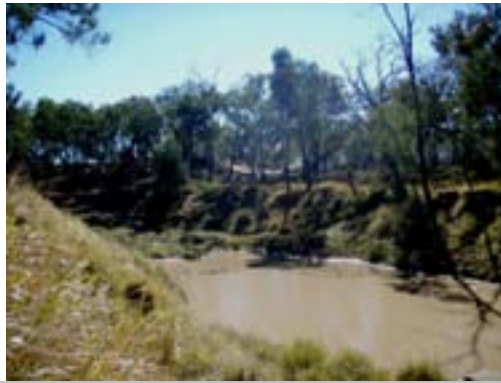
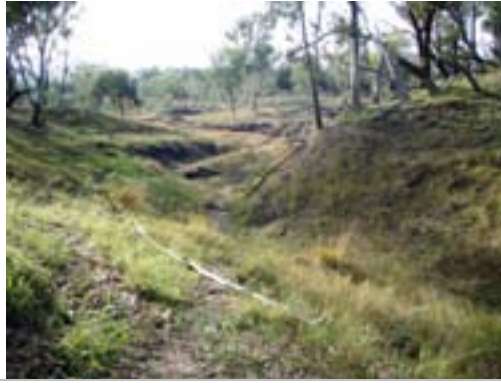
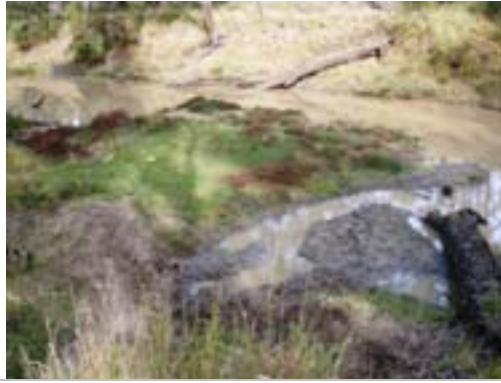
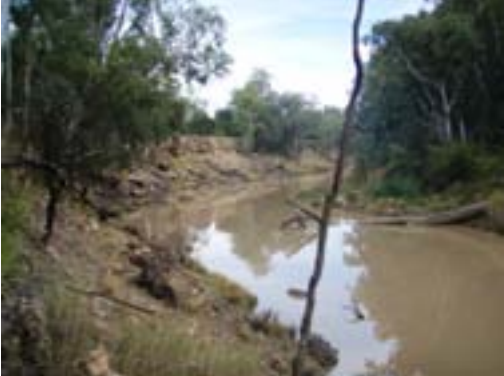
**Figure 4-31 Photographs showing geomorphic condition for Sites GF8, WTF3 and WTF4**

(a) WTF3 bank failure	(b) WTF3 Downstream sediment accumulation and pool

(c) WTF4 Extensive pool and good riparian vegetation	(d) WTF4 Raised bench and sediment accumulation

(e) GF8 Gully	(f) GF8 Gully outfall

(g) GF8 Bank rock outcropping	(h) GF8 Extensive pool

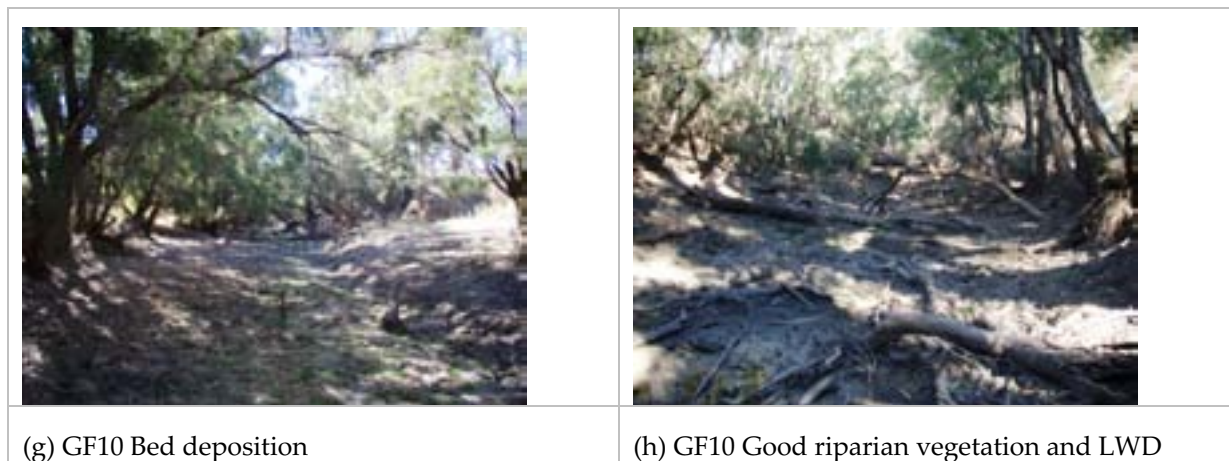
(c) GF3 Bed sedimentation	(d) GF3 Bank instability

(e) GF9 Stable, well vegetated banks	(f) GF9 Terrace and flood channel

**Figure 4-34 Photographs showing geomorphic condition of Sites GF2, GF3, GF9 and GF10**

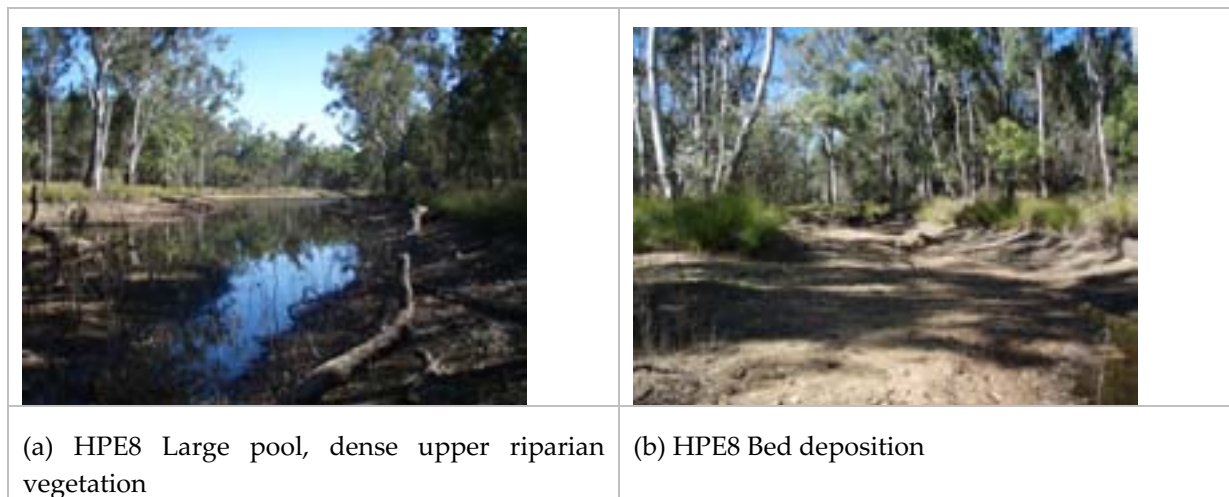
**Figure 4-35 Photographs showing geomorphic condition of HPE8**

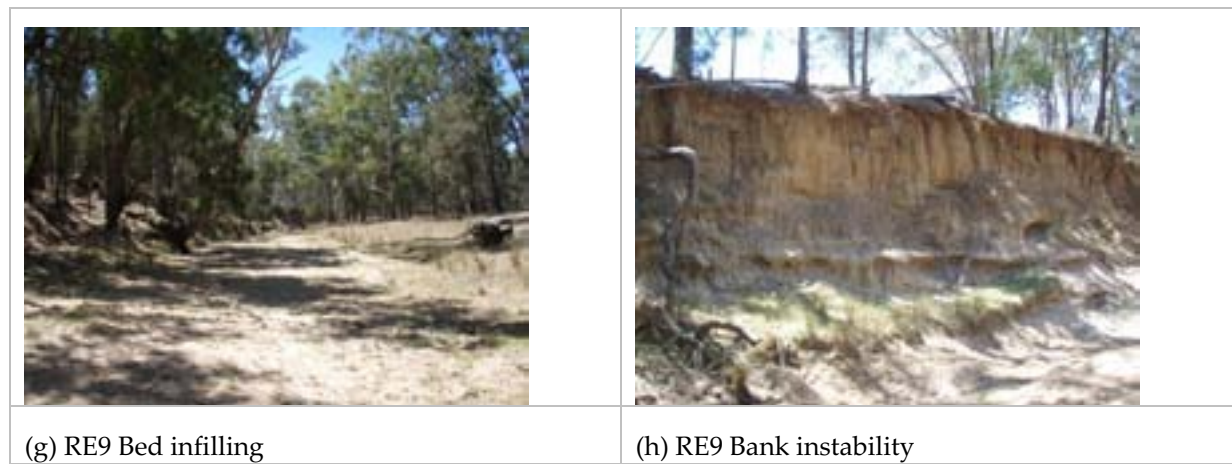
(e) GFE10 Bed deposition	(f) GFE10 Riparian vegetation

**Figure 4-39** Photographs showing geomorphic condition of Sites GFE6, GFE7, GFE10 and RE9
