Australia Pacific LNG Project

Attachment 18: Aquatic Ecology, Water Quality and Geomorphology Impact Assessment –

Gas Transmission Pipeline

March 2010

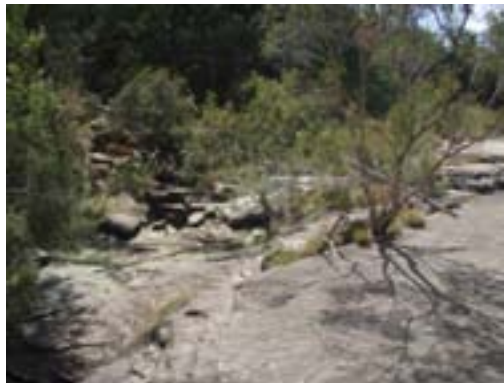
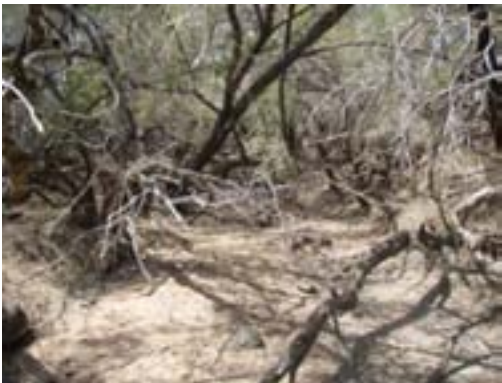
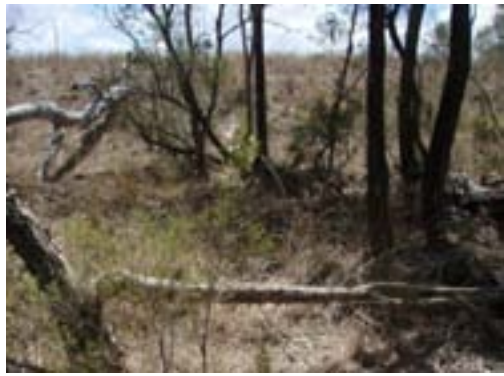
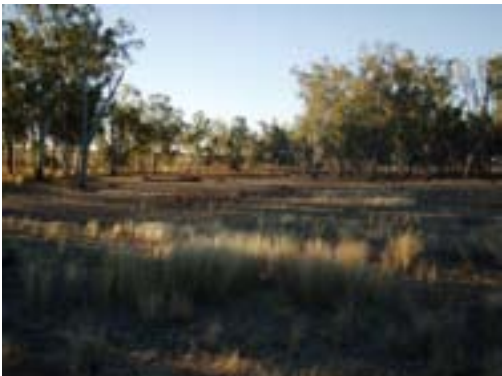
Figure 4-26 Photographs showing geomorphic condition of Sites P3CE10, P3CE11, P3CE12 and RORWB3

(a) P3CE10 Rock outcropping	(b) P3CE10 Flat, uniform bed

(c) P3CE11 Large channel with benches	(d) P3CE11 Bank rock outcropping

(e) P3CE11 Bedrock outcropping	(f) P3CE12 Infilled bed and good within-channel vegetation

(e) P3CE12 Poor floodplain vegetation	(f) RORWB3

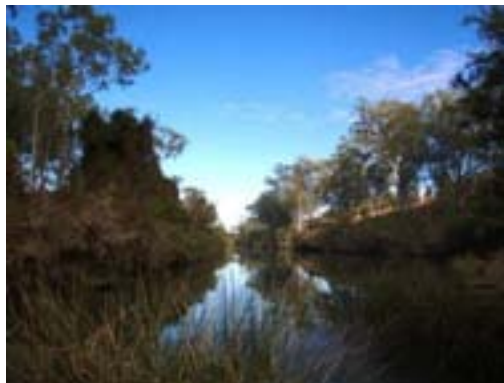
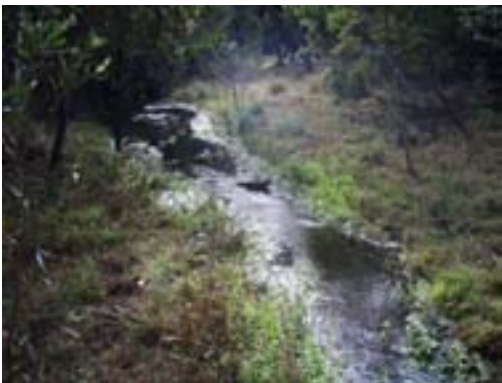
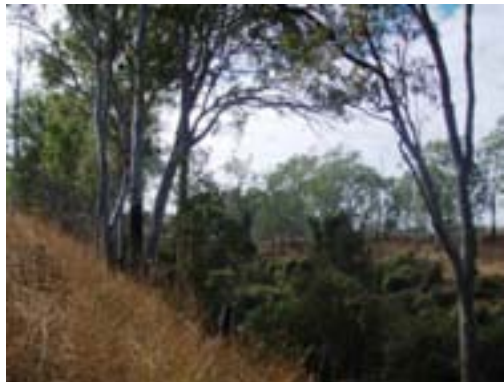
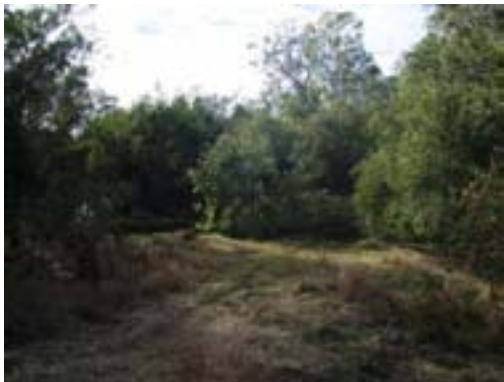
Figure 4-27 Photographs showing geomorphic condition of Site P1

(e) P1 Pool	(f) P1 Riffle

(e) P1 Dense, exotic lower bank vegetation, sparse, native upper bank vegetation	(f) P1 Lower bench
