15 Cultural Heritage

This section addresses non-indigenous cultural heritage issues in relation to the project and is summarised from the Non-Indigenous Cultural Heritage Survey of Caval Ridge, Central Queensland (Archaeo 2008). The non-indigenous cultural heritage survey was conducted under permitting arrangements with the EPA (EPA permit number CHST00240207).

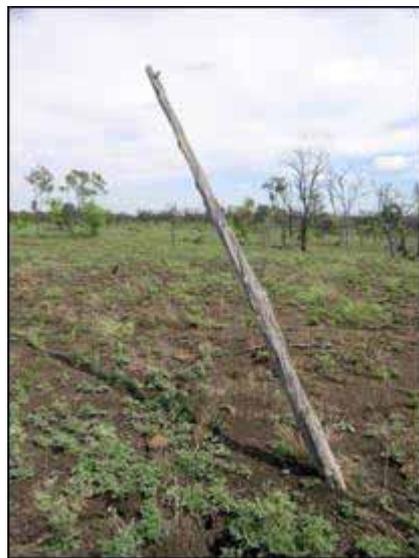
Figure 15.2 North View - Telegraph post

An old telegraph line is located approximately 500 m south of the Peak Downs Highway, in the centre of the project site (Figure 15.1). The remains of the telegraph line are shown in Figure 15.2. The line of timber posts extends for at least 1.5 km in a north-east to south-west alignment. There are at least 15 thin timber posts, positioned approximately 100 m apart, each with a ceramic conductor attached. Most of the posts are on a fairly steep inclination (approximately 45°) with some having completely collapsed. Otherwise, all are in relatively good condition. Original telegraph wire was only sited on one telegraph post.

The telegraph line is located outside the projects area of disturbance and will not be impacted by the project.
