Carmichael Coal Mine and Rail Project Supplementary Environmental Impact Statement

Volume 4, Appendix C3f – Vegetation Reports for SP2 and Laydown areas

- Part 4:
 - SP2 PMAV continued
 - SP2 Laydown Area NCA Vegetation Clearing Permit

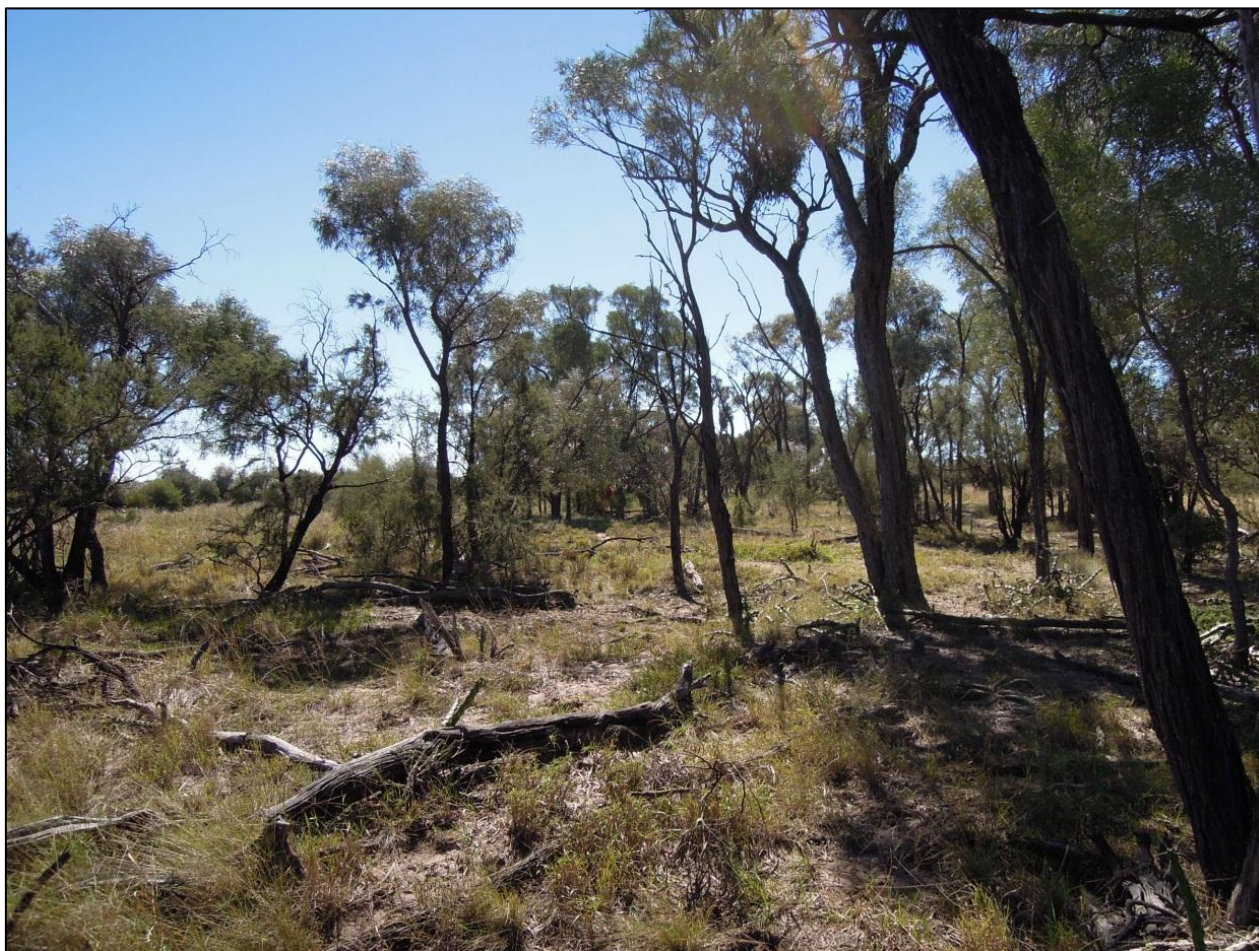
Photo: Area B - Polygon 1

*The area mapped as remnant RE 11.4.8. *Acacia harpophylla* was identified within a very narrow, highly disturbed strip of vegetation. Weed infestation, cattle damage and erosion were evident in the survey area.*

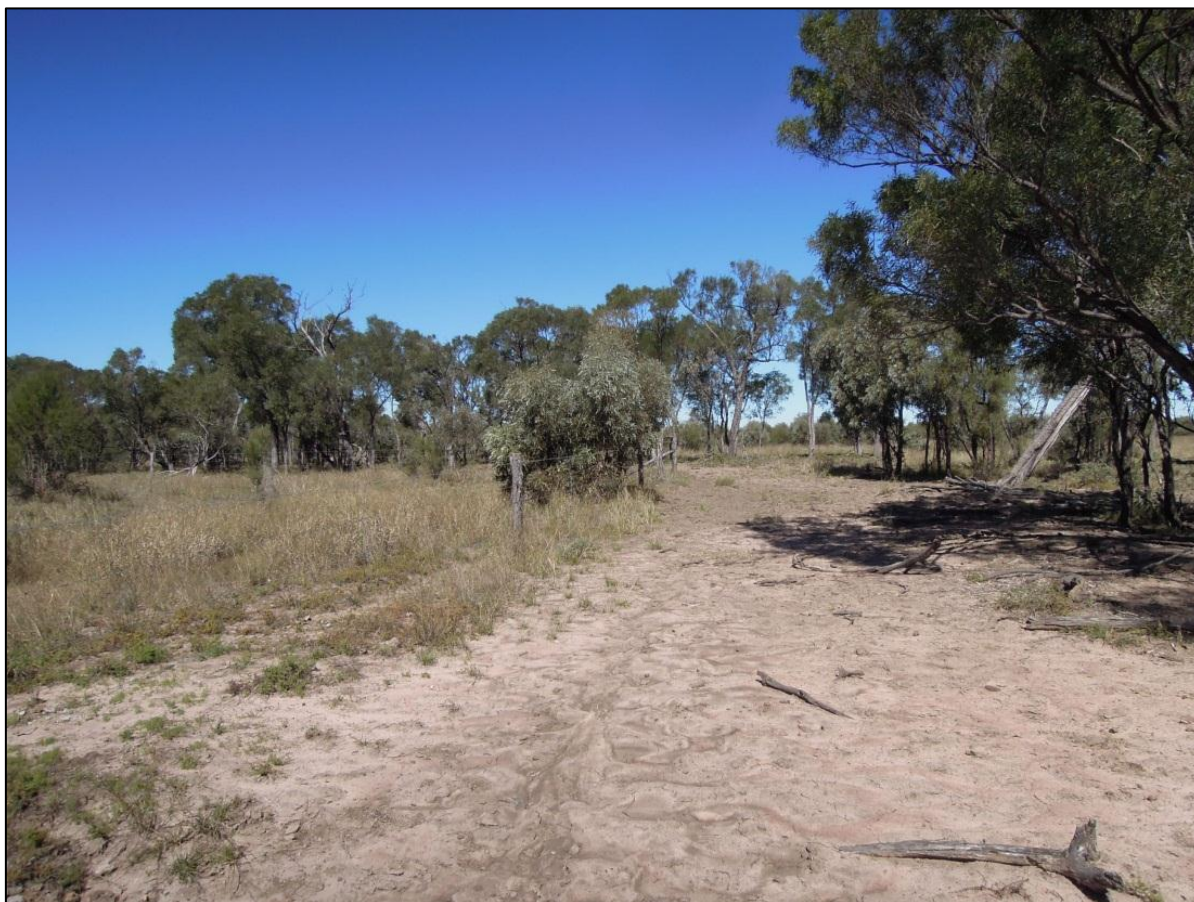
Photo: Area A

*The area mapped as remnant RE 11.4.8. No remnant *Acacia harpophylla* was identified on the northern side of east – west fenceline.*

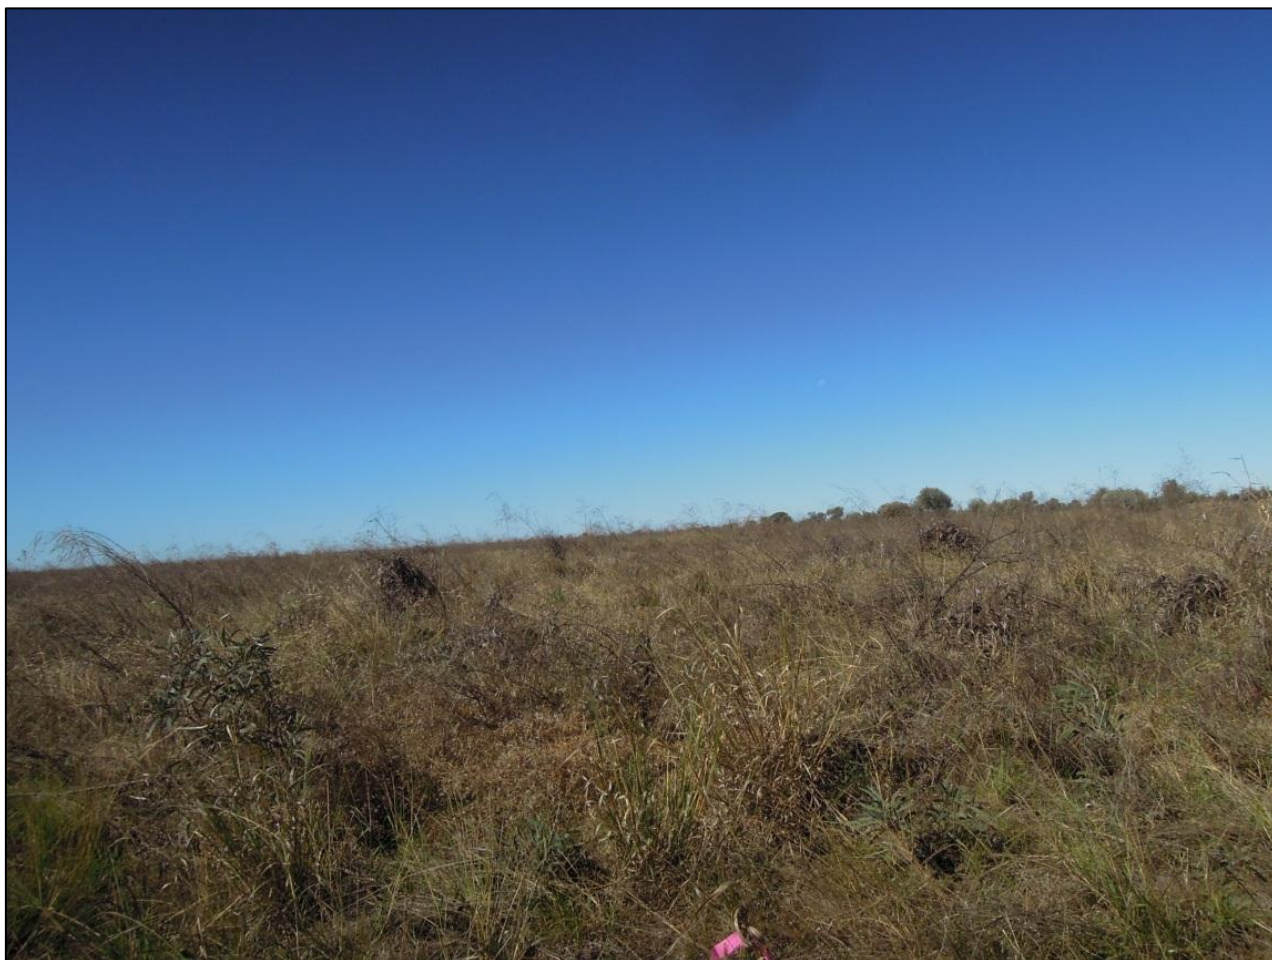
Photo: Area B

*The area mapped as Endangered High Value Regrowth. Area contains very scattered *Acacia harpophylla* and no other other vegetation within the T1, T2 or shrub layer.*

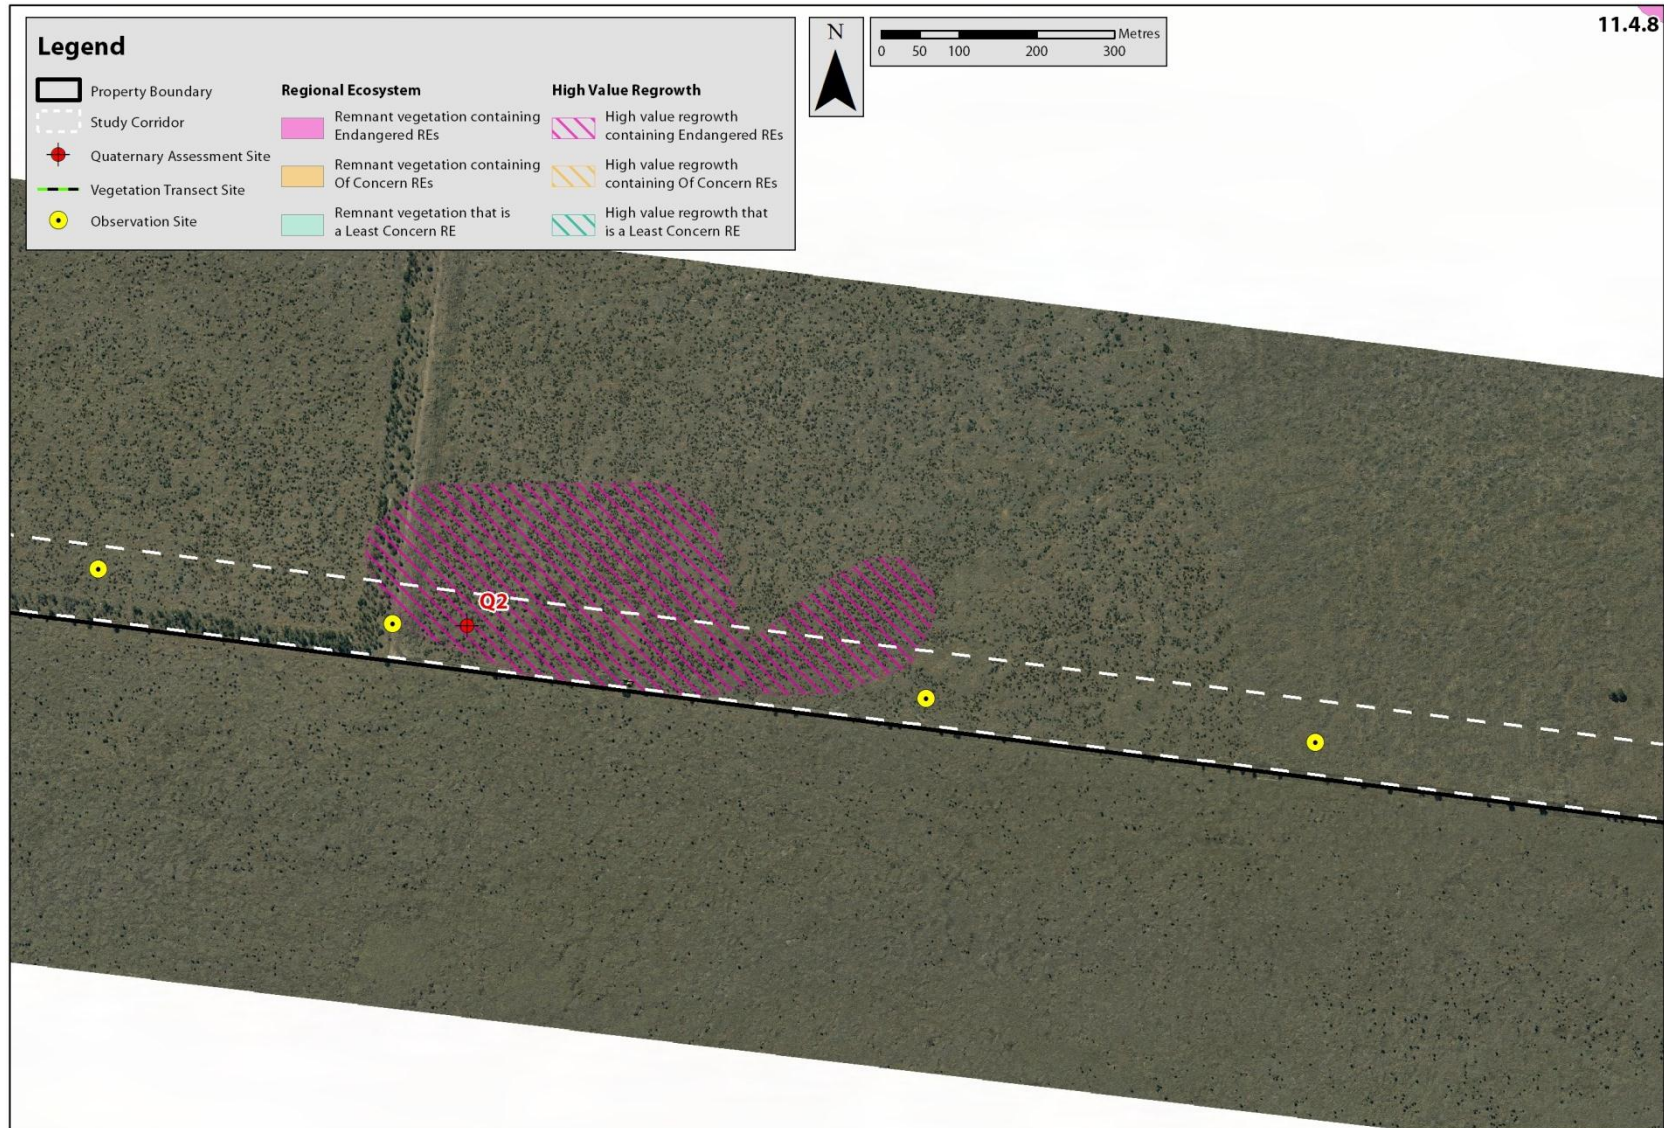
Figure 13: Regional Ecosystem and Survey Effort (Area B)

Site Description		
Location:	T Jones; Lot 8 on DC98	
Site Description:	<p>The site is located within mapped polygon described as Endangered High Value Regrowth – Figure 13</p> <p>The location is within an existing agricultural land holding and observed to contain only occasional very scattered small <i>Acacia harpophylla</i> (Brigalow) specimens (<1m) in height. These scattered individual do not form part of a regrowth vegetation community.</p> <p>The area appears to have been cleared and seeded with sorghum in the past and cattle grazing is apparent within this highly disturbed area.</p> <p>Exotic/introduced weed species including <i>Pennisetum ciliare</i> (Buffel Grass), <i>Parthenium hysterophorus</i> (Parthenium) and <i>Sorghum halepense</i> (Johnsons Grass) are dominant within the survey area</p> <p>Refer to Quaternary Site 2 and Figures 14 for the proposed mapping changes.</p>	
Datum:	GDA94 MGA55

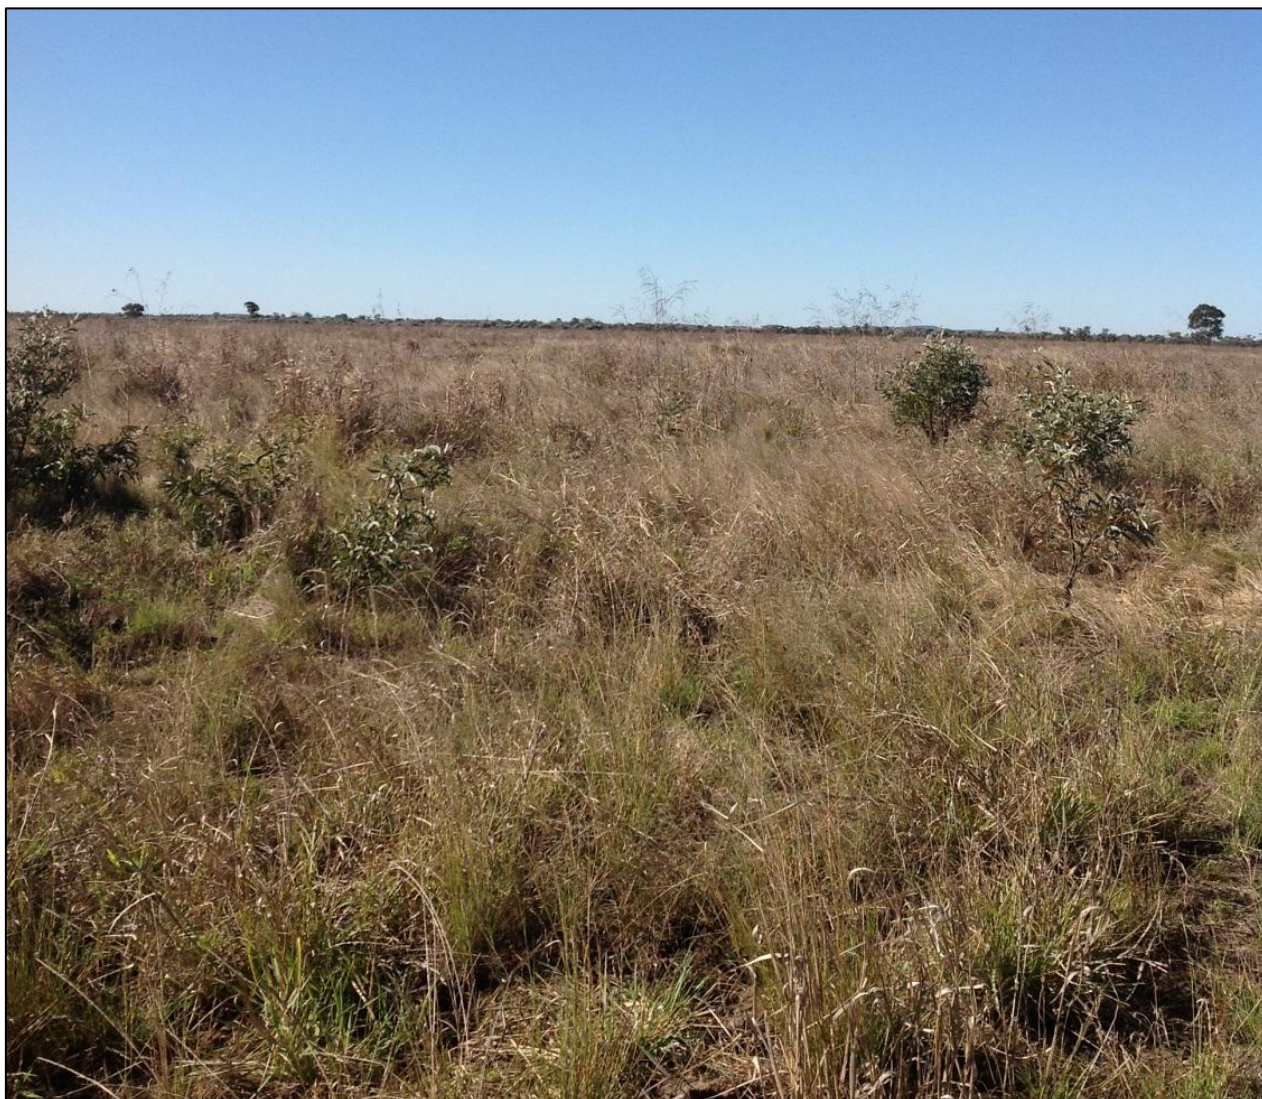
Photo: Area C - Polygon 1

*The area mapped as Endangered High Value Regrowth. Area contains very scattered *Acacia harpophylla* and no other other vegetation within the T1, T2 or shrub layer.*

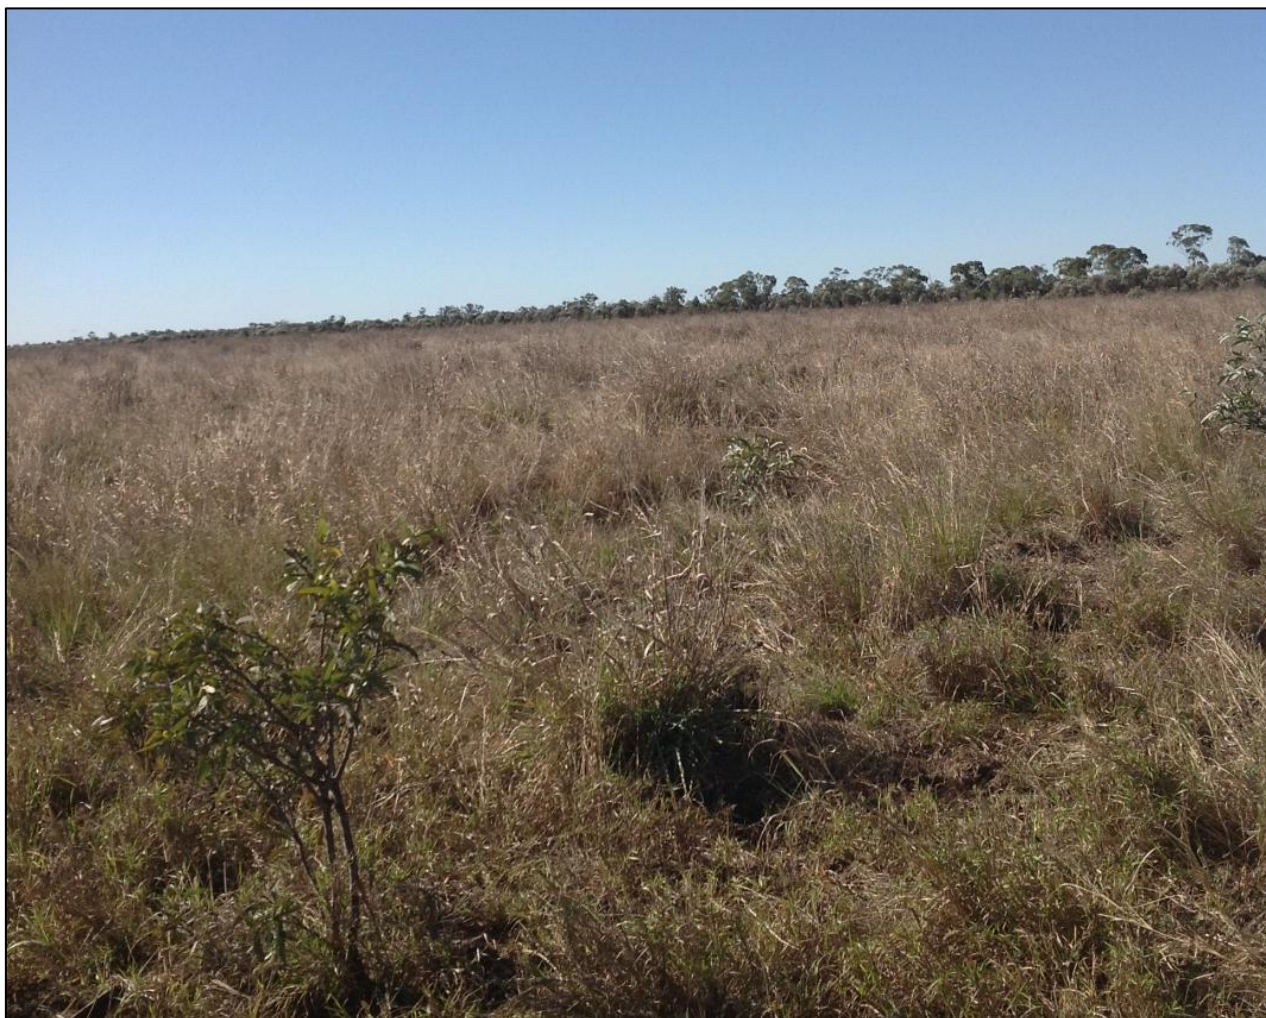
Photo: Area C- Polygon 2

*The area mapped as Endangered High Value Regrowth. Area contains very scattered *Acacia harpophylla* and no other other vegetation within the T1, T2 or shrub layer.*

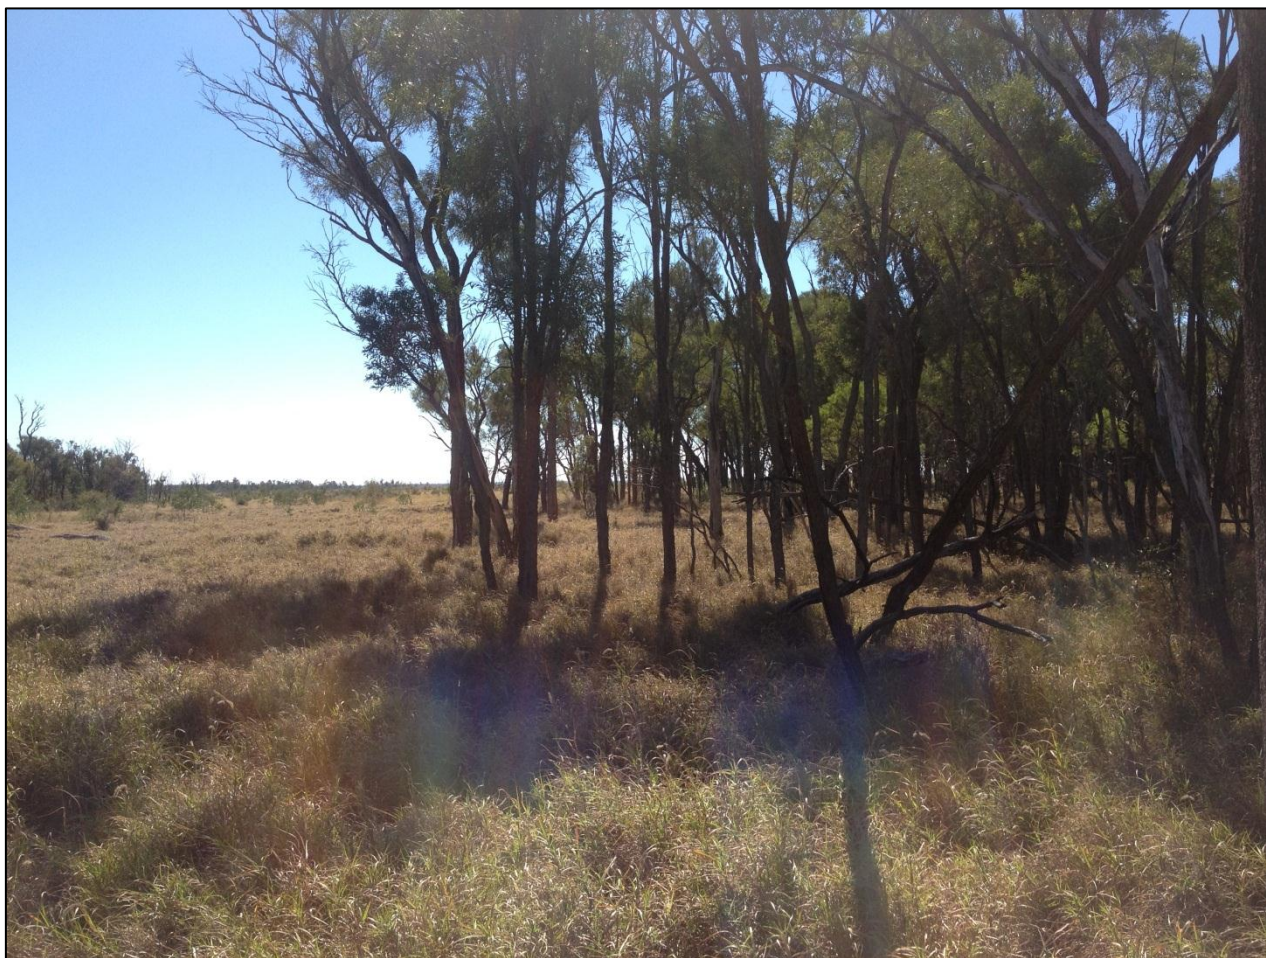
Photo: Area A

The area mapped as remnant RE11.3.1 within the investigation area.

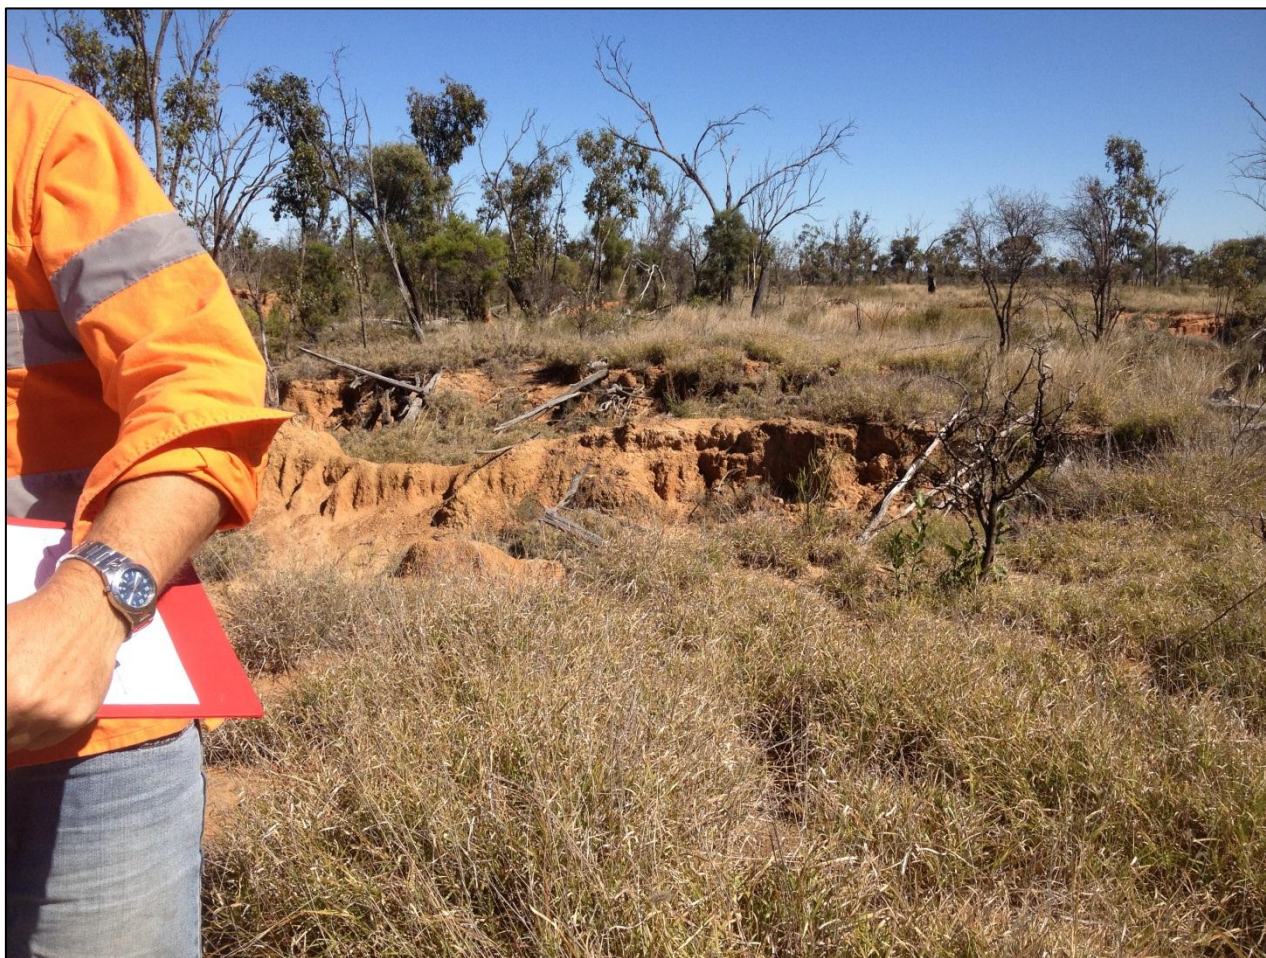
Photo: Area B

The area mapped as remnant RE11.5.3/1.5.9 within the investigation area. Note large areas of erosion within gully lines.

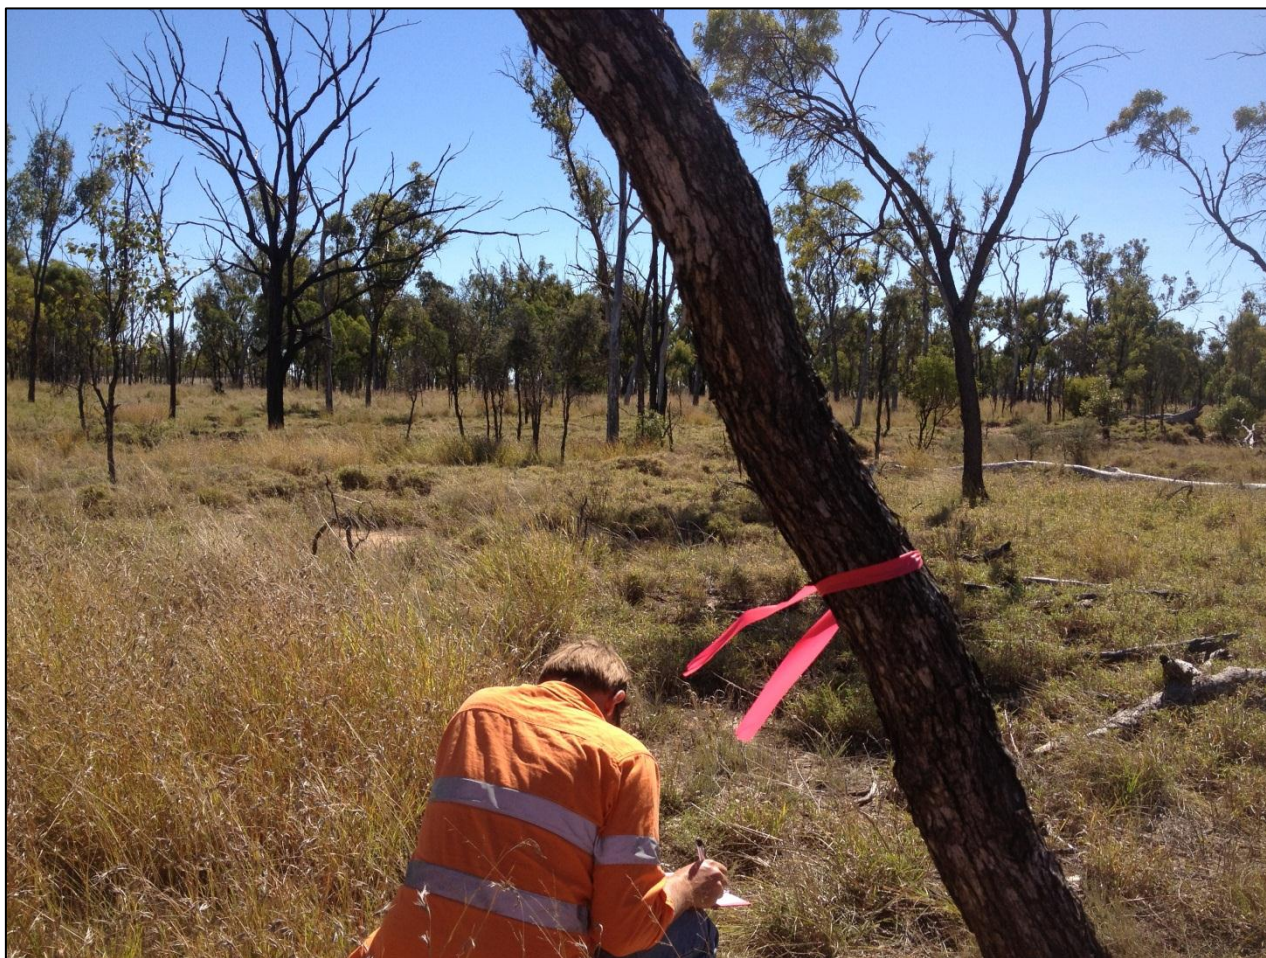
Photo: Area C

The area mapped as remnant RE11.5.3/1.5.9 within the investigation area. High levels of disturbance from grazing, clearing and erosion.

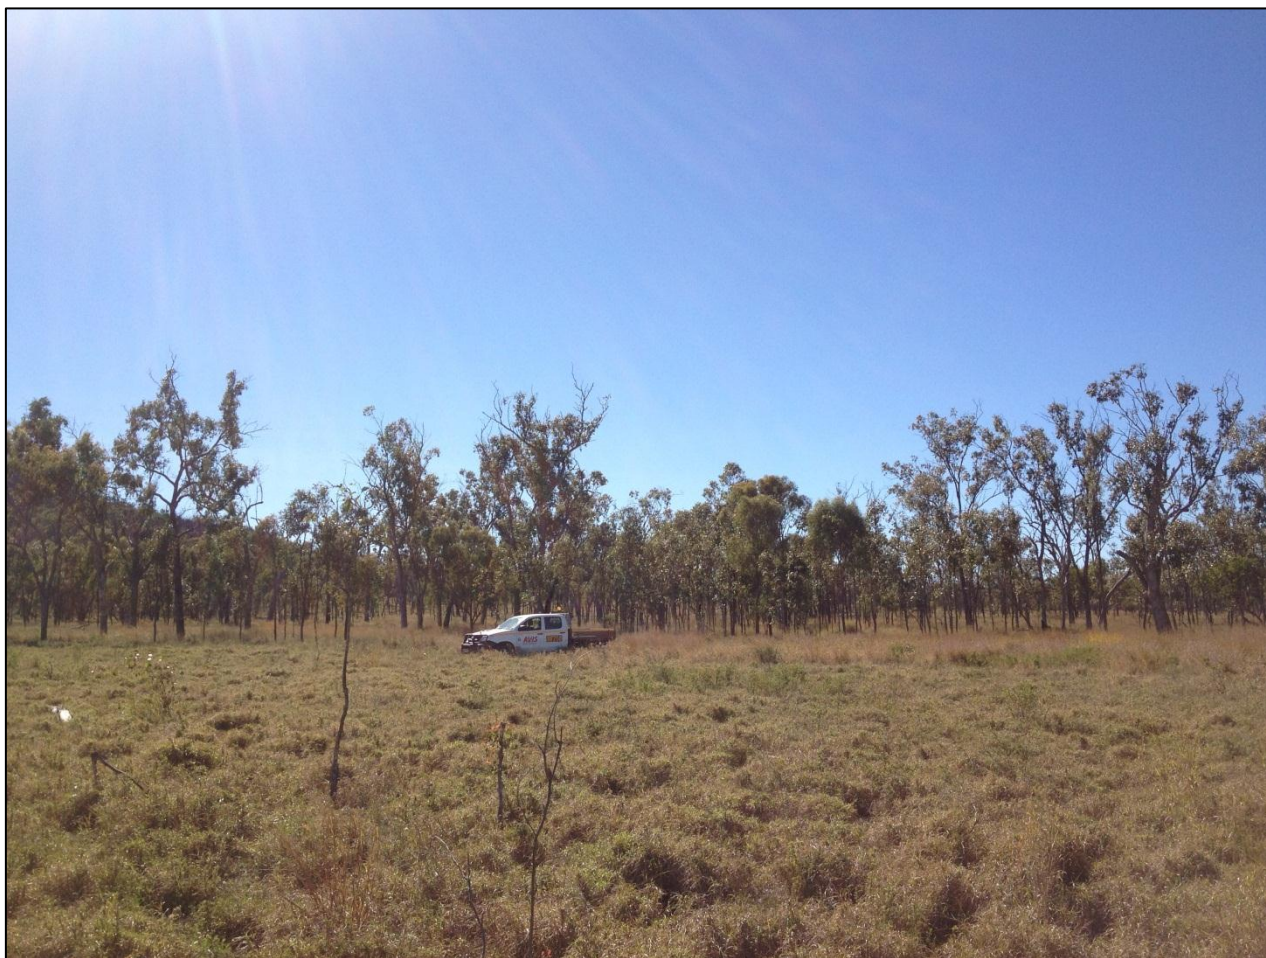
Photo: Area D

*The area mapped as remnant RE11.5.3/1.5.9 within the investigation area. Note dense *Pennisetum ciliare* (Buffel Grass) within understorey.*

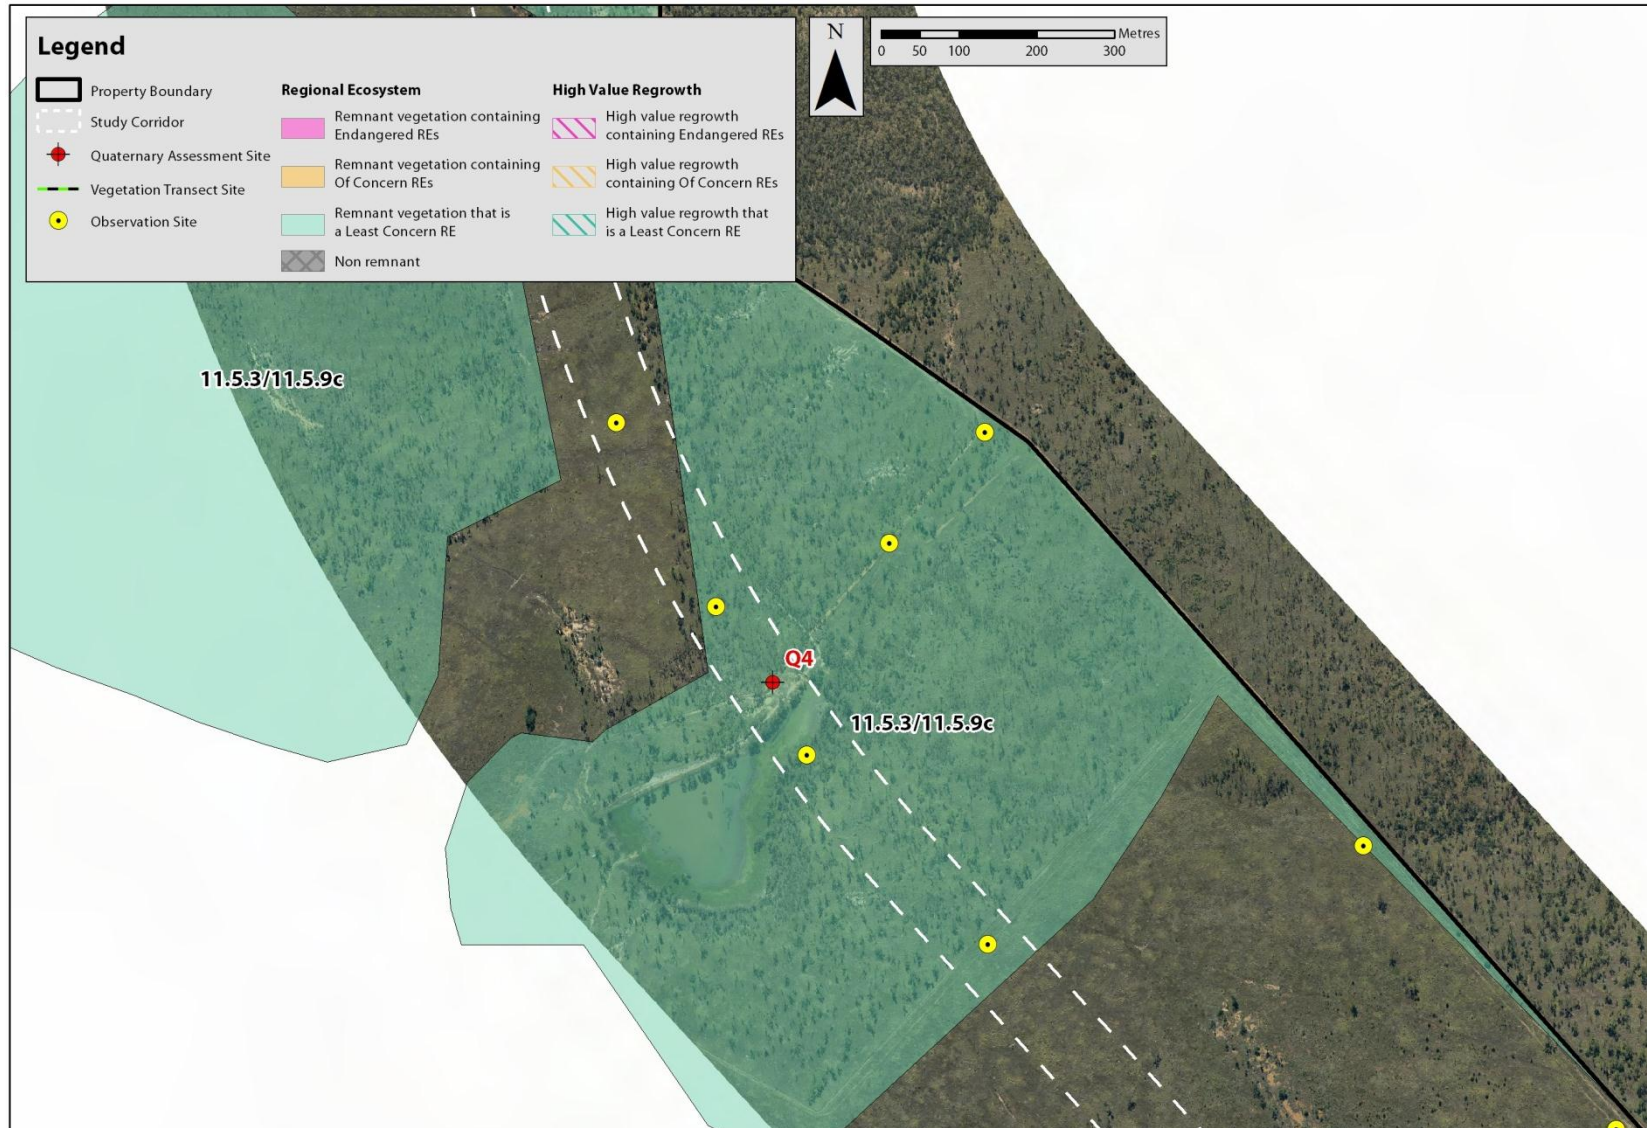
Figure 24: Regional Ecosystem and Survey Effort (Area D – No Changes Proposed)

Site Description		
Location:	E & R Action (Rugby Run); Lot 2 on GV248	
Site Description:	<p>The site is mapped as a composite vegetation community described as Least Concern RE 11.5.3/11.5.9c.</p> <p>The community is described as comprising approximately 50% Least Concern RE 11.5.2 and 50% Least Concern 11.5.9c.</p> <p>Species observed include <i>Eucalyptus populnea</i> and <i>Corymbia clarksonia</i> within the T1 layer and <i>Petalostigma pubescens</i>, <i>Alphitonia excelsa</i> and <i>Acacia excelsa</i> within the T2 and shrub layers.</p> <p>Ground layer was dominated by <i>Pennisetum ciliare</i> and <i>Themeda triandra</i>.</p> <p>Moderate levels of disturbance were observed within the survey area including weed invasion, grazing and historical clearing.</p> <p>Field observations indicate the presence of species consistent with both 11.5.3 and 11.5.9 within the polygons of Area D.</p> <p>Refer to Quaternary site 4 and Figure 24 for proposed mapping changes.</p>

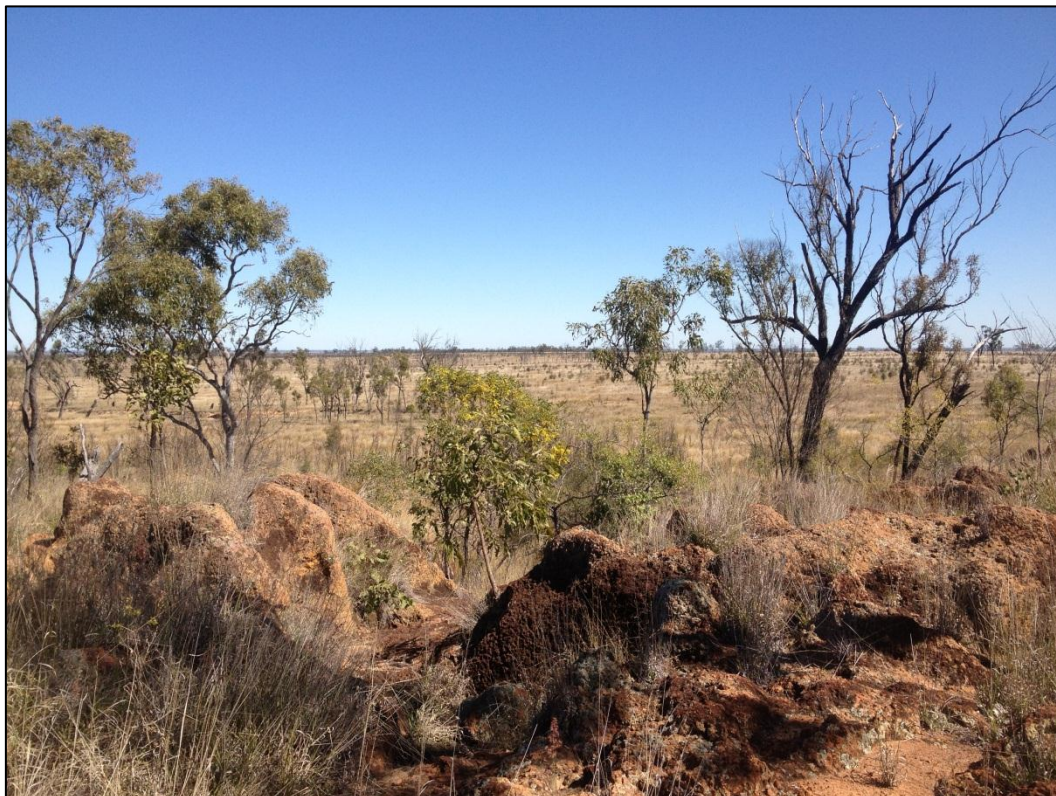
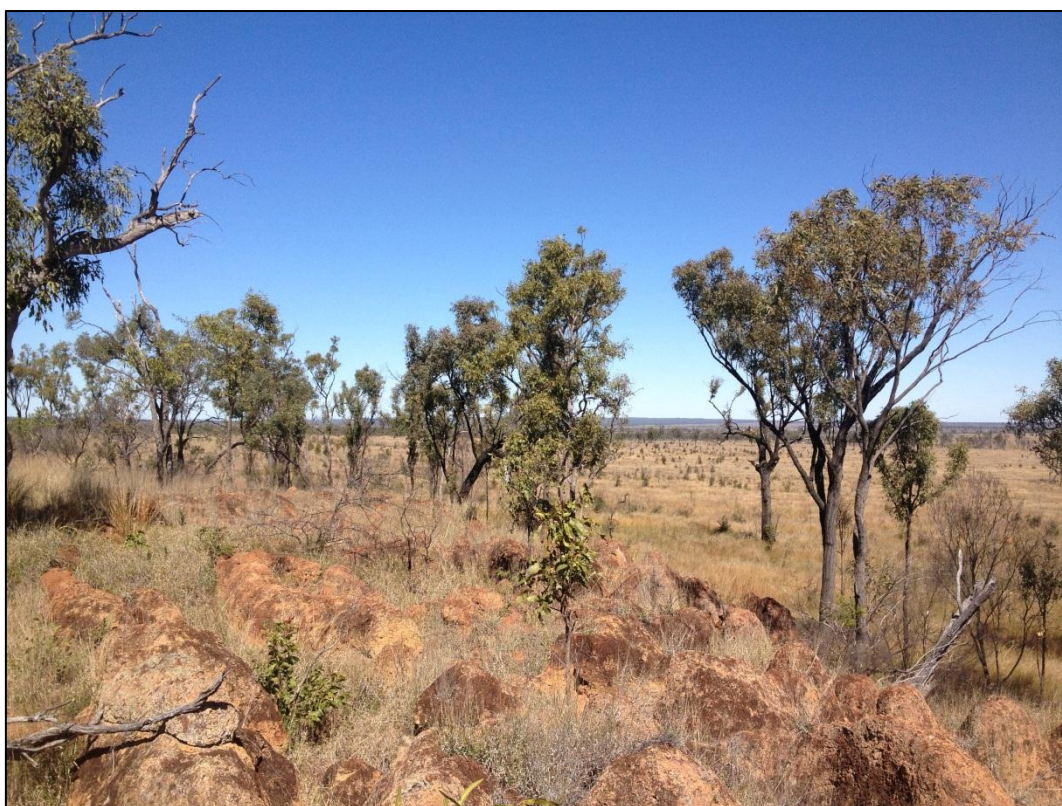
Photo: Area E

The area mapped as remnant RE11.5.3/1.5.9 within the investigation area. Note vegetation positioned on rocky outcrop.

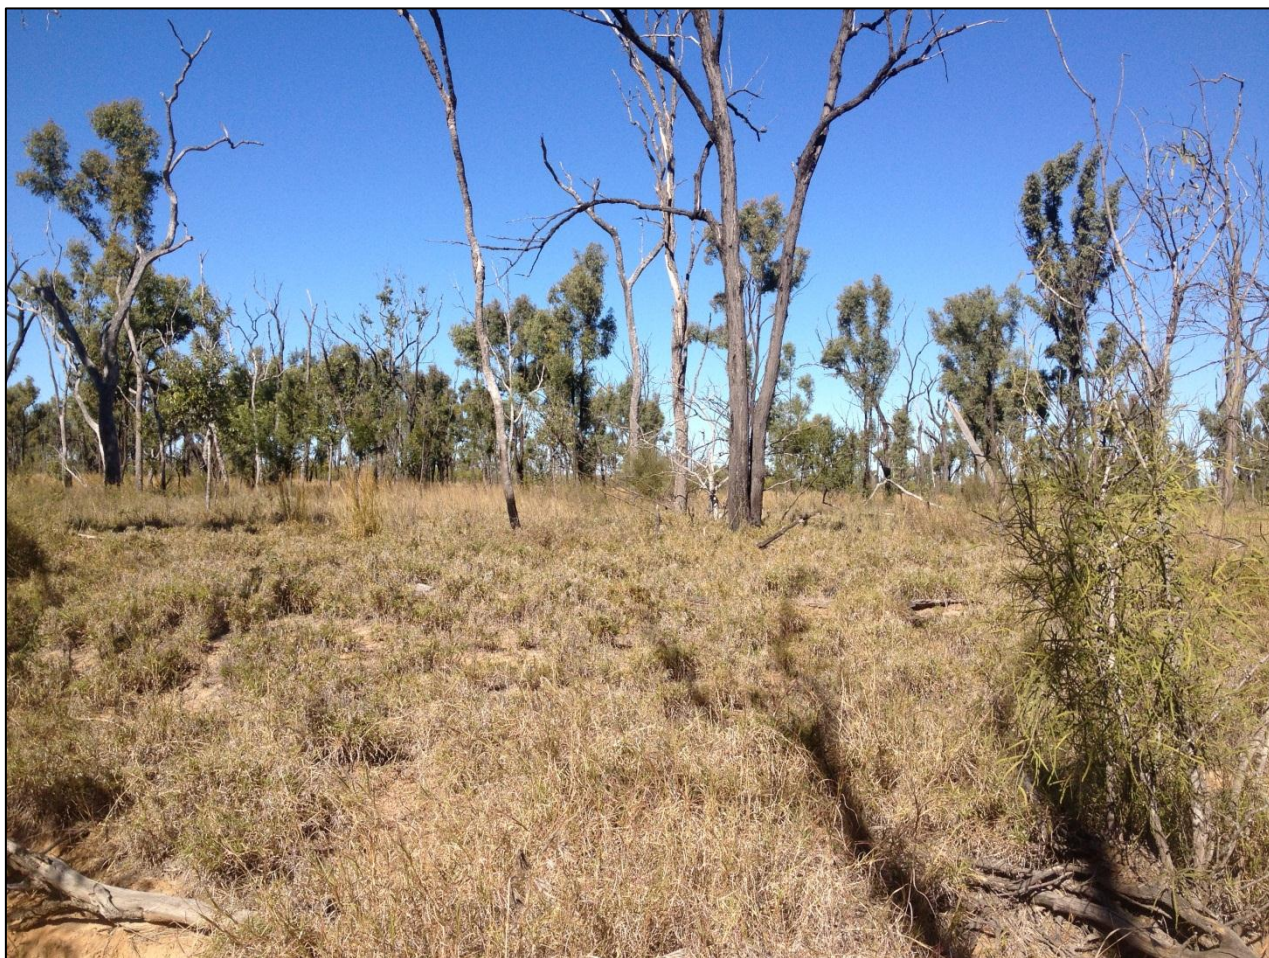
Photo: Area D

*The area mapped as remnant RE11.5.9/11.5.3 within the investigation area. Note dense *Pennisetum ciliare* (Buffel Grass) within understorey. High levels of disturbance from clearing and grazing within survey area.*
