Carmichael Coal Mine and Rail Project Supplementary Environmental Impact Statement

Volume 4, Appendix C3e – Waterway Barrier Works Application for SP1

- IDAS Form 1 Application details
- IDAS Form 27 Waterway Barrier Works (52 Logan Creek crossing detail)
- IDAS Form 27 Section 6 for 69b Mistake Creek
- IDAS Form 27 Section 6 for 78b Belyando River
- Waterway Barrier Works Assessment Report

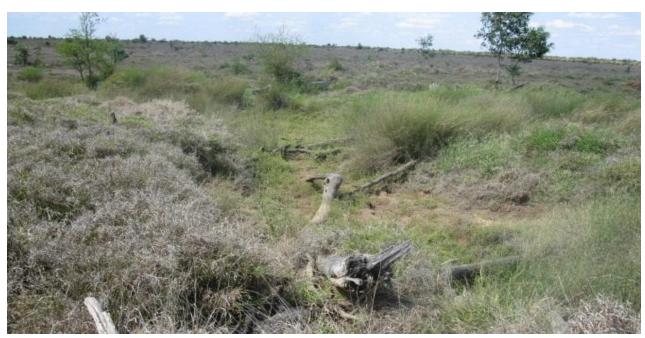
Photo: Example of an incorrectly mapped waterway

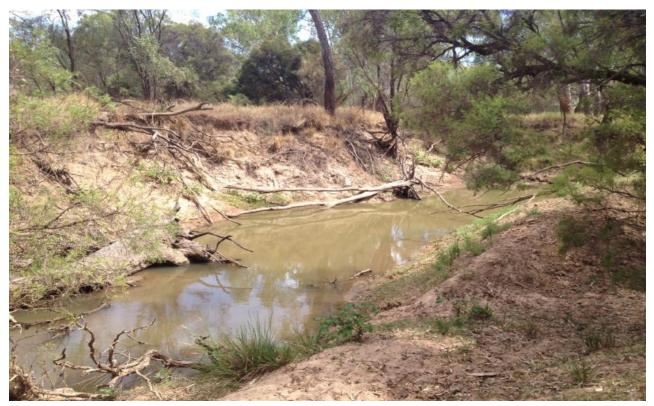
The condition assessment of the Belyando River described a permanent to semi-permanent waterway characterised by sandy substrates and eroded moderate to steep bank structures. Debris along the banks of the river and within the adjoining floodplain indicates significant flows during the wet season. Woody debris and some overhanging vegetation provide habitat opportunities for aquatic fauna.

This part of the Belyando River is characterised by extended pools and runs with sandy bars established on, and following, waterway bends. Due to the bank structure and sandy substrate, the low flow channel within these waterways typically varies following flood flows and deposition of materials.

Photo: Belyando River

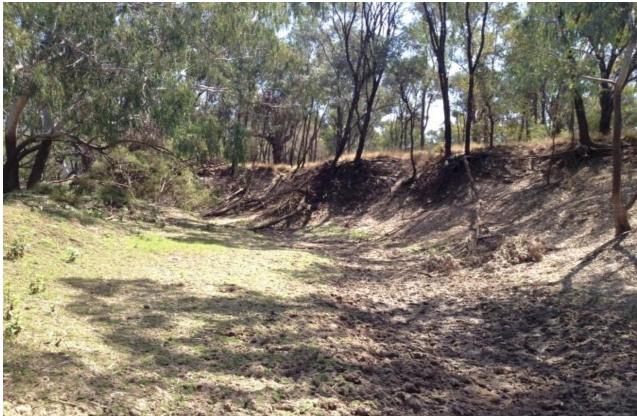
The stream bed of Mistake Creek is comprised of sands, gravel, clays and silts, with sand the dominant substrate observed within the watercourse. Erosion and slumping were observed on both banks predominantly caused by cattle accessing the watercourse and scouring from recent flood events.

Undercutting of riparian vegetation was observed along the watercourse banks, resulting in exposed roots and fallen timber within the area surveyed. Small turbid pools were occasionally observed within the stream bed, but the majority of the watercourse contained no pooled or flowing water.

Photo: Mistake Creek

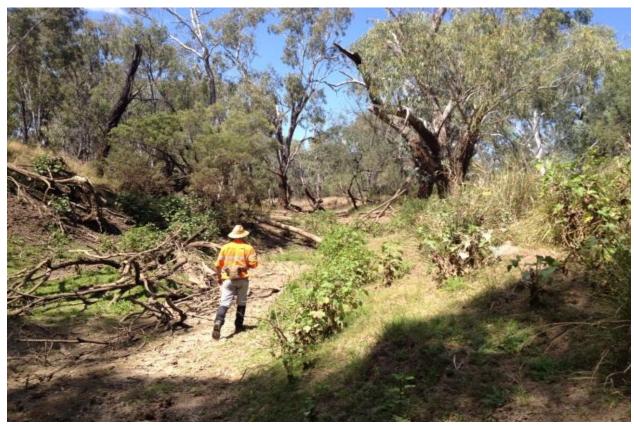
Photo: Mistake Creek

The remains of freshwater molluscs, crustaceans and gastropods were observed on the watercourse beds and banks. In addition *Cyperus* and *Juncus* species were occasionally observed at soakage points.

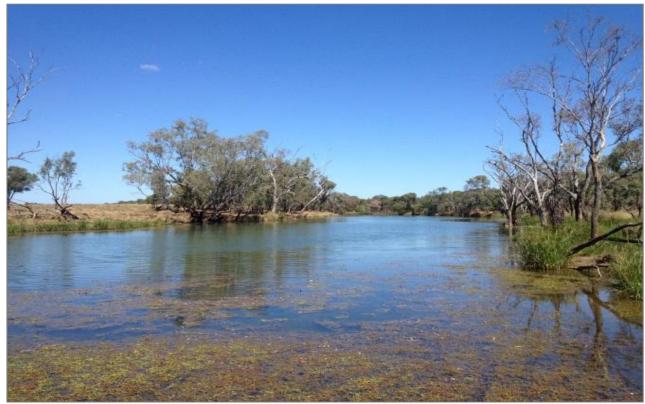
Substantial aquatic habitats in the form of submerged logs and aquatic macrophytes are present. Numerous avifauna were observed utilising this watercourse, including duck, cormorant, heron and ibis species.

Photo: Logan Creek

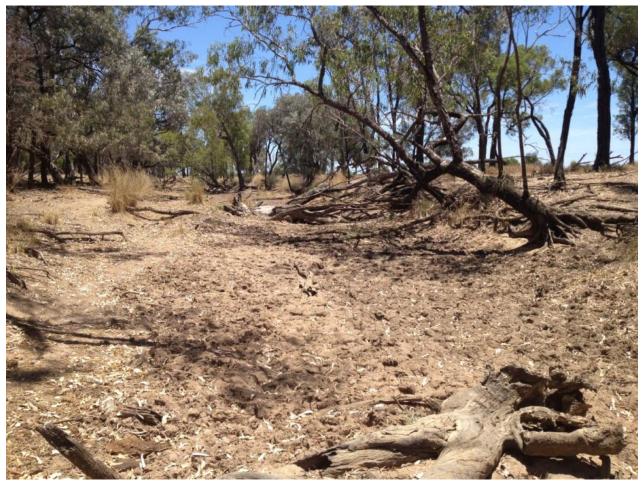
Photo: Eight Mile Creek

Overview	Section	Comment
Fisheries Act Waterway Zoning	Plan 2	Eight Mile Creek is identified as a 'Red waterway' by the Fisheries Spatial Data Layer
Field Determination	Section 1.2	Field assessment of Eight Mile Creek has identified inconsistencies within the 'waterway' classification. The crossing forms a shallow depression which appears to hold limited upstream connectivity. The area is above the upstream limit when considering the FHMOP8.
Proposed Works	Appendix B	A bridge structure is proposed to cross Eight Mile Creek.
Assessment Trigger	Section 1.3	The proposed bridge works are not considered Waterway Barrier Works assessable.

This location was assessed following a dry period and therefore no water was present. No riverine communities were observed which, in combination with the prevailing sandy substrate, indicates this area only holds water for short periods following extensive rainfall events. The 'mapped waterway' is broadly defined as a shallow erosion channel with fringing *Eucalyptus* and *Acacia* species and best described as an ephemeral drainage feature.

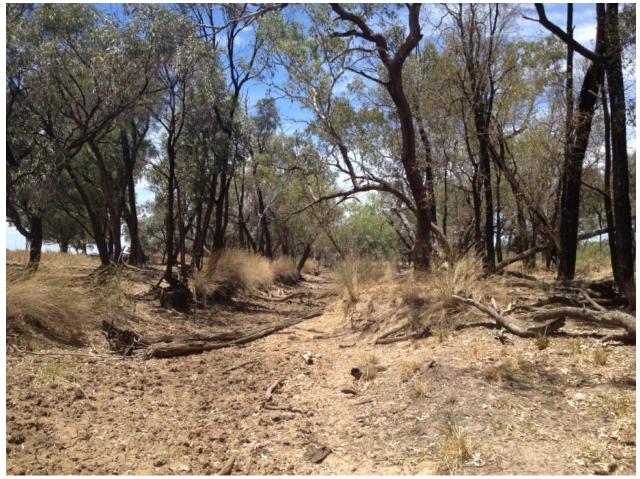
Photo: Eight Mile Creek

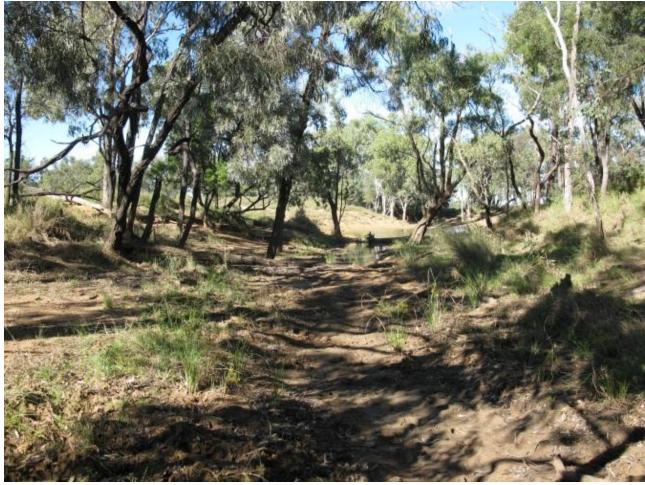
Photo: North Creek

Overview	Section	Comment
Fisheries Act Waterway Zoning	Plan 2	North Creek is identified as an 'Amber waterway' by the Fisheries Spatial Data Layer.
Field Determination	Section 2.2	Field assessment of North Creek has identified inconsistencies within the 'waterway' classification. Some potential exists for this feature to meet the definition of a 'waterway' under the <i>Fisheries Act</i> . However, connectivity may be limited when considering that this feature flows into a downstream floodplain. Fish movement is therefore only likely during extreme flood events. When considering the FHMOP8, this part of North Creek is considered to be above or near the upstream limit of the waterway.
Proposed Works	Appendix B	A bridge structure is proposed to cross North Creek.
Assessment Trigger	Section 2.3	The proposed bridge works are not considered Waterway Barrier Works assessable.

The catchment area for North Creek appears more extensive than Eight Mile Creek when viewing aerial imagery, and this flow path retains fringing vegetation and a more defined channel along the majority of its length. *Eucalyptus coolabah* is the dominant tree located on the banks. Other species identified include *Acacia harpophylla*, *Eucalyptus camaldulensis*, *Terminalia oblongata* and *Eremophila mitchellii*. Shrub and ground species situated on the bank include *Carissa ovata*, *Pennisetum ciliare*, and *Eremophila mitchellii*.

Other plants observed within the stream bed included *Juncus* and *Cyperus* species, indicating the area retains water for extended periods. Macrophytes were not observed within the assessment area.

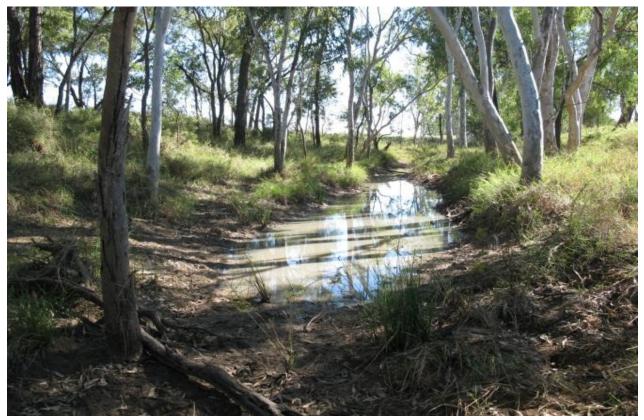
Photo: North Creek

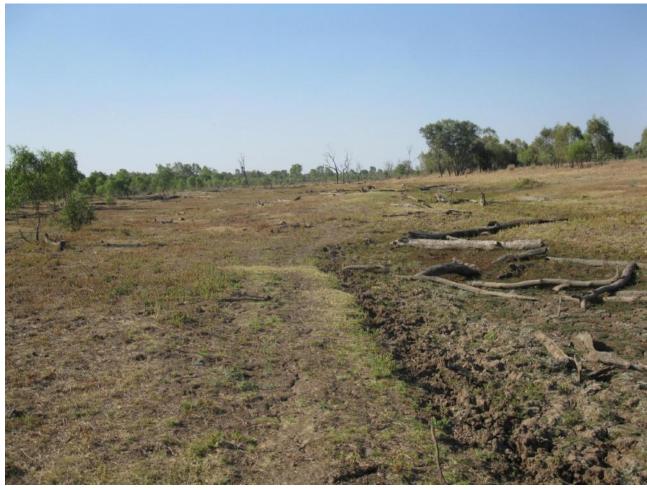
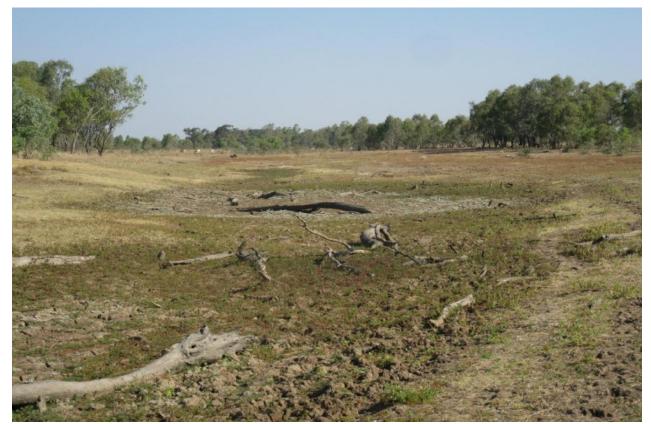
Photo: Ogenbeena Creek

Overview	Section	Comment
Fisheries Act Waterway Zoning	Plan 2	Ogenbeena Creek is identified as an 'Amber waterway' by the Fisheries Spatial Data Layer.
Field Determination	Section 3.2	Ogenbeena Creek is clearly not a 'waterway' as defined by the <i>Fisheries Act 1994</i> . The area is incorrectly mapped by the Fisheries Data Spatial Layer.
Proposed Works	Appendix B	A bridge structure is proposed to cross Ogenbeena Creek.
Assessment Trigger	NA	NA

This part of Ogenbeena Creek is situated within a floodplain. This location does not have any characteristics consistent with the definition of a 'waterway'.

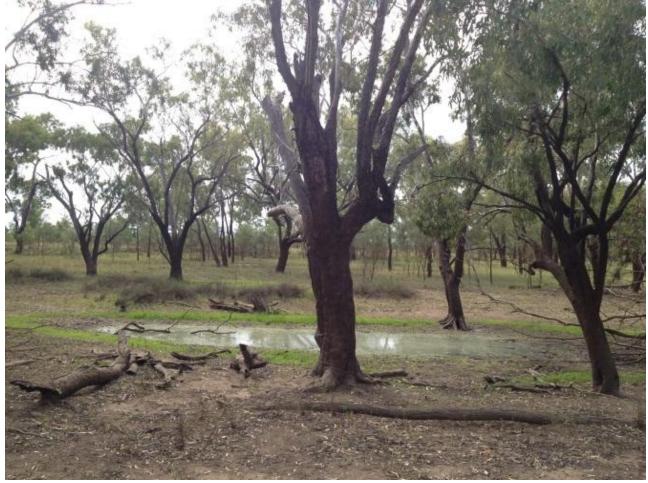
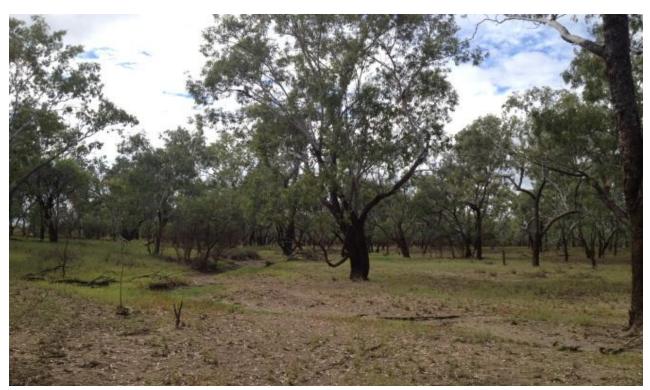
Photo: Ogenbeena Creek (lower crossing)

Overview	Section	Comment
Fisheries Act Waterway Zoning	Plan 2	Ogenbeena Creek (lower crossing) is identified as an 'Amber waterway' by the Fisheries Spatial Data Layer.
Field Determination	Section 4.2	Field assessment of Ogenbeena Creek has identified inconsistencies within the 'waterway' classification. Ogenbeena Creek retains no defined channel features and is not considered a 'waterway' as defined by the <i>Fisheries Act 1994</i> . The area is incorrectly mapped by the Fisheries Data Spatial Layer.
Proposed Works	Appendix B	A bridge structure is proposed to cross Ogenbeena Creek.
Assessment Trigger	NA	NA

This drainage feature flows West to East within an alluvial floodplain before joining to a Stream Order 2 flow path associated with the Belyando River. Boundaries of the flow path could not be clearly defined with only minor depressions along the broader floodplain present. The area does not meet the definition of a 'waterway' under the *Fisheries Act*.

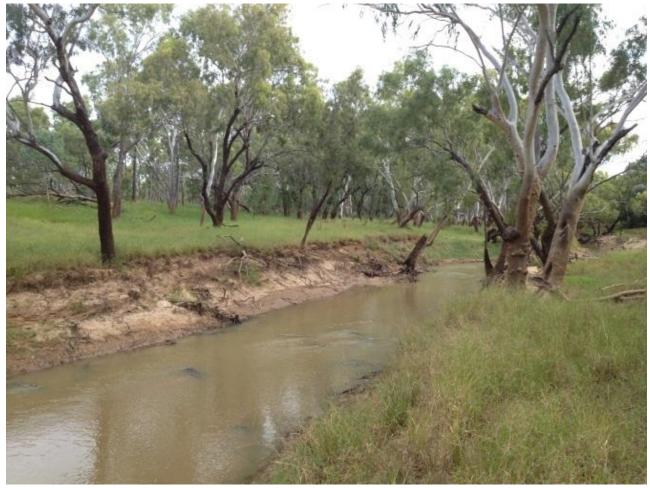
Photo: Belyando River Tributary

Overview	Section	Comment
Fisheries Act Waterway Zoning	Plan 2	This tributary of the Belyando River is identified as an 'Amber waterway' by the Fisheries Spatial Data Layer.
Field Determination	Section 5.2	This Belyando River tributary is clearly a 'waterway' as defined by the Fisheries Act 1994.
Proposed Works	Appendix B	A bridge structure is proposed over this 'waterway'.
Assessment Trigger	Section 5.3	The proposed bridge works are not considered Waterway Barrier Works assessable.

'Waterway' banks showed signs of erosion and slumping associated with cattle grazing and flood disturbance. Vegetation was basically absent from the 'waterway' bank. Freshwater mussels and crab shells were observed scattered along the 'waterway' bed, banks and riparian area.

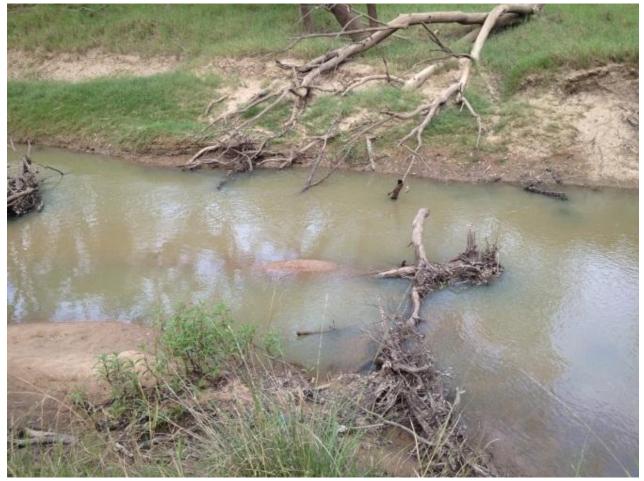
Photo: Belyando River Tributary

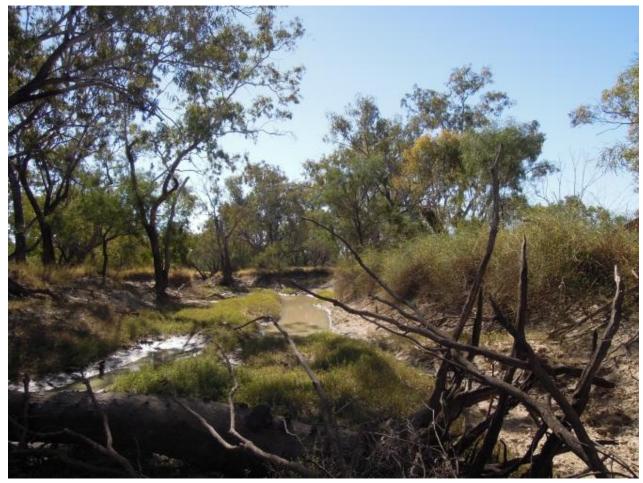
Photo: Belyando River (East Tributary)

Overview	Section	Comment
Fisheries Act Waterway Zoning	Plan 2	This tributary of the Belyando River is identified as an 'Amber' waterway' by the Fisheries Spatial Data Layer
Field Determination	Section 6.2	At this location, the flow path appears to branch from the main Belyando River (upstream) and reconnect further downstream of the rail alignment. This flow path meets the 'waterway' definition.
Proposed Works	Appendix B	A bridge structure is proposed over this 'waterway'.
Assessment Trigger	Section 6.3	The proposed bridge works are not considered Waterway Barrier Works assessable.

This 'mapped waterway' forms part of the Belyando River Floodplain. Riparian vegetation within the alignment at this site is consistent with REs 11.3.25 and 11.3.37. Tree species present include *Eucalyptus coolabah* and *Eucalyptus camaldulensis*. Other species observed within the T2 and shrub layers included *Geijera parviflora, Terminalia oblongata* and *Acacia stenophylla*. The ground layer contained a mix of exotic and native grasses including *Pennisetum ciliare, Dichanthium sericeum, Leptochloa digitata, Enteropogon acicularis* and *Bothriochloa ewartiana*

Some areas of severe erosion, primarily caused through flooding and grazing pressure, were observed. Materials deposited within the stream bed were comprised of sand, small gravel, clays and fine silts. Outside of the 'waterway', the landscape appears highly erodible with a series of gullies and depressions.

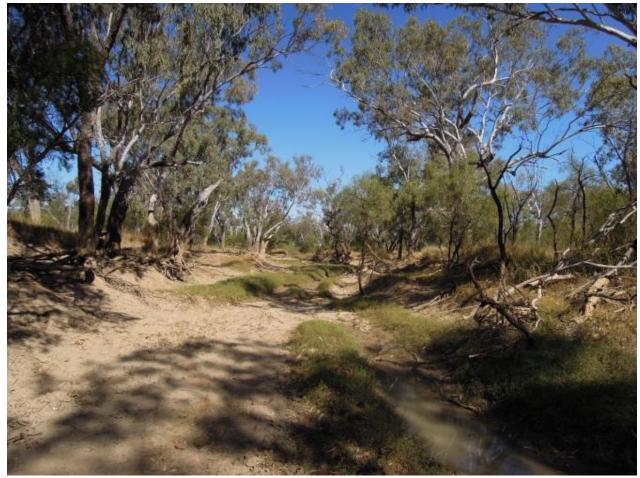
Due to recent rainfall, some pool areas still contained water when the site was assessed, but, due to the seasonal nature of the 'waterway', these pools would only be temporary and not exist during extended periods of drier weather. Utilisation of these pools for long term survival by aquatic fauna species would be highly unlikely.

Photo: Belyando River (East Tributary)

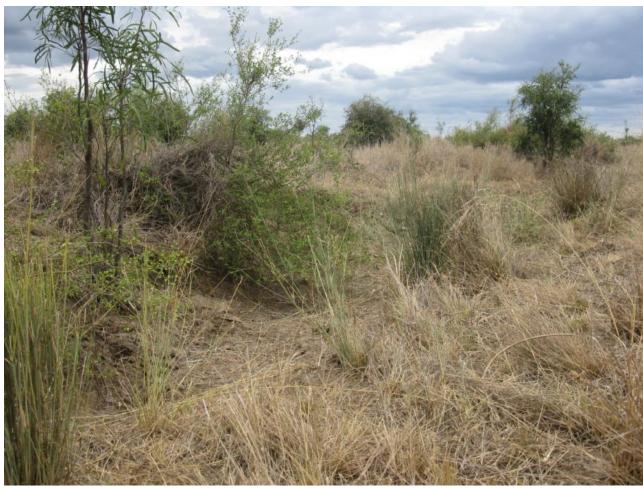
Photo: Unnamed Flow Path (Crossing 73)

Overview	Section	Comment
Fisheries Act Waterway Zoning	Plan 2	This unnamed flow path is identified as an 'Amber waterway' by the Fisheries Spatial Data Layer.
Field Determination	Section 7.2	Field assessment identified the Spatial Data Layer mapping for this location is incorrect. The drainage feature forms an isolated depression.
Proposed Works	N/A	A culvert structure is proposed to cross this unnamed flow path.
Assessment Trigger	Section 7.3	The proposed culvert works are considered Waterway Barrier Works that are self-assessable.

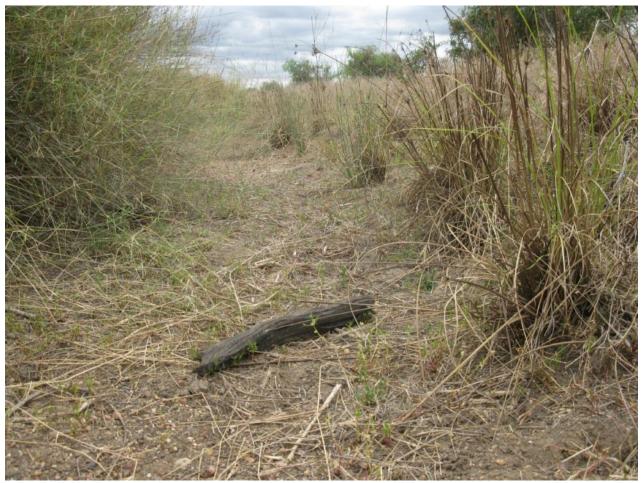
This 'mapped waterway' is situated within a highly disturbed agricultural paddock which retains limited canopy vegetation. The area displays no defined features of a channel capable of providing for fish movement. The mapping error is believed to have originated from the digital Stream Order mapping layer which identifies an approximately 5 km long isolated drainage feature at this site. This mapping layer is generally inaccurate, especially within upper catchment areas.

Photo: Unnamed Flow Path (Crossing 73)

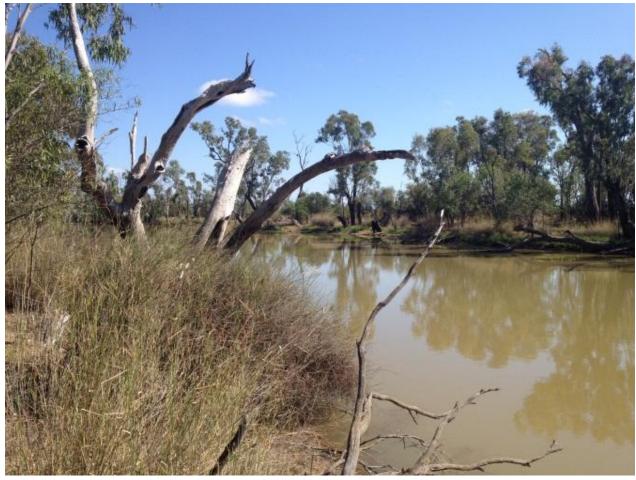
Photo: Water Body near Mistake Creek (Crossing 69d)

Overview	Section	Comment
Fisheries Act Waterway Zoning	Plan 2	This water body near Mistake Creek is not mapped by the Spatial Data Layer.
Field Determination	Section 8.2	This extensive water body appears to form a tributary of Mistake Creek, and aerial imagery suggests it branches from Mistake Creek upstream of the alignment and reconnects further downstream.
Proposed Works	N/A	A culvert structure is proposed to cross this unnamed water body.
Assessment Trigger	Section 8.3	The proposed culvert works are considered Waterway Barrier Works that are self-assessable.

Banks of the water body associated with the alignment at this site are stabilised with grasses and sedges interspersed with variable states of erosion dependent on the location of cattle access points. Numerous habitat values were observed within the water body, including submerged logs and macrophytes.

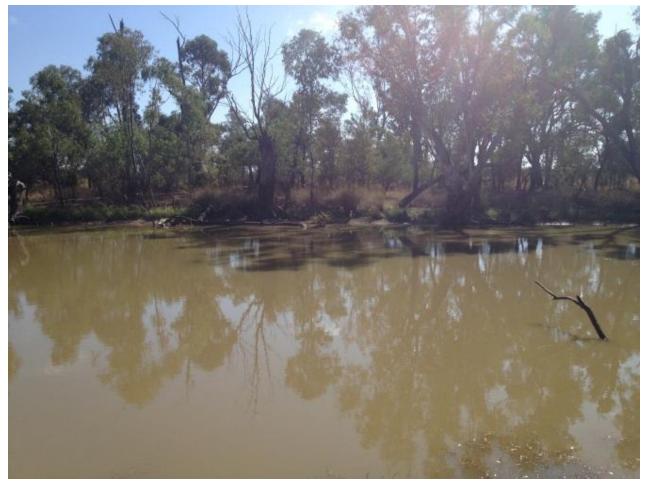
Photo: Water Body near Mistake Creek (Crossing 69d)

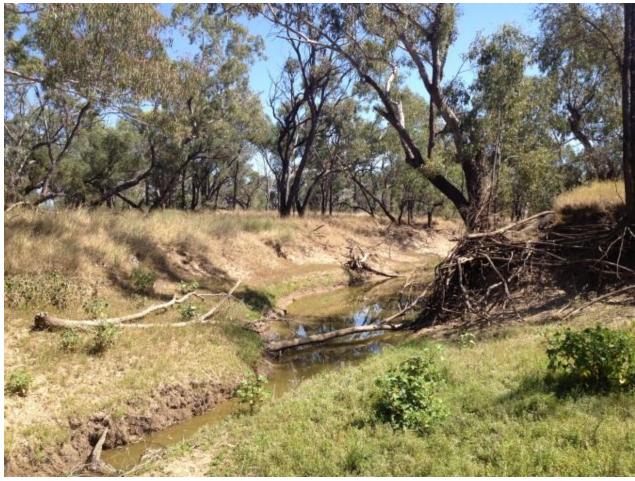
Photo: Mistake Creek Anabranch

Overview	Section	Comment
Fisheries Act Waterway Zoning	Plan 2	This branch of Mistake Creek is identified as an 'Amber waterway' by the Fisheries Spatial Data Layer.
Field Determination	Section 9.2	This branch of Mistake Creek is a 'waterway' as defined by the <i>Fisheries Act 1994,</i> and appears to join upstream and downstream to the main Mistake Creek.
Proposed Works	Appendix B	A bridge structure is proposed to cross this waterway.
Assessment Trigger	Section 9.3	The proposed bridge works are not considered Waterway Barrier Works assessable.

Stream bed materials were formed from sand, gravel, clay and silt materials. Sand formed the greatest percentage of the substrate within the stream bed. Temporary pools were observed in areas where timber had deposited from flood events and silt and sand materials had deposited preventing water deviation.

Observed severe bank erosion and slumping were predominantly caused by grazing and flood disturbances. Erosion has resulted in fallen trees and exposed roots for a number of trees within the assessment area.

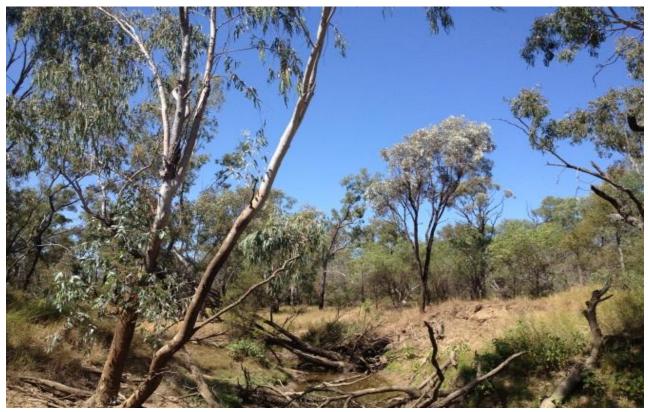
Photo: Mistake Creek Anabranch

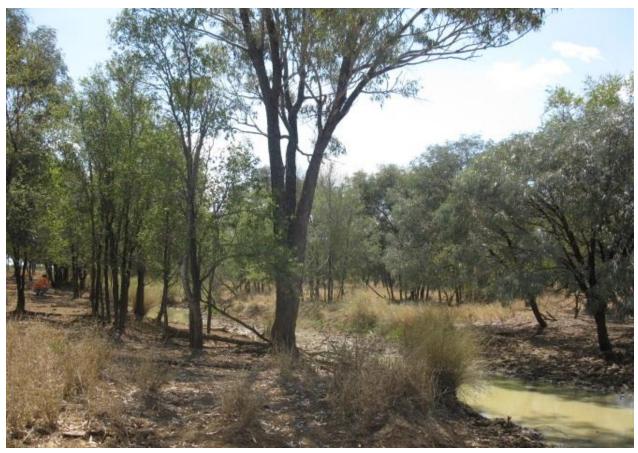
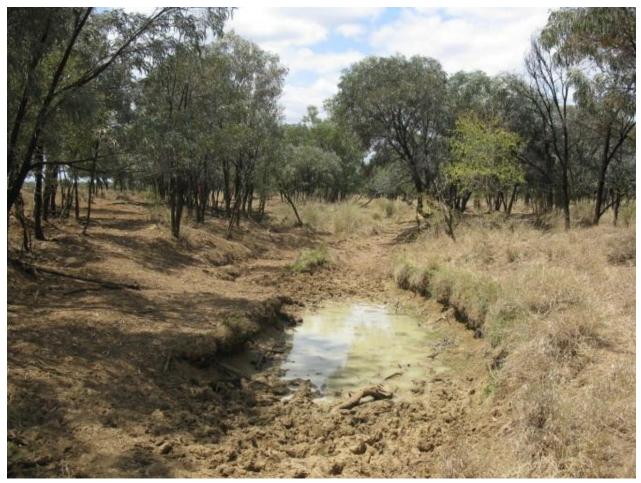
Photo: Gowrie Creek

Overview	Section	Comment
Fisheries Act Waterway Zoning	Plan 2	Gowrie Creek is identified as a 'Purple waterway' by the Fisheries Spatial Data Layer.
Field Determination	Section 10.2	Gowrie Creek has the potential to be a 'waterway' due to its proximity to Mistake Creek and the presence of upstream and downstream water bodies. However, this flow path funnels localised immediate rainfall only, and it appears that the crossing is above the upstream limits of the 'waterway'. Therefore, Gowrie Creek is not considered a 'waterway' as defined by the <i>Fisheries Act 1994</i> .
Proposed Works	Appendix B	A bridge structure is proposed to cross Gowrie Creek.
Assessment Trigger	Section 10.3	The proposed bridge works are not considered Waterway Barrier Works assessable.

Gowrie Creek does not possess all of the fundamental characteristics required for it to be defined as a 'waterway'. The absence of riverine vegetation and the presence of areas where the channel becomes less defined suggest it forms a 'drainage feature' rather than a 'waterway'.

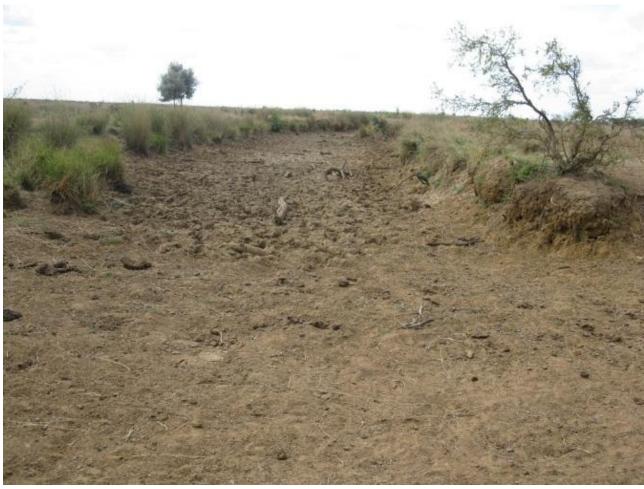
Photo: Gowrie Creek Tributary (Crossing 67)

Overview	Section	Comment
Fisheries Act Waterway Zoning	Plan 2	This Gowrie Creek Tributary is identified as an 'Amber waterway' by the Fisheries Spatial Data Layer.
Field Determination	Section 11.2	This Gowrie Creek Tributary forms isolated broken sections of a depression, and funnels immediate localised rainfall only. At periods of high flow it could connect habitats if present. This Gowrie Creek tributary is therefore not considered a 'waterway' as defined by the <i>Fisheries Act 1994</i> .
Proposed Works	Appendix B	A culvert structure is proposed to cross this Gowrie Creek Tributary.
Assessment Trigger	Section 11.3	The proposed culvert works are considered Waterway Barrier Works that are self-assessable.

This drainage feature was completely dry during the survey and only appears to flow and contain water after periods of intense or continual rainfall. The substrate within the stream bed was comprised predominantly of cracking clays and silt materials.

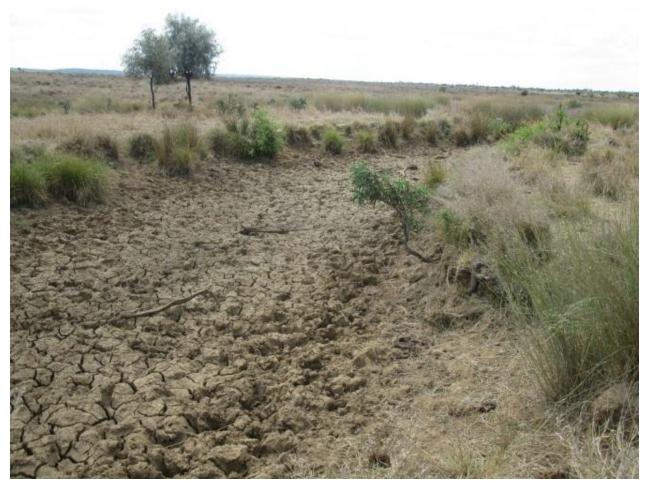
Photo: Gowrie Creek Tributary (Crossing 67)

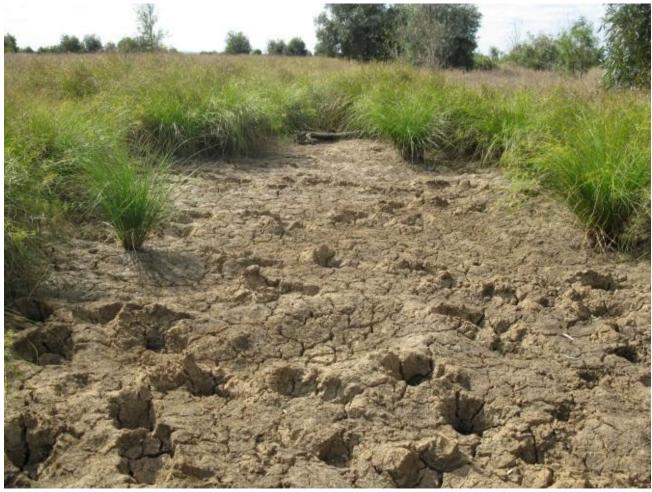
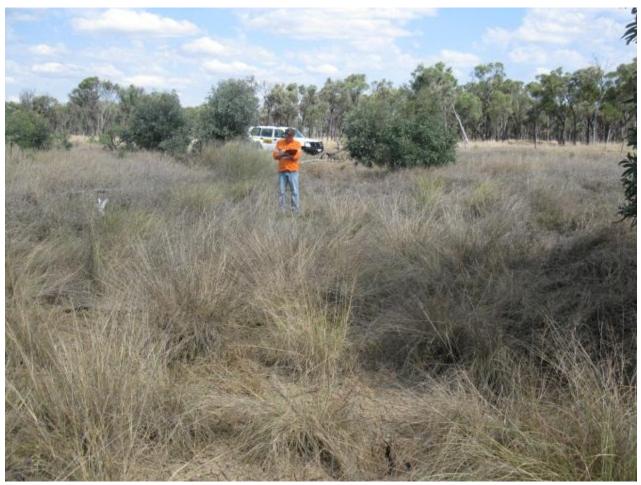
Photo: Gowrie Creek Tributary (Crossing 66)

Overview	Section	Comment
Fisheries Act Waterway Zoning	Plan 2	This Gowrie Creek Tributary is identified as an 'Amber waterway' by the Fisheries Spatial Data Layer.
Field Determination	Section 12.2	This Gowrie Creek Tributary forms isolated broken sections of a depression, funnels immediate localised rainfall only, and would have inadequate flow. It is also poor habitat. This Gowrie Creek tributary is therefore not considered a 'waterway' as defined by the <i>Fisheries Act 1994</i> .
Proposed Works	Appendix B	A culvert structure is proposed to cross this Gowrie Creek Tributary.
Assessment Trigger	Section 12.3	The proposed culvert works are considered Waterway Barrier Works that are self-assessable.

This area contains no features consistent with a 'waterway'. The area has been historically cleared of all woody vegetation and is now dominated by the exotic fodder grass species *Pennisetum ciliare*.

This flow path was completely dry during the survey and only appears to flow and contain water after periods of intense or continual rainfall. The area contained a number of shallow dry depressions.

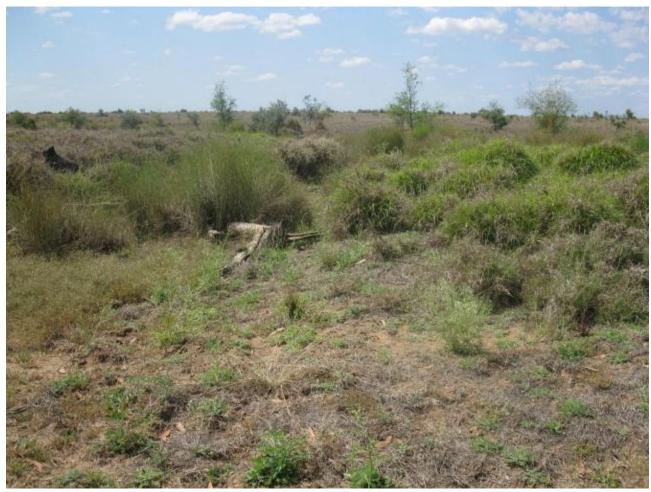
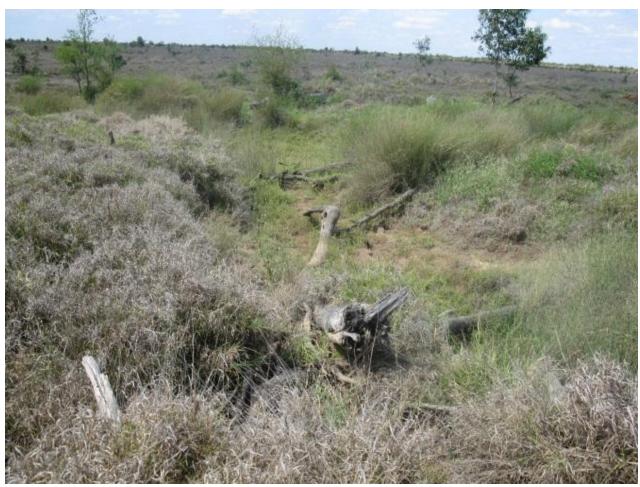
Photo: Gowrie Creek Tributaries (Crossings 64 & 63)

Overview	Section	Comment
Fisheries Act Waterway Zoning	Plan 2	These Gowrie Creek Tributaries are identified as 'Amber waterways' by the Fisheries Spatial Data Layer.
Field Determination	Section 13.2	These Gowrie Creek Tributaries form isolated broken sections of depressions that funnel immediate localised rainfall only and would have inadequate flow. They are also poor habitat, and therefore do not contain features consistent with a 'waterway'.
Proposed Works	Appendix B	A culvert structure is proposed to cross these Gowrie Creek Tributaries.
Assessment Trigger	Section 13.3	The proposed culvert works are considered Waterway Barrier Works that are self-assessable.

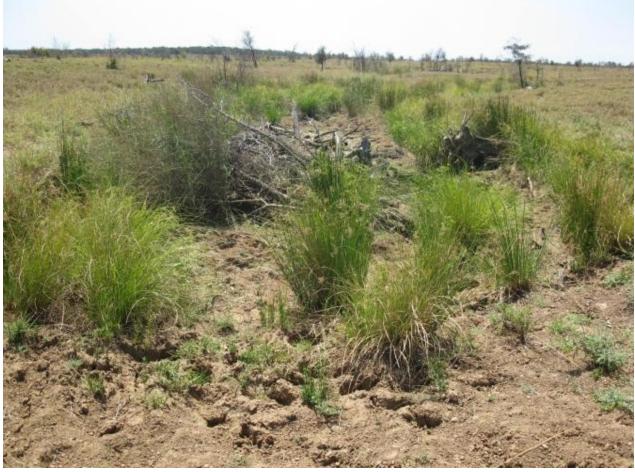
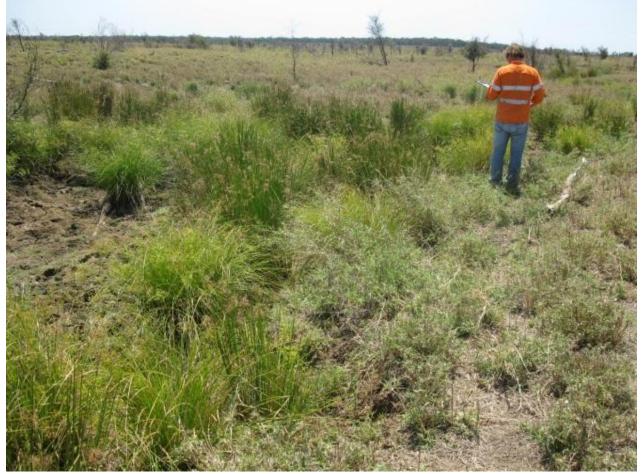
Photo: Unnamed Flow Path (Crossing 60)

Overview	Section	Comment
Fisheries Act Waterway Zoning	Plan 2	This unnamed flow path is identified as a 'Green waterway' by the Fisheries Spatial Data Layer.
Field Determination	Section 14.2	This unnamed flow path forms a drainage depression that does not contain features consistent with a 'waterway'.
Proposed Works	Appendix B	A culvert structure is proposed to cross this unnamed flow path.
Assessment Trigger	Section 14.3	The proposed culvert works are considered Waterway Barrier Works that are self-assessable.

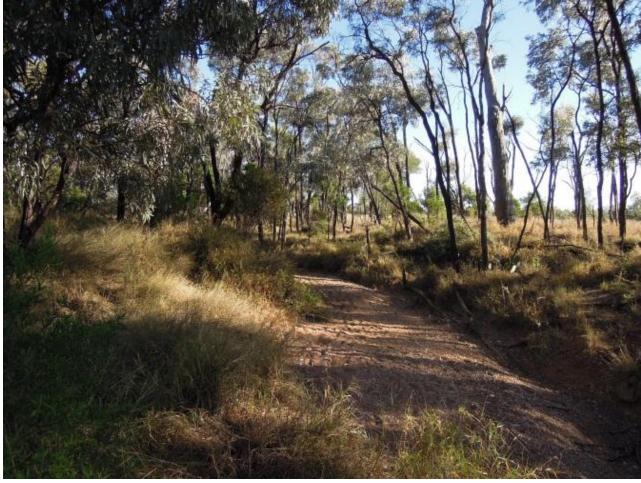
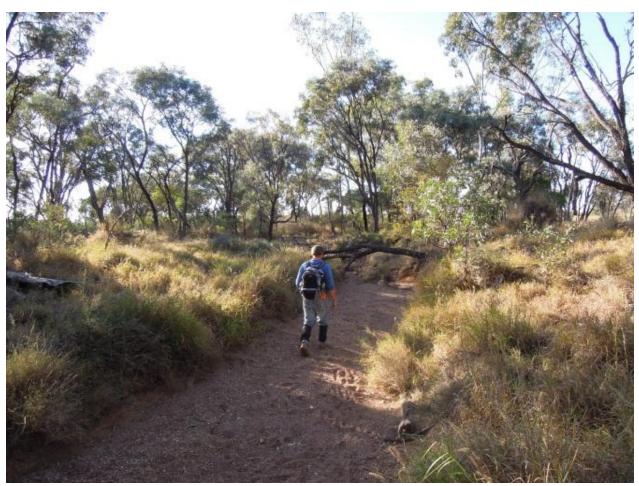
Photo: Unmapped Flow Path (Crossing 59)

Overview	Section	Comment
Fisheries Act Waterway Zoning	Plan 2	This flow path is not mapped by the Spatial Data Layer.
Field Determination	Section 15.2	Although the bed and banks are continuous immediately up- and downstream, this unmapped flow path forms a drainage depression that does not contain features consistent with a 'waterway'.
Proposed Works	Appendix B	A culvert structure is proposed to cross this unmapped flow path.
Assessment Trigger	Section 15.3	The proposed culvert works are considered Waterway Barrier Works that are self-assessable.

The depression is formed by the concentration of overland flow with the substrate comprised of sand and gravel with areas of fine sediment and silts. No pools or areas capable of holding water were observed within the alignment area.

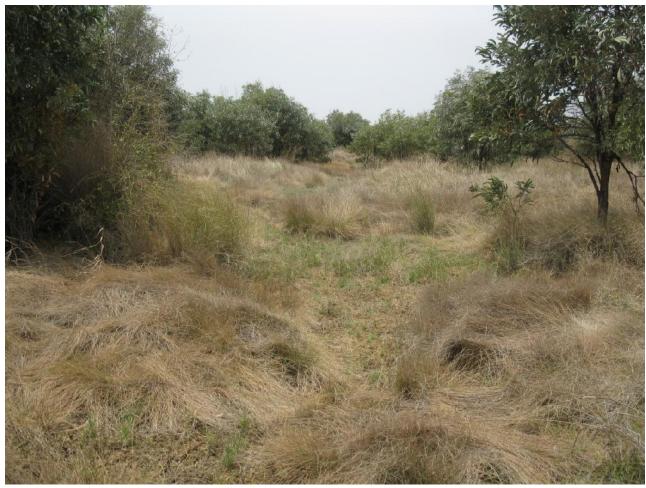
Photo: Unnamed Flow Path (Crossing 56)

Overview	Section	Comment
Fisheries Act Waterway Zoning	Plan 2	This unnamed flow path is identified as an 'Amber waterway' by the Fisheries Spatial Data Layer.
Field Determination	Section 16.2	This unnamed flow path does not contain features consistent with a 'waterway'.
Proposed Works	Appendix B	A culvert structure is proposed to cross this unnamed flow path.
Assessment Trigger	Section 16.3	The proposed culvert works are considered Waterway Barrier Works that are self-assessable.

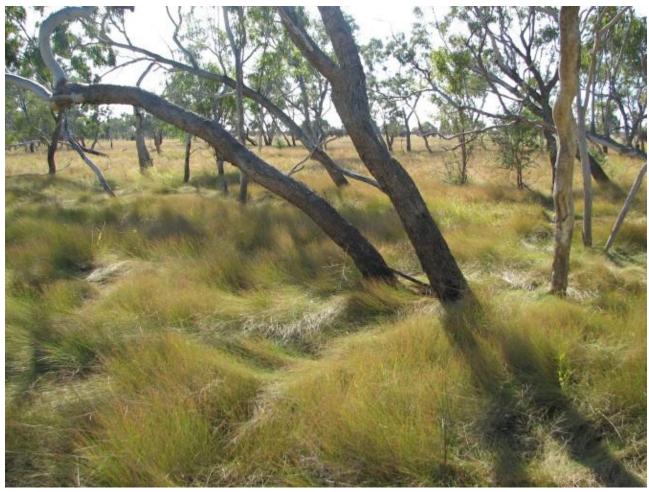
Photo: Logan Creek Tributary (Crossing 53)

Overview	Section	Comment
Fisheries Act Waterway Zoning	Plan 2	This Logan Creek Tributary is identified as an 'Amber waterway' by the Fisheries Spatial Data Layer.
Field Determination	Section 17.2	This Logan Creek Tributary does not contain features consistent with a 'waterway'.
Proposed Works	Appendix B	A culvert structure is proposed to cross this Logan Creek Tributary.
Assessment Trigger	Section 17.3	The proposed culvert works are considered Waterway Barrier Works that are self-assessable.

The area contains no formalised 'waterway' structure, with no obvious stream channels, beds or banks observed during the field survey.

No ponds, pools, riffles or bars were observed within the survey area, and no aquatic habitats were present. Vegetation observed included *Eucalyptus coolabah*, *Terminalia oblongata*, *Eucalyptus populnea*, *Eremophila bigoniiflora*, *Geijera parviflora* and *Citrus glauca*. The shrub layer would be considered very sparse with the ground layer within remnant vegetation dominated by native grasses.
