Cross River Rail
Environmental Impact Statement
Technical Report No. 5 – Surface water
July 2011

**TECHNICAL REPORT NO.5
SURFACE WATER QUALITY**

JULY 2011

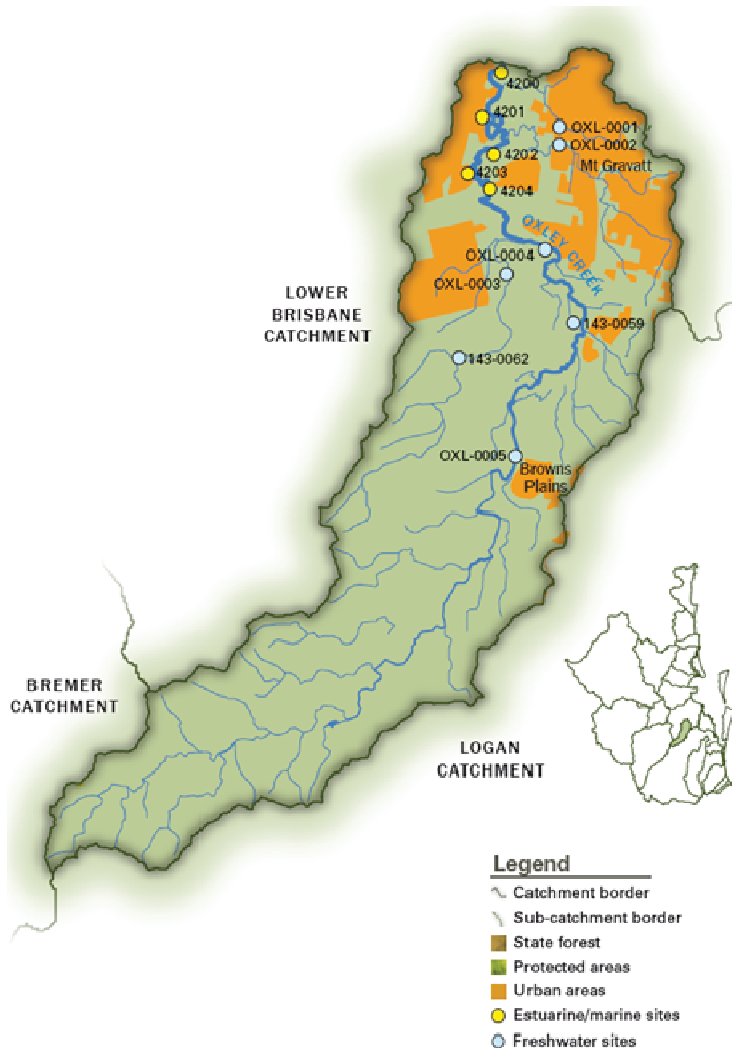
Figure 3-3 Oxley Catchment

Oxley catchment (see **Figure 3-3**) covers an area of 258 km² and lies on the south-western side of Brisbane (EHMP, 2009). The southern section of the catchment is steep and contains elevated regions with native forest and grazing land. Increased development pressure and expansion of rural residential and urban uses, however, has resulted in a loss of forests and farm land (OCCA, 2010; Marston, 2000). A substantial area of undisturbed vegetation remains intact within the Greenbank Military Training Area, in the mid section of the catchment (OCCA, 2010).

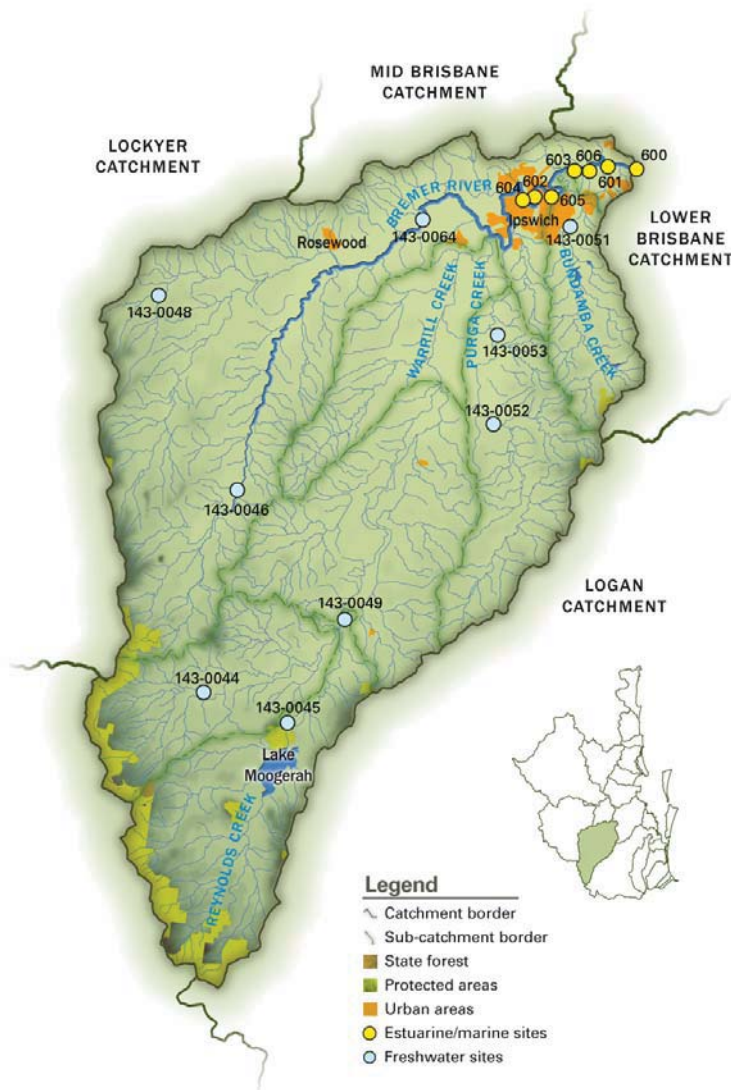
Figure 3-4 Bremer Catchment

The Bremer Catchment (refer to **Figure 3-4**) lies outside the study corridor to the south west of the Lower Brisbane Catchment and covers a total area of 2,031 km², with stream networks extending for 4,425 km (EHMP, 2010). This catchment is included in this report based on the assumption that spoil placement will occur at Swanbank.
