Waratah Coal China First - Preliminary Site Investigation: Contaminated Land

13 September 2010

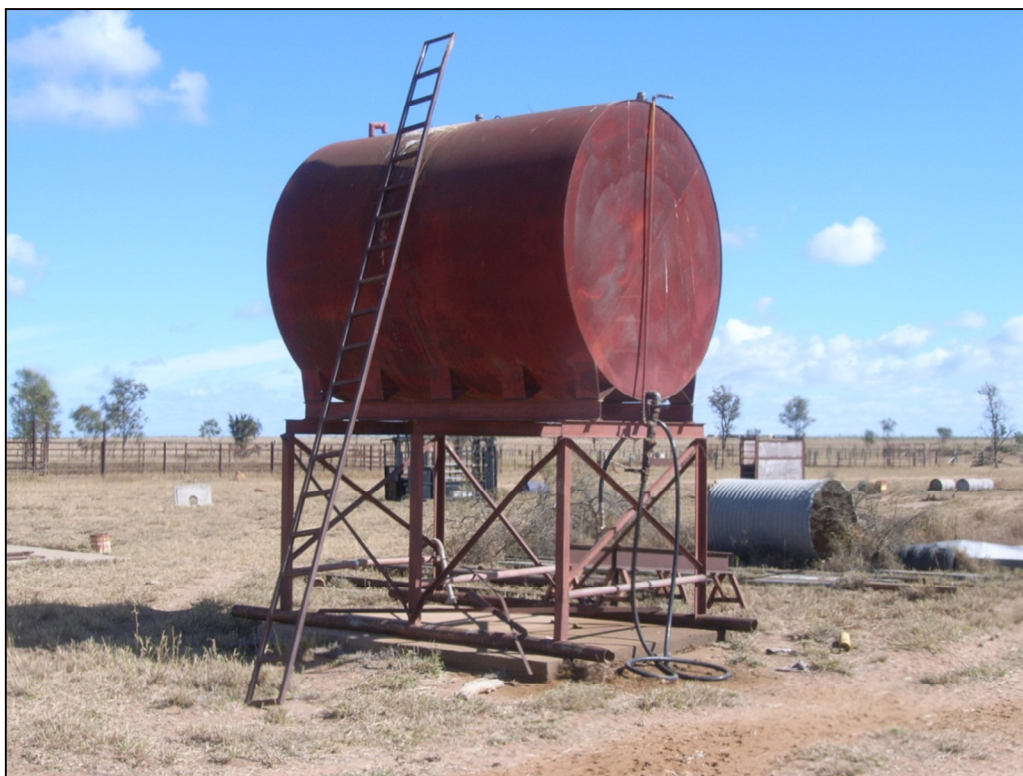
An interview with personnel from 'Kiaora Station' indicated that mine footprint does not include a cattle dip; however, site infrastructure does include an AST (Plate 4-1) and a stockyard with an associated crush.

Plate 4-1: Above Ground Storage Tank on Lot 1

The area of observed hydrocarbon staining was of a limited area (<2m²). Petroleum Hydrocarbons are volatile but biodegrade naturally. Therefore, remnant impacts are often minimal where significant time has elapsed since the use of the compounds. No obvious odours were detected during sampling.

The hydrocarbon impacts to soils based upon site observations of staining and the clay content of the soils present suggest a low potential for significant impacts. Based upon the extent of observed staining, distance to the nearest creeks and prior experience of spills/leakage from similar sized ASTs the potential for impacts to penetrate more than a few decimetres below ground is considered low. It is therefore considered that the impact is unlikely to comprise serious or material environmental harm and presents a low risk.

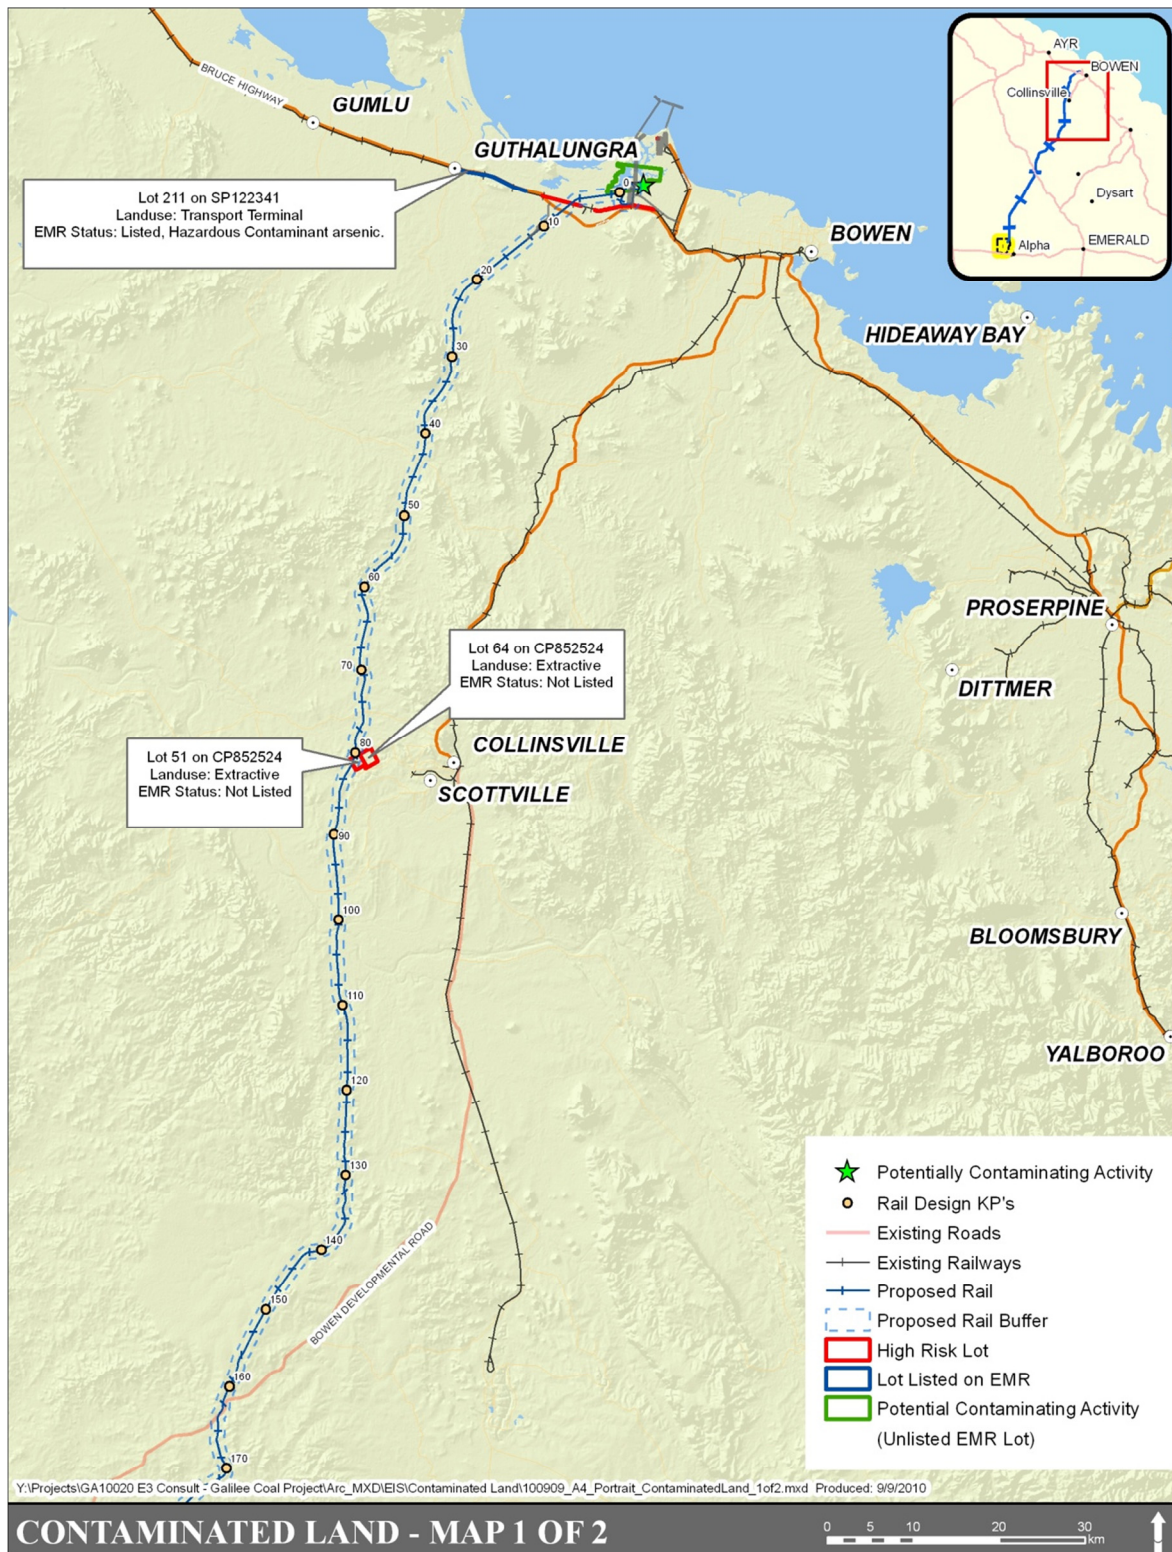
Figure 5-2: Contaminated Land - Rail alignment northern section

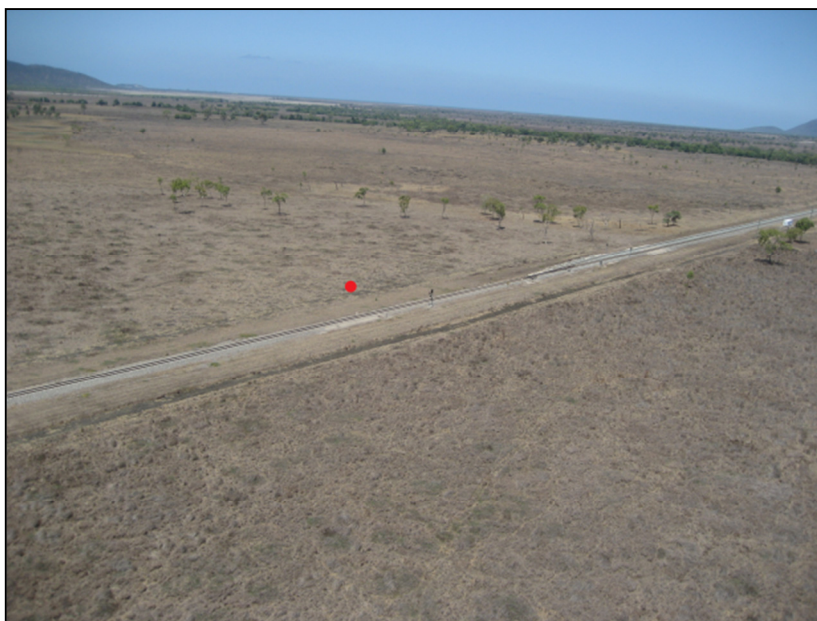
Soil samples were collected immediately adjacent to Lot 211 on SP122341 in which the rail alignment traverses as shown in Plate 5-1.

Plate 5-1: View of Sample Location adjacent to Existing Rail Line.

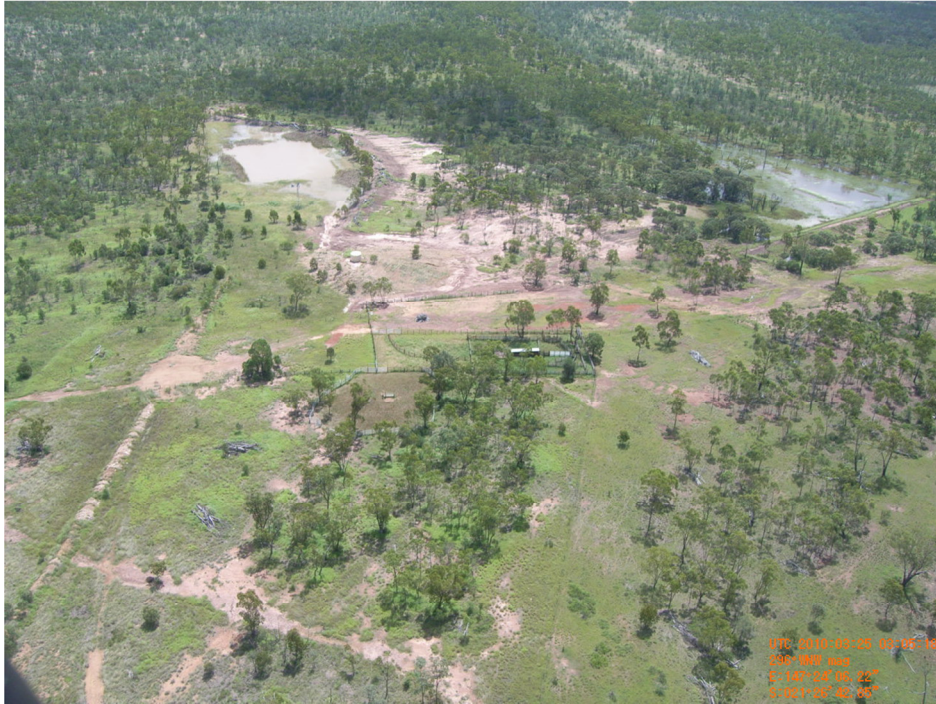
Plate 5-3: Cattle Dip location on Lot 6 on SM 99

The cattle dips included pens, covered yards and drying pads. Mature vegetation was observed around the vicinity of the cattle holding pens. Various access and farm tracks were also evident. Damp areas on some of the drying pads indicated that some of the dips were active. Livestock were not observed within the cattle dips in the rail buffer.

Lot 6 (CD1) intersects the rail alignment between KP185 to KP200. The observed cattle dip is within the 1.6km rail buffer boundary. While site specific sampling has not been undertaken, it is recommended that the site be sampled for any existing contamination or design of the alignment be aware of the site when completing final design.

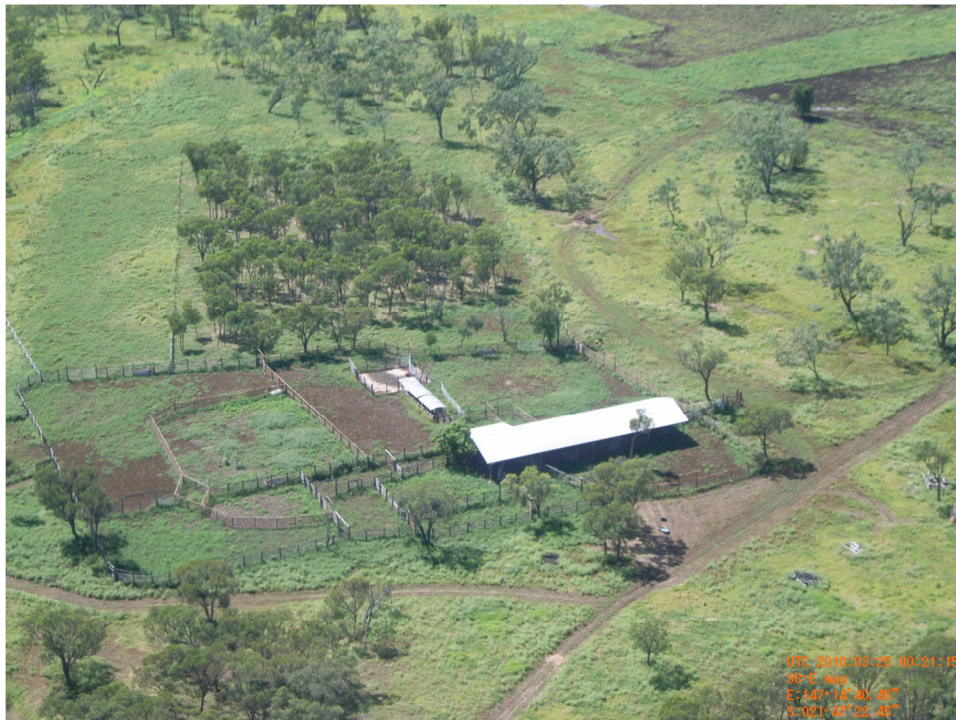
Plate 5-4: Cattle Dip location on Lot 10 on BL 49
