Waratah Coal Pty Ltd

China First Project

**Rail Corridor
Terrestrial Flora and Fauna
Report**

WAR003-ENV-RPT-0003

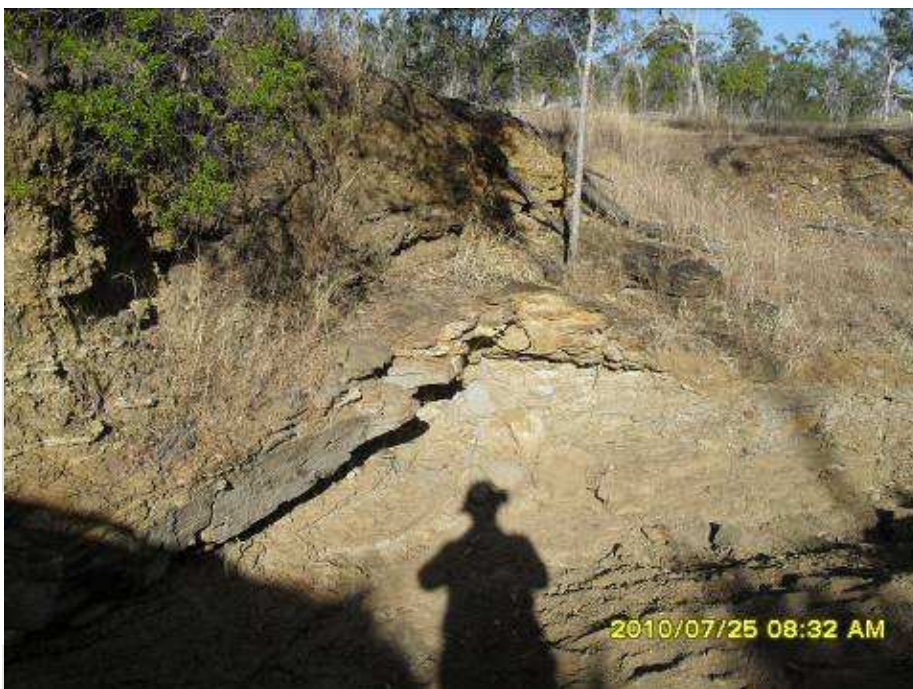
Plate 9 Rocky habitats on sandstone range at KP 122

South of the Bowen Developmental Road (Site 24 nearby) the corridor traverses an area of sandstone range with bare, exposed rock and skeletal soils (Site 25) (**Plate 9**). This area has been extensively burnt recently by a very severe fire; however, sufficient pockets of protected vegetation remained (**Plate 10**). This may be a significant habitat for reptiles and possibly Northern Quoll. In some areas, these rocky hills support Lancewood thickets (Sites 26, 34) (**Plate 3**) with spinifex understorey. Site 28 is in an extensive area or remnant vegetation that is significant in terms of its size and quality with woodlands supporting grassy and shrubby understorey. Fauna habitat values in this area were assessed as high.

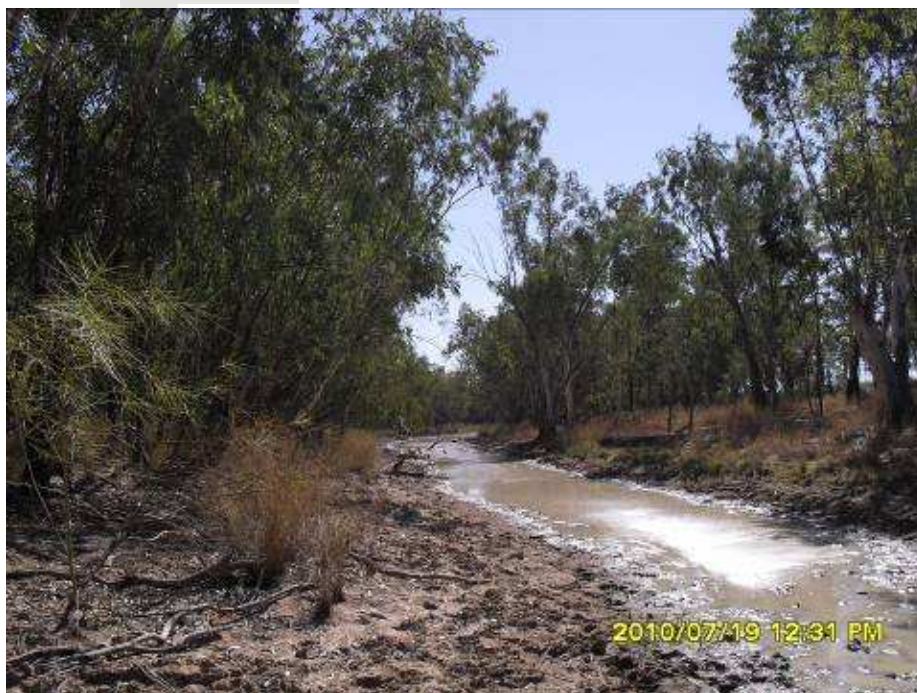
Plate 11 Ephemeral watercourse typical of those transversed by the rail corridor

South of the Suttor Development Road (from Site 29), the corridor enters an extensive region of gently undulating plains, intersected by large, braided river systems (**Plate 11** and **Plate 12**). This includes the Suttor River, Mistake Creek and Belyando River. This area is subject to extensive seasonal inundation and is undoubtedly important habitat for water birds, including migratory species. It may also be significant habitat for the Black-throated Finch. The habitat throughout this region is comprised of open eucalypt woodlands with interspersed patches of Brigalow. Larger trees and dense vegetation predominate in the areas subject to seasonal flooding. Overall habitat quality in this area varied from good to exceedingly poor, depending on the intensity of grazing pressure and extent of Buffel Grass establishment. This pattern continues south to the proposed mine site.

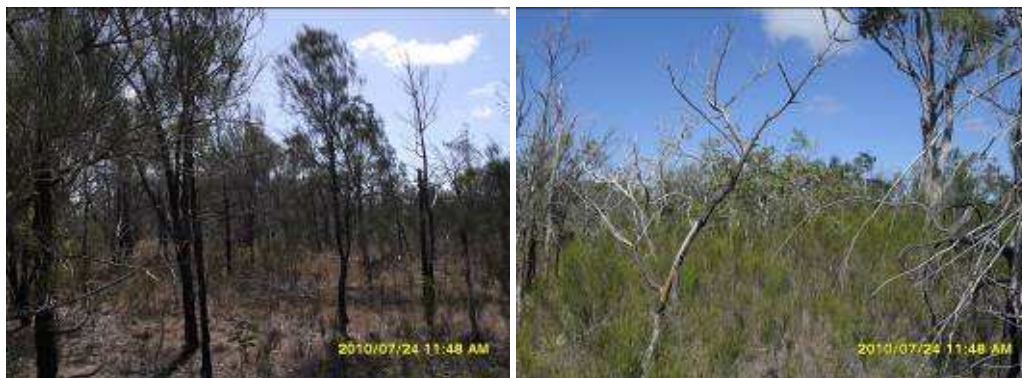
Vegetation Community Site number 01

Regional Ecosystem Profile	
Regional Ecosystem Type:	11.3.32
EPBC Status:	N/A
VMA Status:	Least Concern
EPA Status:	No concern at present
DNRW Mapped as:	11.3.32 / 11.3.30 / 11.3.33
Width of RE:

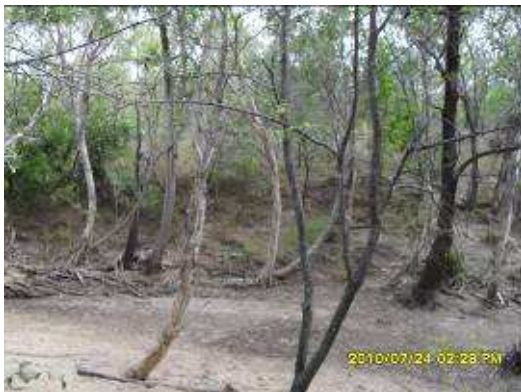
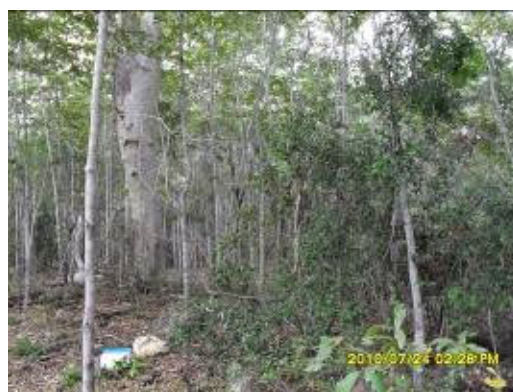
Vegetation Community Site number 02

Regional Ecosystem Profile	
Regional Ecosystem Type:	11.3.25b
EPBC Status:	N/A
VMA Status:	Least Concern
EPA Status:	Of Concern
DNRW Mapped as:	11.3.25
Width of RE:	20 m

Site Description	
Location:	KP14
Site Description:	S02
Orientation of Transect:	North-South
Photo Numbers:	546-547
Datum:	AGD84
Latitude / Longitude:	20.00193 / 147.91020 (RE boundary with 11.3.35)

Vegetation Community Description												
Open forest of <i>Melaleuca fluviatilis</i> with <i>Melaleuca leucadendra</i> and <i>Casuarina cunninghamiana</i> fringing drainage lines.												
Dominant Species (50 m x 10 m area)												
Botanical Species	Status*	Average Height (m)							Abundance (m ² / ha)			
		E	T1	T2	T3	S1	S2	G	E	T1	T2	T3
<i>Melaleuca leucadendra</i>	S		15							2		
<i>Melaleuca fluviatilis</i>	D		15.2							10		
<i>Pleiogynum timorense</i>	A		10							2		
<i>Nauclea orientalis</i>	A					5				1		
<i>Casuarina cunninghamiana</i>	A		17							2		
<i>Carissa ovata</i>							1					
<i>Heteropogon contorta</i>								1				
<i>Trichodesma</i> sp.												
<i>Tephrosia</i> sp.												
<i>Exocarpus</i> sp.												
<i>Alphitonia excelsa</i>												
<i>Discorea</i> sp.												
<i>Cryptostegia grandiflora</i>	##											
<i>Dioscorea</i> sp.												
<i>Pandanus</i> sp.						4

Community Health and Condition	
Overall Health:	Good
Potential EVR Flora Species Habitat:	<i>Eucalyptus raveretiana</i>
EVR Flora Species Recorded:	None
Weed Species:	Noogoora burr, Snake weed, Rubber vine
Weed Cover (%):	15%
Disturbance:	Grazing (very limited)
Disturbance Cover (%):	0

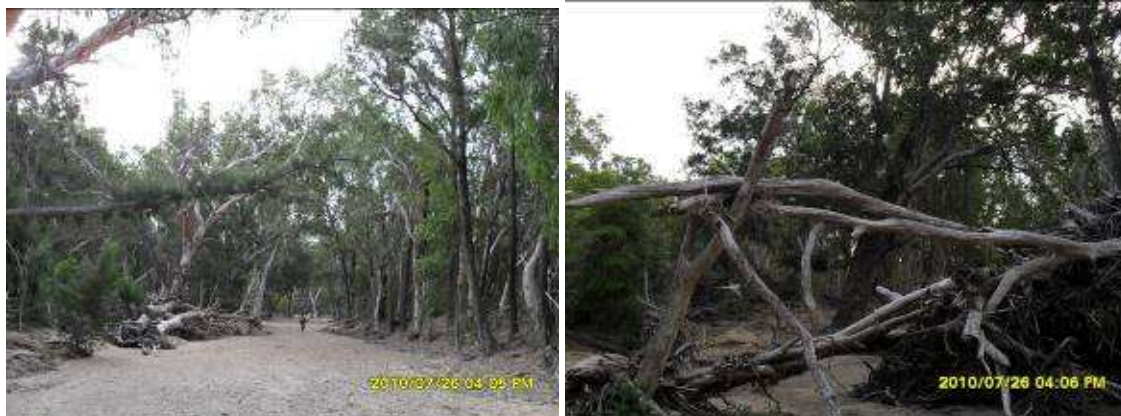
Site number 03

Regional Ecosystem Profile	
Regional Ecosystem Type:	11.3.25b
EPBC Status:	N/A
VMA Status:	Least Concern
EPA Status:	Of concern
DNRW Mapped as:	11.3.25b
Width of RE:	50 m

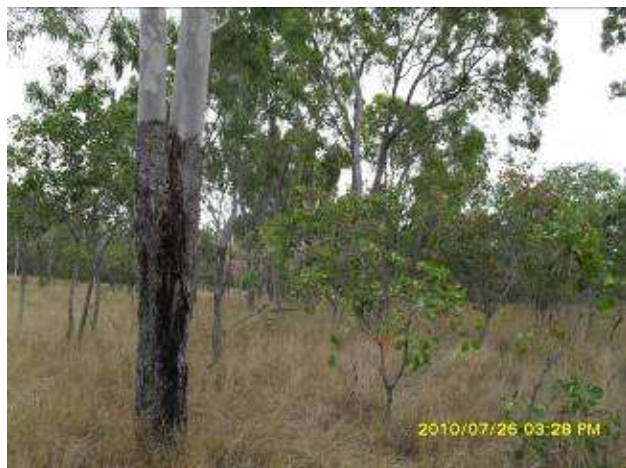
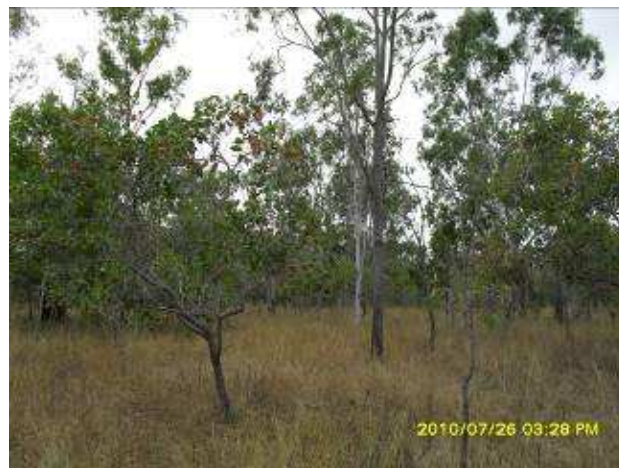
Vegetation Community Site number 04

Regional Ecosystem Profile	
Regional Ecosystem Type:	11.3.35
EPBC Status:	N/A
VMA Status:	Least Concern
EPA Status:	No Concern at Present
DNRW Mapped as:	11.12.1 / 11.12.9 / 11.3.4
Width of RE:	100 m

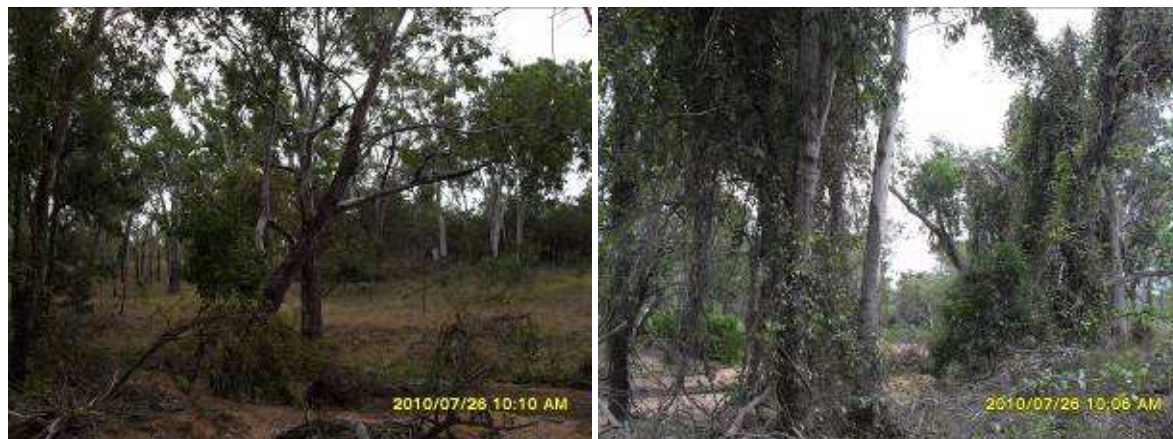
Vegetation Community Site number S05

Regional Ecosystem Profile	
Regional Ecosystem Type:	11.3.25a
EPBC Status:	N/A
VMA Status:	Least Concern
EPA Status:	Of Concern
DNRW Mapped as:	11.3.25
Width of RE:	50m

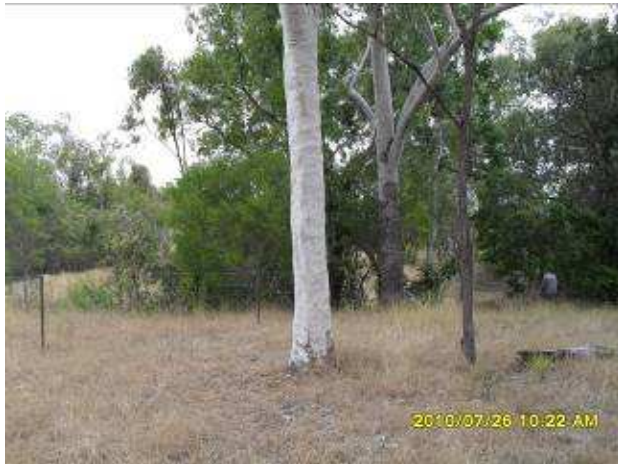
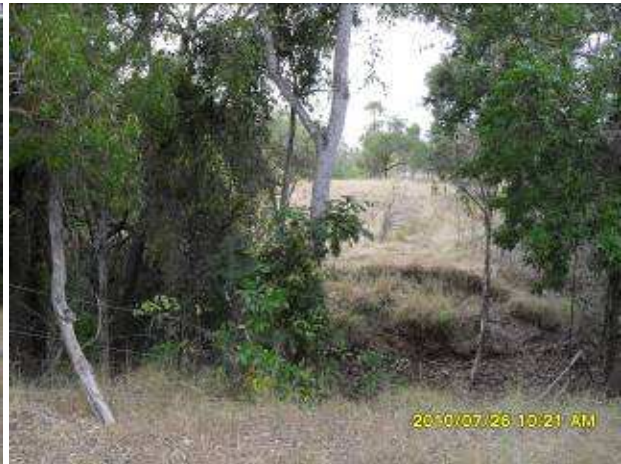
Vegetation Community Site number S06

Regional Ecosystem Profile	
Regional Ecosystem Type:	11.12.1
EPBC Status:	N/A
VMA Status:	Least Concern
EPA Status:	No Concern at Present
DNRW Mapped as:	11.12.1 / 11.3.4
Width of RE:	Non-linear

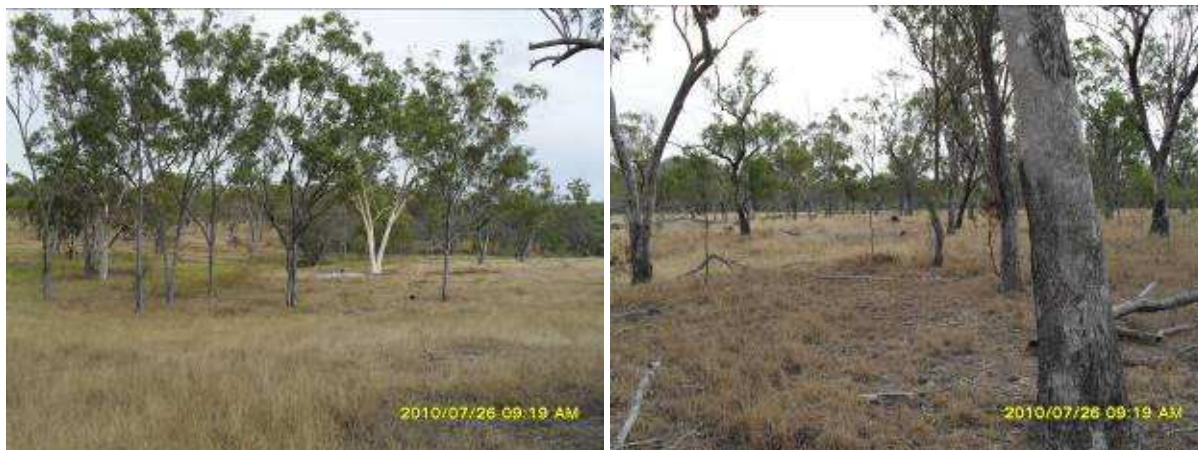
Vegetation Community Site number S07

Regional Ecosystem Profile	
Regional Ecosystem Type:	11.11.9
EPBC Status:	N/A
VMA Status:	Least Concern
EPA Status:	No Concern at Present
DNRW Mapped as:	11.12.1 / 11.3.4
Width of RE:	-20.32116 / 147.78208

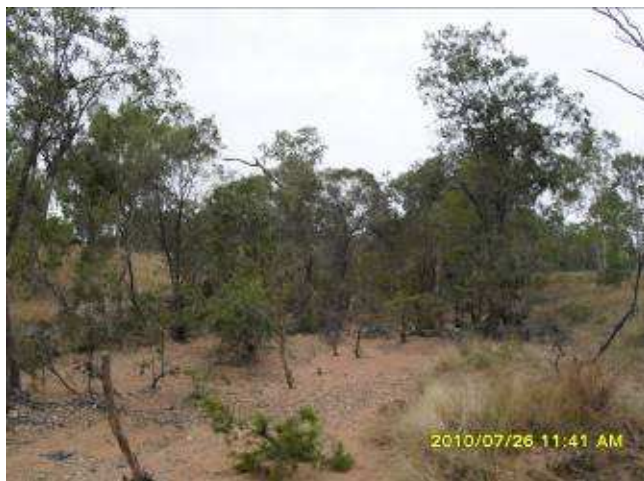
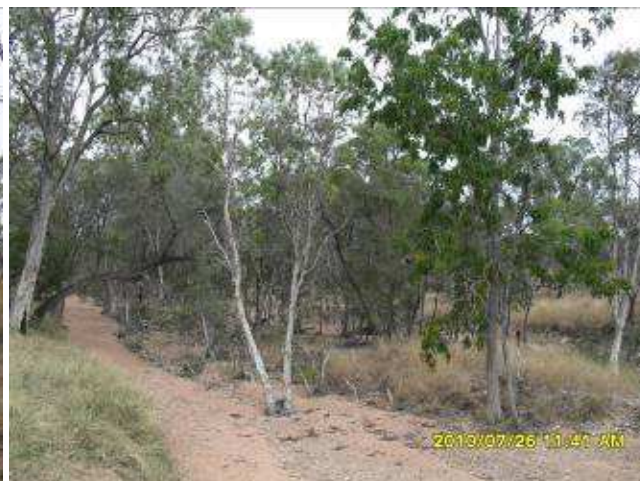
Vegetation Community Site number S08

Regional Ecosystem Profile	
Regional Ecosystem Type:	11.3.25b
EPBC Status:	N/A
VMA Status:	Least Concern
EPA Status:	Of Concern
DNRW Mapped as:	11.12.1 / 11.3.4
Width of RE:	30 m, 11.12.1 adjoins

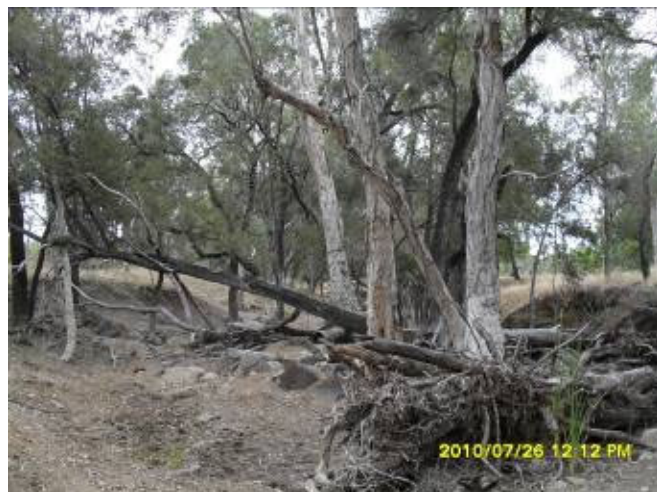
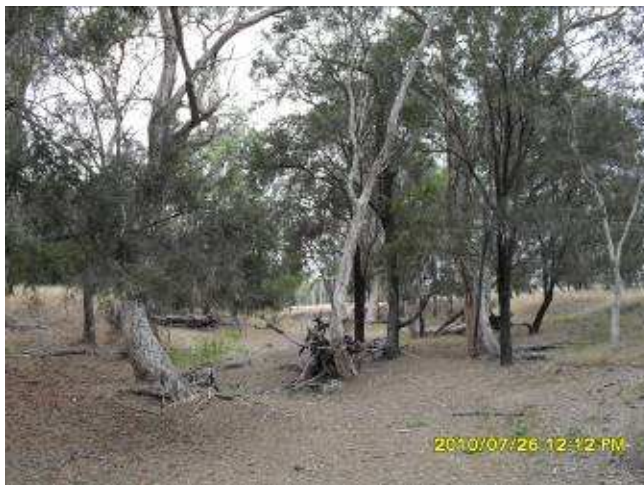
Vegetation Community Site number S09

Regional Ecosystem Profile	
Regional Ecosystem Type:	12.3.25b
EPBC Status:	N/A
VMA Status:	Least Concern
EPA Status:	Of Concern
DNRW Mapped as:	11.12.1 / 11.3.4
Width of RE:	15m

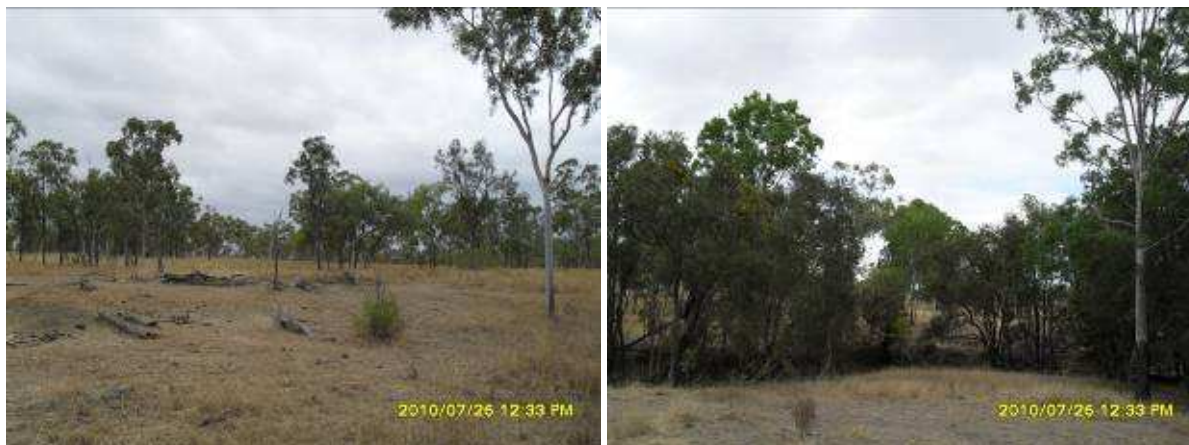
Vegetation Community Site number S10

Regional Ecosystem Profile	
Regional Ecosystem Type:	11.3.25b
EPBC Status:	N/A
VMA Status:	Least Concern
EPA Status:	Of Concern
DNRW Mapped as:	11.12.1 / 11.3.4
Width of RE:	20 m

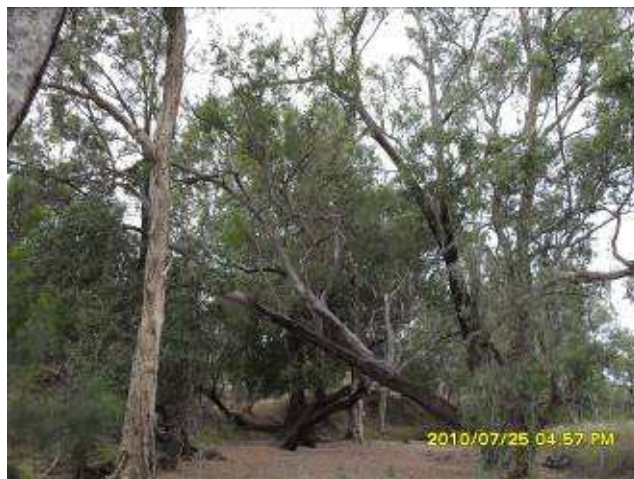
Vegetation Community Site number S11

Regional Ecosystem Profile	
Regional Ecosystem Type:	11.3.25a
EPBC Status:	N/A
VMA Status:	Least Concern
EPA Status:	Of Concern
DNRW Mapped as:	11.3.25 / 11.3.10 / 11.3.1
Width of RE:	30m - gallery community only

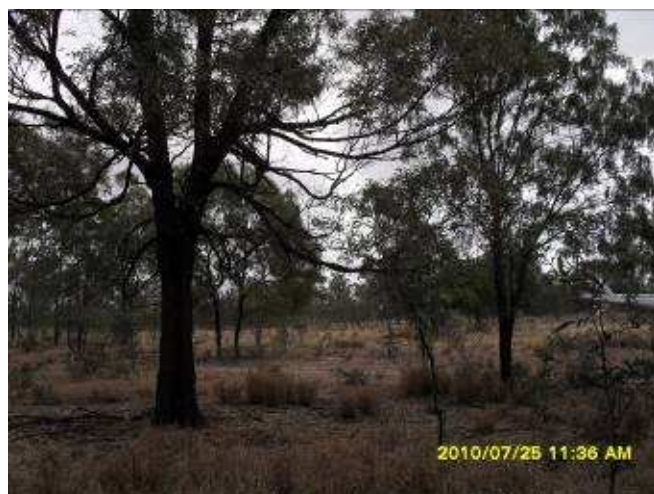
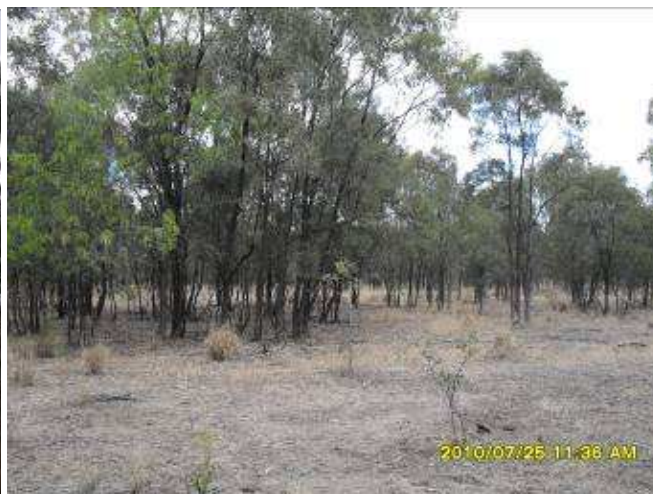
Vegetation Community Site number S12

Regional Ecosystem Profile	
Regional Ecosystem Type:	11.3.1
EPBC Status:	Endangered Ecological Community – Brigalow
VMA Status:	Of Concern
EPA Status:	Of Concern
DNRW Mapped as:	11.3.10 / 11.3.1 / 11.3.25
Width of RE:	100m

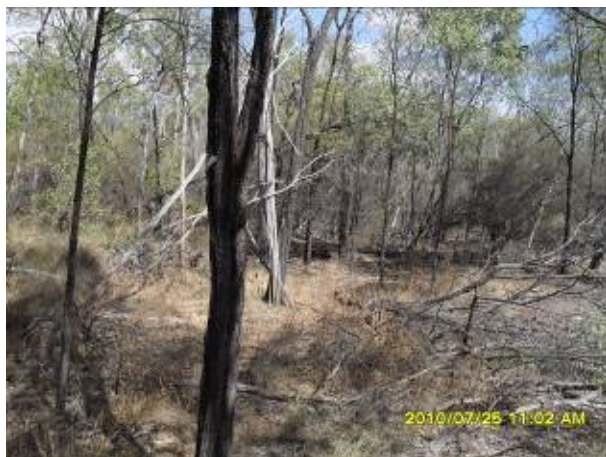
Vegetation Community Site number S13

Regional Ecosystem Profile	
Regional Ecosystem Type:	11.11.1
EPBC Status:	N/A
VMA Status:	Least Concern
EPA Status:	No Concern at Present
DNRW Mapped as:	11.11.1 / 11.11.9
Width of RE:	1km

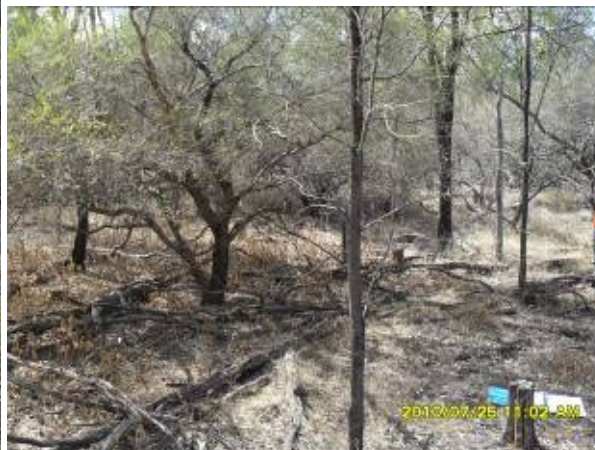
Site Description	
Location:	KP 84
Site Description:	Acacia ridge
Orientation of Transect:	E.W.
Datum:	AGD84
Latitude / Longitude:	-20.57905 / 147.71614

Vegetation Community Description													
Acacia rhodoxylon open forest on metamorphics													
Dominant Species (50 m x 10 m area)													
Botanical Species		Status*	Average Height (m)							Abundance (m ² / ha)			
			E	T1	T2	T3	S1	S2	G	E	T1	T2	T3
Acacia rhodoxylon		D			10							10	
Eucalyptus crebra		S		14							1		
Eucalyptus exerta		A		12							1		
Erythroxylon australe						5							
Lantana camara		##				3							
Alphitonia excelsa													
Eragrostis sp.													
Aristida sp.													
Brachychiton australis													
% Rock	10	% Bare ground	5		% Leaf litter		50		% Cryptogram		0		
Status: D = dominant, C = Co-dominant, S = subdominant, A = associate, EVR = significant species, # = weed, ## = declared plant

Community Health and Condition	
Overall Health:	Heavily disturbed
Potential EVR Flora Species Habitat:	-
EVR Flora Species Recorded:	None
Weed Species:	Common Lantana
Weed Cover (%):	25%
Disturbance:	Ringbarking decades ago, post removal
Disturbance Cover (%):	80%

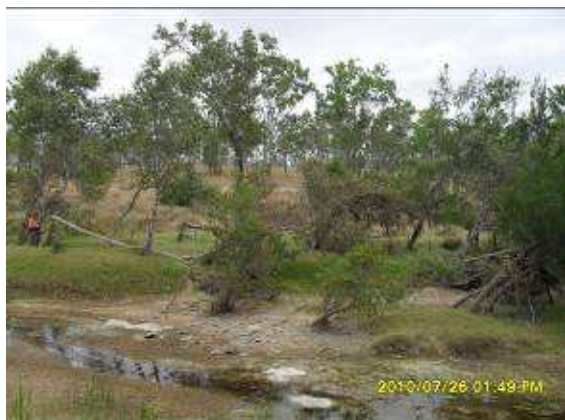
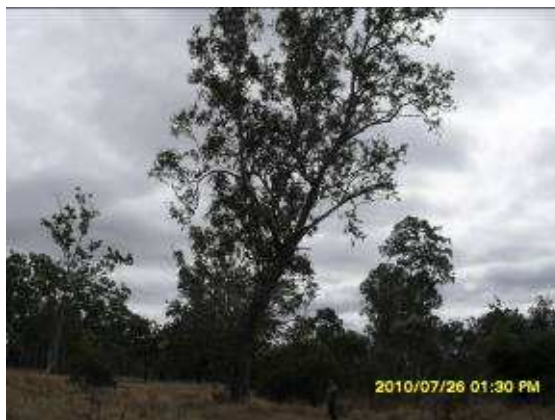
Vegetation Community Site number S14

Regional Ecosystem Profile	
Regional Ecosystem Type:	11.3.25
EPBC Status:	N/A
VMA Status:	Least Concern
EPA Status:	Of Concern
DNRW Mapped as:	11.3.25
Width of RE:	200m

Site Description	
Location:	KP 87
Site Description:	River Crossing
Orientation of Transect:	NS
Datum:	AGD84
Latitude / Longitude:	-20.60581 / 147.7165

Community Health and Condition	
Overall Health:	Good
Potential EVR Flora Species Habitat:	<i>Eucalyptus raveretiana</i>
EVR Flora Species Recorded:	Confirmed <i>Eucalyptus raveretiana</i>
Weed Species:	Parthenium weed, Rubber vine, Castor oil plant, Noogoora burr, Buffel grass
Weed Cover (%):	40%
Disturbance:	Grazing
Disturbance Cover (%):	100%

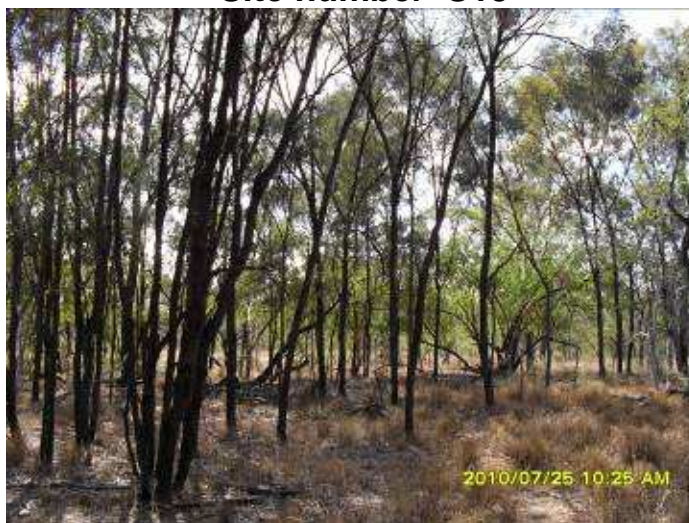
Vegetation Community Site number S15

Regional Ecosystem Profile	
Regional Ecosystem Type:	11.11.13
EPBC Status:	N/A
VMA Status:	Of Concern
EPA Status:	Of Concern
DNRW Mapped as:	11.11.19 / 11.11.1 / 11.11.8 / 11.11.13
Width of RE:	>100m

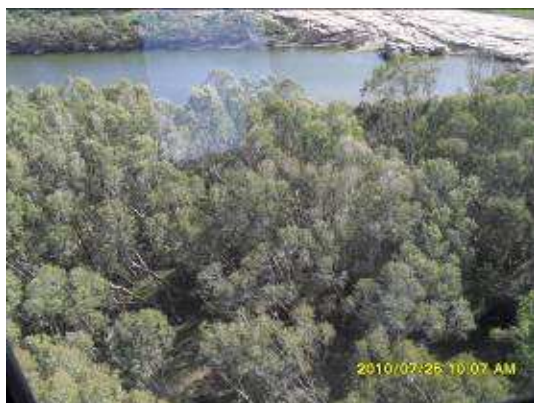
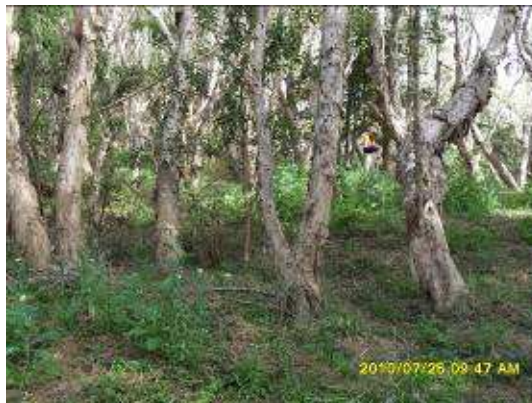
Vegetation Community Site number S16

Regional Ecosystem Profile	
Regional Ecosystem Type:	11.3.25b
EPBC Status:	N/A
VMA Status:	Least Concern
EPA Status:	Of Concern
DNRW Mapped as:	11.3.25b
Width of RE:	100m

Site Description	
Location:	KP 101
Site Description:	Gallery forest, river
Orientation of Transect:	East-West
Datum:	AGD84
Latitude / Longitude:	-20.73231 / 147.71367

Community Health and Condition	
Overall Health:	Good
Potential EVR Flora Species Habitat:	<i>Eucalyptus raveretiana</i>
EVR Flora Species Recorded:	None
Weed Species:	Mexican poppy, Noogora burr, Parthenium weed
Weed Cover (%):	50%
Disturbance:	Flooding, grazing
Disturbance Cover (%):	10%

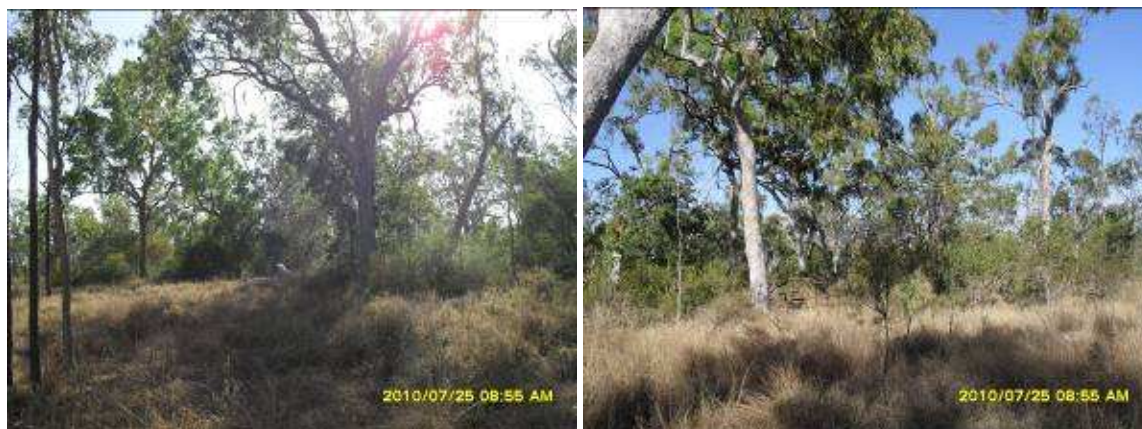
Vegetation Community Site number S17

Regional Ecosystem Profile	
Regional Ecosystem Type:	11.3.35
EPBC Status:	N/A
VMA Status:	Least Concern
EPA Status:	No Concern at present
DNRW Mapped as:	11.3.4 / 11.3.1 / 11.3.25
Width of RE:	200 m

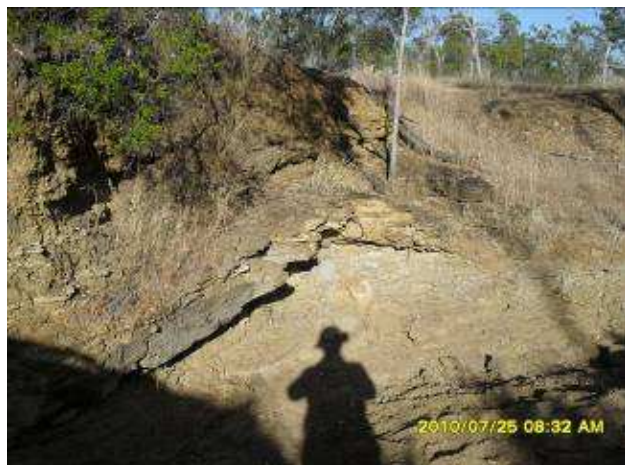
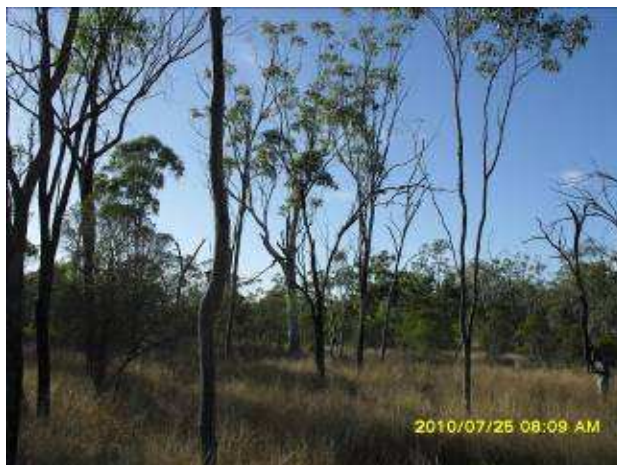
Vegetation Community Site number S18

Regional Ecosystem Profile	
Regional Ecosystem Type:	11.10.12
EPBC Status:	N/A
VMA Status:	Least Concern
EPA Status:	No Concern at Present
DNRW Mapped as:	11.3.4/11.3.1/11.3.25
Width of RE:	>200m

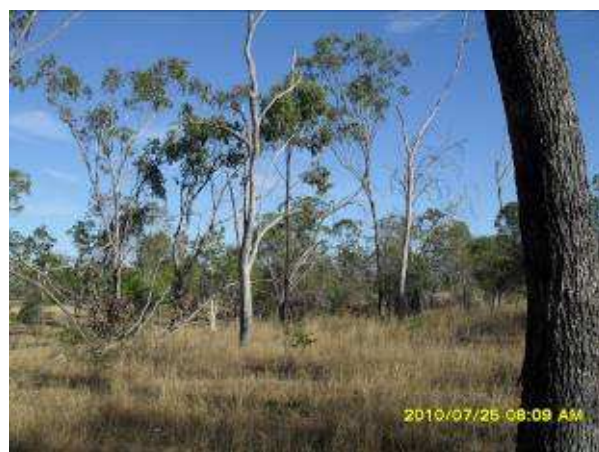
Site Description	
Location:	KP 122
Site Description:	Simple slope
Orientation of Transect:	E-W
Datum:	AGD 84
Latitude / Longitude:	-20.91989 / 147.72241

Vegetation Community Description												
Popular box woodland on lower slope of medium grained sediments. Geology outcropping in gully.												
Dominant Species (50 m x 10 m area)												
Botanical Species	Status*	Average Height (m)							Abundance (m ² /ha)			
		E	T1	T2	T3	S1	S2	G	E	T1	T2	T3
<i>Eucalyptus populnea</i>	D		12							4		
<i>Eucalyptus crebra</i>	A			8								
<i>Eremophila mitchellii</i>						3						
<i>Atalaya hemiglauca</i>							2					
<i>Lysiphyllum</i> sp.							2					
<i>Petalostigma pubescens</i>							2					
<i>Carissa ovata</i>							1					
<i>Flindersia maculata</i>							2					
<i>Aristida</i> sp.								1				
<i>Acacia bidwillii</i>							1					
% Rock	0	% Bare ground		40		% Leaf litter		60		% Cryptogram		0
Status: D = dominant, C = Codominant, S = subdominant, A = associate, EVR = significant species, # = weed, ## = declared plant

Community Health and Condition	
Overall Health:	Good
Potential EVR Flora Species Habitat:	None
EVR Flora Species Recorded:	None
Weed Species:	Buffel grass
Weed Cover (%):	<5%
Disturbance:	Grazing, thinning, erosion
Disturbance Cover (%):	30%

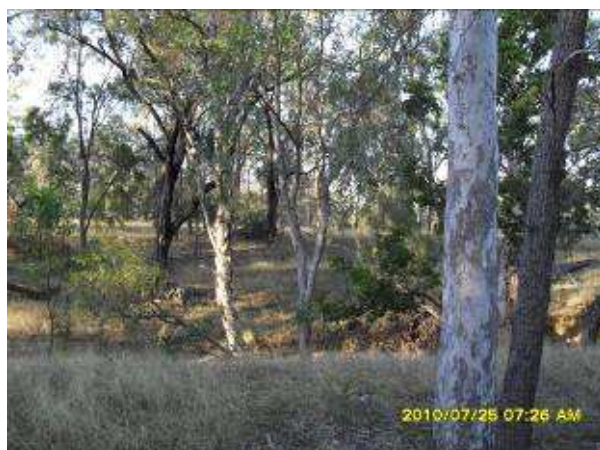
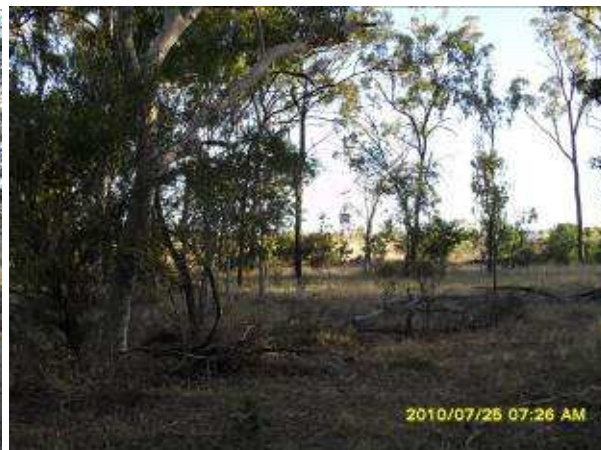
Site number S19

Regional Ecosystem Profile	
Regional Ecosystem Type:	11.3.25
EPBC Status:	N/A
VMA Status:	Least Concern
EPA Status:	Of Concern
DNRW Mapped as:	11.3.4/11.3.1/11.3.25
Width of RE:	200m

Site Description	
Location:	KP 125
Site Description:	Fringing community adjoining non-remnant
Orientation of Transect:	N-S
Photo Numbers:	-
Datum:	AGD 84
Latitude / Longitude:	-20.945908 / 147.726426

Community Health and Condition	
Overall Health:	Good
Potential EVR Flora Species Habitat:	<i>Eucalyptus raveretiana</i>
EVR Flora Species Recorded:	None
Weed Species:	Parthenium weed
Weed Cover (%):	30%
Disturbance:	Grazing
Disturbance Cover (%):	10%

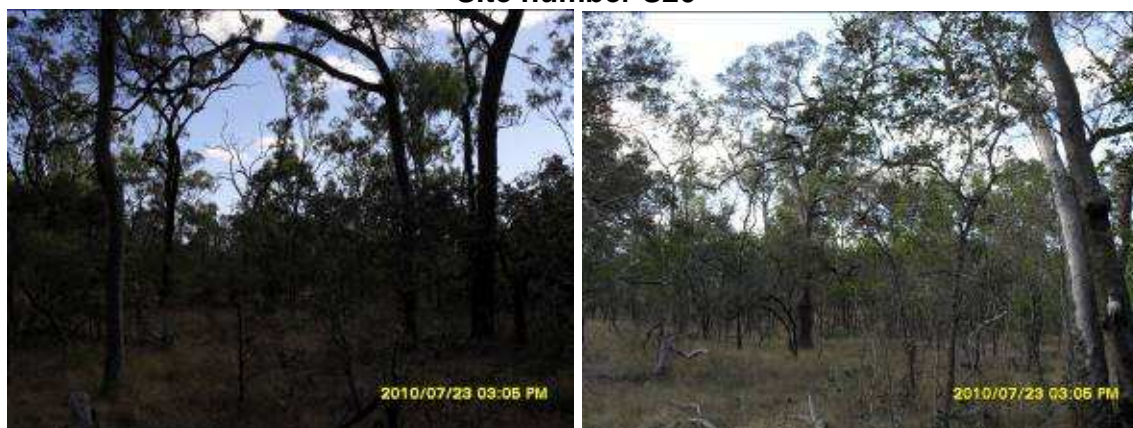
Vegetation Community Site number S20

Regional Ecosystem Profile	
Regional Ecosystem Type:	11.5.9
EPBC Status:	N/A
VMA Status:	Least Concern
EPA Status:	No Concern at Present
DNRW Mapped as:	11.3.2/11.5.3
Width of RE:	Non linear

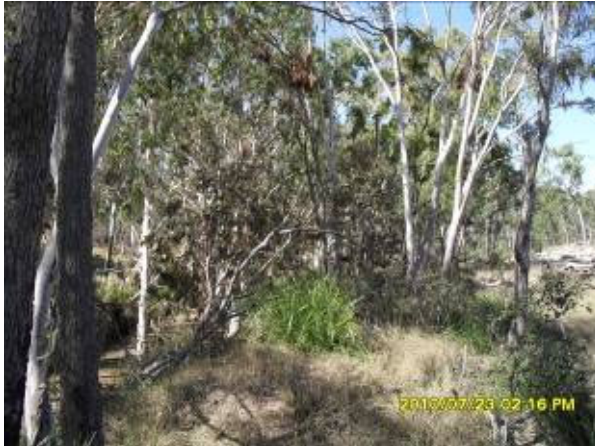
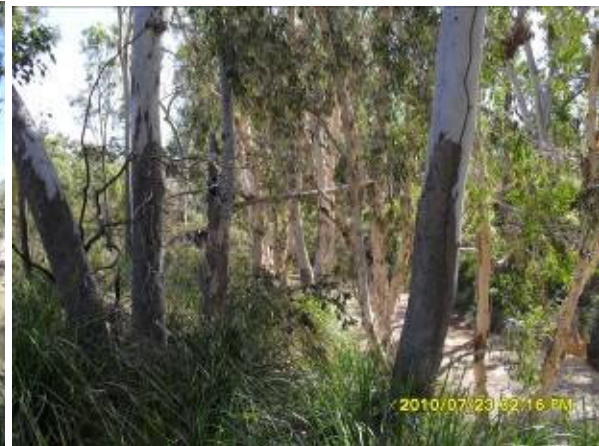
Vegetation Community Site number S21

Regional Ecosystem Profile	
Regional Ecosystem Type:	11.3.25
EPBC Status:	N/A
VMA Status:	Least Concern
EPA Status:	Of Concern
DNRW Mapped as:	11.3.25
Width of RE:	75m

Site Description	
Location:	KP 140.5, 26km NW of Newlands Mine
Site Description:	Watercourse
Orientation of Transect:	270°
Photo Numbers:	102 & 103
Datum:	AGD84
Latitude / Longitude:	-21.06912 / 147.68675

Community Health and Condition	
Overall Health:	Very good
Potential EVR Flora Species Habitat:	<i>Aponogeton queenslandicus</i>
EVR Flora Species Recorded:	Nil
Weed Species:	Nil
Weed Cover (%):	0
Disturbance:	Grazing
Disturbance Cover (%):	2

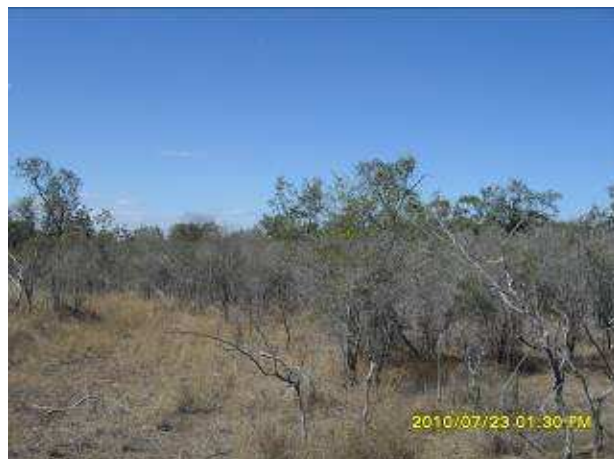
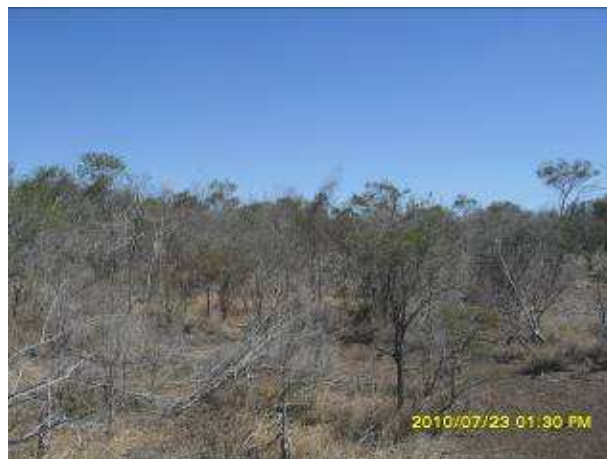
Vegetation Community Site number S22

Regional Ecosystem Profile	
Regional Ecosystem Type:	11.5.10
EPBC Status:	N/A
VMA Status:	Of Concern
EPA Status:	Of Concern
DNRW Mapped as:	11.5.9/11.5.10
Width of RE:	Non linear

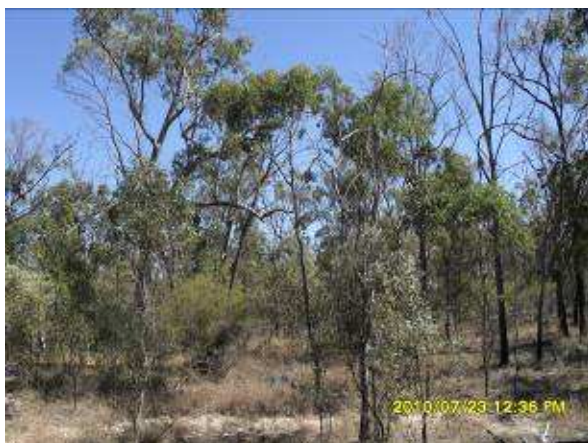
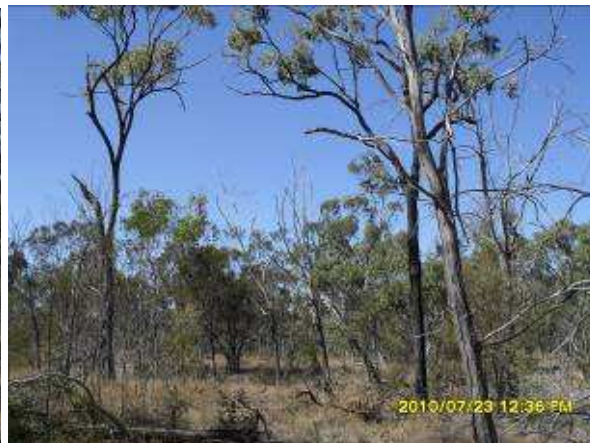
Vegetation Community Site number S23

Regional Ecosystem Profile	
Regional Ecosystem Type:	11.5.9
EPBC Status:	N/A
VMA Status:	Least Concern
EPA Status:	No Concern at Present
DNRW Mapped as:	11.5.9
Width of RE:	Non linear

Site Description	
Location:	KP 156.5, 32km W of Newlands Mine
Site Description:	-
Orientation of Transect:	90°
Photo Numbers:	98 & 99
Datum:	AGD 84
Latitude / Longitude:	-21.18815 / 147.60480

Community Health and Condition	
Overall Health:	Good
Potential EVR Flora Species Habitat:	<i>Acacia jackesiana</i>
EVR Flora Species Recorded:	Nil
Weed Species:	Nil
Weed Cover (%):	0
Disturbance:	Hot fires
Disturbance Cover (%):	20

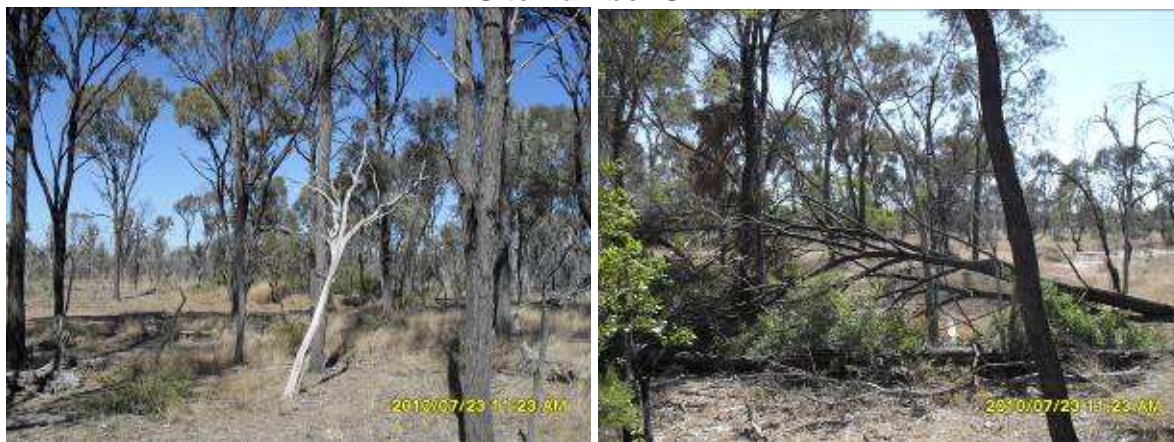
Vegetation Community Site number S24

Regional Ecosystem Profile	
Regional Ecosystem Type:	11.12.21
EPBC Status:	Endangered Ecological Community – Brigalow
VMA Status:	Endangered
EPA Status:	Endangered
DNRW Mapped as:	11.12.1/11.12.21
Width of RE:	Non linear

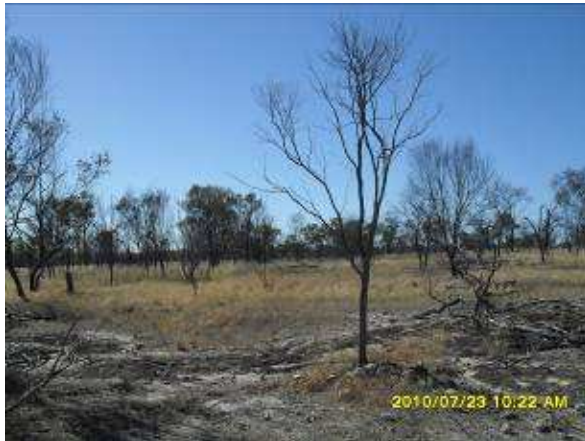
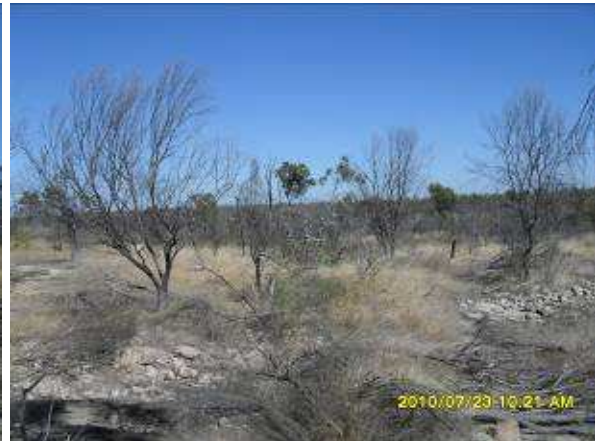
Vegetation Community Site number S25

Regional Ecosystem Profile	
Regional Ecosystem Type:	11.12.2
EPBC Status:	N/A
VMA Status:	Least Concern
EPA Status:	No concern at present
DNRW Mapped as:	11.12.1/11.12.2
Width of RE:	Non linear

Site Description	
Location:	KP 176.5, 42km SW of Newlands mine
Site Description:	-
Orientation of Transect:	180°
Photo Numbers:	86 & 87
Datum:	AGD 84
Latitude / Longitude:	-21.33810 / 147.54303

Community Health and Condition	
Overall Health:	Very degraded
Potential EVR Flora Species Habitat:	<i>Acacia jackesiana</i>
EVR Flora Species Recorded:	Nil
Weed Species:	Nil
Weed Cover (%):	0
Disturbance:	Hot fire
Disturbance Cover (%):	90

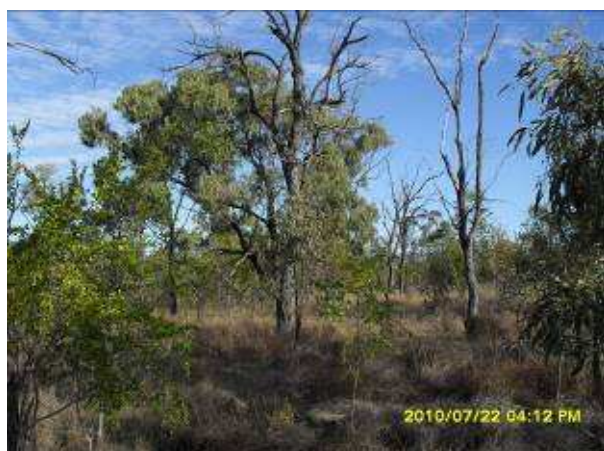
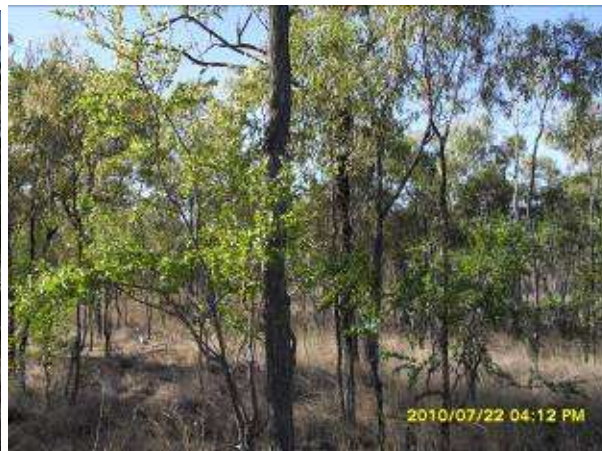
Vegetation Community Site number S26

Regional Ecosystem Profile	
Regional Ecosystem Type:	11.12.1
EPBC Status:	N/A
VMA Status:	Least concern
EPA Status:	No Concern at Present
DNRW Mapped as:	11.12.1 / 11.12.2
Width of RE:	Non linear

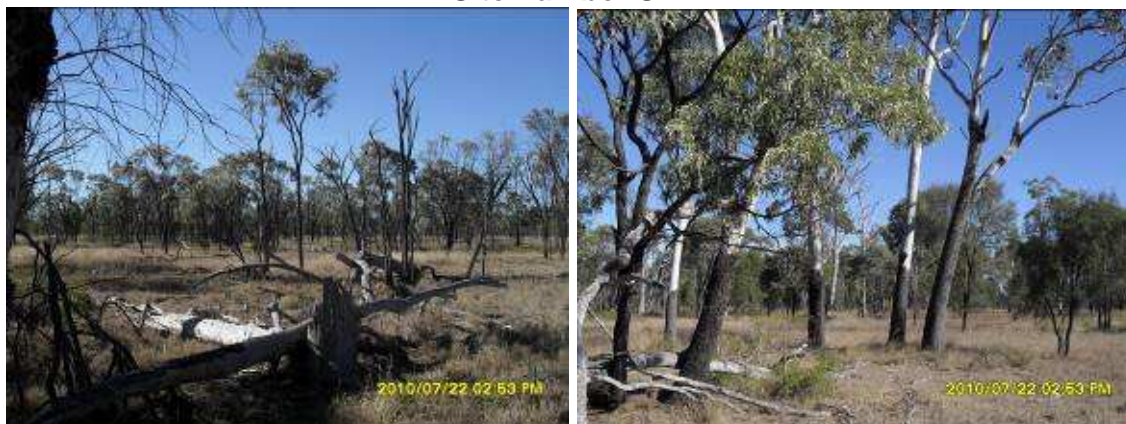
Vegetation Community Site number S27

Regional Ecosystem Profile	
Regional Ecosystem Type:	11.4.8
EPBC Status:	Endangered Ecological Community - Brigalow
VMA Status:	Endangered
EPA Status:	Endangered
DNRW Mapped as:	11.4.8/11.4.11
Width of RE:	Non linear

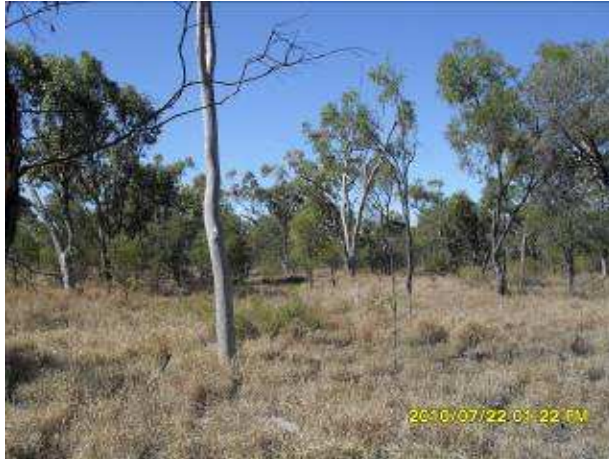
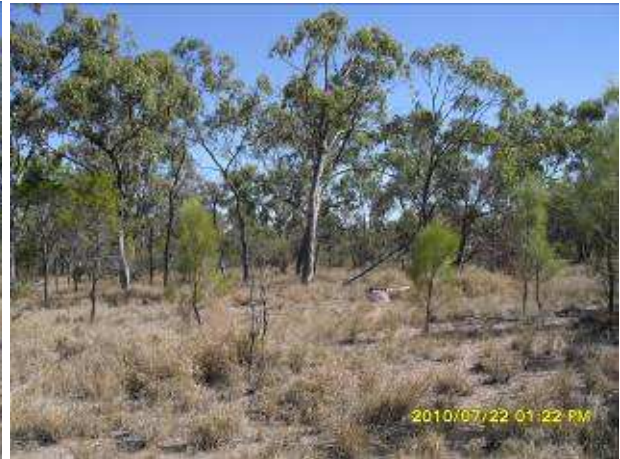
Vegetation Community Site number S28

Regional Ecosystem Profile	
Regional Ecosystem Type:	11.5.3
EPBC Status:	N/A
VMA Status:	Least concern
EPA Status:	No concern at present
DNRW Mapped as:	11.5.3
Width of RE:	Non-linear

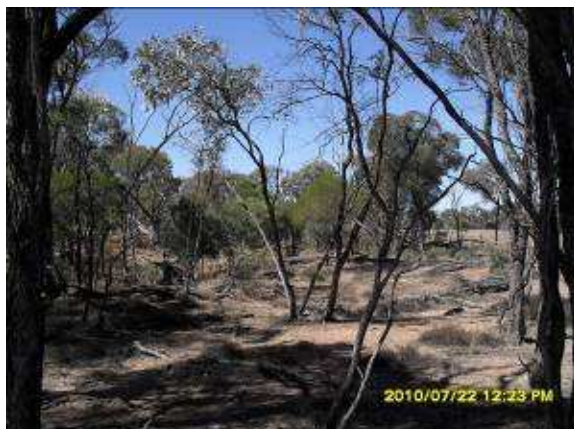
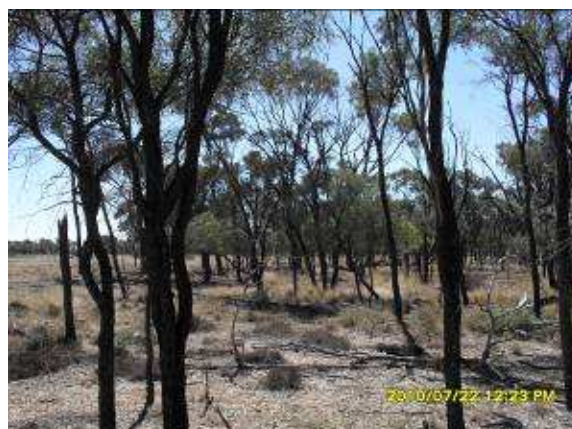
Vegetation Community Site number S29

Regional Ecosystem Profile	
Regional Ecosystem Type:	11.4.5
EPBC Status:	N/A
VMA Status:	Of Concern
EPA Status:	Endangered
DNRW Mapped as:	11.4.5/11.5.3
Width of RE:	150m

Site Description	
Location:	205/206, 70km SW of Newlands Mine
Site Description:	Richard Powell's Property
Orientation of Transect:	270°
Photo Numbers:	74 & 75
Datum:	AGD84
Latitude / Longitude:	-21.52073 / 147.34772

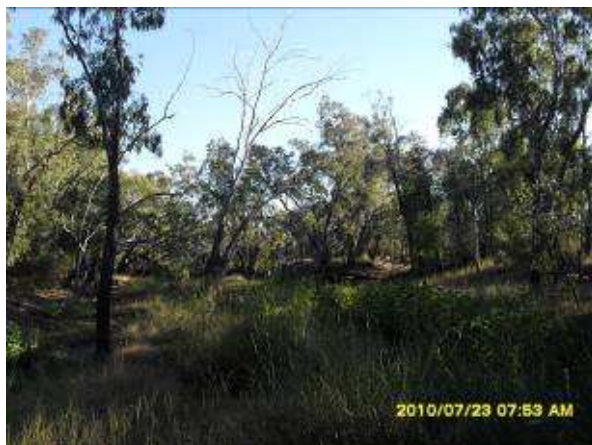
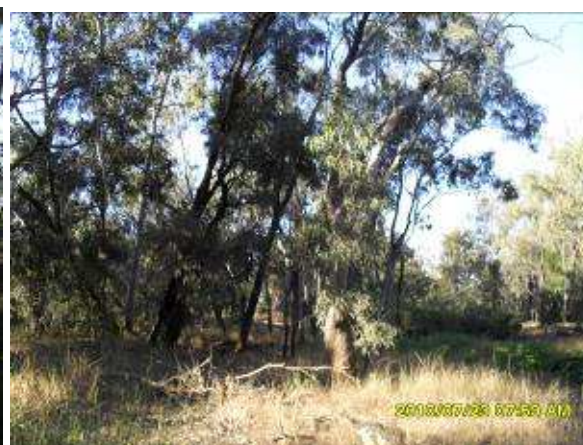
Vegetation Community Site number S30

Regional Ecosystem Profile	
Regional Ecosystem Type:	11.3.37
EPBC Status:	N/A
VMA Status:	Least Concern
EPA Status:	No Concern at Present
DNRW Mapped as:	11.3.37
Width of RE:	100m

Site Description	
Location:	KP226, 90km SW of Newlands Mine
Site Description:	Diamond Creek – Suttor River
Orientation of Transect:	180°
Photo Numbers:	82 & 83
Datum:	AGD 84
Latitude / Longitude:	-21.60022 / 147.17471

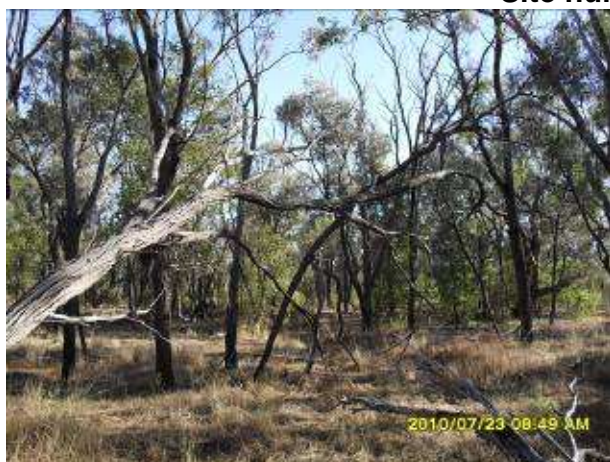
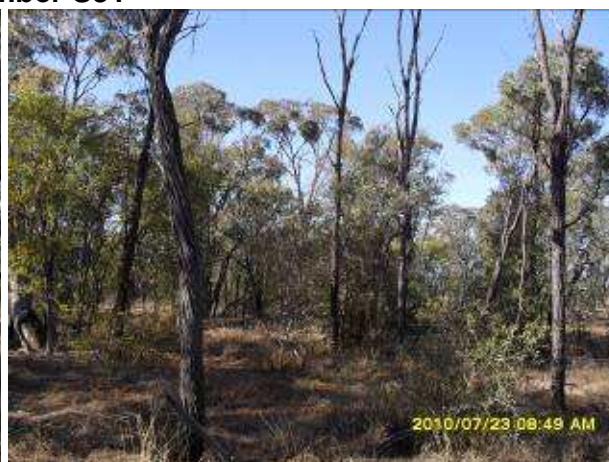
Vegetation Community Site number S31

Regional Ecosystem Profile	
Regional Ecosystem Type:	11.3.1
EPBC Status:	Endangered Ecological Community – Brigalow
VMA Status:	Endangered
EPA Status:	Endangered
DNRW Mapped as:	11.3.3
Width of RE:	>200m

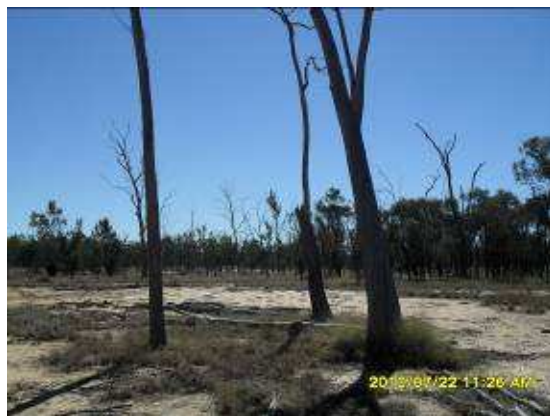
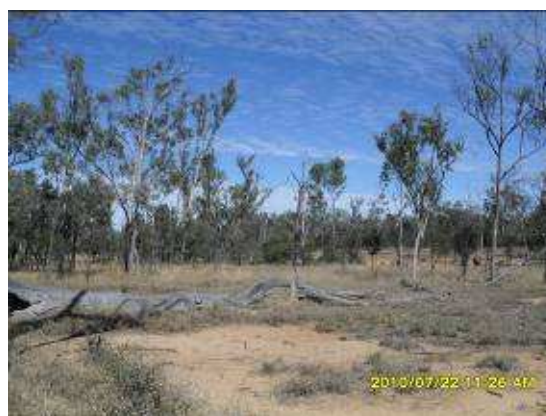
Vegetation Community Site number S32

Regional Ecosystem Profile	
Regional Ecosystem Type:	Non remnant
EPBC Status:	N/A
VMA Status:	N/A
EPA Status:	N/A
DNRW Mapped as:	11.3.3
Width of RE:	Non linear

Site Description	
Location:	KP 232.5
Site Description:	-
Orientation of Transect:	180°
Photo Numbers:	72 & 73
Datum:	AGD 84
Latitude / Longitude:	-21.65655 / 147.15565
