Waratah Coal Pty Ltd

China First Project

**Rail Corridor
Terrestrial Flora and Fauna
Report**

WAR003-ENV-RPT-0003

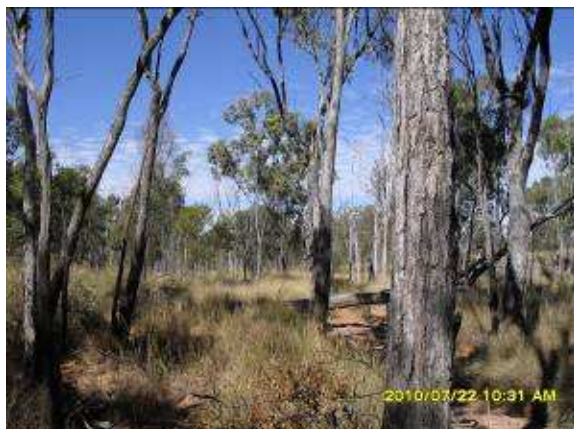
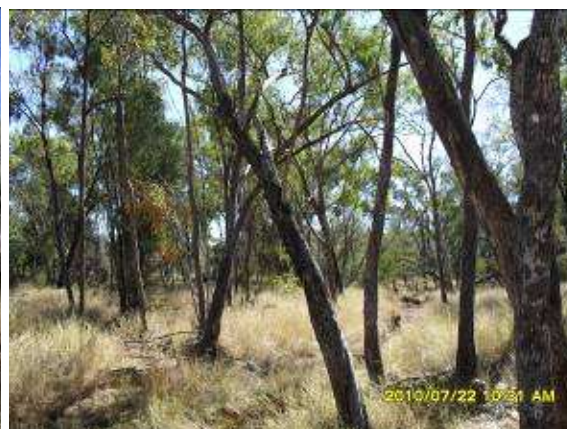
Vegetation Community Site number S33

Regional Ecosystem Profile	
Regional Ecosystem Type:	11.7.3 (non-typical as minor colluvial influence)
EPBC Status:	N/A
VMA Status:	Least Concern
EPA Status:	No Concern at Present
DNRW Mapped as:	11.7.2 / 11.11.13
Width of RE:	150m

Site Description	
Location:	KP 241.5, 102km SW of Newlands Mine
Site Description:	-
Orientation of Transect:	0°
Photo Numbers:	70 & 71
Datum:	AGD 84
Latitude / Longitude:	-21.73332 / 147.12234

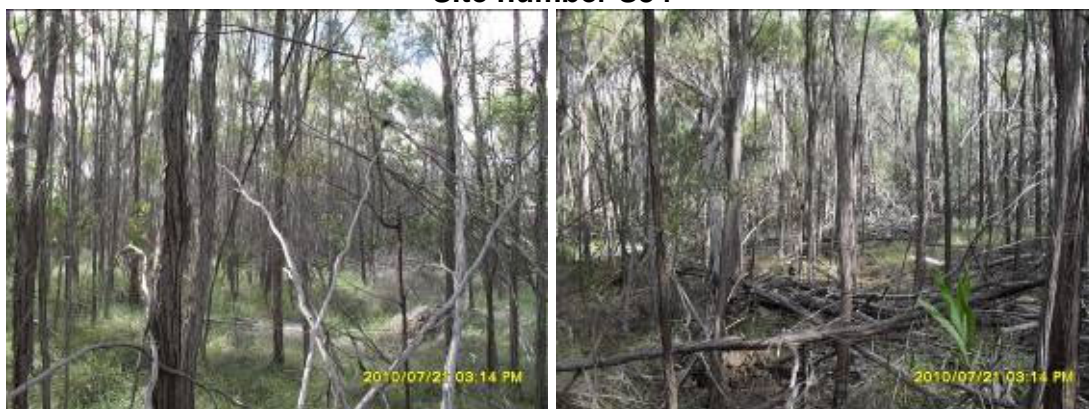
Vegetation Community Site number S34

Regional Ecosystem Profile	
Regional Ecosystem Type:	11.7.2
EPBC Status:	N/A
VMA Status:	Least Concern
EPA Status:	No Concern at Present
DNRW Mapped as:	11.7.2
Width of RE:	Non linear

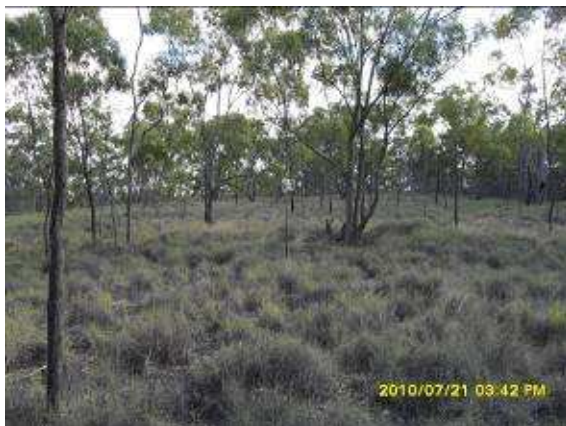
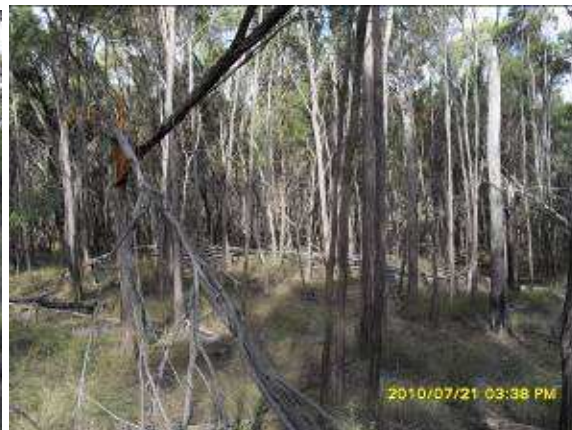
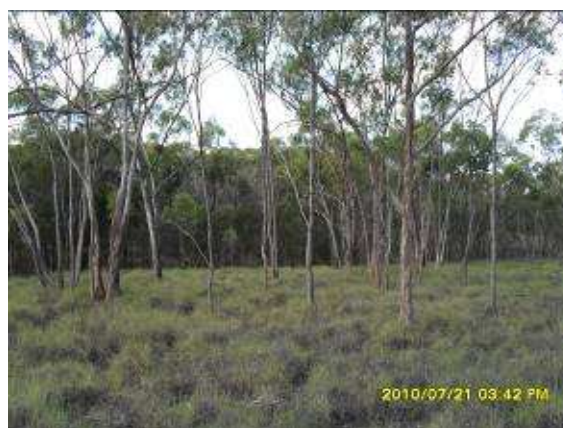
Vegetation Community Site number S35

Regional Ecosystem Profile	
Regional Ecosystem Type:	11.7.3
EPBC Status:	N/A
VMA Status:	Least Concern
EPA Status:	No Concern at Present
DNRW Mapped as:	11.4.9 / 11.7.3
Width of RE:	Non-linear

Site Description	
Location:	KP 245, 216km North of Alpha
Site Description:	-
Orientation of Transect:	180°
Photo Numbers:	62 & 63
Datum:	AGD84
Latitude / Longitude:	-21.75956 / 147.11162

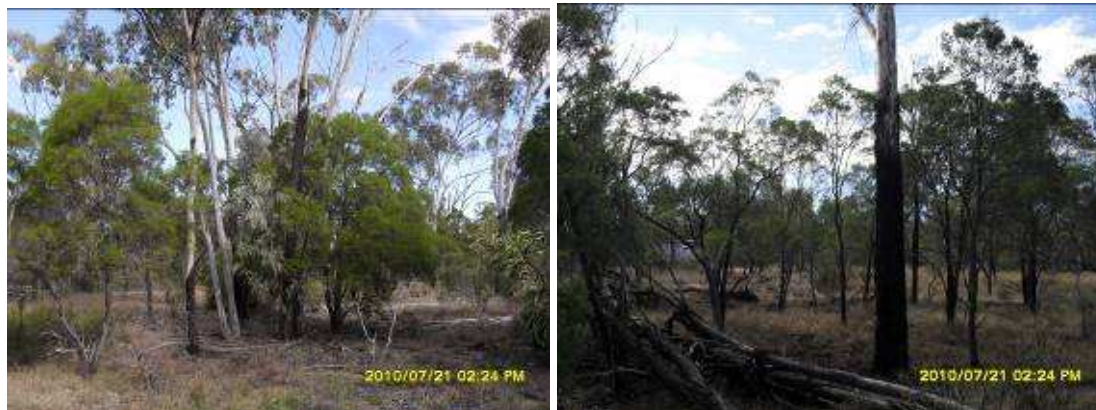
Vegetation Community Site number S36

Regional Ecosystem Profile	
Regional Ecosystem Type:	11.4.8
EPBC Status:	Endangered Ecological Community – Brigalow
VMA Status:	Endangered
EPA Status:	Endangered
DNRW Mapped as:	11.9.10/11.5.3 (11.4.8 adjoining)
Width of RE:	Non linear

Site Description	
Location:	200m W of KP248, 213km N or Alpha
Site Description:	-
Orientation of Transect:	180°
Photo Numbers:	57 & 58
Datum:	AGD 84
Latitude / Longitude:	-21.78717 / 147.10046

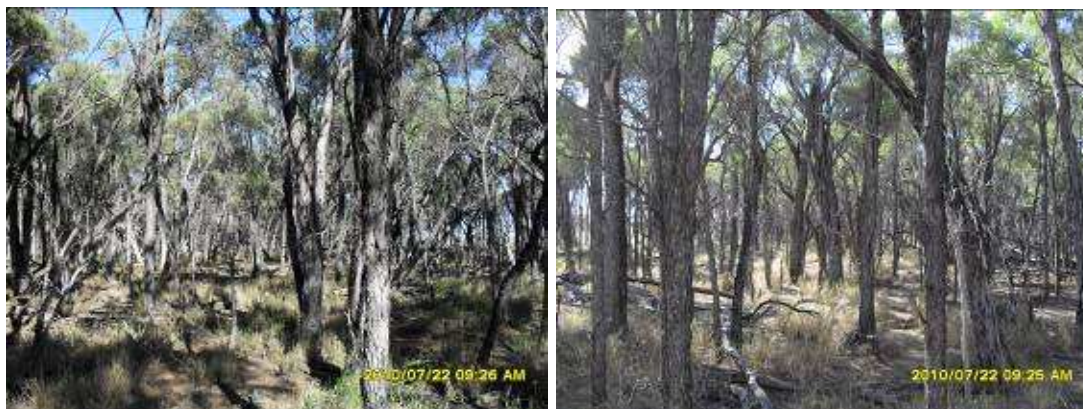
Vegetation Community Site number S37

Regional Ecosystem Profile	
Regional Ecosystem Type:	11.4.6
EPBC Status:	N/A
VMA Status:	Of Concern
EPA Status:	Endangered
DNRW Mapped as:	11.4.8/11.5.3/11.7.3
Width of RE:	250m

Site Description	
Location:	KP260, 116km SW of Newlands Mine
Site Description:	-
Orientation of Transect:	270°
Photo Numbers:	68 & 69
Datum:	AGD 84
Latitude / Longitude:	-21.89063 / 147.09573

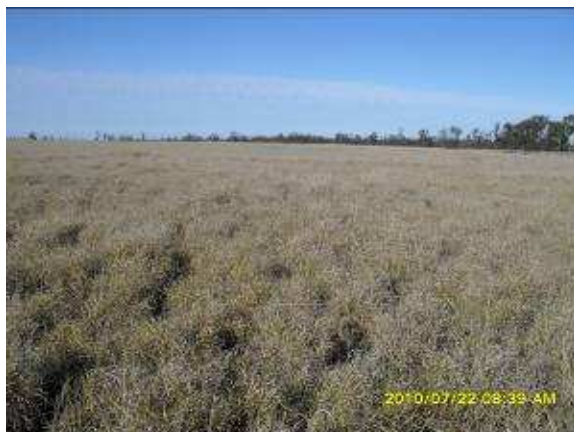
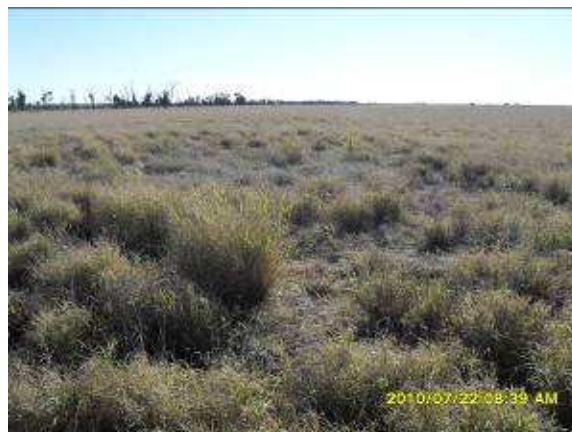
Vegetation Community Site number S38

Regional Ecosystem Profile	
Regional Ecosystem Type:	Non remnant (Buffel grass)
EPBC Status:	N/A
VMA Status:	N/A
EPA Status:	N/A
DNRW Mapped as:	11.4.4
Width of RE:	Non linear

Site Description	
Location:	KP 263, 118km SW of Newmans Mine
Site Description:	-
Orientation of Transect:	0°
Photo Numbers:	66 & 67
Datum:	AGD 84
Latitude / Longitude:	-21.91477 / 147.09343

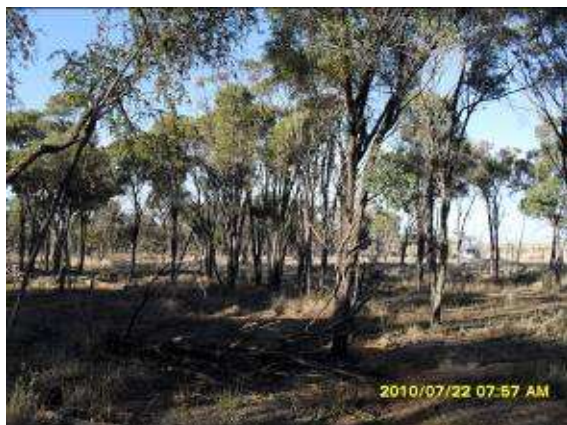
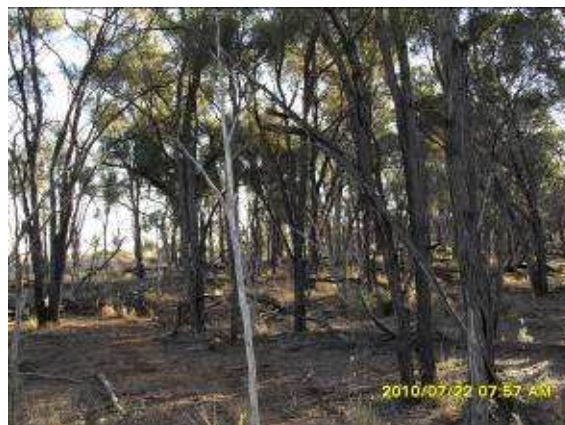
Vegetation Community Site number S39

Regional Ecosystem Profile	
Regional Ecosystem Type:	11.4.6
EPBC Status:	N/A
VMA Status:	Of Concern
EPA Status:	Endangered
DNRW Mapped as:	11.4.8
Width of RE:	Non linear

Site Description	
Location:	KP 270, 124km SW of Newlands Mine
Site Description:	-
Orientation of Transect:	0°
Photo Numbers:	64 & 65
Datum:	AGD 84
Latitude / Longitude:	-21.98700 / 147.08745

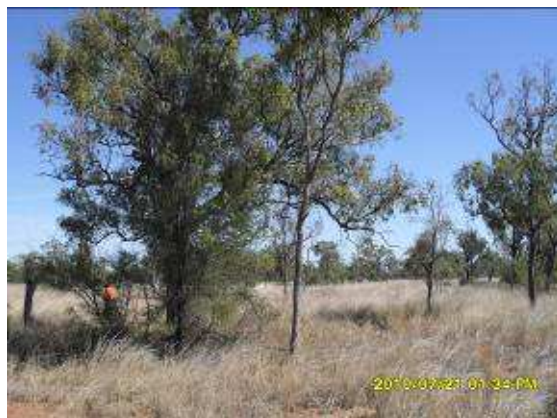
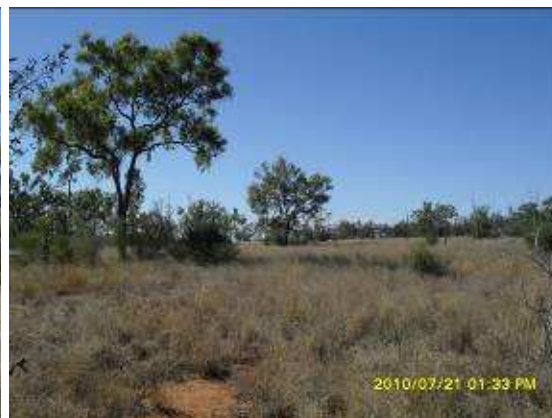
Vegetation Community Site number S40

Regional Ecosystem Profile	
Regional Ecosystem Type:	11.5.3
EPBC Status:	N/A
VMA Status:	Least Concern
EPA Status:	No Concern at Present
DNRW Mapped as:	11.5.12/11.5.3/11.4.6
Width of RE:	Non linear

Site Description	
Location:	KP 275, 187km North of Alpha
Site Description:	-
Orientation of Transect:	180°
Photo Numbers:	55 & 56
Datum:	AGD 84
Latitude / Longitude:	-22.02953 / 147.07623

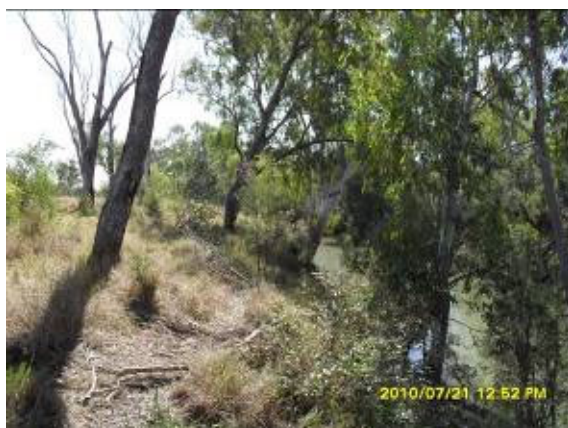
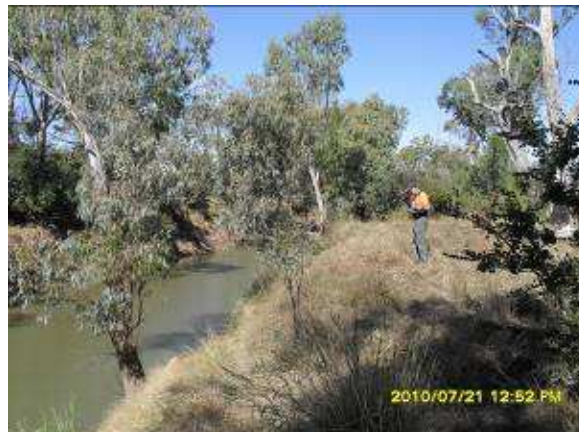
Vegetation Community Site number S41

Regional Ecosystem Profile	
Regional Ecosystem Type:	11.3.25
EPBC Status:	N/A
VMA Status:	Least Concern
EPA Status:	Of Concern
DNRW Mapped as:	11.3.25
Width of RE:	100m

Site Description	
Location:	KP 284, 178km North of Alpha
Site Description:	Mistake creek
Orientation of Transect:	180°
Photo Numbers:	53 & 54
Datum:	AGD 84
Latitude / Longitude:	-22.09784 / 147.04530

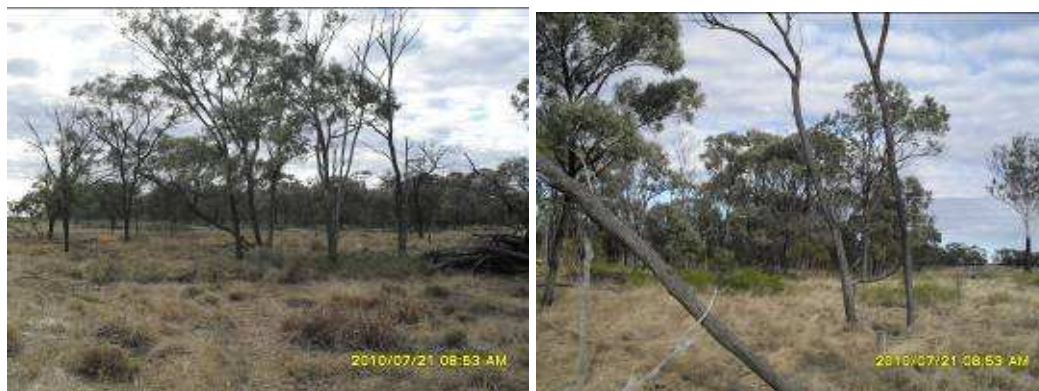
Vegetation Community Site number S42

Regional Ecosystem Profile	
Regional Ecosystem Type:	11.3.1
EPBC Status:	Endangered Ecological Community – Brigalow
VMA Status:	Endangered
EPA Status:	Endangered
DNRW Mapped as:	11.3.3/11.3.5
Width of RE:	20-50m

Site Description	
Location:	KP 306, 157km North of Alpha
Site Description:	-
Orientation of Transect:	225°
Photo Numbers:	47 & 48
Datum:	AGD 84
Latitude / Longitude:	-22.27326 / 146.93661

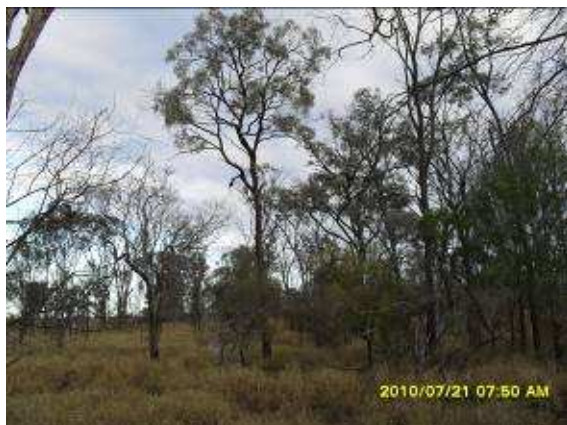
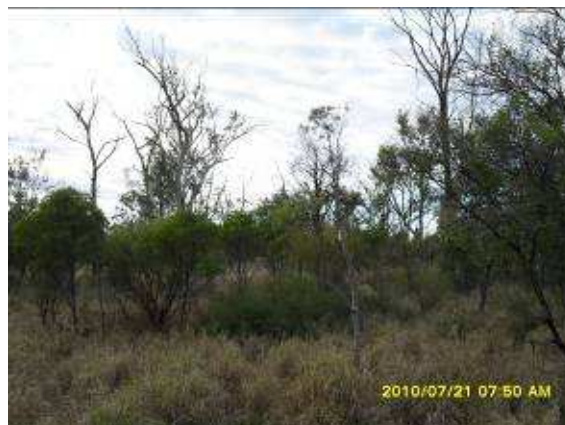
Vegetation Community Site number S43

Regional Ecosystem Profile	
Regional Ecosystem Type:	11.4.8
EPBC Status:	Endangered Ecological Community – Brigalow
VMA Status:	Endangered
EPA Status:	Endangered
DNRW Mapped as:	11.4.8/11.3.5
Width of RE:	50m

Site Description	
Location:	KP308.5, 155km North of Alpha
Site Description:	Beresford Station Northern boundary
Orientation of Transect:	90°
Photo Numbers:	45 & 46
Datum:	AGD 84
Latitude / Longitude:	-22.29099 / 146.92194

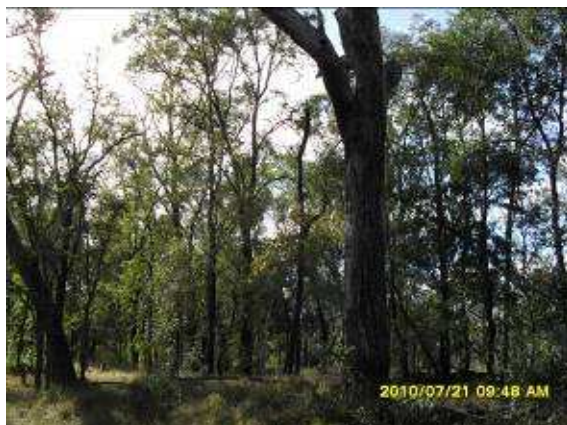
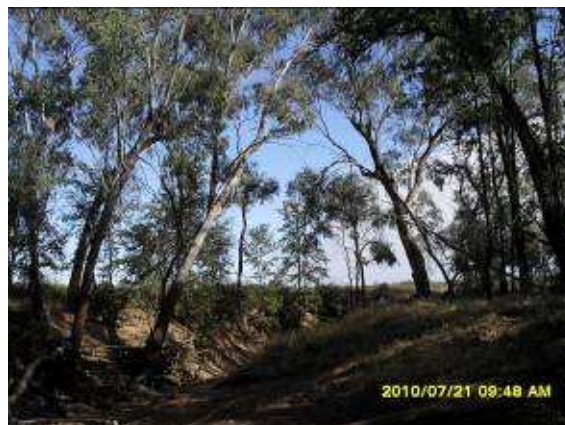
Vegetation Community Site number S44

Site Description	
Location:	KP 316, 147km North of Alpha
Site Description:	Watercourse crossing
Orientation of Transect:	270°
Photo Numbers:	49 & 50
Datum:	AGD 84
Latitude / Longitude:	-22.35128 / 146.88335

Vegetation Community Description												
<i>Eucalyptus coolabah</i> woodland on alluvial watercourse with Brigalow (including RE 11.3.1 in adjoining patches).												
Dominant Species (50 m x 10 m area)												
Botanical Species	Status*	Average Height (m)							Abundance (m ² /ha)			
		E	T1	T2	T3	S1	S2	G	E	T1	T2	T3
<i>Eucalyptus coolabah</i>	D		20		6					13		
<i>Acacia harpophylla</i>	S		20	12	6					7		
<i>Terminalia oblongata</i>	S			12	6						2	
<i>Lysicarpus carronii</i>					6							
<i>Carissa ovata</i>						1						
<i>Parthenium hysterophorus</i>	##							0.3				
<i>Citrus glauca</i>						1.5						
<i>Grewia retusifolia</i>						1.5						
<i>Sporobolus</i> sp.								0.3				
<i>Jasminum didymum</i>								0.5				
<i>Pennisetum ciliare</i>	D							0.5				
<i>Paspalidium caespitosum</i>								0.5				
<i>Capparis lasiantha</i>								0.3				
% Rock	0	% Bare ground		35		% Leaf litter		20		% Cryptogram		0

Community Health and Condition	
Overall Health:	Good
Potential EVR Flora Species Habitat:	-
EVR Flora Species Recorded:	Nil
Weed Species:	Parthenium weed, Buffel grass
Weed Cover (%):	30% (<1% Parthenium weed)
Disturbance:	Grazing
Disturbance Cover (%):	30%

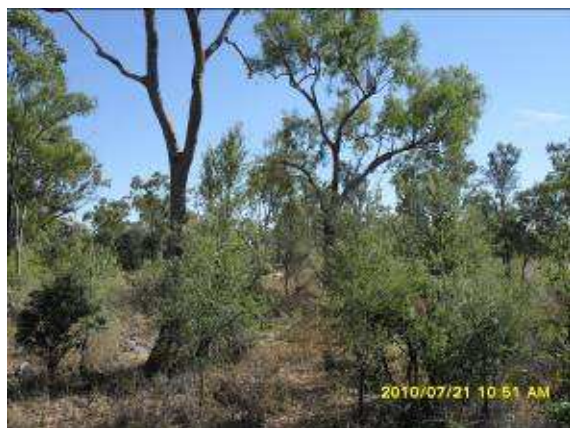
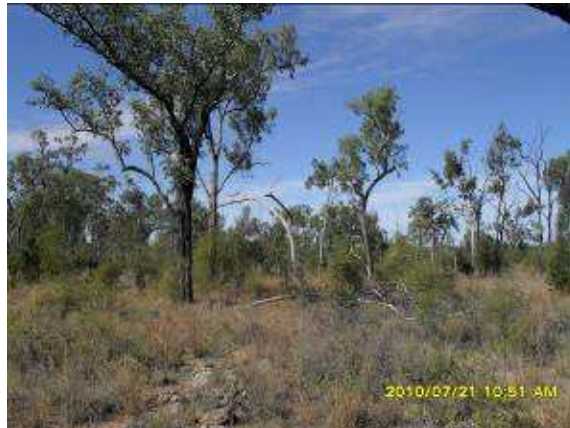
Vegetation Community Site number S45

Site Description	
Location:	KP 319, 144km North of Alpha
Site Description:	Just east of end of east-west rocky ridge
Orientation of Transect:	90°
Photo Numbers:	51 & 52
Datum:	AGD 84
Latitude / Longitude:	-22.38001 / 146.86798

Community Health and Condition	
Overall Health:	Good
Potential EVR Flora Species Habitat:	-
EVR Flora Species Recorded:	Nil
Weed Species:	No declared, Red natal grass
Weed Cover (%):	10
Disturbance:	Grazing
Disturbance Cover (%):	5

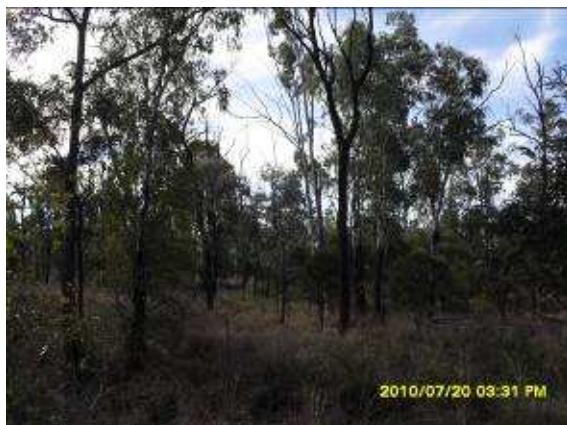
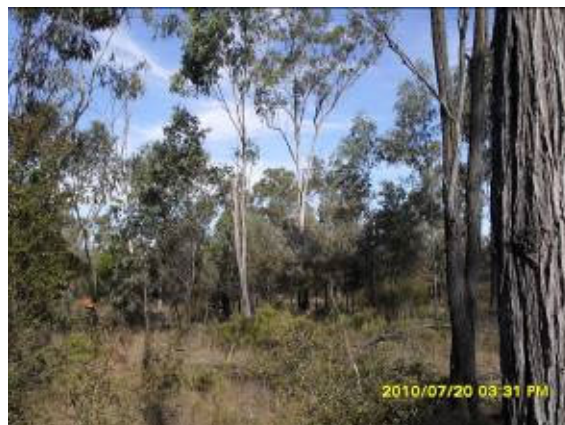
Vegetation Community Site number S46

Site Description	
Location:	KP 330, 134km North of Alpha
Site Description:	-
Orientation of Transect:	145°
Photo Numbers:	43 & 44
Datum:	AGD 84
Latitude / Longitude:	-22.46101 146.81813

Vegetation Community Description												
<i>Eucalyptus cambageana</i> woodland with <i>Acacia harpophylla</i> .												
Dominant Species (50 m x 10 m area)												
Botanical Species	Status*	Average Height (m)							Abundance (m ² /ha)			
		E	T1	T2	T3	S1	S2	G	E	T1	T2	T3
<i>Eucalyptus cambageana</i>			15	10						4	2	
<i>Acacia harpophylla</i>			15	10		5				1	2	
<i>Terminalia oblongata</i>				10		5						
<i>Eremophila mitchellii</i>						4						
<i>Carissa ovata</i>							1					
<i>Themeda triandra</i>								1				
<i>Dichanthium</i> sp.								0.5				
<i>Sporobolus australiasicus</i>								0.3				
<i>Paspalidium caespitosum</i>								0.5				
Dead Standing Timber				10								
% Rock	0	% Bare ground		20		% Leaf litter		20		% Cryptogram		30
Status: D = dominant, C = Codominant, S = subdominant, A = associate, EVR = significant species, # = weed, ## = declared plant

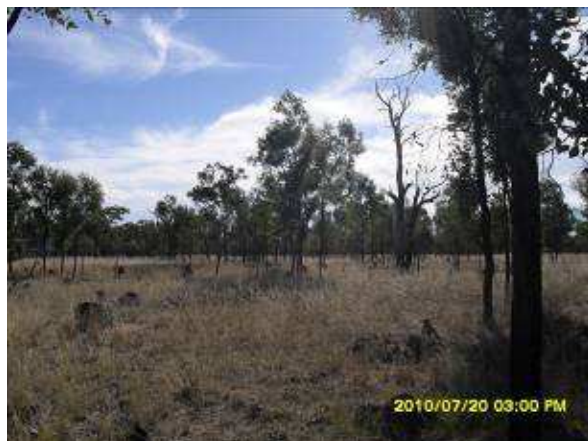
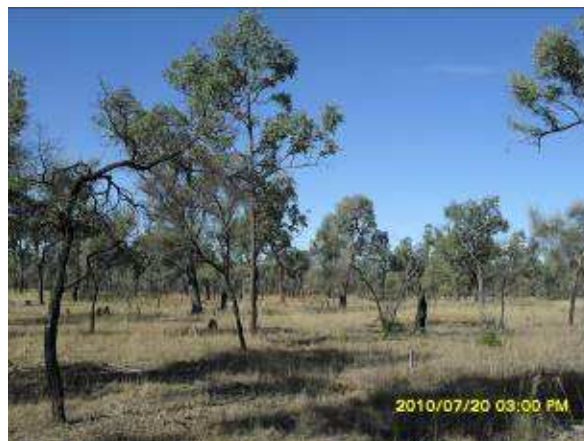
Vegetation Community Site number S47

Site Description	
Location:	KP 338, 127km North of Alpha
Site Description:	-
Orientation of Transect:	90°
Photo Numbers:	41 & 42
Datum:	AGD 84
Latitude / Longitude:	-22.52189 / 146.78763

Vegetation Community Description													
<i>Eucalyptus melanophloia</i> open woodland													
Dominant Species (50 m x 10 m area)													
Botanical Species		Status*	Average Height (m)							Abundance (m ² /ha)			
			E	T1	T2	T3	S1	S2	G	E	T1	T2	T3
<i>Eucalyptus melanophloia</i>		D		15	8						3	3	
<i>Corymbia intermedia</i>		A											
<i>Acacia coriacea</i>						5	1						
<i>Carissa ovata</i>							1						
<i>Aristida calycina</i>							0.5						
<i>Aristida latifolia</i>							1						
<i>Heteropogon contortus</i>							0.5						
<i>Themeda triandra</i>							0.5						
% Rock	0	% Bare ground		30		% Leaf litter		30		% Cryptogram		20	
Status: D = dominant, C = Codominant, S = subdominant, A = associate, EVR = significant species, # = weed, ## = declared plant

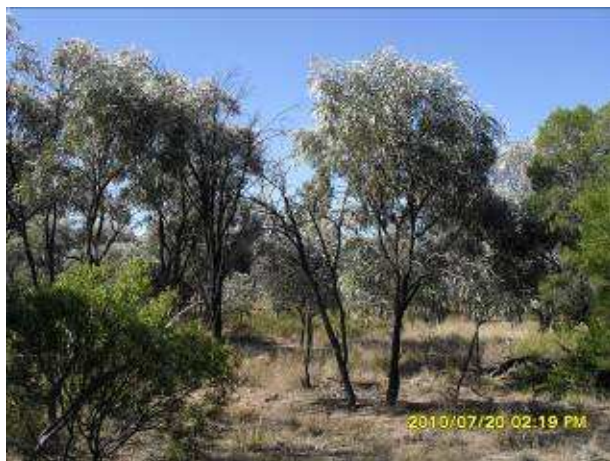
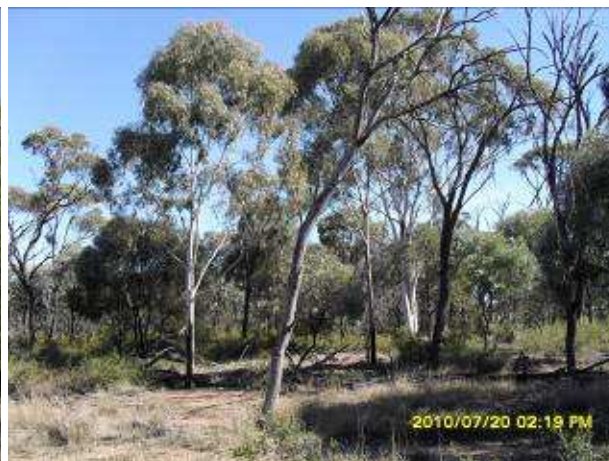
Vegetation Community Site number S48

Site Description	
Location:	KP 341, 123km north of Alpha
Site Description:	-
Orientation of Transect:	180°
Photo Numbers:	39 & 40
Datum:	ADG84
Latitude / Longitude:	-22.55662 / 146.76105

Vegetation Community Description													
<i>Eucalyptus thozetiana</i> and <i>Acacia harpophylla</i> woodland on old sedimentary rocks.													
Dominant Species (50 m x 10 m area)													
Botanical Species		Status*	Average Height (m)						Abundance (m ² /ha)				
			E	T1	T2	T3	S1	S2	G	E	T1	T2	T3
<i>Acacia harpophylla</i>		D		15	9	6					1	2	1
<i>Eucalyptus thozetiana</i>		A		17	9						1		
<i>Eremophila mitchellii</i>							5						
<i>Flindersia dissosperma</i>							4						
<i>Carissa ovata</i>								1					
<i>Sporobolus australasicus</i>									0.3				
<i>Pennisetum ciliare</i>									0.5				
<i>Enneapogon</i> sp.									0.4				
<i>Lysicarpus carronii</i>					8								
% Rock	5	% Bare ground		15		% Leaf litter		40		% Cryptogram		10	
Status: D = dominant, C = Codominant, S = subdominant, A = associate, EVR = significant species, # = weed, ## = declared plant

Community Health and Condition	
Overall Health:	Very good
Potential EVR Flora Species Habitat:	-
EVR Flora Species Recorded:	Nil
Weed Species:	No declared weeds, Buffel grass
Weed Cover (%):	15
Disturbance:	Grazing
Disturbance Cover (%):	15

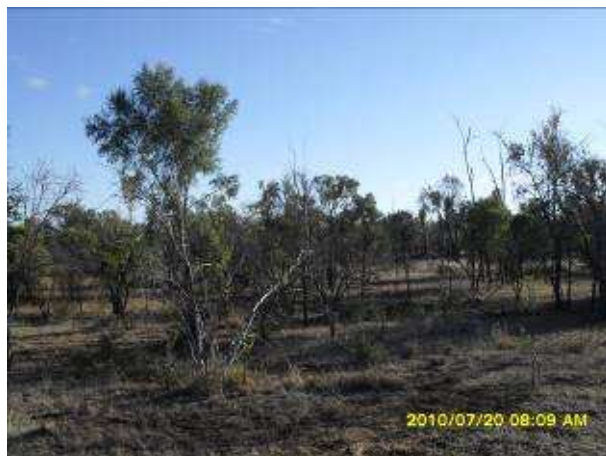
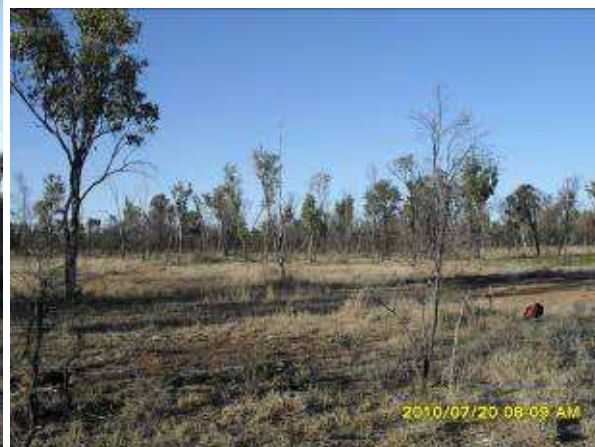
Vegetation Community Site number S49

Site Description	
Location:	KP352, 115km North of Alpha
Site Description:	Burnt out / Regrowth paddock.
Orientation of Transect:	180°
Photo Numbers:	22 & 23
Datum:	AGD 84
Latitude / Longitude:	-22.61750 / 146.68875

Community Health and Condition	
Overall Health:	Destroyed (no mature trees)
Potential EVR Flora Species Habitat:	-
EVR Flora Species Recorded:	Nil
Weed Species:	Nil declared, Buffel grass dominant
Weed Cover (%):	30% Buffel grass
Disturbance:	Grazing
Disturbance Cover (%):	30%

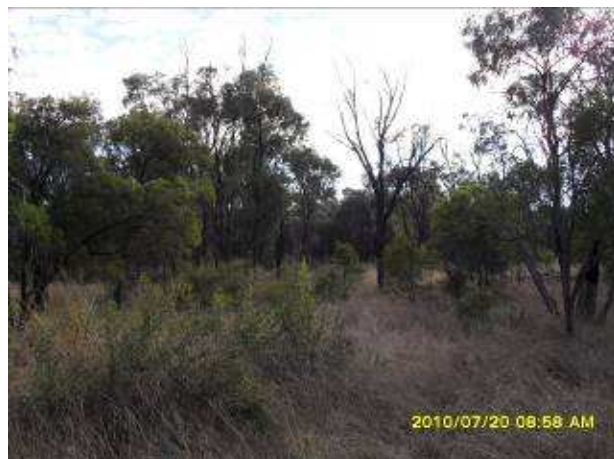
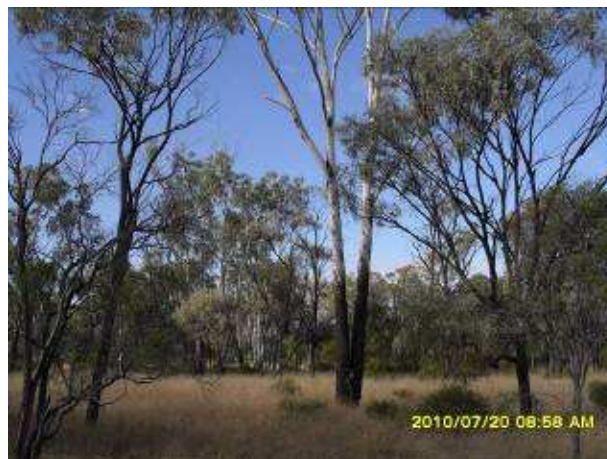
Vegetation Community Site number S50

Site Description	
Location:	700m East of KP 355, 115km North of Alpha
Site Description:	-
Orientation of Transect:	180°
Photo Numbers:	24 & 25
Datum:	AGD 84
Latitude / Longitude:	-22.63778 / 146.68367

Vegetation Community Description												
<i>Eucalyptus cambageana</i> , <i>Acacia harpohpylla</i> woodland in excellent condition.												
Dominant Species (50 m x 10 m area)												
Botanical Species		Status*	Average Height (m)						Abundance (m ² /ha)			
			E	T1	T2	T3	S1	S2	G	E	T1	T2
<i>Eucalyptus cambageana</i>		D	20							2		
<i>Acacia harpohpylla</i>		D		12	6						4	
<i>Eucalyptus populnea</i>		A		12								
<i>Acacia cambagei</i>		A		10	6							
<i>Eremophila mitchellii</i>							4					
<i>Myoporum montatum</i>								1				
<i>Carissa ovata</i>								1				
<i>Aristida calycina</i> var. <i>praealta</i>		D							1			
<i>Heteropogon contortus</i>									1			
<i>Enchaleana tomentosa</i>									0.3			
% Rock	0	% Bare ground		10		% Leaf litter		40		% Cryptogram		0
Status: D = dominant, C = Codominant, S = subdominant, A = associate, EVR = significant species, # = weed, ## = declared plant

Community Health and Condition	
Overall Health:	Excellent
Potential EVR Flora Species Habitat:	-
EVR Flora Species Recorded:	Nil
Weed Species:	Nil
Weed Cover (%):	0
Disturbance:	Nil
Disturbance Cover (%):	0

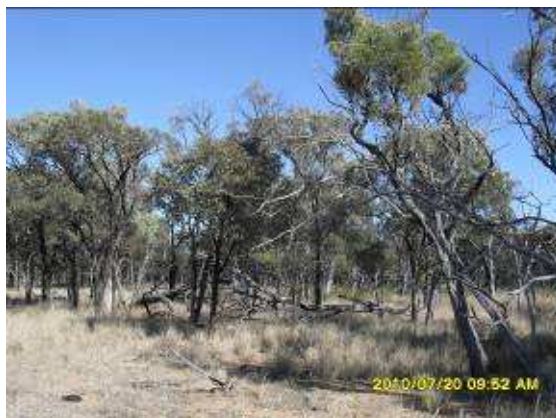
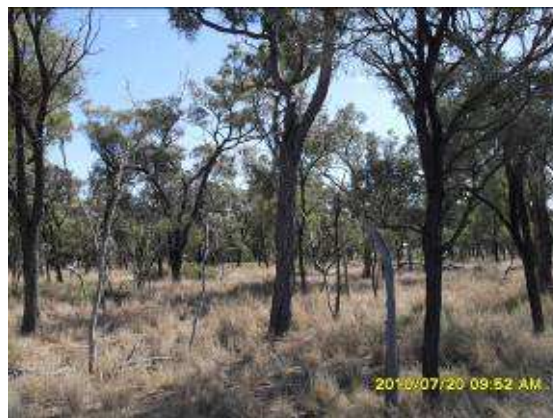
Vegetation Community Site number S51

Site Description	
Location:	KP 358.5
Site Description:	-
Orientation of Transect:	0°
Photo Numbers:	27 & 28
Datum:	AGD 84
Latitude / Longitude:	-22.66513 / 146.65994

Vegetation Community Description												
Acacia cambagei woodland on clay plains												
Dominant Species (50 m x 10 m area)												
Botanical Species	Status*	Average Height (m)							Abundance (m ² /ha)			
		E	T1	T2	T3	S1	S2	G	E	T1	T2	T3
Acacia cambagei	C		11							11		
Acacia harpohpylla	C		11							7		
Eremophila mitchellii						3	1					
Lysiphyllum carronii				5								
Carissa ovata							1					
Pennisetum ciliare	#							0.5				
Enteropogon acicularis								0.5				
Scleroleana sp.								0.2				
Enchylaena tomentosa								0.2				
% Rock	0	% Bare ground		30		% Leaf litter		30		% Cryptogram		0
Status: D = dominant, C = Codominant, S = subdominant, A = associate, EVR = significant species, # = weed, ## = declared plant

Community Health and Condition	
Overall Health:	Good
Potential EVR Flora Species Habitat:	-
EVR Flora Species Recorded:	Nil
Weed Species:	No declared, Buffel grass
Weed Cover (%):	30%
Disturbance:	Grazing
Disturbance Cover (%):	30%

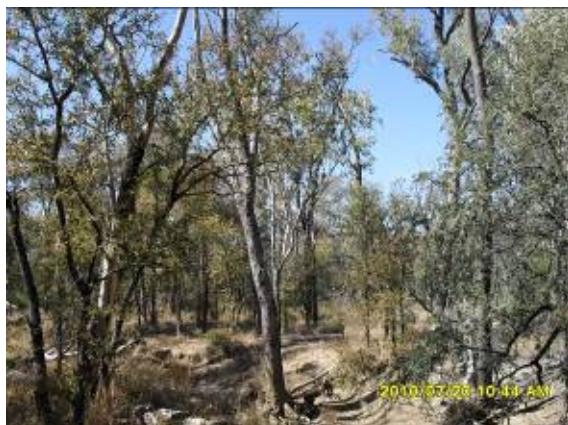
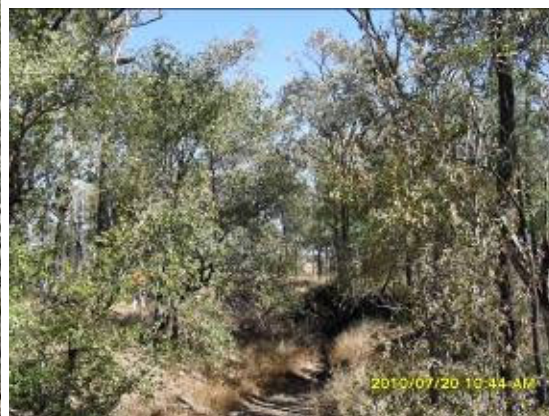
Vegetation Community Site number S52

Site Description	
Location:	KP 368, 101km North of Alpha
Site Description:	Unmapped vegetated watercourse
Orientation of Transect:	90°
Photo Numbers:	29 & 30
Datum:	AGD84
Latitude / Longitude:	-22.74125 / 146.60928

Vegetation Community Description												
Acacia harpohpylla open forest with Eucalyptus orgadophila co-dominate along watercourse (uncleared)												
Dominant Species (50 m x 10 m area)												
Botanical Species	Status*	Average Height (m)							Abundance (m ² /ha)			
		E	T1	T2	T3	S1	S2	G	E	T1	T2	T3
Eucalyptus orgadophila	C	18	17									
Acacia harpophylla	C		15	8								
Terminalia oblongata				8								
Lysiphyllum carronii				7		2						
Carissa ovata							1					
Pennisetum ciliare	#							1				
Dichanthium sp.								1				
Creekbank herbage (indeterminate)								0.3				
Sida spp.								0.2				
Acacia cambagei	A			7								
Xanthium occidentale	#							0.2				
% Rock	0	% Bare ground		40		% Leaf litter		20		% Cryptogram		5
Status: D = dominant, C = Codominant, S = subdominant, A = associate, EVR = significant species, # = weed, ## = declared plant

Community Health and Condition	
Overall Health:	Good
Potential EVR Flora Species Habitat:	-
EVR Flora Species Recorded:	Nil
Weed Species:	Noogoora burr, Buffel grass
Weed Cover (%):	30%
Disturbance:	Grazing
Disturbance Cover (%):	30%

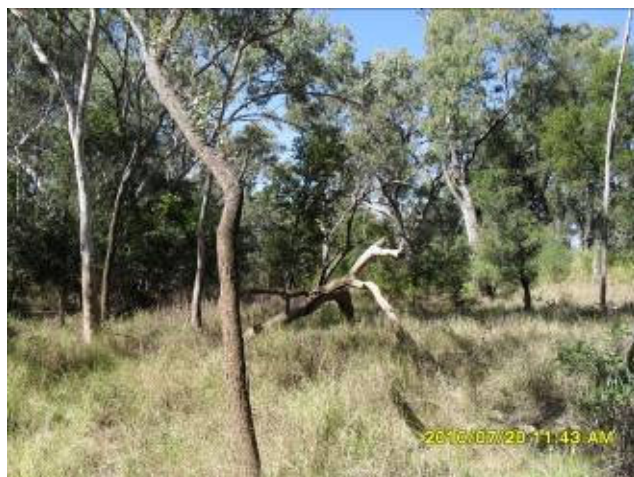
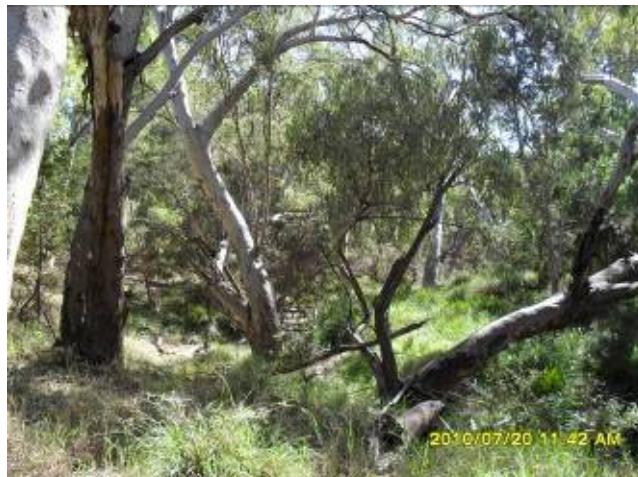
Vegetation Community Site number S53

Site Description	
Location:	KP 381, 90km North of Alpha
Site Description:	Sandy creek
Orientation of Transect:	0°
Photo Numbers:	34, 35 & 36 (33 of adjoining creek)
Datum:	AGD 84
Latitude / Longitude:	-22.83789 / 146.54057

Community Health and Condition	
Overall Health:	Very good
Potential EVR Flora Species Habitat:	<i>Aponogeton queenslandicus</i>
EVR Flora Species Recorded:	Nil
Weed Species:	Noogoora burr
Weed Cover (%):	20
Disturbance:	Grazing
Disturbance Cover (%):	20

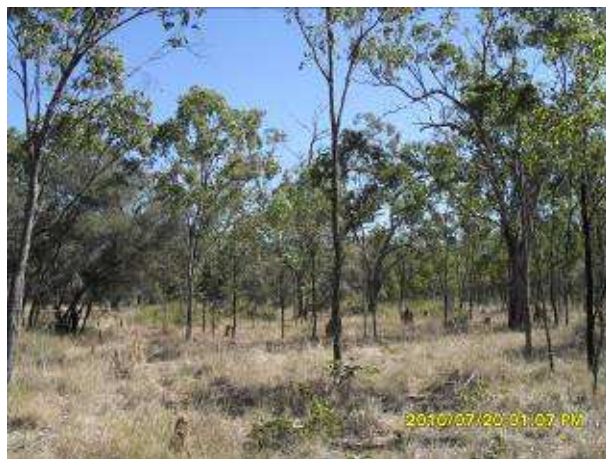
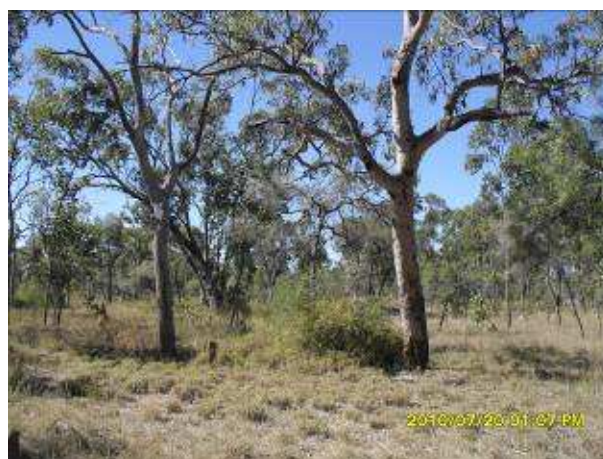
Vegetation Community Site number 54

Site Description	
Location:	KP 389, 83km North of Alpha
Site Description:	Timbered paddock
Orientation of Transect:	45°
Photo Numbers:	37 & 38
Datum:	AGD 84
Latitude / Longitude:	-22.90081 / 146.52403

Vegetation Community Description												
<i>Eucalyptus populnea</i> open woodland on alluvial plains.												
Dominant Species (50 m x 10 m area)												
Botanical Species	Status*	Average Height (m)							Abundance (m ² /ha)			
		E	T1	T2	T3	S1	S2	G	E	T1	T2	T3
<i>Eucalyptus populnea</i>	D		17	8								
<i>Eucalyptus melanophloia</i>	S		17	8								
<i>Corymbia</i> sp. (bloodwood)	A		17									
<i>Grevillea pteridifolia</i>												
<i>Archidendropsis basaltica</i>				6								
<i>Acacia coriacea</i>				6								
<i>Acacia decora</i>				8								
<i>Carissa ovata</i>						4						
<i>Grevillea parallela</i>						4						
<i>Grewia retusifolia</i>							1.3					
<i>Ennaeopogon</i> sp.							1					
<i>Arisitida latifolia</i>							1					
<i>Heteropogon contortus</i>								0.5				
<i>Panicum</i> sp.								1				
<i>Sida</i> sp.								0.5				
<i>Aristida calycina</i>								0.5				
<i>Maytenus cunninghamii</i>							1

Community Health and Condition	
Overall Health:	Very good
Potential EVR Flora Species Habitat:	<i>Desmodium macrocarpum</i>
EVR Flora Species Recorded:	Nil
Weed Species:	Nil
Weed Cover (%):	0
Disturbance:	Grazing
Disturbance Cover (%):	5%

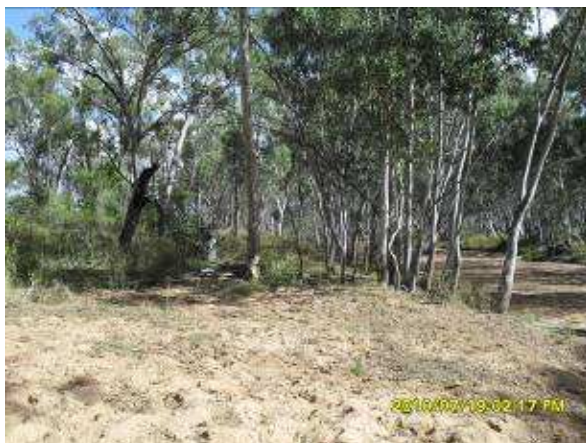
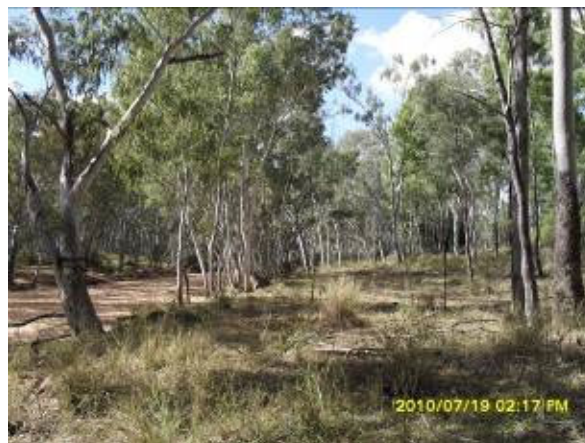
Vegetation Community Site number S55

Site Description	
Location:	KP 397.5, 74km North of Alpha
Site Description:	Sandy creek
Orientation of Transect:	180°
Photo Numbers:	20 & 21
Datum:	AGD 84
Latitude / Longitude:	-22.98449 / 146.52677

Community Health and Condition	
Overall Health:	Good
Potential EVR Flora Species Habitat:	-
EVR Flora Species Recorded:	N/A
Weed Species:	Mimosa bush
Weed Cover (%):	3
Disturbance:	Grazing
Disturbance Cover (%):	15

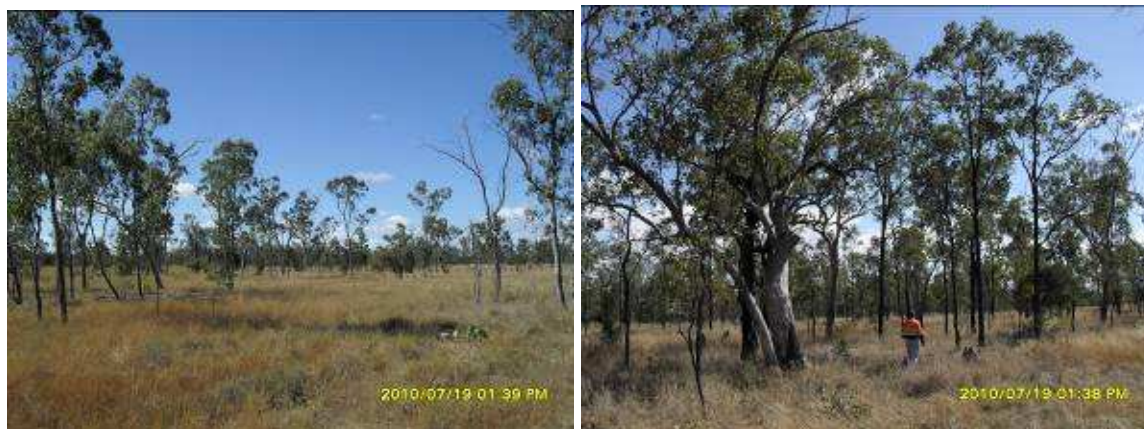
Vegetation Community Site number S56

Site Description	
Location:	KP 406, 66km north of Alpha
Site Description:	Treed paddock
Orientation of Transect:	300°
Photo Numbers:	18 & 19
Datum:	AGD 84
Latitude / Longitude:	-23.05902 / 146.52313

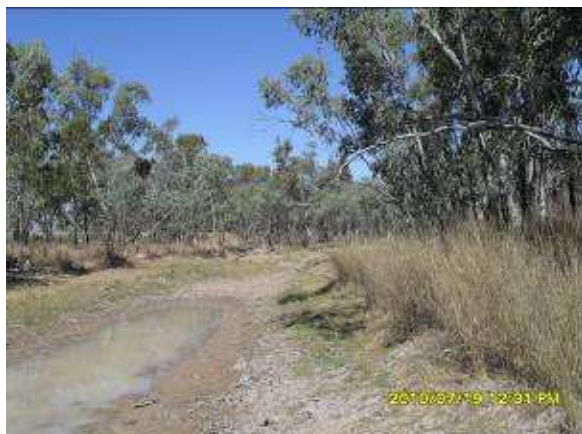
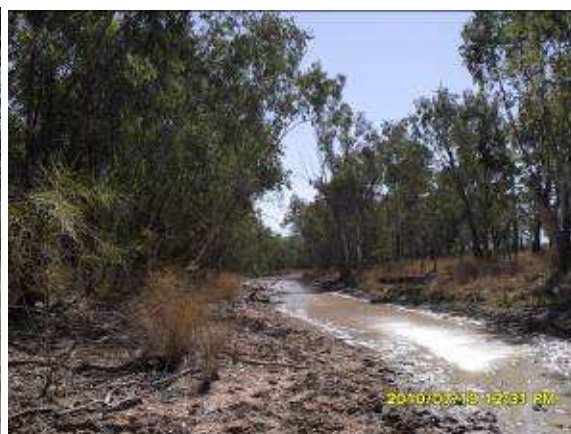
Vegetation Community Site number S57

Site Description	
Location:	KP 415, 57km North of Alpha
Site Description:	Sandy creek
Orientation of Transect:	0°
Photo Numbers:	16 & 17
Datum:	AGD 84
Latitude / Longitude:	-23.13989 / 146.52144

Vegetation Community Description													
Eucalyptus camaldulensis open woodland along watercourse. Adjoined by Eucalyptus populnea open woodland (RE 10.3.7)													
Dominant Species (50 m x 10 m area)													
Botanical Species		Status*	Average Height (m)							Abundance (m ² /ha)			
			E	T1	T2	T3	S1	S2	G	E	T1	T2	T3
Eucalyptus camaldulensis		D		15	8		4						
Eucalyptus populnea		S		13									
Acacia excelsa		A			6								
Atalaya hemiglauca							2						
Carissa ovata							2						
Parkinsonia aculeata		##					2						
Acacia farnesiana		#											
Chloris divaricata								1					
Leptochloa digitata								1.5					
Paspalidium sp.								0.7					
Bothriochloa decipiens													
Panicum larcomianum													
% Rock	0	% Bare ground		30		% Leaf litter		70		% Cryptogram		0	
Status: D = dominant, C = Codominant, S = subdominant, A = associate, EVR = significant species, # = weed, ## = declared plant

Community Health and Condition	
Overall Health:	Good
Potential EVR Flora Species Habitat:	-
EVR Flora Species Recorded:	Nil
Weed Species:	Parkinsonia, Mimosa bush
Weed Cover (%):	2
Disturbance:	Grazing, cattle pugs
Disturbance Cover (%):	15
