Waratah Coal China First Project - Aquatic Ecology

14 December 2010

E3 Consulting Australia Pty Ltd
ABN 44 242 443 207
30 Qualtrough St
Woolloongabba
QLD
4102
Tel: +61 7 3303 8775
Fax: +61 7 3828 6999

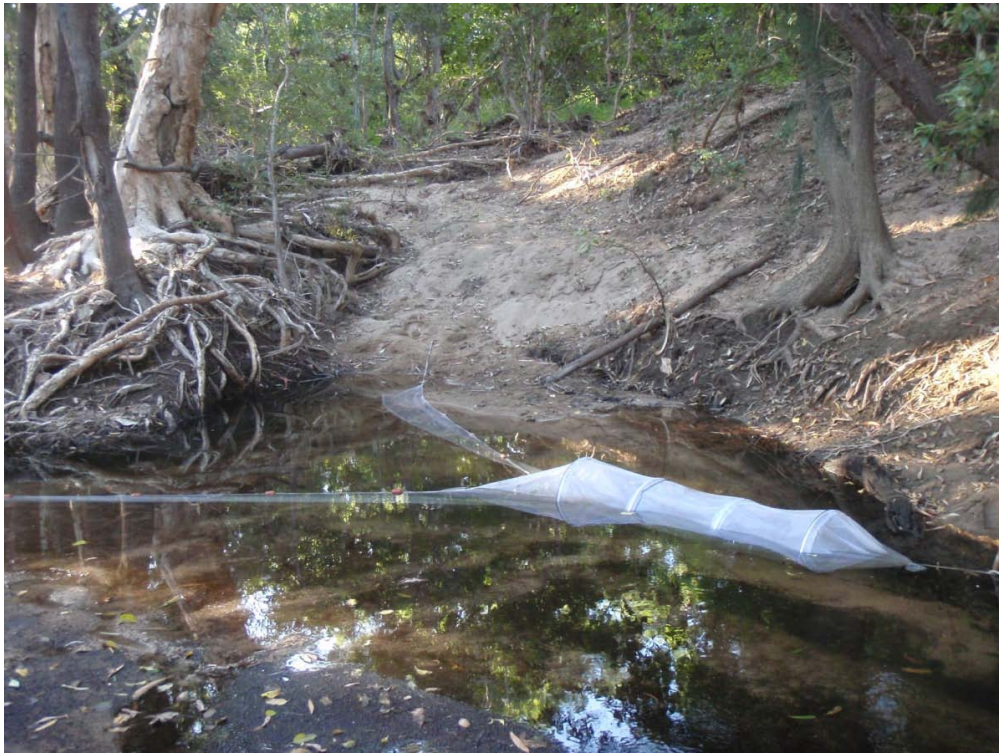
Plate 2-1: Fyke Net

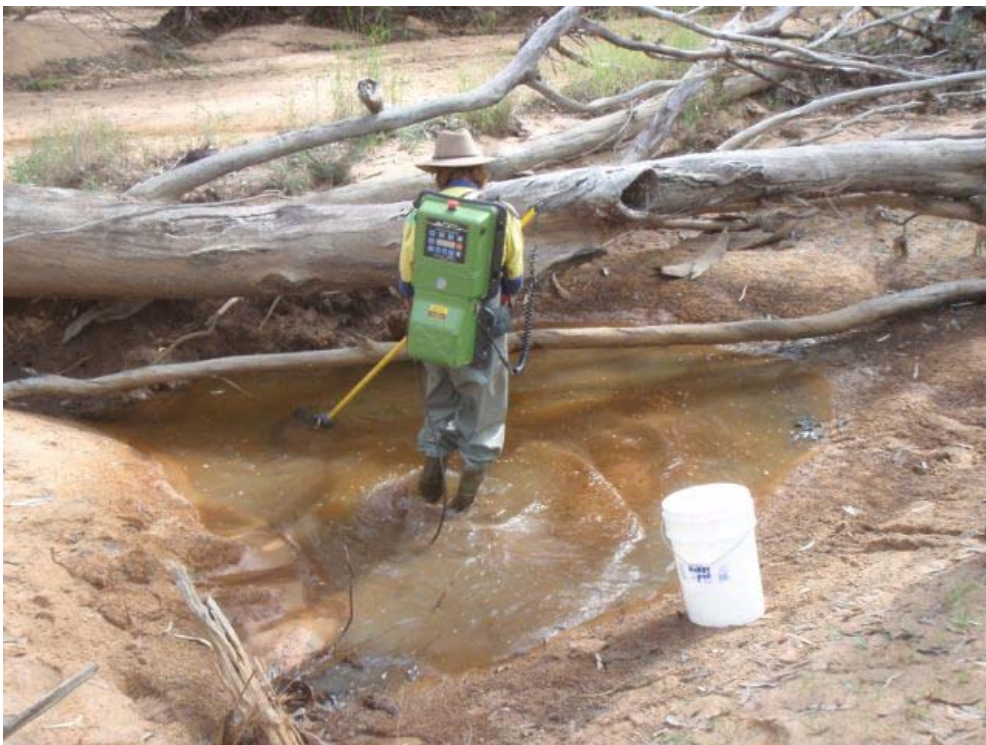
Plate 2-2: Electrofishing at AQ13

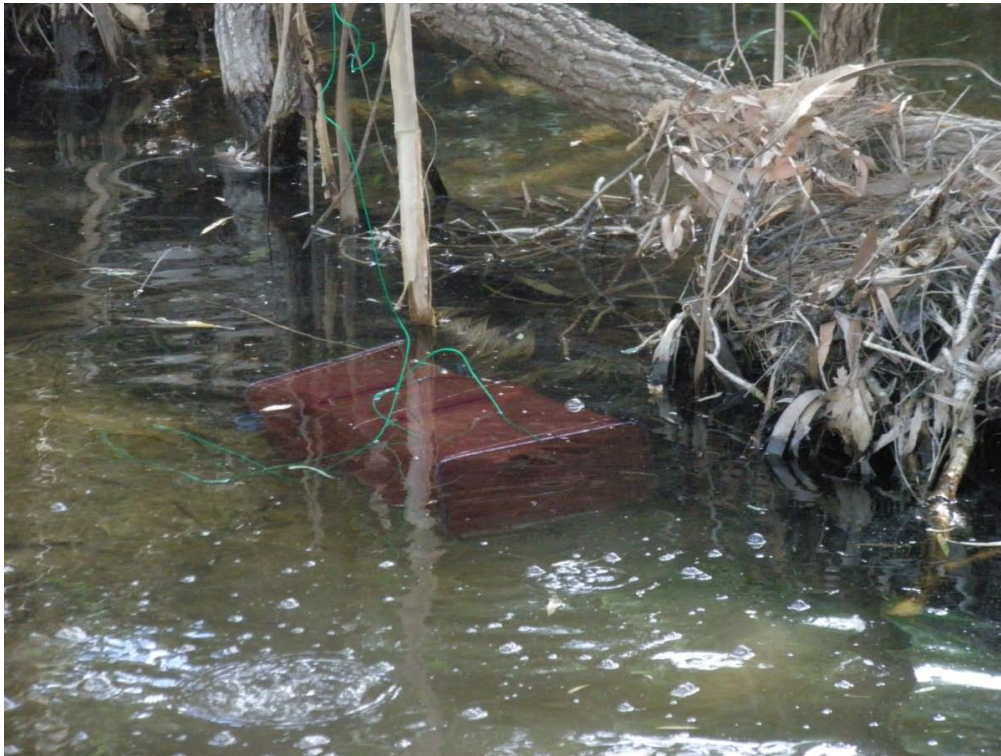
Plate 2-3: Bait Trap

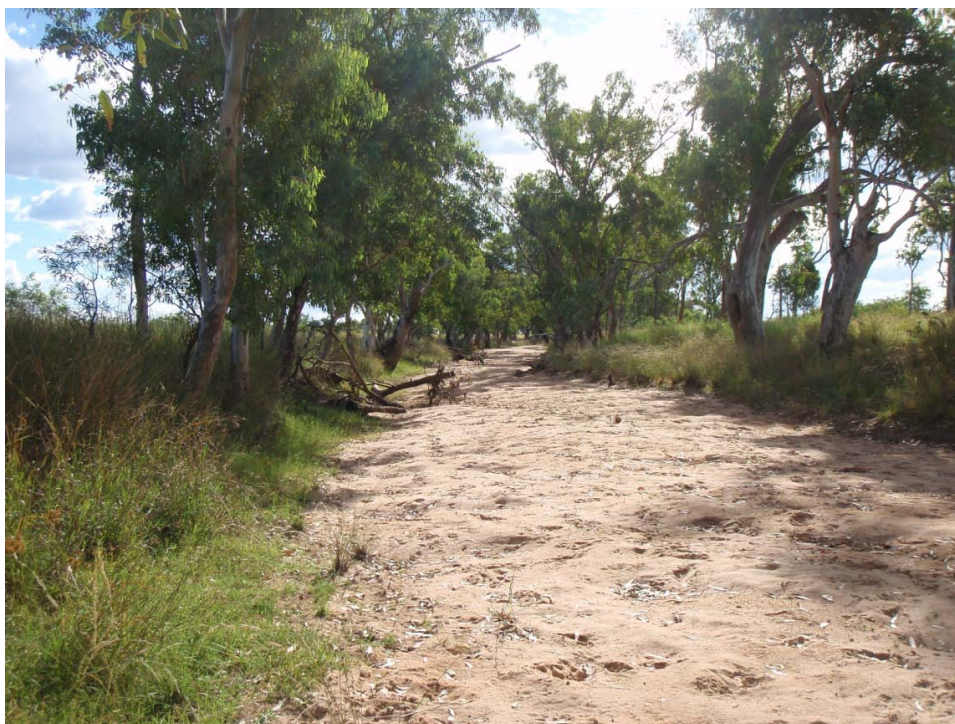
Plate 3-1: AQ14 - Malcolm Creek

The site surveyed is a 6m wide sand bed dominated stream channel. Riparian overstorey vegetation is dominated by woodland consisting of isolated *Eucalyptus camaldulensis* with an ecotone comprised of *Callitris intratropica*. The channel is occluded with sand beds with a few emergent macrophyte species recorded on clayey channel margins. Dense stands of riparian grasses including *Heteropogon contortus* and *Themeda australis* were observed on the channel levees. No weeds were recorded and no significant erosion of channel banks was observed.

Habitat features present indicate that the seasonal aquatic habitats including shallow riffles, runs and pools, sand beds, undercut banks, root masses, leaf litter piles, clay banks and large woody debris. The substrate was dominated by coarse sand, though the channel margins were clayey. The hydrological regime of the site is highly seasonal. For example, only 40 days prior to the sampling, the stream had good flow. A detailed description of the sites including photos is shown in Appendix A.

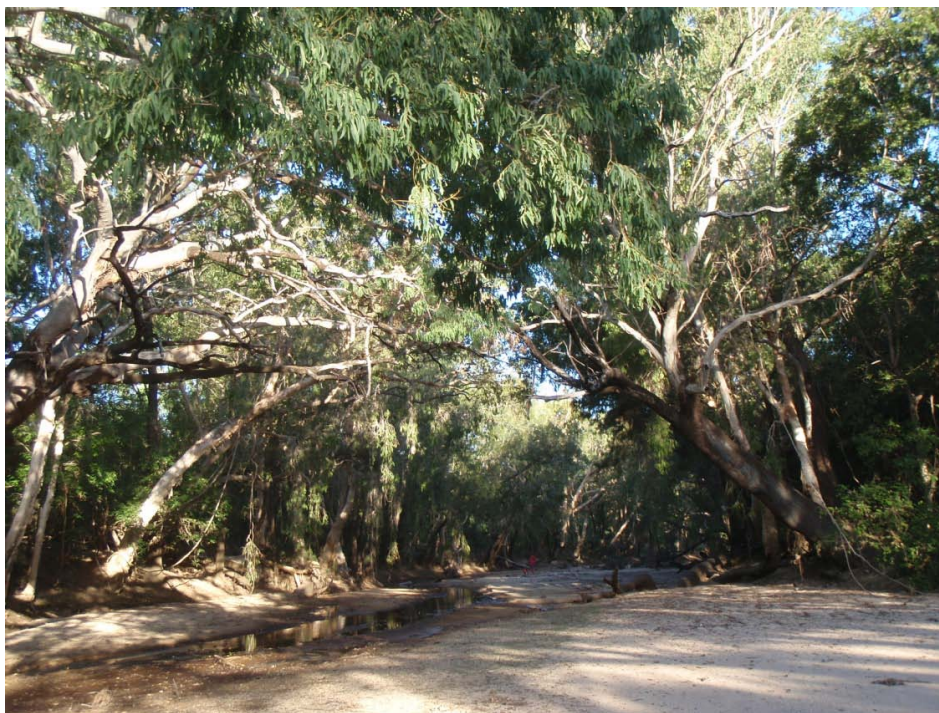
Plate 4-1: AQ3 - A tributary of the Elliot River

Melaleucas. No sites were flooded during the sampling events; however all showed signs of recent flooding. All three sites displayed low to medium vegetation complexity and contained running water with some riffles. The substrates were sandy with some pebbles and gravel.
