# Gladstone Nickel Project Environmental Impact Statement Supplement

## Marine Impacts from Extraction of Seawater from the Calliope River

Gladstone  
Pacific Nickel LTD

## Supplementary Marine Ecological Investigations

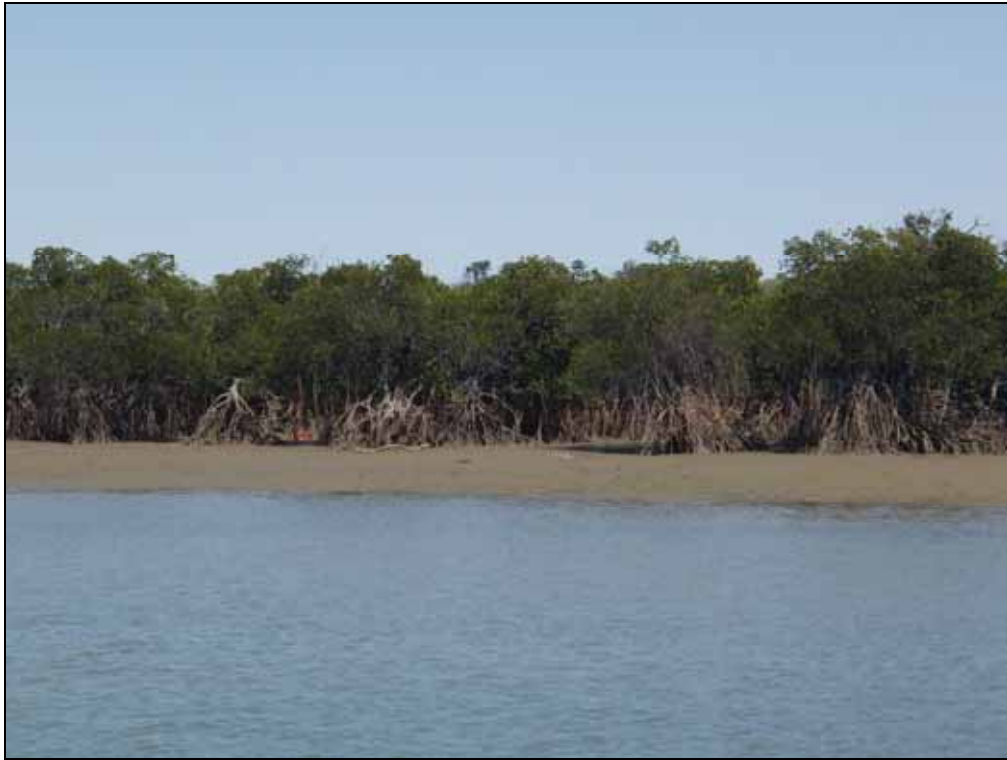
**Figure 2 West side of Calliope River mouth**

The western bank features dense red mangroves (*Rhizophora stylosa*) to approximately 4 m in height in the intertidal zone (Figure 2). The canopy density could not be calculated accurately, although the canopy appeared closed. Low tide conditions revealed the exposed mud supported small patches of seagrass and what appeared to be filamentous green algae. This assessment is consistent with the intertidal wetland mapping in the Connell Hatch (2006).

Part of the intertidal zone adjacent to the sampling transect on the western bank featured a number of dead mangrove plants. Whilst the cause of death of these individuals is unknown, erosion and root exposure caused by boat wash is not an uncommon occurrence in estuarine systems, and may have contributed to mangrove mortality in this instance.

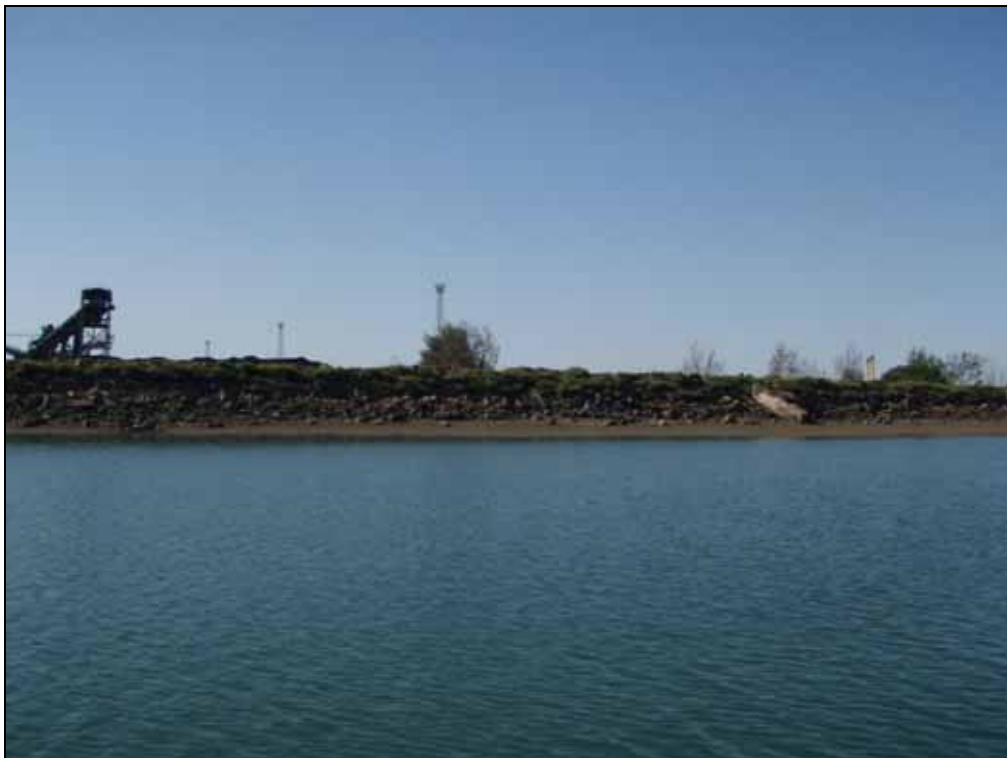
**Figure 3 East side of Calliope River mouth**

The eastern bank has been substantially modified, and in the area adjacent to the sampling transect, only scattered juvenile red mangroves were observed (Figure 3).

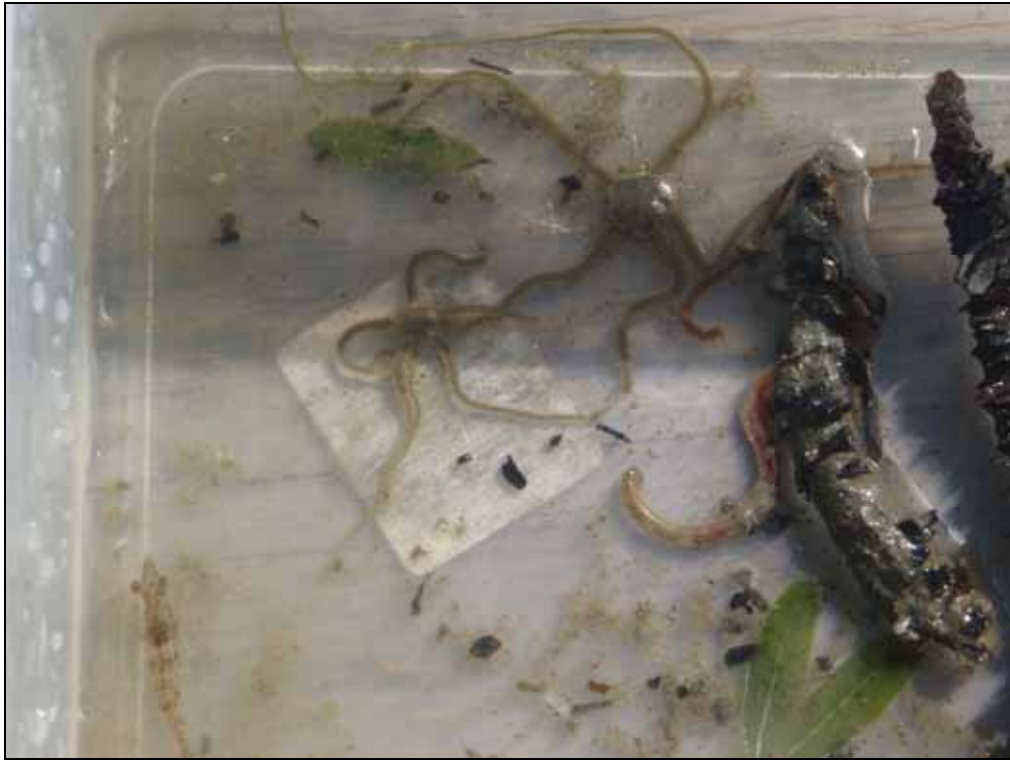
**Figure 4 Representative flora and fauna at sites 163, 171 and 172**

Sparse to moderate cover of seagrass (*Halophila ovalis*) was detected towards the western bank (sites 163, 171 and 172) along with gastropods, bivalves, polychaete worms, brittlestars and shrimp (*Acetes* sp.). Figure provides examples of representative flora and fauna detected at sites towards the western bank. No flora or fauna were detected at sites in the middle of the channel (sites 164 – 168). Filamentous red algae and tube worms were observed attached to gravel at sites 169 and 170 (Figure 5).

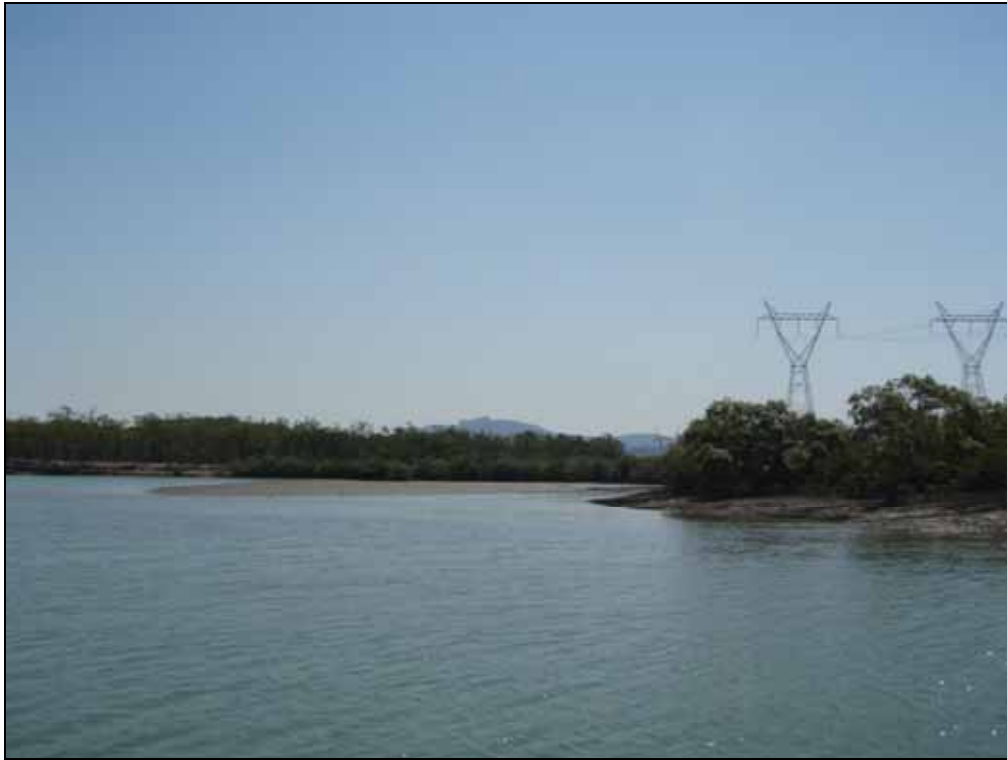
The system is estuarine and bank conditions are typified by the presence of mud flats and mangrove communities in the intertidal zone (see Figure 7). Red mangrove (*Rhizophora stylosa*) is the dominant mangrove species in this area, although grey mangrove (*Avicennia marina*) was also readily identifiable. Connell Hatch (2006) notes that the yellow mangrove (*Ceriops tagal*) is also present in this area, primarily as a component of mixed *Avicennia* or *Avicennia/Rhizophora* assemblages.

**Figure 7 Seawater intake location, looking north, showing exposed mudflats, anabranch (to the right) and eroded bank (top left)**

The area where it is proposed to install a seawater intake has similarly low levels of infauna. The erosion of the river and anabranch banks is probably natural, but may be likely to continue into the future, necessitating bank stabilisation if a seawater intake were to be installed.

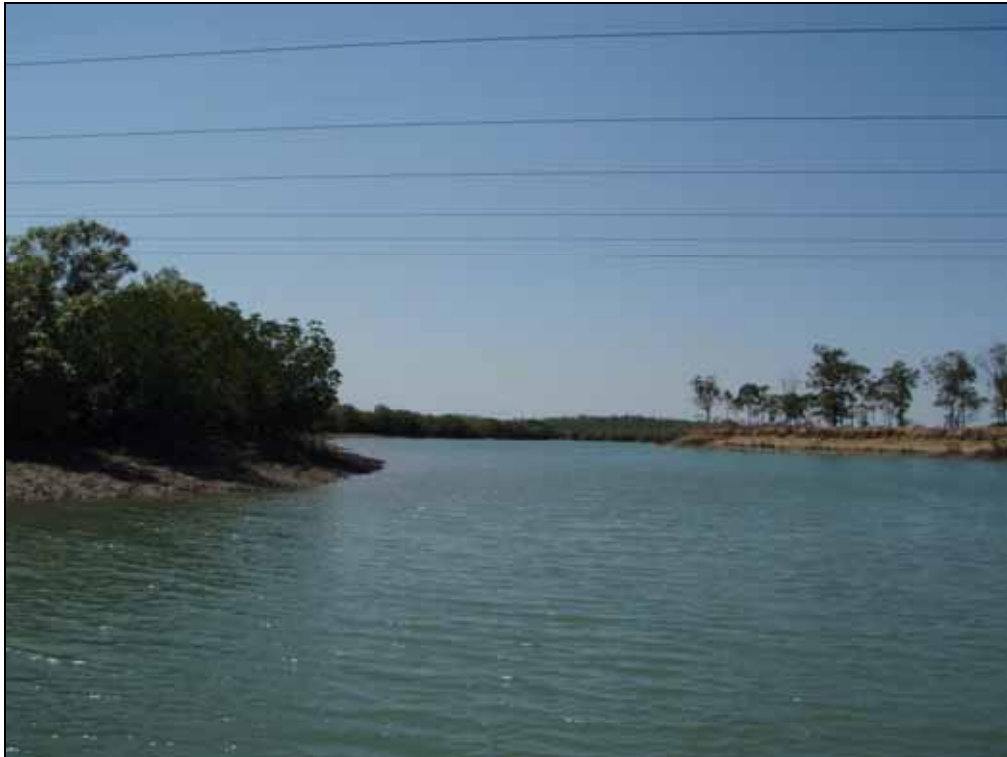
The outside river bends feature active weathering of the bank and in these places bank height can exceed 5 m from MHWS. Two locales adjacent to the sampling site display these effects; the eastern bank of the anabranch immediately upstream of the confluence with the oxbow, and the westernmost portion of the northern bend in the oxbow. The vegetation communities in these areas are typically Eucalypt woodlands. Ongoing bank erosion is causing undermining of the roots and subsequent tree collapse and mortality. The water velocity along this reach has scoured the channel to a depth of 4+ m (AHD) close to the bank, with only a steep narrow low bench formed at the toe of the eroded vertical bank. Scattered juvenile red mangroves have colonised this bench.

**Figure 8 Looking northwest along the anabranch, showing exposed mudflats (left) and eroded bank (top right)**

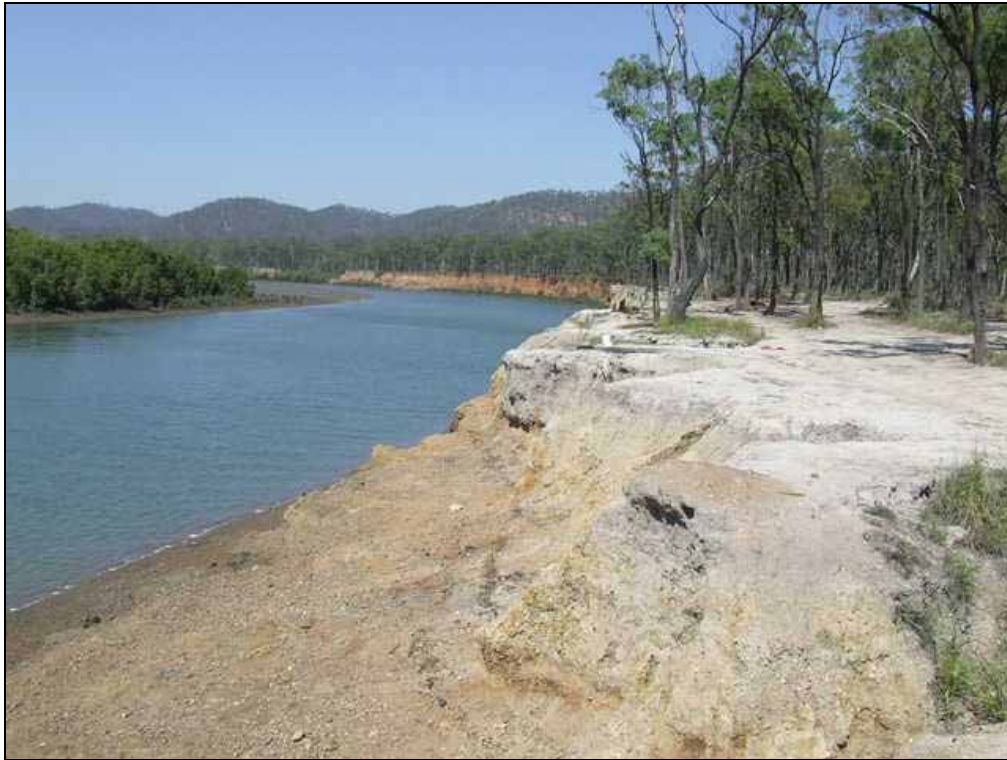
**Figure 9 Eroded bank – looking south west along the oxbow of the Calliope River**
