## 5. Topography, geology and soils

This chapter describes the existing environment, potential impacts and mitigation measures related to topography, geology and soils within the proposed Jilalan Rail Yard project area. The assessment has been based on a review of previous soil and land studies, geotechnical information and field investigations.

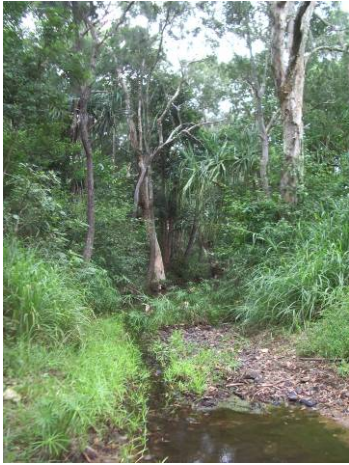
| Location | Landform elements and topographical relief | Observations and descriptions |
|---|---|---|
| <p>Land Survey Site 4 (LS4)</p> | <p>Open depression at the base of a moderately inclined simple slope downstream of the rail yard to an open depression adjacent to a level to very gently inclined flat within a gently undulating plain (GP)</p> | <p>Observation site LS4 was located along the stream channel of Elizabeth Creek between the Goonyella Branch Line and Gurnetts Road</p> <ul style="list-style-type: none"> <li>Surrounding land use was a mix of grazing and sugar cane production</li> <li>Riparian vegetation was relatively dense with a mix of native, exotic and weed species</li> <li>Culverts direct stream flow beneath Gurnetts Road</li> <li>Active erosion processes included gravity driven scouring from overland flow towards the stream channel (refer Chapter 7)</li> <li>Widely spaced convergent stream channels are the dominant drainage feature of the surrounding area</li> </ul> |

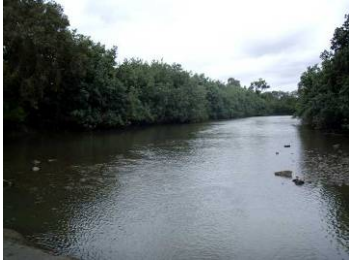
| Location | Landform elements and topographical relief | Observations and descriptions |
|---|---|---|
| <p>Land Survey Site 5 (LS5)</p> | <p>Open depression adjacent to level to gently inclined flat within a level plain (LP) and bounded to the west by a gently undulating plain (GP)</p> | <p>Observation site LS5 was located immediately west of the project area at the Smyths Road crossing of Plane Creek</p> <ul style="list-style-type: none"> <li>Riparian vegetation along both banks of the stream channel were dominated by dense stands of marine plants (refer Chapter 6)</li> <li>Land use within the surrounding area was dominated by sugar cane production</li> <li>Culverts and floodway direct stream flow beneath Smyths Road</li> <li>Exposed soil profile along the eastern bank indicated an A horizon comprising of light brown sandy clay over a B horizon of yellow brown sandy clay overlying marine mud</li> <li>Active erosion processes included gravity driven scouring from overland flow and tidal influences (refer Chapter 7)</li> </ul> |

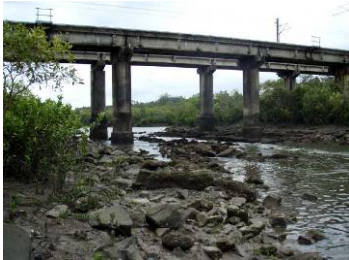
| Location | Landform elements and topographical relief | Observations and descriptions |
|---|---|---|
| <p>Land Survey Site 6 (LS6)</p> | <p>Open depression adjacent to level to very gently inclined flat within a level plain (LP)</p> | <p>Observation site LS6 was located north of the project area where the Goonyella Branch Line crosses Plane Creek</p> <ul style="list-style-type: none"> <li>Riparian vegetation along both banks of the stream channel were dominated by dense stands of marine plants (refer Chapter 6)</li> <li>Active erosion processes included gravity driven scouring and aggradation and sediment deposition within the base of the stream channel resulting from overland flow and tidal inundation processes (refer Chapter 7)</li> </ul> |

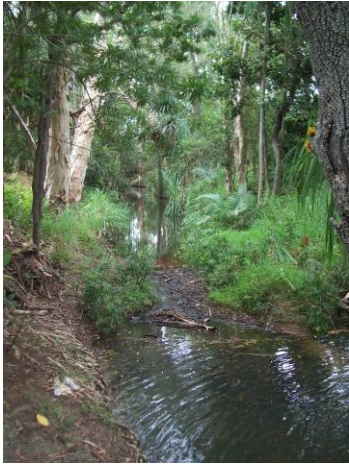
| Location | Landform elements and topographical relief | Observations and descriptions |
|---|---|---|
| <p>Land Survey Site 7 (LS7)</p> | <p>Open depression at the base of a moderately inclined simple slope downstream of the rail corridor to an open depression adjacent to a level to very gently inclined flat within a gently undulating plain (GP)</p> | <p>Observation site LS7 was located along the stream channel of Willy Creek between the Goonyella Branch Line and Gurnetts Road</p> <ul style="list-style-type: none"> <li>Riparian vegetation was relatively dense with a mix of native, exotic and weed species and the surrounding land use was a mix of grazing and sugar cane production</li> <li>Culverts direct stream flow beneath Gurnetts Road</li> <li>Active erosion processes included gravity driven scouring from overland flow to the stream channel (refer Chapter 7)</li> <li>Widely spaced convergent stream channels are the dominant drainage feature of the surrounding area</li> </ul> |

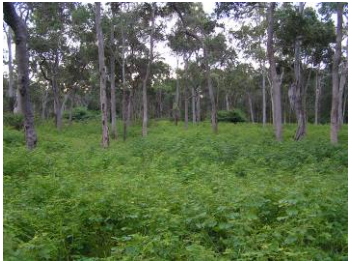
| Location | Landform elements and topographical relief | Observations and descriptions |
|---|---|---|
| <p>Land Survey Site 8 (LS8)</p> | <p>Level to gently inclined plain on the western side of the rail corridor within a gently undulating plain (GP)</p> | <p>Observation site LS8 was located within the relatively level plain on the western side of the Goonyella Branch Line rail corridor adjacent to Plane Creek</p> <ul style="list-style-type: none"> <li>The vegetation comprised open woodland with dense mixed undergrowth of native, weed and exotic species and the surrounding land use is predominantly grazing on unimproved pasture</li> <li>Culverts direct overland flow from east to west beneath the rail corridor</li> <li>Active erosion of exposed soils along drainage lines and overland flow paths</li> <li>Widely spaced unidirectional drainage lines intercept the plain and direct runoff to Plane Creek</li> </ul> |

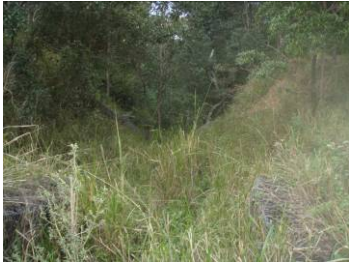
| Location | Landform elements and topographical relief | Observations and descriptions |
|---|---|---|
| <p>Land Survey Site 9 (LS9)</p> | <p>Open depression at the base of a maximal lower slope downstream of the rail corridor within a gently undulating plain (GP)</p> | <p>Observation site LS9 was located within the gently undulating plain between the western side of the Goonyella Branch Line rail corridor and Plane Creek</p> <ul style="list-style-type: none"> <li>The vegetation was dominated by relatively open woodland with mid-dense to dense undergrowth of small shrubs and grasses with a mix of native, exotic and weed species and surrounding land use is predominantly grazing on unimproved pasture</li> <li>Culverts direct channelised overland flow towards Plane Creek</li> <li>Active erosion of exposed surface and subsurface soils resulting in significant gully and tunnel erosion within drainage lines and overland flow channels</li> <li>Widely spaced unidirectional drainage lines direct runoff to Plane Creek</li> </ul> |

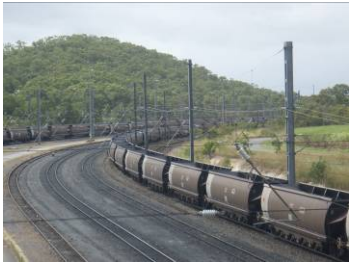
| Location | Landform elements and topographical relief | Observations and descriptions |
|---|---|---|
| <p>Land Survey Site 14 (LS14)</p> | <p>Gently to moderately inclined lower simple slope of a rolling low rise (RL) adjacent to urban/industrial land</p> | <p>Observation site LS14 was located adjacent to Armstrong Beach Road on the western side of the Jilalan rail corridor</p> <ul style="list-style-type: none"> <li>The vegetation was dominated by relatively open woodland with a mix of native, exotic and weed species and surrounding land use is predominantly grazing on unimproved pasture and urban/industrial development associated with the Jilalan Rail Yard and corridor</li> <li>Active erosion on exposed soils</li> </ul> |

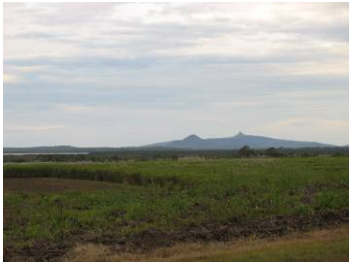
| Location | Landform elements and topographical relief | Observations and descriptions |
|---|---|---|
| <p>Land Survey Site 15 (LS15)</p> | <p>Very gently to gently inclined gently undulating rise (GR)</p> | <p>Observation site LS15 was located adjacent to Gurnetts Road on the eastern side of the rail corridor</p> <ul style="list-style-type: none"> <li>The vegetation within this area is dominated by cleared areas utilised for cane farming with a mix of native, exotic and weed species associated with the riparian areas</li> <li>Surface soils appear relatively stable</li> <li>Drainage lines and overland flow paths tend to form widely spaced convergent channel networks associated with Elizabeth Creek</li> </ul> |
