# Northern Link

TECHNICAL REPORT NO. 5  
SURFACE WATER

- May 2008

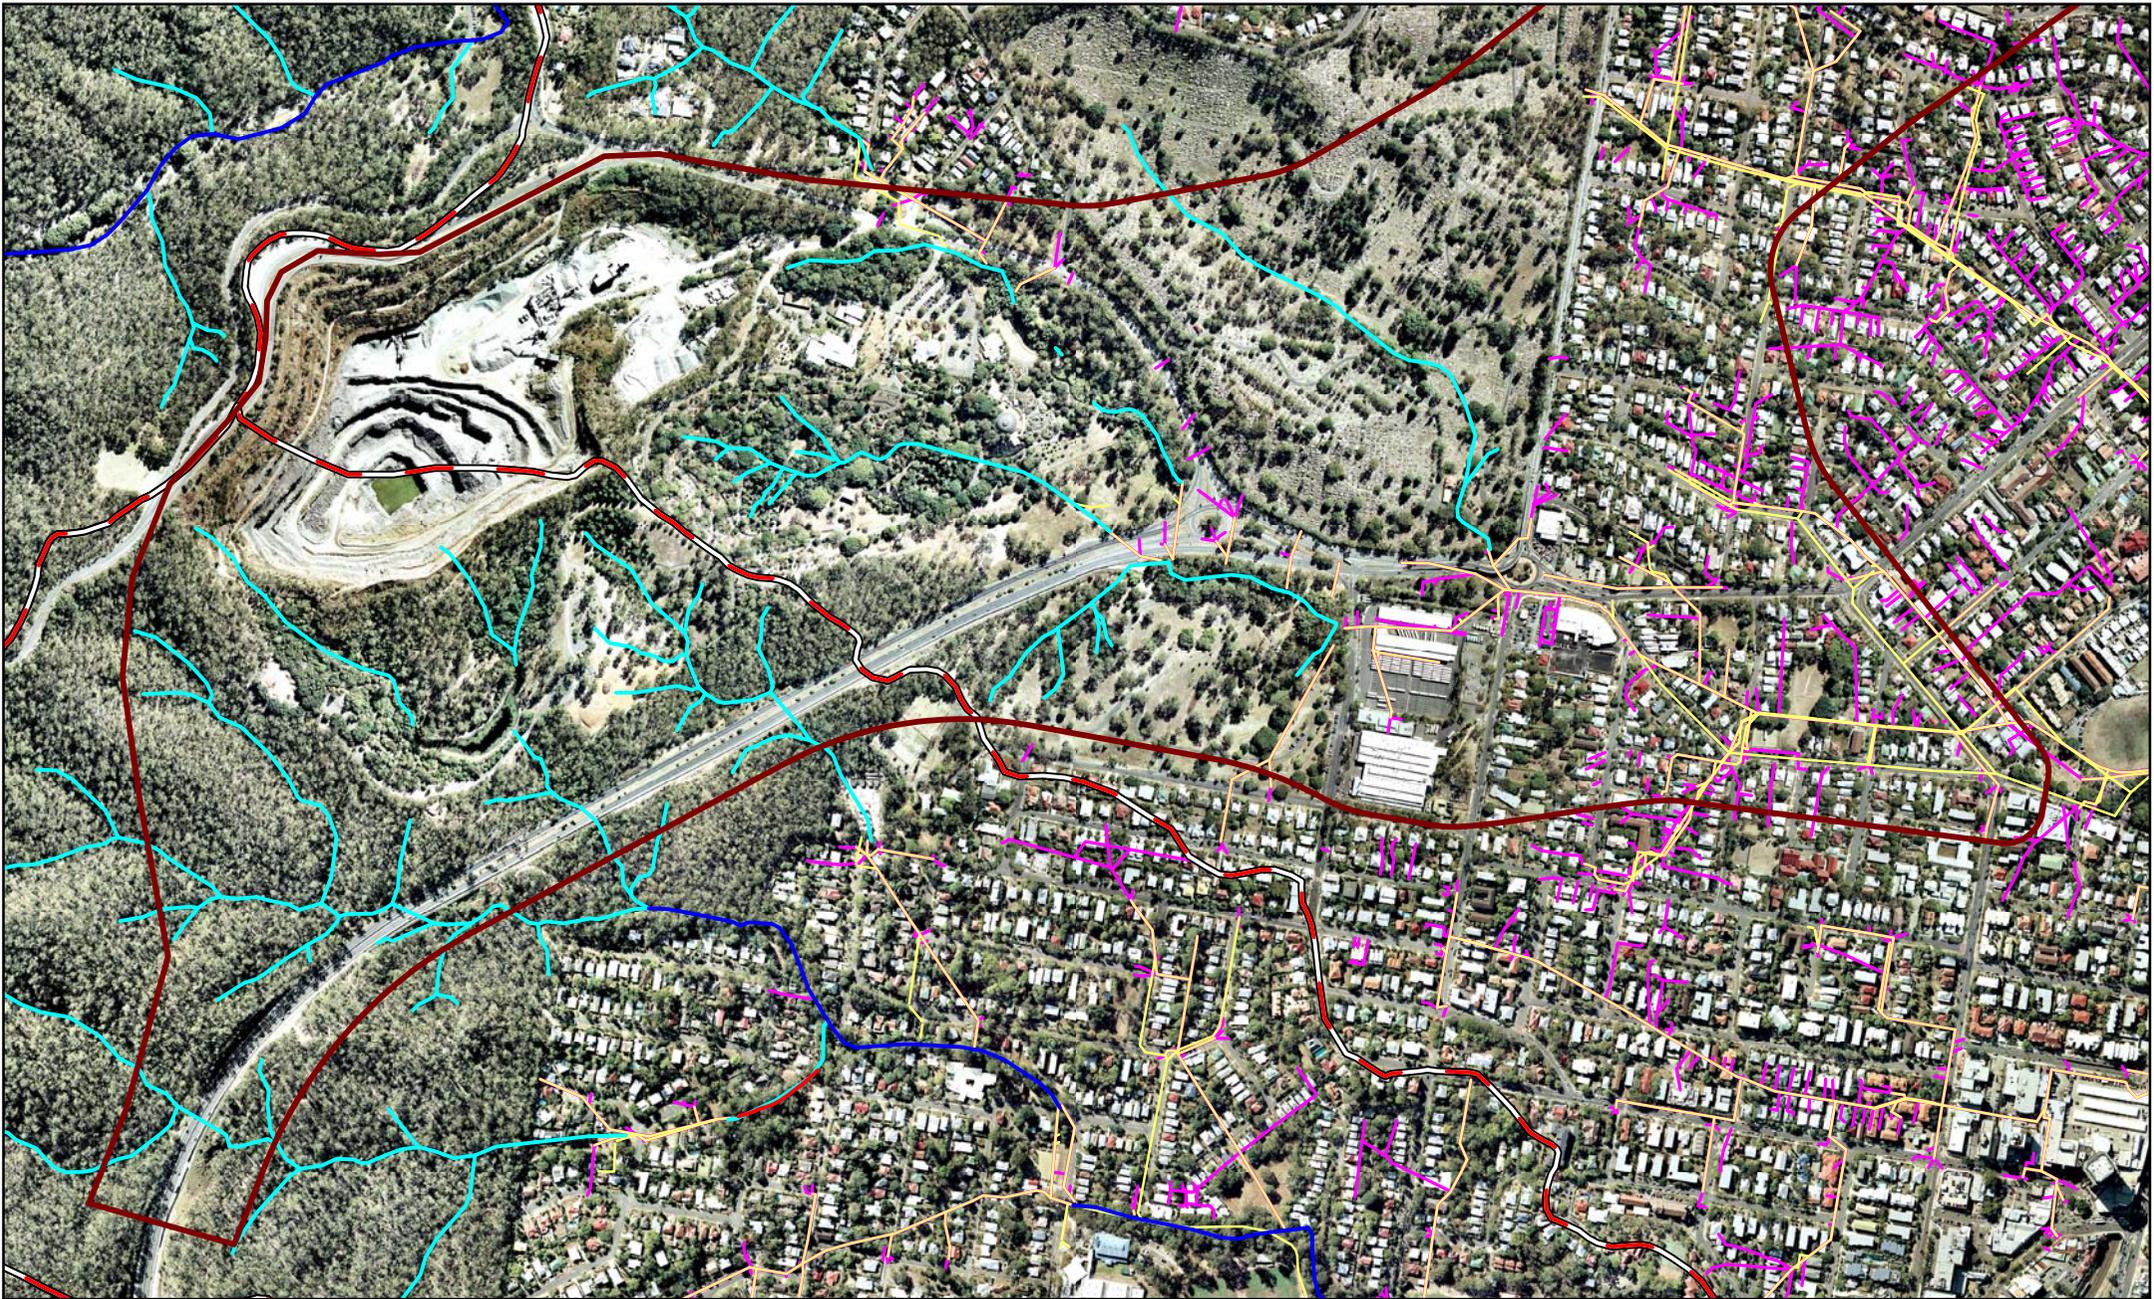
Figure 1A

Surface Water - Overview

At the extreme In this section of the study corridor, drainage flows through open gullies within Brisbane Forest Park before passing under the Western Freeway and Milton Road and into an urban stormwater system which discharges ultimately into the Brisbane River (refer Figure 1a).

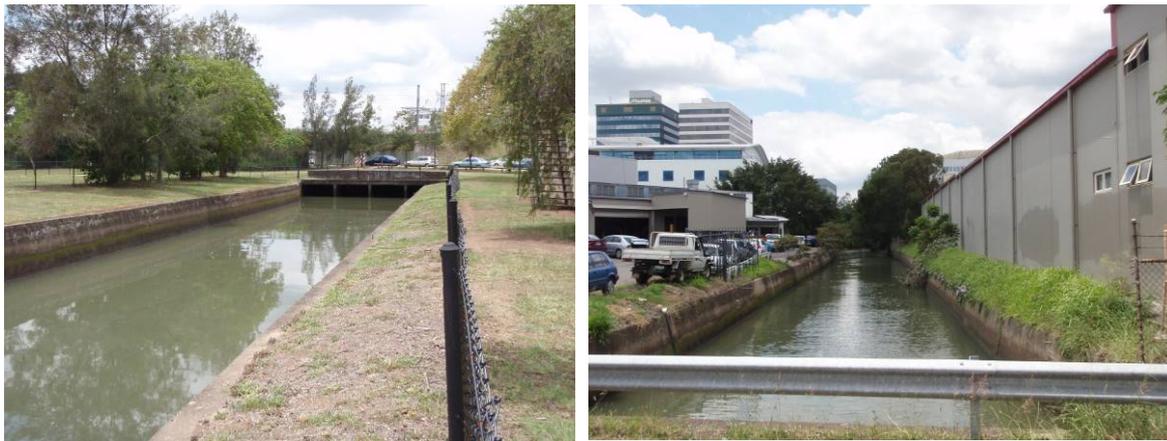
■ *Figure 2 : Open concrete-lined tidal drainage channels downstream of the study corridor at Milton Park and Kilroe Street prior to discharge into the Milton Reach of the Brisbane River*

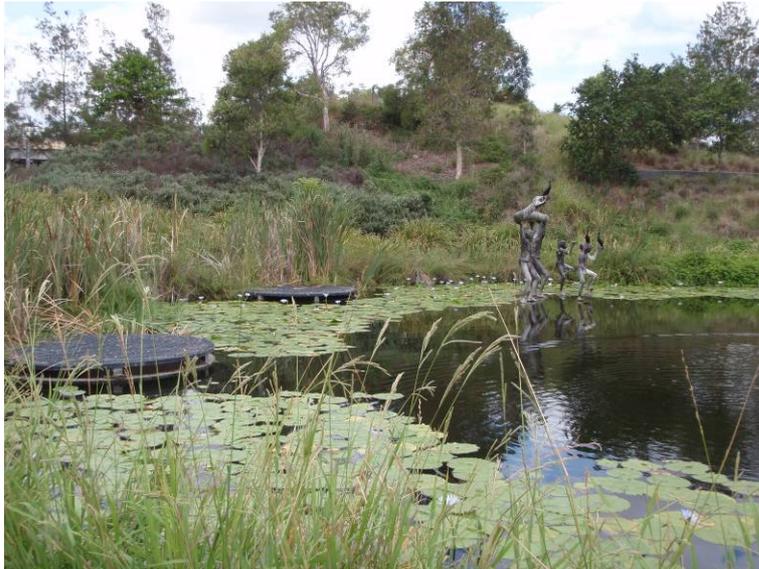
■ *Figure 3: York's Hollow, Victoria Park a culturally significant wetland habitat within Victoria Park adjacent to the Inner City Bypass*

At the Eastern end of the study corridor the most significant features from a drainage and water quality perspective are the Victoria Park Drain at Herston and York's Hollow, a culturally significant wetland within Victoria Park (Figure 3). The York's Hollow wetland was part of the original lagoon system in the area, which was rehabilitated and remodelled as part of the Inner City Bypass project in 2000. This wetland provides an important habitat for waterbirds and acts as a fish refuge/breeding area.

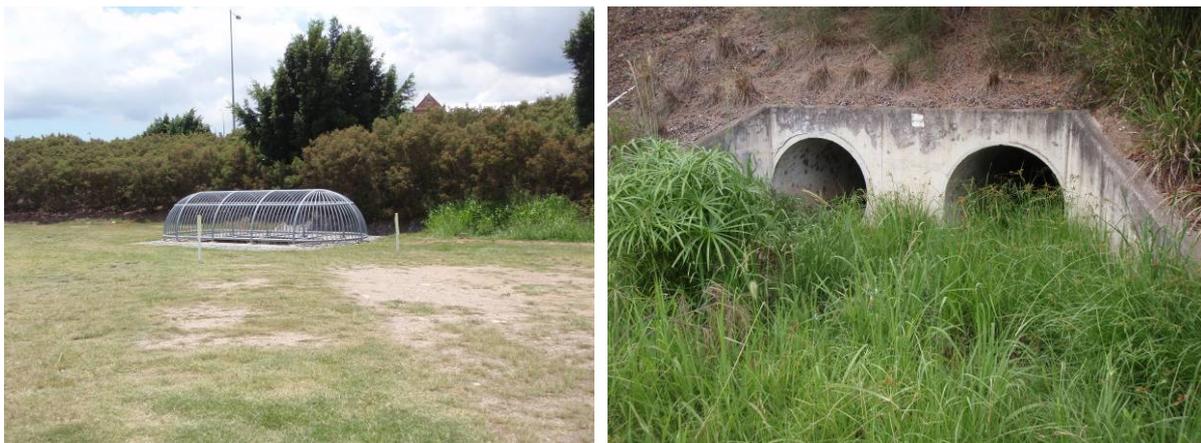
■ *Figure 4: Victoria Park detention basin outlet and stormwater culverts from the Inner City Bypass*

The catchment for the Victoria Park drainage system extends from the suburb of Red Hill, with a defined flowpath beginning west of Kelvin Grove Road, flowing through the Kelvin Grove Urban Village, the Brisbane Grammar School playing fields on Victoria Park Road and along the Inner City Bypass (ICB). The stream runs parallel to the ICB and includes significant above and below ground drainage infrastructure. Within Victoria Park a major detention basin is sited between the ICB and the multi-story hospital car park in Herston Road. The outlet from this basin discharges to an underground brick arch drain/reinforced concrete pipe (Figure 4) which runs beneath the north-western corner of the RNA showground before discharging into Enoggera Creek. This existing drain from Victoria Park is a diversion of a stream which previously ran through the RNA showground discharging into the Brisbane River at Newstead, upstream from Breakfast Creek.
