# LINDEMAN GREAT BARRIER REEF RESORT PROJECT ENVIRONMENTAL IMPACT STATEMENT

# Lindeman Island Resort Safe Harbour and Temporary Barge Access: Marine Ecology Survey

Reference:  
R.B20346.002.00.Marine  
Ecology.docx  
Date: October 2013  
Confidential

Prepared for:	White Horse Australia
Prepared by:	BMT WBM Pty Ltd (Member of the BMT group of companies)

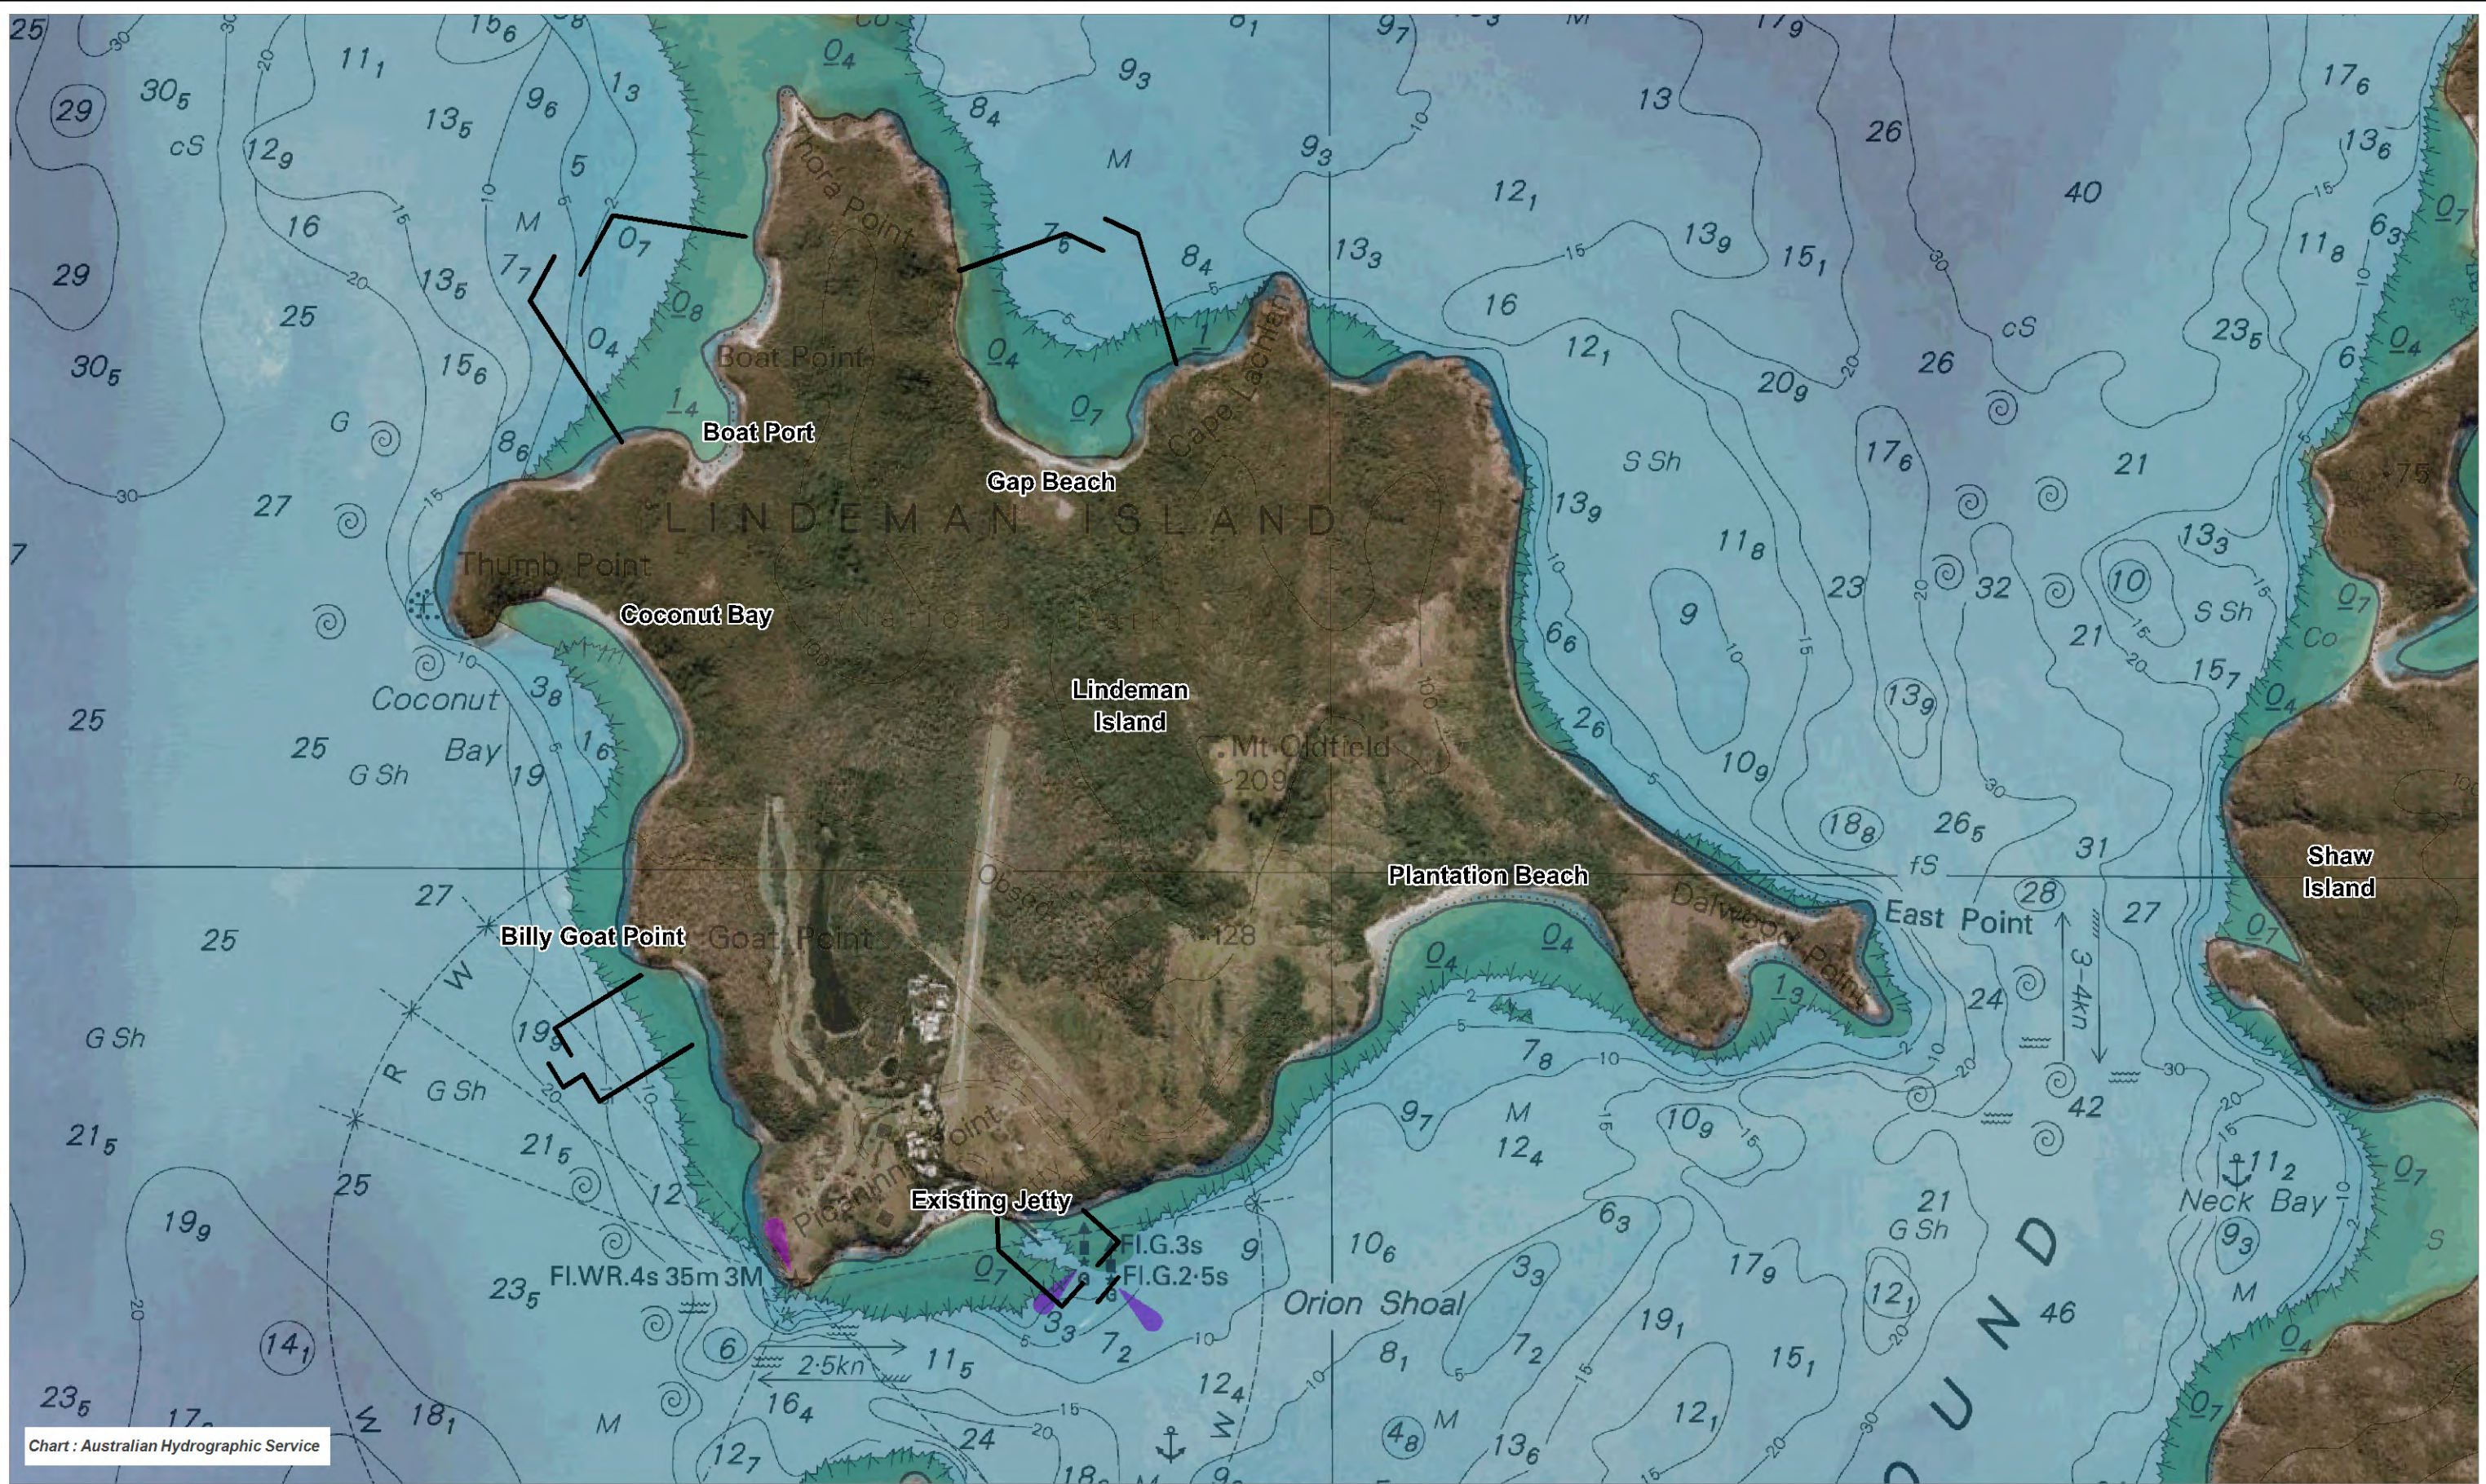
Figure:  
**1-1**

**Title:**  
**Lindeman Island Locality Plan and Study Locations**

BMT WBM (2013) modelled ambient winds at gale forces (40 knot from 8 major directions) and 3 cyclones (approx. 1:100 ARI) with outputs at each of the potential safe harbour locations shown in Figure 1-1. Existing data (storm tide levels, bathymetry, winds and waves) were used to set up models to determine wave climates at each location. Marina designs considered the height of breakwaters to resist cyclonic conditions, given macro-tidal conditions environment and significant storm surge. The ability to provide safe passage in storm conditions was also considered. Some designs provided berths for larger vessels (in the order of 50m length, which require around 4.2m of clear water depth). The volume of rock required to build marina infrastructure above and below - 5 m LAT contours, and the volume of dredging required for these berths and access channels and fairways, were also calculated. Preliminary estimates of breakwater arrangements, armour size and volumes were made. A cost estimate of \$250/m<sup>3</sup> of breakwater was applied to all calculations.

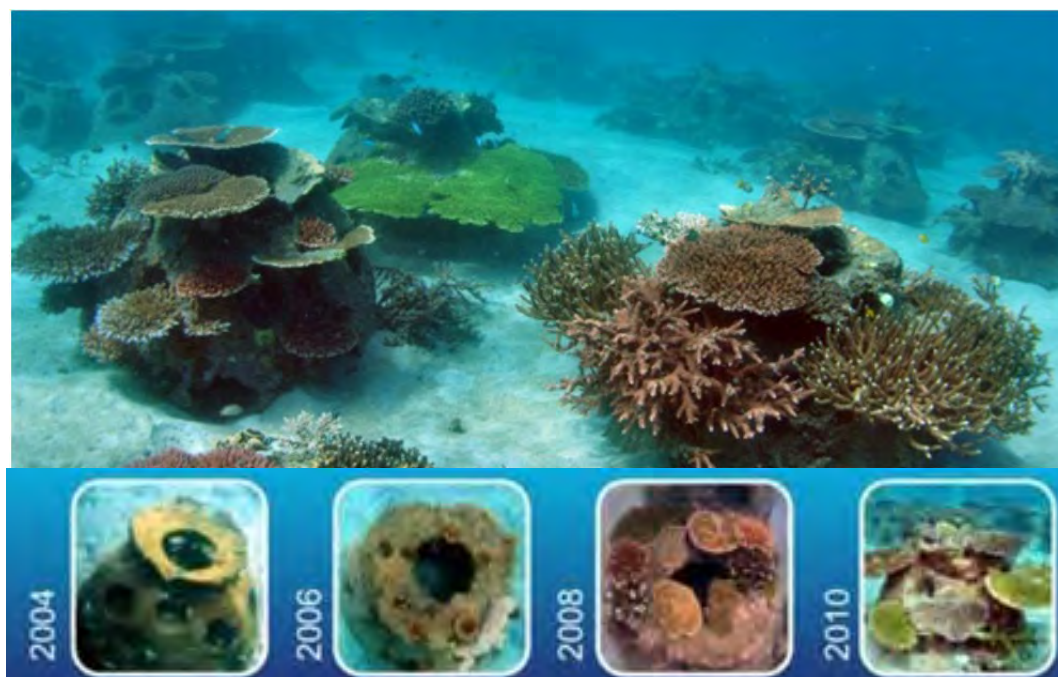
Figure 6-1 Example of “Reef Balls” used as artificial reefs

Residual impacts of habitat loss may be offset in a variety of ways, by using habitat forming construction materials, by creating new reef habitats elsewhere, and by relocating structural elements of habitat away from the intended footprint. Harbour construction materials consisting of pre-fabricated armour structures such as “x-bloc” can increase the rugosity of the seawall structure and provide additional habitat. Structures such as x-bloc and “reef balls” (Figure 6-1) can be used to form new areas of reef over adjacent bare sand habitat. Corals from the footprint area could be transplanted onto these structures, or used to increase coral cover over the surrounding reef outside of the footprint. The appropriateness of these measures as offsets will need to be discussed with GBRMPA.
