4. Topography, geology and soils

This section describes the existing environment and potential impacts related to topography, geology and soils within the proposed MLARP area. The assessment has been based on a review of available information and field investigations. This section addresses the following:

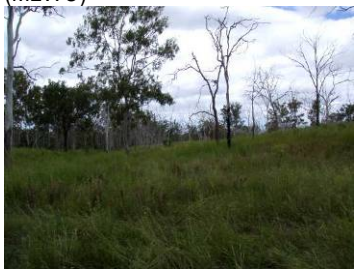
Site (Project area)	Landform pattern	Slope	Dominant vegetation
BH02/TP03 (MLWO)

Low Hills	Moderately inclined	Tallest stratum is trees (12.01 – 20 m) with a sparse crown and foliage cover class. Mid stratum are trees (1.01 – 3 m) with an isolated plants crown and foliage cover class. Ground cover is sod grass (0.51 – 1 m) with crown and foliage cover class of dense (>70%)
BH12 (MLEO)

Review of *Land Systems of the Capricornia Coast Map 3 Calliope Area* (DPI 1995) indicated the Calliope land system group (refer Table 4.1) has moderate Melonhole Gilgai as a major soil characteristic. Landform survey observations were consistent with the DPI mapping with Gilgai being observed at BH02/TP03.

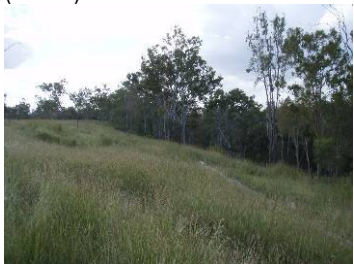
Low Hills	Very Steep	Tallest stratum is trees (12.01 – 20 m) with a sparse crown and foliage cover class. Mid stratum are trees and shrubs (1.01 – 3 m) with a very sparse crown and foliage cover class. Ground cover is tussock grass (0.51 – 1 m) with crown and foliage cover class of dense (>70%)

Review of *Land Systems of the Capricornia Coast Map 3 Calliope Area* (DPI 1995) indicated the Calliope land system group (refer Table 4.1) has moderate Melonhole Gilgai as a major soil characteristic. Landform survey observations were consistent with the DPI mapping with Gilgai being observed at BH12, TP10 and TP08.

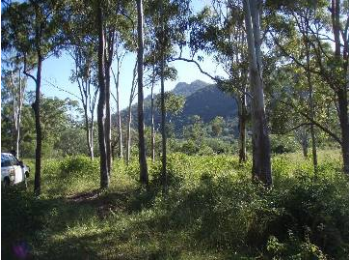
Site (Project area)	Landform pattern	Slope	Dominant vegetation
BH21 (NCL/EEMBL)

Hills	Steeply inclined	Tallest stratum is trees (12.01 – 20 m) with a sparse crown and foliage cover class. Mid stratum are trees and shrubs (3.01 – 6 m) with a sparse crown and foliage cover class. Ground cover is tussock grass (0.51 – 1 m) with crown and foliage cover class of mid dense (30-70%)
LF 01 (NCL/EEMBL)

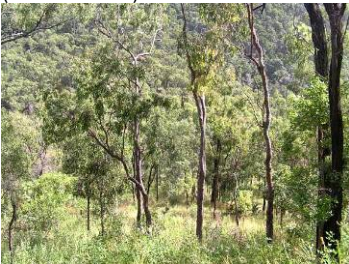
Hills	Very steeply inclined	Tallest stratum is trees (12.01 – 20 m) with a very sparse crown and foliage cover class. Mid stratum are trees and shrubs (3.01 – 6 m) with an isolated clumps crown and foliage cover class. Ground cover is tussock grass (0.26 – 0.5 m) with crown and foliage cover class of mid dense (30-70%)
TP02 (MLWO)

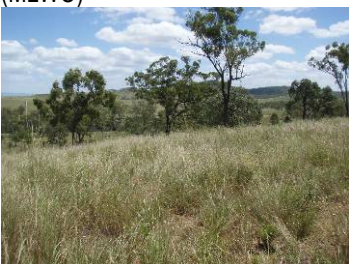
Low Hills	Moderately inclined	Tallest stratum is trees (12.01 – 20 m) with an isolated plants crown and foliage cover class. Ground cover is tussock grass (0.26 – 0.5 m) with crown and foliage cover class of dense (>70%)

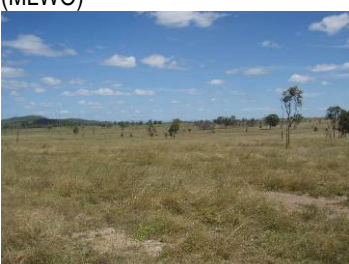
TP05 (MLWO)

Low Hills	Moderately inclined	Tallest stratum is trees (12.01 – 20 m) with an isolated plants crown and foliage cover class. Ground cover is tussock grass (0.26 – 0.5 m) with crown and foliage cover class of dense (>70%)
TP06 (MLEO)

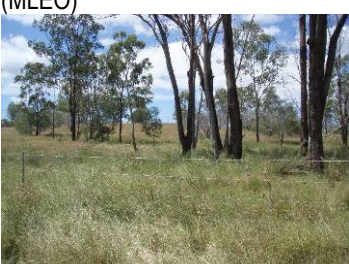
Rises	Gently inclined	Tallest stratum is trees (12.01 – 20 m) with a sparse crown and foliage cover class. Mid stratum are trees (6.01 – 12 m) with a very sparse crown and foliage cover class. Ground cover is tussock grass (0.51 – 1 m) with crown and foliage cover class of mid dense (30-70%)

Alluvium was encountered on the floodplain between the Calliope River and the Bruce Highway. Test pit TP06 was excavated at the northern end of the proposed Moura Link Eastern and Western Options and encountered alluvium to a depth of 2.50 m below surface level. The alluvium comprised yellow brown, high plasticity, silty clay with a trace of sand and gravel and some ferruginous nodules. The silty clay was observed to a varying consistency that ranged from soft to firm to a 1.00 m depth, stiff to very stiff to 1.70 m and very stiff to hard to a 2.50 m depth. The DCP results for TP06 indicated blows of 1 to 3 between depths of 0.40 m to 1.20 m. This alluvium deposit was also encountered at Larcom Creek and comprised pale brown, low plasticity, firm to stiff, gravelly clay to a 1.25 m depth.

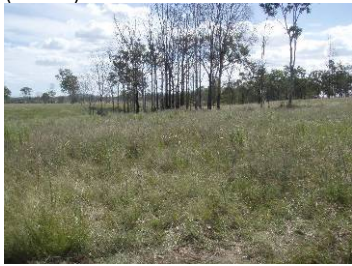
Site (Project area)	Landform pattern	Slope	Dominant vegetation
TP07 (MLEO)

Rises	Very gently inclined	Tallest stratum is trees (12.01 – 20 m) with a mid dense and sparse crown and foliage cover class. Mid stratum are trees (1.01 – 3 m) with a very sparse crown and foliage cover class. Ground cover is tussock grass (0.26 – 0.5 m) with crown and foliage cover class of mid dense (30-70%)
TP08 (MLEO)

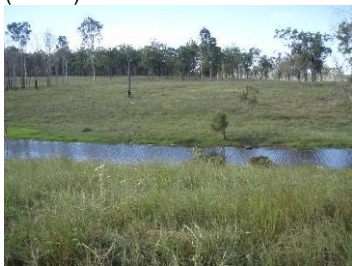
Rises	Steeply inclined	Tallest stratum is trees (12.01 – 20 m) with an isolated clumps crown and foliage cover class. Mid stratum are trees (3.01 – 6 m) with an isolated clumps crown and foliage cover class. Ground cover is tussock grass (0.51 – 1 m) with crown and foliage cover class of dense (>70%)
TP10 (LF) (MLEO)

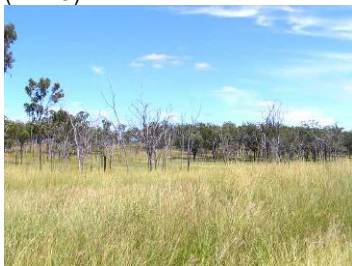
Rises	Moderately inclined	Tallest stratum is trees (12.01 – 20 m) with a sparse crown and foliage cover class. Ground cover is tussock grass (1.01 – 3 m) with crown and foliage cover class of dense (>70%)

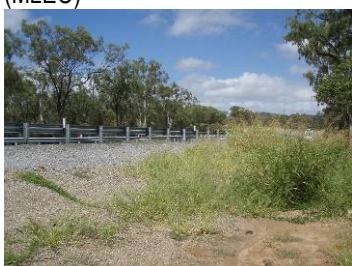
TP12 (MLEO)

Rises Made Land (road corridor)	Moderately inclined	Tallest stratum is trees (20.01 – 35 m) with a sparse crown and foliage cover class. Mid stratum are trees (3.01 – 6 m) with a very sparse crown and foliage cover class. Ground cover is tussock grass (0.51 – 1 m) with crown and foliage cover class of mid dense (30 - 70%)
TP13 (MLN)

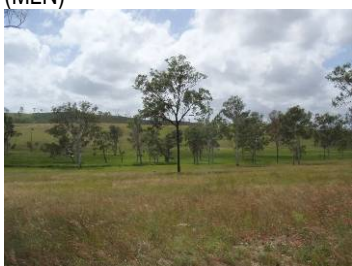
Rises	Moderately inclined	Tallest stratum is trees (12.01 – 20 m) with a very sparse crown and foliage cover class. Mid stratum are trees (3.01 – 6 m) with an isolated clumps crown and foliage cover class. Ground cover is tussock grass (0.26 – 0.5 m) with crown and foliage cover class of dense (>70%)

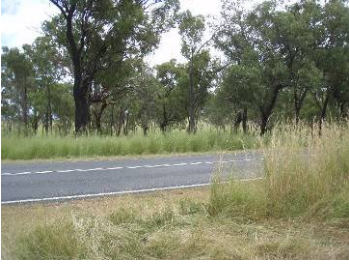
Site (Project area)	Landform pattern	Slope	Dominant vegetation
TP14 (MLN)

Rises Made Land (road corridor)	Gently inclined	Tallest stratum is trees (12.01 – 20 m) with a sparse crown and foliage cover class. Mid stratum are trees (1.01 – 3 m) with a very sparse crown and foliage cover class. Ground cover is tussock grass (0.51 – 1 m) with crown and foliage cover class of dense (>70%)
TP16 (NCL/EEMBL)

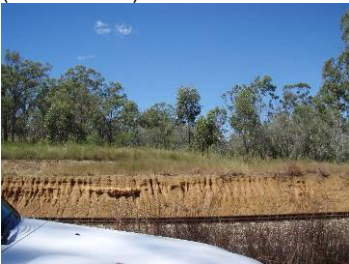
Low Hills Made Land (rail corridor)	Moderately inclined	Tallest stratum is trees (12.01 – 20 m) with a very sparse crown and foliage cover class. Mid stratum are trees (3.01 – 6 m) with an isolated clumps crown and foliage cover class. Ground cover is tussock grass (0.26 – 0.5 m) with crown and foliage cover class of dense (>70%)
TP17 (MLN)

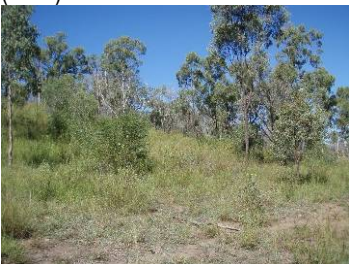
Low Hills Made Land (road corridor)	Moderately inclined	Tallest stratum is trees (12.01 – 20 m) with a sparse crown and foliage cover class. Mid stratum are trees (1.01 – 3 m) with an isolated plants and foliage cover class. Ground cover is tussock grass (0.26 – 0.5 m) with crown and foliage cover class of dense (>70%)

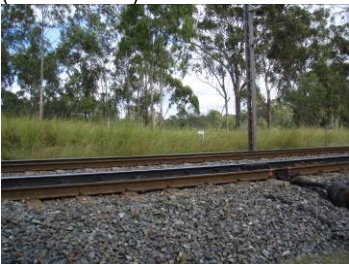
TP22 (MLN) (NCL/EEMBL)

Rises Made Land (rail corridor)	Gently inclined	Tallest stratum is trees (>35.01 m) with a mid dense crown and foliage cover class. Mid stratum are trees (3.01 – 6 m) with a sparse crown and foliage cover class. Ground cover is tussock grass (1.01 – 3 m) with crown and foliage cover class of dense (>70%)
TP23 (ARY) (NCL/EEMBL)

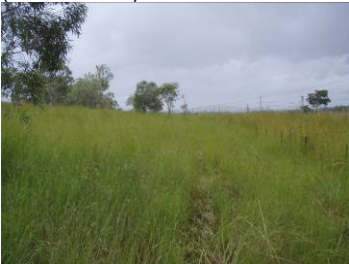
Rises Made Land (rail corridor)	Moderately inclined	Tallest stratum is trees (12.01 – 20 m) with a sparse crown and foliage cover class. Mid stratum are trees (3.01 – 6 m) with a sparse crown and foliage cover class. Ground cover is tussock grass (0.26 – 0.5 m) with crown and foliage cover class of dense (>70%)

Gilgai were observed around the Larcom Creek floodplain around TP28, TP29 and TP30, and at TP23 and 25.

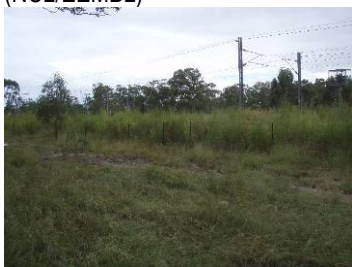
Site (Project area)	Landform pattern	Slope	Dominant vegetation
TP24 (ARY) (NCL/EEMBL)

Rises Made Land (rail corridor)	Moderately inclined	Tallest stratum is trees (12.01 – 20 m) with a sparse crown and foliage cover class. Mid stratum are trees (1.01 – 3 m) with a sparse crown and foliage cover class. Ground cover is tussock grass (0.26 – 0.5 m) with crown and foliage cover class of dense (>70%)
TP25 (ARY) (NCL/EEMBL)

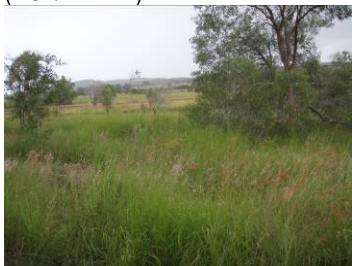
Rises	Moderately inclined	Tallest stratum is trees (12.01 – 20 m) with a sparse crown and foliage cover class. Mid stratum are trees (1.01 – 3 m) with a sparse crown and foliage cover class. Ground cover is tussock grass (0.51 – 1 m) with crown and foliage cover class of dense (>70%)
TP27 (ARY) (NCL/EEMBL)

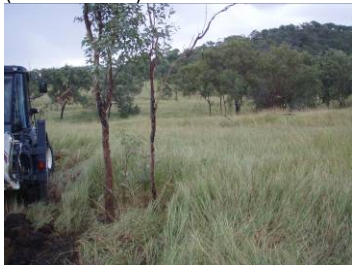
Low Hills	Gently inclined	Tallest stratum is trees (12.01 – 20 m) with a very sparse crown and foliage cover class. Mid stratum are trees (1.01 – 3 m) with a very sparse crown and foliage cover class. Ground cover is tussock grass (0.51 – 1 m) with crown and foliage cover class of dense (>70%)

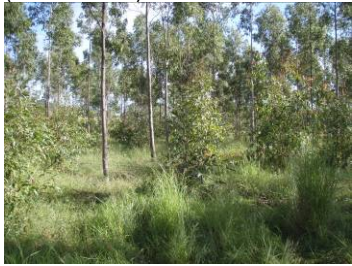
TP28 (ARY) (NCL/EEMBL)

Rises	Gently inclined	Tallest stratum is trees (6.01 – 12 m) with a mid dense crown and foliage cover class. Mid stratum are trees (1.01 – 3 m) with a very sparse crown and foliage cover class. Ground cover is sod grass (1.01 – 3 m) with crown and foliage cover class of mid dense (30-70%)
TP29 (ARY) (NCL/EEMBL)

Microrelief refers to relief up to a few metres about the plane of the land surface. Gilgai is surface microrelief associated with soils containing shrink-swell clays. Gilgai consists of mounds and depressions showing varying degrees of order. (McDonald *et al* 1990). Gilgai were observed around the Larcom Creek floodplain around TP28, TP29 and TP30.

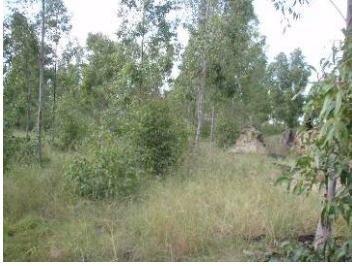
Stagnant Alluvial Plain	Gently inclined	Tallest stratum is trees (6.01 – 12 m) with a mid dense crown and foliage cover class. Mid stratum are trees (1.01 – 3 m) with a very sparse crown and foliage cover class. Ground cover is sod grass (1.01 – 3 m) with crown and foliage cover class of mid dense (30-70%)

TP29	Endohypersodic, Massive Black Vertosol	<p>Clay soils with shrink-swell properties that exhibit strong cracking when dry and at depth have slickensides and/or lenticular structural aggregates. May have gilgai microrelief.</p> <ul style="list-style-type: none"> A clay field texture or 35% or more clay throughout the solum except for thin, surface crusty horizons 0.03 m or less thick When dry, open cracks occur at some time in most years. These are at least 0.005 m wide and extend upward to the surface or to the base of any plough layer, self-mulching horizon, or thin, surface crusty horizon Slickensides and/or lenticular peds occur at some depth in the solum <p>A subhorizon of the solum below 0.5 m has an Exchangeable Sodium Percentage (ESP) of 15% or greater and has a massive or weak blocky (usually > 0.05 m peds) A horizon, and there is no surface crusty horizon with the dominant colour class being black.</p>

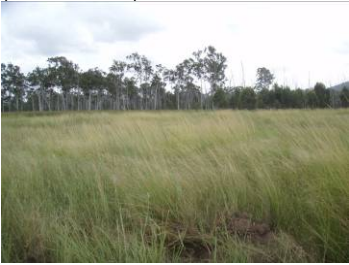
Site (Project area)	Landform pattern	Slope	Dominant vegetation
TP30 (ARY) (NCL/EEMBL)

Stagnant Alluvial Plain Made Land (rail and road corridor)	Gently inclined	Tallest stratum is trees (6.01 – 12 m) with an isolated plants crown and foliage cover class. Ground cover is sod grass (1.01 – 3 m) with crown and foliage cover class of dense (>70%)
TP31 (ARY) (NCL/EEMBL)

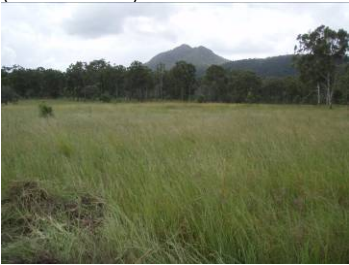
Alluvial Plain	Very gently inclined	Tallest stratum is trees (12.01 – 20 m) with an isolated clumps crown and foliage cover class. Mid stratum are trees (3.01 – 6 m) with a very sparse crown and foliage cover class. Ground cover is tussock grass (0.51 – 1 m) with crown and foliage cover class of dense (>70%)
TP32 (ARY) (NCL/EEMBL)

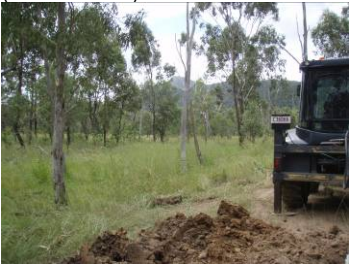
Mountains Made Land (rail and road corridor)	Very gently to moderately inclined	Tallest stratum is trees (12.01 – 20 m) with a mid dense crown and foliage cover class. Mid stratum are trees (1.01 – 3 m) with a very sparse crown and foliage cover class. Ground cover is tussock grass (0.51 – 1 m) with crown and foliage cover class of mid dense (30-70%)

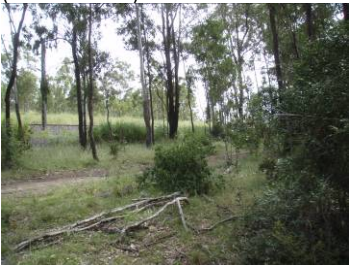
TP33 (ARY) (NCL/EEMBL)

Mountains Made Land (rail corridor)	Level to steeply inclined	Tallest stratum is trees (12.01 – 20 m) with a mid dense crown and foliage cover class. Mid stratum are trees (1.01 – 3 m) with a sparse crown and foliage cover class. Ground cover is tussock grass (0.51 – 1 m) with crown and foliage cover class of mid dense (30-70%)
TP34 (NCL/EEMBL)	Rises Made Land (road corridor)	Moderately inclined	Tallest stratum is trees (12.01 – 20 m) with an isolated clumps crown and foliage cover class. Mid stratum are trees (3.01 – 6 m) with an isolated clumps crown and foliage cover class. Ground cover is tussock grass (0.51 – 1 m) with crown and foliage cover class of mid dense (30-70%)

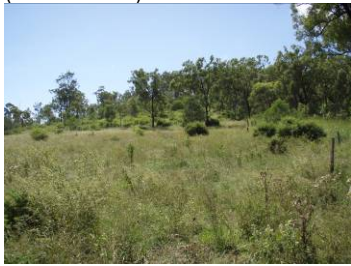
Site (Project area)	Landform pattern	Slope	Dominant vegetation
TP35 (NCL/EEMBL)

Rises	Moderately inclined	Tallest stratum is trees (12.01 – 20 m) with a sparse crown and foliage cover class. Mid stratum are trees (3.01 – 6 m) with a very sparse crown and foliage cover class. Ground cover is tussock grass (0.51 – 1 m) with crown and foliage cover class of mid dense (30-70%) and lantana (1.01 – 3 m) with crown and foliage cover class of sparse (10-30%)
TP36 (NCL/EEMBL)

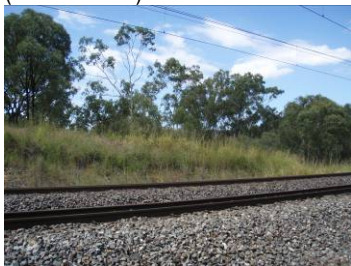
Low Hills Made Land (rail corridor)	Moderately inclined	Tallest stratum is trees (12.01 – 20 m) with a sparse crown and foliage cover class. Mid stratum are trees (3.01 – 6 m) with a very sparse crown and foliage cover class. Ground cover is tussock grass (0.51 – 1 m) with crown and foliage cover class of mid dense (>70%)
TP37 (NCL/EEMBL)

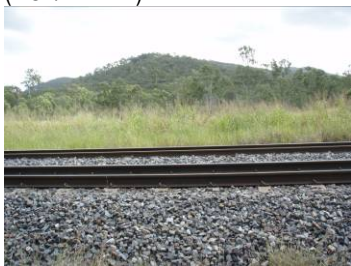
Low Hills Made Land (rail corridor)	Very steeply inclined	Tallest stratum is trees (12.01 – 20 m) with a mid dense crown and foliage cover class. Mid stratum are trees (6.01 – 12 m) with a sparse crown and foliage cover class. Ground cover is tussock grass (1.01 – 3 m) with crown and foliage cover class of mid dense (>70%)

During excavation for the soil sampling the material being extracted were inspected for any signs of ASS material (ie sulphur smell or jarosite). At TP37 a sulphur smell was noted in the underling layers and two samples were collected for pH field and pH field oxidised testing. The result obtained from this analysis did not meet the characteristics of an ASS and were not submitted for further ASS testing.

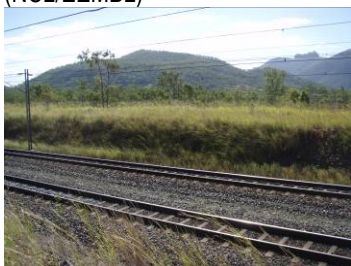
TP38 (NCL/EEMBL)

Rises Made Land (rail corridor)	Moderately inclined	Tallest stratum is trees (12.01 – 20 m) with a very sparse crown and foliage cover class. Mid stratum are trees (3.01 – 6 m) with an isolated plants crown and foliage cover class. Ground cover is tussock grass (0.51 – 1 m) with a crown and foliage cover class of dense (>70%)
TP39 (NCL/EEMBL)

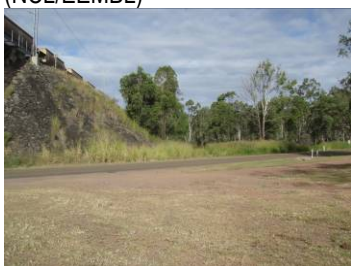
Rises Made Land (rail bridge and embankment)	Gently to Very Steeply inclined	Tallest stratum is trees (12.01 – 20 m) with a very sparse crown and foliage cover class. Mid stratum are trees (3.01 – 6 m) with an isolated plants crown and foliage cover class. Ground cover is tussock grass (0.51 – 1 m) with crown and foliage cover class of mid dense (30-70%) and sod grass (<0.25 m) with a crown and foliage cover class of dense (>70%)

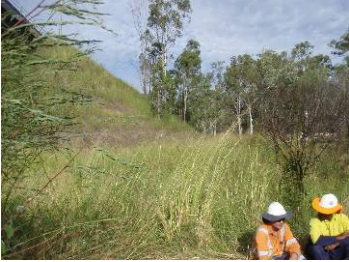
Site (Project area)	Landform pattern	Slope	Dominant vegetation
TP40 (NCL/EEMBL)

Rises Made Land (rail bridge and embankment)	Gently inclined	Tallest stratum is trees (12.01 – 20 m) with an isolated clumps crown and foliage cover class. Mid stratum are trees (1.01 – 3 m) with an isolated clumps crown and foliage cover class. Ground cover is tussock grass (0.51 – 1 m) with crown and foliage cover class of mid dense (30-70%)

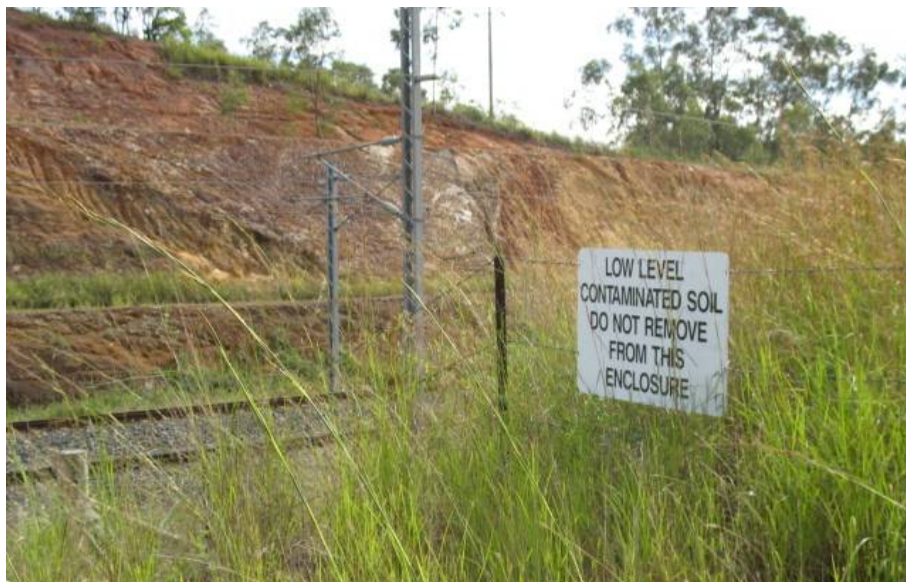
Along the NCL, on Lot 72 on SP122249 which is located to the north of Lot 356 on FTY1160, a stockpile of soil, with a sign “Low Level Contaminated Soil Do Not Remove from this Enclosure”, was noted. Information supplied by QR relating to this soil is contained in the Interviews Section below.

Photo 4.1 Contaminated soil at eastern end of NCL section
