# Redevelopment of Land at Caboolture: Aquatic Ecology Investigations for the Proposed Northeast Business Park

**The Ecology Lab** Pty Ltd

Report Number – 44/0405B

Report Status – Main Report Version 5, Final, 27/11/2007

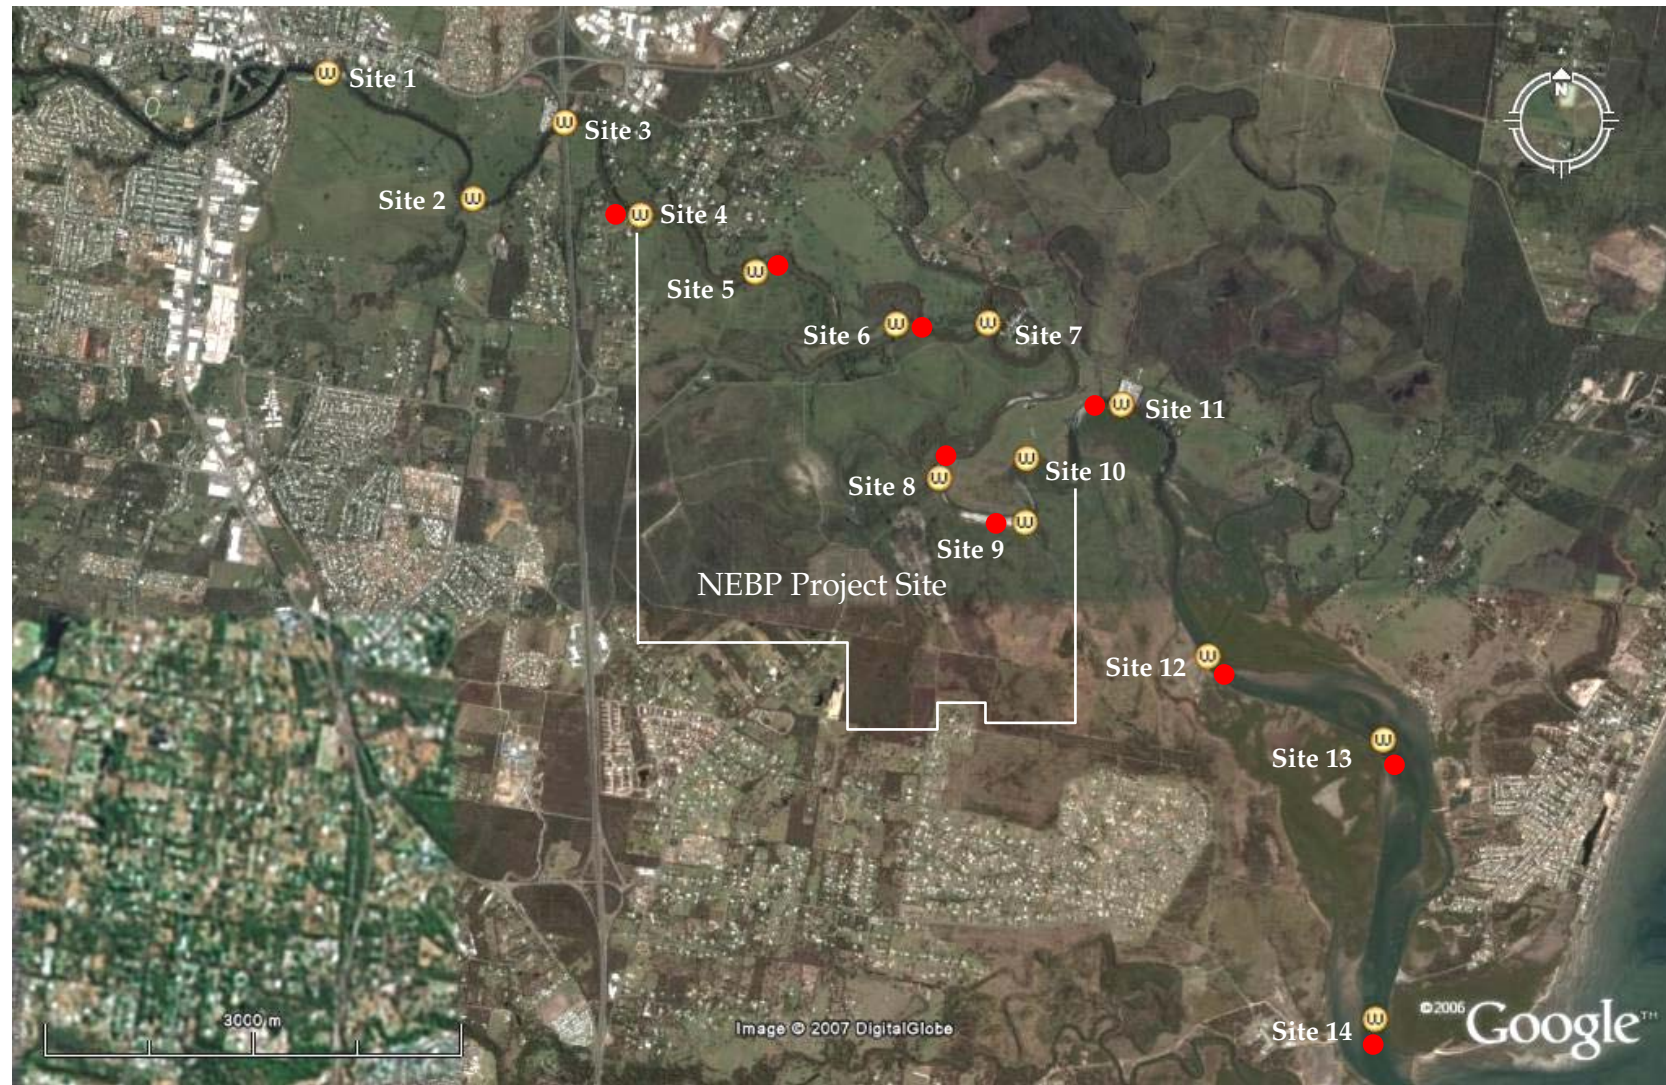
**Figure 3.** Location of water quality sites 1 – 14 (Yellow dots) sampled in December 2005 and in January, April and August 2006. Red dots indicate sites where benthos and sediment were also sampled in April 2006. White lines indicate site boundary.

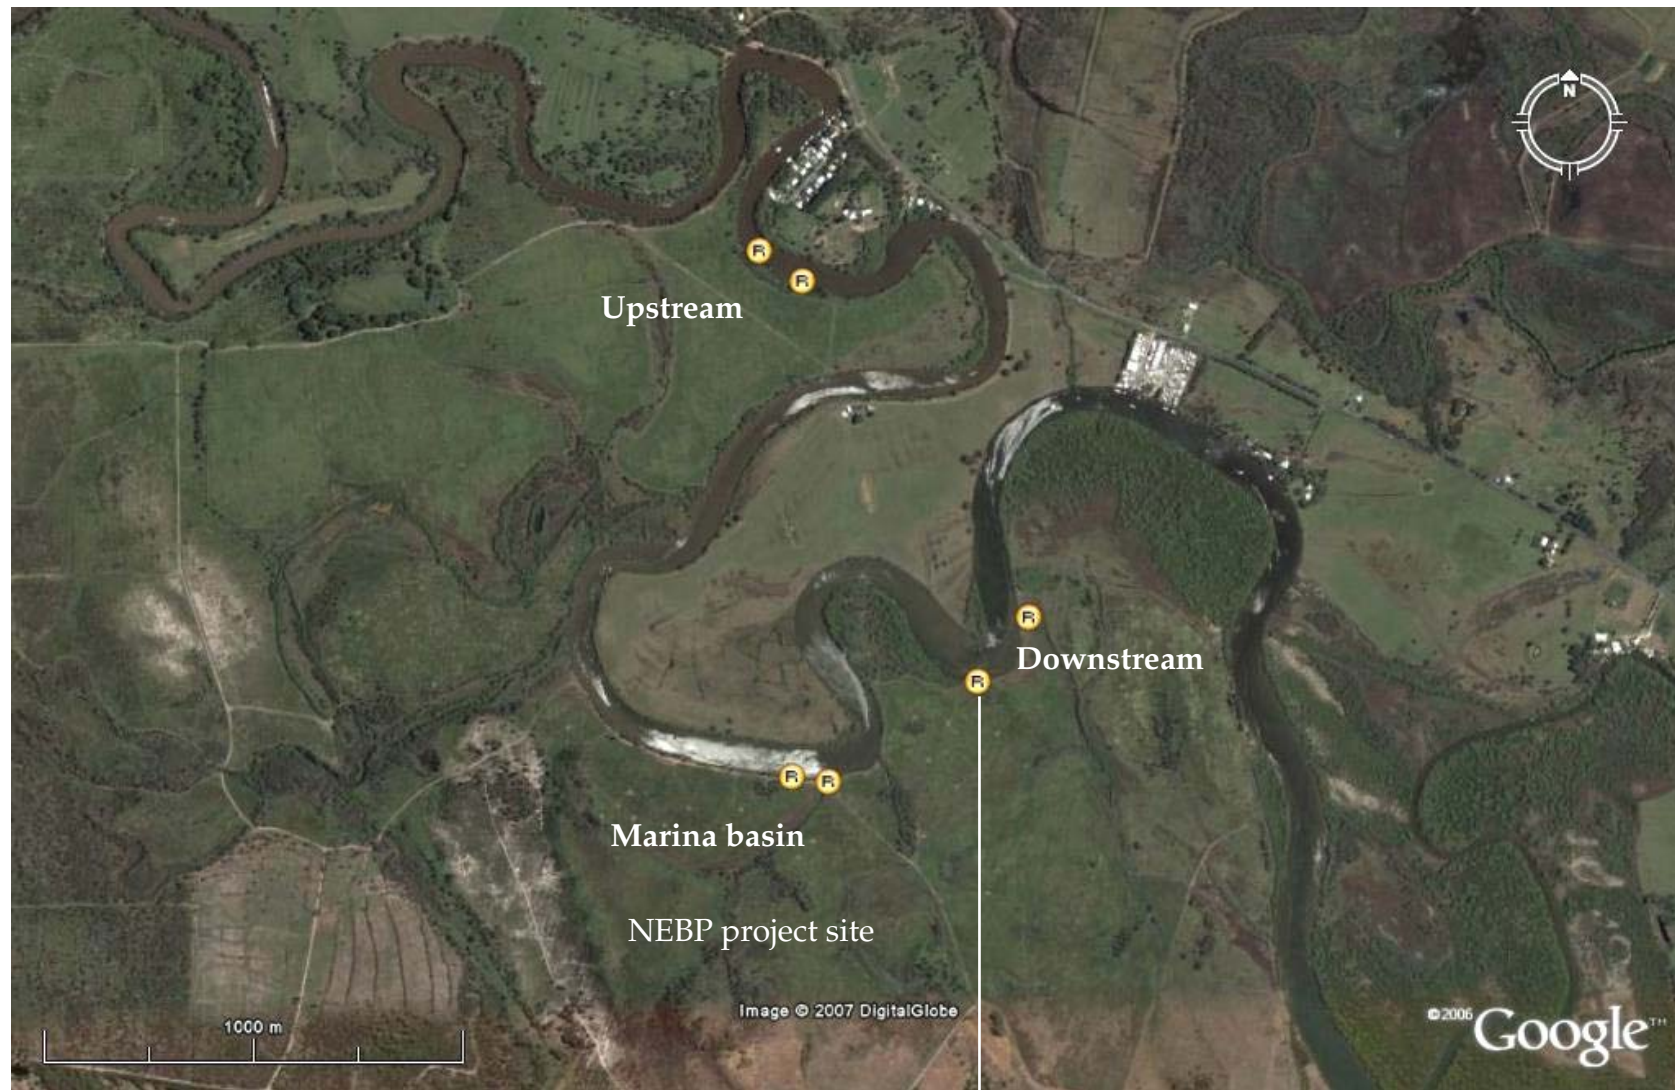
**Figure 5.** Location of Riverbank benthos sampling sites (August 2006).

**Table 25.** Mean and standard error (SE;  $n = 4$ ) for samples of benthic invertebrates collected in the intertidal zone of bank locations along the Caboolture River, April 2006. See Figure 5 for site positions.

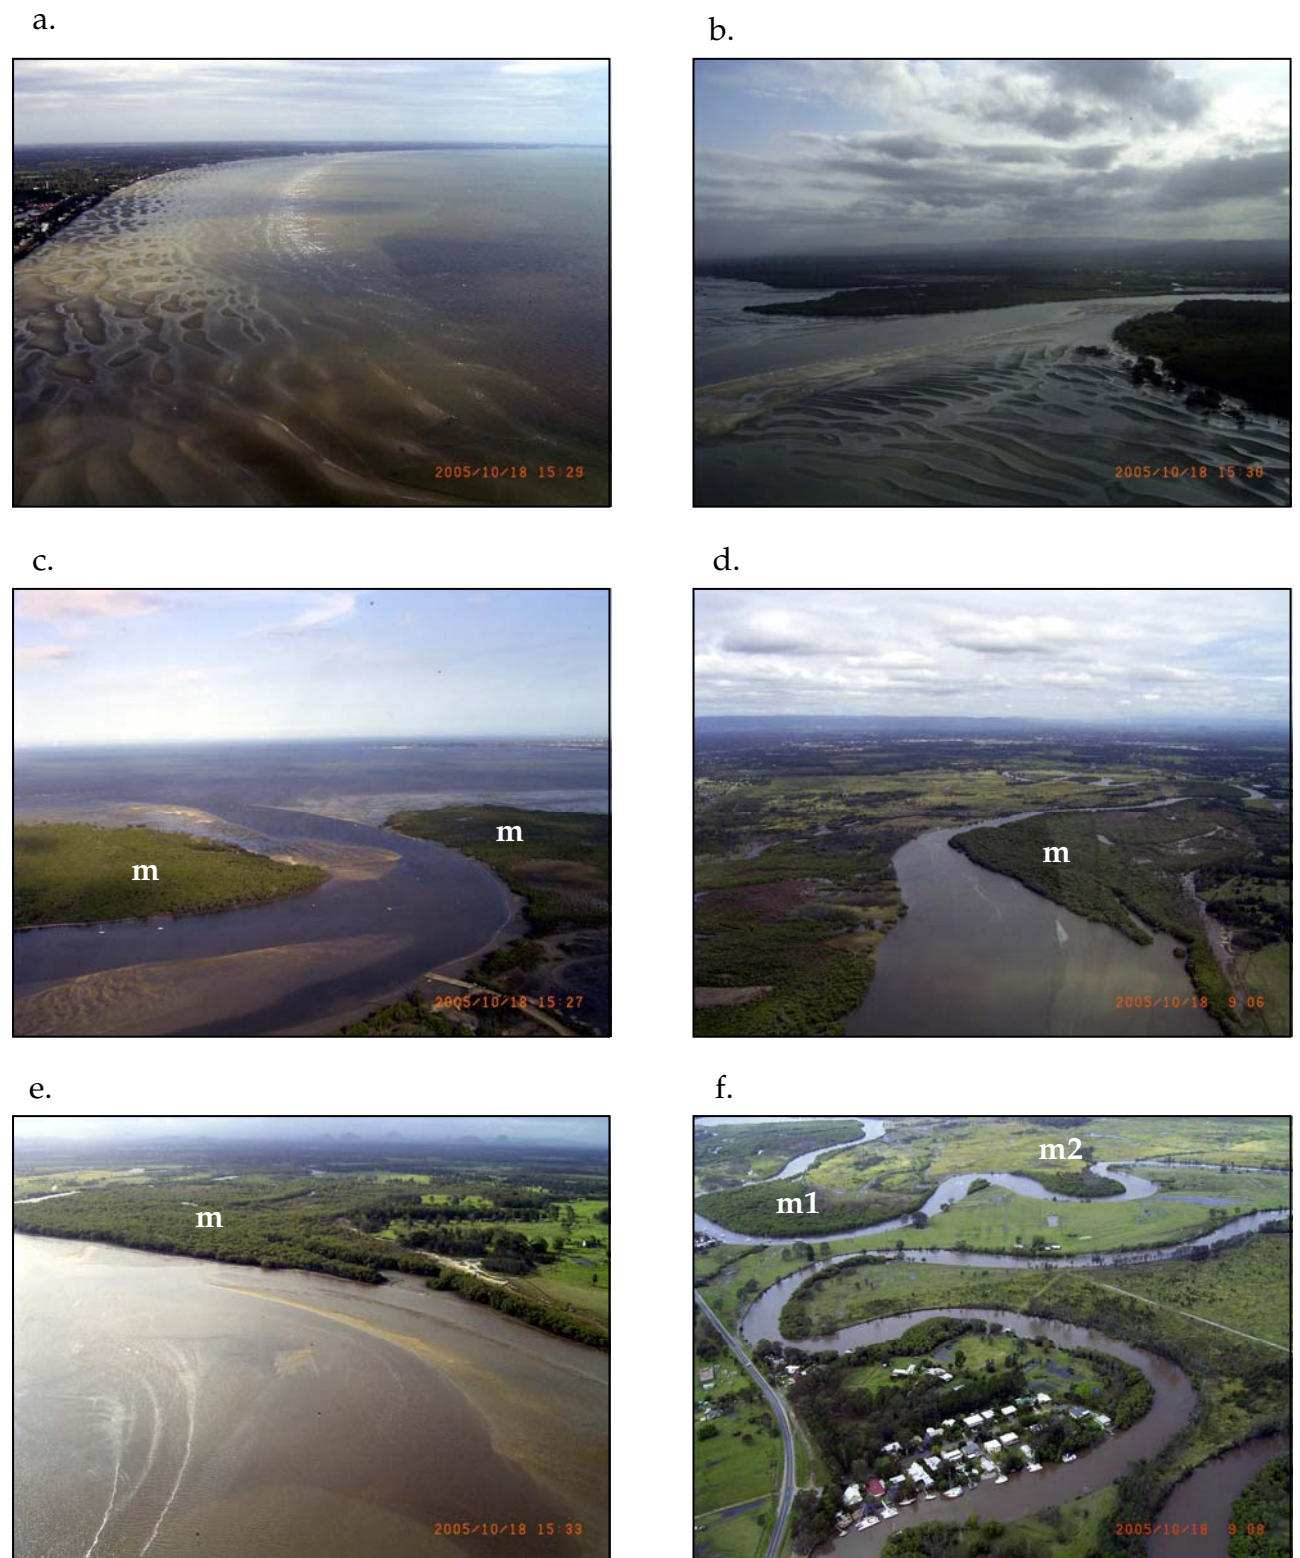
**Plate 1.** Aerial photographs of key features of the Caboolture River: a) tidal flats on Deception Bay north of Caboolture R.; b) entrance to Caboolture R. looking upstream; c) entrance to Caboolture R. looking towards Deception Bay – note well defined tidal flats; d) large stands of mangroves (m) just upstream of river entrance; e) mud/sand flat adjacent to river channel and mangroves; f) mangroves in middle reach of river (m1 & m2) – m2 is within buffer area on NEBP property.

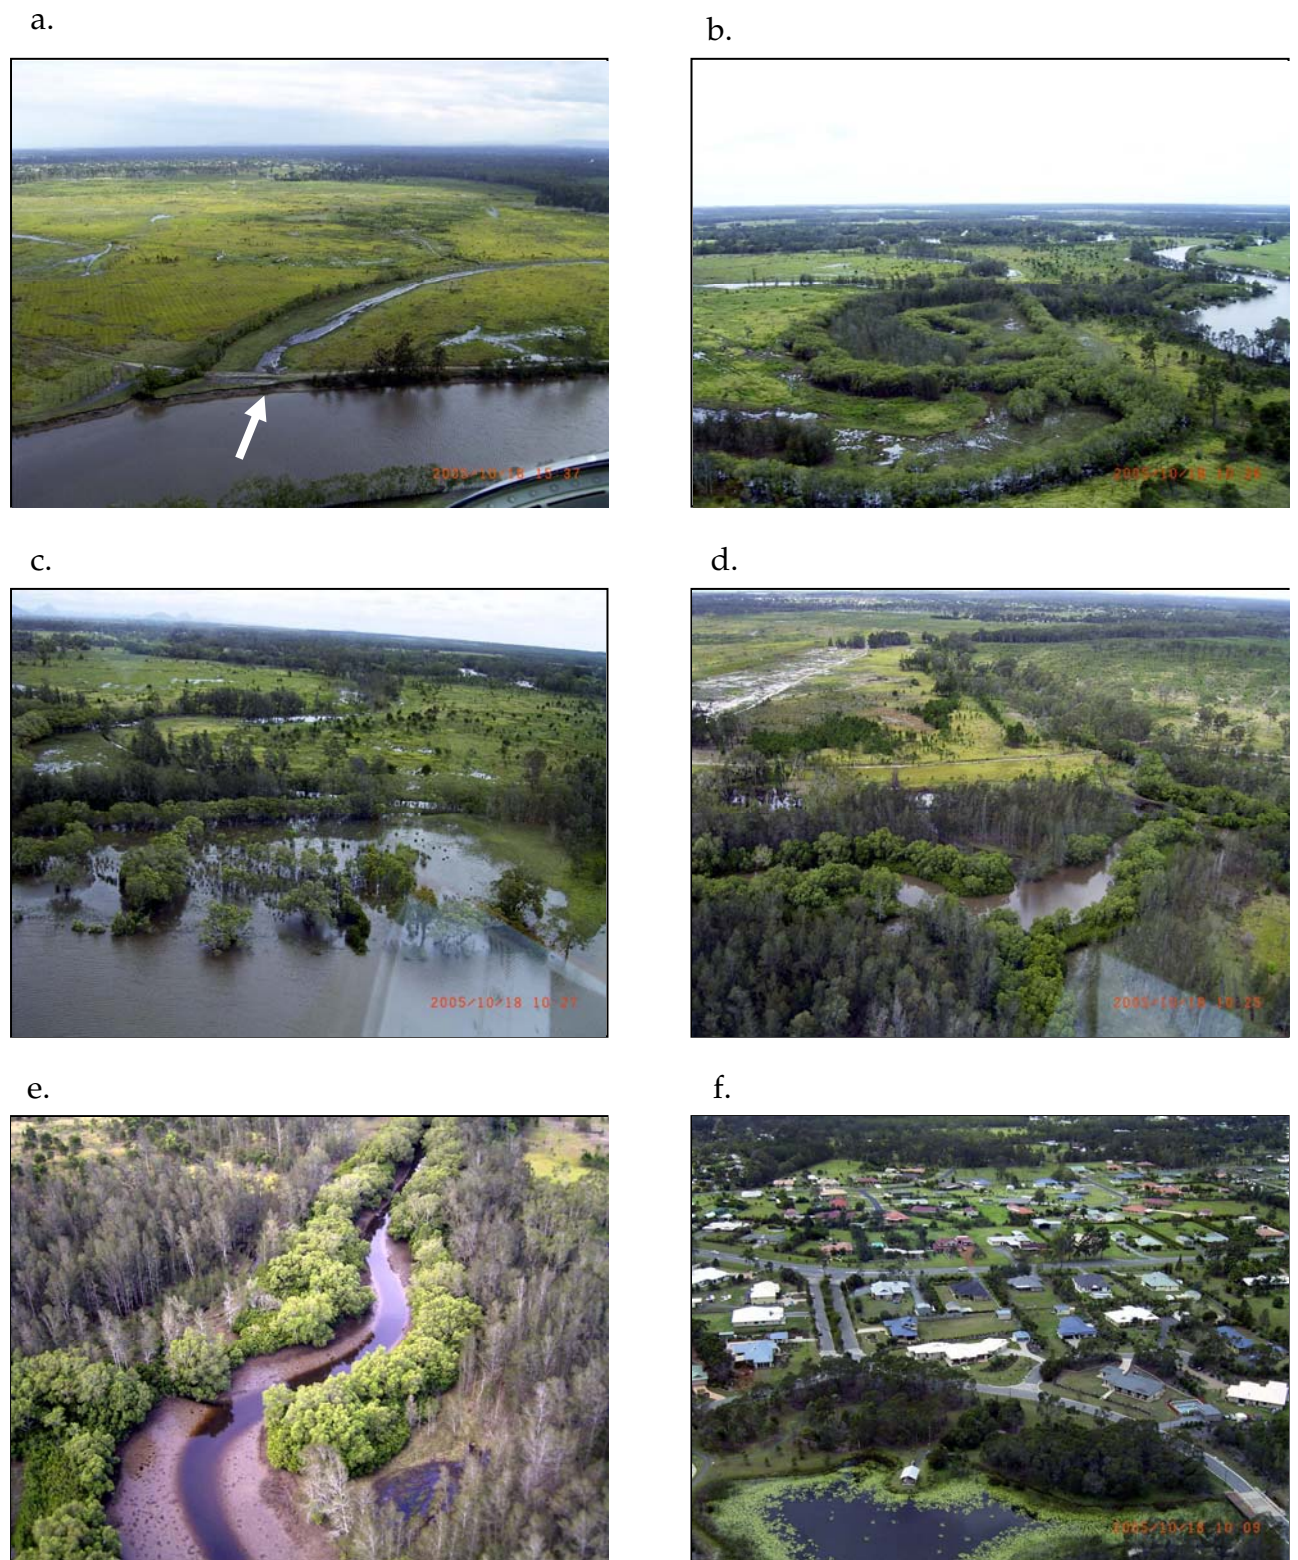
**Plate 2.** Aerial photographs of key features of the NEBP and surrounds: a) proposed entrance to the marina (arrow); b) large wetland at western end of NEBP; c) large wetland within NEBP inundated at spring high tide; d) Raff Creek within NEBP at high tide; e) Raff Creek at low tide; f) artificial freshwater pond upstream of NEBP and upstream of tidal influence. NOTE: saltmarsh and mangrove wetlands shown within NEBP in plates b-e occur within proposed buffer areas on NEBP property.

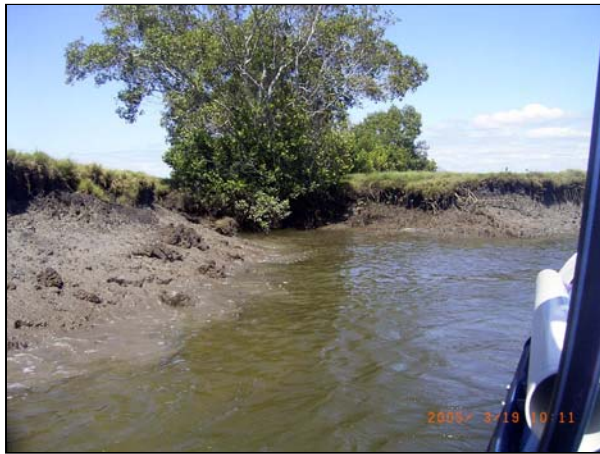
a.

**Plate 3.** Photographs of key features of the aquatic habitats of the NEBP property: a) entrance from the Caboolture River to small tidal channel at eastern end of property (adjacent to proposed marina entrance); b) mangroves along tidal channel in (a); c) stony culvert across tidal channel, looking “upstream”; d) entrance to Raff Creek from Caboolture River; e) further upstream in Raff Creek, showing muddy banks; f) saltmarshes with mangroves in the background. All wetlands, except (a) & (b) within proposed buffer areas.

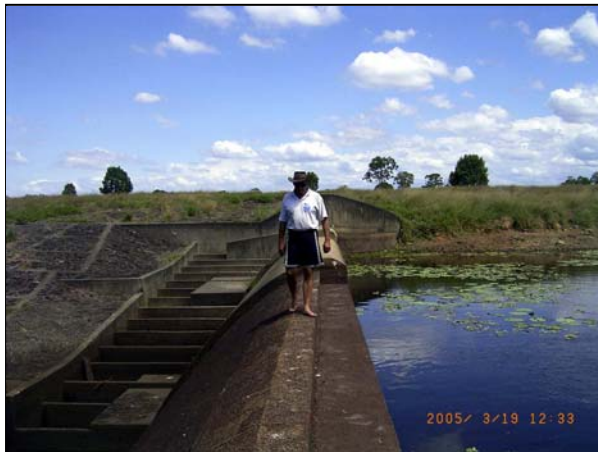
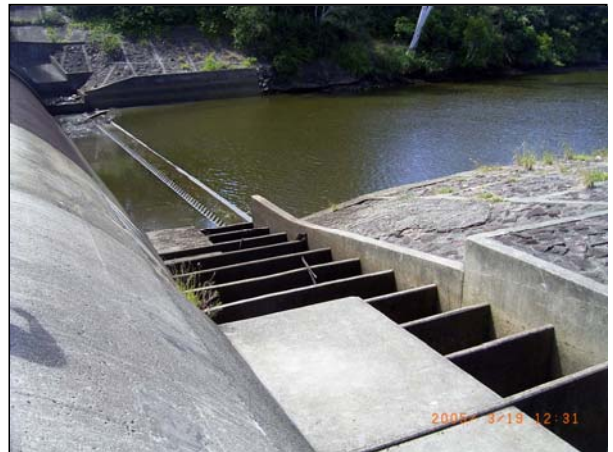
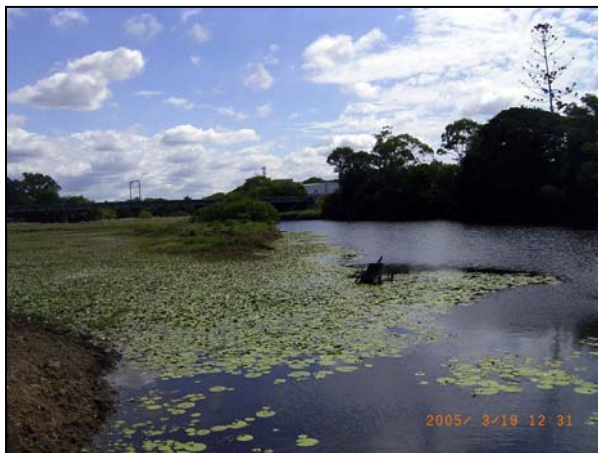
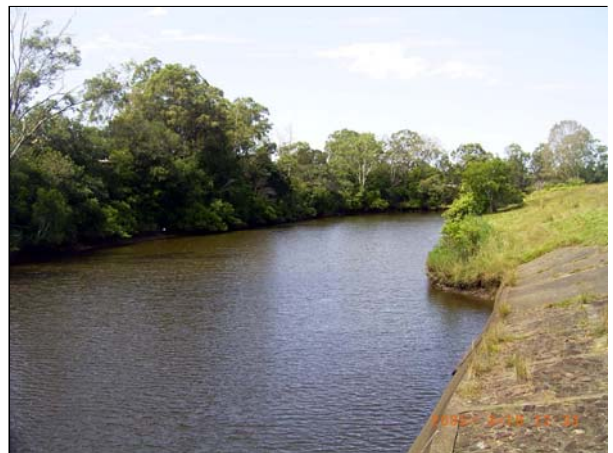
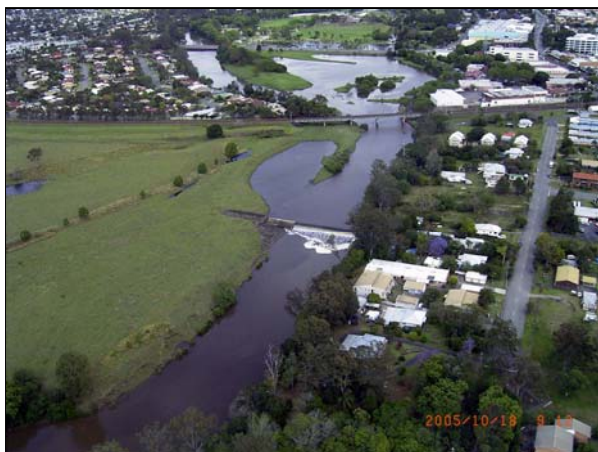
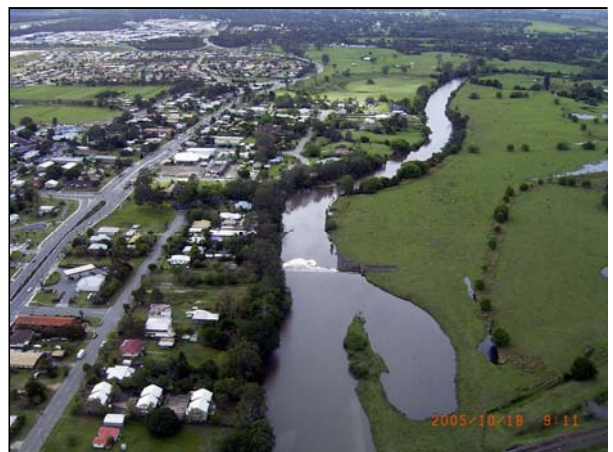
**Plate 4.** Photographs of Caboolture Weir (upstream of NEBP property): a) weir spillway - upstream to the right of plate; b) fishway on downstream, southern side of weir; c) upstream of weir under dry conditions – note extensive macrophytes; d) downstream of weir under dry conditions – no large beds of macrophytes present; e) overtopping of the weir - upstream view - no macrophytes evident; f) overtopping of weir – downstream view.

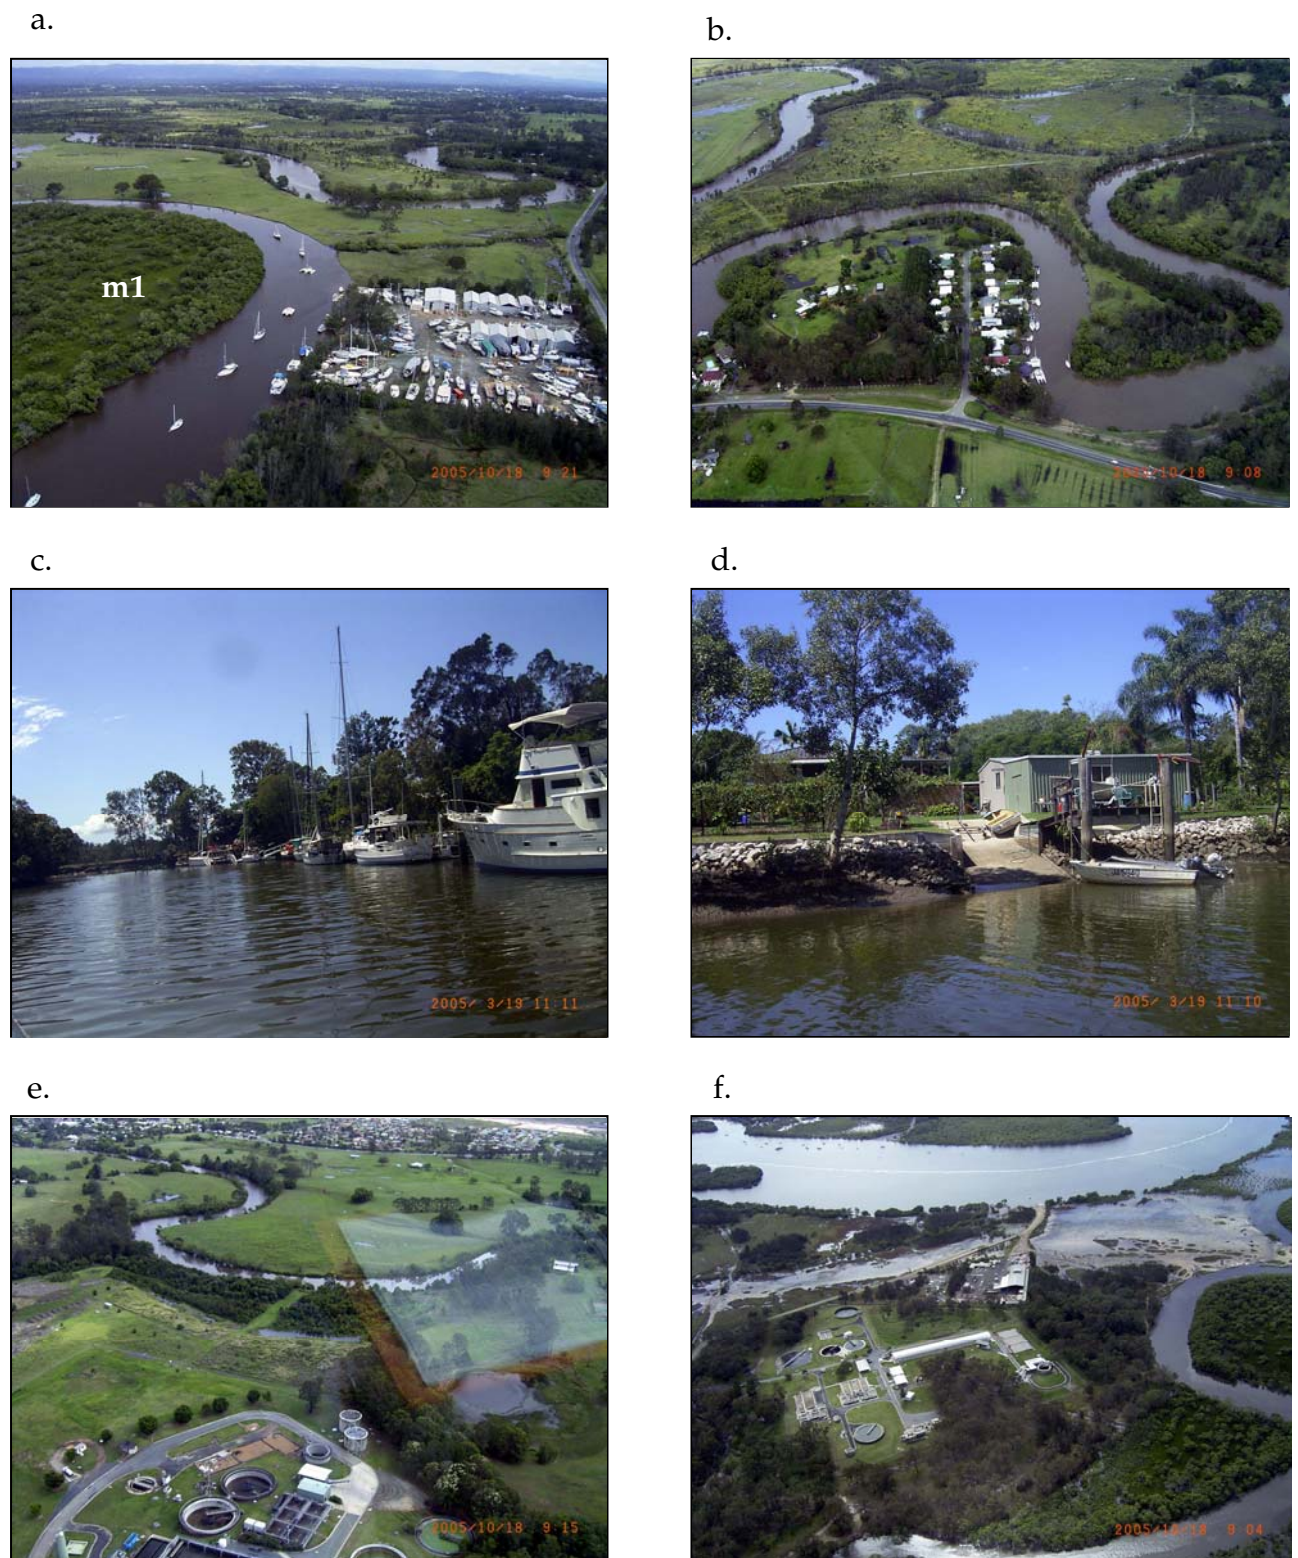
**Plate 5.** Photographs of existing infrastructure, Caboolture River): a) commercial marina and slipway downstream of NEBP property, with large stand of mangroves (m1) previously shown in Plate 1f; b) waterfront properties and private berths adjacent to Beachmere Rd and opposite NEBP property; c) water view of same area as shown in (b); d) private boat ramp, mooring piles and erosion control works; e) Caboolture Waste Water Treatment Plant (WWTP) with Caboolture R. in background; f) Burpengary WWTP between Caboolture R. (upper) and Burpengary Ck.

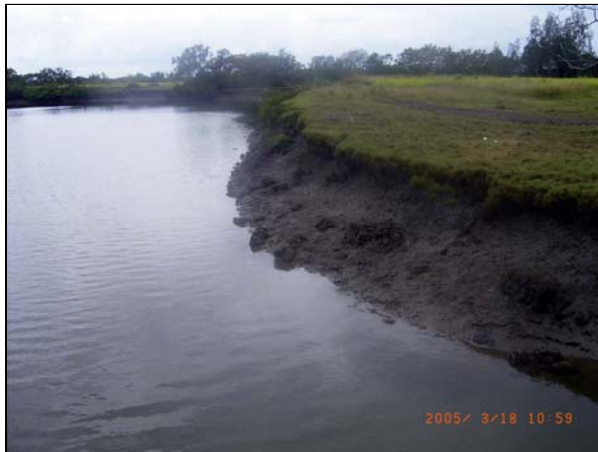
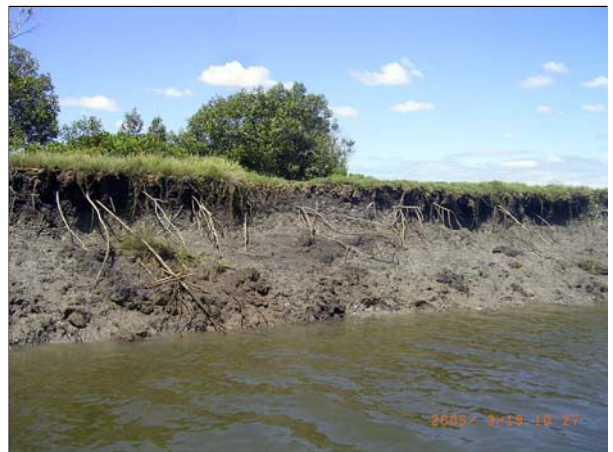
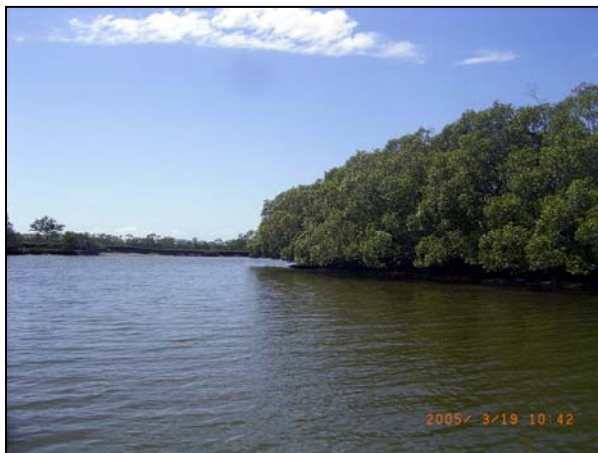
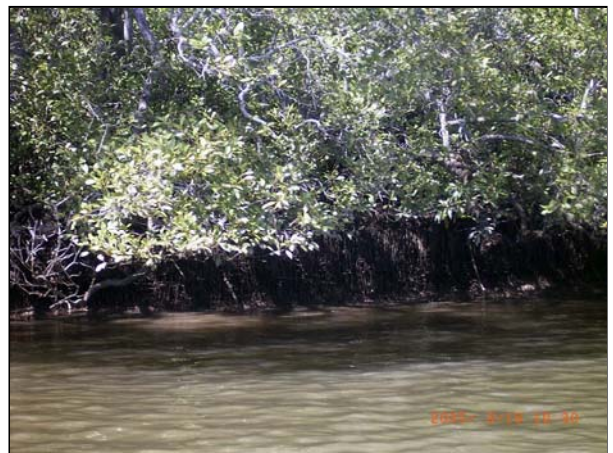
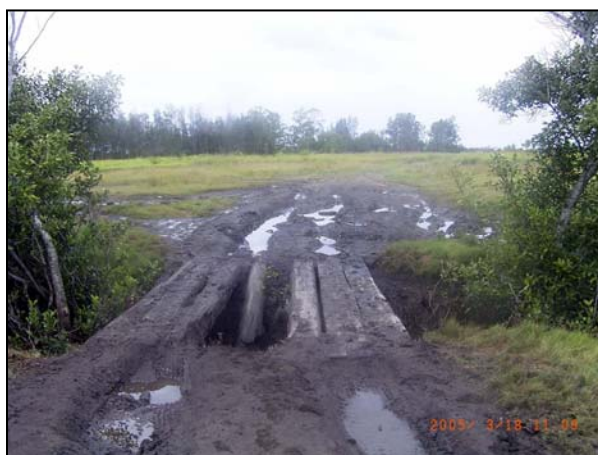
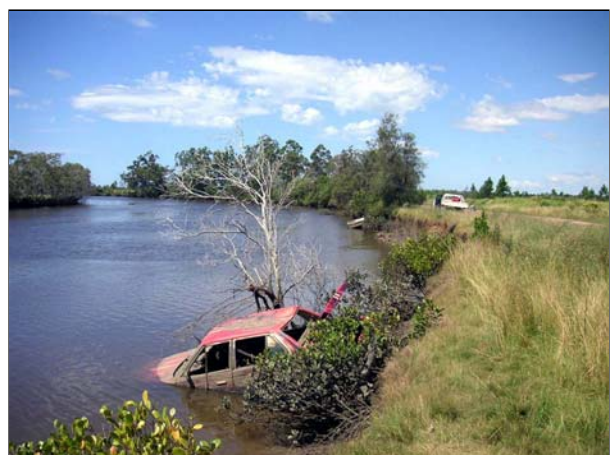
**Plate 6.** Erosion issues, Caboolture River: a & b) bare river banks with erosion evident in intertidal zone; c) mature mangroves overhanging river; d) pneumatophores (peg roots) of mangroves stabilising the shoreline; e) onsite erosion from unauthorised vehicles; f) car dumped in the Caboolture River on project site upstream of entrance to proposed marina basin.

The left bank of the river was found to be more eroded than the right; this was attributed to greater land use for grazing and to shoreline development. Areas with mangroves tended to be well-armoured, with much less erosion than more exposed banks. Cardno (2007e) prioritised erosion pressures in terms of decreasing order as follows:
