CHAPTER 8

Terrestrial Ecology

This chapter assesses the impact of the Six Mile Creek Dam upgrade project on terrestrial ecology in and around the Project area.

Six Mile Creek Dam Safety Upgrade Project

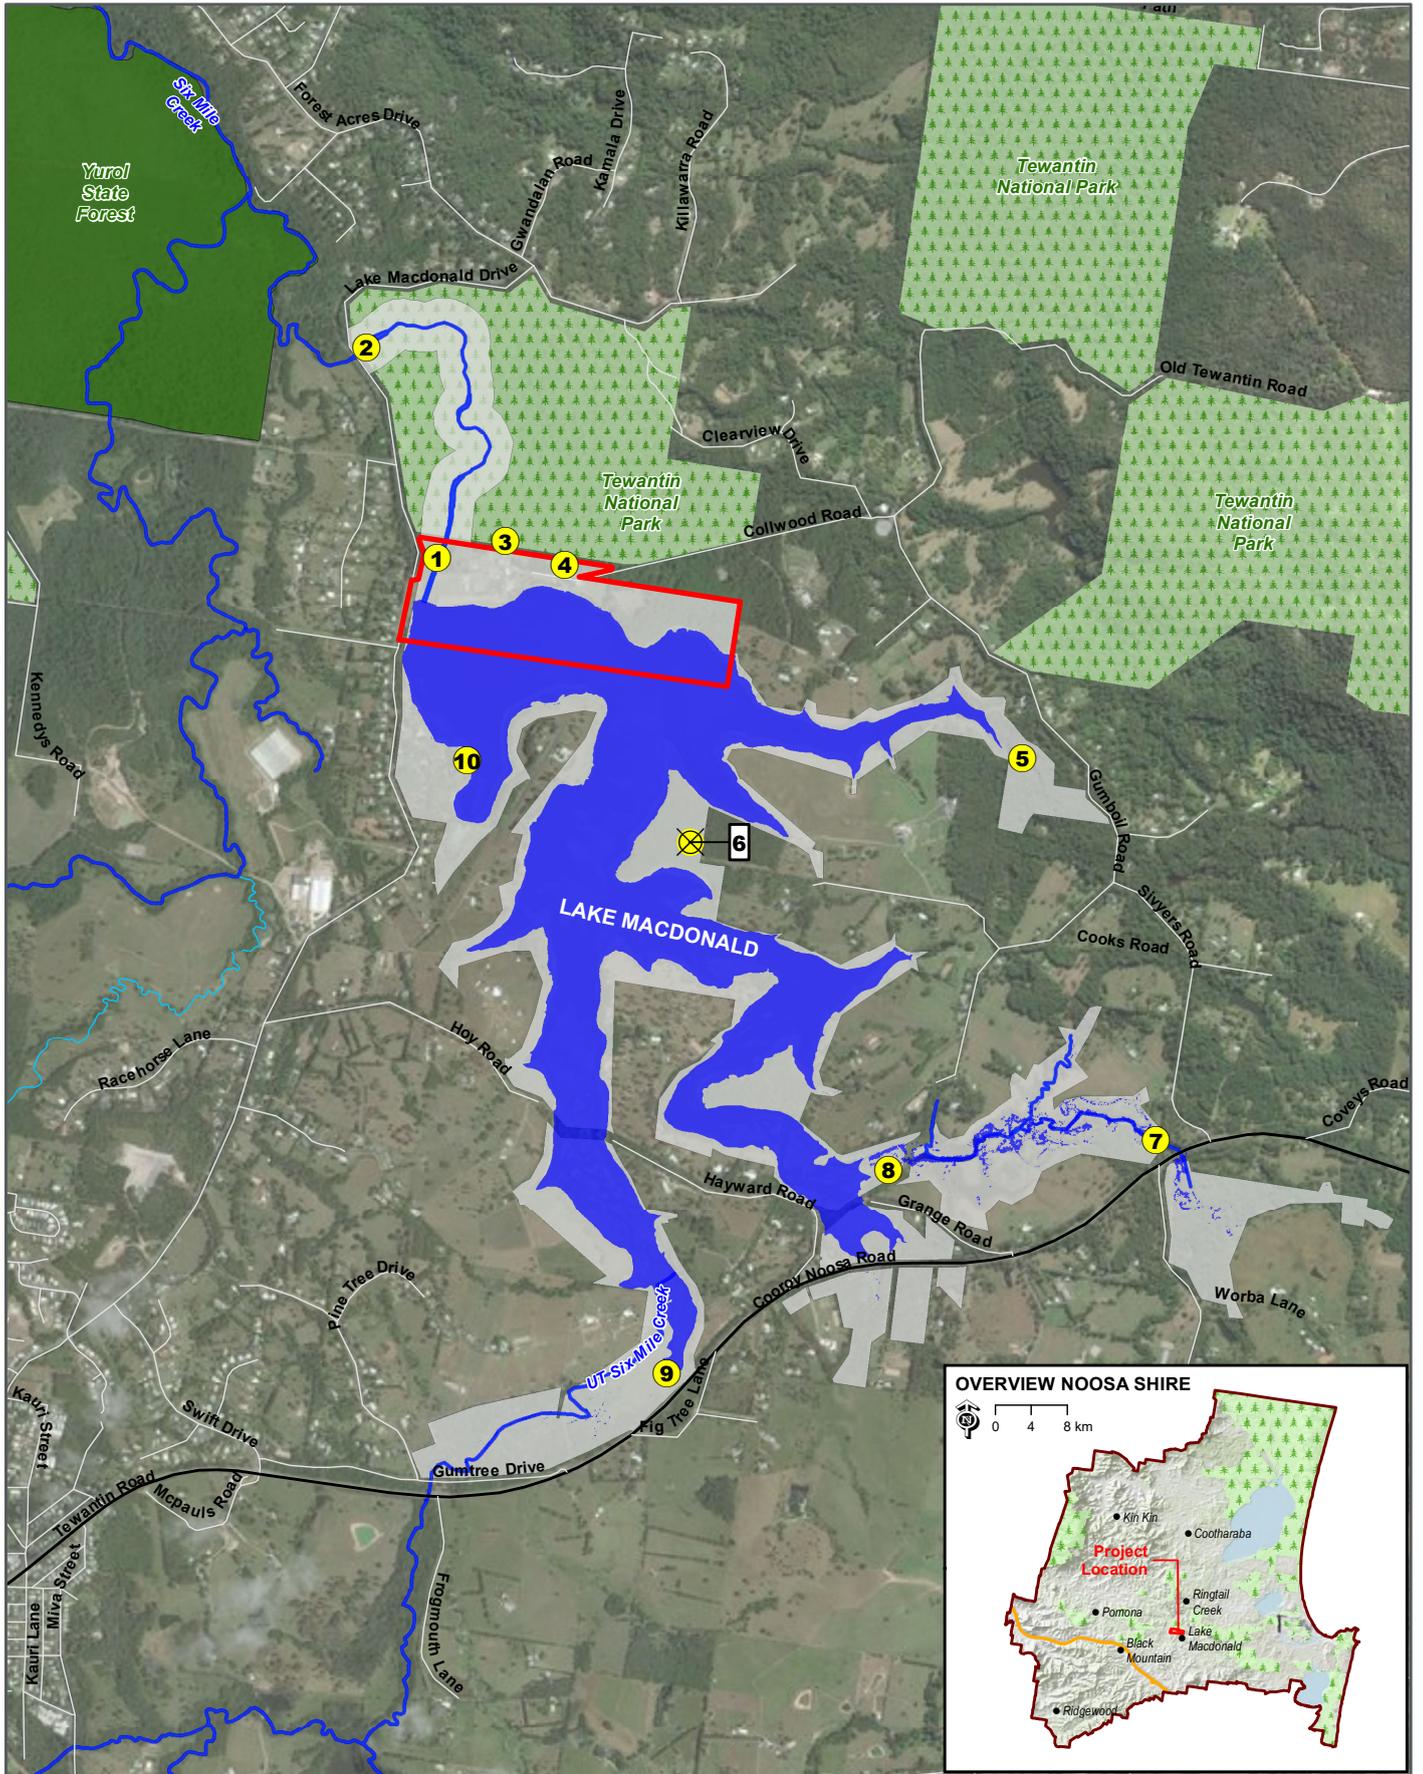
FIGURE 8-1: PROJECT AREA AND STUDY AREA EXTENT

To determine the broader impact of the Project on ecological values, the terrestrial ecological assessment assessed the Project area (primary impact area) and the wider study area, which encompasses all extents of Lake Macdonald. Assessment of the study area is important to identify impacts that may occur in shallow areas of the lake as a result of lowering the water levels during construction. The Project area and study area referred to throughout this chapter are illustrated in Figure 8-1.

No works are to be undertaken within the National Park, but will be immediately adjacent and upstream (refer to Figure 8-1). Indirect impacts may occur to this area during the construction and operational phases of the Project. This comprises potential degradation of the edges of the National Park through removal of adjacent vegetation which currently provides a buffer to the National Park. Edge effects, as discussed in section 8.4.2, may occur within the National Park. However, the Project will not have a significant residual impact on protected areas.

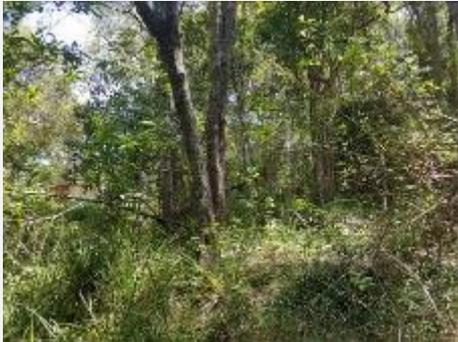
SITE NUMBER AND LOCATION	DESCRIPTION OF MAPPED VEGETATION COMMUNITY	SITE PHOTOGRAPH
<p>Site 1</p>	<p>Remnant RE 12.3.2</p> <p><i>Eucalyptus grandis</i> tall open forest on alluvial plains</p>

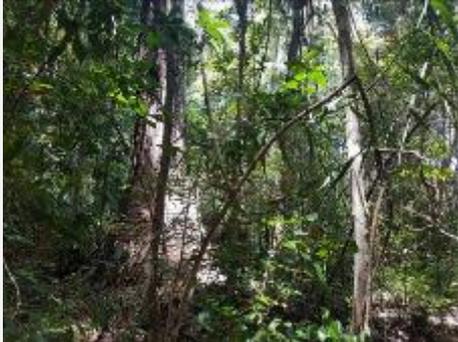
<p>Site 2</p>	<p>Remnant RE 12.3.2</p> <p><i>Eucalyptus grandis</i> tall open forest on alluvial plains</p>

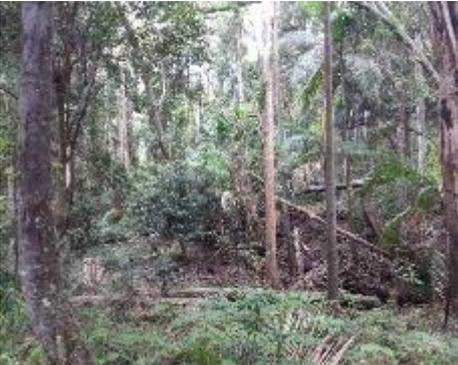
SITE NUMBER AND LOCATION	DESCRIPTION OF MAPPED VEGETATION COMMUNITY	SITE PHOTOGRAPH
<p>Site 3</p>	<p>Regrowth RE 12.9-10.1 / RE 12.9-10.17</p> <p>Tall open forest often with <i>Eucalyptus resinifera</i>, <i>E. grandis</i>, <i>E. robusta</i>, <i>Corymbia intermedia</i> on sedimentary rocks.</p> <p><i>Eucalyptus acmenoides</i>, <i>E. major</i>, <i>E. siderophloia</i> +/- <i>Corymbia citriodora</i> subsp. <i>variegata</i> woodland on sedimentary rocks</p>

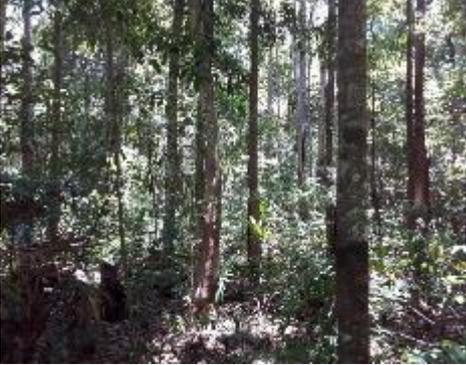
<p>Site 4</p>	<p>Remnant RE 12.9-10.1 / RE 12.9-10.17</p> <p>Tall open forest often with <i>Eucalyptus resinifera</i>, <i>E. grandis</i>, <i>E. robusta</i>, <i>Corymbia intermedia</i> on sedimentary rocks.</p> <p><i>Eucalyptus acmenoides</i>, <i>E. major</i>, <i>E. siderophloia</i> +/- <i>Corymbia citriodora</i> subsp. <i>variegata</i> woodland on sedimentary rocks</p>

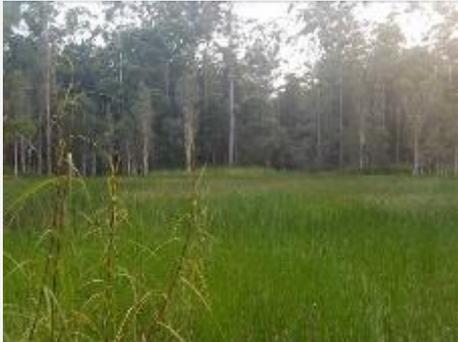
<p>Site 5</p>	<p>Remnant RE 12.9-10.1 / RE 12.9-10.17 and 12.3.2</p> <p>Tall open forest often with <i>Eucalyptus resinifera</i>, <i>E. grandis</i>, <i>E. robusta</i>, <i>Corymbia intermedia</i> on sedimentary rocks.</p> <p><i>Eucalyptus acmenoides</i>, <i>E. major</i>, <i>E. siderophloia</i> +/- <i>Corymbia citriodora</i> subsp. <i>variegata</i> woodland on sedimentary rocks.</p> <p><i>Eucalyptus grandis</i> tall open forest on alluvial plains.</p>

The field survey revealed a general lack of hollow-bearing trees (live and dead) across the study area. The highest density of hollows was observed in the forested areas of Site 5 with three hollow bearing trees within a 25 m x 25 m area. Within the assessment area for Site 1, one hollow bearing tree was observed. No hollow bearing trees were observed within the remaining survey sites. Most hollow-bearing trees at Site 5 were dead trees.

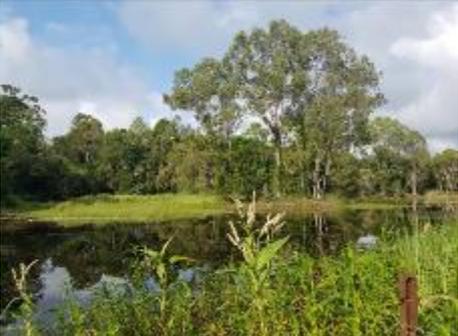
<p>Site 6 – permission was not granted to access this site, so it was not surveyed.</p>		
<p>Site 7</p>	<p>Non-remnant vegetation (Acacia and Eucalypt regrowth) open water and fringing wetland vegetation</p>

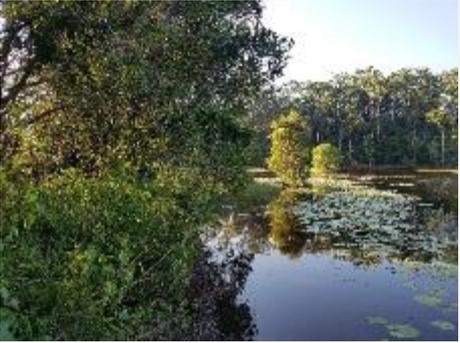
SITE NUMBER AND LOCATION	DESCRIPTION OF MAPPED VEGETATION COMMUNITY	SITE PHOTOGRAPH
<p>Site 8</p>	<p>Non-remnant vegetation (Acacia and Eucalypt regrowth), open water and fringing wetland vegetation</p>

Maggie goose (*Anseranas semipalmata*) and comb-crested jacana (*Irediparra gallinacea*) were observed in significant numbers at this site at Site 8, in the southern sections of the lake. There was evidence of breeding by the magpie goose at Site 9. While these species are not listed as threatened under Queensland legislation, they are listed as threatened under NSW legislation. The south east Queensland population could therefore be considered significant. There is also potential for white-bellied sea-eagle (*Haliaeetus leucogaster*), which is an EPBC migratory species, to use this area of the lake intermittently.

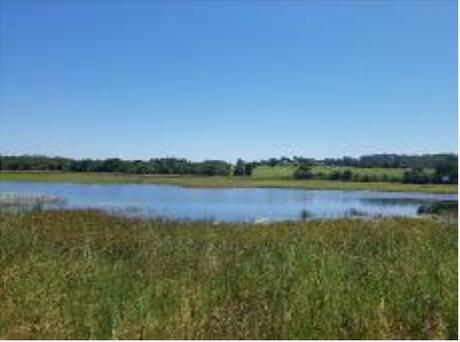
<p>Site 9</p>	<p>Non-remnant vegetation, open water and fringing wetland vegetation</p>

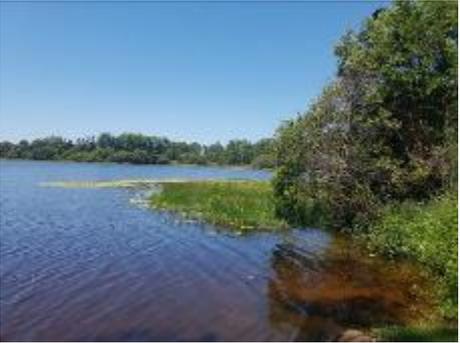
<p>Site 10</p>	<p>Non-remnant vegetation, open water and fringing wetland vegetation</p>

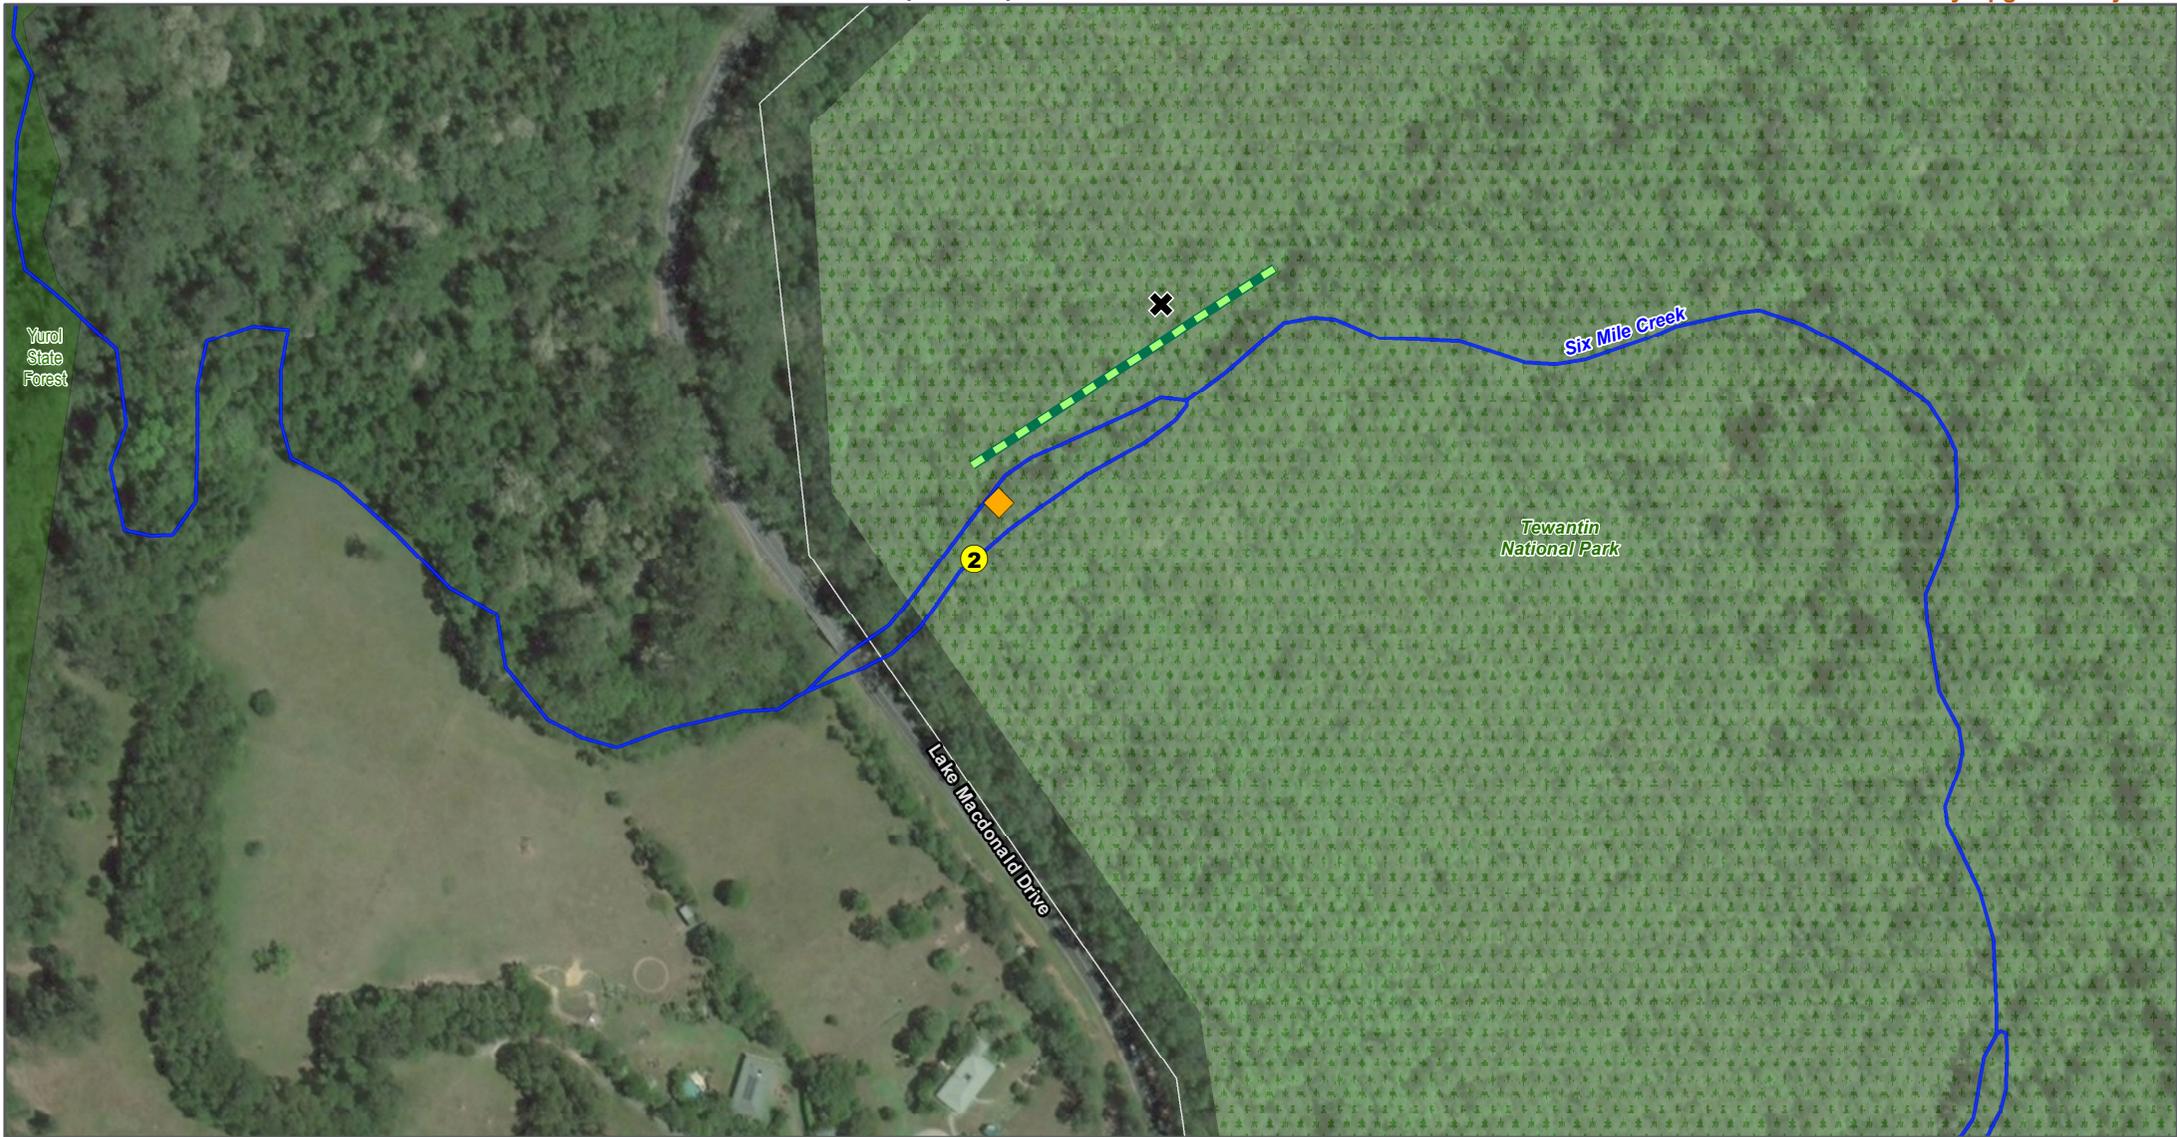
FIGURE 8-4: FAUNA SURVEY LOCATIONS AND ANIMALS IDENTIFIED (PART 2)

Survey techniques were chosen for specific locations based on the targeted species in that area. A variety of techniques were selected and, except for amphibians and the common death adder, carried out in accordance with the Terrestrial Vertebrate Fauna Survey Guidelines for Queensland Version 2.0 (Eyre et al. 2014). Surveys for amphibians were conducted in accordance with the Survey Guidelines for Australia's Threatened Frogs under the EPBC Act. The survey for the common death adder (*Acanthopis antarcticus*) was conducted in accordance with the Targeted Species Survey Guidelines for the species (Rowland 2012). A summary of the methods conducted at each site is provided in Table 8-3. The location of specific fauna surveys is shown in Figure 8-3, Figure 8-4, and Figure 8-5. Where survey techniques are not specifically mapped, they were undertaken at the survey site location.

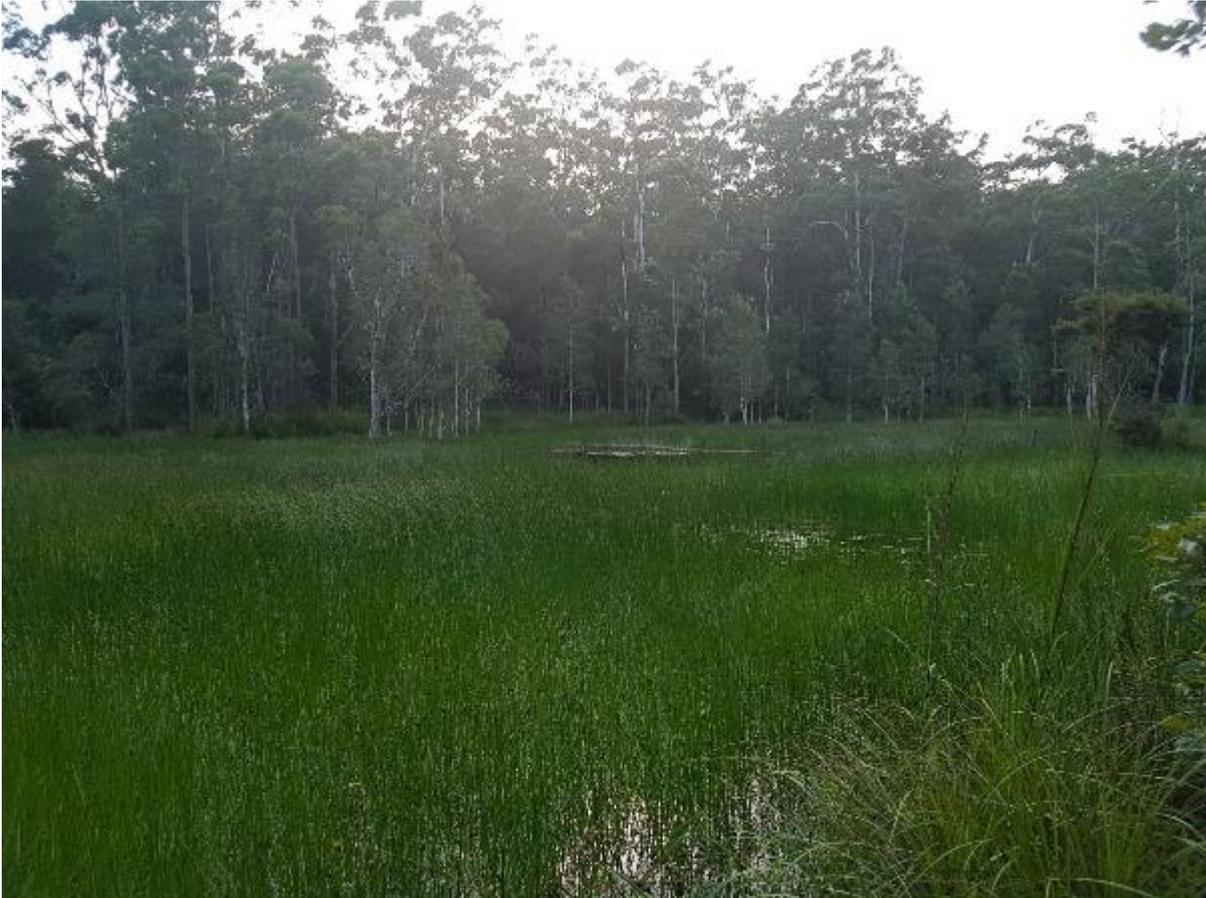
Figure 8-8: Wetland habitat at Site 5

At approximately 700 m downstream of the dam wall, Six Mile Creek is mapped as a wetland on the Vegetation Management Wetlands Map. No additional areas in the study area are identified as wetland areas on this map, despite having wetland habitat values. The upper reaches of Lake Macdonald create shallow, open wetland habitat (refer to Figure 8-8). These areas provide habitat for a range of aquatic / wetland bird and amphibian species.

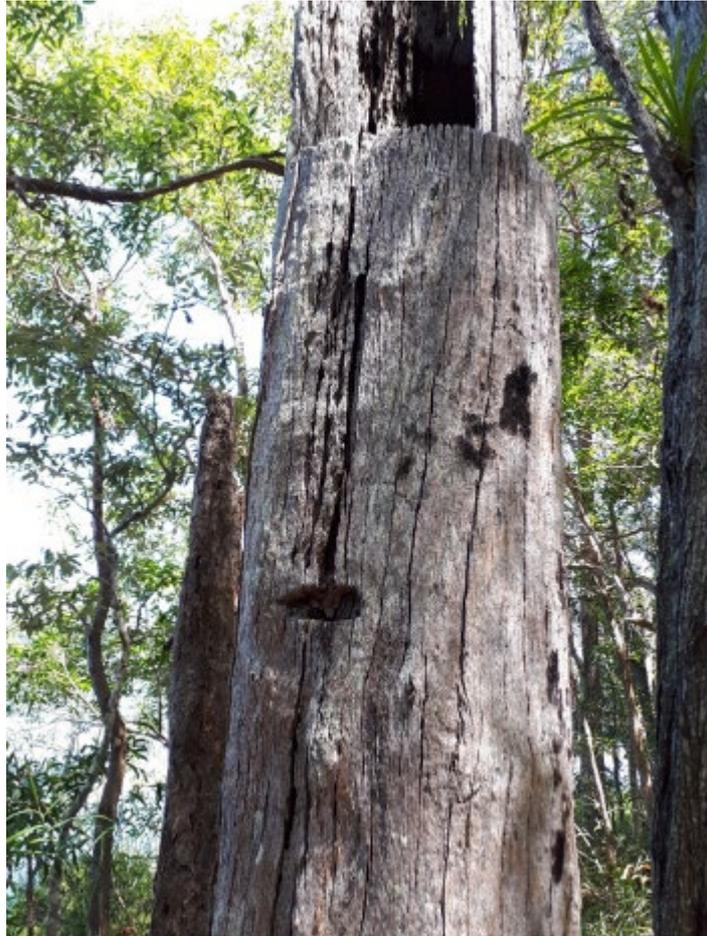
Figure 8-9: Remains of historical logging

Historical logging is evident in Tewantin National Park. The larger trees (e.g. more than 100 cm diameter at breast height (DBH)) have historically been ringbarked, logged and killed, but still remain as stags throughout the park. Figure 8-9 shows springboard notches associated with historical logging. The remaining vegetation communities are generally intact and representative of regional ecosystem communities.

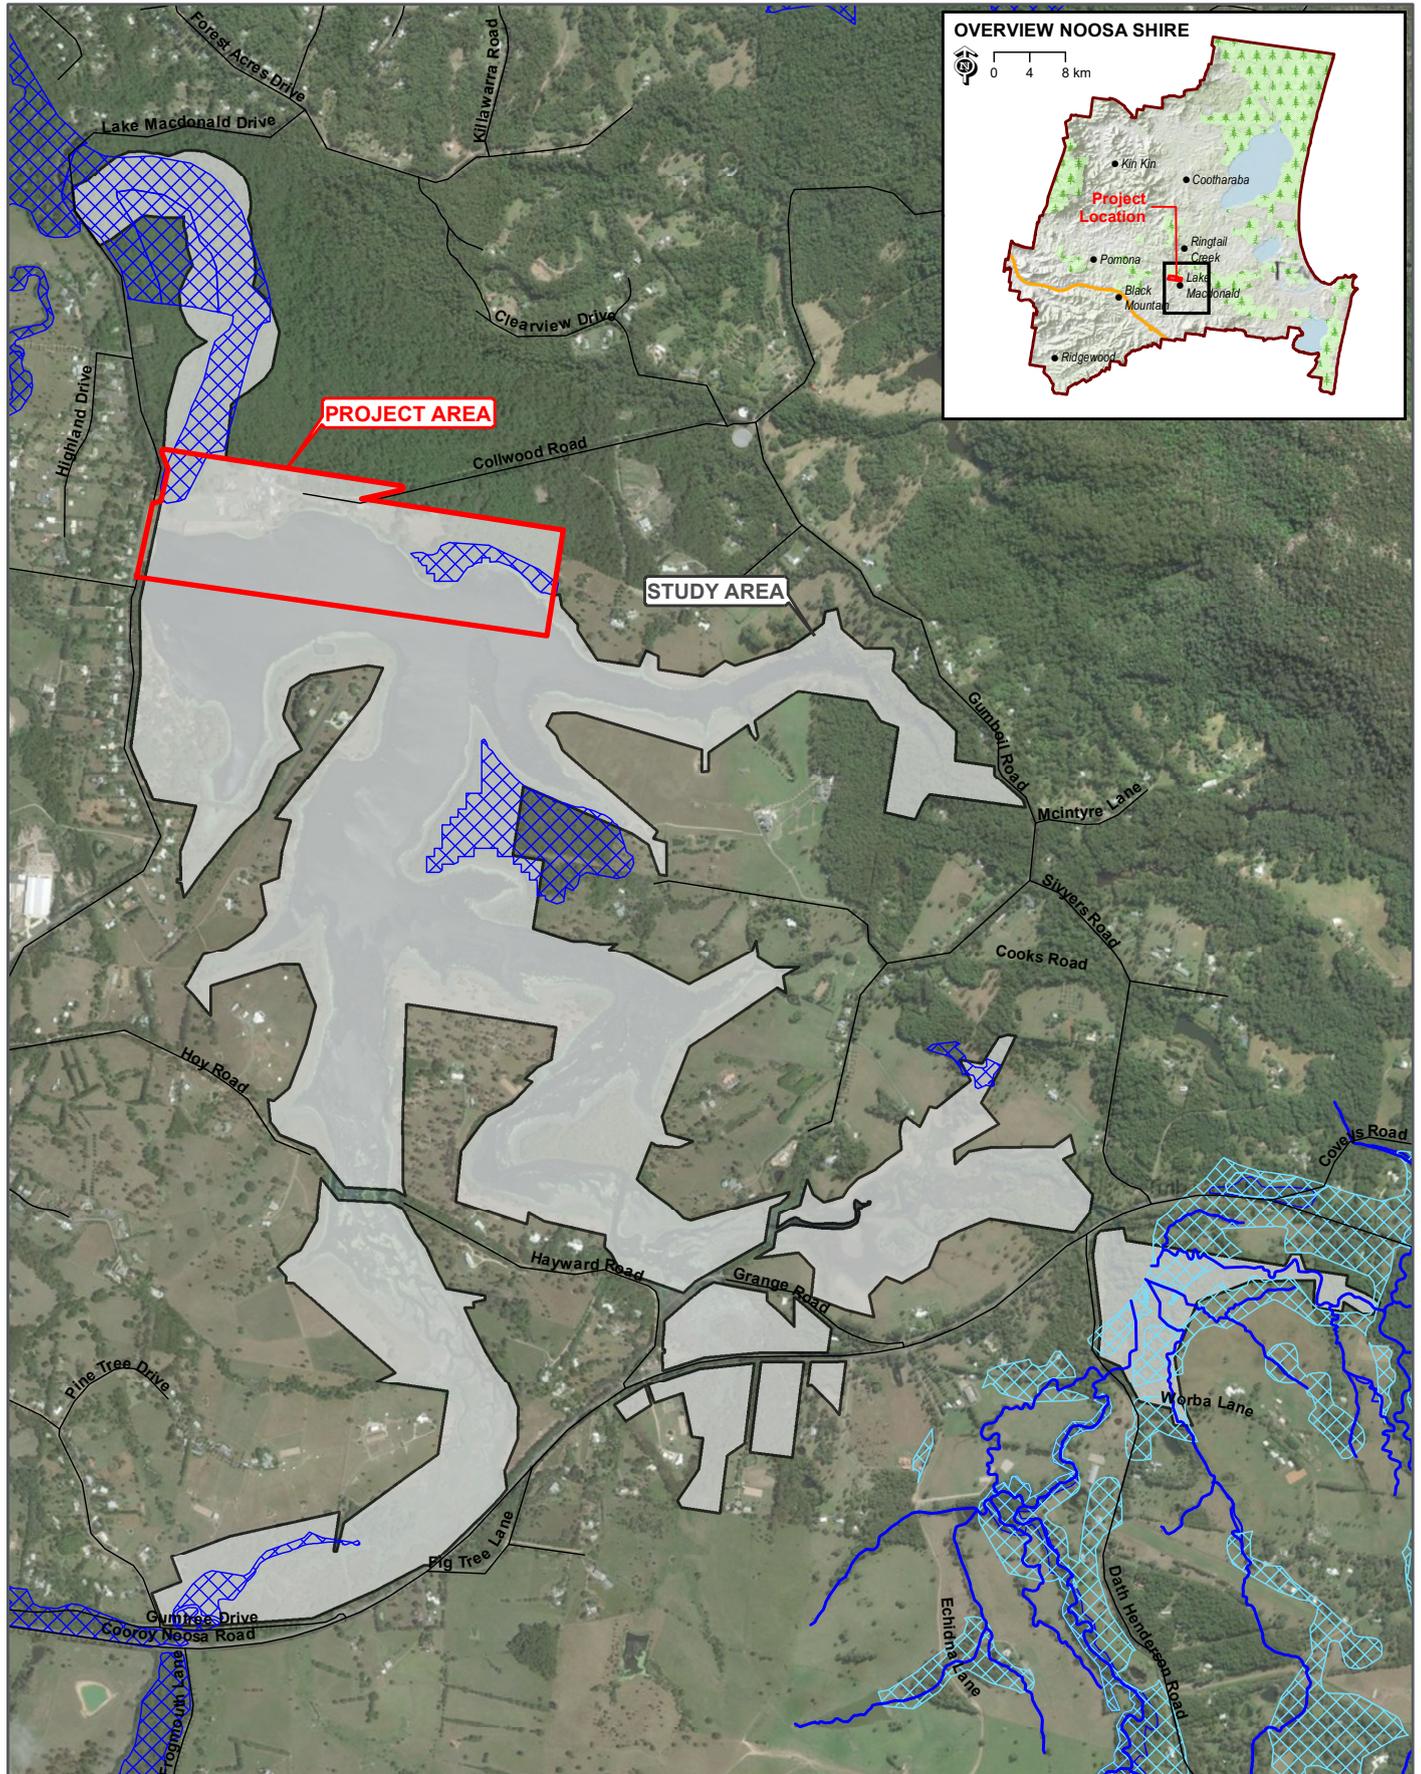
FIGURE 8-11: MSES WETLAND

In the vegetation south of Camp Cooroora, high ecological significance wetlands will be directly impacted through vegetation clearing. Other wetland areas, including around Site 6 and along Six Mile Creek upstream, may be indirectly impacted temporarily as a result of the lake lowering. Under the Significant Residual Impact Guideline, activities that result in permanent degradation of landform, vegetation or water quality associated with the above wetlands may trigger a significant residual impact. Vegetation clearing in the vicinity of Camp Cooroora may therefore trigger a significant impact that requires offsets if no approval exemptions apply for the Project. If required, it is possible that for offset calculations, some of the mapped wetland impact areas will co-occur with other of concern RE areas proposed to be cleared.
