Re: Townsville Ocean Terminal - Marine Habitat Map Interpretation

Attached please find a series of 6 biological distribution maps for the area to the west of the area known as the Duck Pond in Cleveland Bay, and for the specified section of Ross Creek associated with the proposed temporary bridge overpass for the Townsville Ocean Terminal.

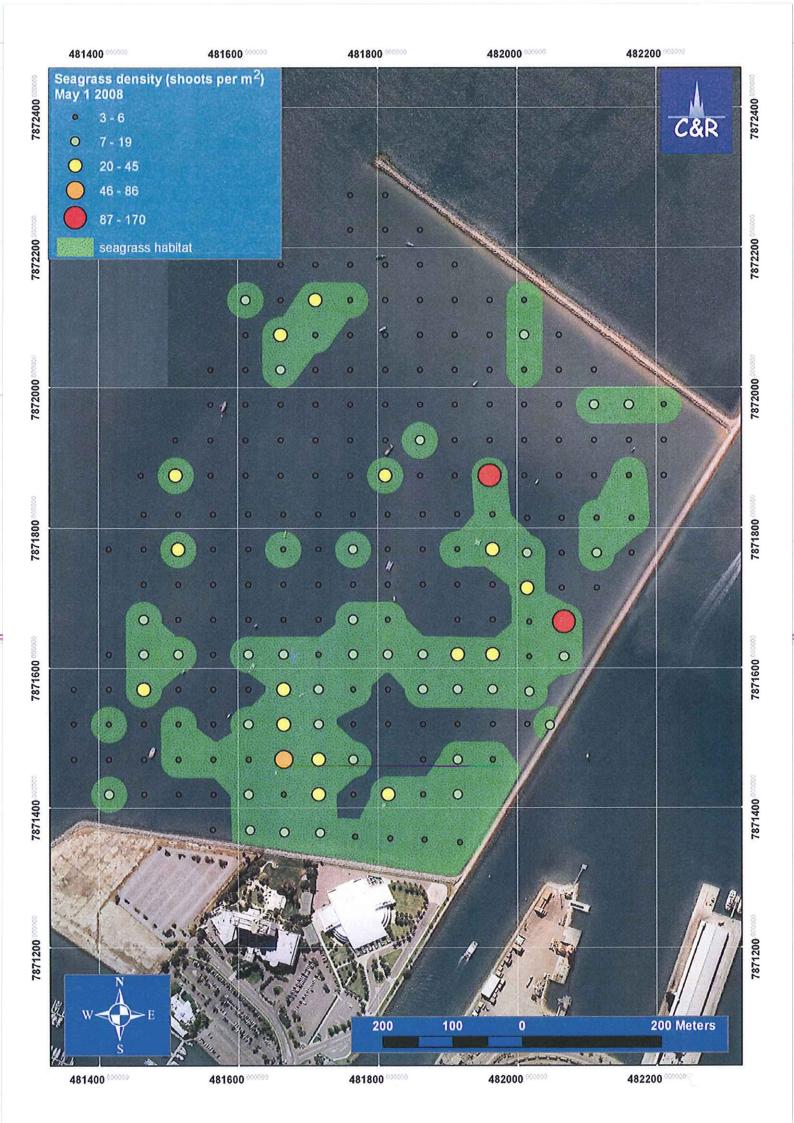
Map 1: Seagrass density

The density estimates shown in the map are derived from five replicate 25 by 25cm quadrats at each point – these sampling units were kept small by the extremely low visibility throughout the site. Open dots reflect points where no seagrasses were found. Seagrasses occur in the project footprint at low densities. Scattered patches are found in the northern half of the area, with a more contiguous cover occurring in the southern half. The species occurring throughout the area are *Halophila ovalis* and *H. spinulosa*, with isolated occurrences of *Halodule uninervis*. No dugong feeding scars were observed during this survey.

Overall, seagrass areas covered 17.9ha, or 30.5% of the project site.

The only substrate type found in the project site, apart from the rock walls, was fine silt.

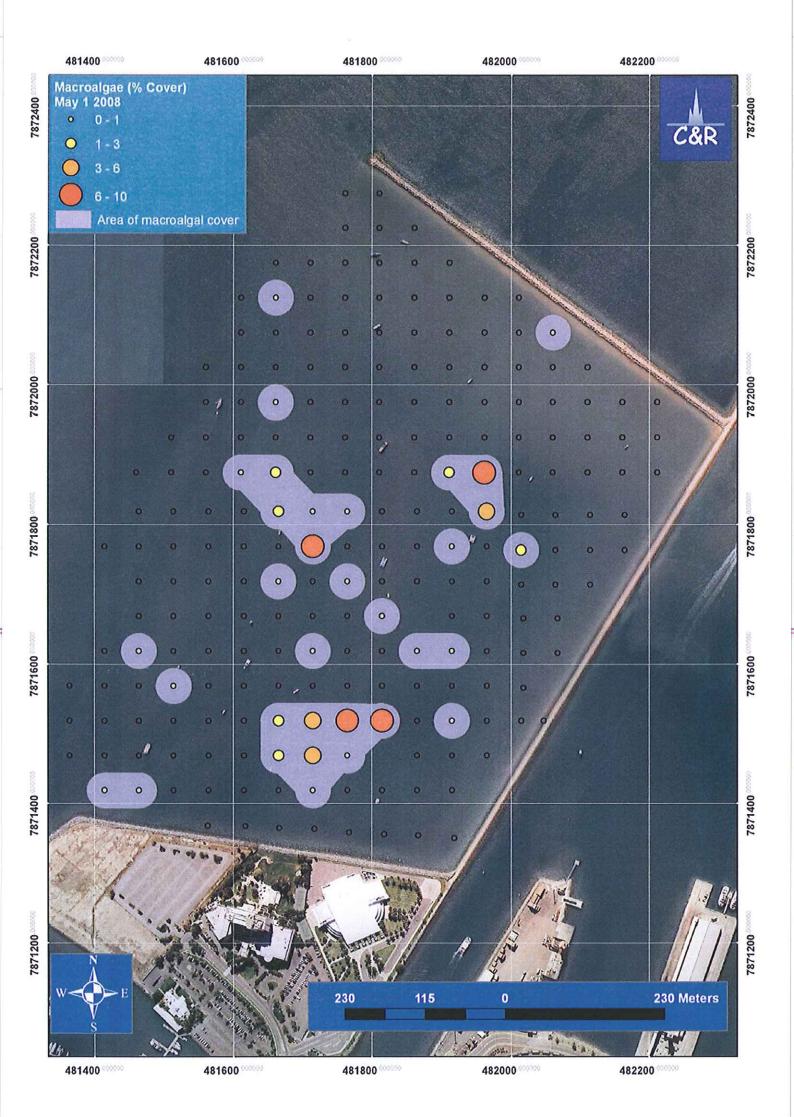
Map 2: Macroalgal cover

The % cover of macroalgal species in the project footprint was minimal, and spread out in sparse patches over the southern two thirds of the area. The most abundant and widespread species was the calcified red alga *Jania* sp., with isolated patches of *Caulerpa* sp (green algae) and filametous red algae.

Overall, macroalgae covered 7.9ha, or 13.9% of the project site.

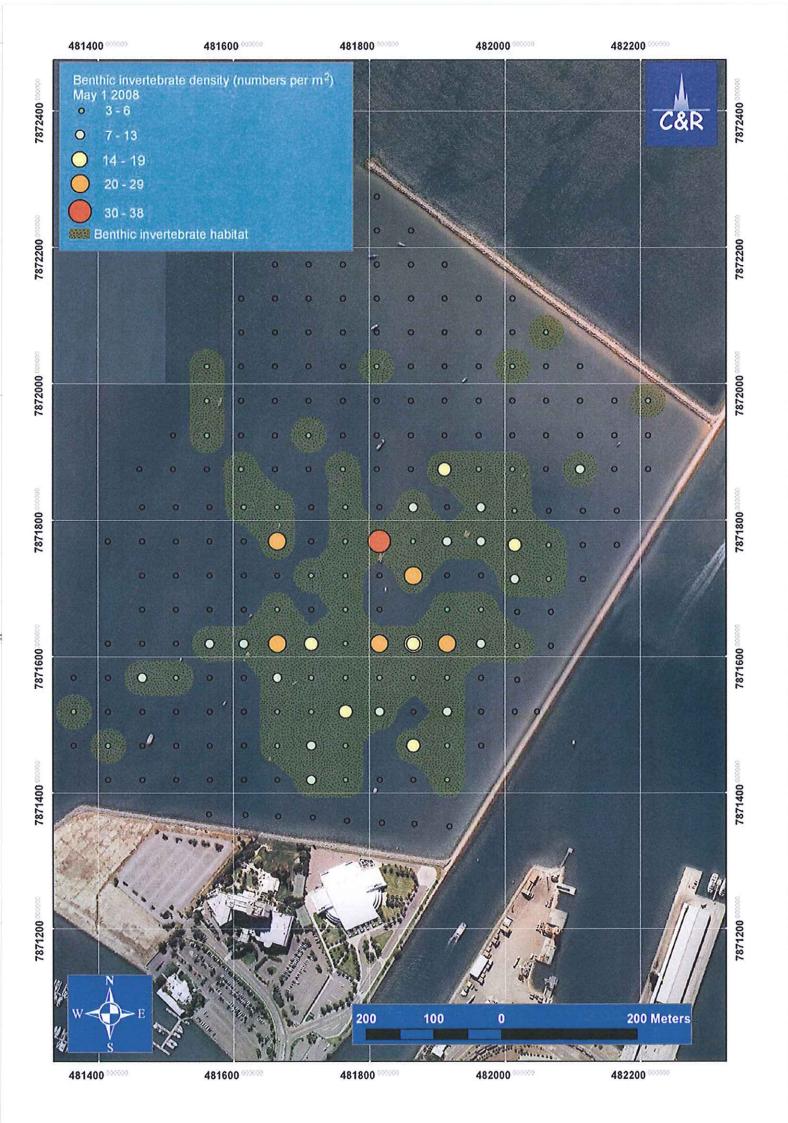
Map 3: Benthic macroinvertebrate density

The benthic macroinvertebrate community included bivalves (scallops and oysters), hydroids, crinoids (feather stars), ascidians (both colonial and individual), sponges, flatworms, nudibranchs, crayfish and polychaetes (worms). Overall, there was a low density of invertebrates, with most organisms found in the southern two-thirds of the site. Many of these invertebrates have been recorded in the diets of commercially and recreationally important fish that occur in Cleveland Bay (see Appendix 1 in Nature Conservation Report).

Overall, benthic invertebrate habitat comprised 21.3ha, or 36.3% of the project site.

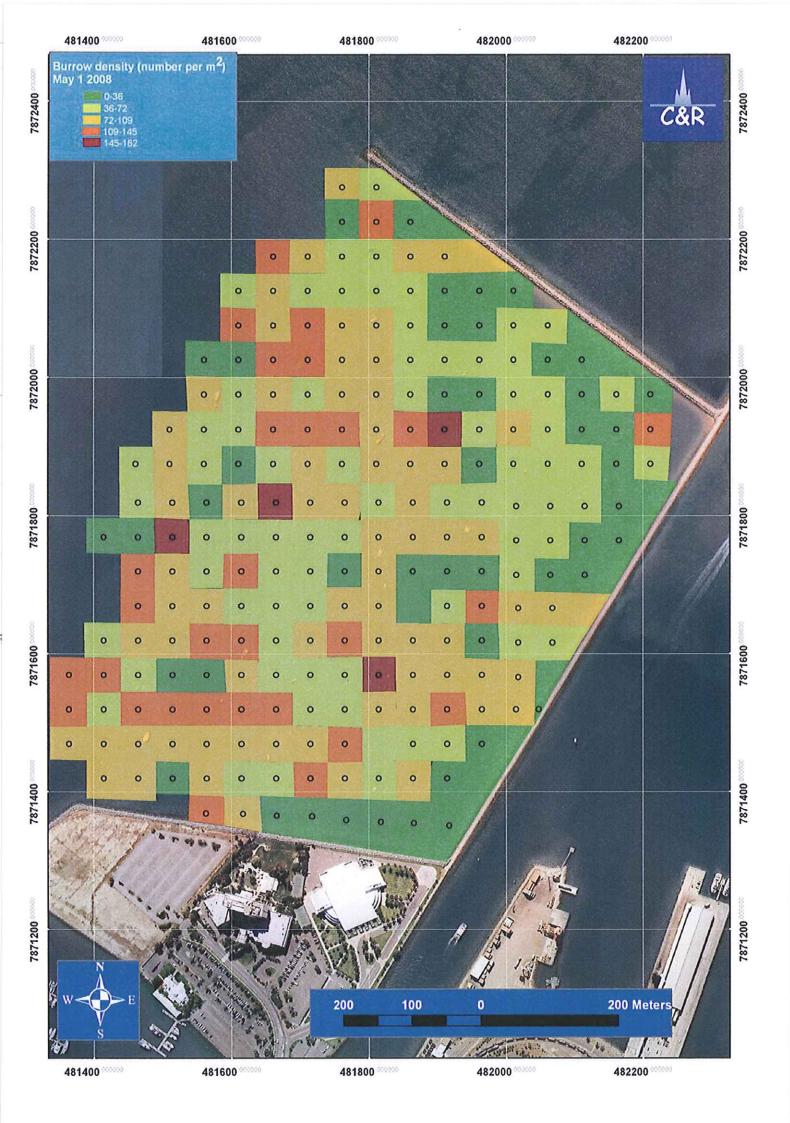
Map 4: Invertebrate burrow density

Burrows in the sediment give an indication of the density of sediment-dwelling organisms within the site. These can also be important components in the diets of commercially and recreationally targeted fish (see Appendix 1 in Nature Conservation Report). Burrows primarily signal the presence of worms, crustaceans and small fish in the area; two fish in the family Gobiidae were observed during the surveys. Burrows are seen as evidence of live animals because they are likely to collapse when not regularly 'maintained' by the inhabitants. Most of the project footprint had very high densities of invertebrate burrows of varying sizes (a few mm to approximately 10cm in diameter). The highest densities were generally found towards the middle of the site.

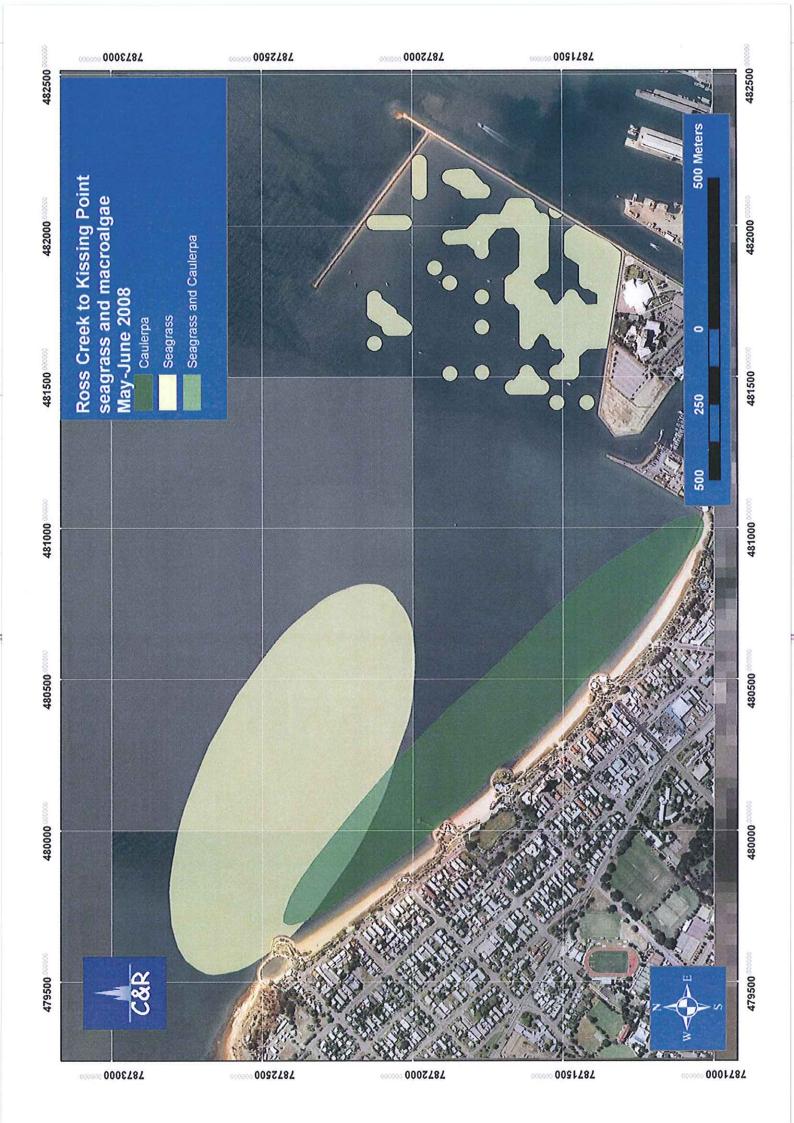
Map 5: Ross Creek to Kissing Point marine plant map

There is a dense bed of *Caulerpa* sp., a green alga, extending from the lower intertidal (exposed to the air only on mid- to king low tides) approximately 200m seaward from the Strand along its whole length. Seagrasses occur in sparse patches (approx. 10-20% cover) at the southeastern end of the seagrass bed, becoming more contiguous towards Kissing Point. The area near Kissing Point also contains a diverse soft-bottom community including sponges, bryzoans, ascidians and other sessile invertebrates. These provide habitat for juvenile fish (observed during the June survey) and mobile invertebrates. These communities also increase in density towards Kissing Point.
