Ron Rumble Pty Ltd
Consulting Acoustical & Vibration Engineers

**Townville Ocean Terminal Project
Scrap Ship Loading Measurements**

Test Reference: MT/08/6488.Tst

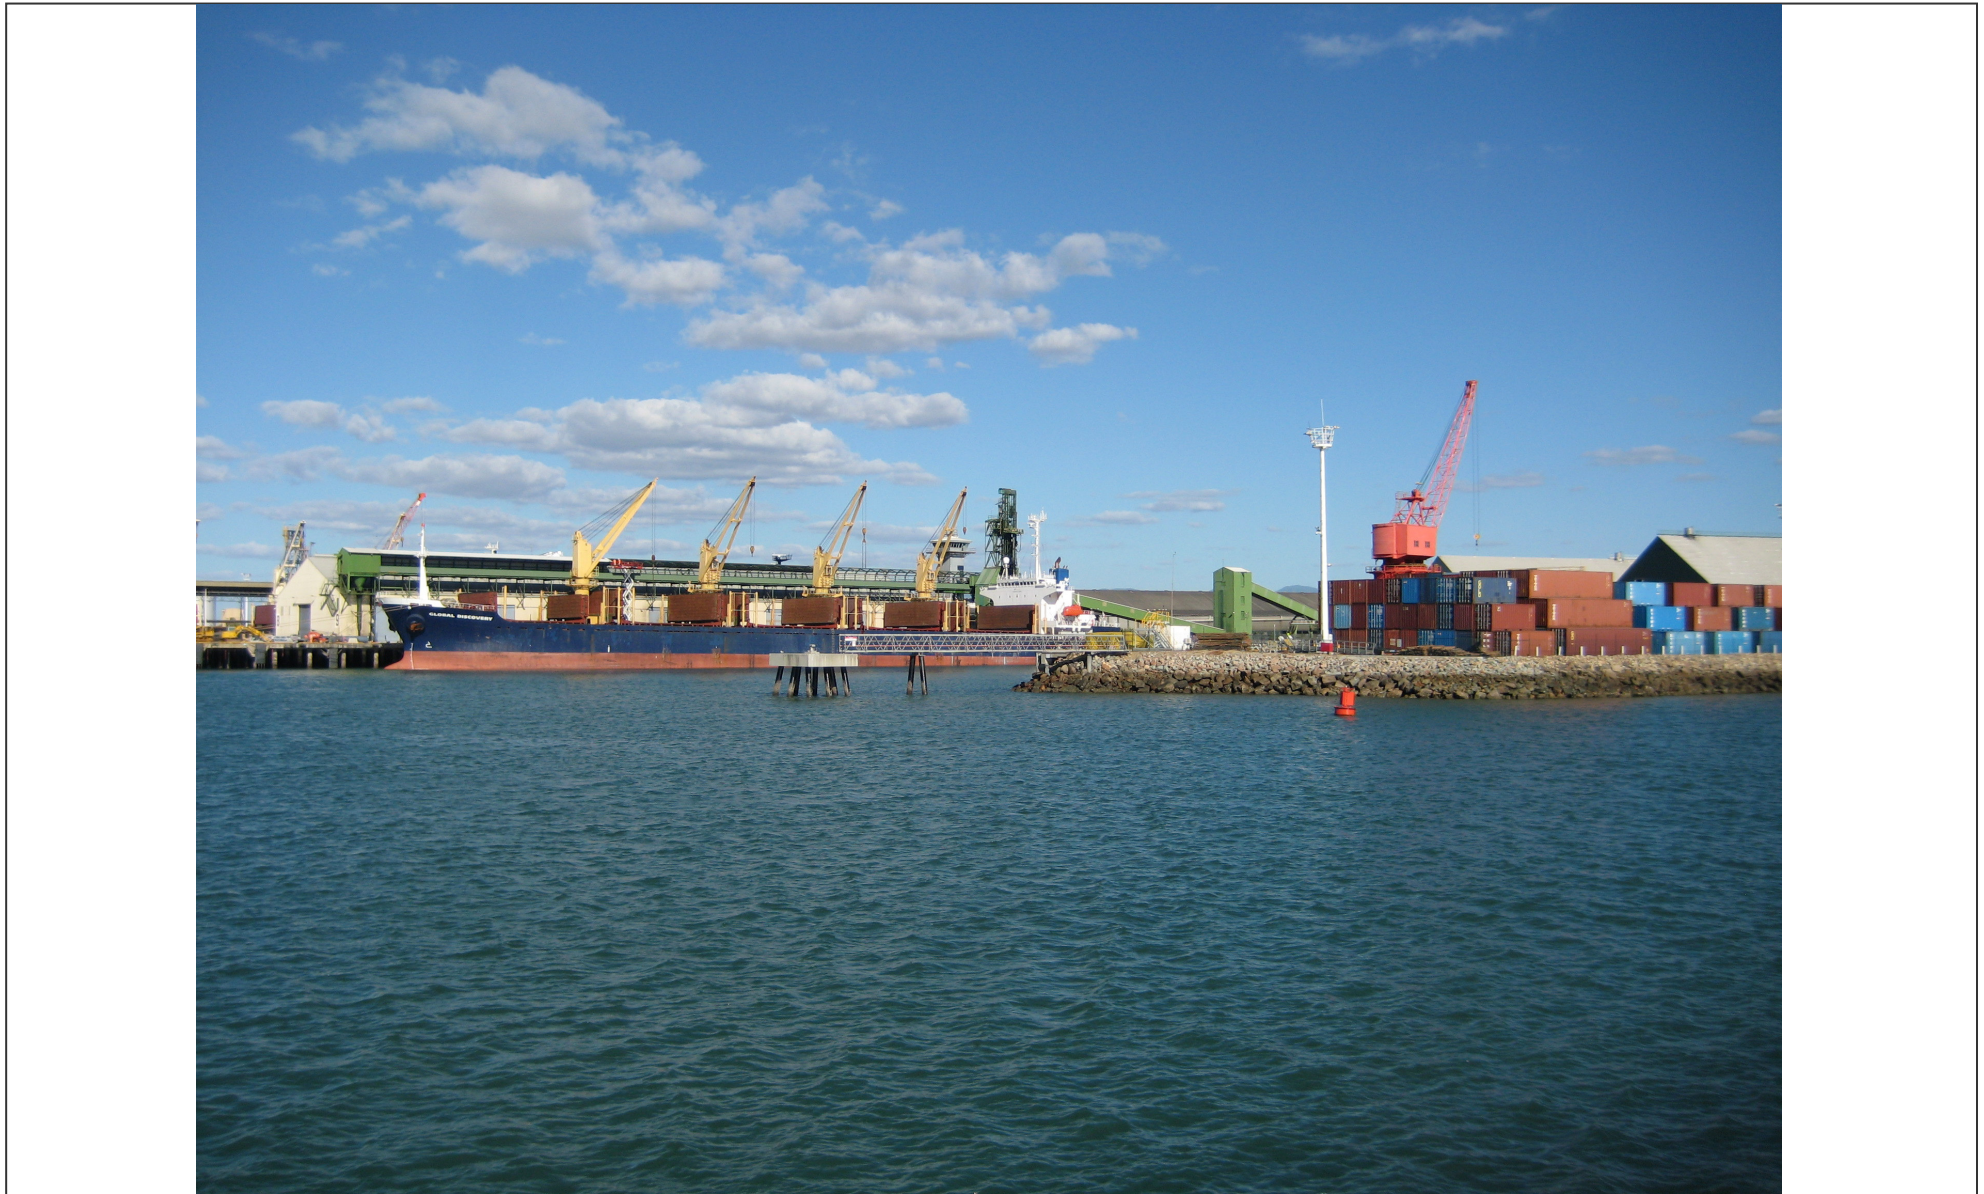
Figure 2: Photo of Scrap Ship from Measurement Location

An aerial photograph showing the Breakwater Marina and surrounding area is shown in Figure 1. The location of the scrap ship is also shown in this figure, which was Berth 9. Photos of the scrap ship from the measurement location can be seen in Figure 2 and Figure 3.

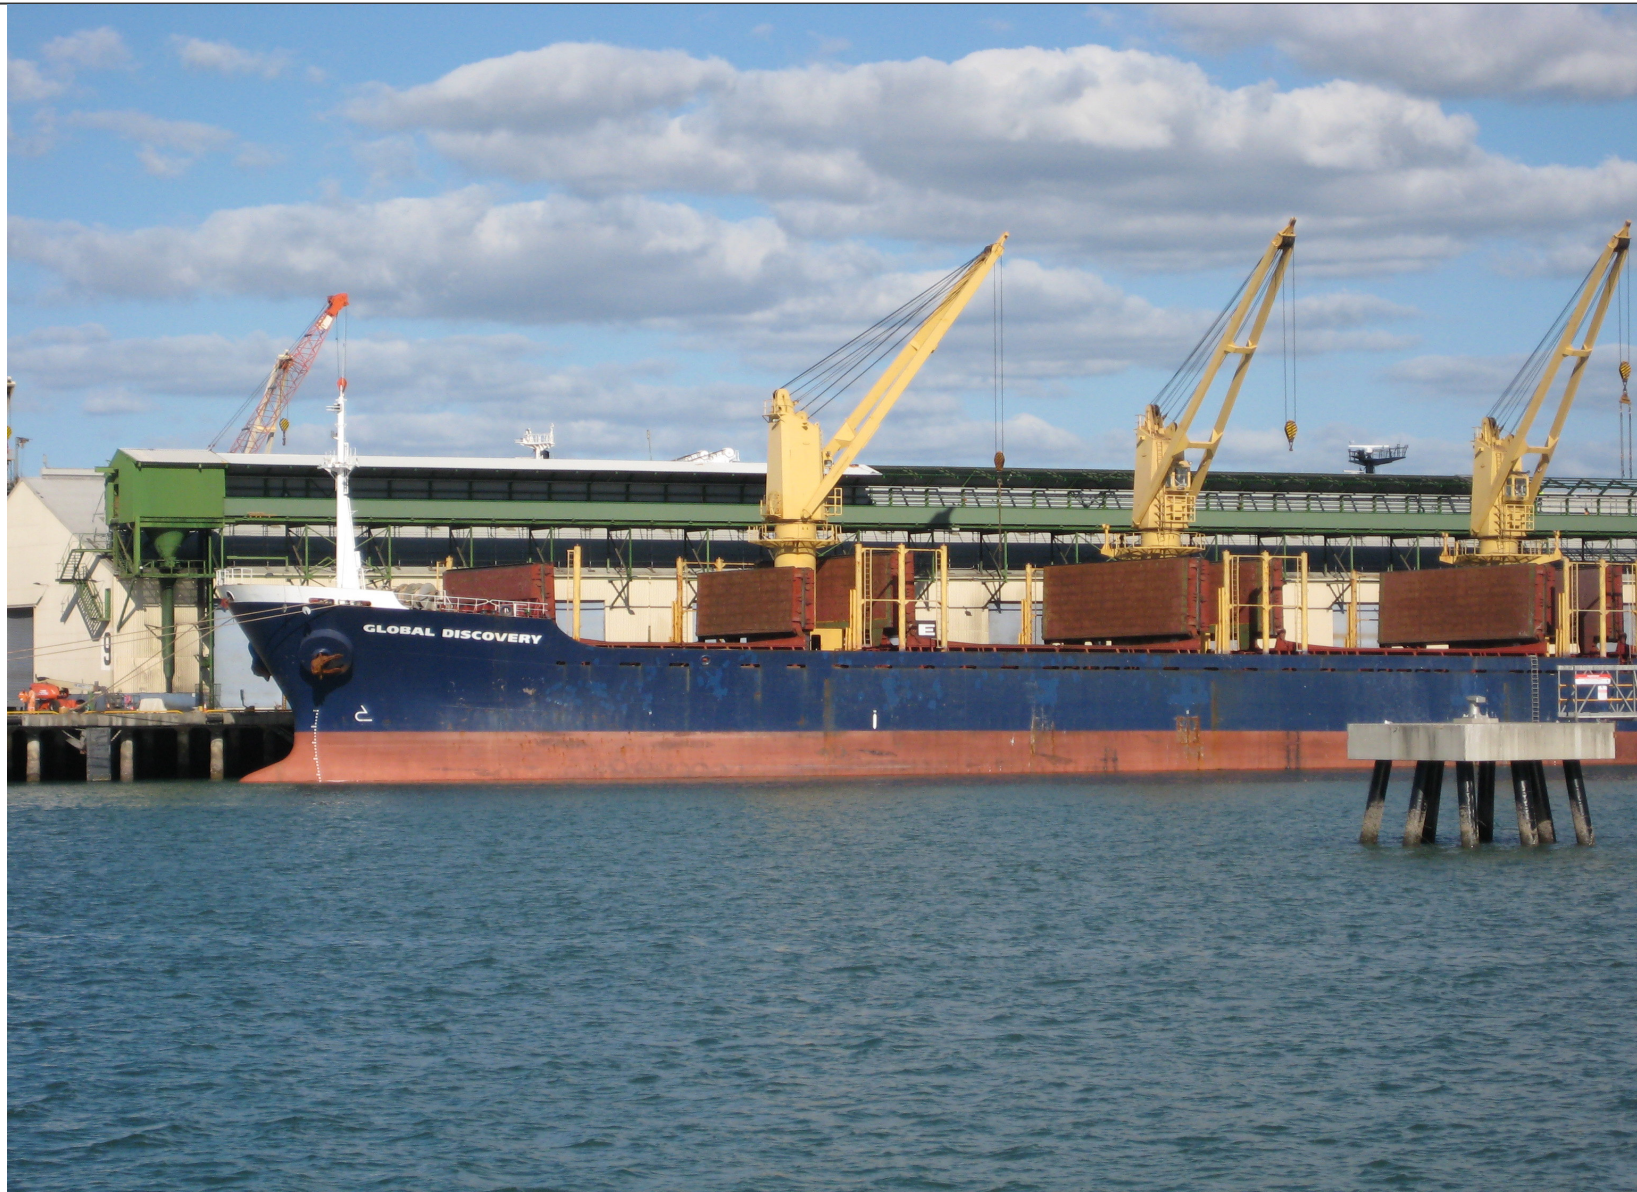
Figure 3: Photo of Scrap Ship from Measurement Location – Closer view

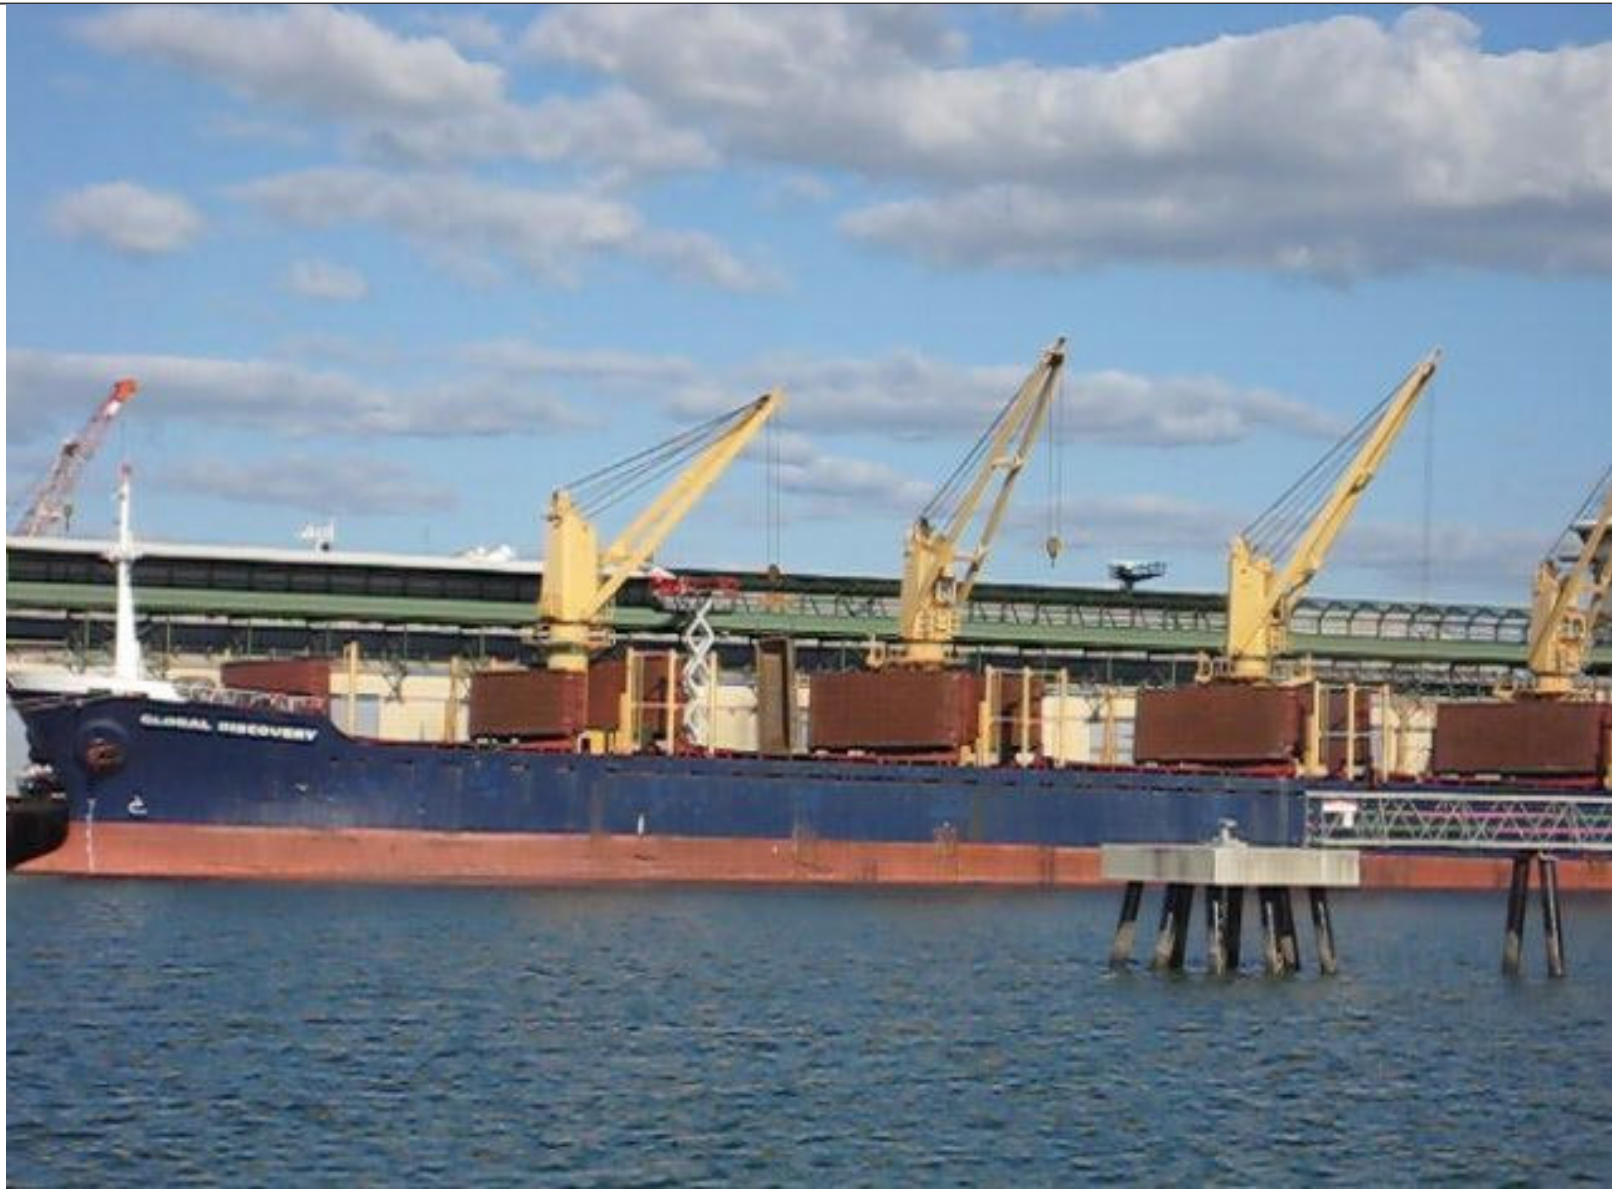
Figure 4: Photo of Scrap Ship from Measurement Location – with empty container on crane
