APPENDIX A1

Additional Field Studies for Townsville Port Expansion Project

Additional Field Studies for Townsville Port Expansion Project AEIS

Reference: R.B21057.002.03.AEIS_Additional Field
Studies.docx
Date: March 2016
Confidential

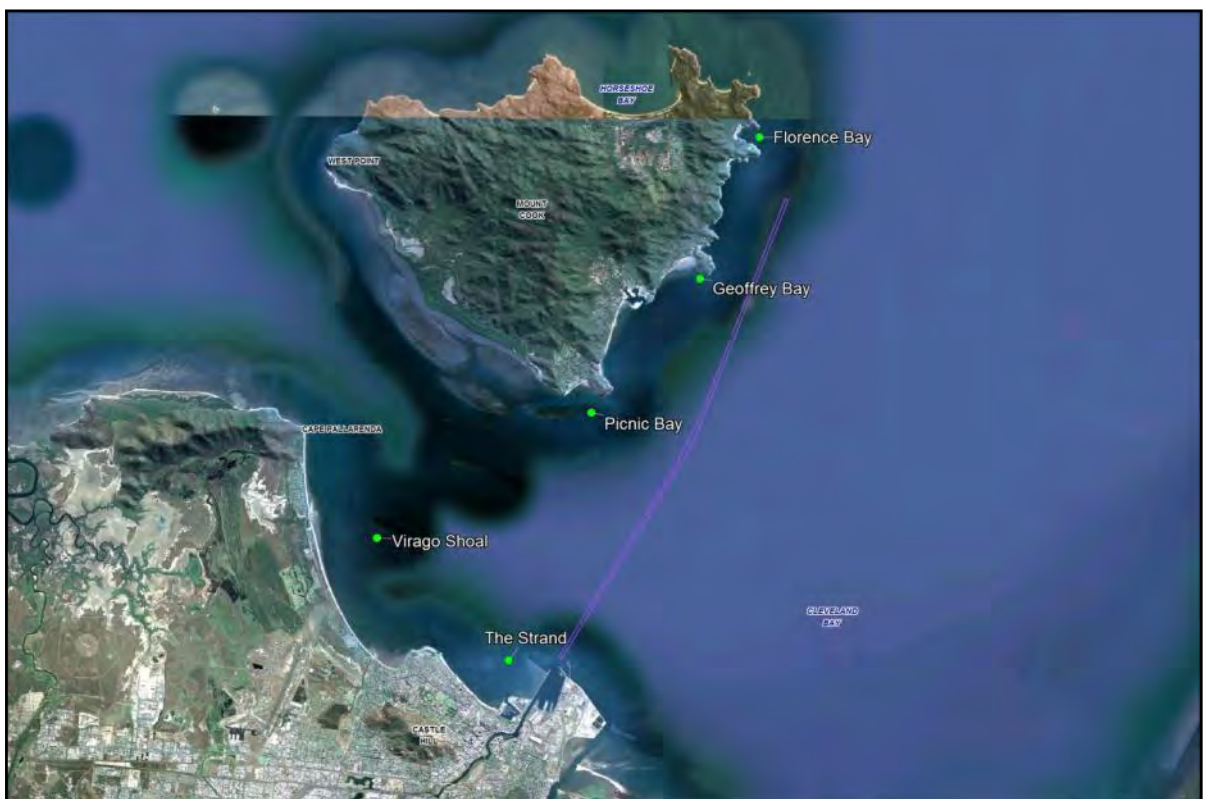
Figure 2-1 Location of Water Quality Monitoring Instruments

Water quality monitoring was carried out at five stations containing benthic primary producer habitats (seagrass and/or corals) and in areas most likely to be affected by dredge plumes. Two stations were located in nearshore areas close to the mainland (the Strand and Virago Shoal), and three locations were located in offshore waters on the east coast of Magnetic Island (Geoffrey Bay, Florence Bay and Picnic Bay) (Table 2-1 and Figure 2-1).

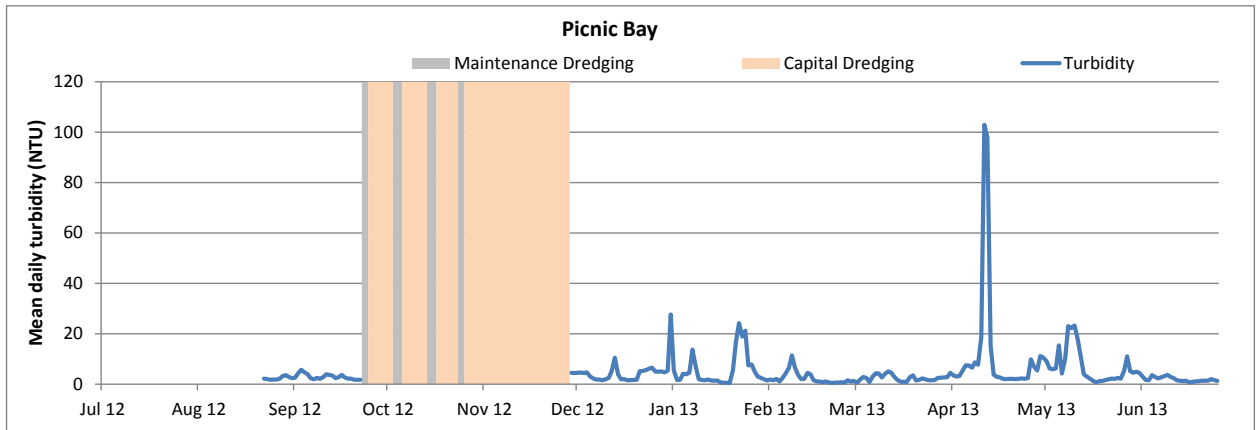
Figure 2-2 Picnic Bay Turbidity

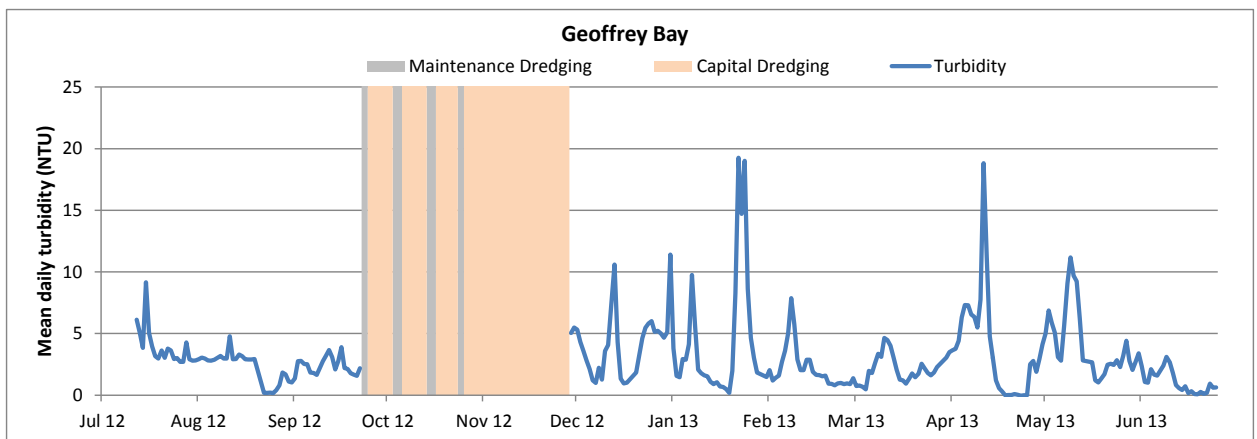
Figure 2-3 Geoffrey Bay Turbidity

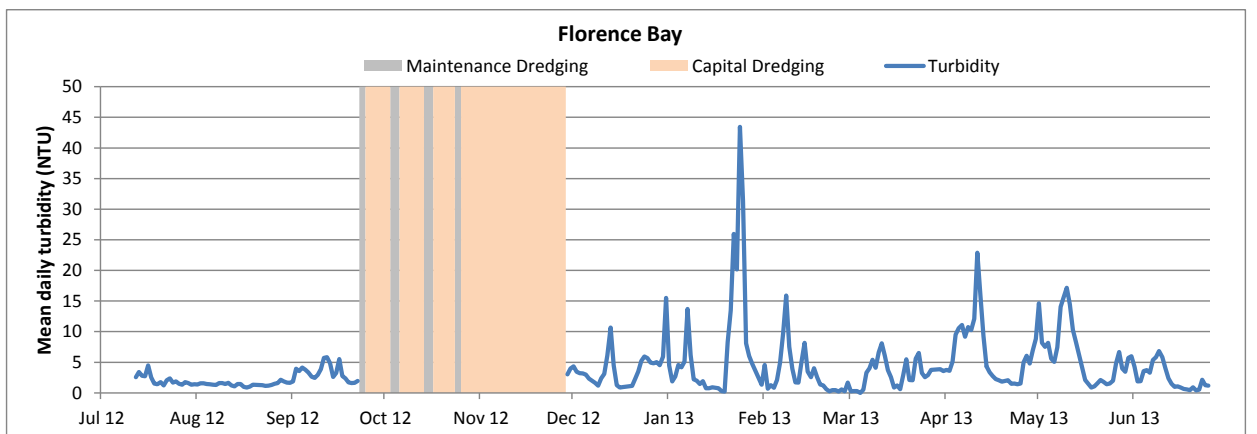
Figure 2-4 Florence Bay Turbidity

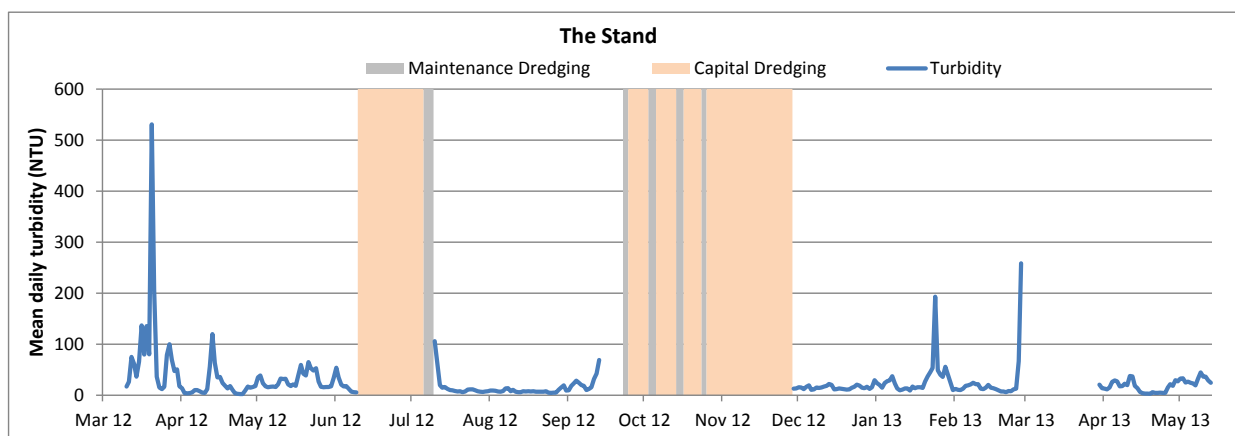
Figure 2-5 Strand Turbidity

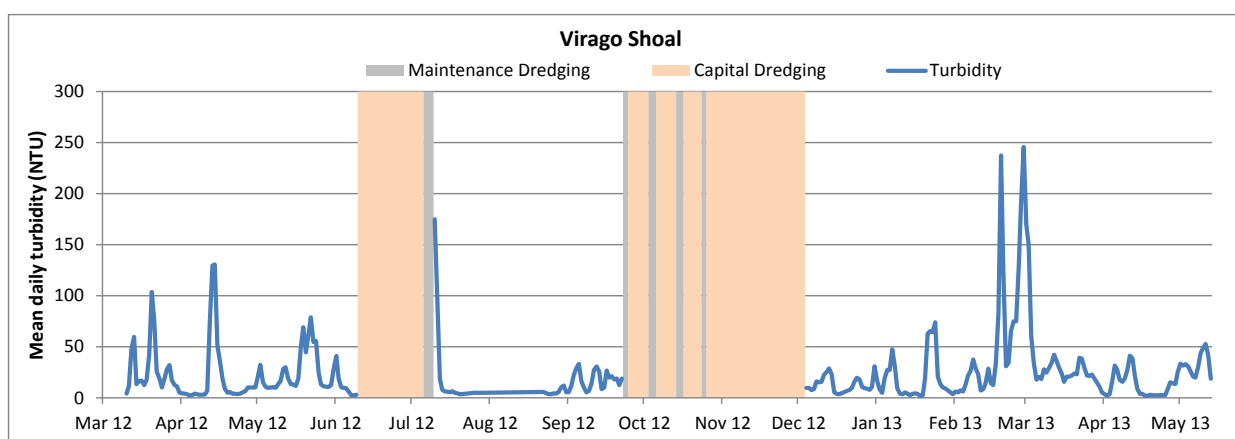
Figure 2-6 Virago Shoal Turbidity

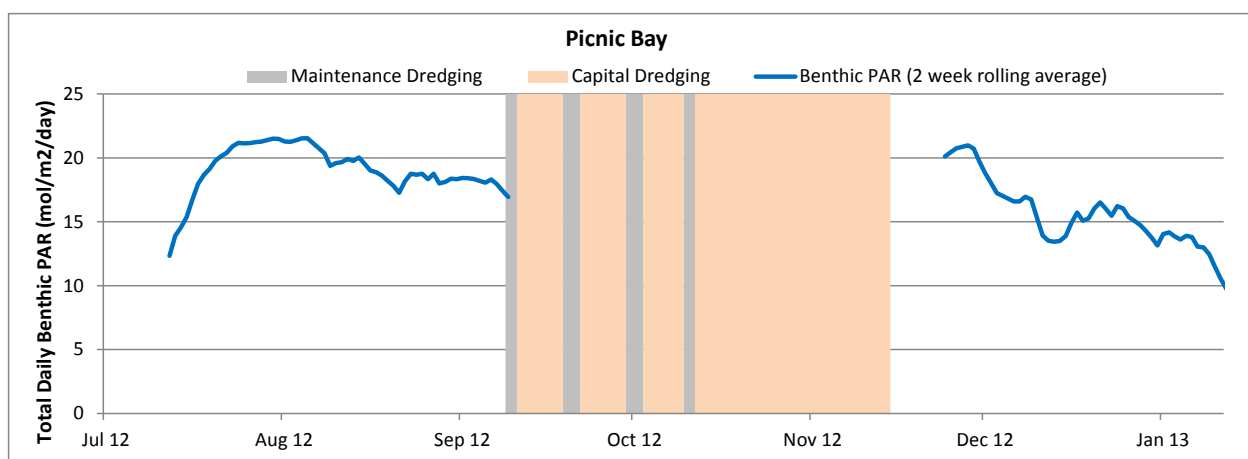
Figure 2-7 Picnic Bay Total Daily Benthic PAR (mol/m²/day) (2 week rolling average)

- Total daily benthic PAR (2 week rolling average) for sites along Magnetic Island ranged from 10 to 20 mol/m²/day at Picnic Bay, 5 to 8 mol/m²/day at Geoffrey Bay, and 5 to 20 mol/m²/day at Florence Bay. It should be noted that benthic PAR is influenced by the depth of water at each instrument.
- Total daily benthic PAR (2 week rolling average) for nearshore sites ranged from 2 to 12 mol/m²/day at the Strand and 2 to 14 mol/m²/day at Virago Shoal.

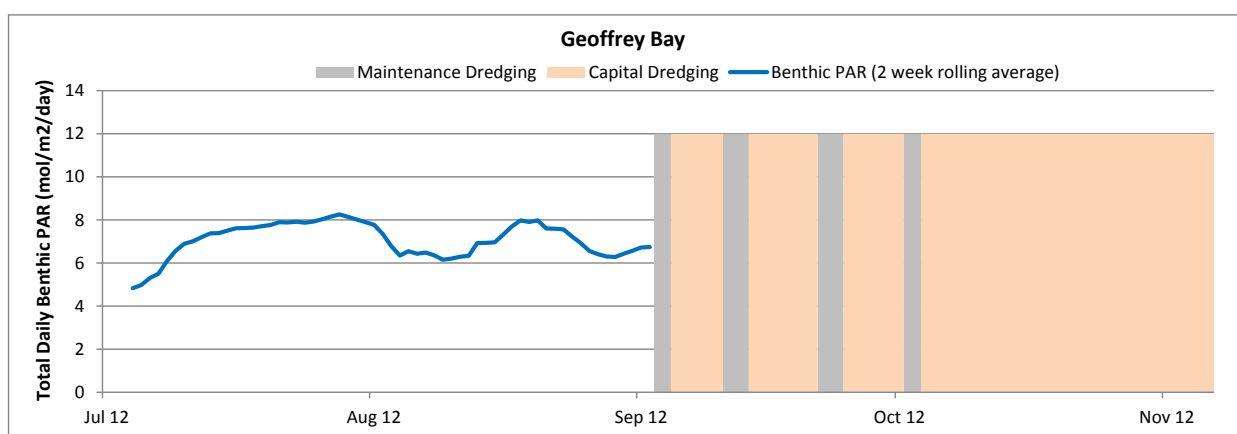
Figure 2-8 Geoffrey Bay Total Daily Benthic PAR (mol/m²/day) (2 week rolling average)

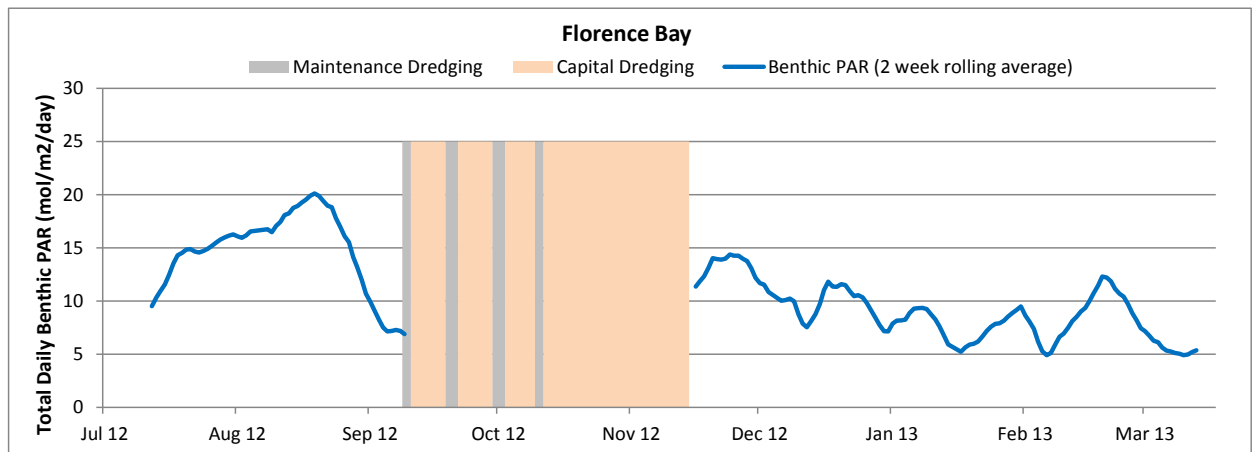
Figure 2-9 Florence Bay Total Daily Benthic PAR (mol/m²/day) (2 week rolling average)

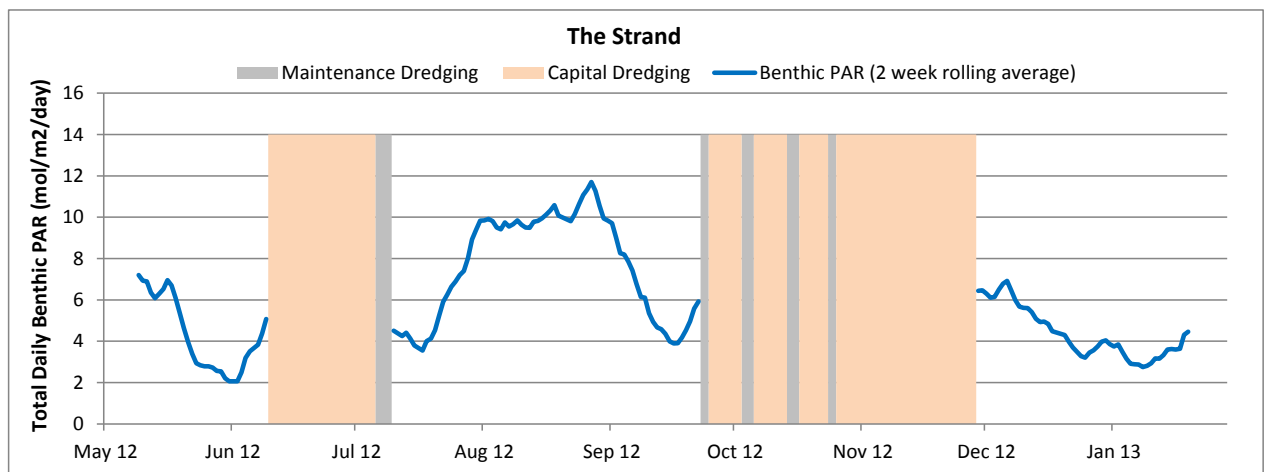
Figure 2-10 Strand Total Daily Benthic PAR (mol/m²/day) (2 week rolling average)

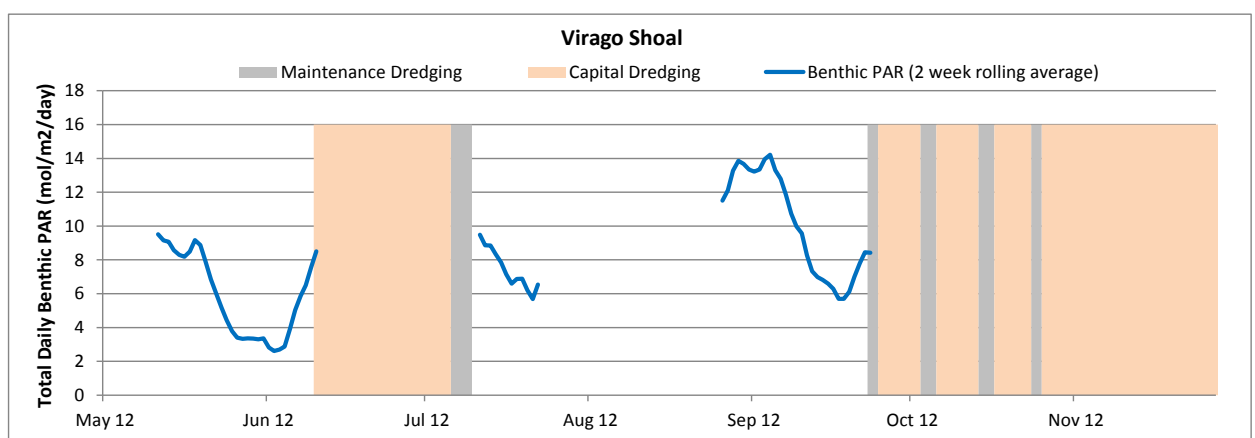
Figure 2-11 Virago Shoal Total Daily Benthic PAR (mol/m²/day) (2 week rolling average)

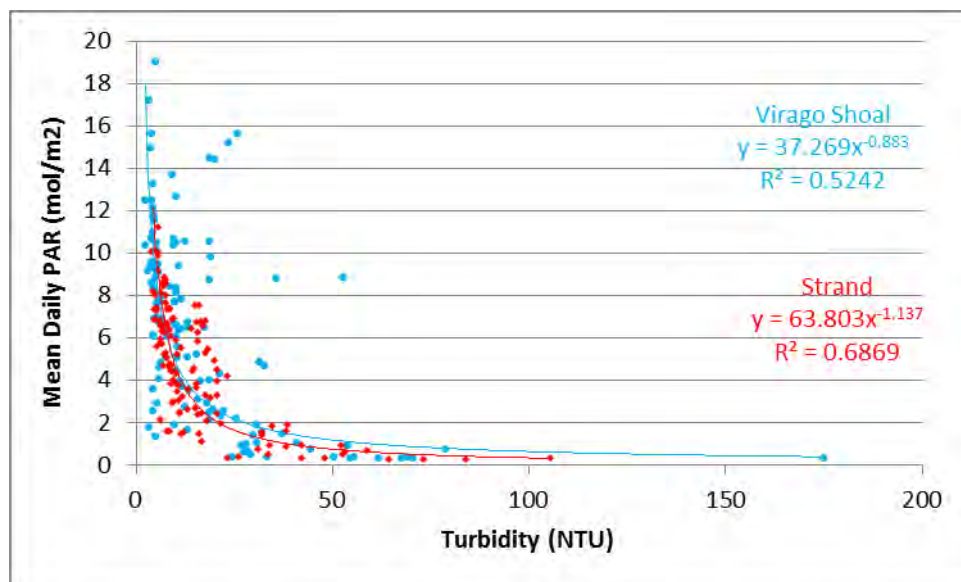
Figure 2-12 Relationship between Mean Daily PAR and Turbidity at Virago Shoal

Daily light requirements for several species of seagrass have been developed in Townsville (Collier *et al.* 2012a; 2012b) and Gladstone (Chartrand *et al.* 2012). In order to compare changes in turbidity (NTU) and PAR, and subsequent light-based impacts of turbidity, the relationships between mean daily PAR and NTU was estimated using data from the Virago Shoal and the Strand (Figure 2-12). The Virago Shoal relationship was used to examine putative impacts because the instrument was situated within an existing *Halophila* meadow, it is relatively distant from the influence of the Ross Creek and Ross River (for better comparison with modelled data), and was situated in water depths consistent with the presence of *Halophila* sp. (2.2- 6.17 m below the water surface, mean = 4.01 m). Mean daily PAR was calculated for ease of comparison with established daily light requirement values for seagrass. Fitted relationships were similar at the two locations.

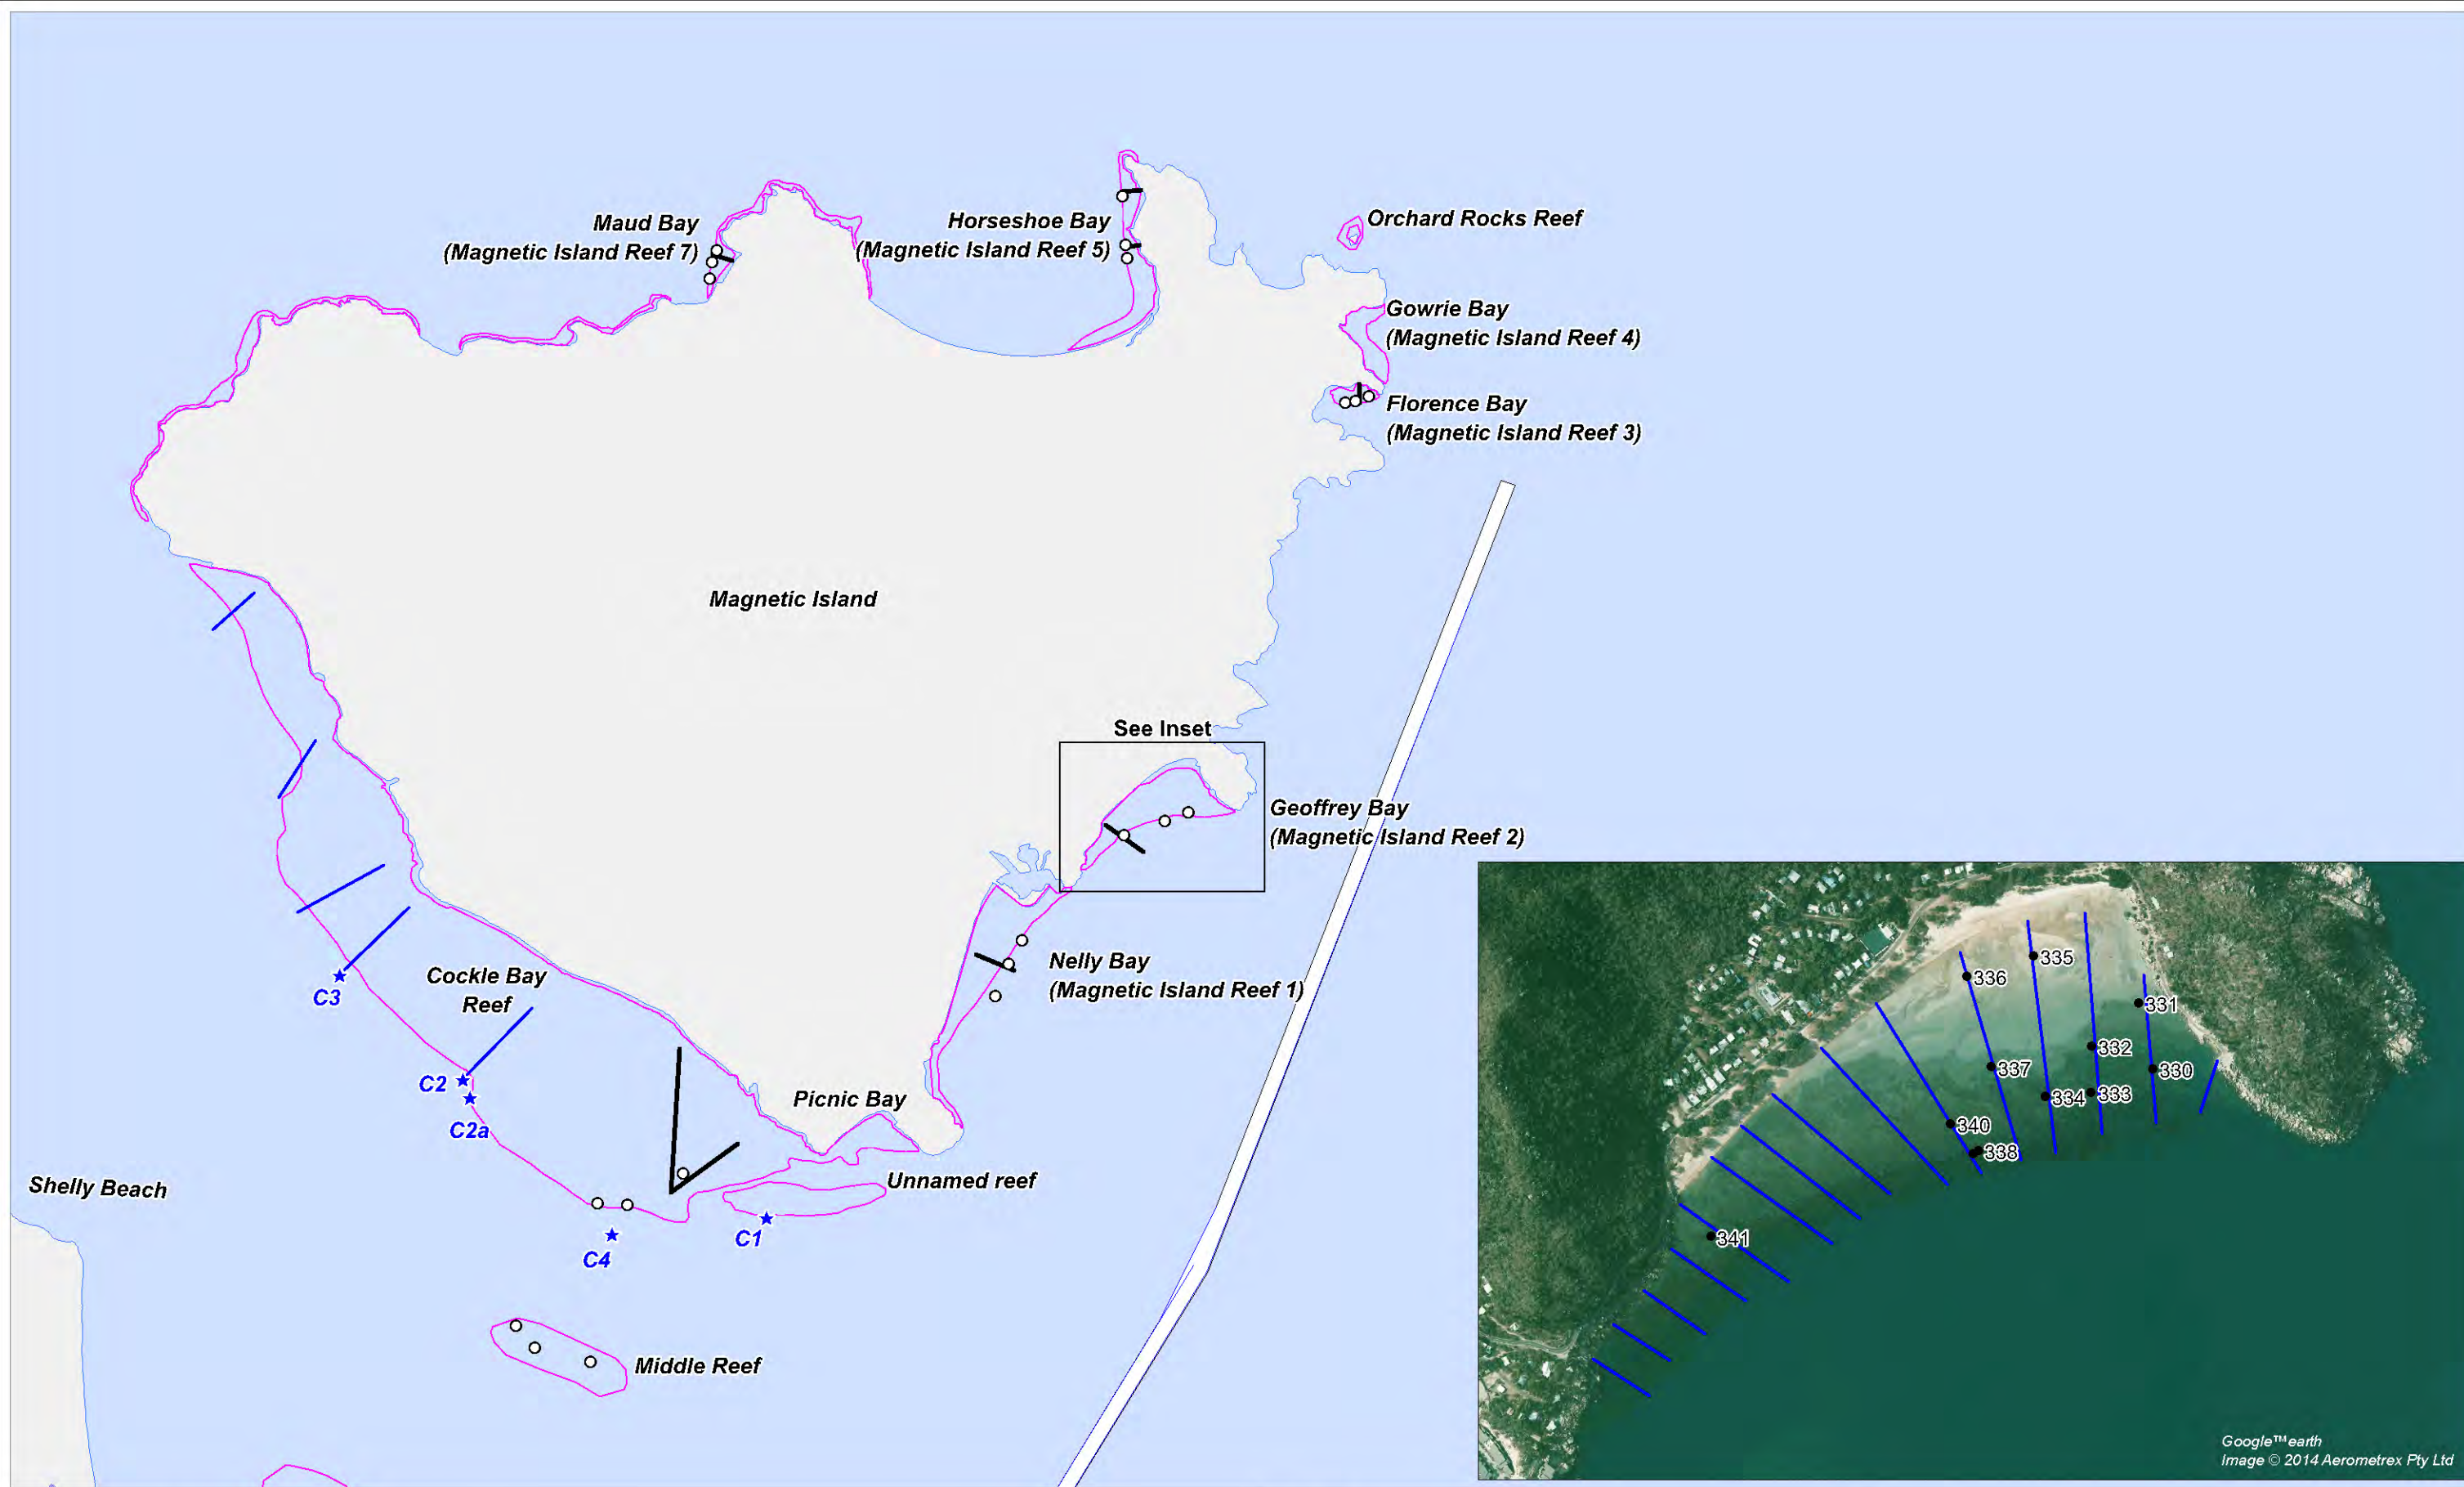
Title: **Locations of snorkel and photo transects surrounding Magnetic Island and Middle Reef**

At Geoffrey Bay, 15 transects (separated by a distance of 70 m) were surveyed by divers on snorkel, covering a total distance of 5 km. The position of transects is shown in Figure 3-1 (see inset). Any features (outcrops of rock or coral) bearing any similarity to stromatolites or microbial mats were photographed, and GPS points were taken using a submersible GPS tethered to a surface float.

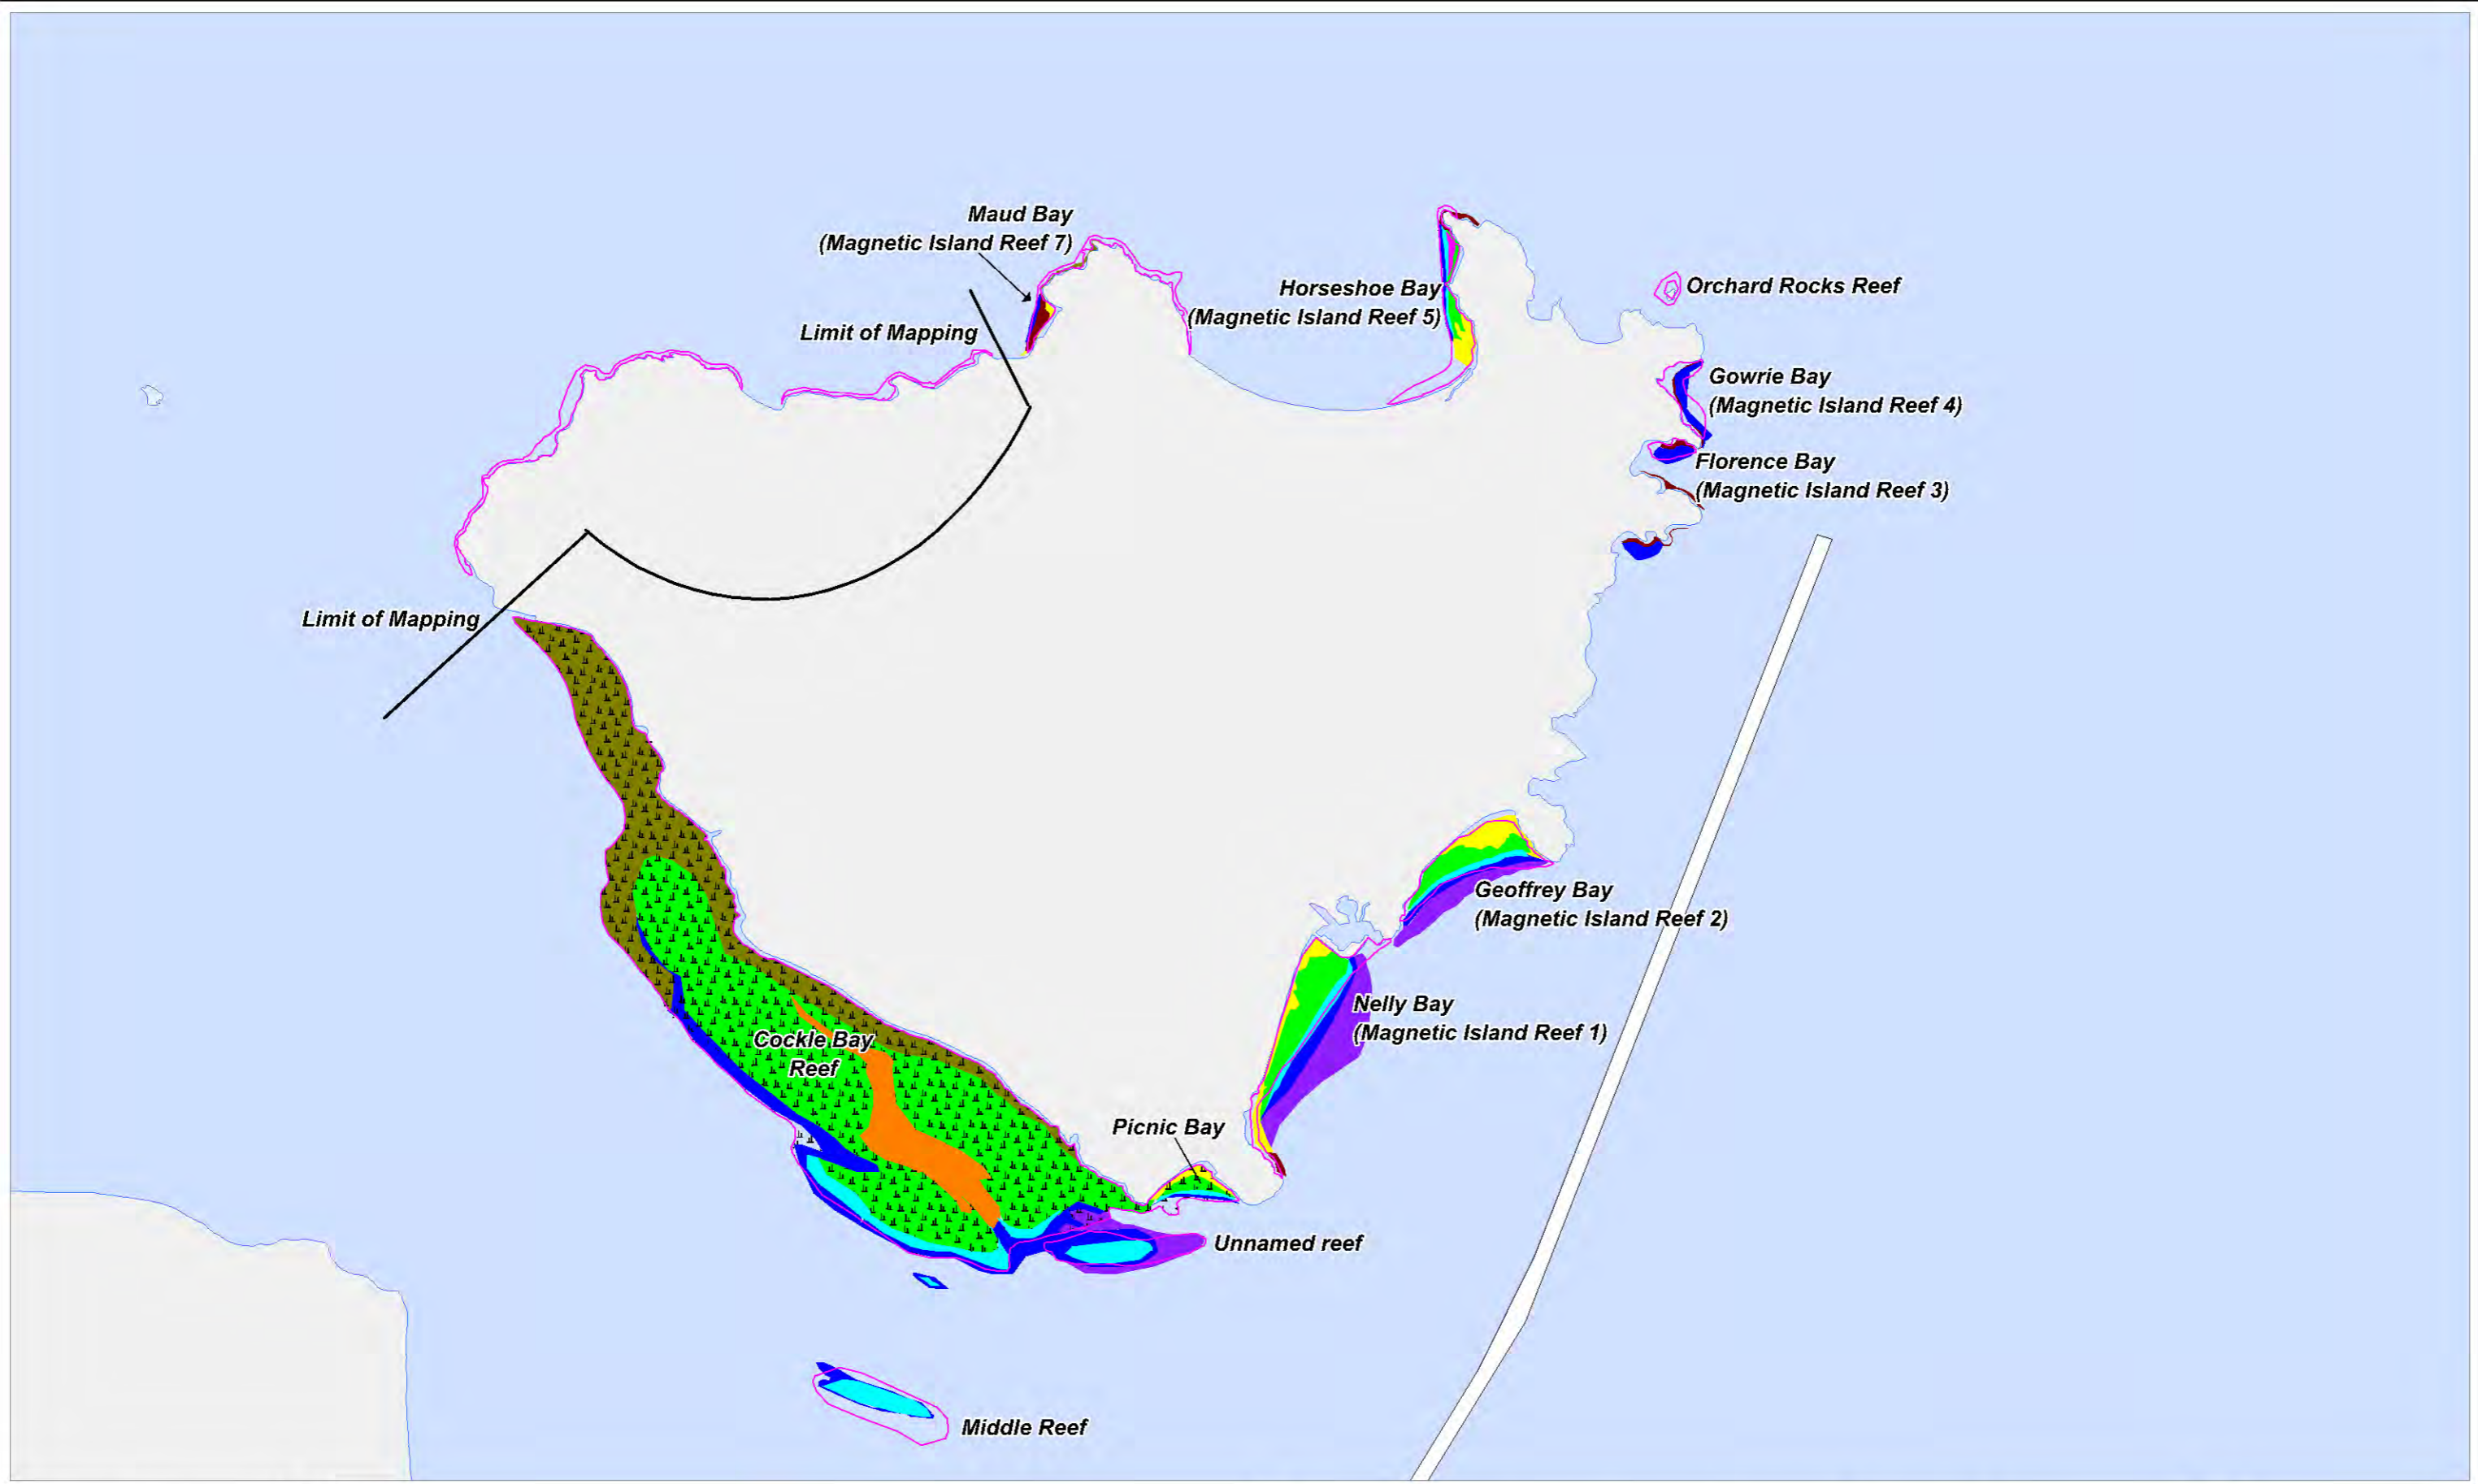
A shallow lagoon (shaded orange in Figure 3-2) was located in the centre of the reef flat, and contained microatolls and occasional coral outcrops. The substrate in this lagoon was composed of sandy mud and seagrass was present in places. The lagoon area appeared to include natural deeper areas as well as deeper sections that may have created or exacerbated by human disturbances such as historic dredging, or altered hydrodynamics associated with the pipeline alignment between Cape Pallarenda and Magnetic Island.

The reef crest at Cockle Bay Reef was structurally similar to that of the reef edge/slope, and often had highly simplified habitat structure. The reef edge had the densest cover of living hard coral, which progressively became less prominent with distance in a north-westerly direction, towards Cape Pallarenda and Rattlesnake Island. There was no distinct reef edge habitat north-west of site C3; instead a low gradient reef flat (with occasional seagrass patches) gradually merged with the seabed. This characteristic is not reflected in the GBRMPA Gazetteer layer for Cockle Bay, but it is identified on the Australian Navigation Chart 256.

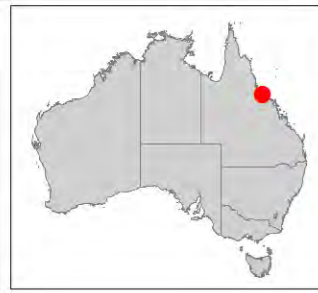
New Channel Extent		Unconsolidated Reef Flat (Sand)
	Coral Reefs (GBRMPA Gazetteer)		Reef Flat with Macroalgae
	Reef Flat with Soft Coral and Algae		Scattered Micro-atolls
	Unconsolidated Mud		"Reef Crest"
	Granite Boulders With Occasional Coral and Algae		Reef Slope/ Edge
	Seagrass Meadow		Occasional Bomboras and Scattered Rubble

Figure 3-2 shows the distribution of different reef habitat types on Cockle Bay Reef.

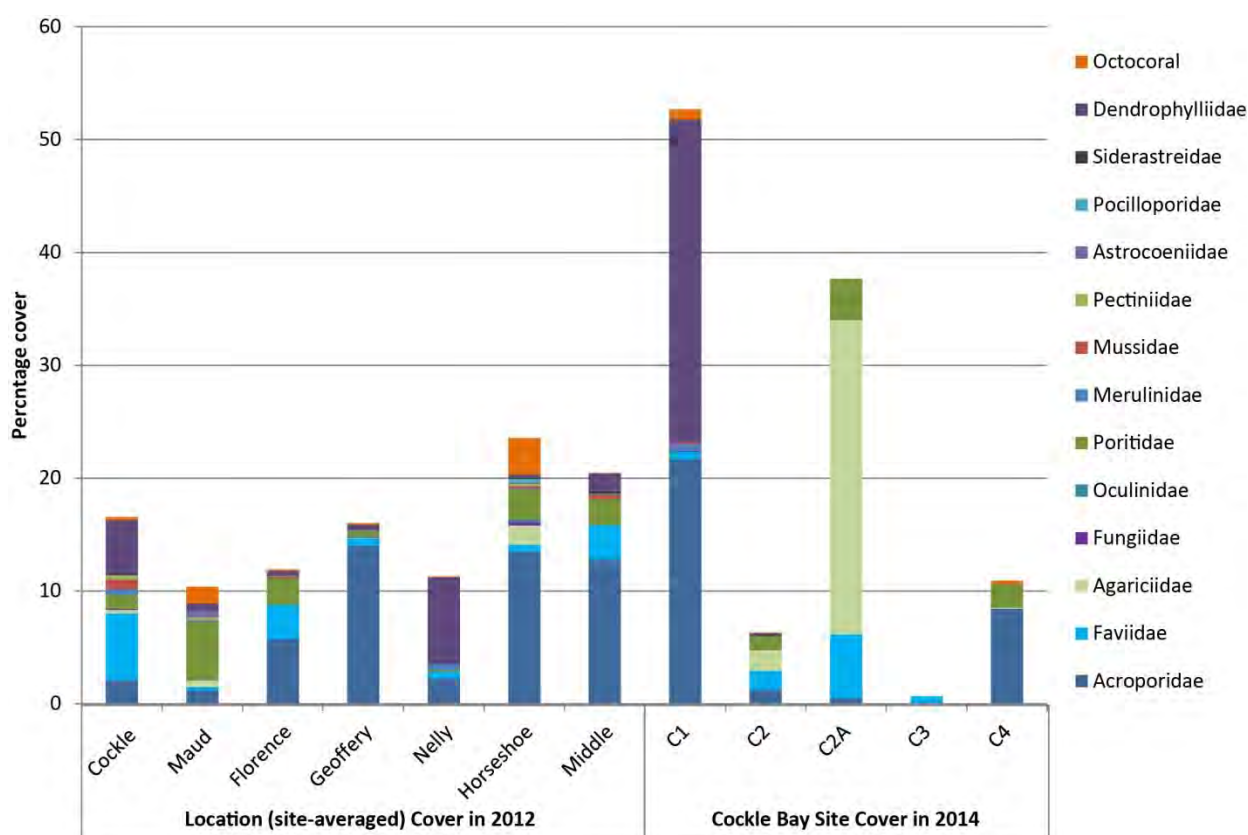
Figure 3-3 Percent cover of living coral at Cockle Bay Reef Sites (C1-C4) and sites visited previously

- Site C2 had low living coral cover and was not dominated by any particular taxa.
- Site C3 was almost devoid of living hard coral cover apart from occasional small colonies of *Goniastrea* and *Favites* (Faviidae).

- Site C4 had approximately 10% coral cover, which was comparable with cover observed at Maud, Florence, and Nelly Bays. Coral cover at Site C4 was dominated by *Montipora* and *Acropora* with occasional *Porites* and *Lobophyllia* (Mussidae) colonies.

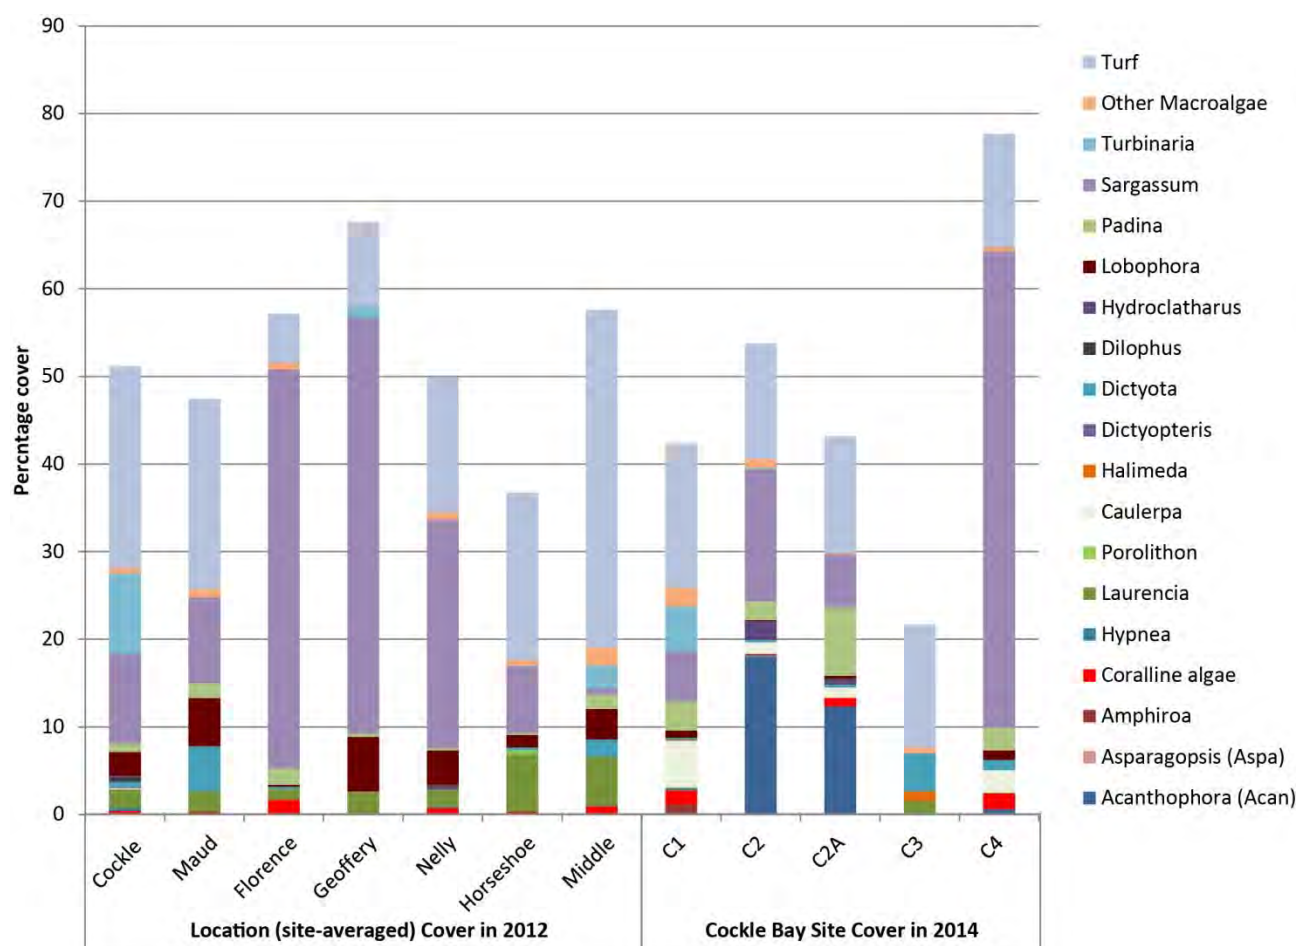
Figure 3-4 Percent cover of macroalgal forms at Cockle Bay Reef Sites (C1-C4) and sites visited previously

Macroalgal communities differed between the previously surveyed sites and the additional sites at Cockle Bay Reef (Figure 3-5). The additional Cockle Bay Reef sites had a higher percentage cover of *Acanthophora* and *Caulerpa* than the sites surveyed previously. *Asparagopsis* was also observed at site C3, which had not been observed previously. *Sargassum* was the dominant macroalgae at most sites, the exception being C3 which lacked suitable hard substrate for holdfast attachment. Otherwise, the additional Cockle Bay Reef sites had *Sargassum* cover that was similar to that observed elsewhere around Magnetic Island.

Differences in macroalgal species present between the two surveys may be related to spatial or temporal differences that have occurred between survey events. Geographical differences in communities may have been the result of a greater influence of catchment runoff at Cockle Bay Reef, alternatively some of the differences in macroalgal communities may simply be explained by broad-scale temporal changes that have occurred since 2012.

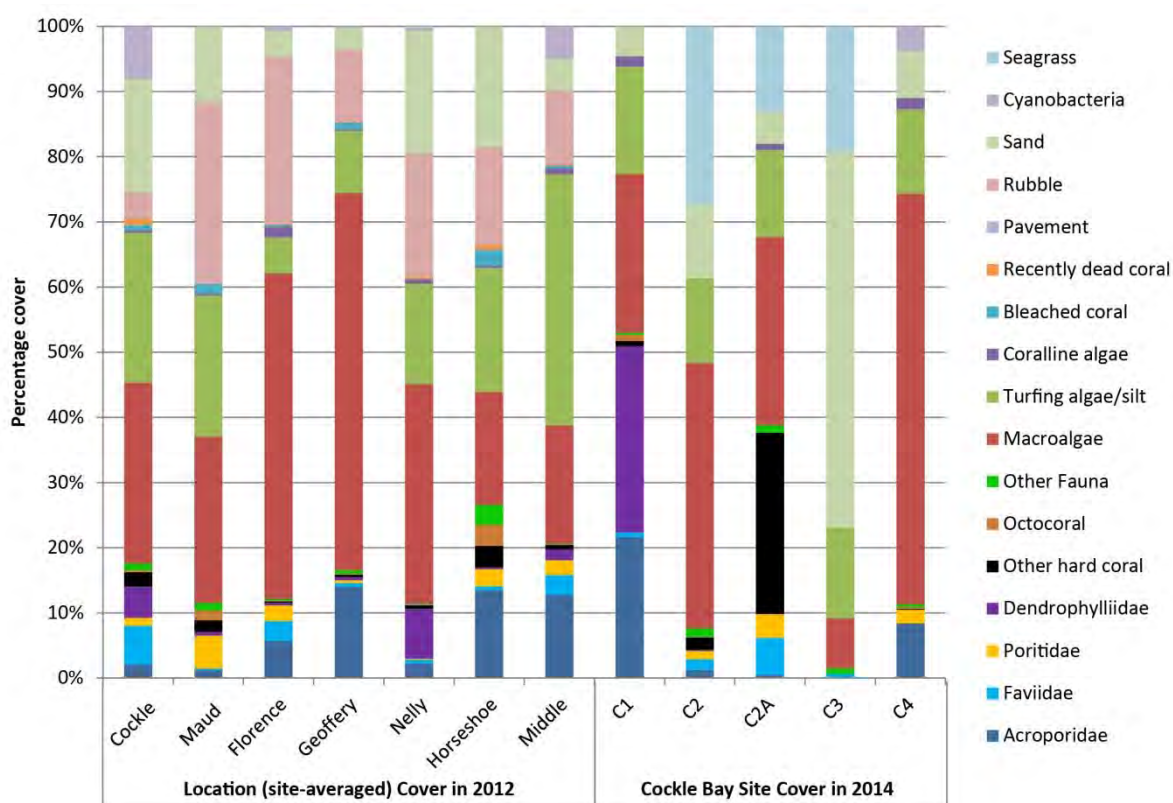
Figure 3-5 Percent cover of major cover types at Cockle Bay Reef Sites (C1-C4) and sites visited previously

Other benthic classes (Figure 3-5) also differed between Cockle Bay Reef sites and other sites surveyed in 2012. Seagrass was abundant at sites C2, C2A and C3 (13-27%), but was uncommon at other reef sites. Sand was a dominant form of cover at Site C3, while macroalgal cover much

lower compared to other sites, reflecting the lack of a clear reef edge and available hard substrates in this area. Unlike the 2012 survey, no coral bleaching was observed at the additional Cockle Bay sites sampled in 2014. This was not unexpected given the difference in season (and water temperature) between the two events; the 2012 survey was conducted in summer while the 2014 survey occurred in spring.

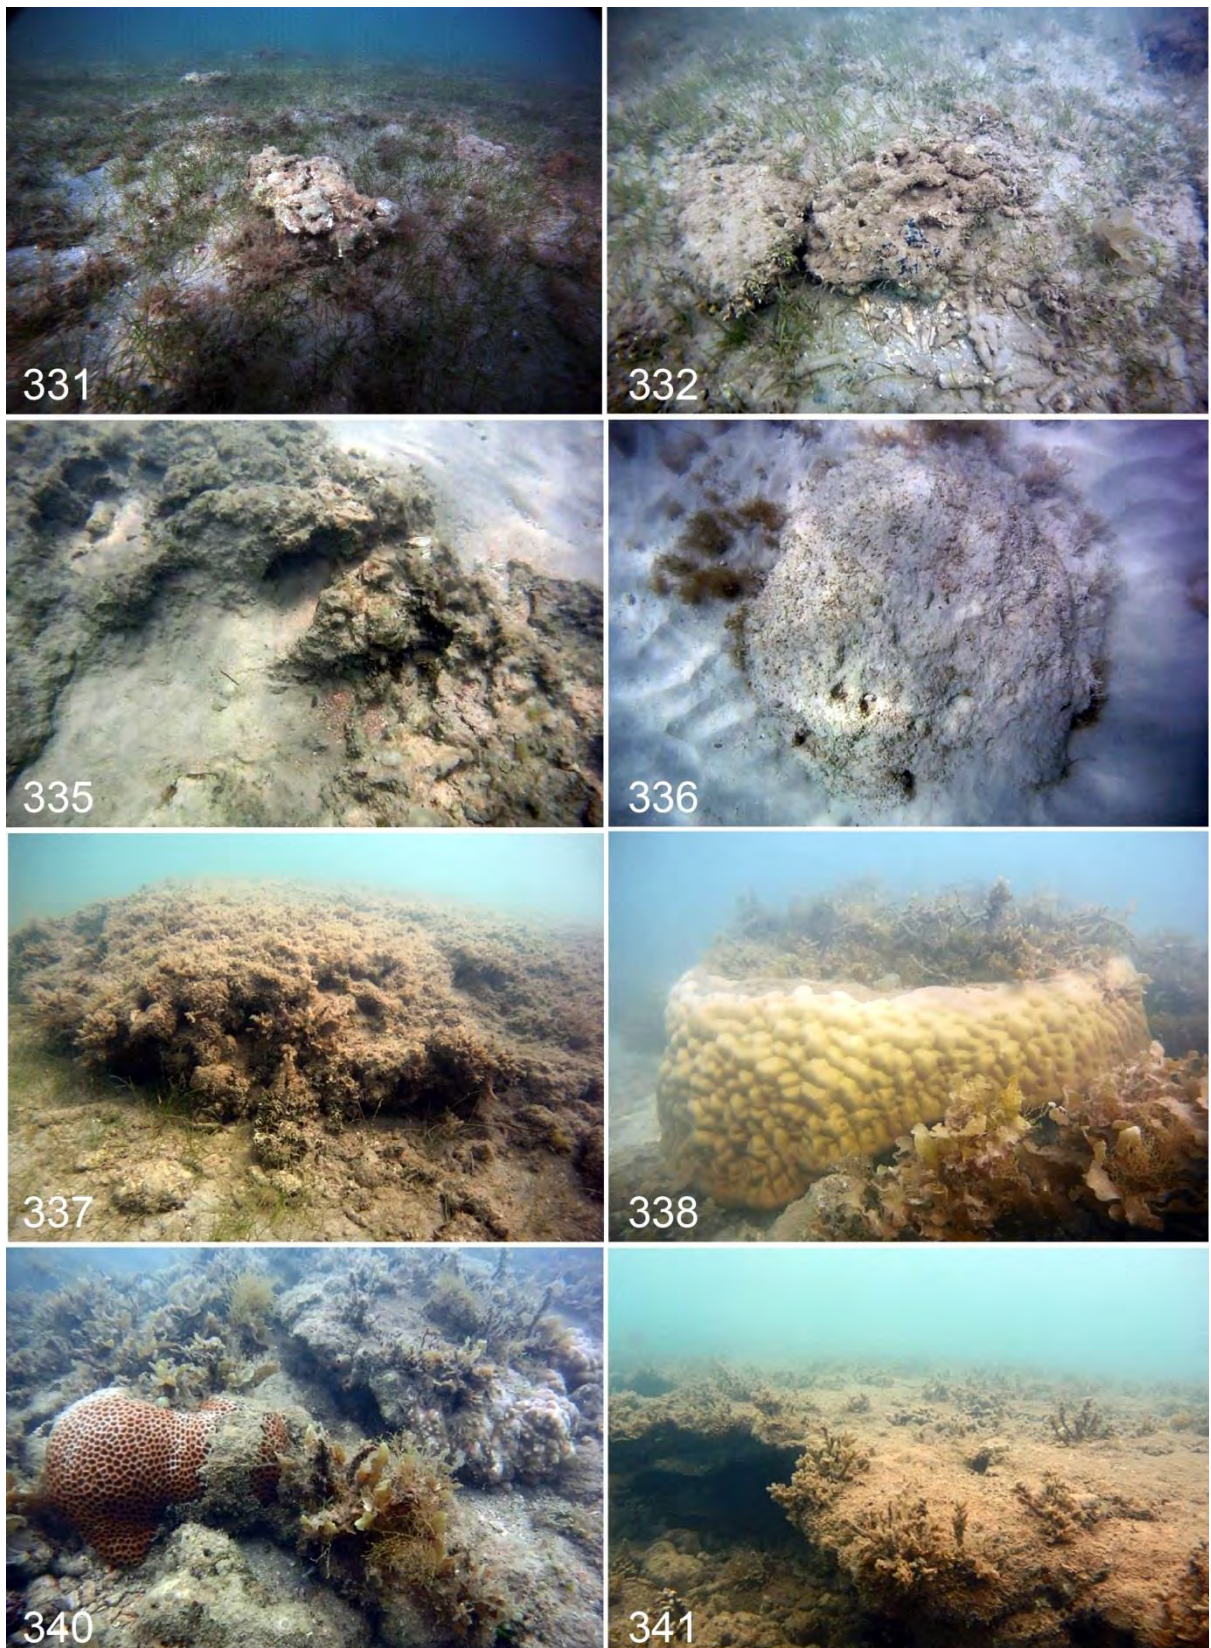
Figure 3-6 Potential stromatolites and microbial mats observed at Geoffrey Bay (see Figure 3-1 for photo locations)

Based on the above information, the presence of stromatolites at Geoffrey Bay is possible but inconclusive. The structures could be either low-profile microbial mounds created by cyanobacteria as suggested by John Talent, or they could be weathered coral microatolls covered in turfing algae and cyanobacteria. Sectioning of rock sample and identification of bacterial lamina would be required in this regard. The structures bear little physical resemblance to stromatolites from Shark Bay or the Caribbean, but have been likened to fossilised structures from the Tethys Sea in modern day Italy (John Talent pers. com. in Farabegoli *et al.* 2007).
