APPENDIX A1

Additional Field Studies for Townsville Port Expansion Project

Additional Field Studies for Townsville Port Expansion Project AEIS

Reference: R.B21057.002.03.AEIS_Additional Field
Studies.docx
Date: March 2016
Confidential

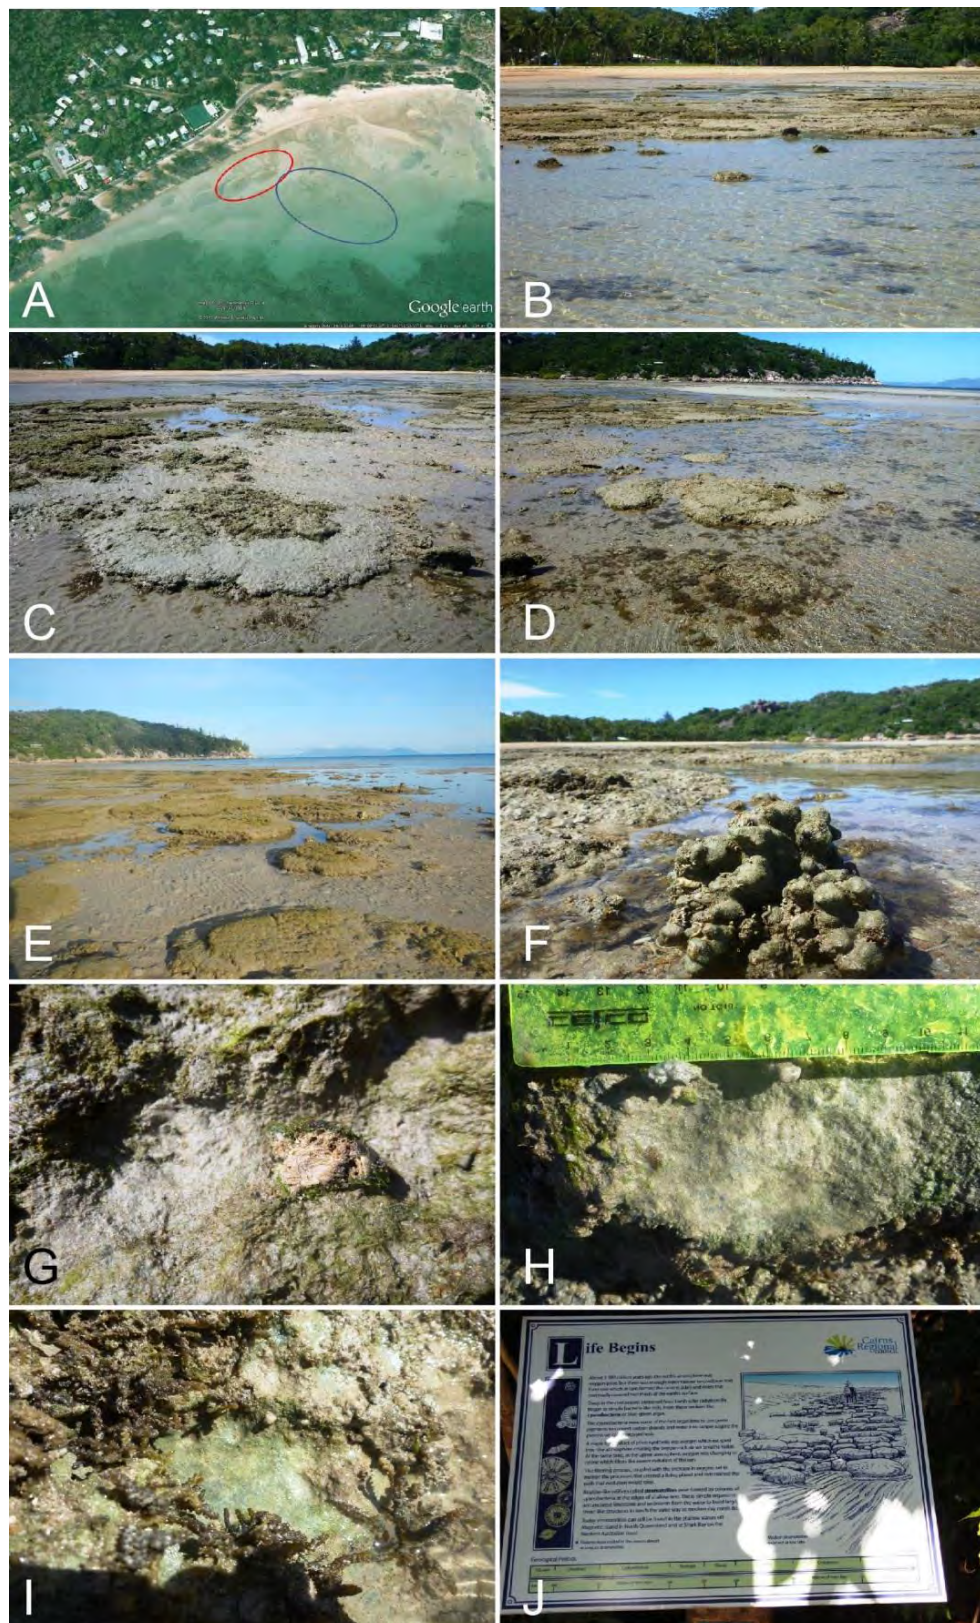
Figure 3-7 Photos of potential stromatolites supplied by Jane Mellors; photo locations (A); structures at low tide (B-E); close-ups (F-I); interpretive signage located in Cairns referencing Magnetic Island stromatolites

Dr Jane Mellors from James Cook University (JCU) was also consulted regarding the status of stromatolites at Geoffrey Bay. Dr Mellors provided information and several photos of structures that are currently the subject of research by JCU researchers.

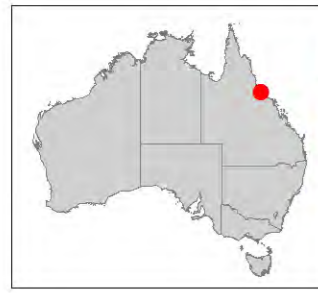
Figure
4-1

- Acoustic Transects**
- Data Points 2010-12
 - Data Points 2014

Of the 15,271 acoustic records collected, 12,995 had cluster confidences >95% and these were retained. Data collection parameters were set to those used in 2011 and 2012. Lines for additional data collection are shown in Figure 4-1. Some new data was collected over the previous line work to better facilitate comparison between the two datasets.

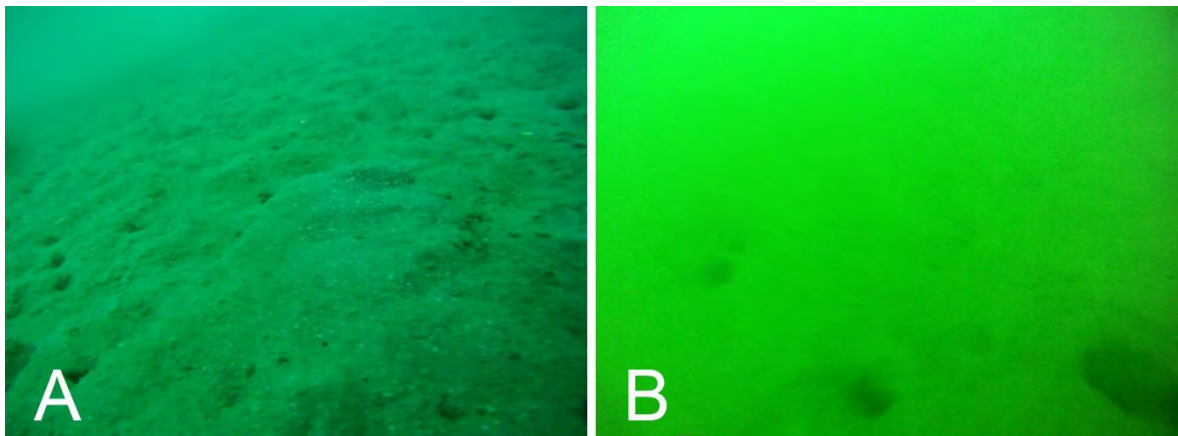
Figure 4-5 Screen captures from the channel widening area: bioturbation with slight surface dimpling at site M7 (A); poor visibility and burrows at site M6 (B).

Sites adjacent to the existing channel area, within the channel widening footprint (M4-M7) had sparse epifaunal communities (Figure 4-5). While visibility was low, conditions were sufficient to determine that sessile epifaunal communities (such as corals and sponges) were absent, with small to medium sized burrows (most likely goby burrows) occasionally observed. These results were similar to that of the EIS, which depicted similar sparse communities over the existing DMPA and channel extension areas.

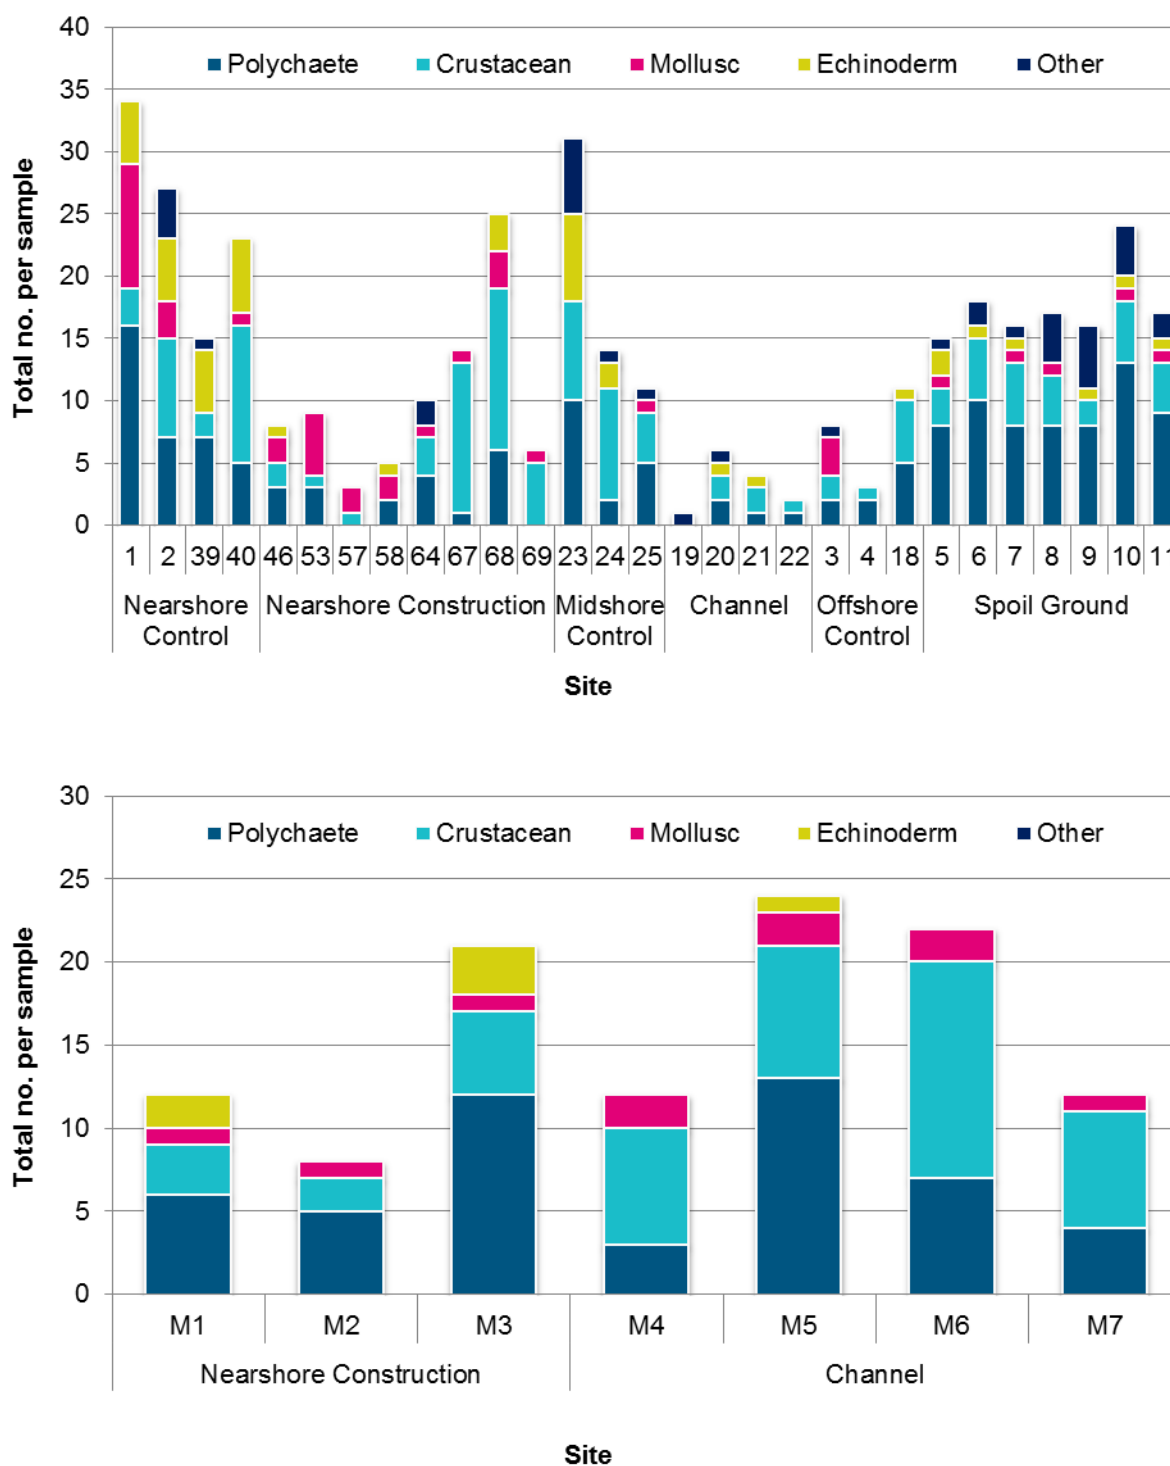
Figure 4-6 Composition of infaunal communities collected in 2012 (above) and in 2014 (below)

Infaunal communities collected during the EIS and in September 2014 had similar compositions of major taxonomic groups with polychaetes and crustaceans generally numerically dominating samples (Figure 4-6). There were substantially more “other” fauna collected during the EIS, and these consisted of peanut worms, sipunculids, blind gobies, and branchiostomids (lancelets).

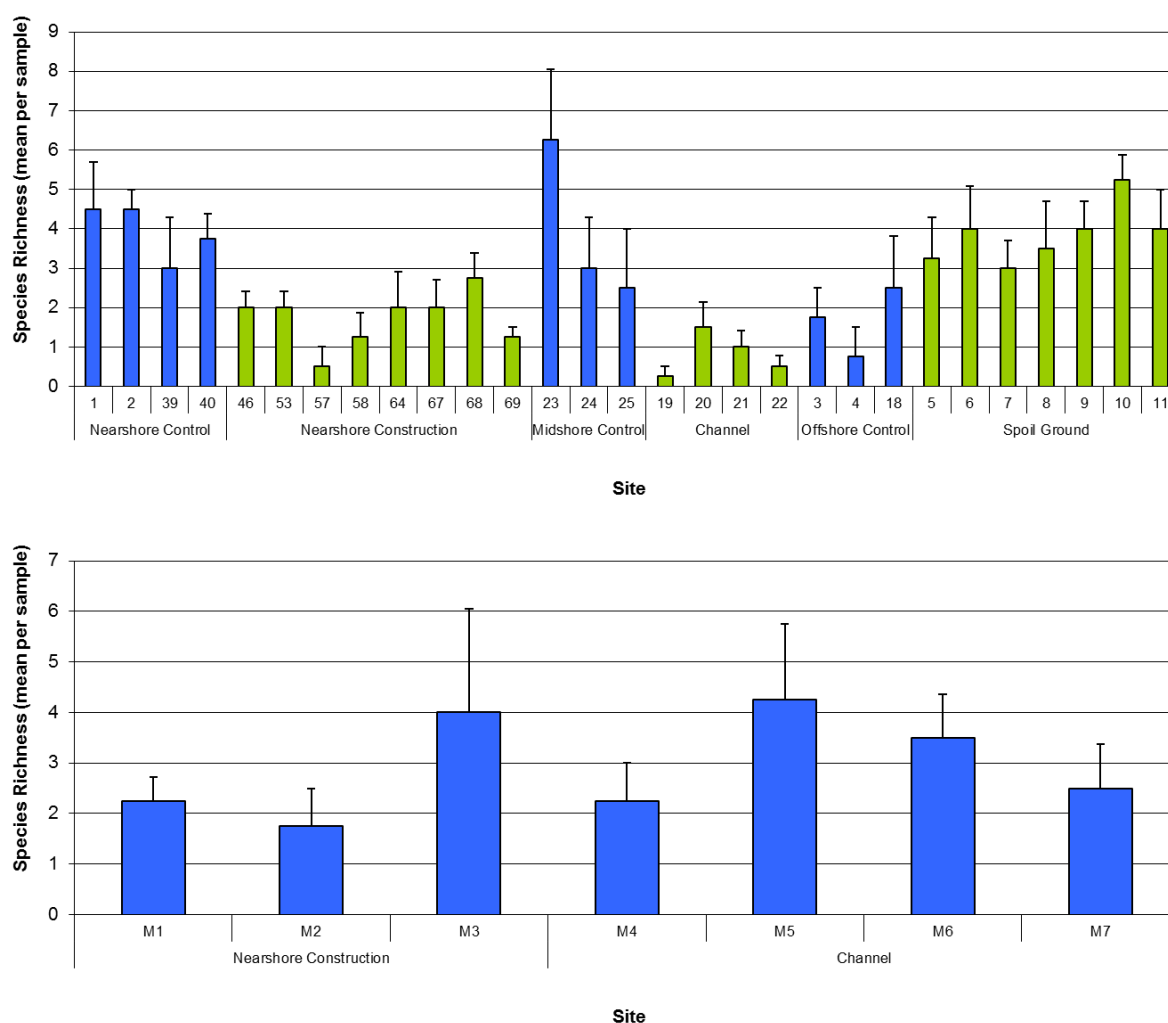
Figure 4-7 Mean (\pm SE) species richness of infaunal communities collected in 2012 (above) and in 2014 (below)

While there were fewer minor phyla observed in the 2014 survey, taxonomic richness was generally similar between the two events, within representative areas (Figure 4-7). The nearshore

construction area had an average of between 2-3 taxa per site in the EIS while taxonomic richness ranged between about 2-4 individuals in 2014. Taxonomic richness was higher in the channel widening area in 2014 than it was in the channel area during the EIS; however, it should be noted that the channel widening area represents a relatively undisturbed habitat compared to the channel area which undergoes maintenance dredging.

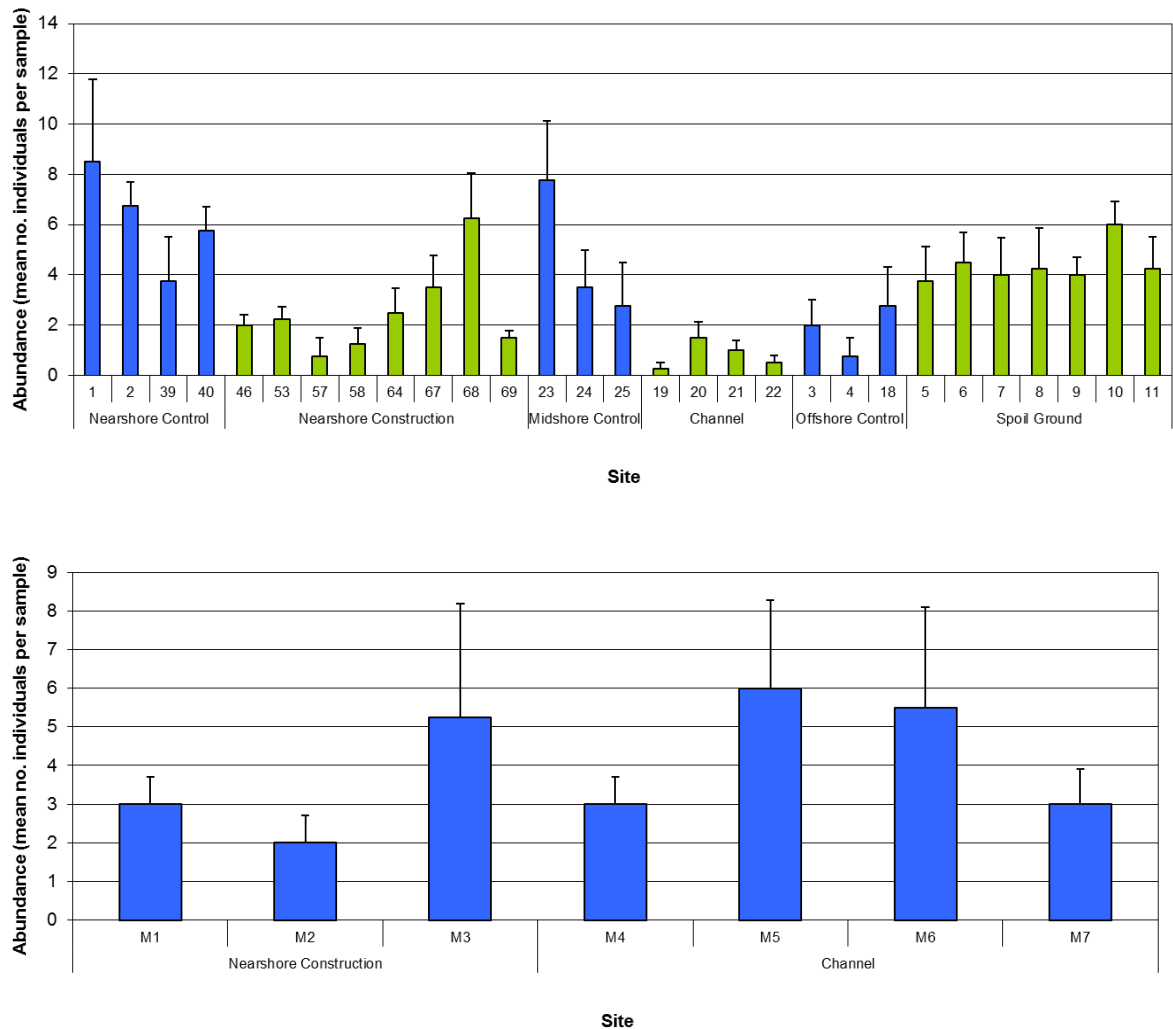
Figure 4-8 Mean (\pm SE) abundance of infaunal communities collected in 2012 (above) and in 2014 (below)

Patterns in taxonomic richness among representative areas and sampling events were very similar to those observed for overall abundance, with the nearshore construction area having the lowest abundance, followed by the channel widening area, and the DMPA had the most abundant communities (Figure 4-8).
