**Wandoan Coal Project:  
Southern Coal Seam Methane  
Water Supply Pipeline,  
Aquatic Ecology Impact  
Assessment**

**PB Australia Pty Ltd**

**frc** environmental

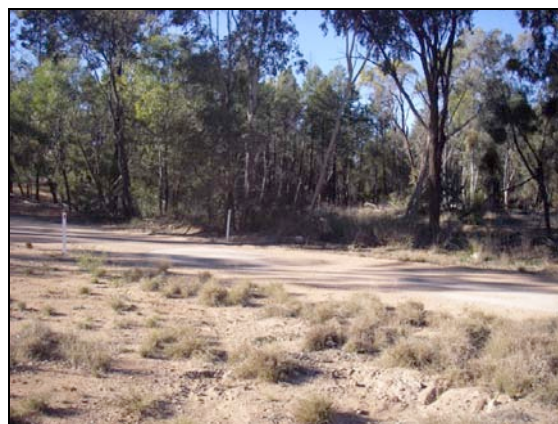
Figure 4.3

The bridge pylons at the crossing of Wallan Creek are unlikely to restrict aquatic fauna movement.

The bridge crossings at Dogwood (site 6), Wallan (site 9) and Eleven Mile (site 10) creeks, are unlikely to restrict aquatic fauna movement, even though debris was noted around the pylons (Figure 4.3). Box culverts are likely to allow reasonable aquatic fauna passage in most cases, but severe scouring downstream of culverts, and accretion and snagging upstream of culverts, is likely to restrict passage on L Tree Creek, and tributaries of Nine Mile and L Tree creeks (sites 13, 15 & 16) (Figure 4.4 and Figure 4.5).

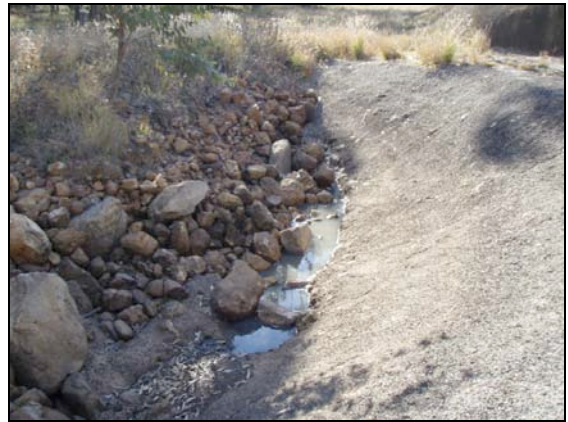
Figure 4.5

Upstream obstructions at the box culvert at L Tree Creek (site 16).

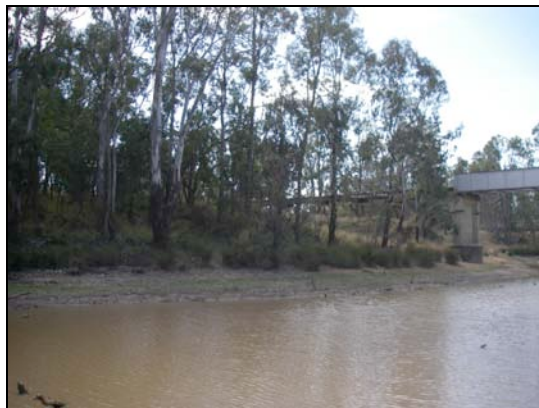
Figure 4.6

Wide and tall riparian vegetation at Dogwood Creek (site 6).

Throughout the study area, riparian zones were generally 10 – 20 m wide, but the riparian zone was more than 30 m wide at Wallan Creek (site 9), Eleven Mile Creek (site 10), Dogwood Creek (site 6) and a tributary to L Tree Creek (site 15) (Figure 4.6). Conversely, riparian zones were almost entirely cleared at tributaries to Eleven Mile and Sandy Flat creeks (sites 8 and 22) (Figure 4.7 and Figure 4.8). Grasses typically dominated the riparian zone of the creeks, although shrubs and trees also grew at most sites.

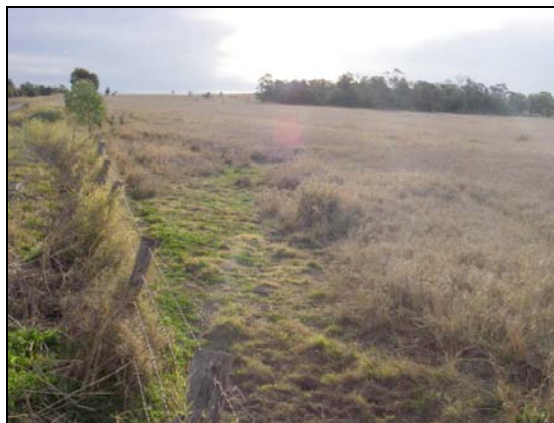
Figure 4.7

Mostly cleared riparian vegetation consisting only of grasses at a tributary to Sandy Flat Creek (site 22).

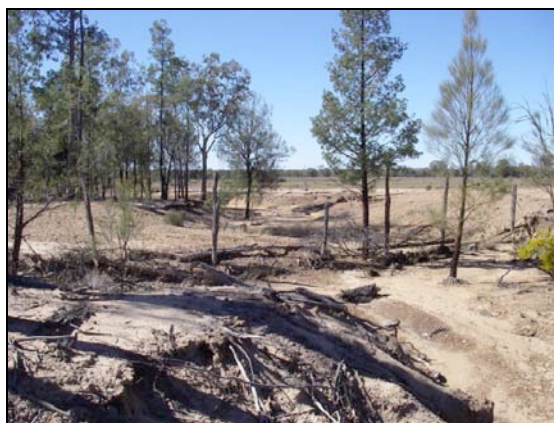
Figure 4.8

Riparian vegetation cleared from the right bank but relatively intact along the left bank at a tributary to Eleven Mile Creek (site 8).

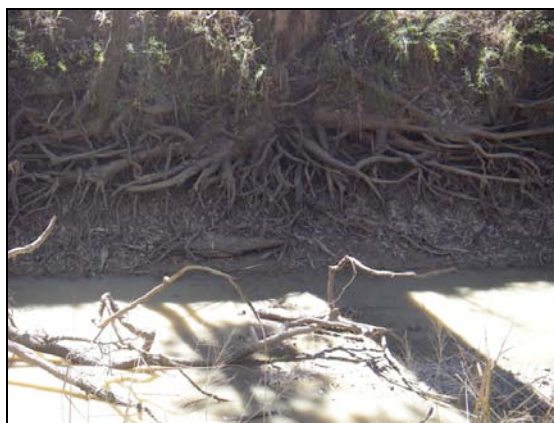
Figure 4.9

Extensive tree root stabilising the bank on Eleven Mile Creek (site 10).

There was considerable bank erosion at most sites in the study area. Vertical banks were common and appeared to be the result of water scouring during periods of high flow. Despite the steep banks, bank stability was often maintained by a relatively high cover of bank vegetation and by the root systems of larger trees (Figure 4.9). On Eleven Mile Creek and its tributaries (sites 10, 11 and 12) and on a tributary to Sandy Flat Creek (site 22) disturbance caused by cattle access was observed (Figure 4.10).

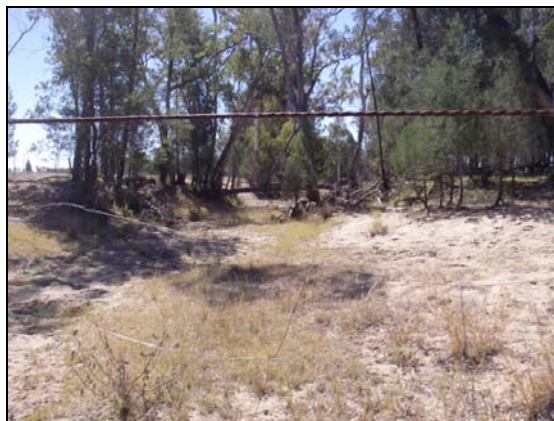
Figure 4.10

Cattle trails collapsing stream banks east of the highway crossing at Eleven Mile Creek (site 12).

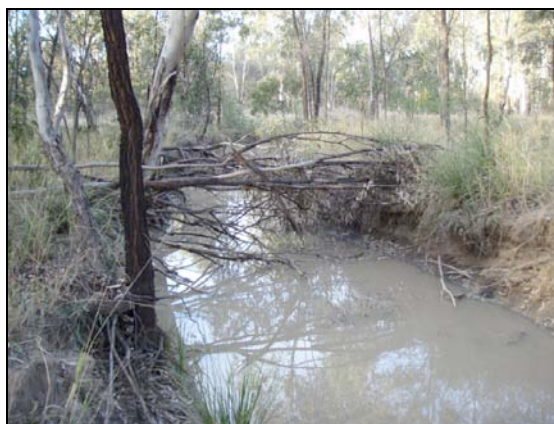
Figure 4.11

Overhanging vegetation, stick piles, and undercut banks at a tributary to L Tree Creek (site 15).

The condition of habitats within streams was variable but some physical aquatic habitat was found at most of the sites. Habitat was generally in the form of small woody debris, fallen logs and tree roots (Figure 4.11 and Figure 4.12). Cobbles, boulders, overhanging vegetation and instream vegetation were also observed, but seldom inundated, at the time of survey. These features would provide in-stream habitat during times of flow or when water levels are higher. At sites surveyed in higher order creeks, there was generally greater habitat availability, as there was more water present and large trees on the banks provided tree roots and fallen branches / logs as habitat (Figure 4.13).

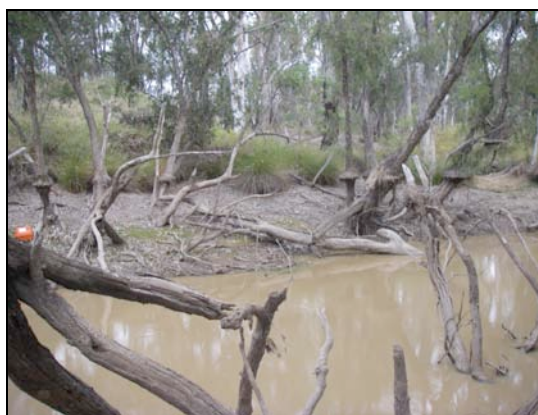
Figure 4.12

Fallen logs at Dogwood Creek (site 5).

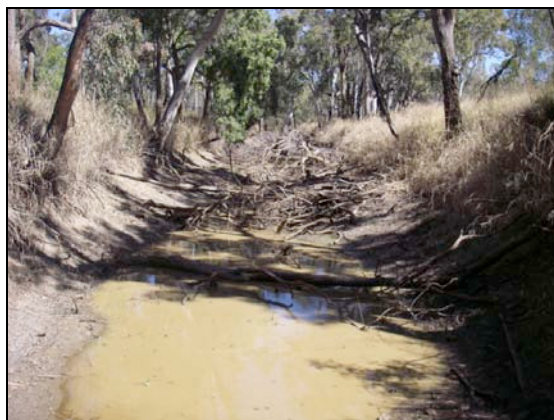
Figure 4.13

Tree roots and branch piles at Wallan Creek (site 9).

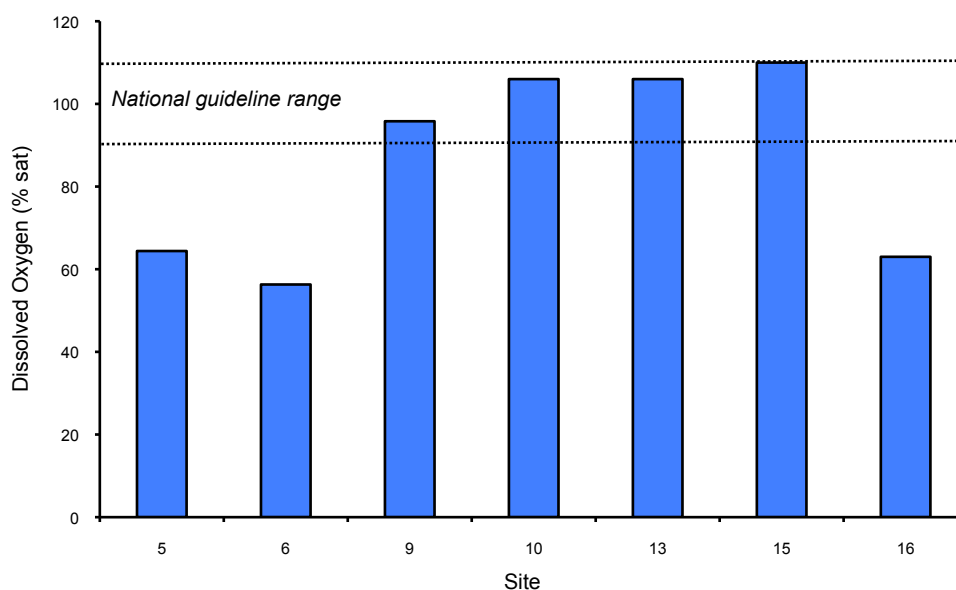
Figure 4.17 Dissolved oxygen at each site that held water along the southern water supply pipeline route, compared with the National water quality guideline for upland rivers (ANZECC & ARMCANZ 2000).

Dissolved oxygen (DO) levels were within the QWQG range in Wallan Creek (site 9), Eleven Mile Creek (site 10) and tributaries to Nine Mile and L Tree creeks (sites 13 and 15), but were below the QWQG range in Dogwood (sites 5 and 6) and L Tree creeks (site 16) (Figure 4.17). Low DO concentrations at Dogwood and L Tree creeks was probably due to high biological oxygen demand, low mixing, and shading.

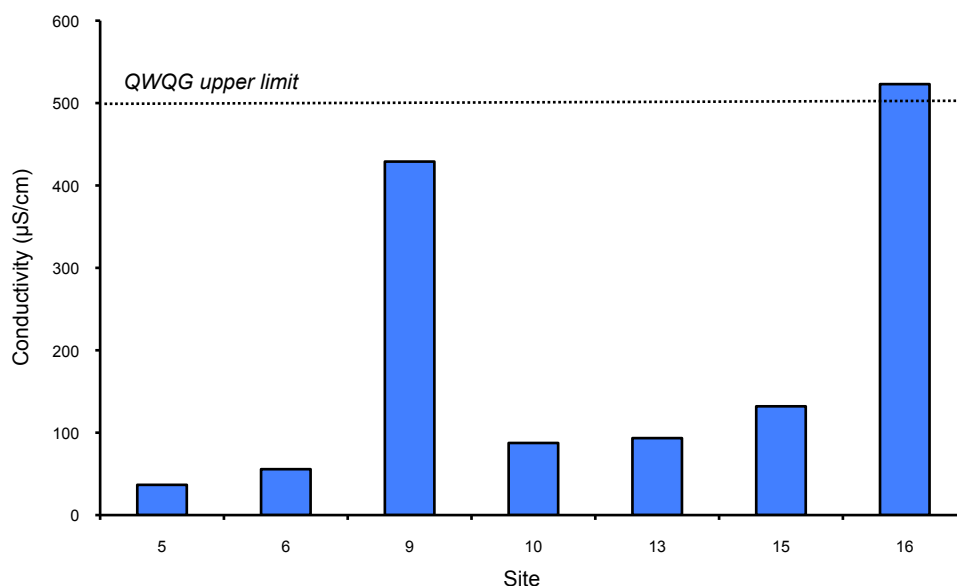
Figure 4.19 Electrical conductivity at each site that held water along the southern water supply pipeline route, compared with the QWQG upper limit for the Murray Darling region (preliminary guideline based on the 75<sup>th</sup> percentile of data from the Fitzroy central salinity zone; EPA 2007a).

Conductivity ranged from 37  $\mu\text{S}/\text{cm}$  at Dogwood Creek (site 5) to 523  $\mu\text{S}/\text{cm}$  at L Tree Creek (site 16) (Figure 4.19). Conductivity was below the QWQG upper limit (EPA 2007a) for all sites except Wallan and L Tree creeks. It should be noted that the QWQG value for conductivity is a preliminary guideline only (EPA 2007a).

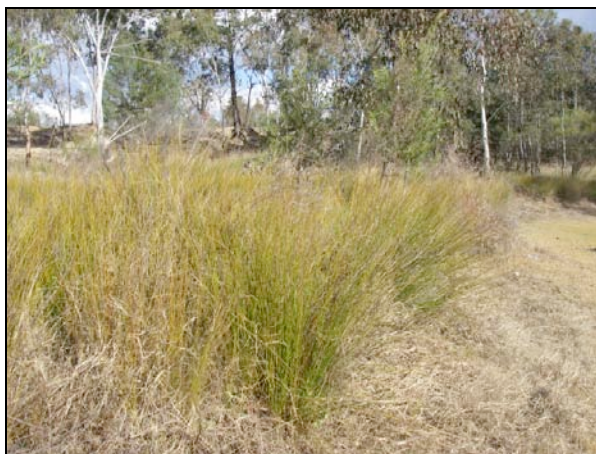
Figure 4.20

Common rush was the most abundant and common macrophyte.

Several macrophytes could only be identified to genus level, due to the absence of seeds or flowers. The most abundant and common macrophyte was the common rush (*Juncus usitatus*), which was present at six of the seven sites where macrophytes were observed (Figure 4.20).

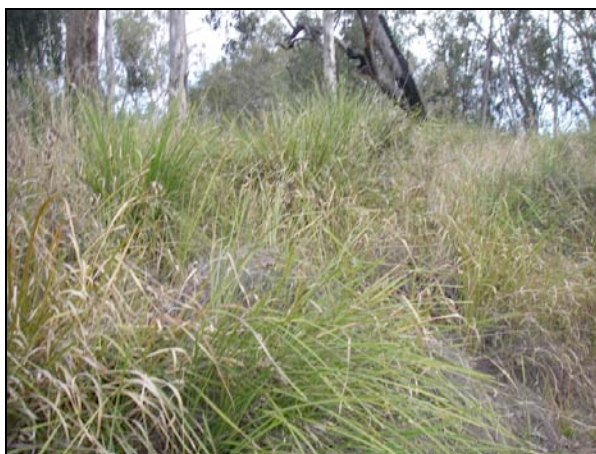
Figure 4.21

*Lomandra* sp. grew on the bank at Dogwood Creek (site 6).

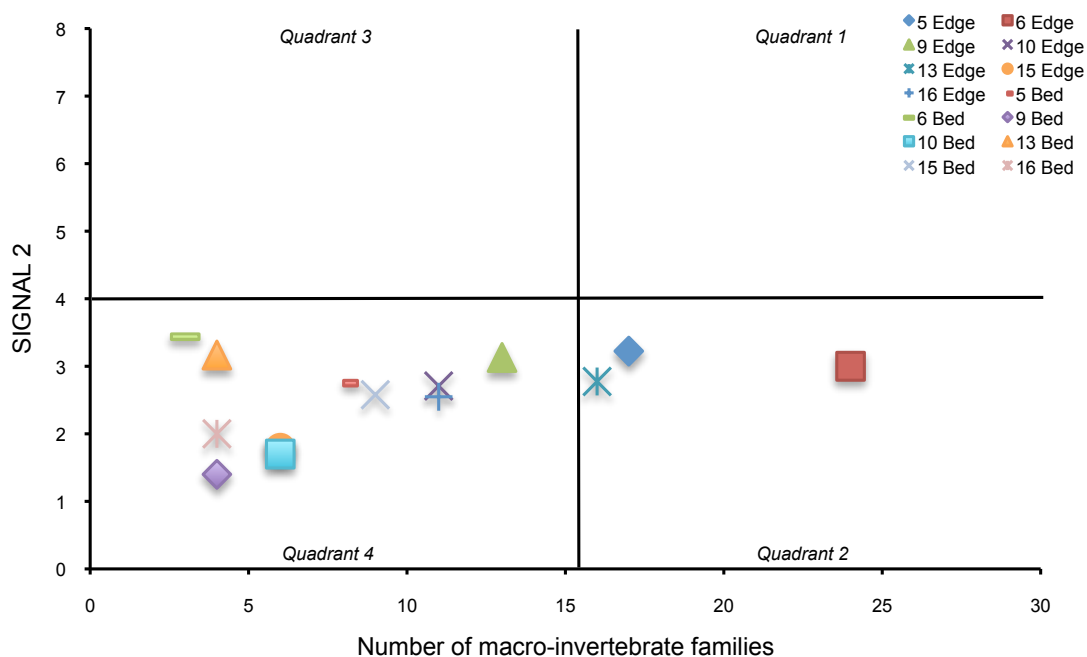
Figure 4.24 SIGNAL 2 / Family Bi-plot for the macro-invertebrate communities sampled from edge and bed habitats in the study area.

It is likely that the waterways of the study area are subject to agricultural pollution (e.g. nutrient enrichment) from the surrounding land uses. However, for ephemeral and intermittent waterways such as those in the study area, the interim boundaries for the SIGNAL 2 / Family Bi-plots may not adequately distinguish sites that are impacted by anthropogenic disturbance from those that are naturally impacted (B. Chessman [NSW Centre for Natural Resources], pers. comm. 2003, 21 October). It is recommended that only limited interpretation should be made of the absolute position of scores within the matrix.

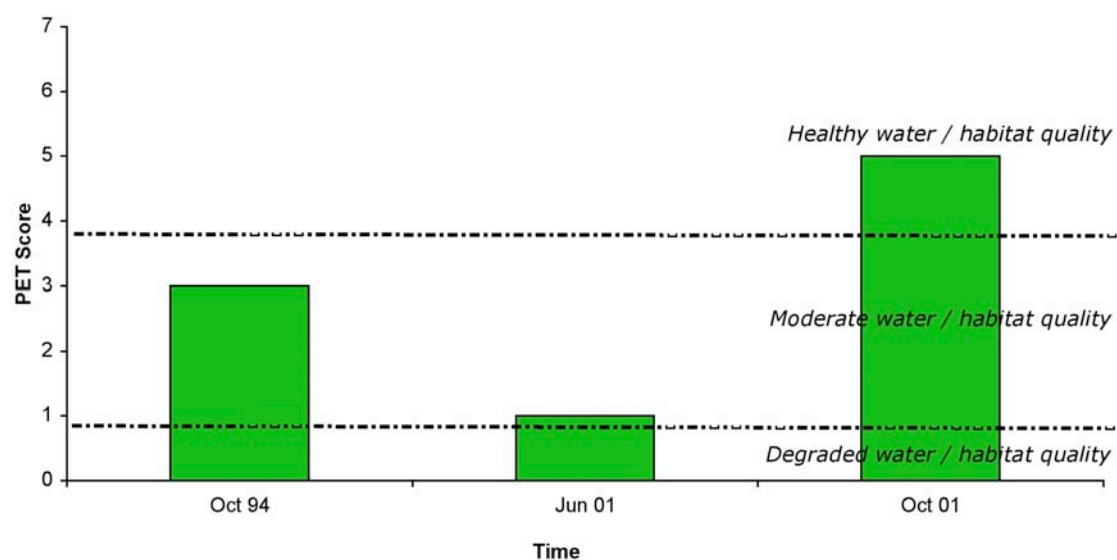
Figure 4.31 PET richness in rocky pool habitat of the Dawson River at Taroom (DNRW site 130302A).

The PET Richness of bed and edge habitats in the Dawson River at Taroom was indicative of moderate to good habitat and / or water quality (Figure 4.30 – Figure 4.32). PET Richness varied over time, but was generally higher than the PET richness that has been recorded in the Juandah Creek Subcatchment (see Aquatic Ecology Technical Report of Chapter 17B in Volume 1).

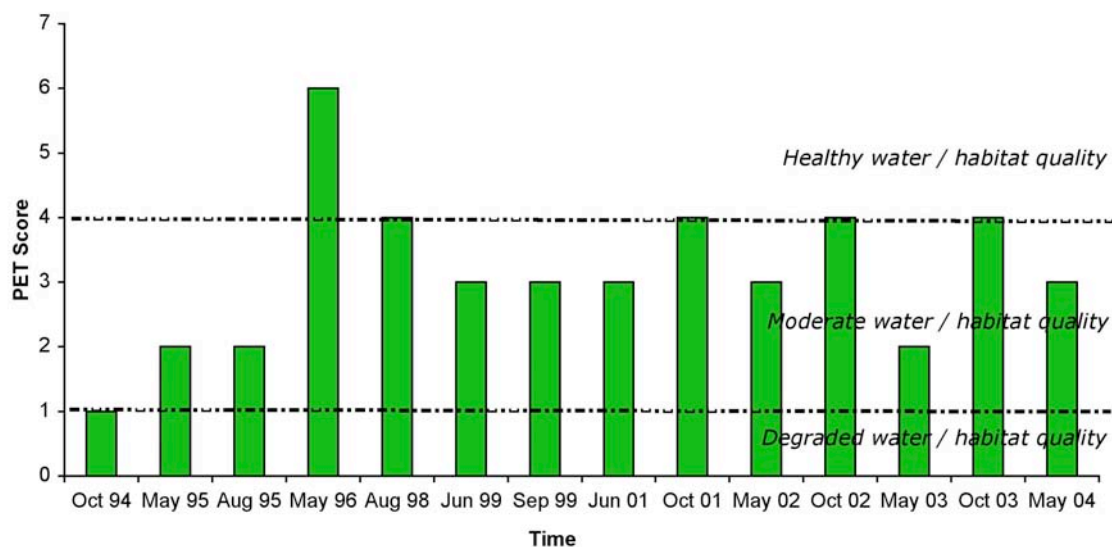
Figure 4.32 PET richness in edge habitat of the Dawson River at Taroom (DNRW site 130302A).

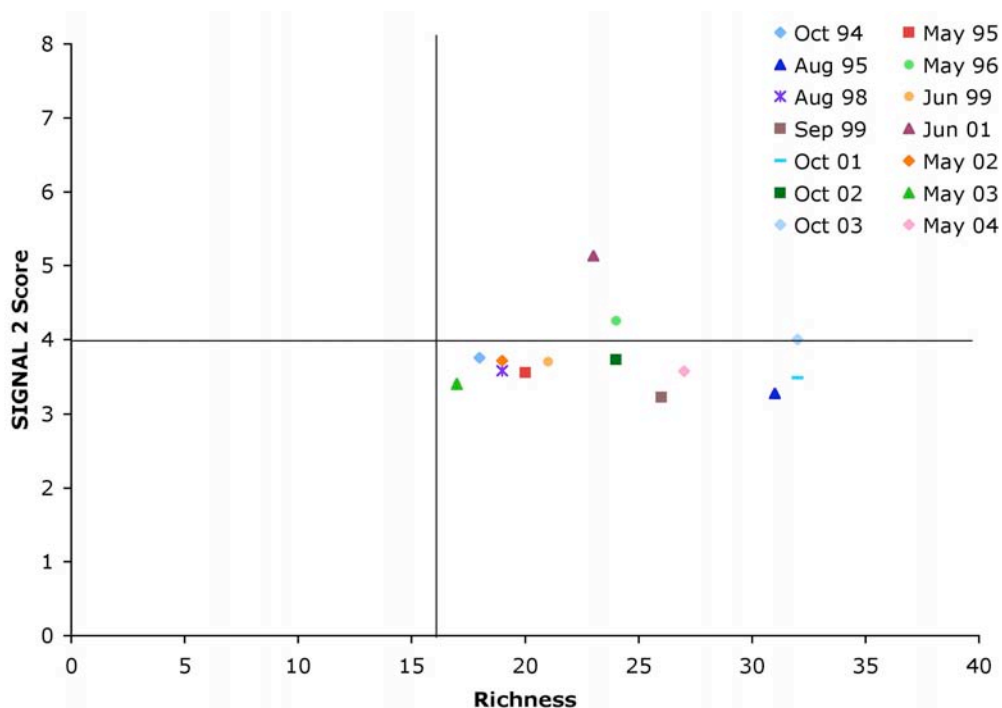
Figure 4.35 SIGNAL 2 / family bi-plot for edge habitat of the Dawson River at Taroom (DNRW site 130302A).

The SIGNAL 2 / family bi-plots for communities sampled from the Dawson River are indicative of fair to good habitat and water quality in the Dawson River at Taroom. However, the macro-invertebrate communities may be affected by high nutrient or salinity levels, urban or agricultural pollution, and / or harsh physical conditions (Figure 4.33 – Figure 4.35; Attachment B). Similar results would be expected for the waterways within the Juandah Creek Subcatchment that are crossed by the southern CSM water supply pipeline route.

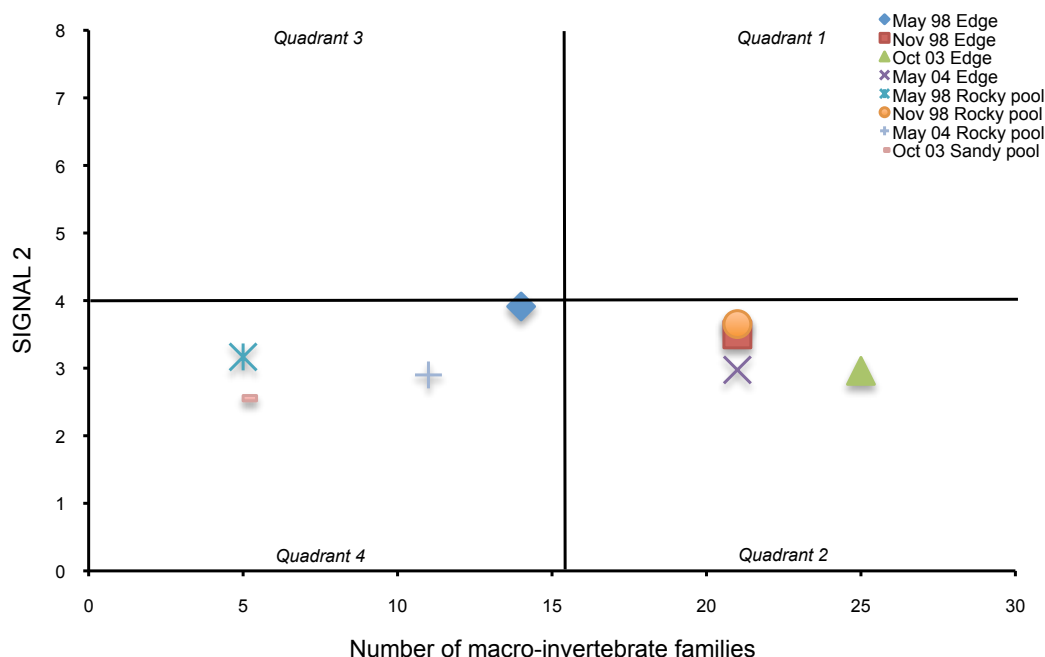
Figure 4.38 SIGNAL 2 / family bi-plot for edge, rocky and sandy pool habitats of Dogwood Creek at Paradise Crossing (DNR&W site 4222059).

The SIGNAL 2 / family bi-plots for communities sampled from Dogwood Creek are indicative of poor to fair habitat and water quality in the Condamine River. The macro-invertebrate communities may be affected by high nutrient or salinity levels, urban or agricultural pollution, and / or harsh physical conditions (Figure 4.38; Attachment B).

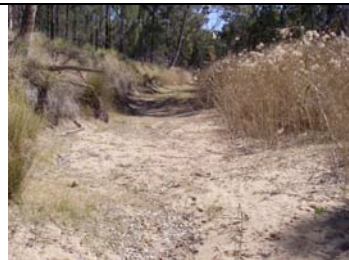
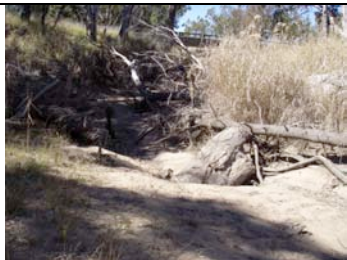
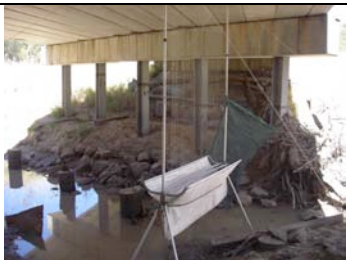
<b>08.06.11 Wandoan South</b>	<b>Wallan Creek</b>	Cond.
	Survey Date: 15-08-08 Written By: TS Date Issued: Sept 2008 Approved By: LT	frc site number 9 UTM Zone 56K 215747 E 7058513 N WGS84

View upstream through the site (15-08-08)	View downstream through the site (15-08-08)	Macrophytes at the site (15-08-08)	Bat trap under a bridge at the site (15-08-08)

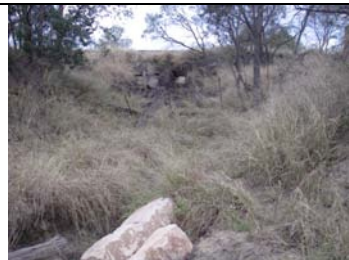
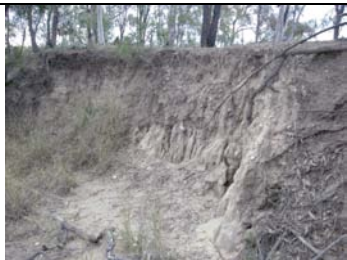
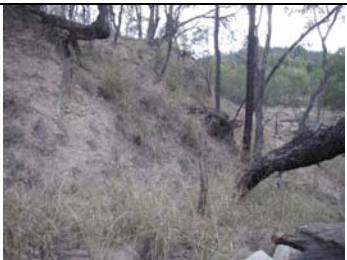
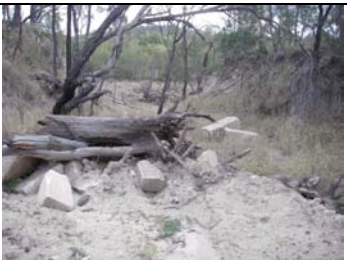
Written By:	TS	Approved By:	LT	
	Date Issued:	Sept 2008	UTM	Zone 56K 206115 E 7074312 N WGS84

View upstream through the site (14-08-08)	View of right bank (14-08-08)	View of left bank (14-08-08)	View downstream through the site (14-08-08)
