Australia Pacific LNG Project

Attachment 8: Preliminary Site Investigation - Land Contamination Report - Gas Fields

Executive summary

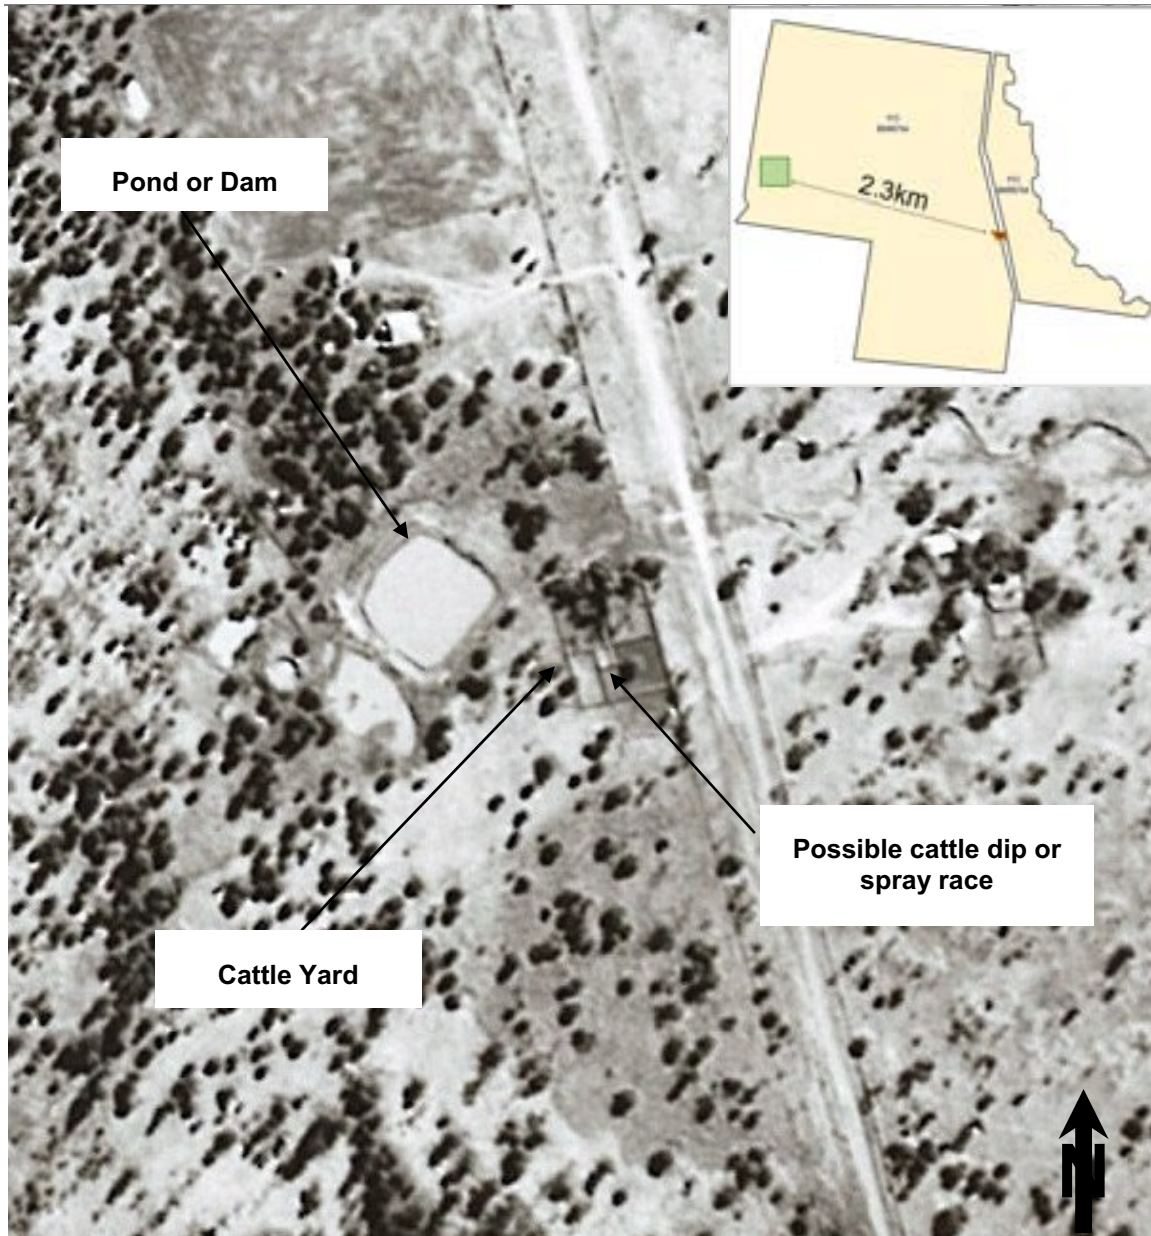
Plate 4.1 Cattle yard located on Lot 113 BWR754 (1956)

The cattle yard contains a rectangular roofed structure which could be a cattle dip or spray race. The yard is also isolated from residences and a water source is nearby (refer Figure 2).

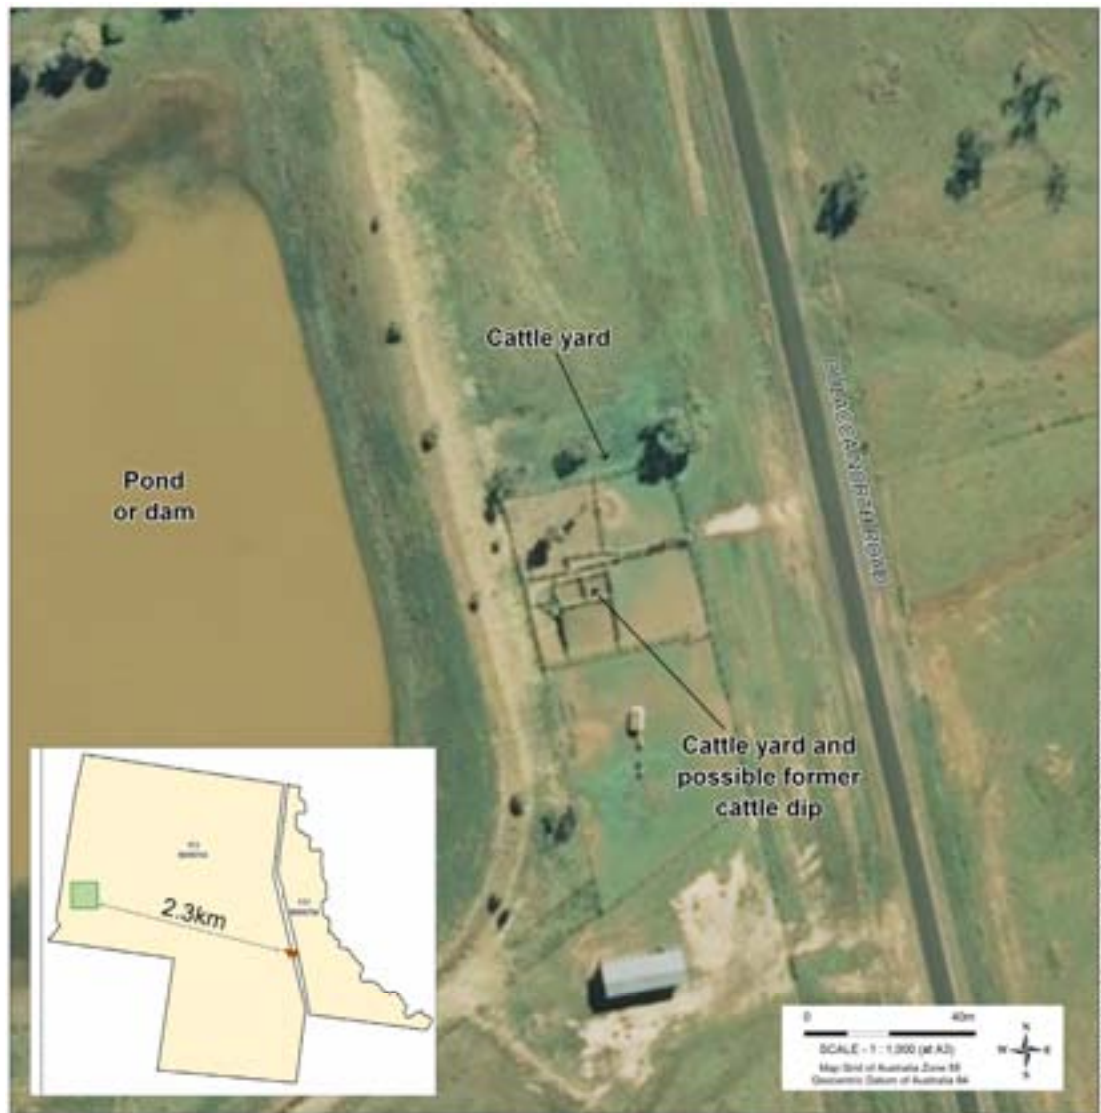
Plate 4.2 Cattle yards located on Lot 113 BWR754 (2007-2008)

The configuration of the cattle yard has slightly changed from the 1956 photograph and the roofed structure is no longer present. A cattle crush is present for directing cattle in and out of the yard. This cattle yard is located approximately 2.3km east-south-east of a proposed gas production facility (refer Figure 2). The cattle yard is not likely to pose a contaminated land concern for the construction of the proposed facility. Further investigation of the cattle yard for potential contamination is not considered necessary.

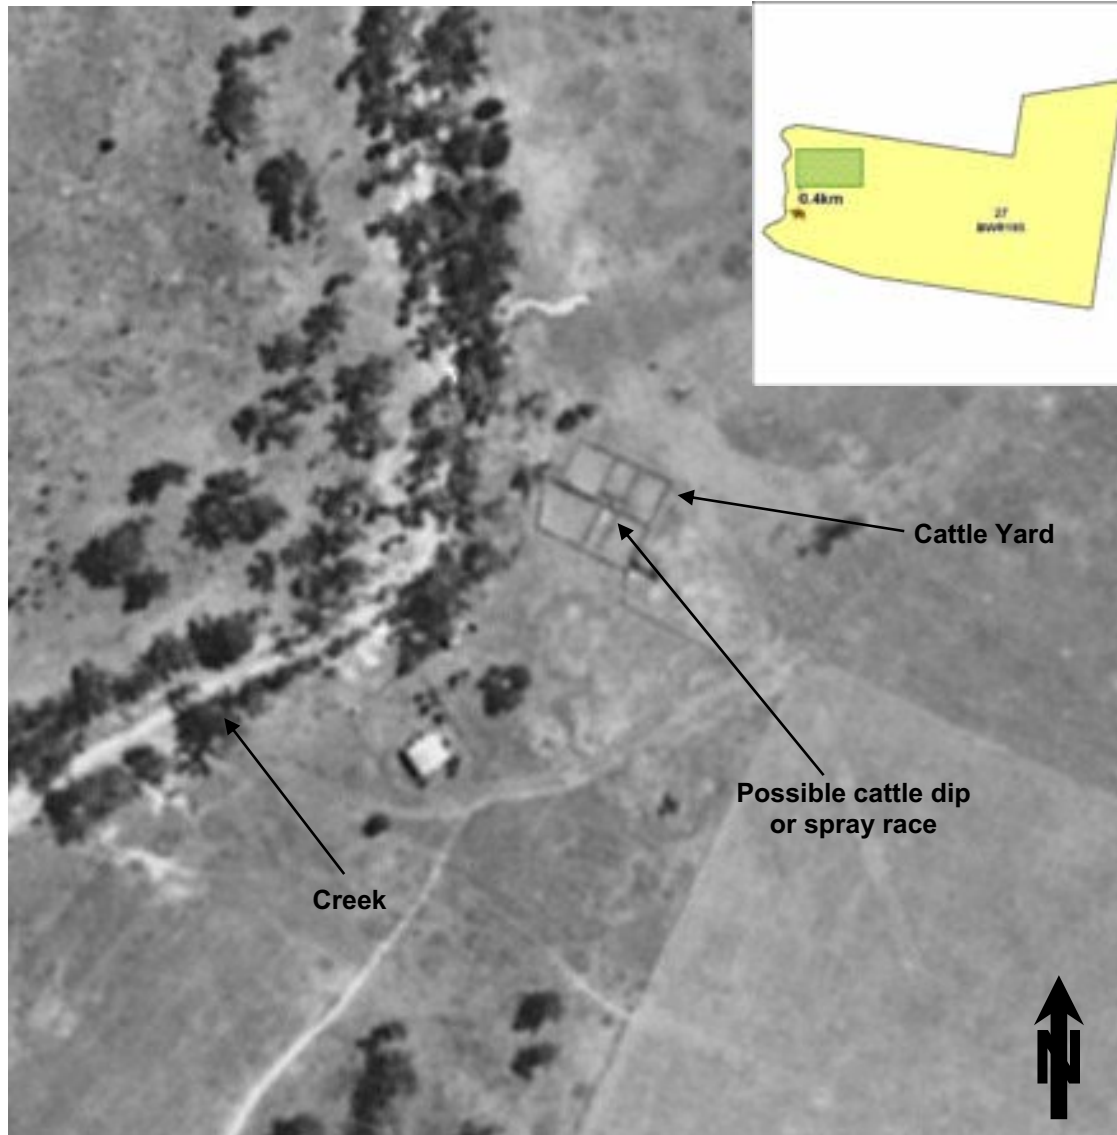
Plate 4.3 Cattle yard located on Lot 27 BWR195 (1962)

The cattle yard is isolated and near a creek and there is a rectangular structure present which could be cattle dips or spray races. The cattle yard is located approximately 0.4km south of a proposed gas production facility (refer Figure 2). The cattle yard is not likely to pose a contaminated land concern for the construction of the proposed facility. Further investigation of the cattle yard for potential contamination is not considered necessary. Note that there were no 2007-2009 satellite images available for review for this area.

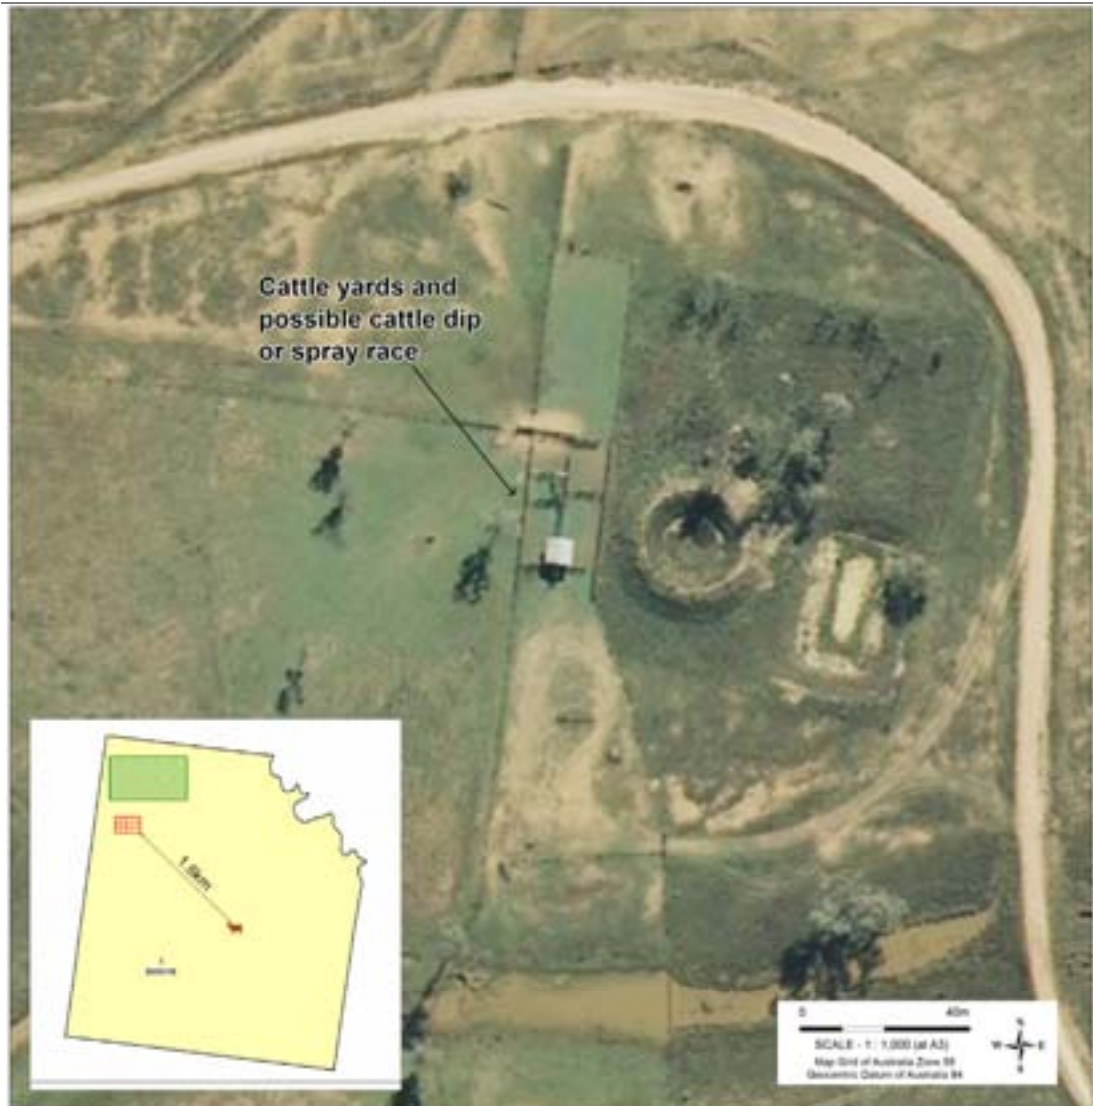
Plate 4.4 Cattle yard located on Lot 5 BWR748 (2007-2008)

The cattle yard appears aged and is isolated from residence. There is a roofed structure present which could be for shading. The cattle yard is located approximately 1.6km southeast from a proposed water transfer network (refer Figure 2). The cattle yard is not likely to pose a contaminated land concern for the construction of the proposed facility. Further investigation of the cattle yard for potential contamination is not considered necessary.

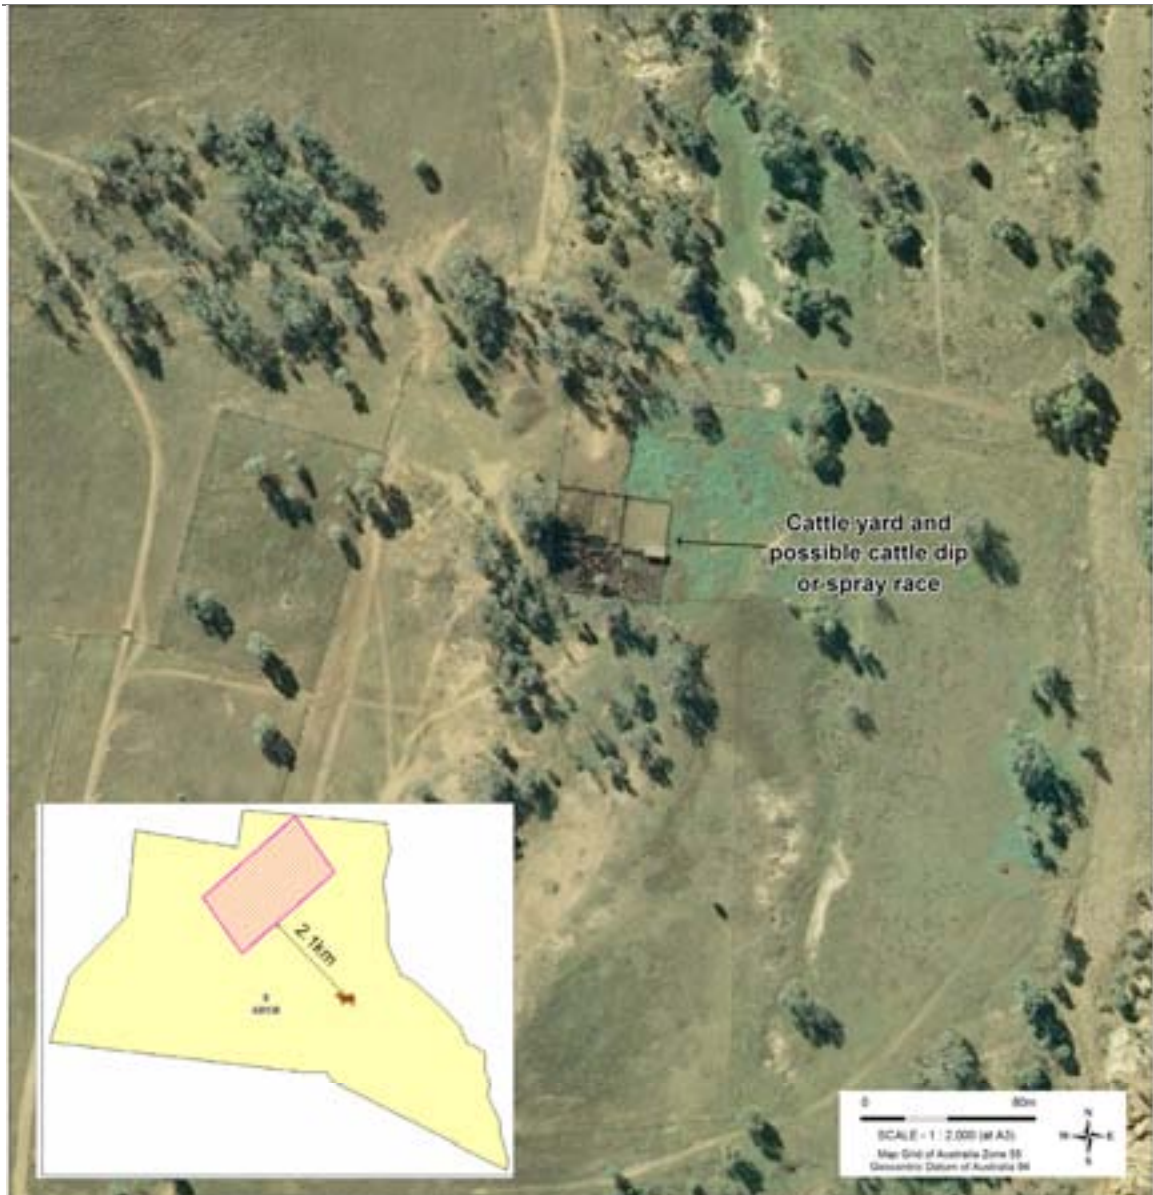
Plate 4.5 Cattle yard located on Lot 8 AB138 (2009)

The cattle yard appears to be aged and is isolated from residences. There are cattle present and a roofed structure visible but this could be used for shading. The location is within the northern boundary of the gas fields and therefore there is a greater risk that a dip or spray race is or was present. The cattle yard is located approximately 2.1km southeast from a proposed water treatment facility (refer Figure 2). The cattle yard is not likely to pose a contaminated land concern for the construction of the proposed facility. Further investigation of the cattle yard for potential contamination is not considered necessary.

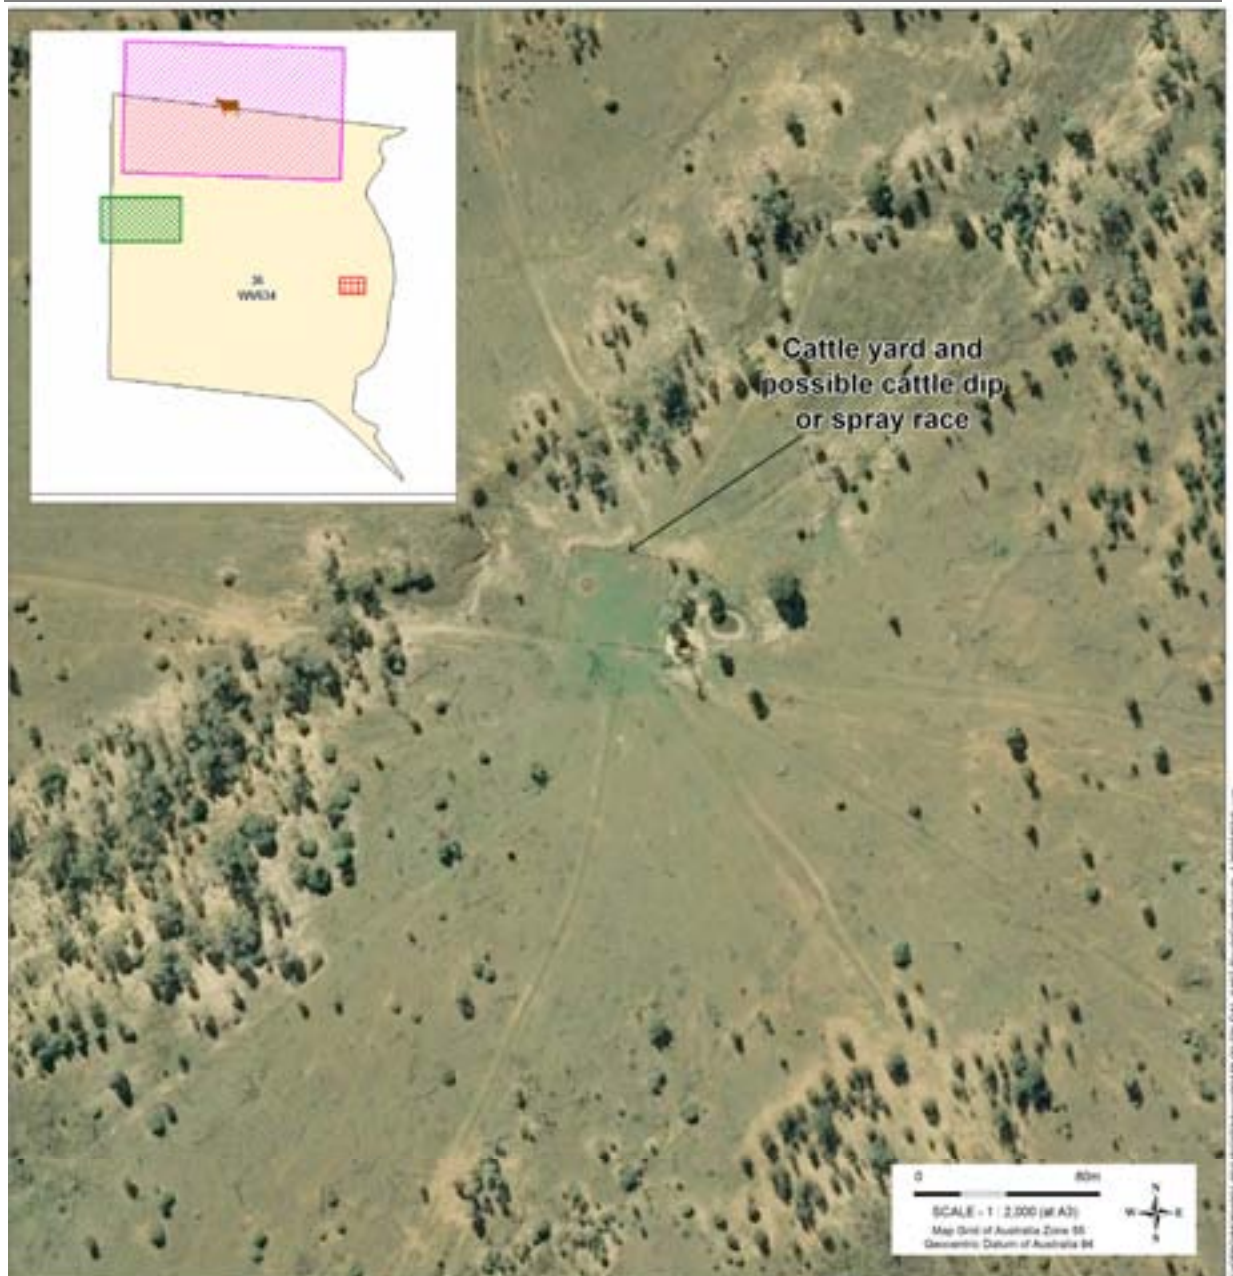
Plate 4.6 Cattle yard located on Lot 36 WV634 (2007-2008)

This cattle yard is isolated and appears aged. There is one roofed structure present; however it does not resemble a cattle dip or spray race. The circular feature towards the left side of the yard is also difficult to distinguish. The location of this yard is within the foot print of a proposed water treatment facility (refer Figure 2). This yard represents an area where construction activities may have the potential to disturb pre-existing contamination. This area should be further investigated in accordance with the guidelines referenced in Section 1.4.1.

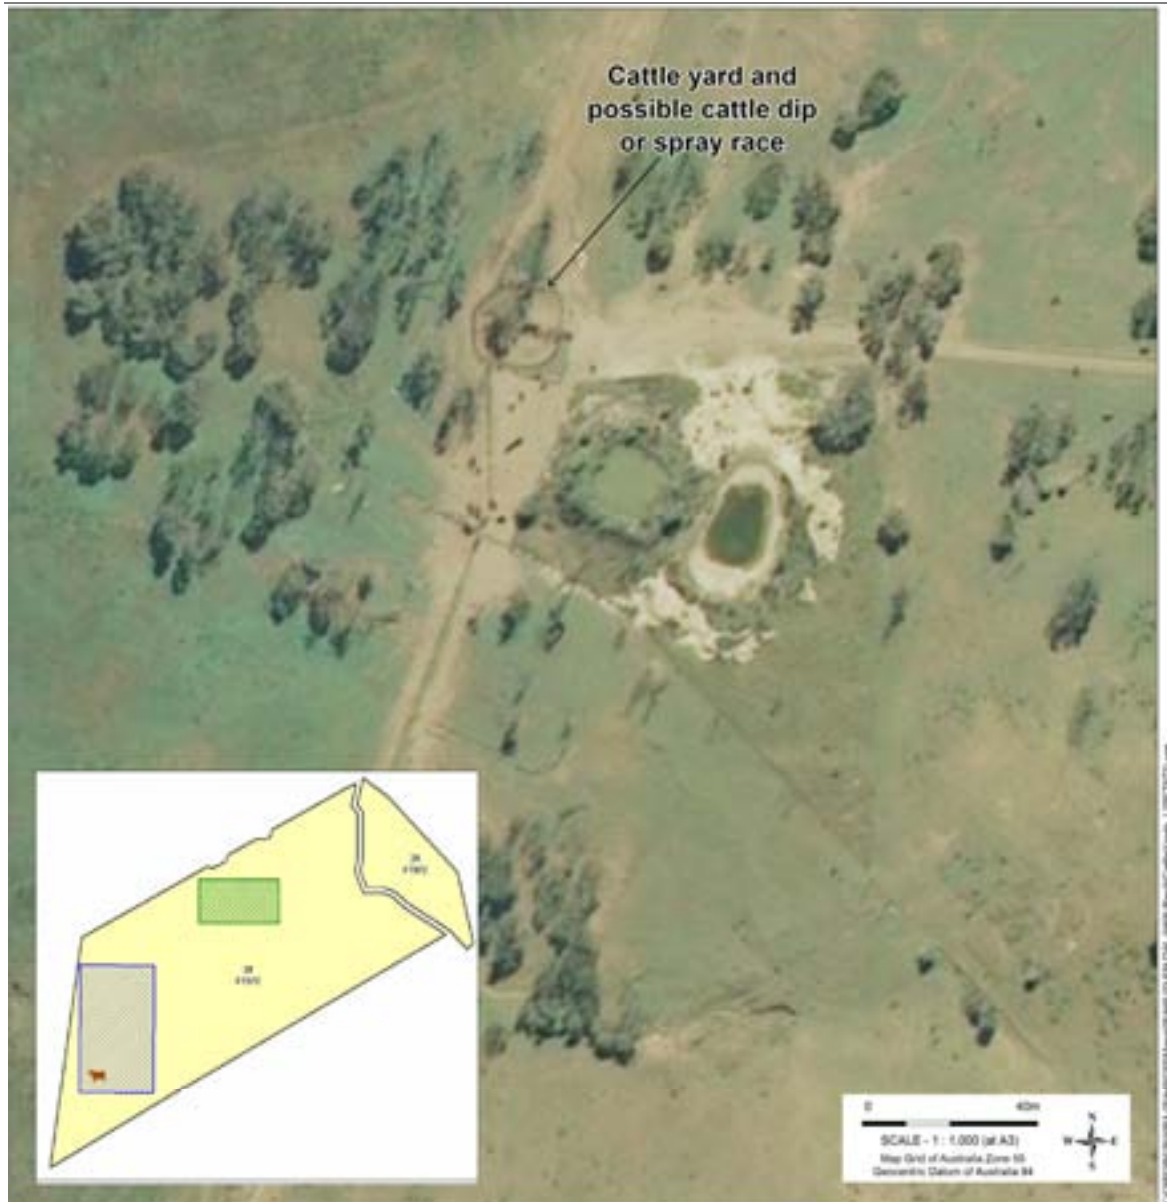
Plate 4.7 Cattle yard located on Lot 28 FT972 (2007-2008)

This cattle yard is circular and appears aged and could contain a structure which may be a cattle dip or spray race but from the photograph it is unclear to define. The yard is isolated from residences and located near two dams which could be water sources and is also located within the foot print of a proposed brine pond (refer Figure 2). This yard represents an area where construction activities may have the potential to disturb pre-existing contamination. This area should be further investigated in accordance with the guidelines referenced in Section 1.4.1.

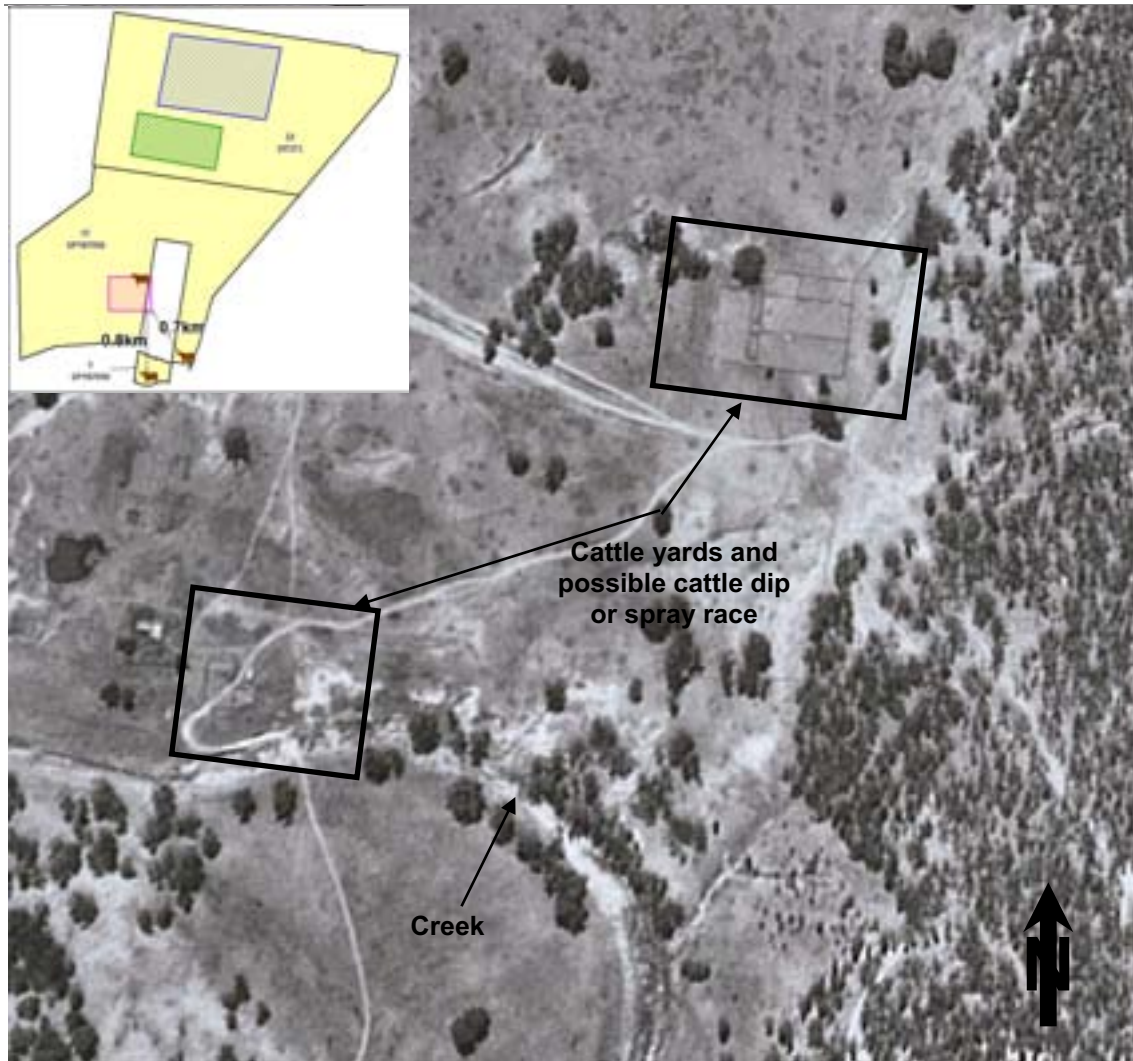
Plate 4.8 Cattle yard located on Lot 1 and 17 SP187050 (1959)

These two cattle yards are isolated near a creek and there are rectangular structures present which could be cattle dips or spray races. They are located approximately 0.7km and 0.8km from a proposed water treatment facility (refer Figure 4).

A third cattle yard was identified on Lot 17 SP187050 during the site inspection which is positioned within the footprint of the proposed water treatment facility. This is discussed in Section 4.4.

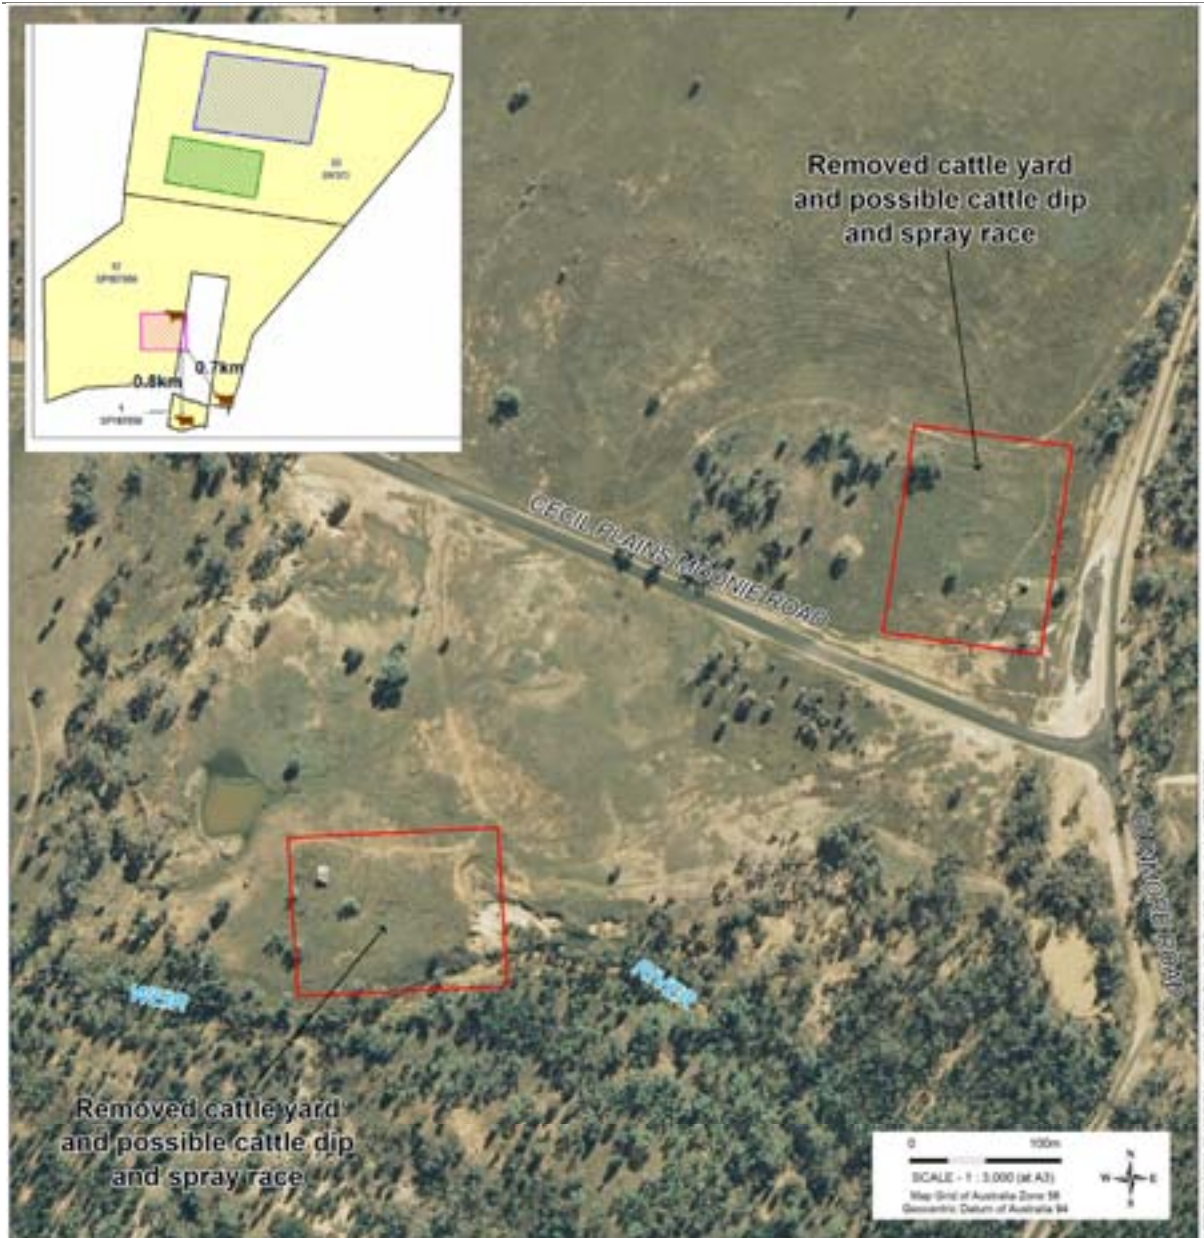
Plate 4.9 Cattle yard located on Lot 1 and 17 SP187050 (2007-2008)

Both cattle yards have been removed. The cattle yards are not likely to pose a contaminated land concern for the construction of the proposed facility water treatment facility given their proximity of 0.7km and 0.8km. Further investigation of the cattle yards for potential contamination is not considered necessary.

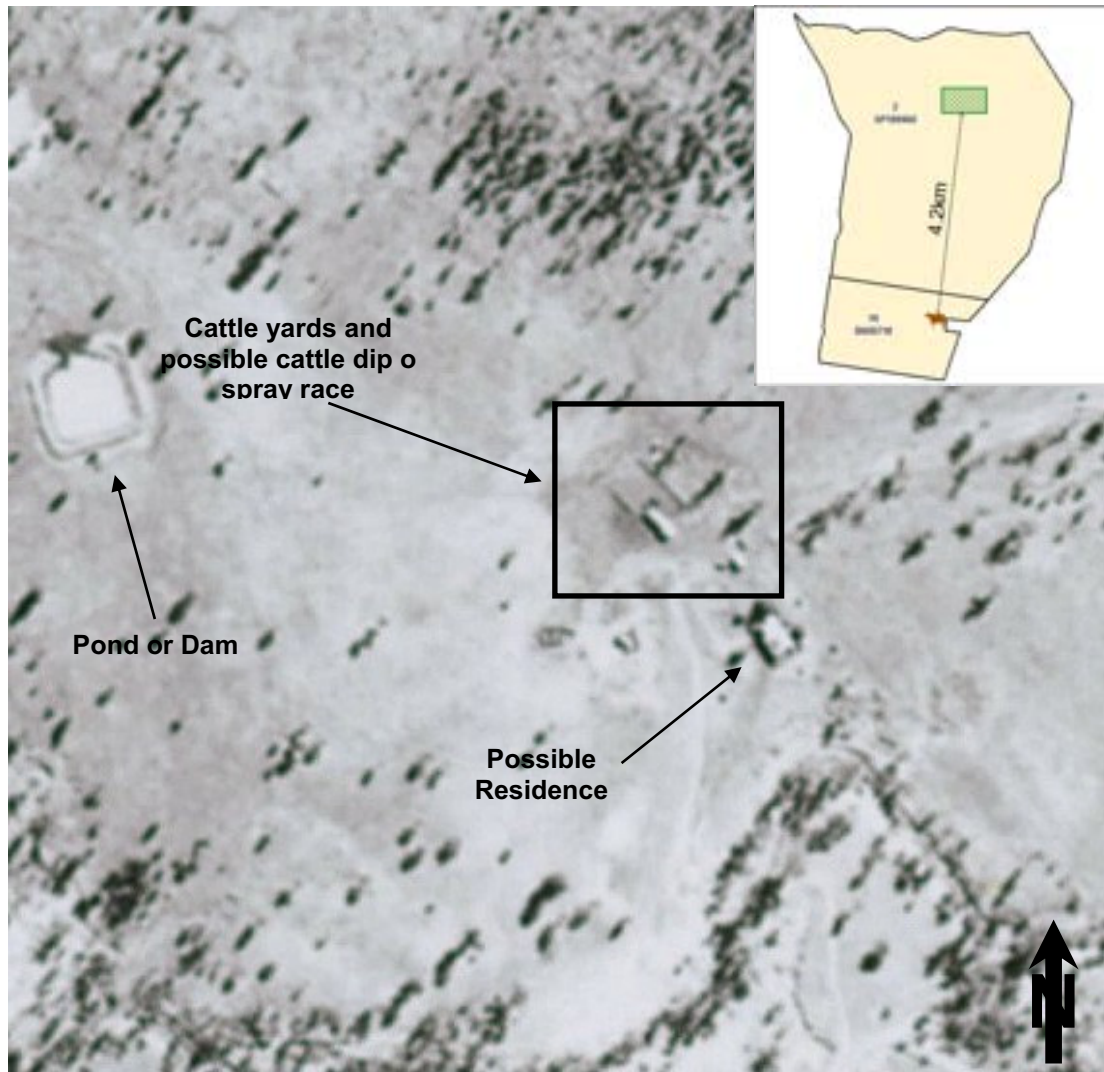
Plate 4.10 Cattle yard located on Lot 10 BWR718 (1956)

Scattered structures are present within the cattle yards which could be cattle dips or spray races. The cattle yards are located approximately 4.2km south of a proposed gas plant facility (refer Figure 2). This was not one of the original 60 lots that were targeted during the PSI because this location is not within a lot containing a proposed major facility.

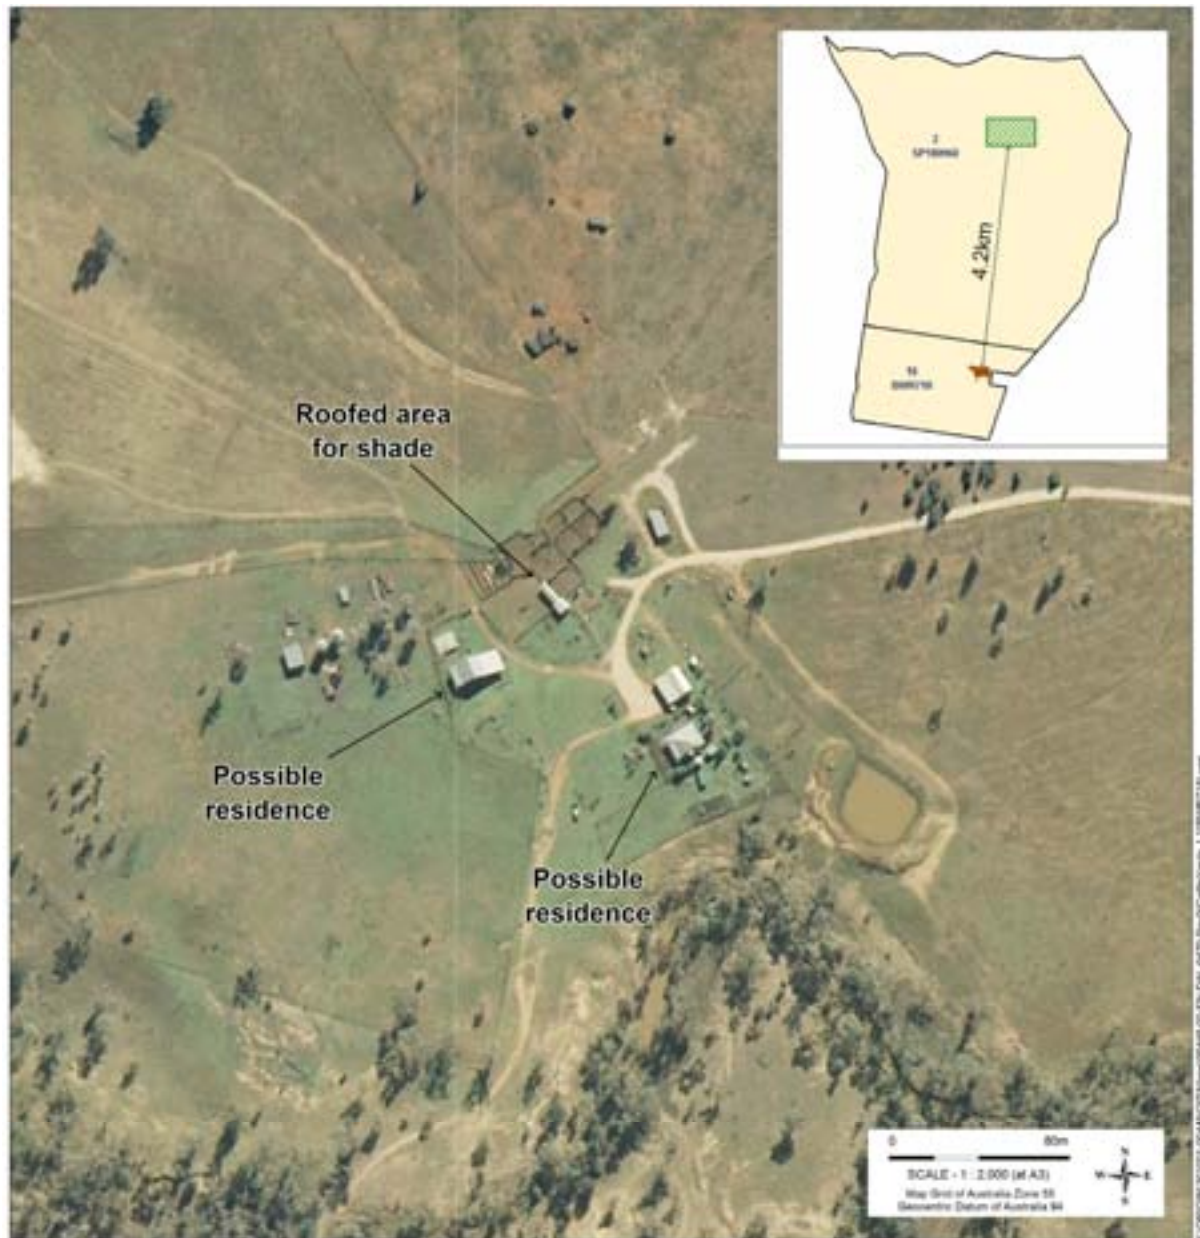
Plate 4.11 Cattle yards located on Lot 10 BWR718 (2007-2008)

The cattle yard has been expanded and a roofed structure is present, which is likely to be for shading. Possible residences are also visible. It is unlikely this site would contain a cattle dip or spray race at present and poses a low risk to the proposed gas processing facility. Further investigation of the cattle yard for potential contamination is not considered necessary.

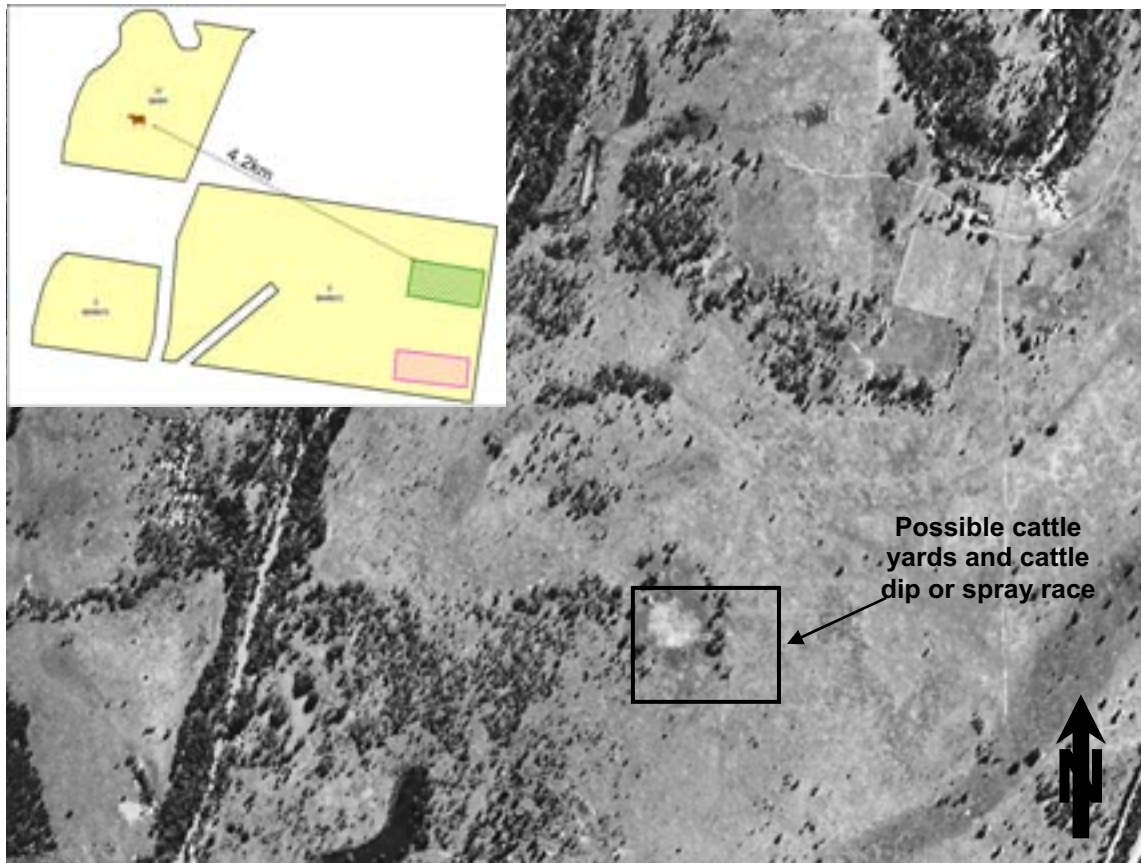
Plate 4.12 Cattle yard locate on Lot 37 BWR1 (1956)

The cattle yard is not clearly visible in this photograph. The cattle yard is approximately 4.2km north-west of a proposed gas production facility located on Lot 2 on BWR573 (refer Figure 3). This was not one of the original 60 lots that were targeted during the PSI because this location is not within a lot containing a proposed major facility.

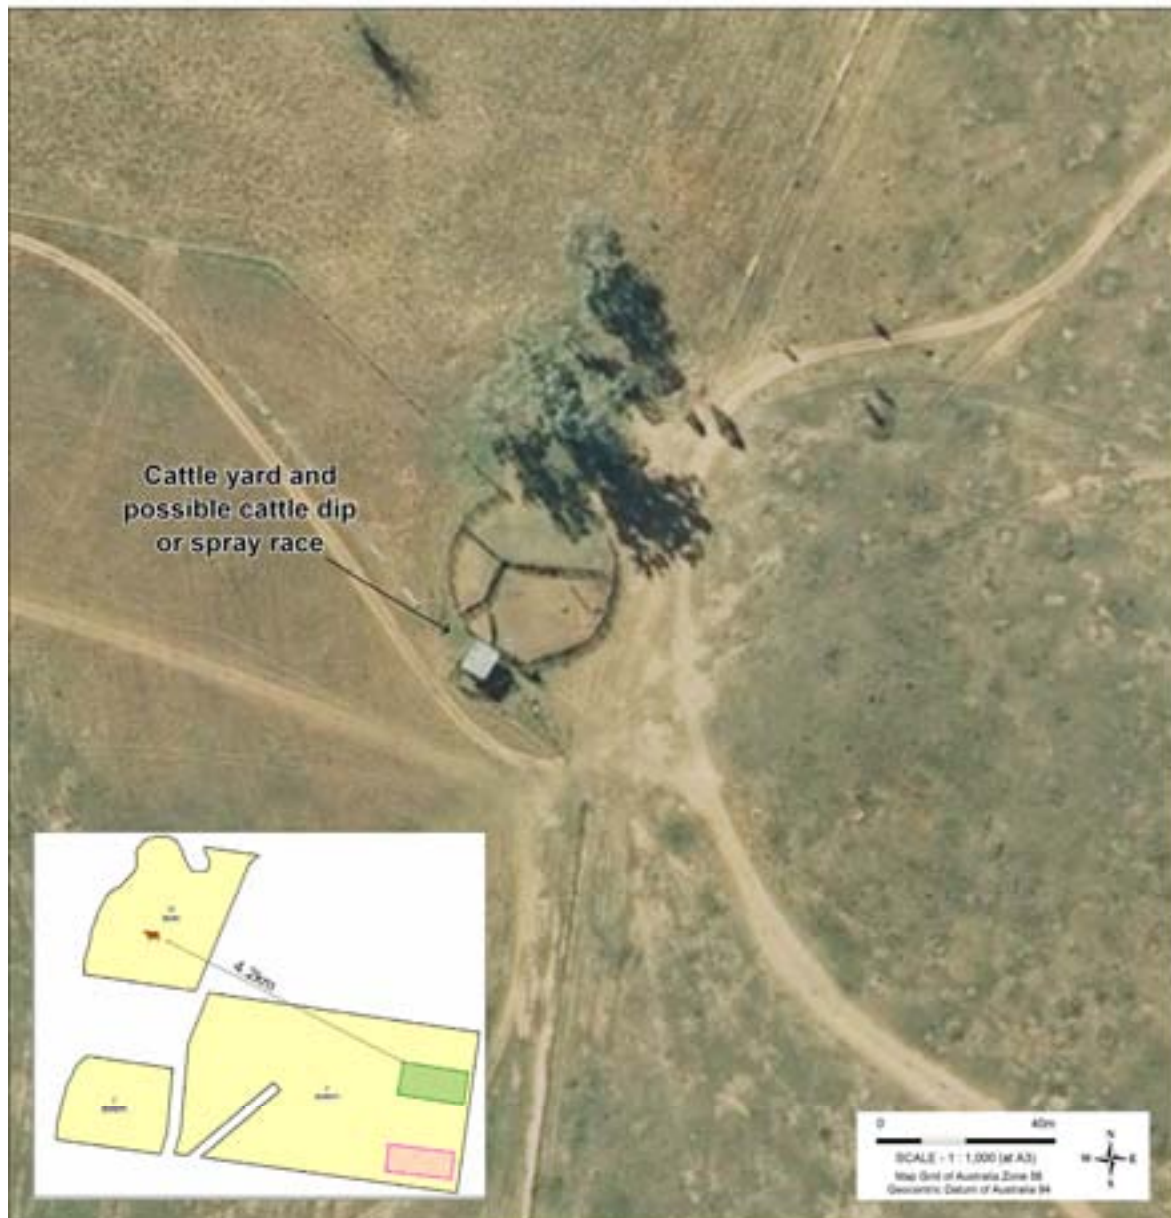
Plate 4.13 Cattle yard located on Lot 37 BWR1 (2007-2008)

The cattle yard is circular which DEEDI indicated could be a spray race for sheep, however there is no structure at the centre of the yard. The roofed structure present could be for shading. The cattle yard is not likely to pose a contaminated land concern for the construction of the proposed gas production facility given the distance of 4.2km. Further investigation of the cattle yard for potential contamination is not considered necessary.

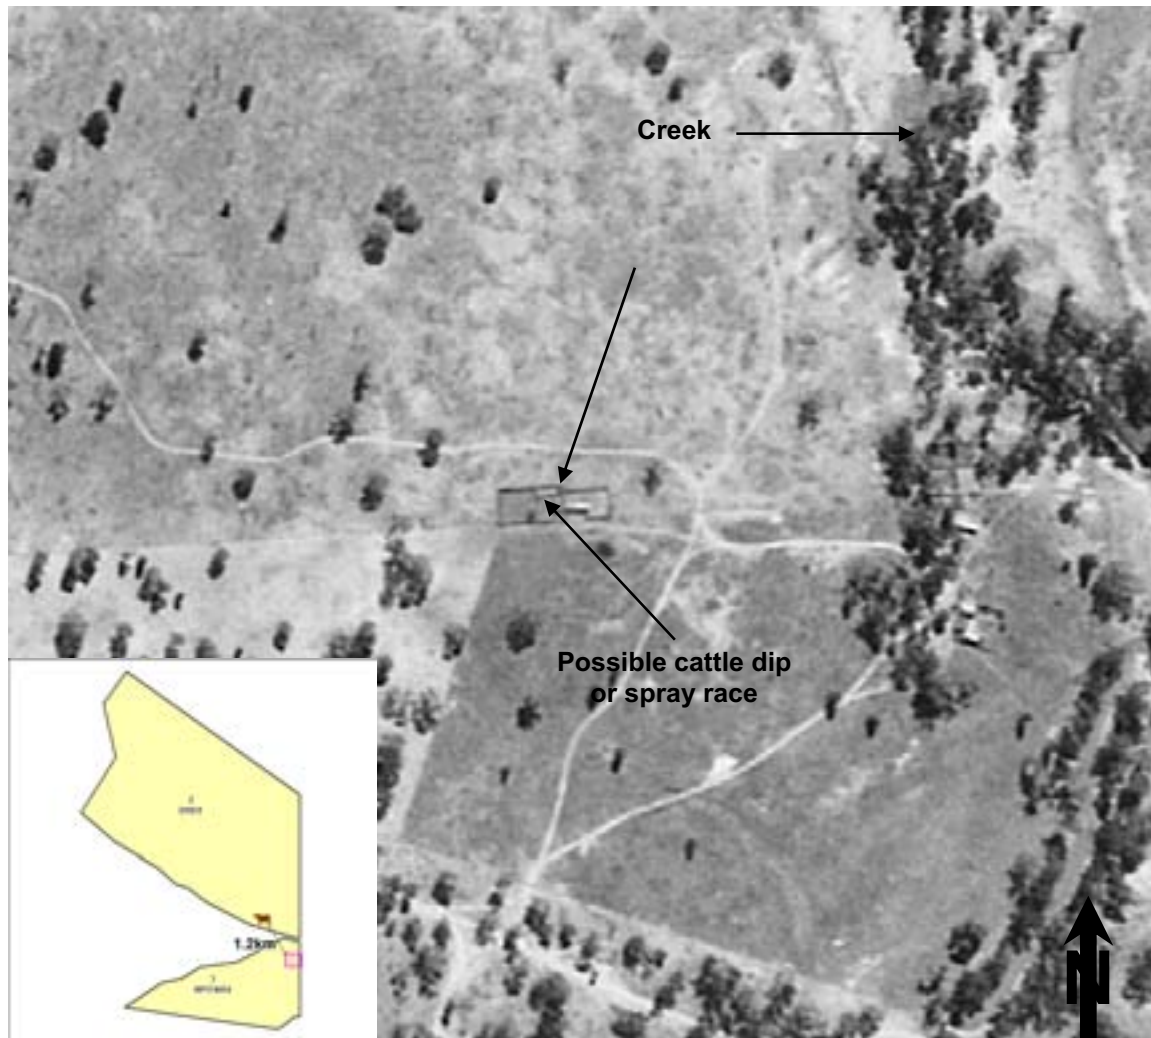
Plate 4.14 Cattle yard located on Lot 2 DY831 (1959)

The cattle yard contains two rectangular-roofed structures which could be a cattle dip or spray race. The yard is also isolated from residences and a creek is nearby which could provide a source of water for a possible dip or spray race. The creek is not adjacent to the cattle yard and therefore not likely to be impacted by possible contaminants that may be present should a cattle dip or spray race be present. The cattle yard is located approximately 1.2km northwest of a proposed water treatment facility located on Lot 3 on RP174414 (refer Figure 4). This was not one of the original 60 lots that were targeted during the PSI because this location is not within a lot containing a proposed major facility.

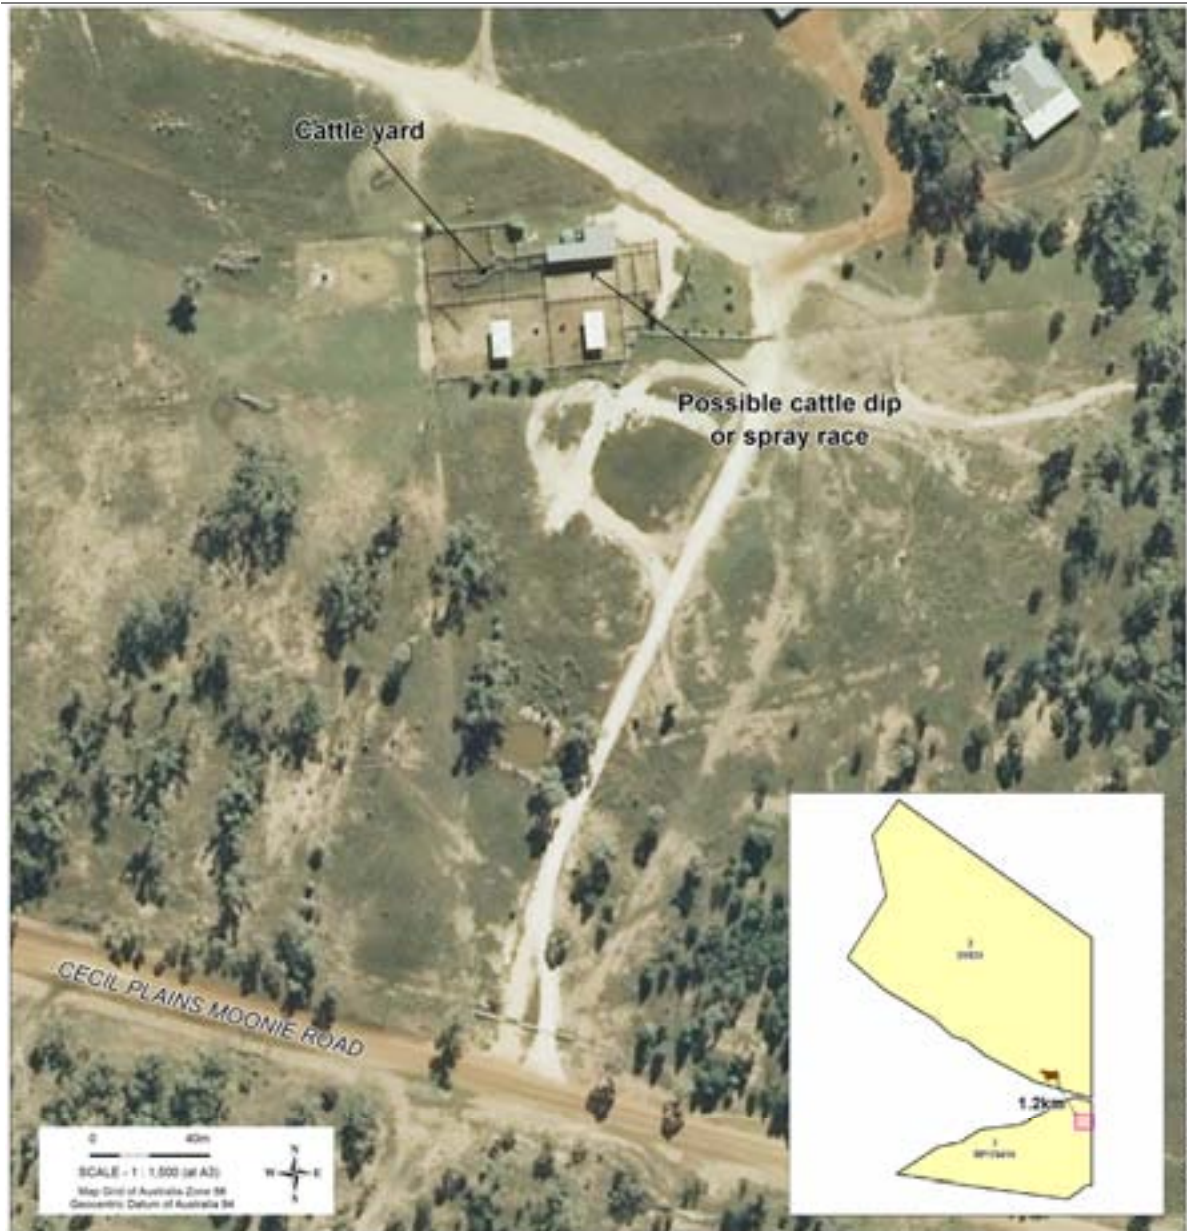
Plate 4.15 Cattle yard located on Lot 2 DY831 (2007-2008)

The cattle yard has been expanded and a residence established nearby. A roofed structure is present along with two new roofed structures which were probably used for shade. A tank is located adjacent to the rectangular structure which could provide water to a dip or spray race. The crushes at either end of the rectangular structure were common features of cattle dips. The cattle yard is not likely to pose a contaminated land concern for the construction of the proposed water treatment facility given the distance of 1.2km. Further investigation of the cattle yard for potential contamination is not considered necessary.
