Australia Pacific LNG Project

Attachment 8: Preliminary Site Investigation - Land Contamination Report - Gas Fields

Executive summary

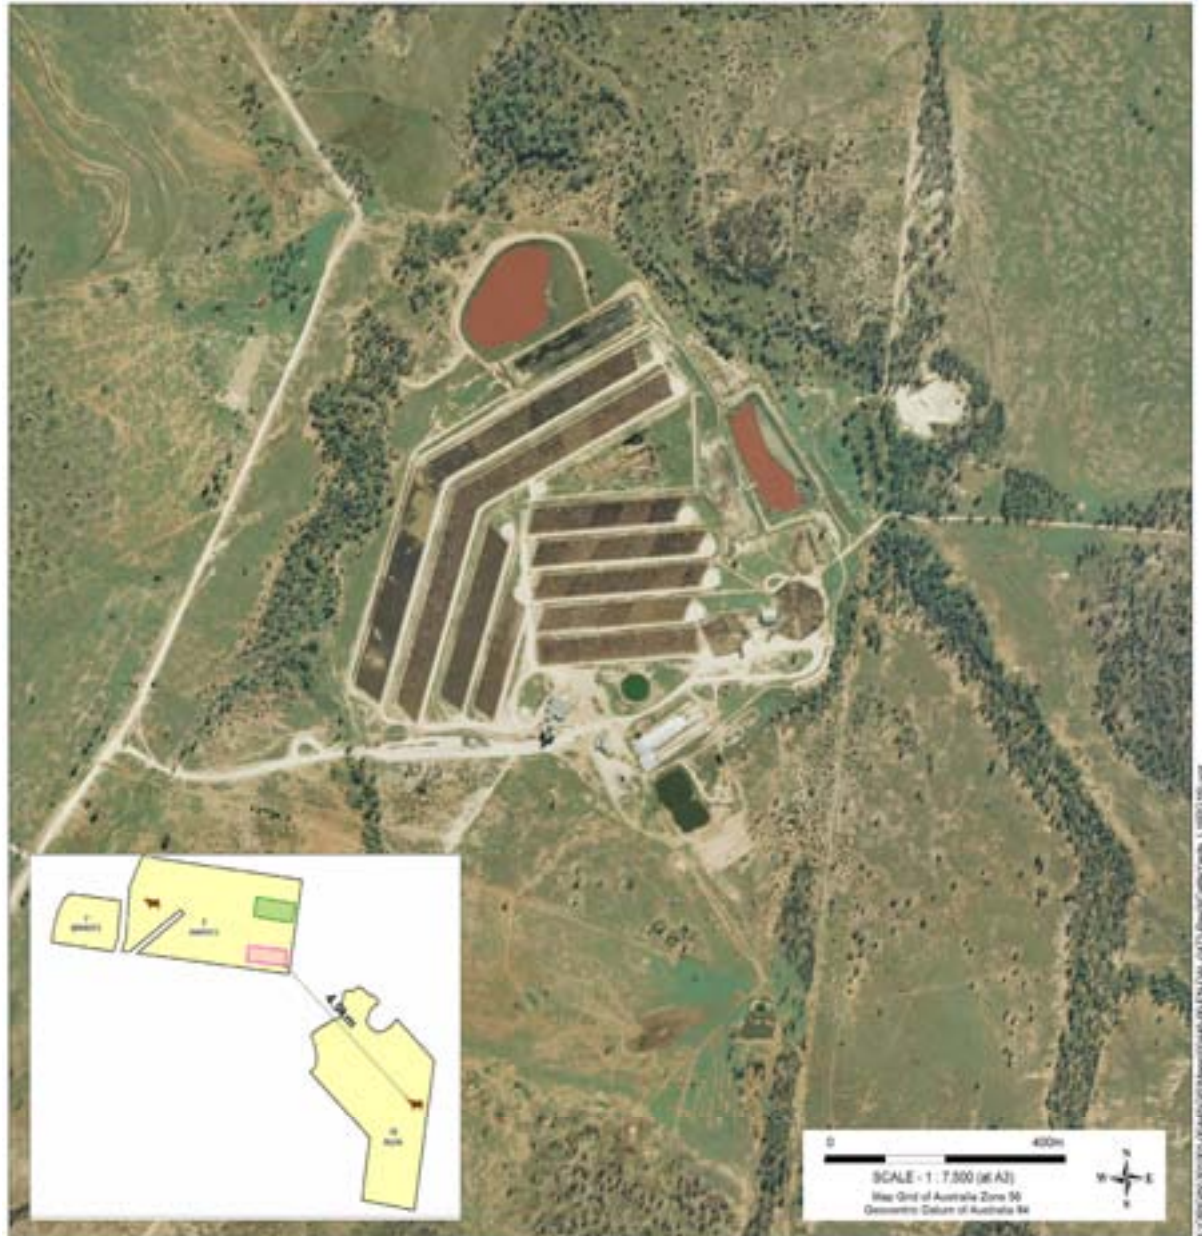
Plate 4.16 Feed lot located on Lot 16 RG16 (2007-2008)

The cattle feedlot is owned by MDH Pty Ltd. It is located within Lot 16 RG16 (refer Figure 3). This lot is not proposed to contain a major facility. The closest major facility is a proposed water treatment facility located approximately 4.9km north-west, on Lot 2 on BRW573. Advice from DEEDI indicated that plunge dips and spray races were not expected to be present within feedlots, and as a result, no further investigations are required.

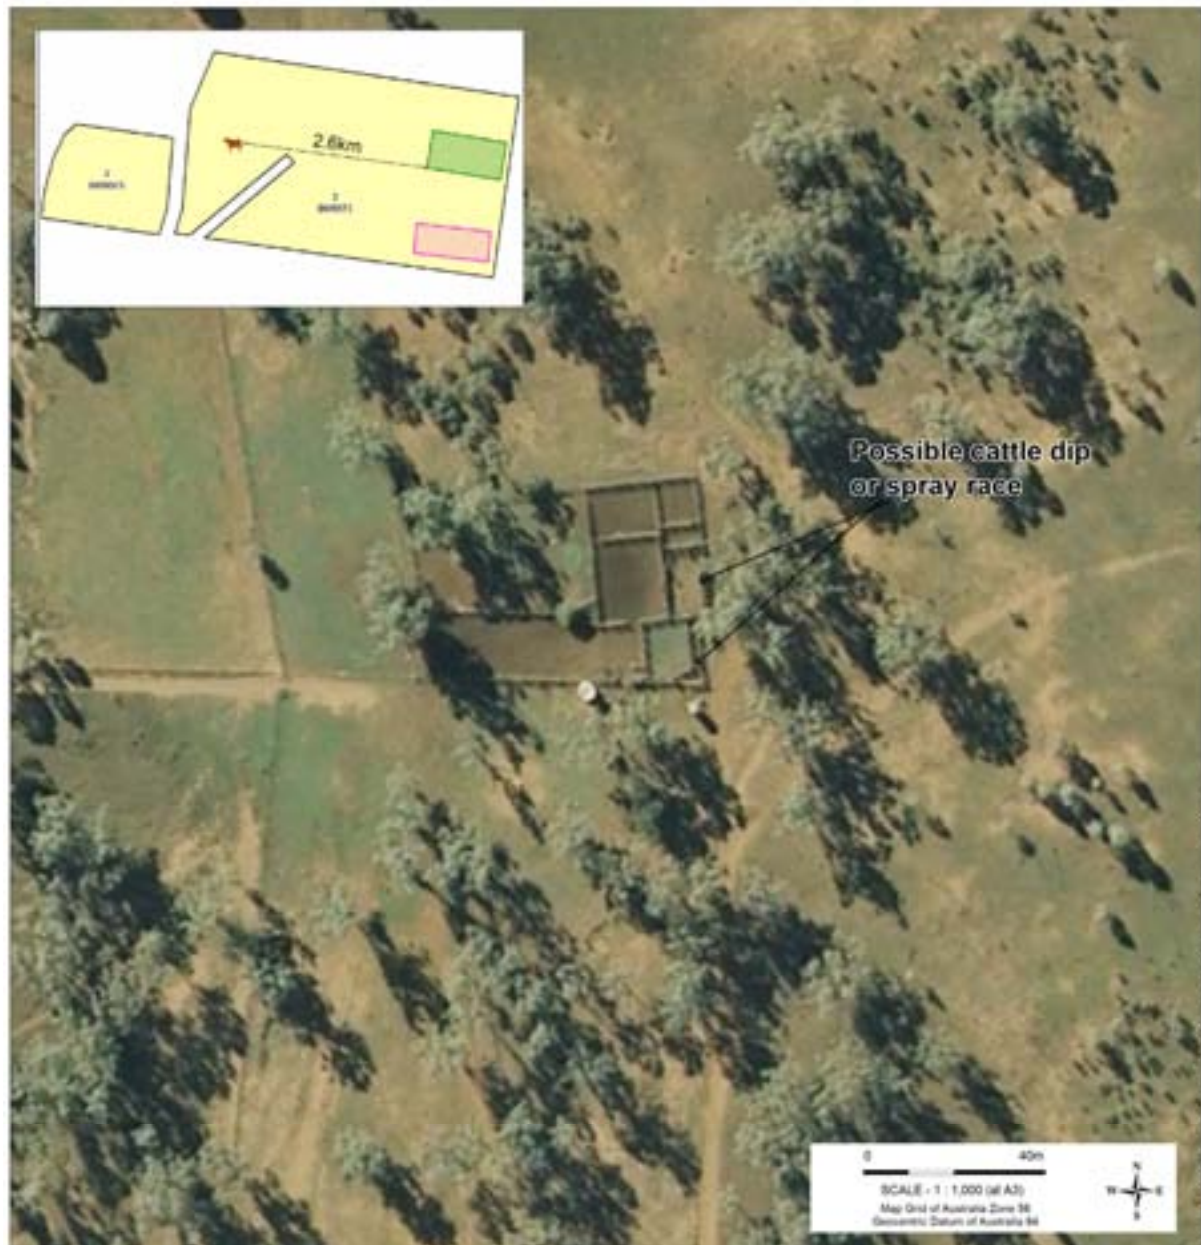
Plate 4.17 Cattle yard located on Lot 2 BRW573 (2007-2008)

This cattle yard is located on Lot 2 BRW573 (refer Figure 3) which is not one of the original 60 lots that were targeted. It contains a series of holding pens and a rectangular structure, possibly a cattle dip or spray race, which is located in the lower right corner as shown. Lot 2 is not near the tick-infested zone and according to DEEDI would not likely be in a cattle dip or spray race area. The closest major facility is a proposed gas processing facility located approximately 2.6km east of the yard, and on this basis, further investigation of the cattle yard for potential contamination is not considered necessary.

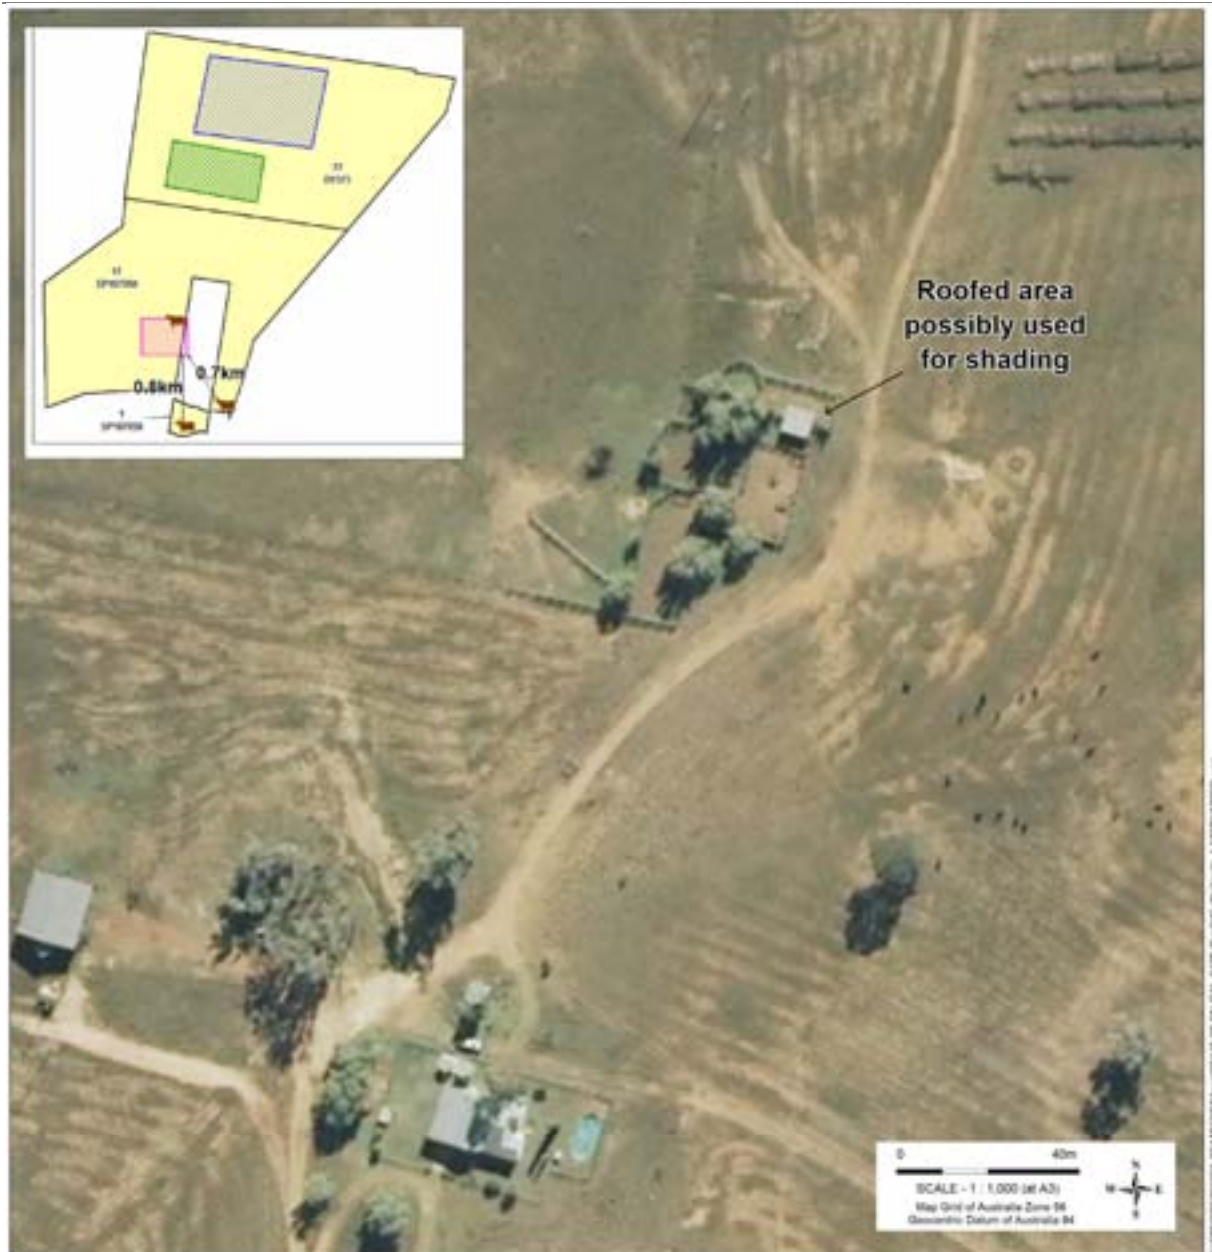
Plate 4.18 Cattle yard located Lot 17 SP187050 (2007-2008)

This cattle yard is located on Lot 17 SP187050. Lot 17 is not near the tick-infested zone and according to DEEDI would not likely be in a cattle dip or spray race area, however the cattle yard is within the footprint of a proposed water treatment facility located on this lot (refer Figure 4). This yard represents an area where construction activities may have the potential to disturb pre-existing contamination, and therefore further investigations are required. There are also two other cattle yards located 0.7km and 0.8km from the proposed location of the water treatment facility. These yards were identified during the aerial photograph review, as discussed in Section 4.3 (i.e. Plate 4.8) and would not require further investigation.

These three cattle yards represent areas where construction activities may have the potential to disturb pre-existing contamination, and therefore soil investigations are required to assess the possible occurrence of hazardous contaminants. The investigations would need to be comprehensive and follow the guidelines and standards listed in Section 1.4.1.

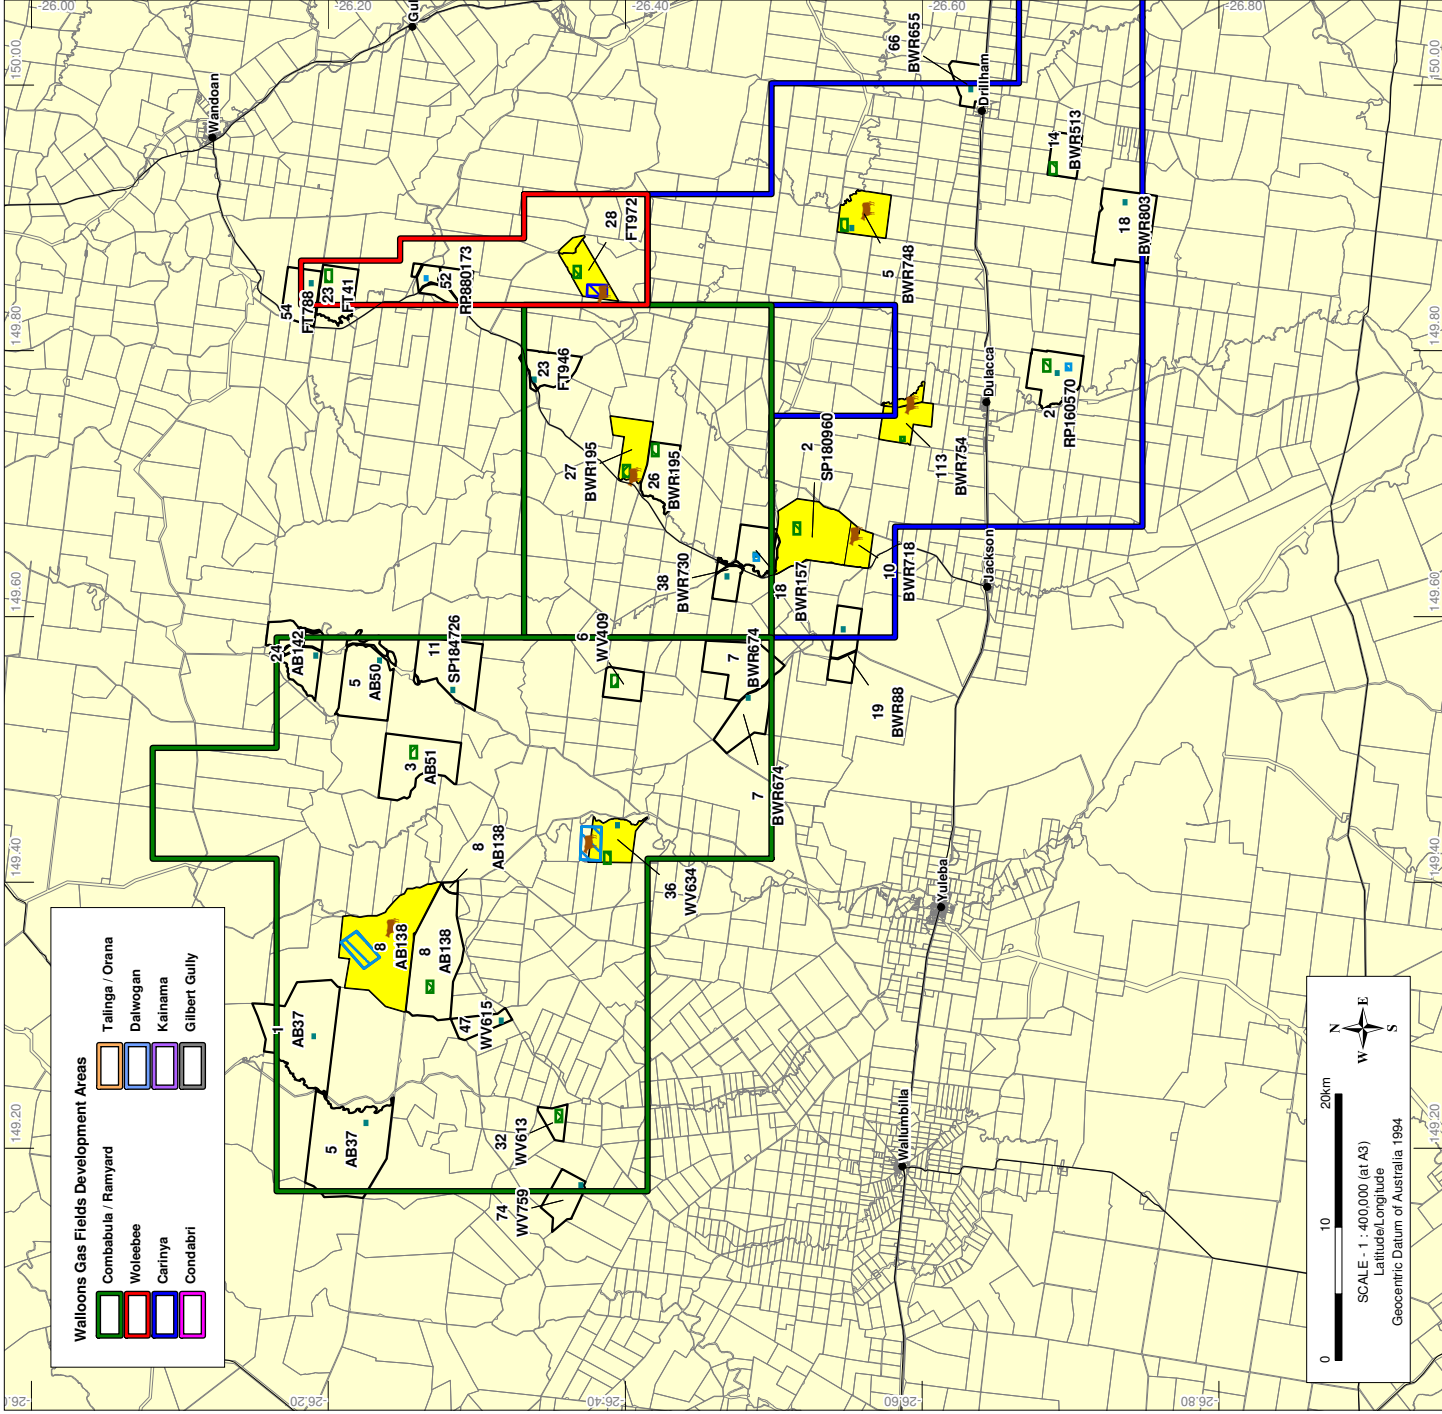
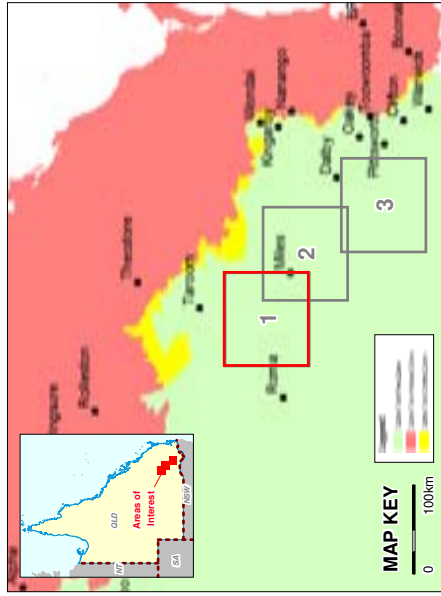
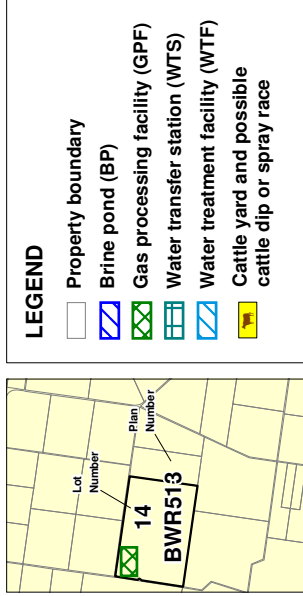
QUEENSLAND CATTLE TICK ZONES

As at 7 December 2005

- By the 1950s and 1960s, cattle dips and spray races were common. Some farmers chose to hand spray insecticides on stock rather than use the conventional method. Organochlorine (OC) pesticides replaced arsenic during this period. OC pesticides were phased out of use by the 1970s and 1980s because of their toxic and persistent nature. OC pesticides were replaced by Organophosphate (OP) pesticides which later were replaced by carbamates, amidine compounds and synthetic pyrethrins.
