Australia Pacific LNG Project Supplemental information to the EIS

Acid Sulfate Soils Assessment of "The Narrows" - Pipeline

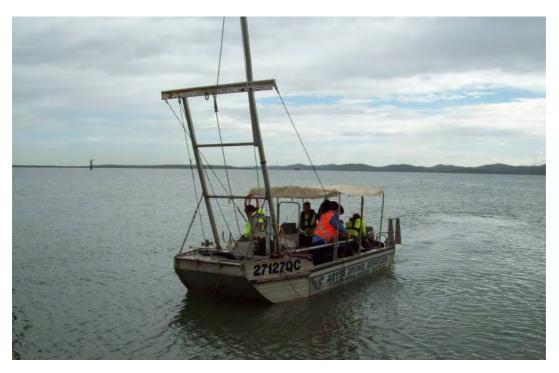
Plate 2-1 Vessel vibracore setup

Each location was to be sampled to at least 1m beyond the depth of potential disturbance. This meant sampling to approximately 3.5mBGL in the mudflats and an average depth of 5.5m below the sea floor in the Narrows sub-tidal crossing. As noted within a similar study completed for the Gladstone Port Corporation (GPC) EIS of dredge areas 1b and 2a (Golder Associates, 2009), stiff material at approximately 3m sediment depth restricted deeper coring even when a pneumatic vibracorer was used. Any coring below this depth would therefore need more powerful drilling equipment operated from specialised jack-up barges to penetrate hard materials. This approach was considered to be cost and time prohibitive for the purposes of this investigation. As a result, the less powerful but more versatile vibracoring method operated from a flat bottom boat was selected (refer Plate 2-1). This equipment was easily transferred to the mudflats with use of a hovercraft. Here, the vibracore was supported by a portable A-frame which was re-established at each location (refer Plate 2-2).

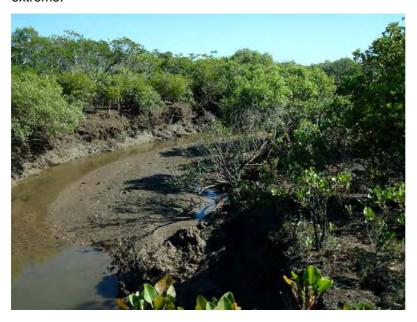
Plate 3-1 Humpy Creek

Three creeks occur within the study area: Targinie, Humpy and Mosquito Creek (refer Figure 1.1). These creeks are tidally influenced and are characterised by steep and often near vertical banks lined with dense mangroves and small inlets (refer

Plate 3-1) [Ross, 2002]. They occur adjacent to intertidal flats (refer Section 3.1.2) and supratidal flats (refer Section 3.1.3). The ASS located within these creeks has been rated by Ross (2002) as low to extreme.

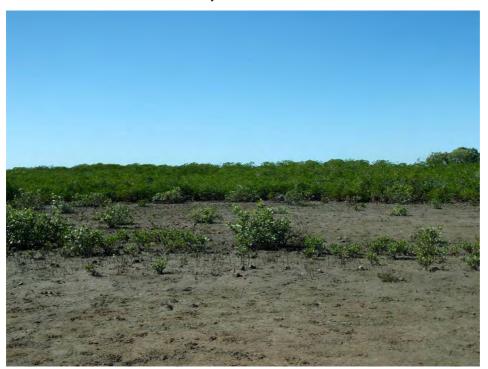
Plate 3-2 Intertidal (mangrove) flat

These flats are characterised by mangrove vegetation, shallow channels and regular saline tidal inundation and are situated between low and high tides (Ross, 2002) [Refer Figure 1.1]. Ross (2002) identified that the highest levels of oxidisable sulfur are associated with the mangroves in these flats as the mangroves provide a constant source of rotting organic matter under anaerobic conditions essential for ASS formation. Plate 3-2, taken near sampling location MF10, provides an example of these intertidal flats within the study area.

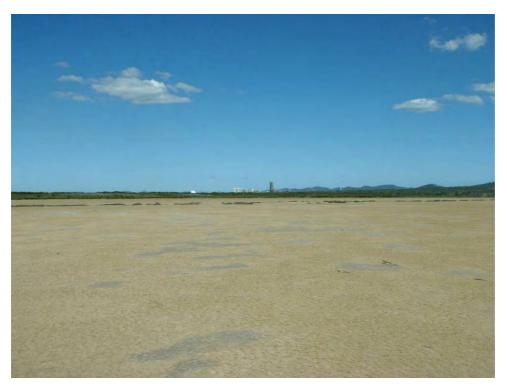
Plate 3-3 Supratidal (salt) flat

These flats occur adjacent to intertidal flats and are generally bare of vegetation, salt-encrusted, are very gently sloping and occupy the area between high and spring tides (Ross, 2002) [Refer Figure 1.1]. Some small areas of marine grasses can occur, however the extreme soil salinity restricts mangrove growth (Ross, 2002). The PASS within these flats has been rated as low to extreme, however the extreme rating is more common (Ross, 2002). Plate 3-3, taken near sampling location MF17, provides an example of these supratidal flats within the study area.

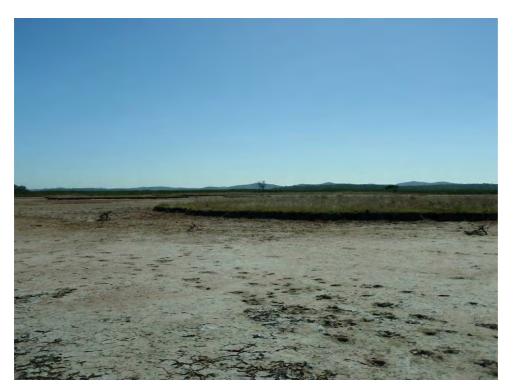
Plate 3-4 Extratidal flat

These flats are elevated above the supratidal flats but occur below the extreme storm surge level (Ross, 2002). They are generally occupied by marine couch grassland but can have occurrences of tea tree and eucalypt woodland on the landward margin of confined areas, while on the seaward side can have a characteristic step created by erosion (Ross, 2002). Plate 3-4 was taken from sampling location MF05 looking towards the extratidal flat where MF06 is located. The ASS hazard is rated from very low to extreme, however a low rating is common (Ross, 2002).
