CAIRNS SHIPPING DEVELOPMENT PROJECT

BASELINE ASSESSMENT - DREDGED MATERIALS

Cairns Shipping Development Project

Report Number. 1546223-006-R-Rev2

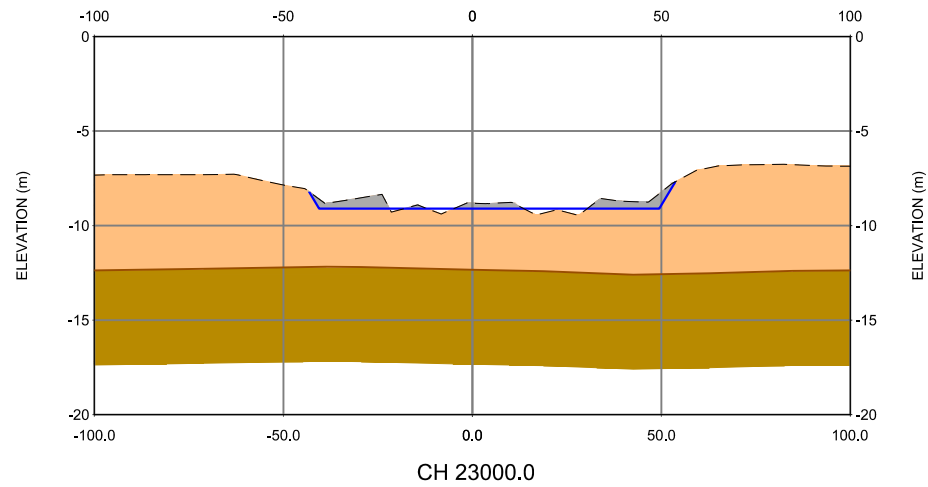
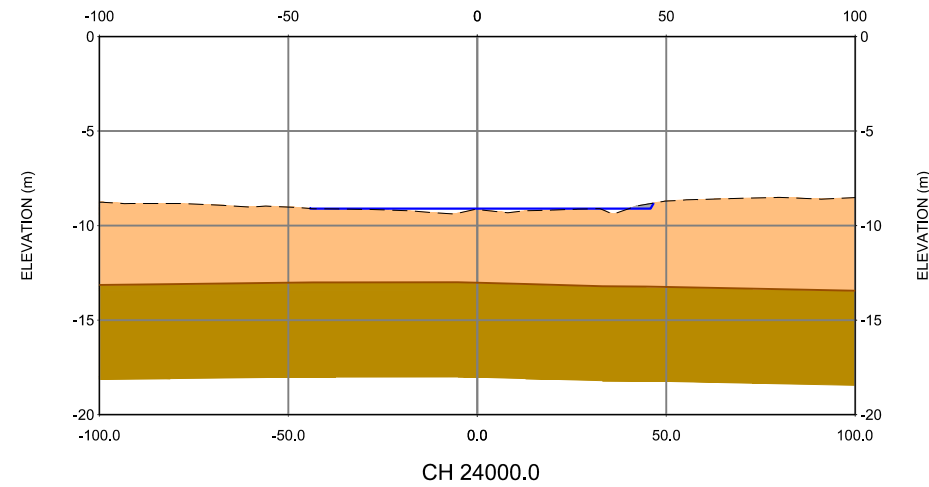
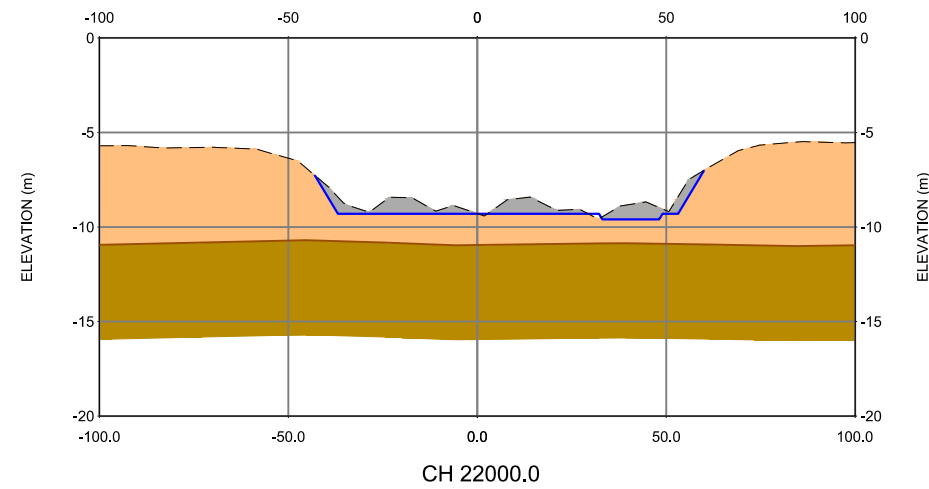
PROJECT NO. 1546223	DOCUMENT No 006	REV. 2	FIGURE F006
------------------------	--------------------	-----------	----------------

- LEGEND**
- PROPOSED DREDGE SPOIL
 - CHANNEL SURVEY 160825
 - SOFT CLAY
 - REV B REVISED DRAFT EIS CHANNEL DESIGN MODEL
 - STIFF CLAY
 - SOFT CLAY - STIFF CLAY INTERFACE

Cross sections generated from the ground model are presented as Figures F004 to F006. It is noted that in some cases the existing seabed is already below the maintenance dredge level.
