CAIRNS SHIPPING DEVELOPMENT PROJECT

Revised Draft Environmental Impact Statement

APPENDIX P: Marine Ecology Baseline Report (2016)

Cairns Shipping Development EIS - Marine Ecology Baseline Report

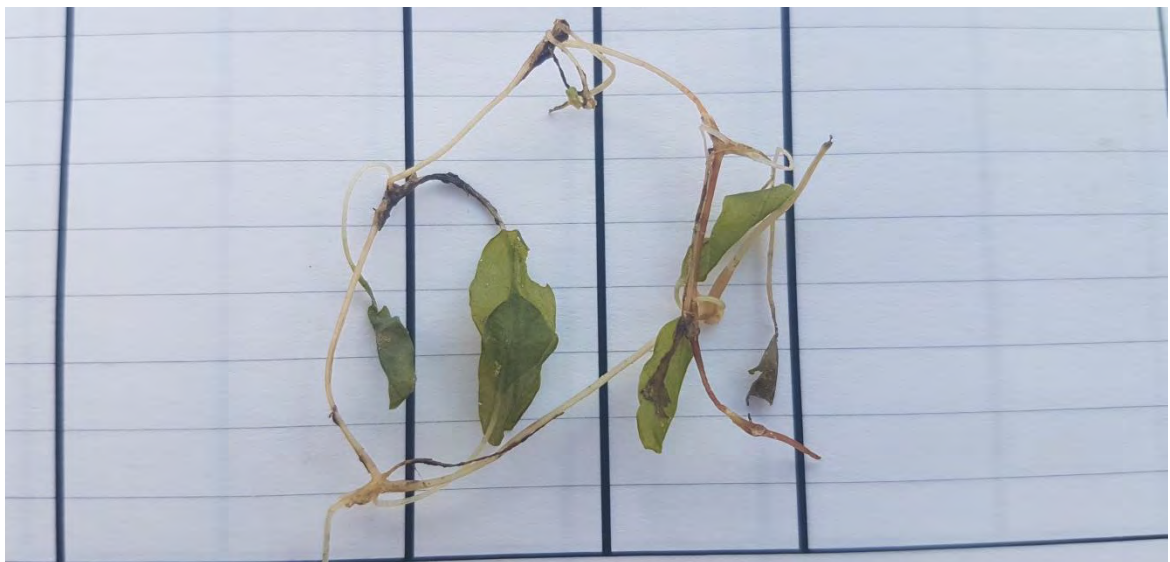
Figure 3-3 Seagrass (*Halophila ovalis*) incidentally recorded at Magazine Creek (TRIN3)

- Magazine Creek (TRIN3) – seagrass was recorded in a gill net deployed in the lower intertidal/ upper subtidal zone at Magazine Creek. Leaves were small and damaged, but the sample was tentatively identified as *Halophila ovalis*.
- Firewood Creek (site FF2) – *Halophila ovalis* was recorded in a benthic grab sample at site FF2, which was located inside the bund.

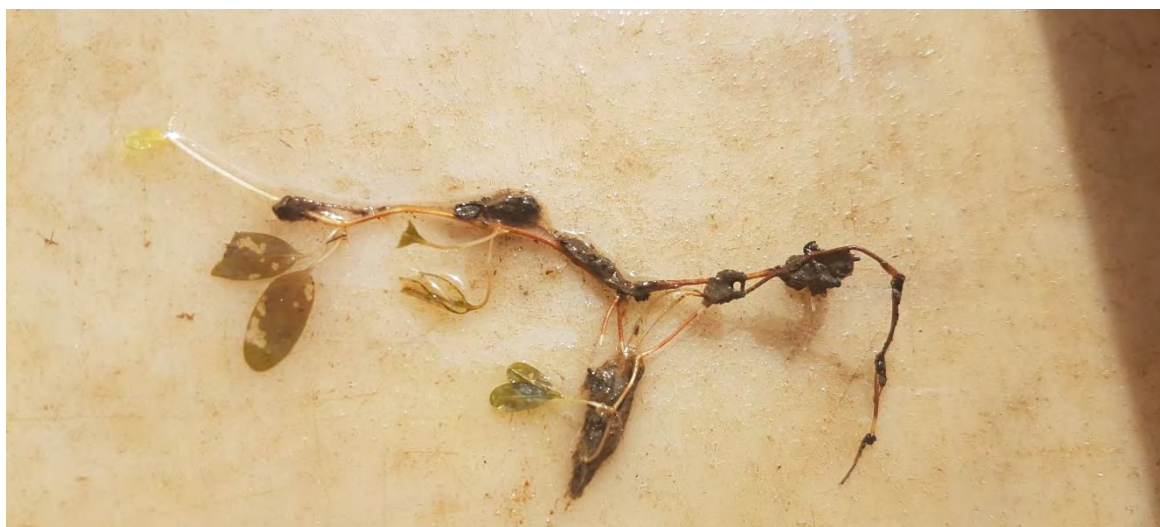
Figure 3-4 Seagrass (*H. ovalis*) from a benthic grab in Firewood Creek (FF2)

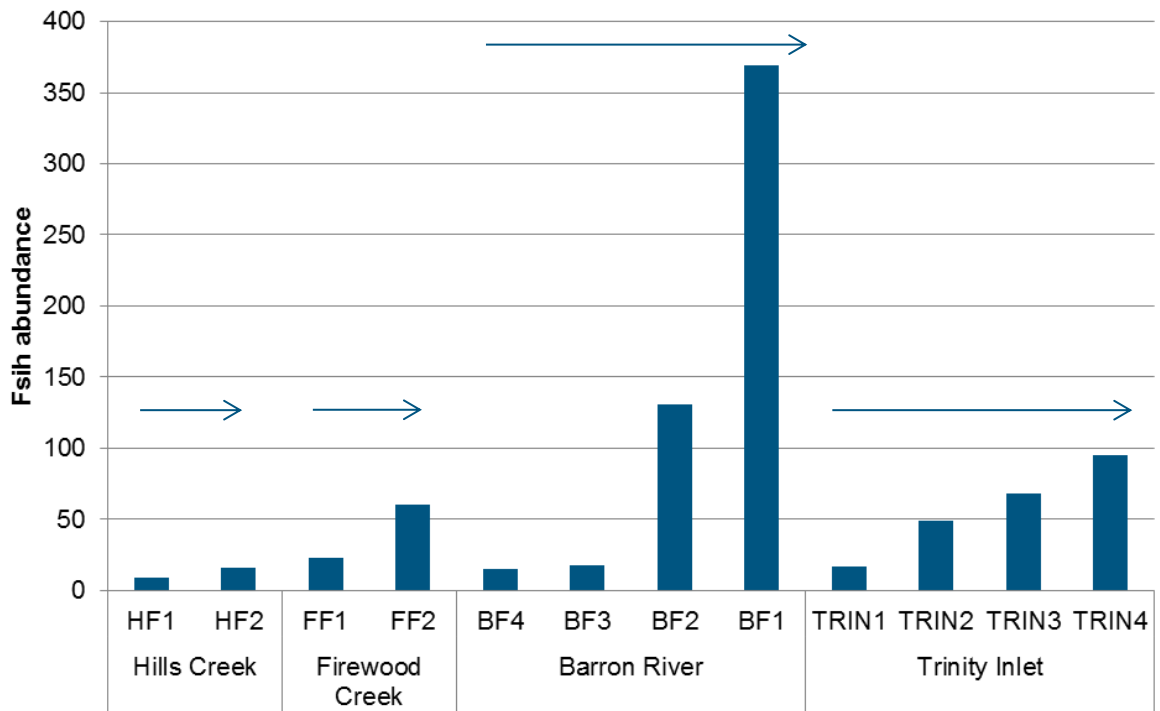
Figure 3-5 Total fish abundance at each of the sites within each waterway (arrows indicate site gradient towards the sea)

Diverse and abundant fish communities were observed within Trinity Inlet, Barron River, Hills Creek and Firewood Creek. Fish abundance tended to increase with distance downstream in all estuarine waterways² (Figure 3-5), but there were no clear spatial gradients in species richness (Figure 3-6).

Hills Creek had low catches (abundance) but species richness was within the range recorded in other waterways. The bunded parts of Hills Creek (HF1, HF2) contained fewer species and individuals than the site located downstream at the confluence of Hills Creek and Trinity Inlet (TRIN4). This spatial gradient was not observed at Firewood Creek, where the most abundant and richest catches were made inside the bund at FF2, which was higher than the downstream site located at the confluence of Firewood Creek and Trinity Inlet (TRIN2). The riparian vegetation at FF2 was in reasonably good condition, unlike that surrounding site FF1 where a major disturbance to the riparian zone was still evident. Site FF1 had the lowest fish species richness and abundance of all sites in Firewood Creek.

Barron River had consistently high species richness across sites, whereas abundance increased markedly with distance downstream. The highest richness was observed at site BF2, and the high abundance at BF1 (369 fish) was mostly due to a large catch of herring.

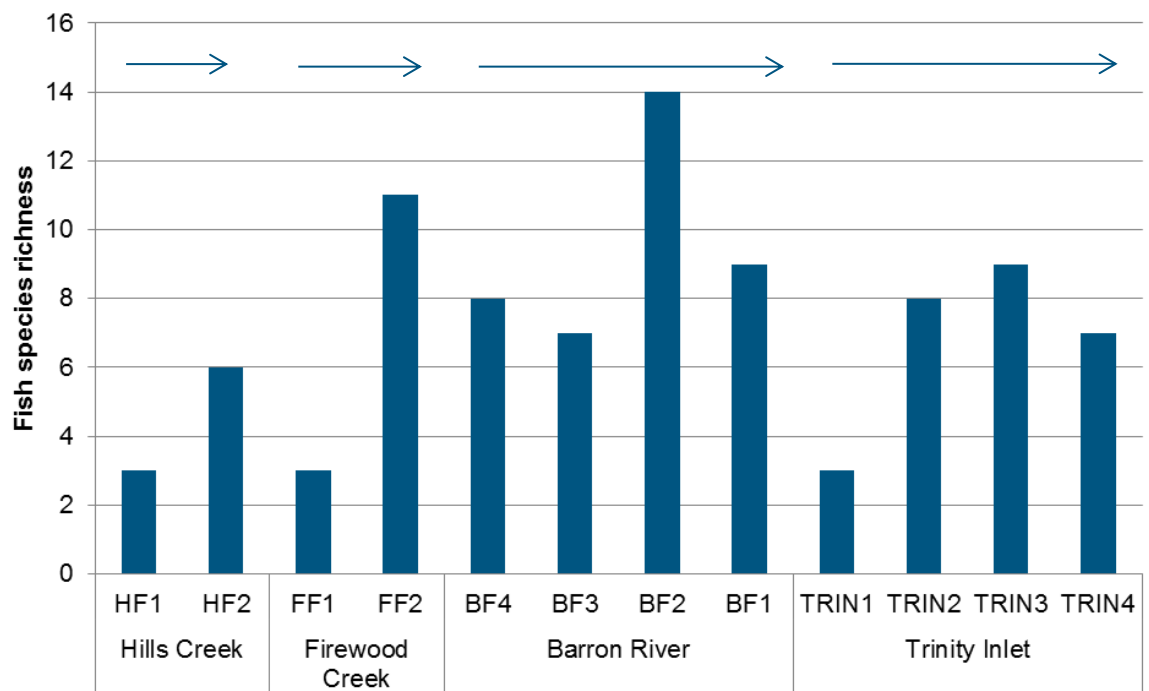
Figure 3-6 Species richness at each of the sites within each waterway (arrows indicate site gradient towards the sea)

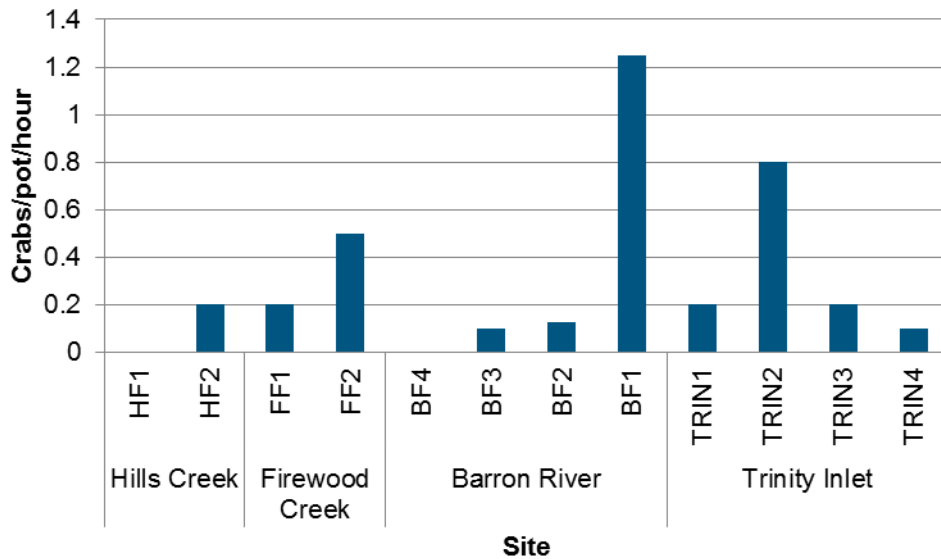
Figure 3-7 Crab catch per unit effort (crabs/ pot/ hr)

Mud crabs (*Scylla serrata*) generally dominated catches in Trinity Inlet and East Trinity, whereas sand crabs (*Portunus pelagicus*) dominated catches in the downstream reaches of the Barron River. Only two mud crabs were collected in the whole of the Barron River.

High abundances of crabs were recorded at site BF1 on the Barron River (sand crabs), and Firewood Creek sites (FF2 and TRIN2) which had high catches of mud crabs.

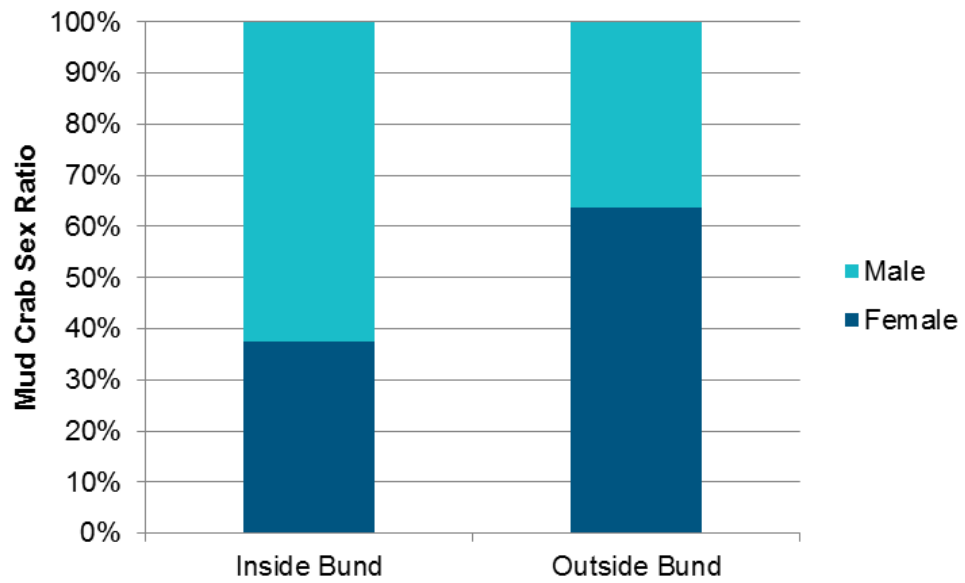
Figure 3-10 Sex ratios for mud crab catches inside and outside of the bund wall at East Trinity

Mud crab catches also varied upstream and downstream of the bund. Mud crabs upstream of the bund were larger (both males and females) than in downstream areas, and were predominantly male compared to predominantly female downstream (Figure 3-8, Figure 3-9, Figure 3-10). This suggests either habitat partitioning by sex and age, or possibly an effect of fishing pressure (noting that no crabbing occurs upstream of the bund, except in the vicinity of the tide gates).

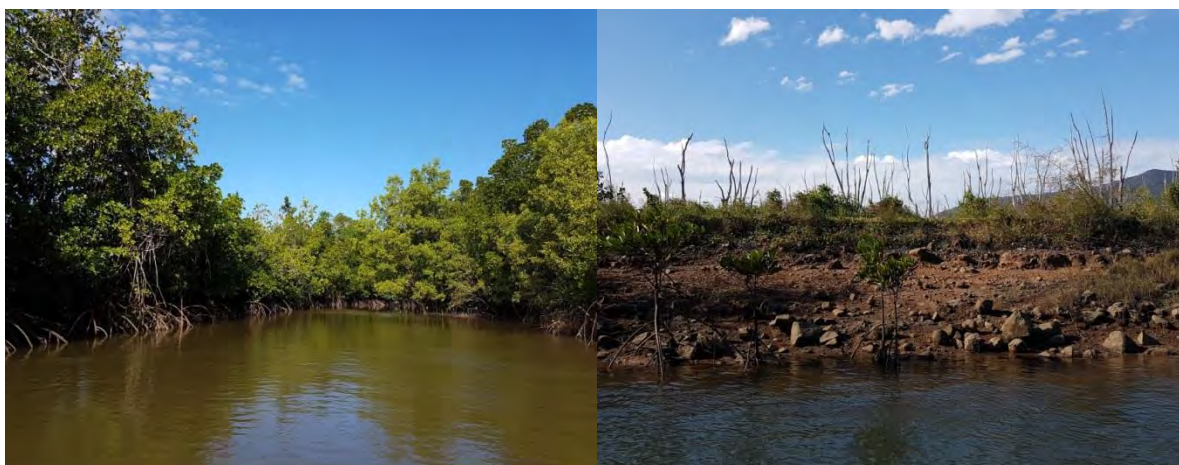
Figure 3-11 *Rhizophora* and *Sonneratia* in good condition downstream of the bund on Firewood Creek (left); and small *Rhizophora* and *Osbornia* growing on the bund wall (right)

Outside of the bund the mangrove vegetation was typically dominated by red mangrove (*Rhizophora*) with occasional *Sonneratia alba* (Figure 3-11) particularly on accreting inside meanders where connectivity has been completely cut off by the bund. Vegetation communities were typically in good condition with the exception of those against the bund wall which were in poor condition but in a recovery state (Figure 3-11).

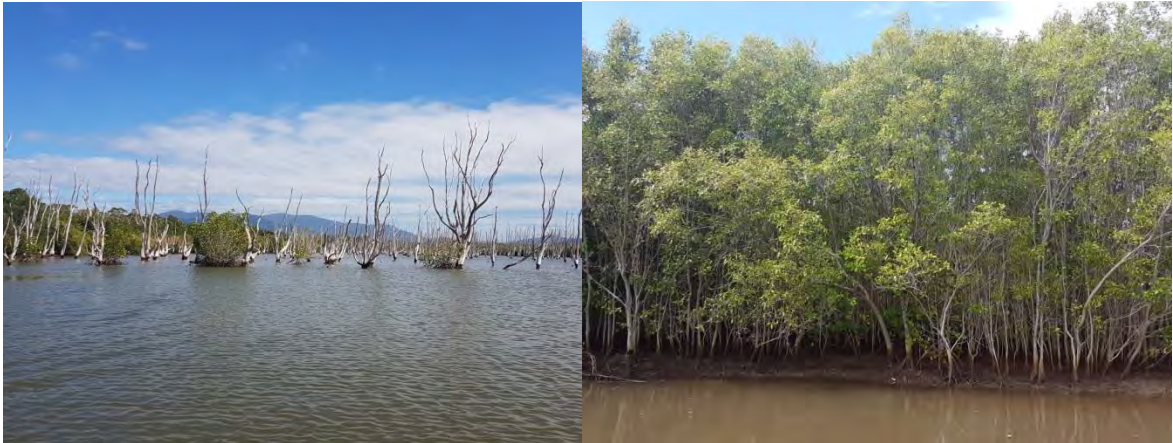
Figure 3-12 *Rhizophora* and *Aegiceras* re-colonising ponded regions in the south-eastern sector of Firewood Creek (left); and dense *Avicennia marina* dominating the riparian zone in the north-west sector of the bund (right)

Riparian communities inside the bund of Firewood Creek varied greatly in condition. The inundated area consisted of a complicated chain of fragmented oxbows, often connected by narrow tie-channels, and shallow ponded areas. The south-eastern sector of the bunded area within Firewood Creek was in a highly disturbed condition. This sector was mostly comprised of ponded open water with dead *Melaleuca* snags and isolated (regrowth) mangroves (mostly *Rhizophora* and *Aegiceras corniculatum*) (Figure 3-12). Riparian vegetation was in better condition towards the north-west sector of the bunded area, and was dominated by *Avicennia marina* (Figure 3-12).

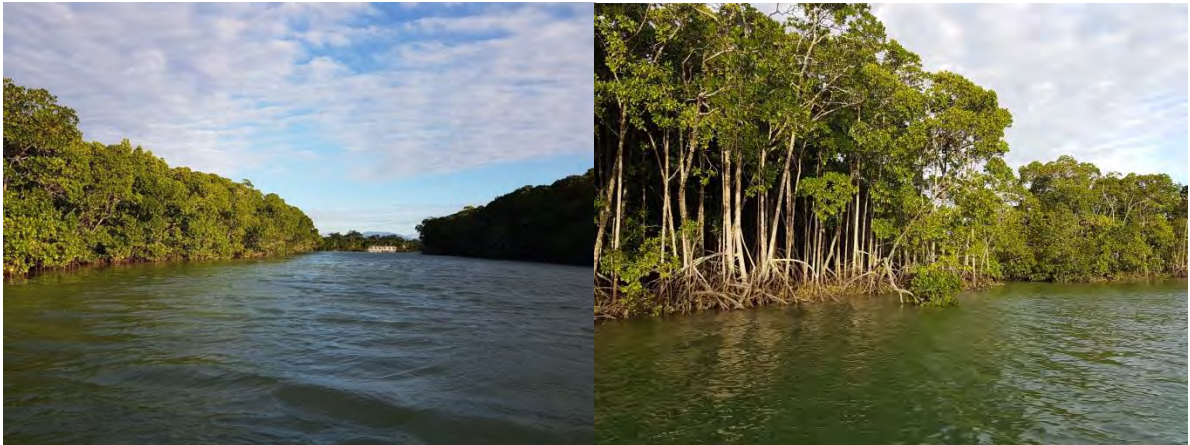
Figure 3-14 Mangroves in good condition downstream of the bund on Hills Creek

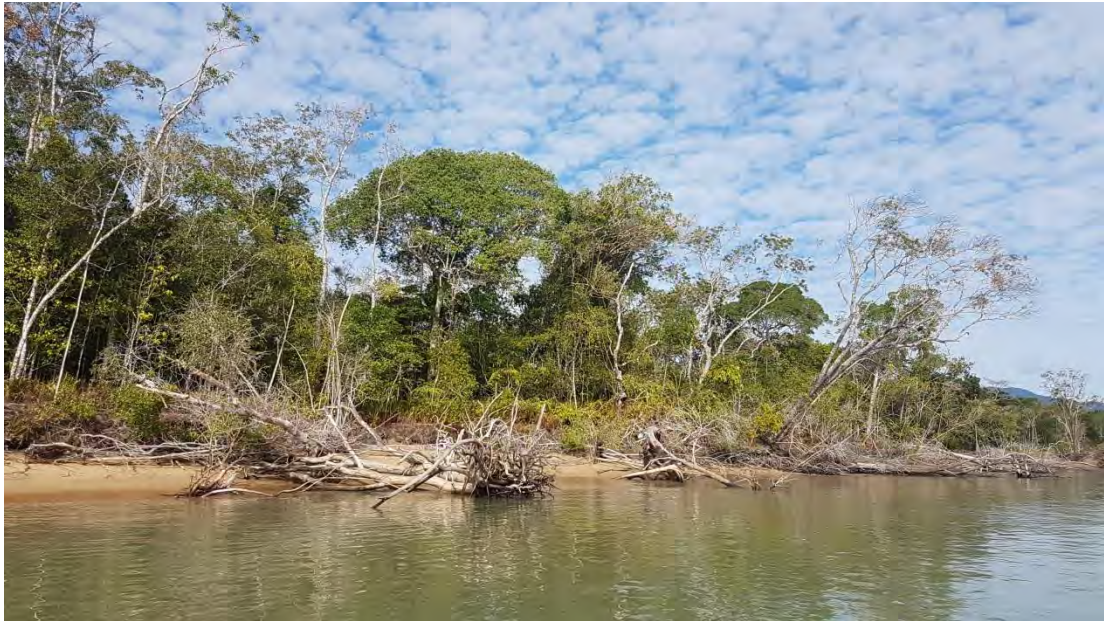
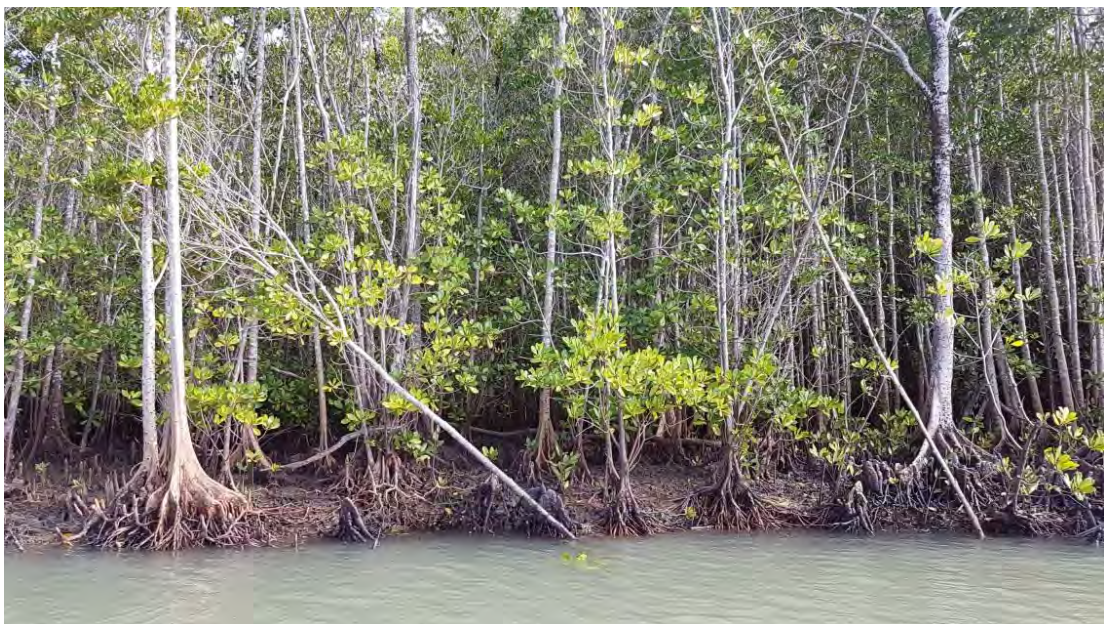
Figure 3-15 Eroding shoreline near the mouth of the Barron River (above); *Bruguiera* dominating an outside meander in a downstream reach of the Barron River (below)

In the lower estuary (upstream of the river mouth), the mangroves *Bruguiera* and *Rhizophora* dominated on the outside of eroding meander bends (Figure 3-15), whereas *Avicennia* and *Sonneratia* dominated on the inside accreting meanders and straight sections of the river (Figure 3-16). There were several sections of bank showing major disturbances to riparian vegetation, along the downstream left bank in particular.

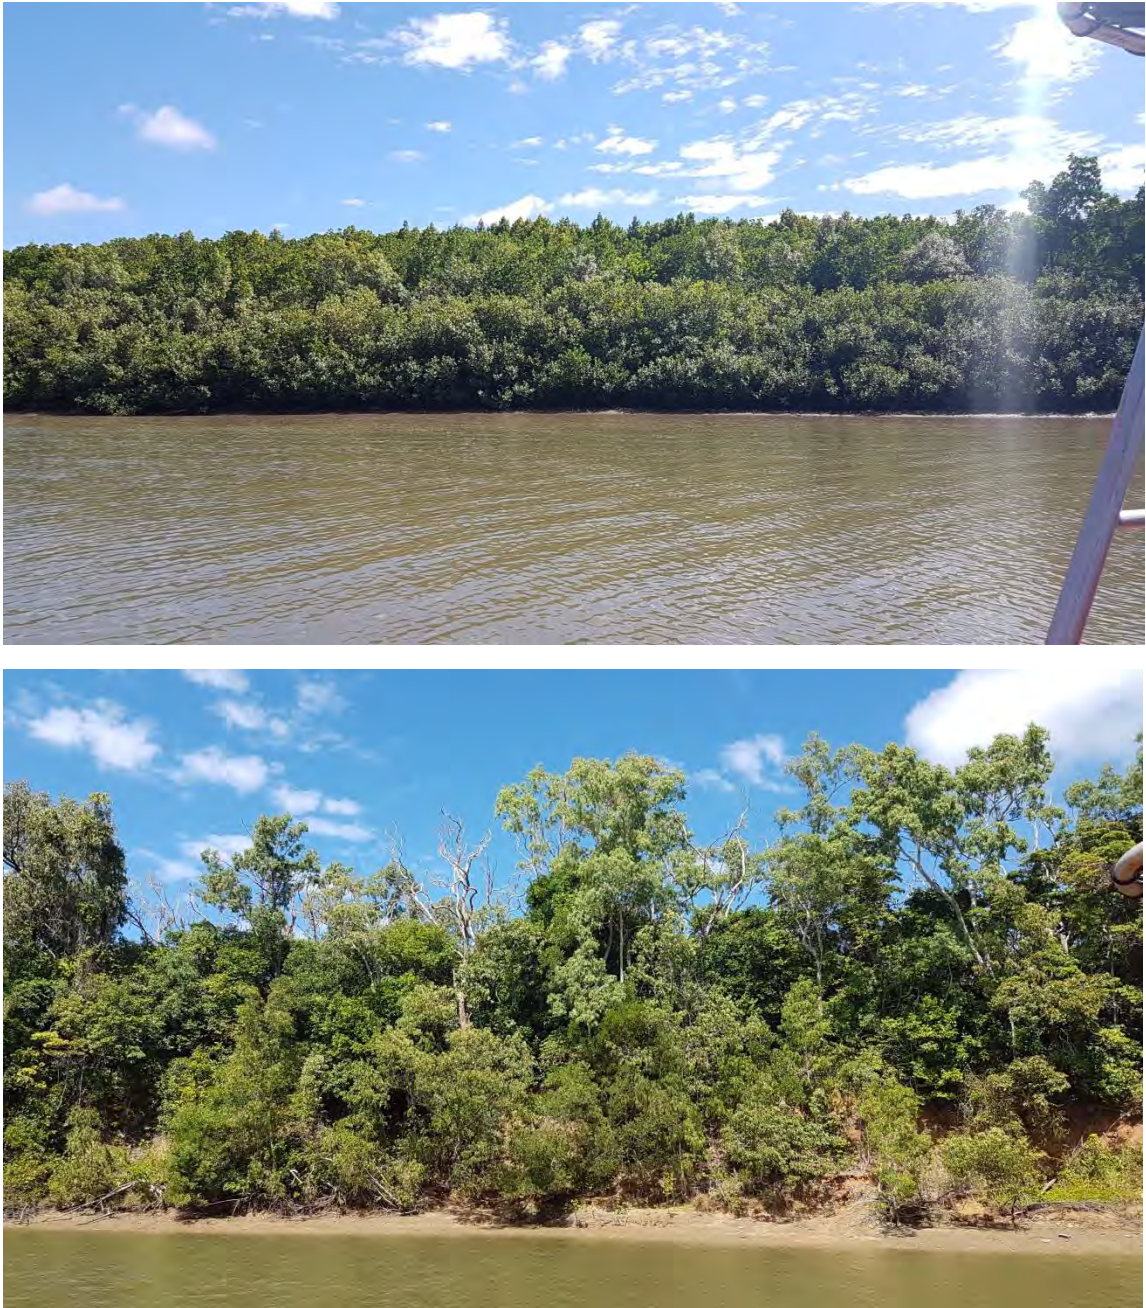
Figure 3-16 *Avicennia* and *Sonneratia* dominating a straight section of river (above); *Melaleuca* and other salt-sensitive species growing near the high water mark upstream from the Bruce Highway (below)

At the first bend upstream of the Bruce Highway Bridge, pockets of non-mangrove riparian habitat begin to become more prevalent in the riparian fringe. At this bend, the downstream right bank has a large number of *Melaleuca* and other less marine tolerant species growing down towards the high water mark.

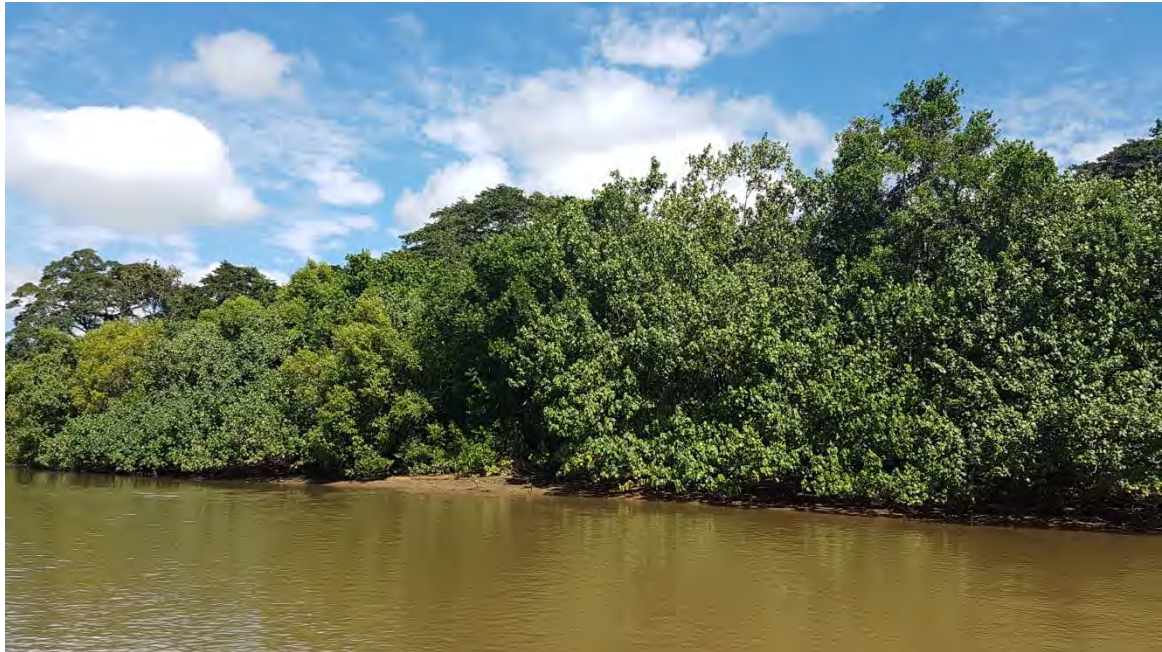
Figure 3-17 A mixture of *Hibiscus* and occasional mangrove in the riparian community opposite Northern Sands

From the Bruce Highway Bridge to Northern Sands the proportion of mangroves in the riparian fringe becomes progressively less (Figure 3-17), to the point where mangroves are no longer present upstream of the Northern Sands site.

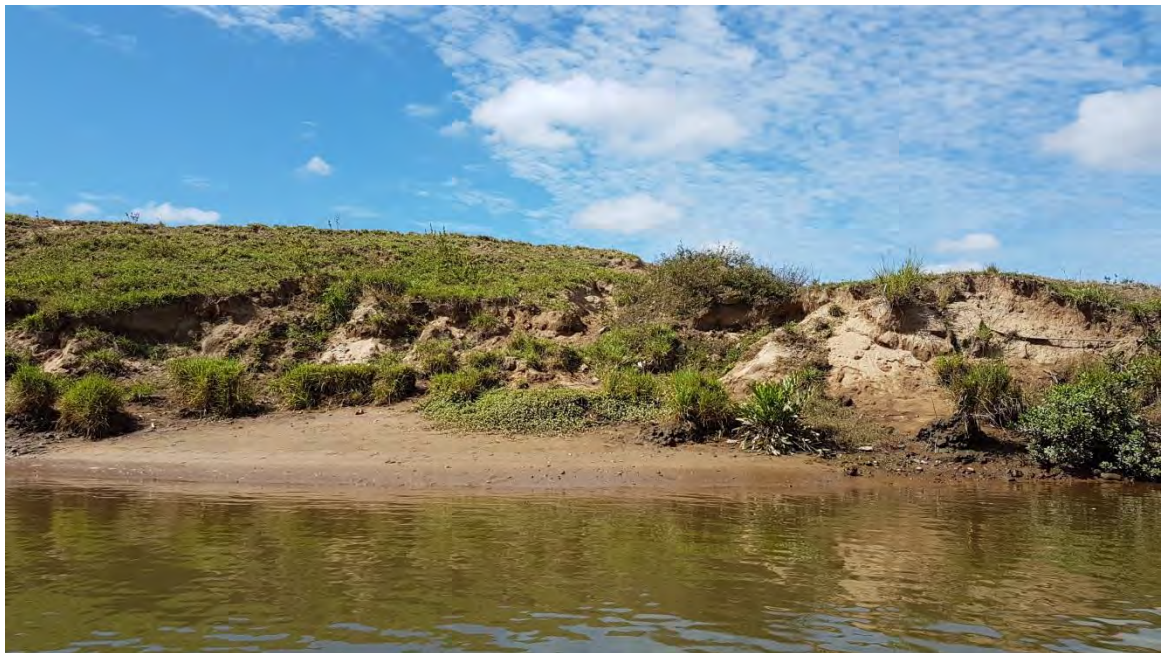
Figure 3-18 Highly disturbed riparian zone on the downstream left bank, upstream of the Northern Sands site

Upstream of the Northern Sands site are mixtures of non-remnant, highly disturbed vegetation fringing agricultural lands () and several other fringing wetland communities including the endangered fringing riverine wetland communities (7.3.23a).

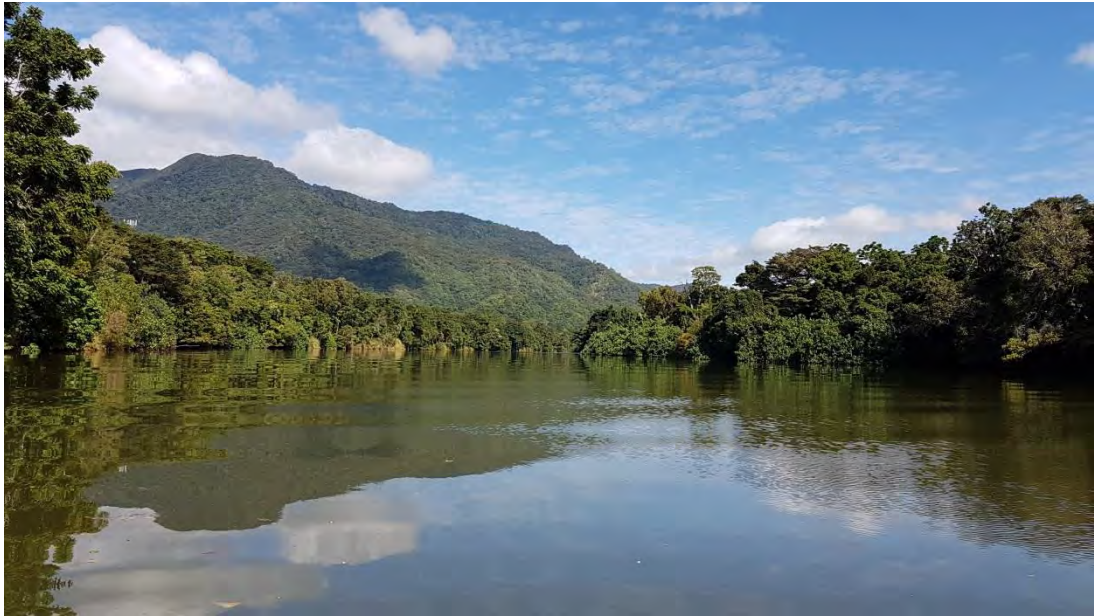
Figure 3-19 Fringing wetland community 7.3.23a to the right of screen near the most upstream extent of the survey
