# CAIRNS SHIPPING DEVELOPMENT PROJECT

### APPENDIX V: East Trinity Soils Values Assessment Report (2016)

**BASELINE SOILS REPORT - EAST TRINITY**  
**Cairns Shipping Development**  
**Project**

**Report Number.** 1546223-004-R-Rev3

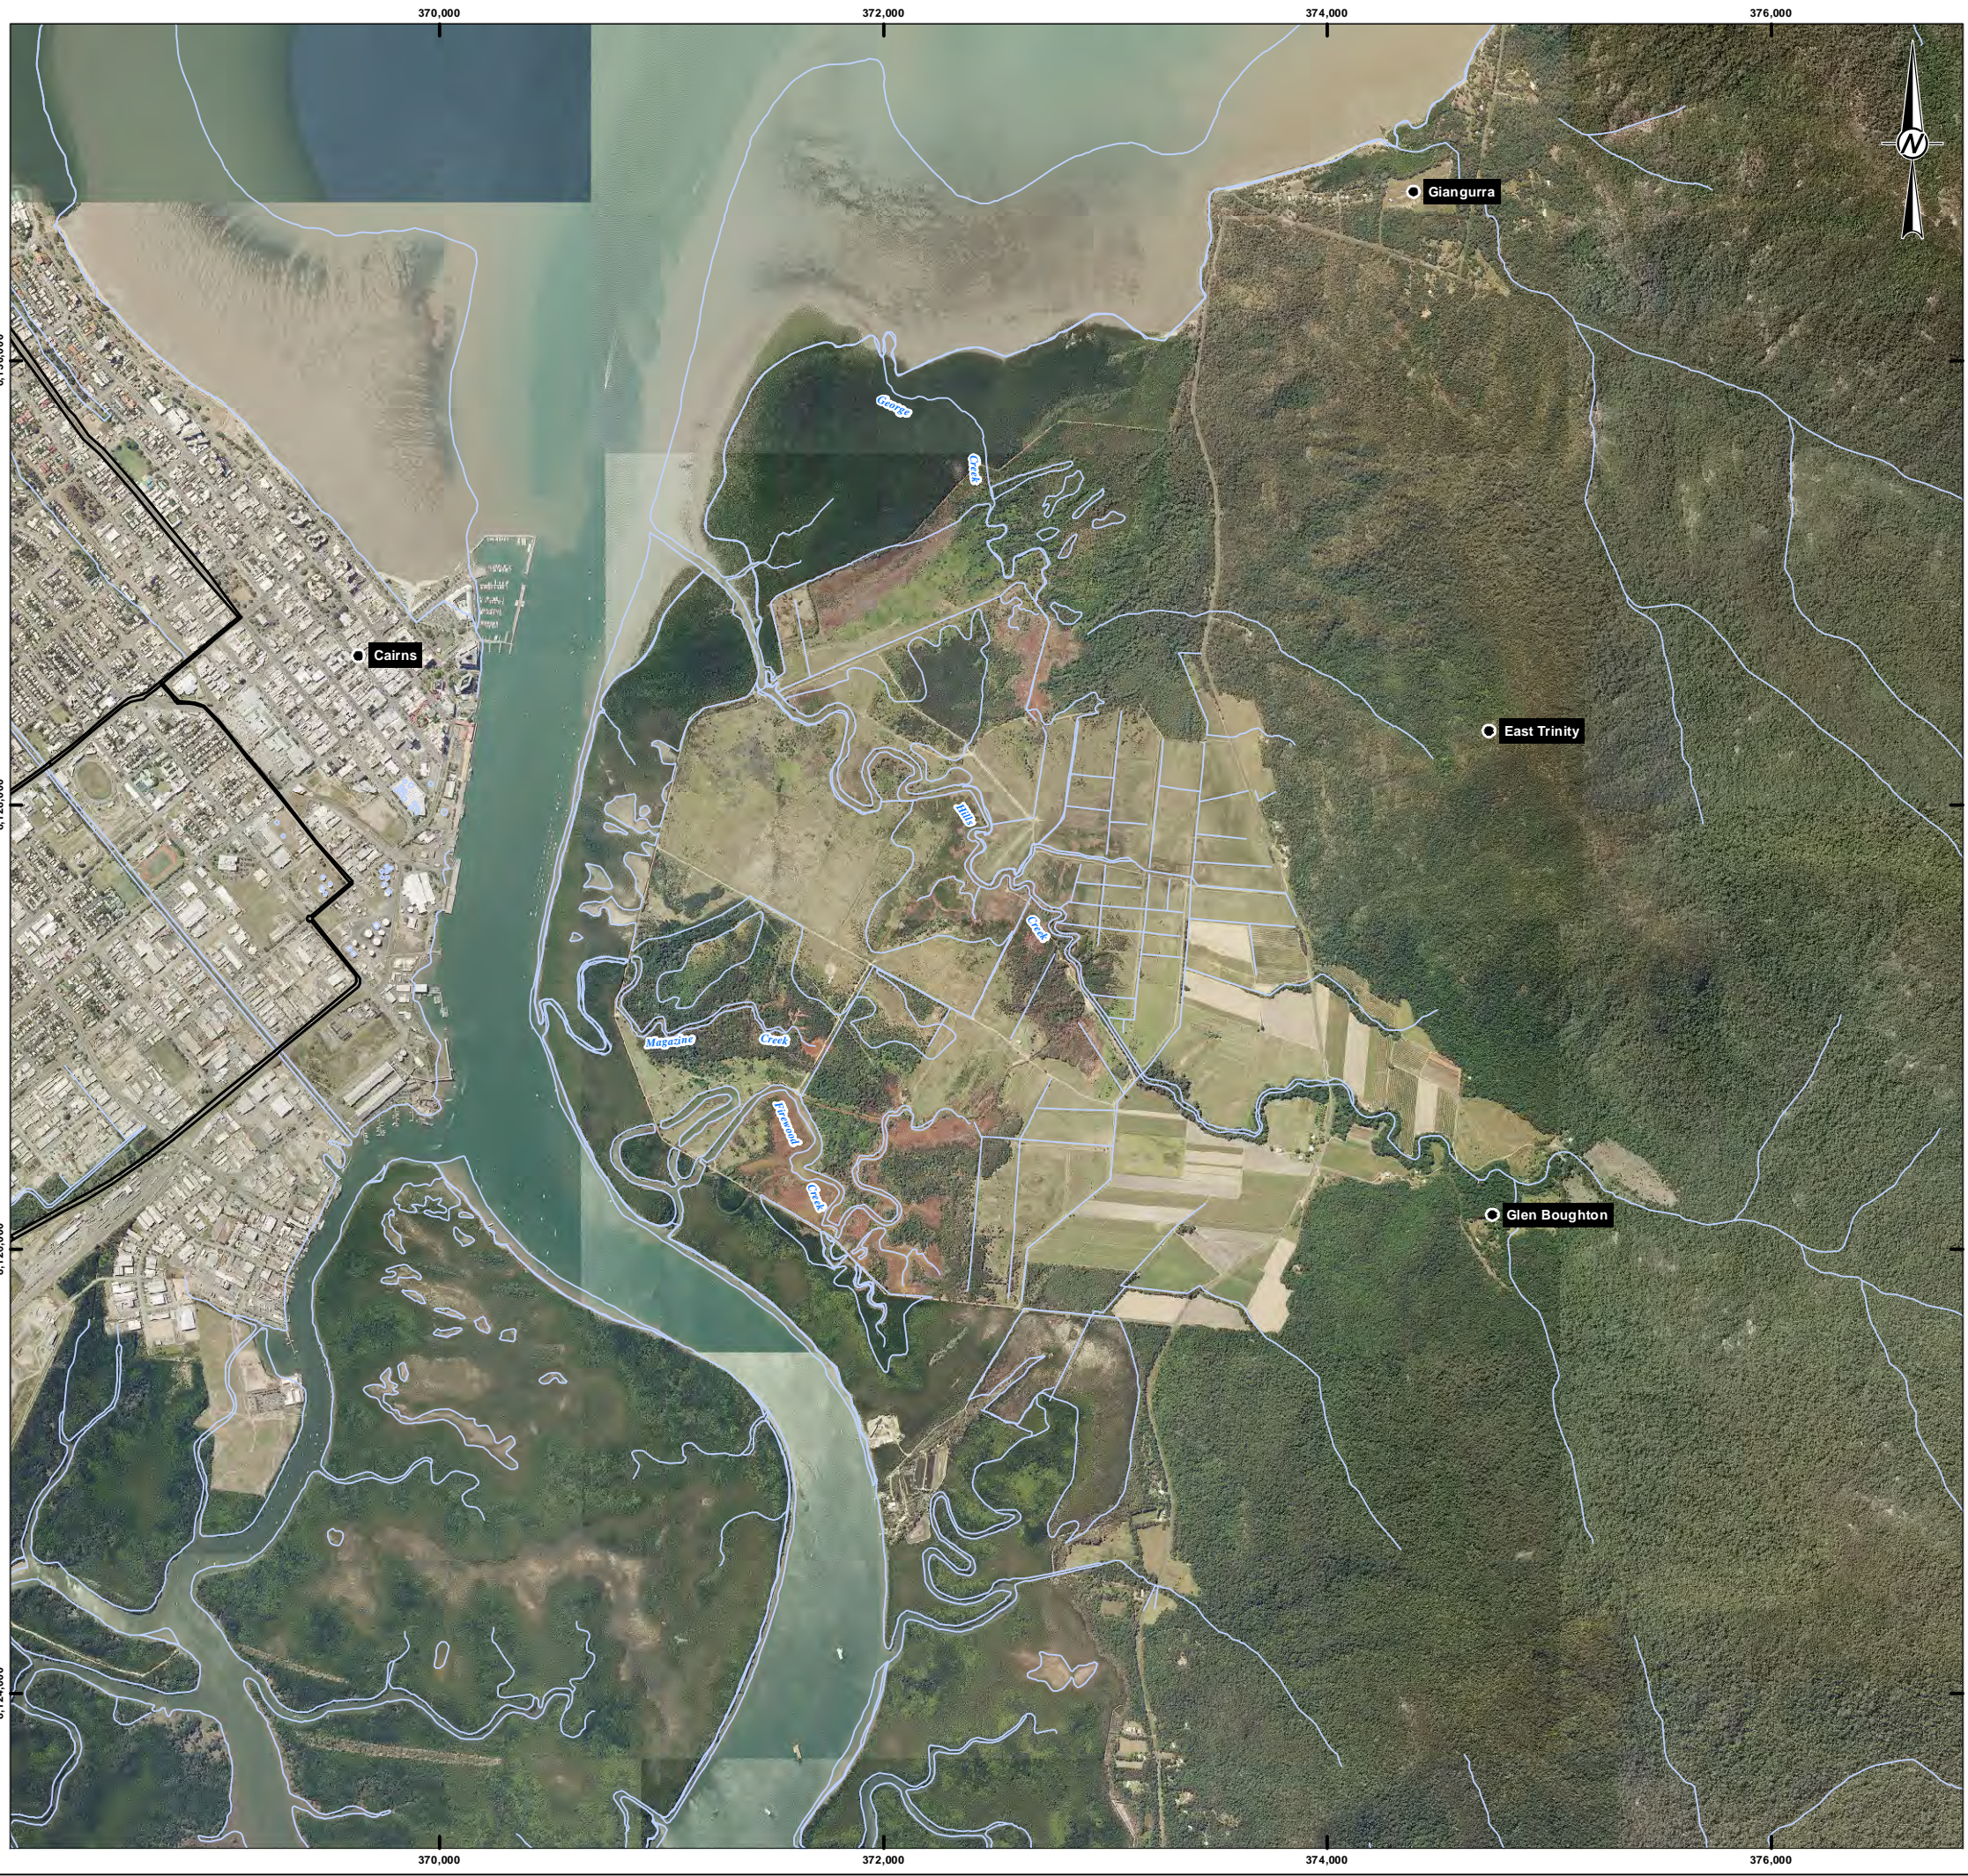
Levels across the site are typically below 2.5m AHD. Four creek systems (Firewood Creek, Magazine Creek, Hills Creek and Georges Creek, see Figure 1) originally flowed through the site prior to construction of the perimeter bund. Levels in the vicinity of these creek lines are typically below 0.5m AHD.

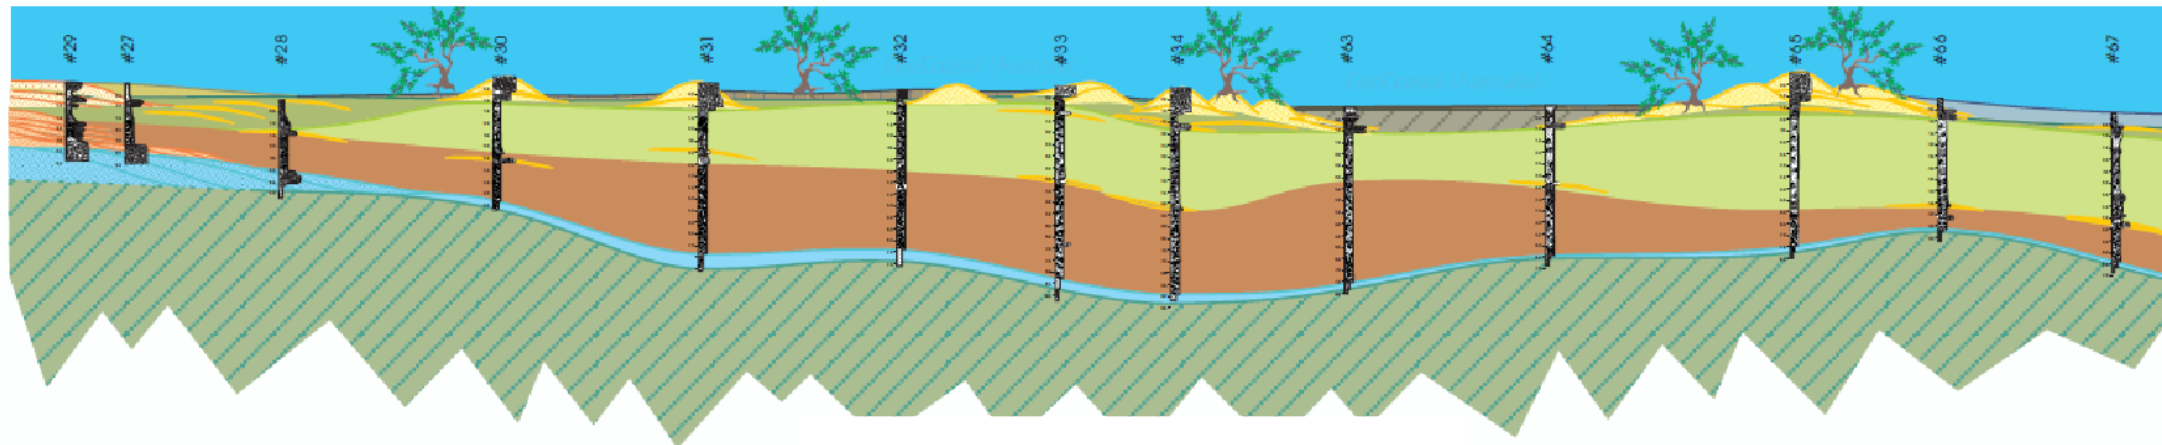
Stratigraphic cross-section along Transect 1, East Trinity.

Interpreted stratigraphic sections for the East Trinity site, Smith et al (2003) are reproduced on Figures 3A and 3B, and indicate:

- The younger (Holocene age) alluvial deposits are generally present to depths of about 2m to 4m below the ground surface at the eastern end of the site, progressively increasing in depth towards the west. At the western margins of the site the thickness of Holocene deposits typically ranged between about 6.5m and 12m, increasing to a depth of about 22m between Hills Creek and Magazine Creek.
- The younger alluvial deposits are underlain by older (Pleistocene age), consolidated alluvial deposits.
- Permian age Granite bedrock underlie the alluvial deposits at depths of at least 90 m near Trinity Inlet.

These ground conditions are consistent with the interpreted stratigraphy for the East Trinity site, Smith et al (2003) discussed previously and as shown on Figure 3.

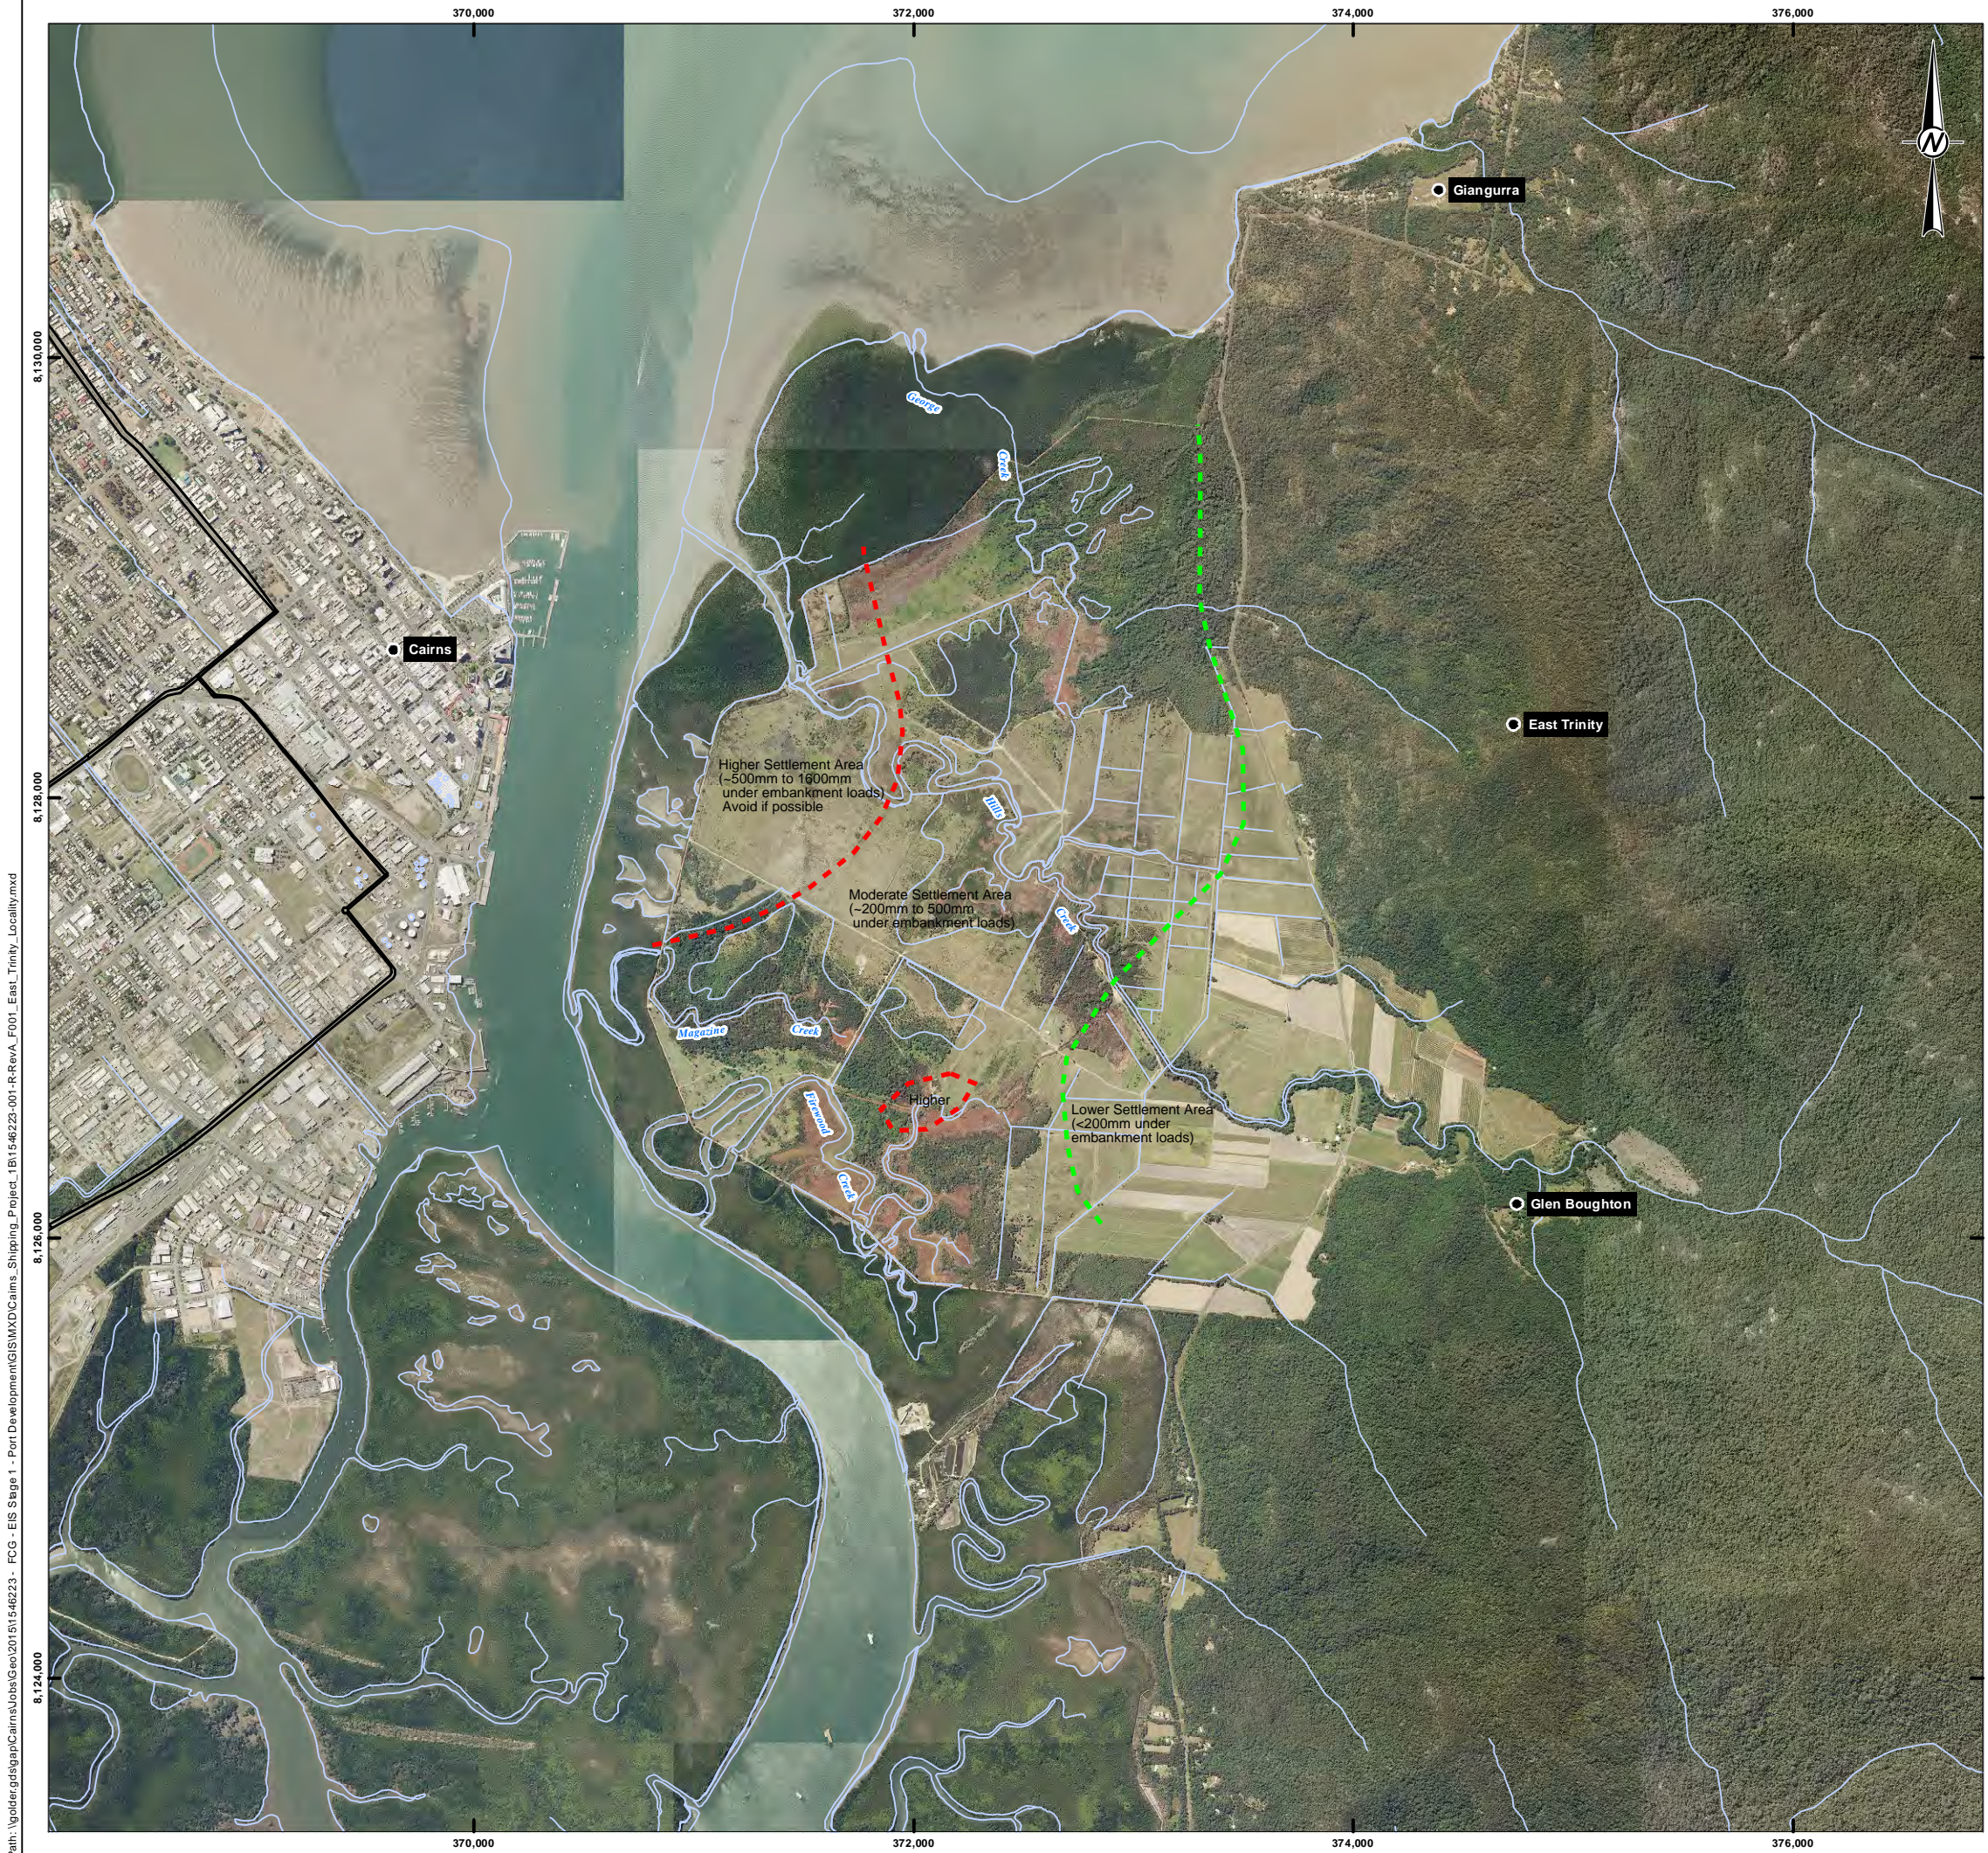
The Holocene age alluvium is typically soft and highly compressible. Design of ponds will need to consider total and differential settlements induced by the embankments and by the dredged materials. Areas where greatest potential settlement could be expected are marked on Figure 6.

- The near surface soils are underlain by a varying thickness of highly compressible clays, typically increasing in thickness from the eastern to western side of the site. Design of the ponds will need to consider settlements induced by the embankments and by the dredged materials. Allowance for contingency measures may need to be made (e.g. topping up of embankments and/or remedial works on decant structures may be required). Figure 6 provides an indication of the expected variability of settlement.
