CAIRNS SHIPPING DEVELOPMENT PROJECT

Revised Draft Environmental Impact Statement

**EAST TRINITY BASELINE
HYDROGEOLOGICAL ASSESSMENT**

Report Number. 1546223-007-R-Rev2

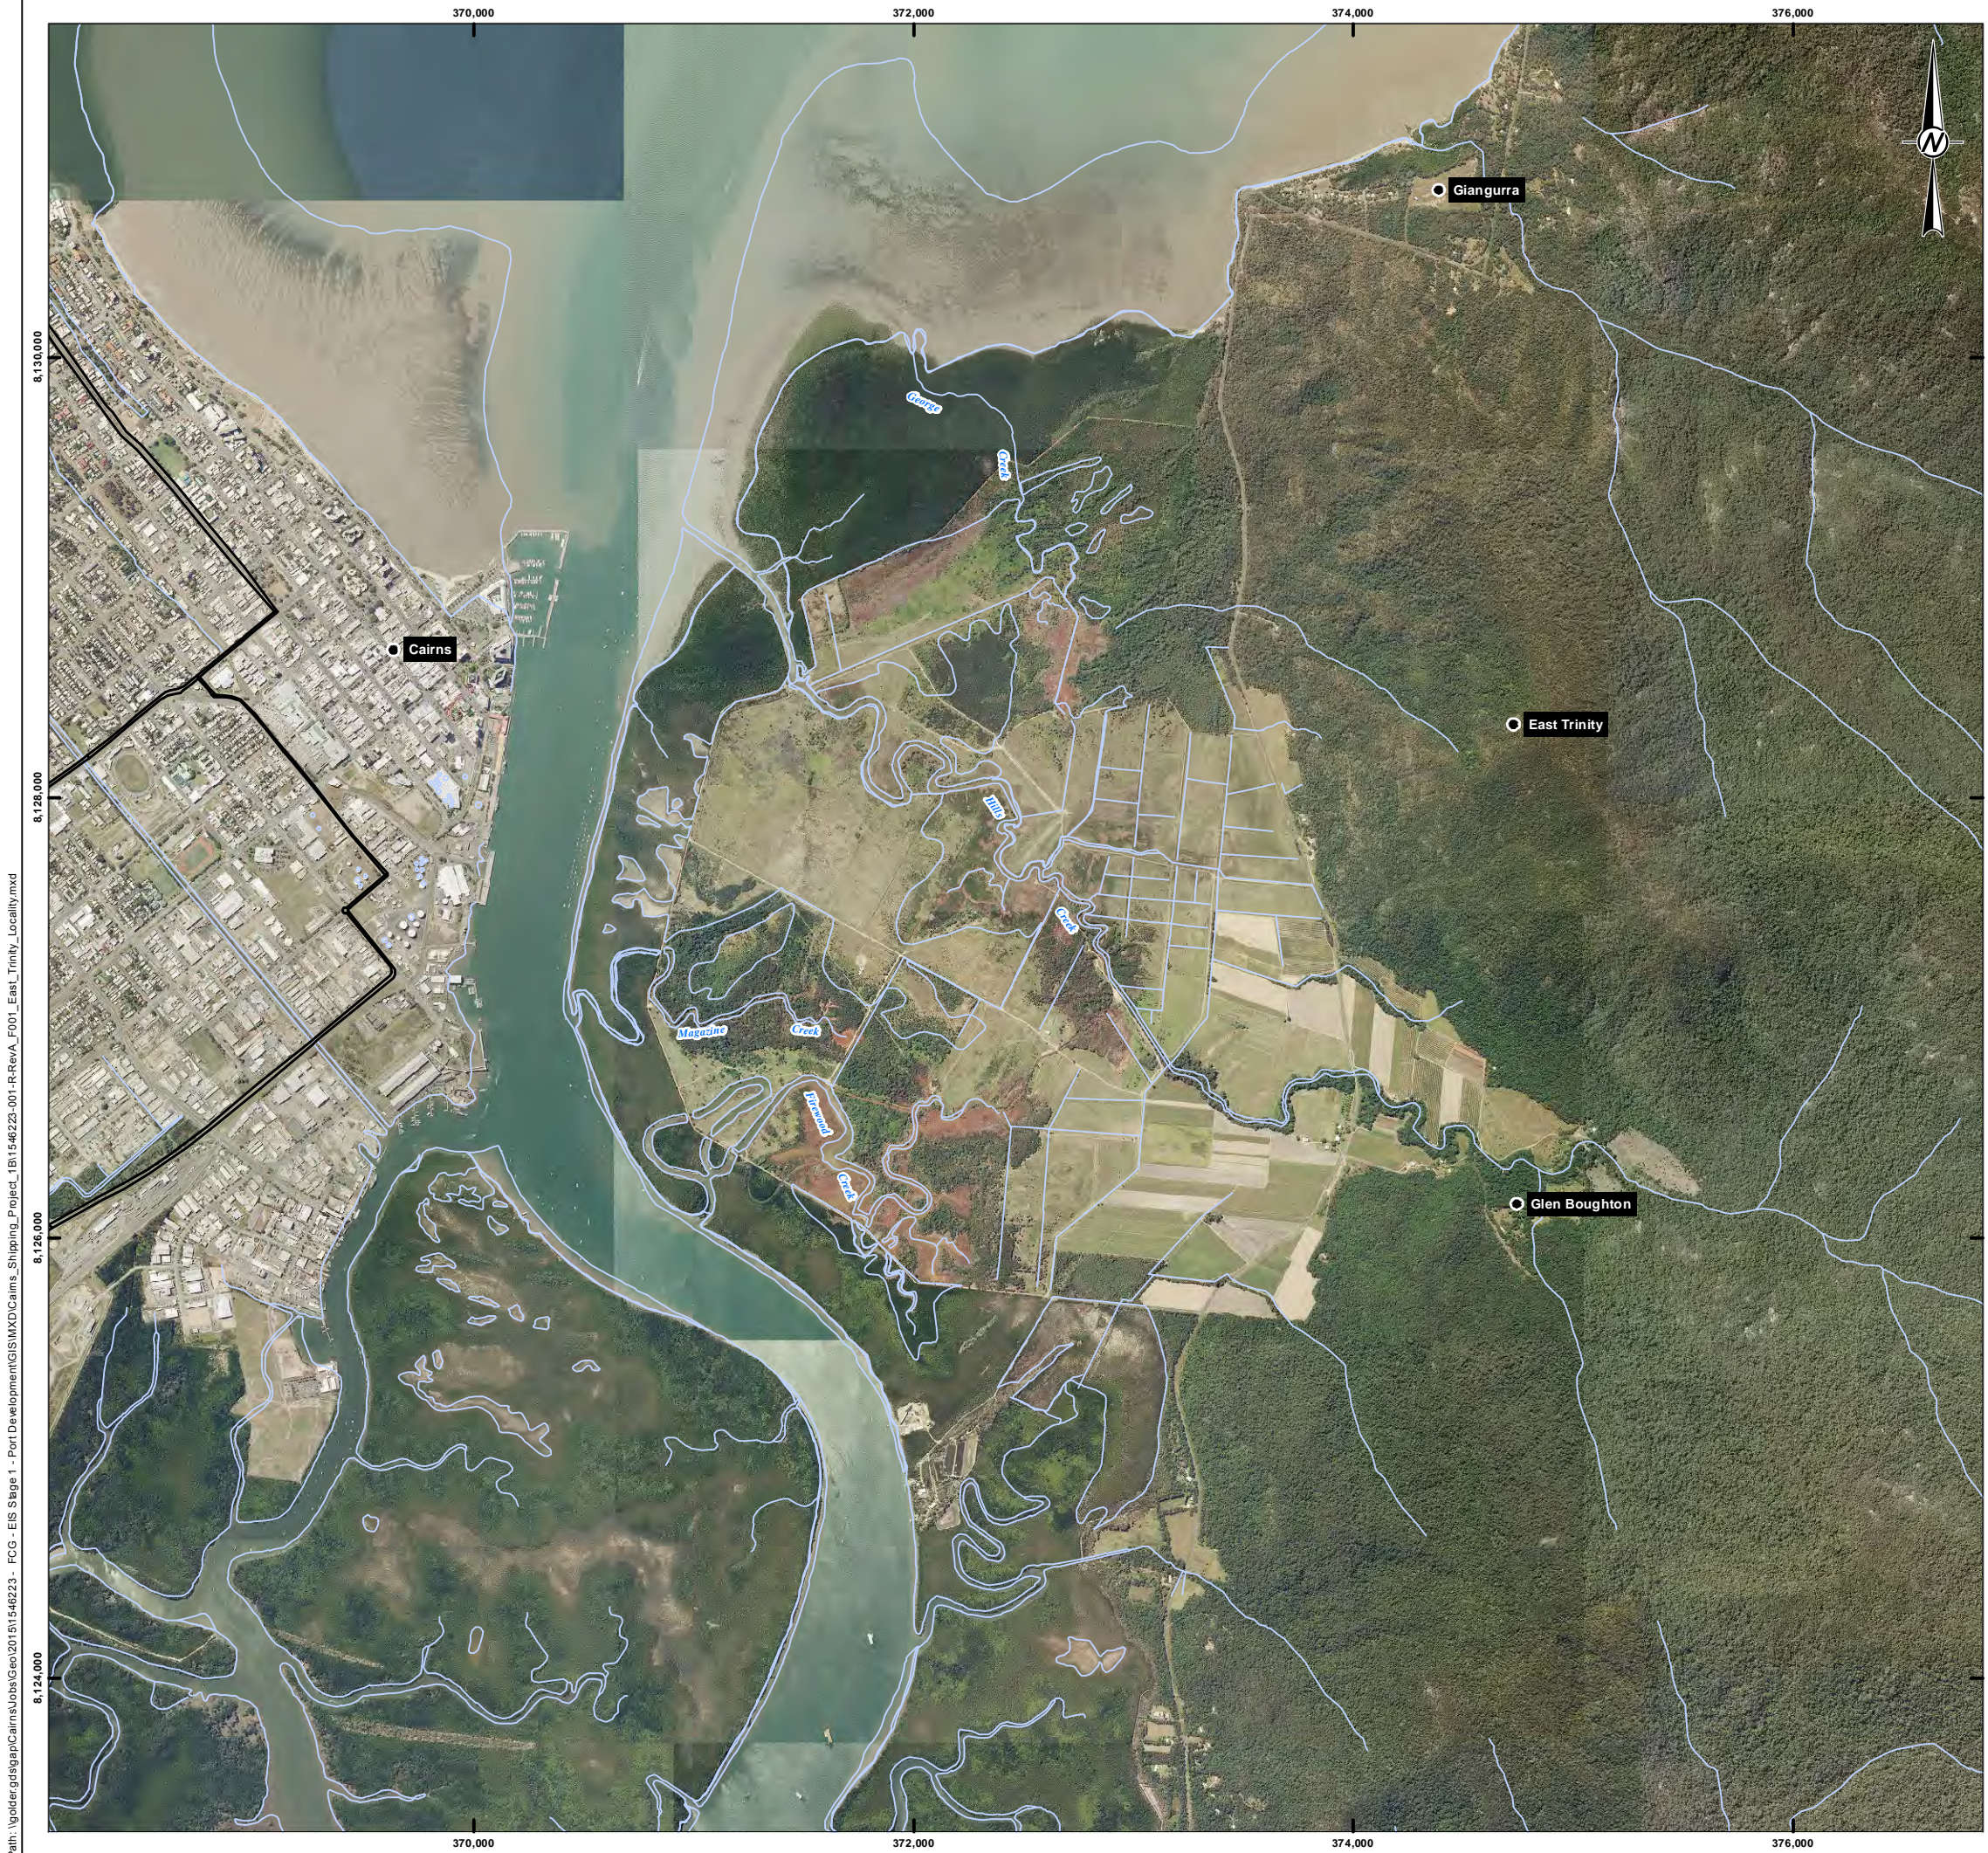
Figure 1 - Locality: East Trinity

This report is based on a desktop review of available information and addresses the placement of capital dredged material within a new bunded site or sites within the general East Trinity area, see Figure 1.

Levels across the site are typically below 2.5m AHD. Four westward flowing creek systems (Firewood Creek, Magazine Creek, Hills Creek and Georges Creek, see Figure 1) originally flowed through the site prior to construction of the perimeter bund. Levels in the vicinity of these creek lines are typically below 0.5m AHD.

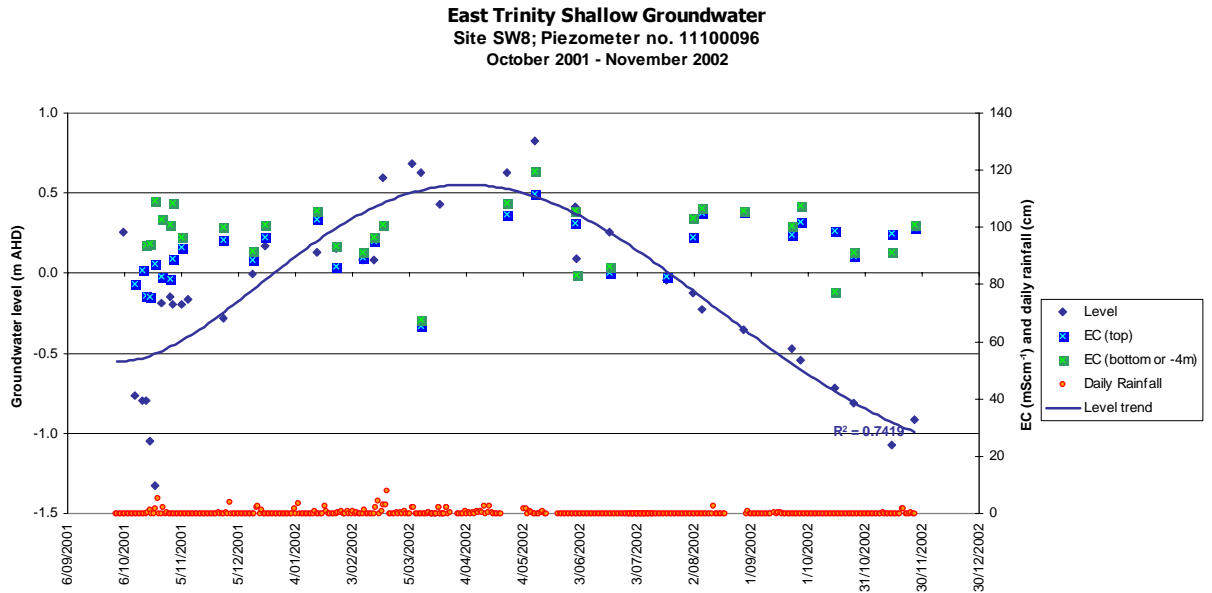
Piezometer 11100096 data (Figures D2-a and D2-b) show both the delayed response to rainfall events and EC measurements unaffected by alterations to the surface water system that are evident in the data from piezometer 95. The pH increase after June 2002 (Figure D2-b) corresponds to the cessation of rainfall and therefore is likely to be influenced by a decrease in the acid flushing from the soil, where it is formed *in situ*, and into the groundwater system. This is further supported by the pH drop following the small rainfall event in October 2002.

Figure D2-a. EC, groundwater level and daily rainfall data for shallow groundwater piezometer 11100096 at site SW8.

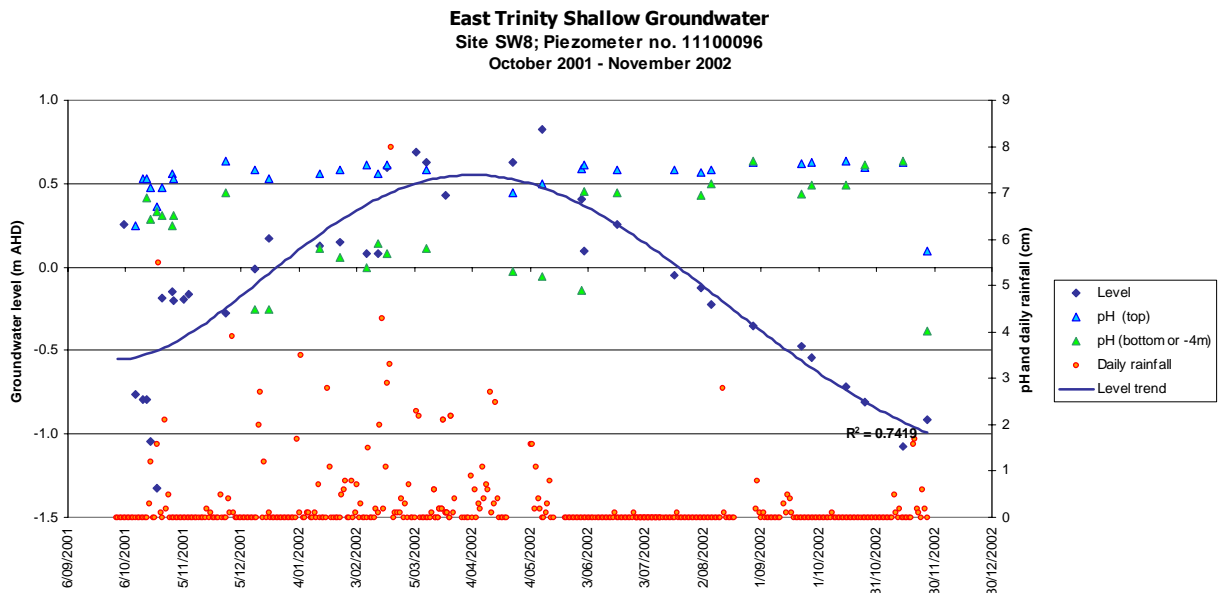
Figure D2-b. pH, groundwater level and daily rainfall data for shallow groundwater piezometer 11100096 at site SW8.

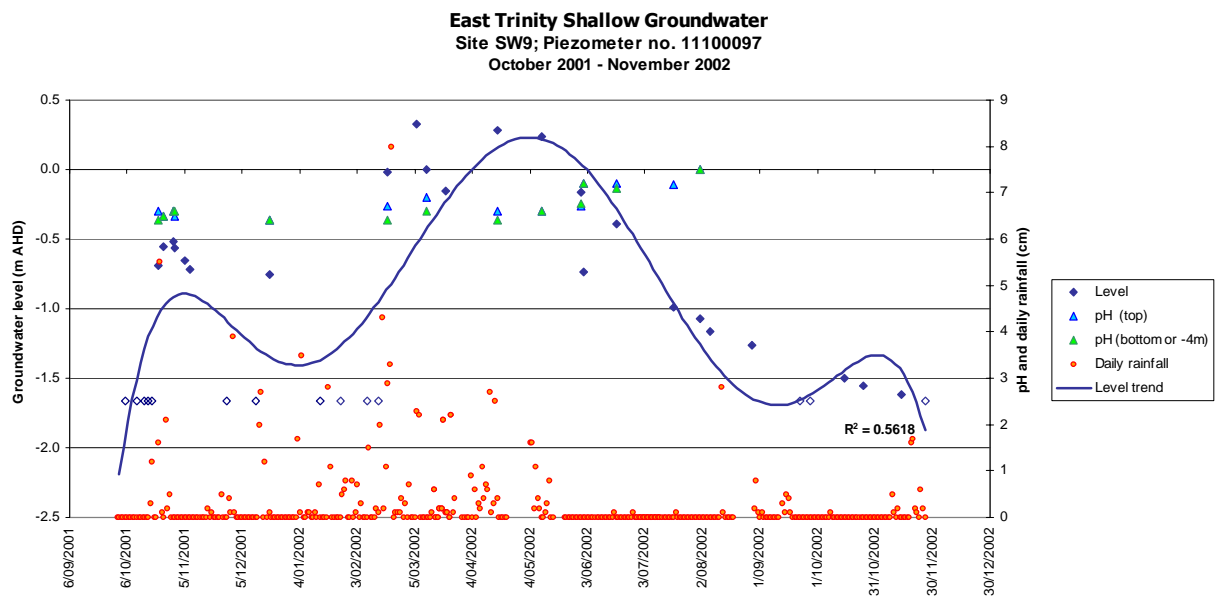
Data from piezometer 11100097 are shown in Figures D3-a and D3-b. This is obviously a very dynamic system. The spike in groundwater levels in September 2002 may have been influenced by the particularly high water levels in the drainage lines on-site. Increased drain water levels were due to the confluence of the automatic tidal regulators (ATRs) allowing an increased amount of water into the site's drainage system and the mid-point of the tidal cycle where low tides are relatively high and prohibit the opening of the ATRs on the ebb tide, therefore backing up the water in the on-site drainage system.

Figure D3-b. pH, groundwater level and daily rainfall data for shallow groundwater piezometer 11100097 at site SW9.
