CAIRNS SHIPPING DEVELOPMENT PROJECT

Revised Draft Environmental Impact Statement

APPENDIX Y: Soils Impact Assessment Proposed Pipelines: Northern Sands DMPA Report (2017)

Report Number. 1546223-022-R-Rev2

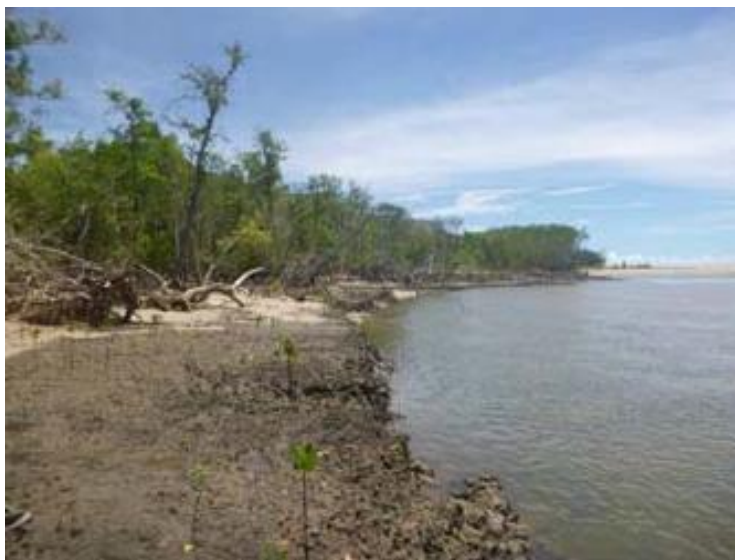
Richters Creek where pipeline comes ashore

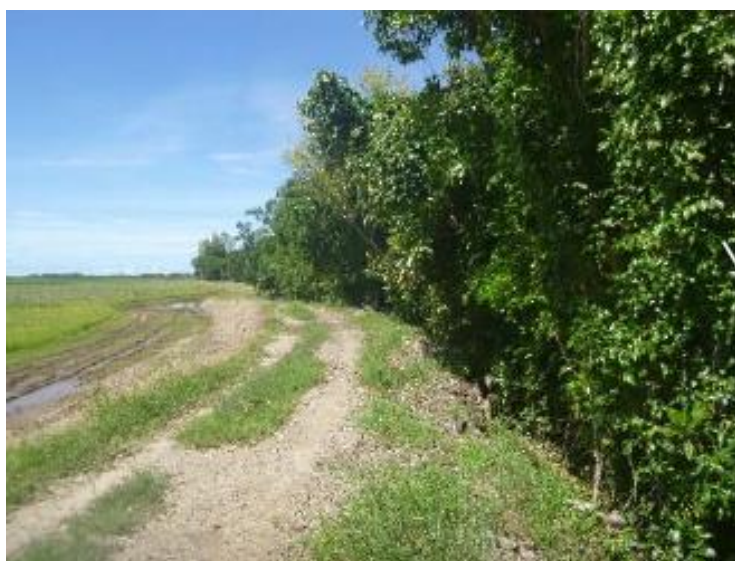
Typical headland around cane farm - north side of Richters Creek

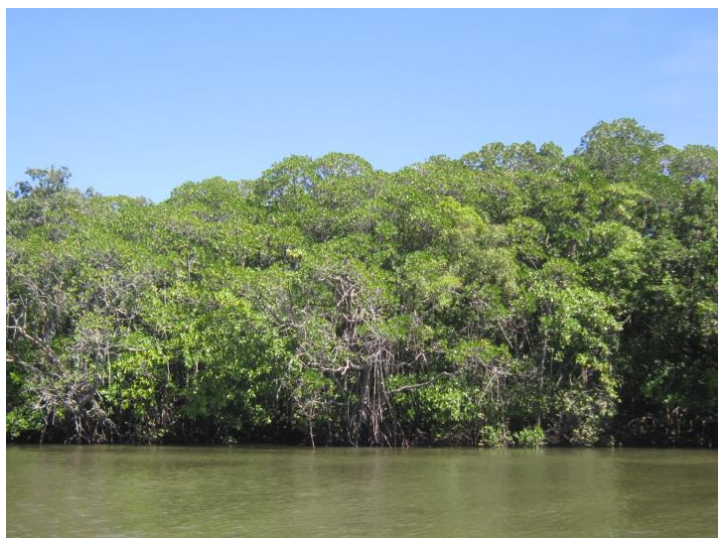
North bank of creek crossing

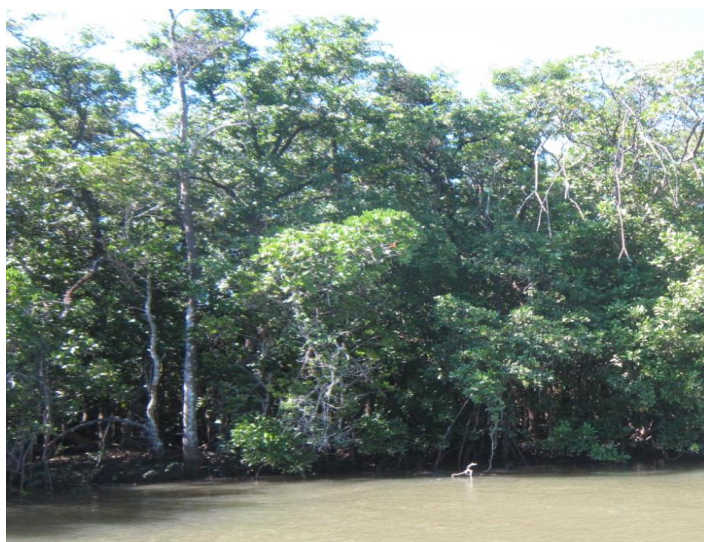
South bank of creek crossing

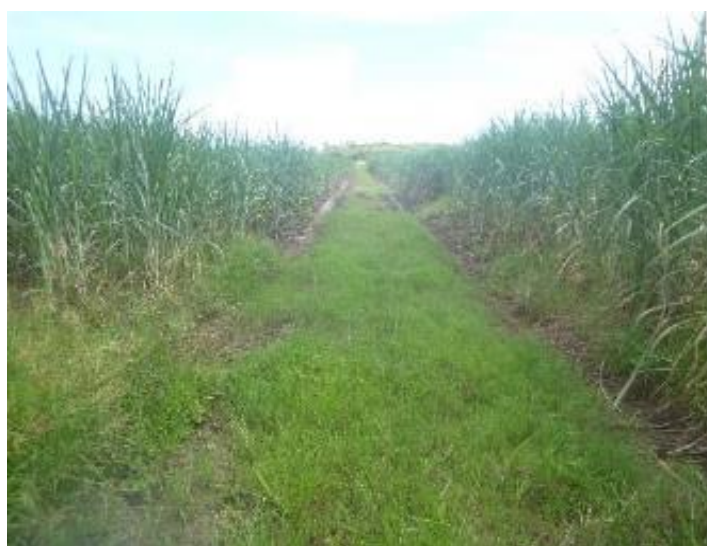
Typical headland through cane farm south side of Richters Creek
