**Carmichael Coal Mine and Rail Project
Supplementary Environmental Impact Statement**

Volume 4, Appendix C3h – Watercourse Determination Review

Water Act 2000 Watercourse Determination & Riverine Protection Permit Review

6396
22 March 2013
Adani Mining Pty Ltd

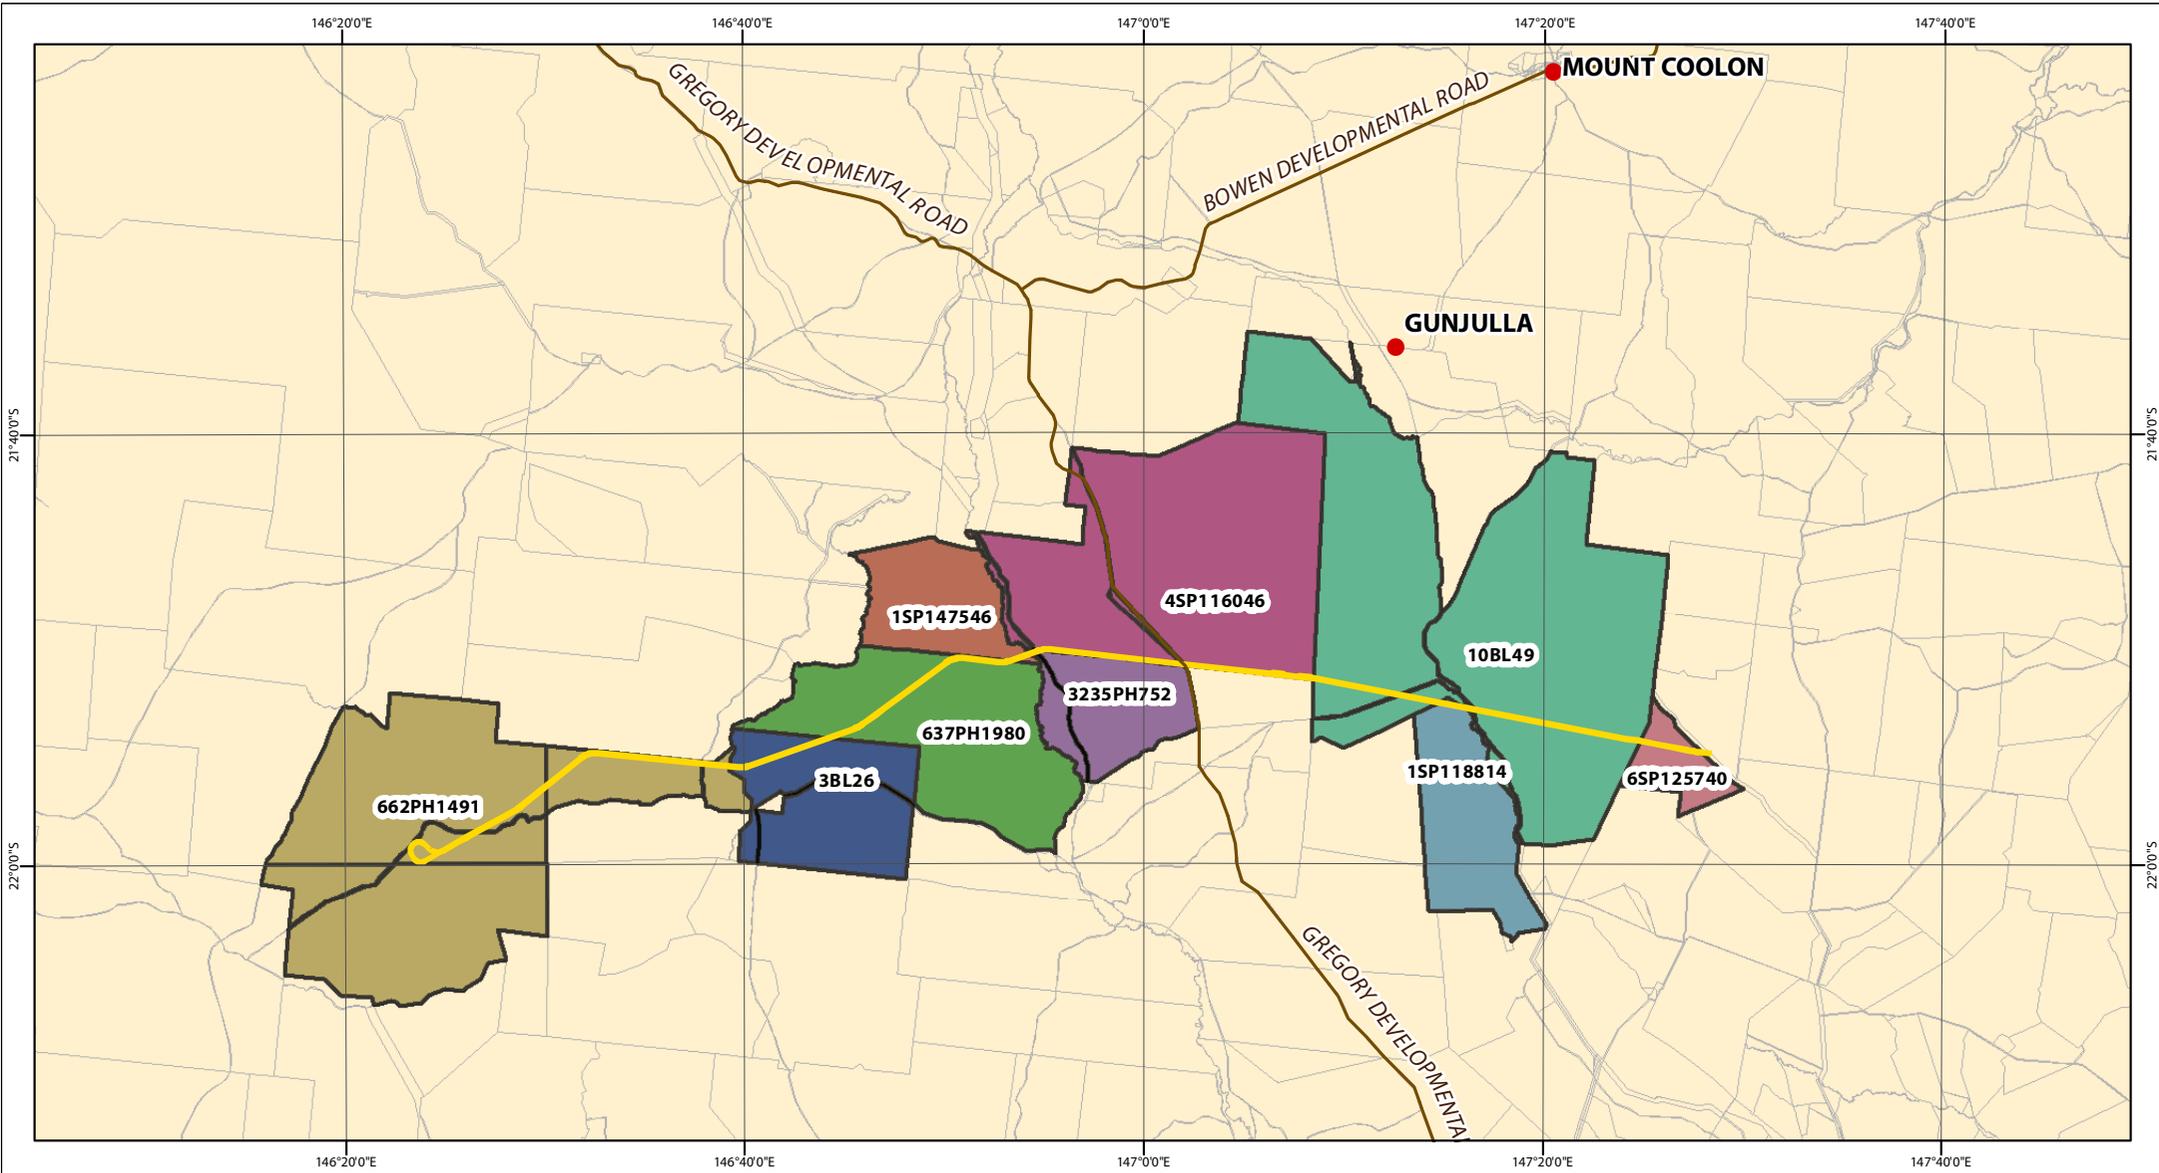
Plan 1 Rail Project Overview (SP-1)

Rail transport of output coal is proposed via an alignment connecting the mine site with the existing Goonyella and Newlands rail systems to facilitate export via the Port of Hay Point / Abbot Point. This report pertains to Separable Portion 1 (SP-1), or the 'west rail', which traverses approximately 120 km eastward from the Mine to Moranbah (Refer to **Plan 1** – Rail project overview).

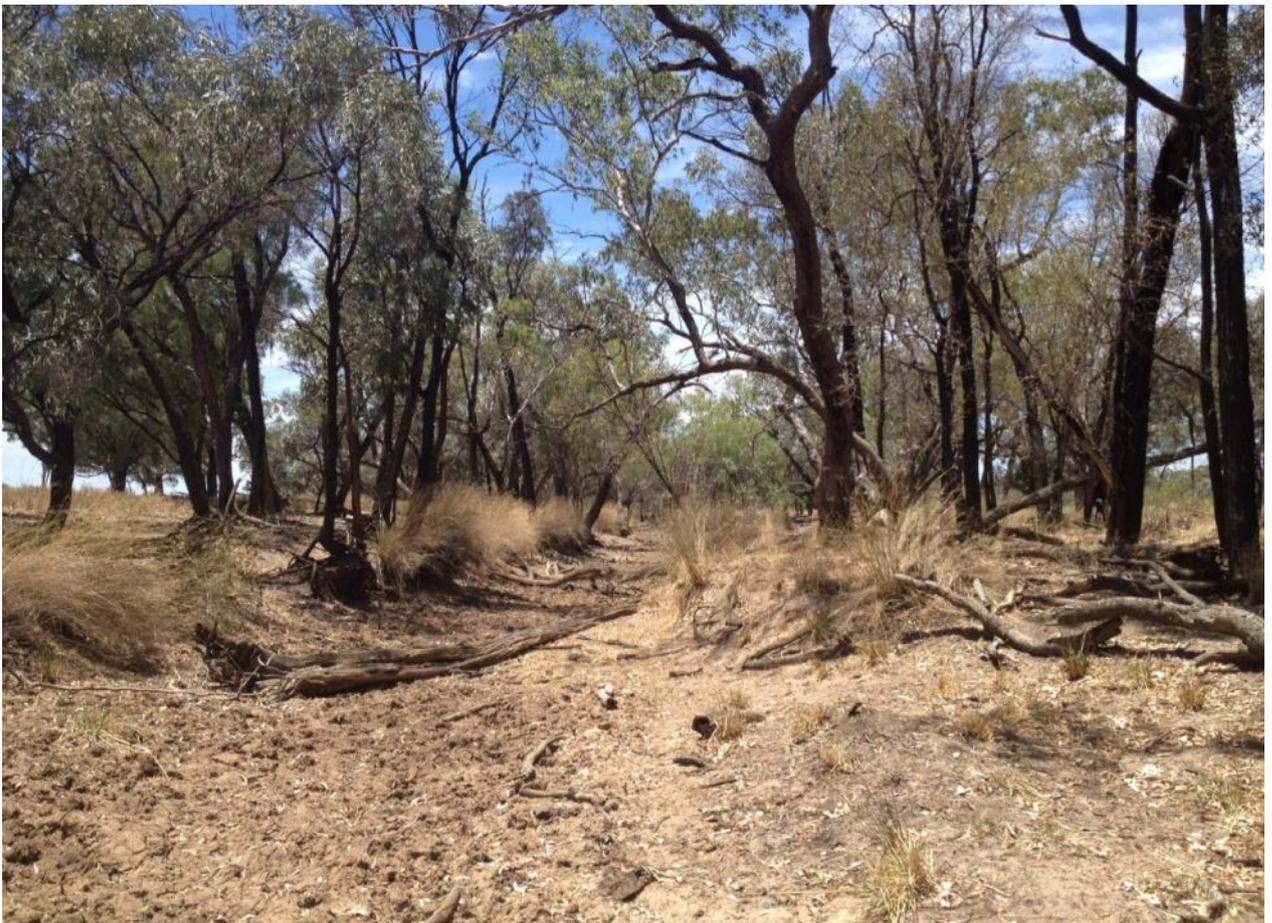
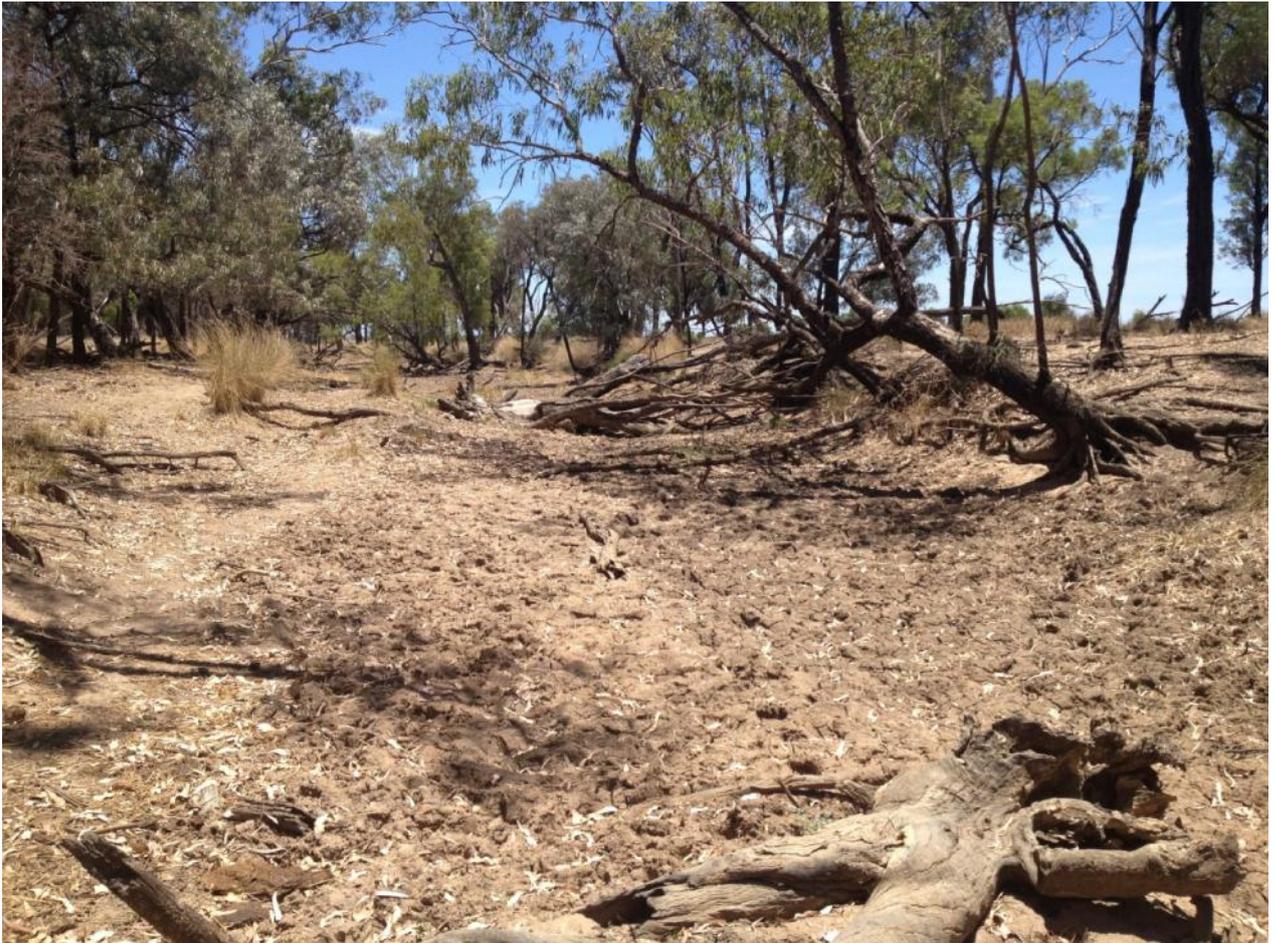
Photo: Eight Mile Creek

Overview	Comment / Description
Stream Order Number (according to State Government mapping databases)	3
Area determination (according to the <i>Water Act 2000</i> based on identified exclusion criteria)	<p>This crossing location fits the definition of a drainage feature.</p> <ul style="list-style-type: none"> • Funnels immediate localised rainfall only. • Only flows for a short period following rainfall. • Lacks a riverine environment.

Eight Mile Creek is an ephemeral drainage feature. This location was assessed following a dry period and therefore no water was present. No riverine communities were observed which, in combination with the prevailing sandy substrate, indicates this area only holds water for short periods following extensive rainfall events. The 'mapped watercourse' is broadly defined as a shallow erosion channel with fringing *Eucalyptus* and *Acacia* species. This area is considered to meet the definition of a 'drainage feature' and is therefore not considered a 'watercourse' as relevant to the *Water Act 2000*.

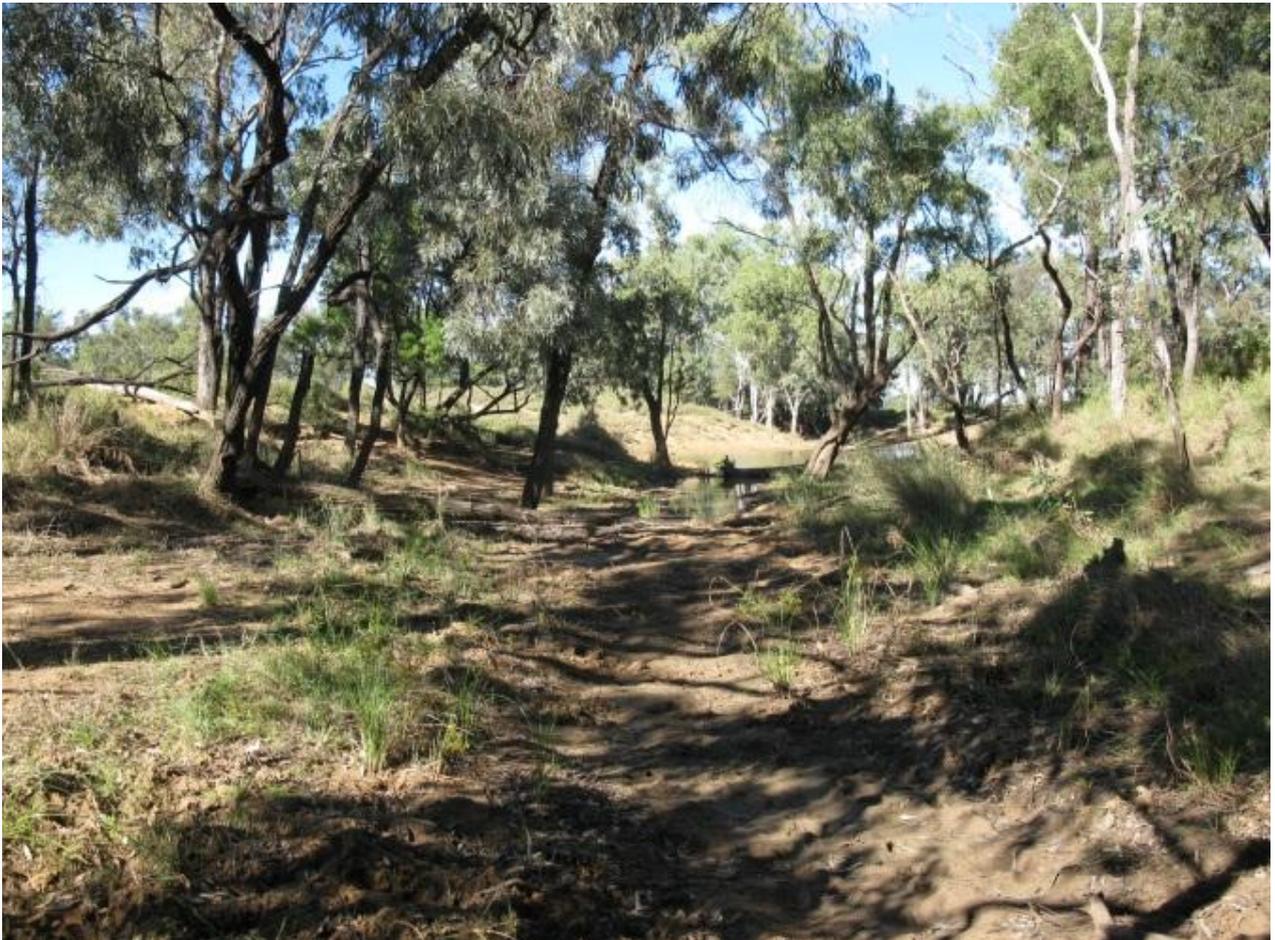
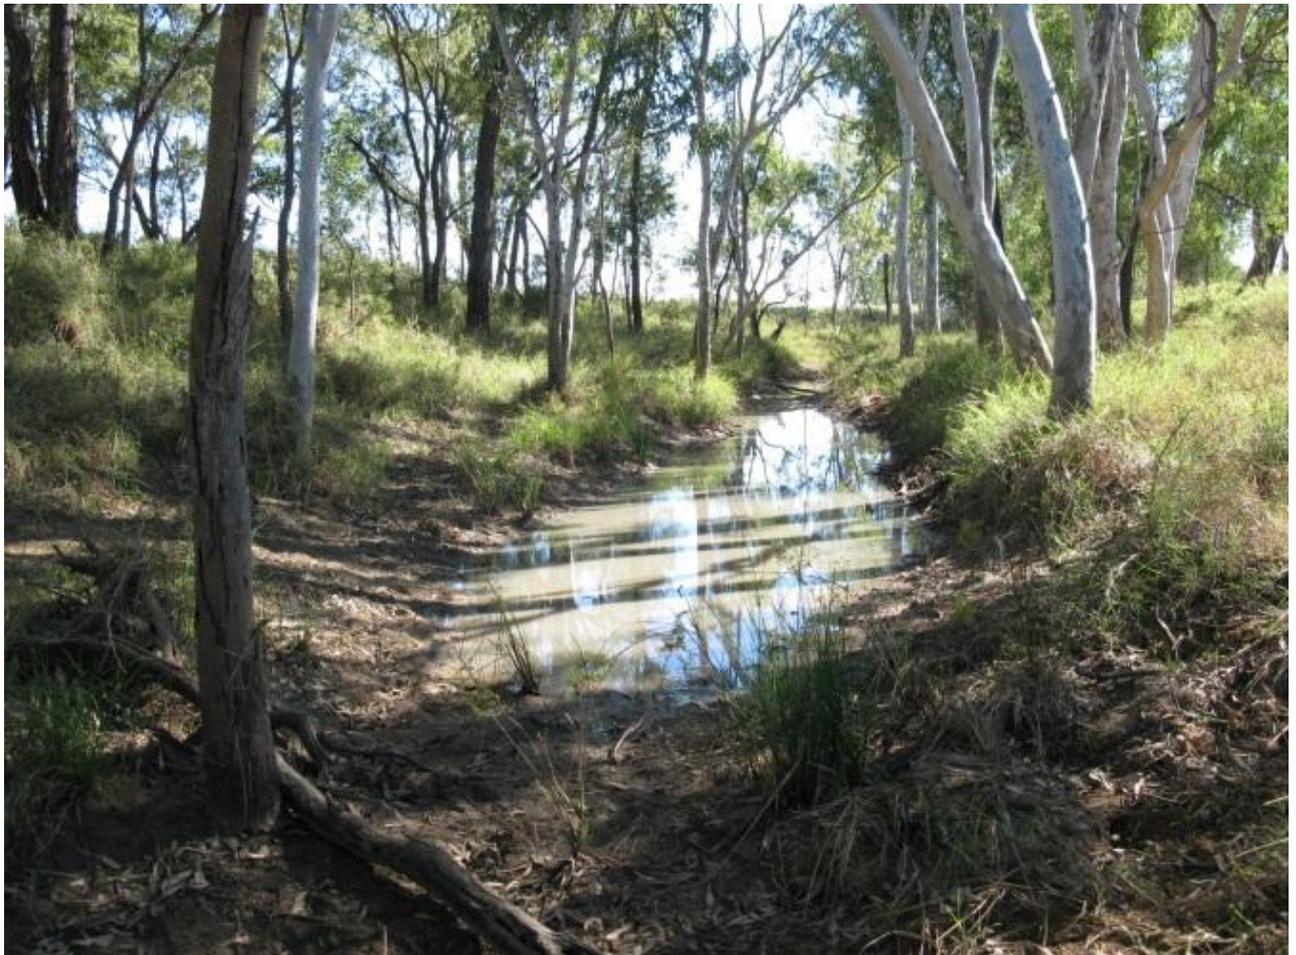
Photo: North Creek

Overview	Comment / Description
Stream Order Number (according to State Government mapping databases)	2
Area determination (according to the <i>Water Act 2000</i> based on identified exclusion criteria)	<p>This crossing location fits the definition of a drainage feature.</p> <ul style="list-style-type: none"> • Funnels immediate localised rainfall only. • Only flows for a short period following rainfall. • Lacks a true riverine environment.

Eucalyptus coolabah is the dominant tree species along the 'drainage feature' banks. Other species identified included *Acacia harpophylla*, *Eucalyptus camaldulensis*, *Terminalia oblongata* and *Eremophila mitchellii*. Shrub and ground species recorded along the banks included *Carissa ovata*, *Pennisetum ciliare*, and *Eremophila mitchellii*. Weed species located within, and adjoining, the 'drainage feature' included *Pennisetum ciliare*, *Eriocereus martini* and *Opuntia tomentosa*.

Species observed within the 'drainage feature' bed included *Juncus* and *Cyperus* species, with their presence potentially linked to wetter conditions maintained by the nearby dam. Due to its location within the upper catchment area, North Creek is considered to be a 'drainage feature' and not a 'watercourse'.

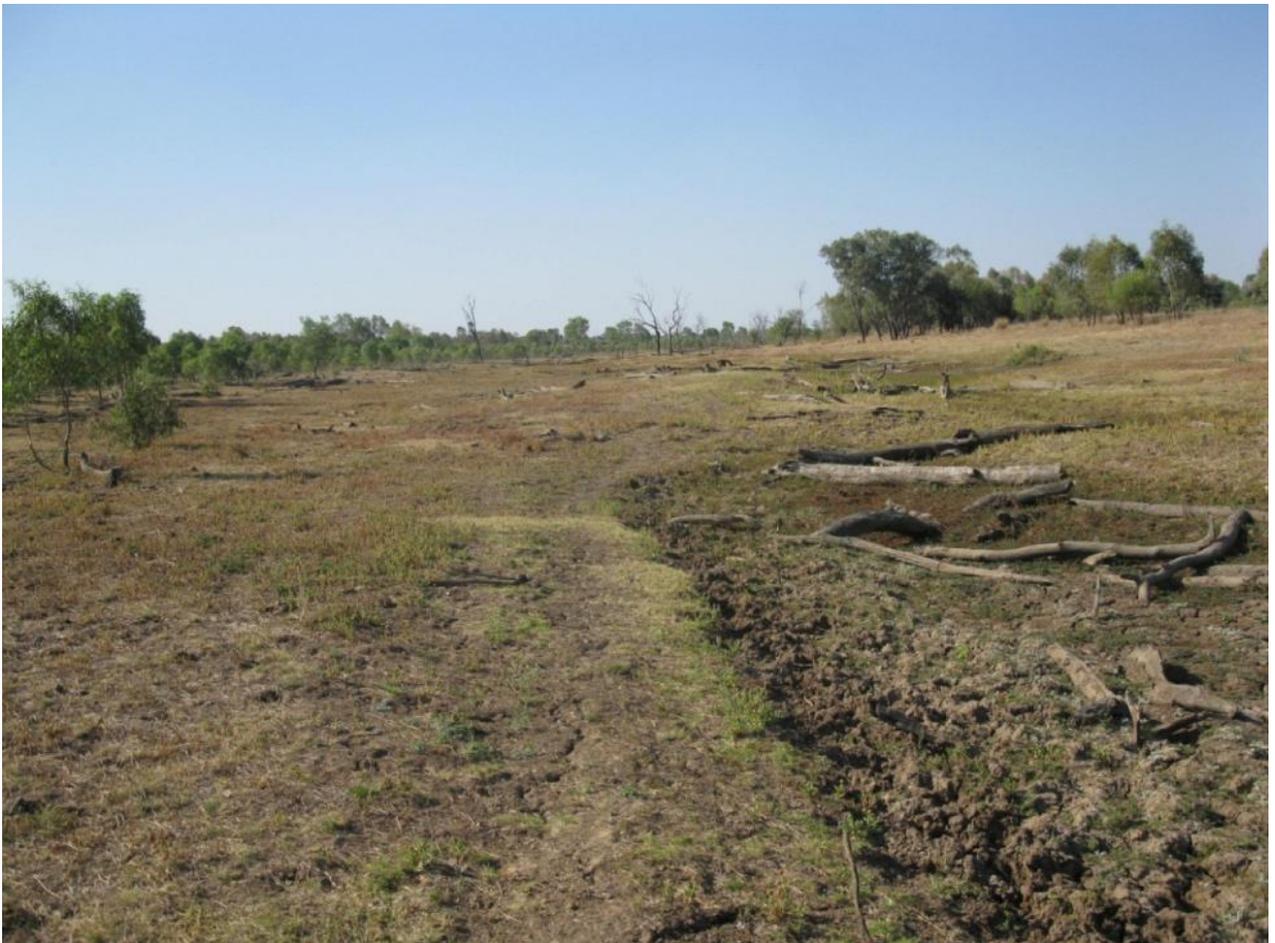
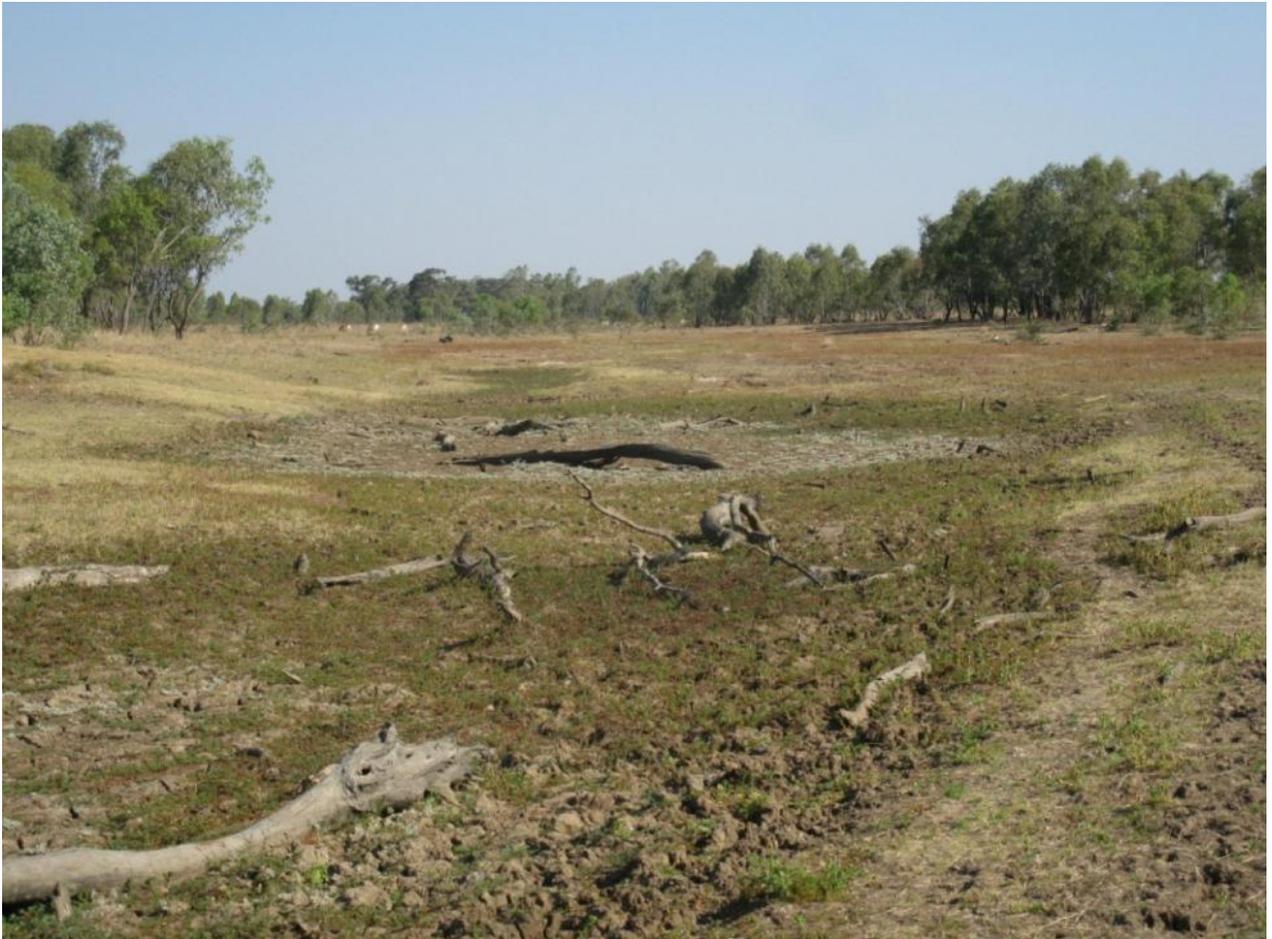
Photo: Ogenbeena Creek

Overview	Comment / Description
Stream Order Number (according to State Government mapping databases)	1
Area determination (according to the <i>Water Act 2000</i> based on identified exclusion criteria)	This crossing location does not contain any defined channel features and is considered a flood plain.

This part of Ogenbeena Creek is situated within a flood plain and is best described as a shallow drainage depression, which includes a mapped lacustrine wetland. This location does not have any characteristics consistent with the definition of a 'watercourse'.

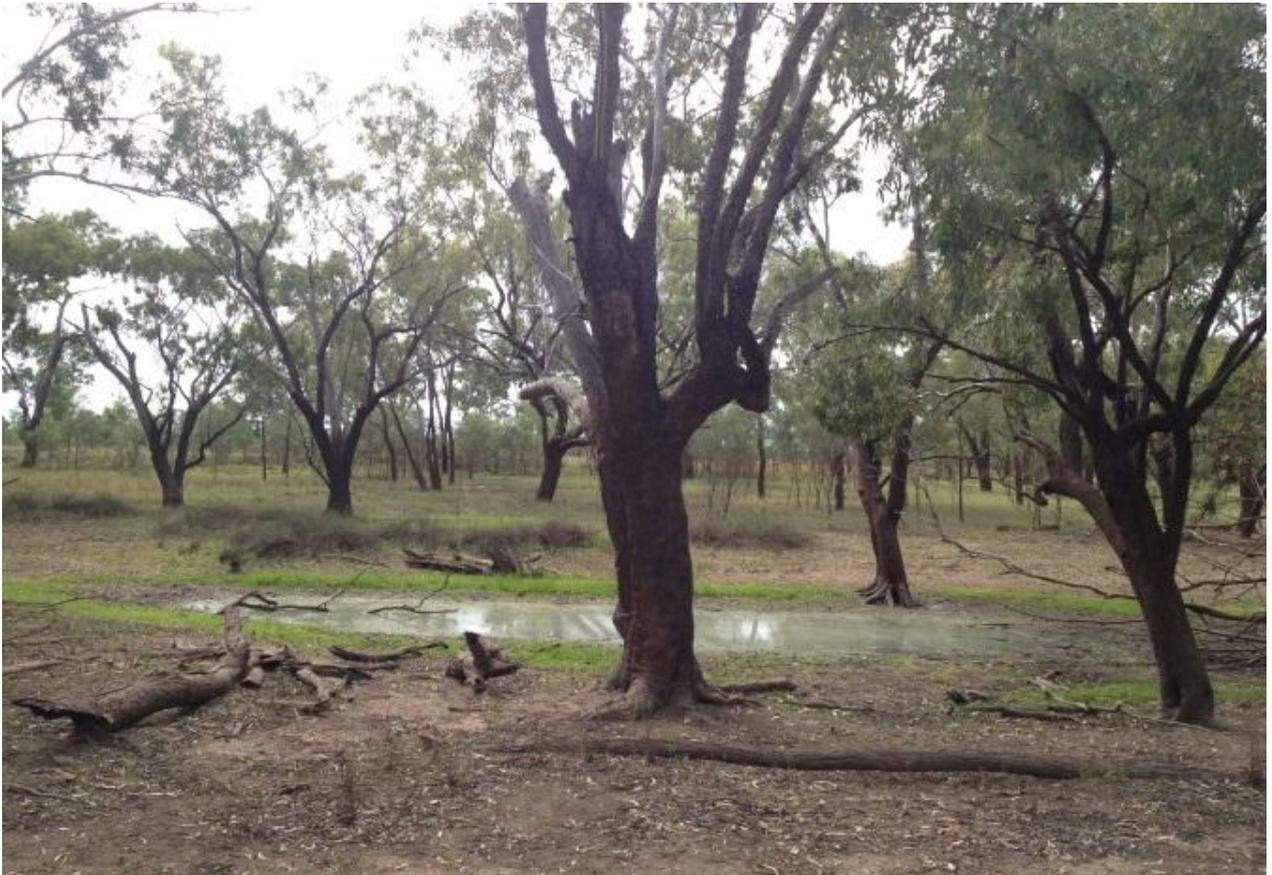
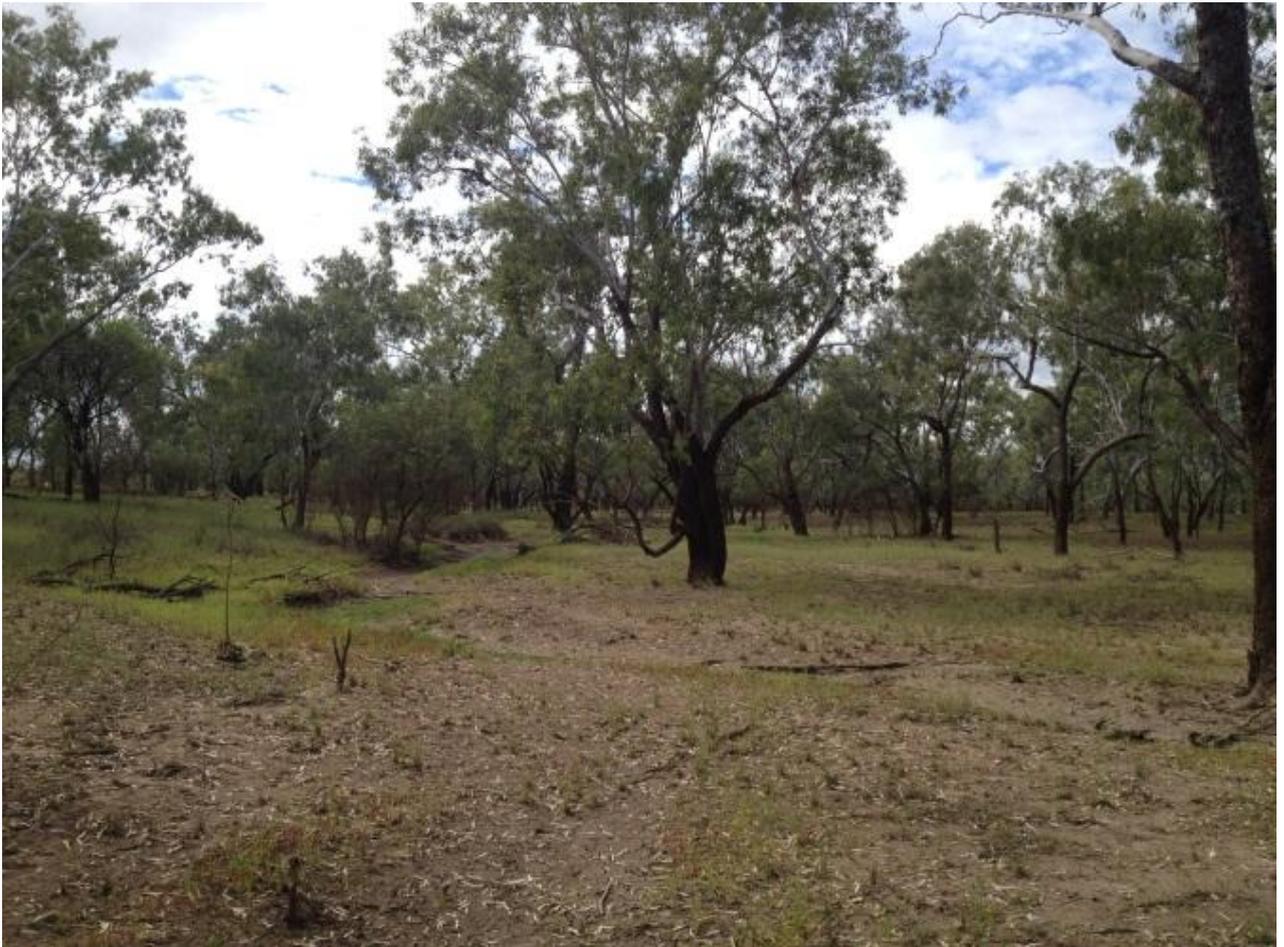
Photo: Ogenbeena Creek (lower crossing)

Overview	Comment / Description
Stream Order Number (according to State Government mapping databases)	1
Area determination (according to the <i>Water Act 2000</i> based on identified exclusion criteria)	<p>This crossing location fits the definition of a drainage feature.</p> <ul style="list-style-type: none"> • Funnels immediate localised rainfall only. • Only flows for a short period following rainfall. • Lacks a true riverine environment.

Vegetation associated with this site included *Eucalyptus coolabah* with a sparse mid layer containing *Eucalyptus populnea* and *Terminalia oblongata*. *Muehlenbeckia florulenta* was present within the shrub layer, but, in general, the shrub and ground layer was very sparse. Grazing and cattle utilisation of this area was not as obvious with respect to other areas along the SP-1 alignment. Small individual *Parthenium hysterophorus* plants were observed within the silt deposited from recent flooding events.

This part of Ogenbeena Creek is best described as an overland flow path with occasional eroded areas and depressions. The area does not display characteristics associated with a 'watercourse'.

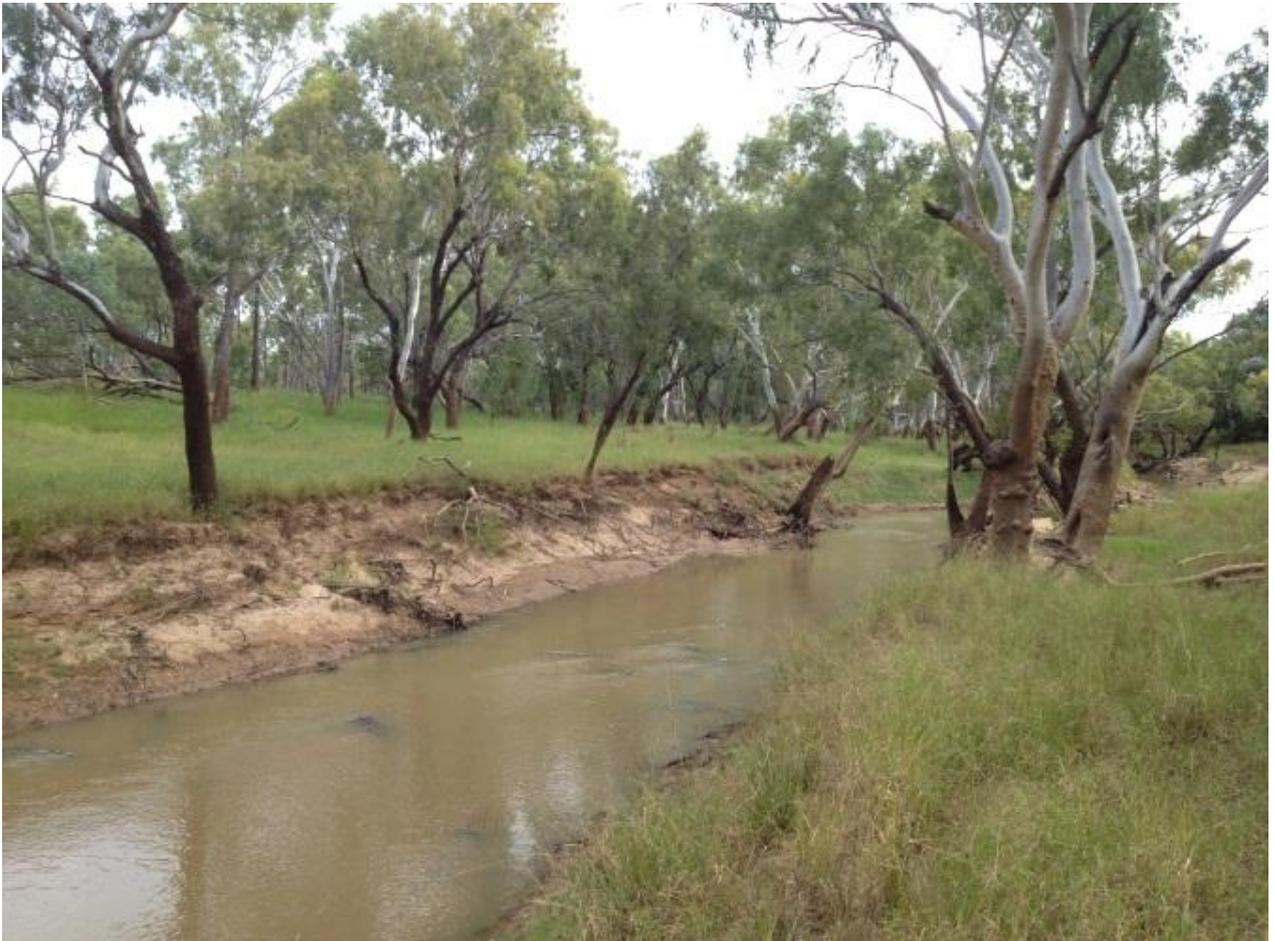
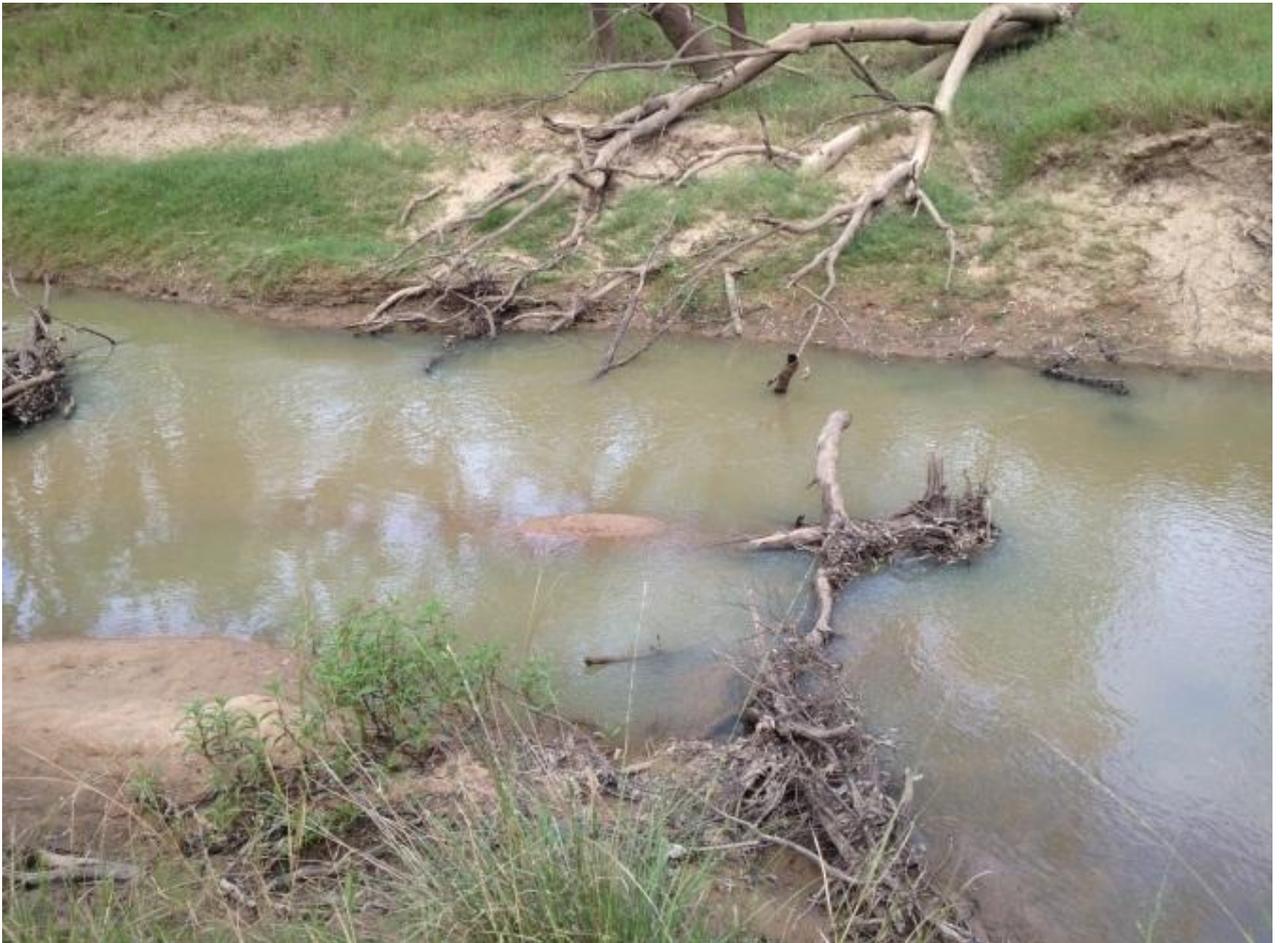
Photo: Belyando River Tributary

Overview	Comment / Description
Stream Order Number (according to State Government mapping databases)	2
Area determination (according to the <i>Water Act 2000</i> based on identified exclusion criteria)	This crossing location fits the definition of a watercourse .

'Watercourse' banks showed signs of erosion and slumping associated with grazing and flood disturbance, with vegetation largely absent. Freshwater mussels and crab shells were observed scattered along the 'watercourse' bed, bank and riparian area.

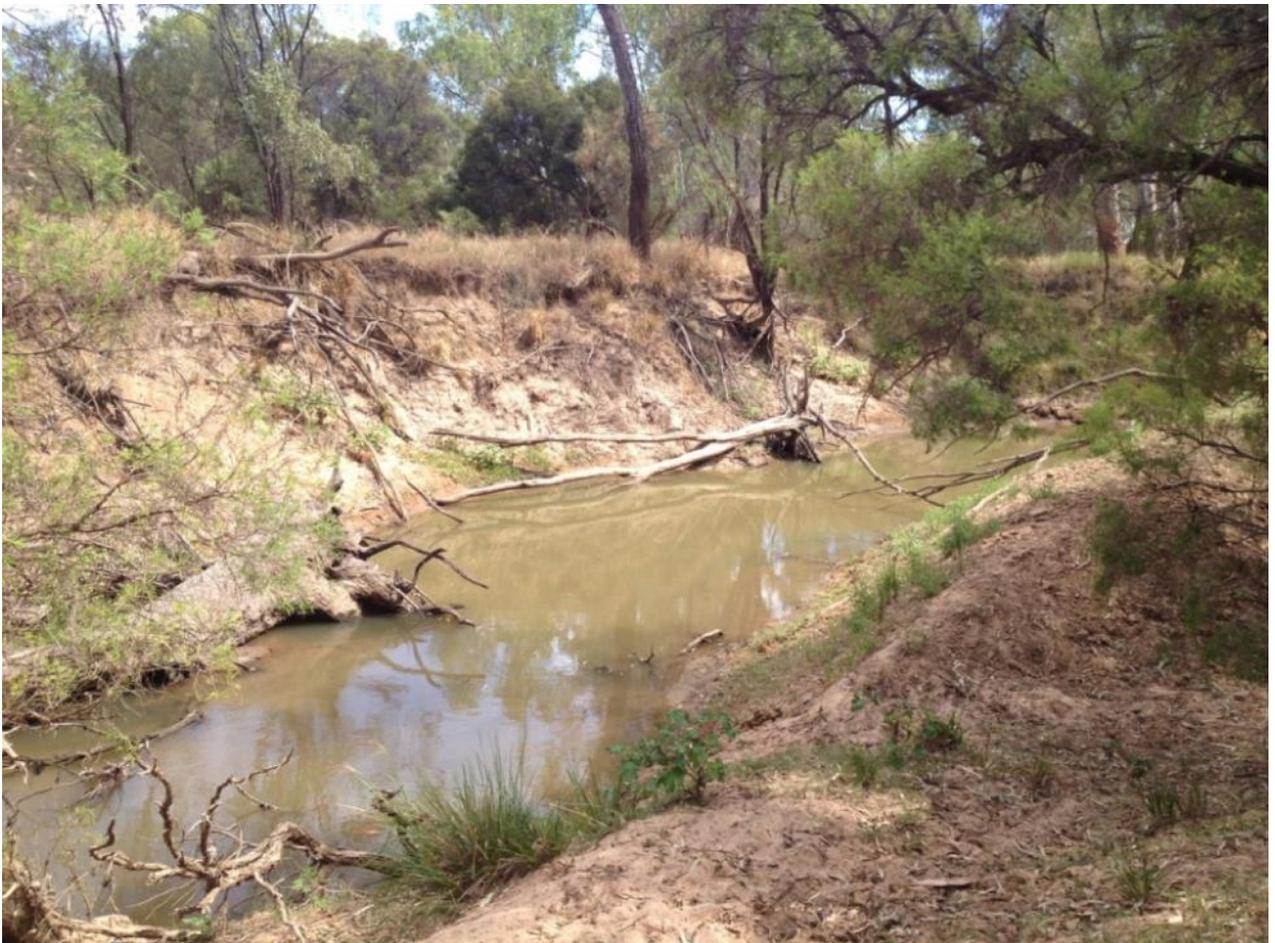
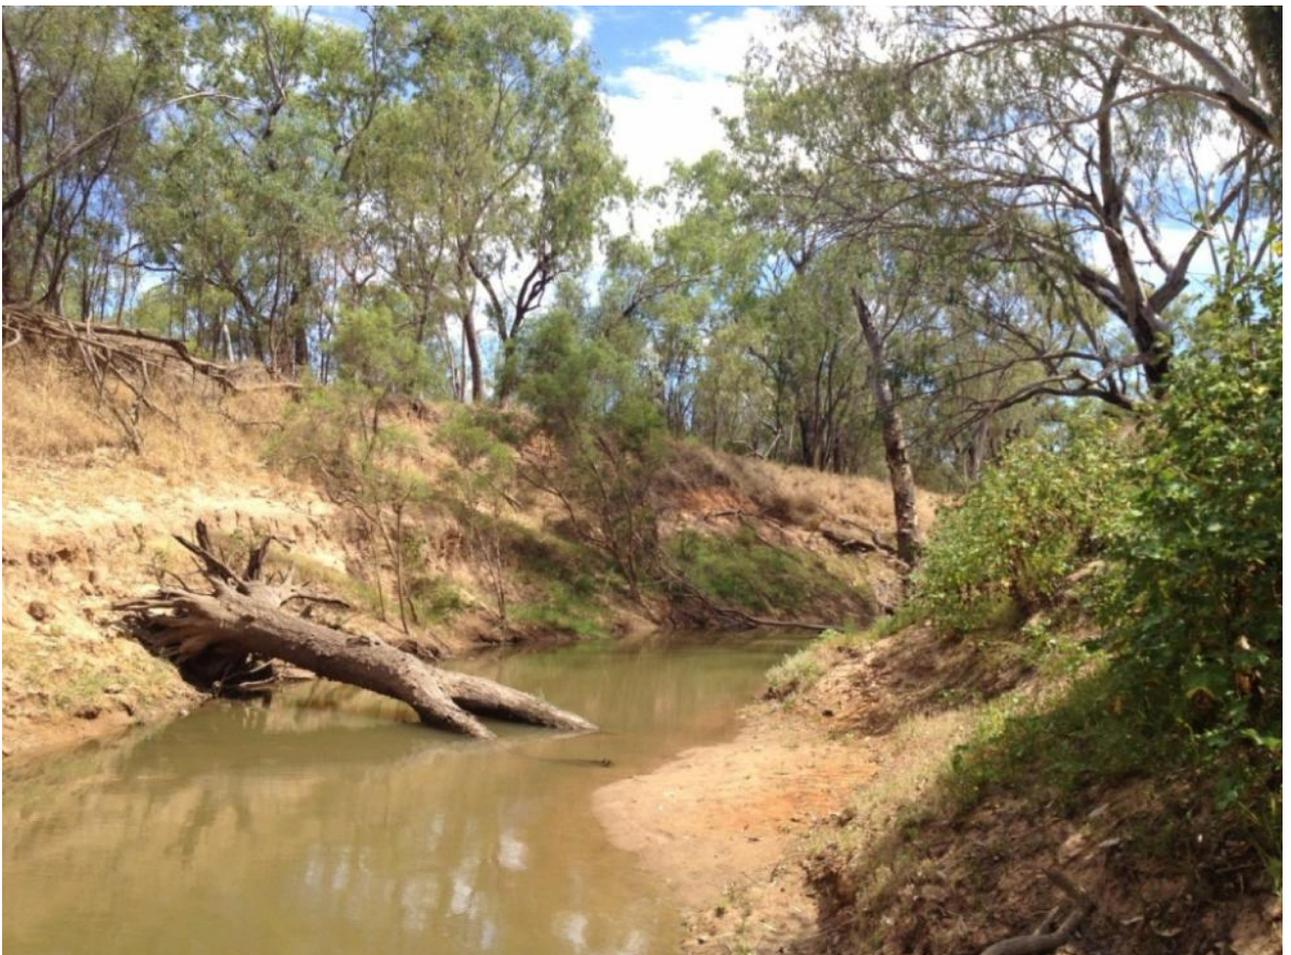
Photo: Belyando River

Overview	Comment / Description
Stream Order Number (according to State Government mapping databases)	8
Area determination (according to the <i>Water Act 2000</i> based on identified exclusion criteria)	This crossing location fits the definition of a watercourse .

This 'watercourse' forms the main section of the Belyando River. Vegetation either side of this 'watercourse' is mapped as containing a composite Endangered Regional Ecosystem categorised as RE 11.3.25 / 11.3.37 / 11.3.1. Species recorded throughout the assessment site were consistent with Least Concern RE 11.3.25 / 11.3.37. No species representing the Endangered RE 11.3.1 were observed.

Eucalyptus camaldulensis was the dominant species fringing the 'watercourse,' while *Eucalyptus coolabah* dominated the adjacent floodplain areas. It is also noted that some riparian species, including patches of *Melaleuca bracteata* and *Acacia salicina*, were also recorded within the sub-canopy layer. Although ground layer species were dominated by exotics, patches of native species were observed, including *Lomandra longifolia* and *Muehlenbeckia florulenta*. Some flood debris was noted high above the top bank indicating significant flow during flood events.

Contemporary aerial imagery overlaid with a digital terrain model demonstrates that this part of the 'watercourse' system includes a series of pools, runs and sediment bars along its length. The analysis shows a flow path on the western and eastern sides of the broader floodplain. These areas appear to be eroded, lower lying parts of the flood plain which are regularly inundated.

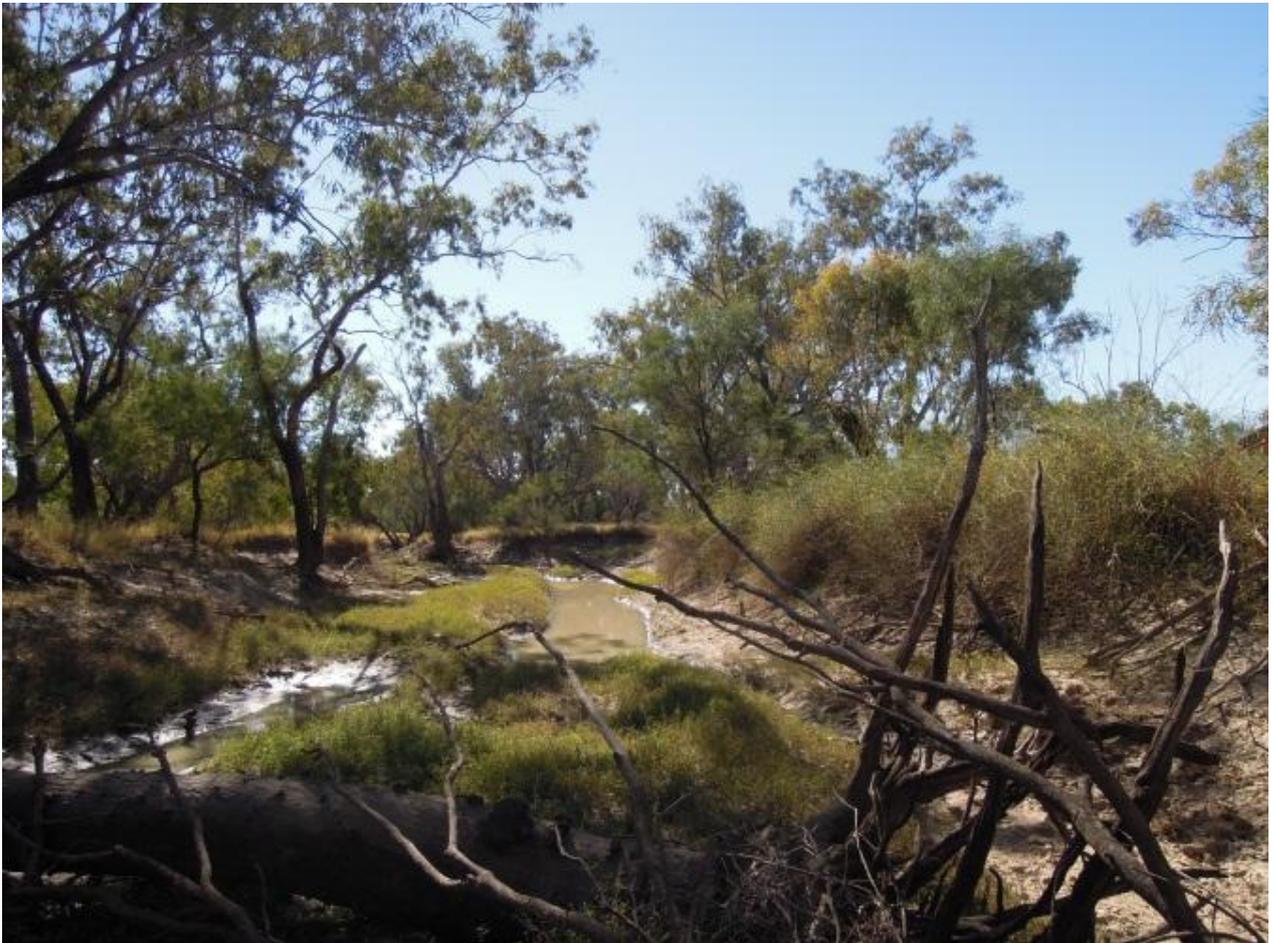
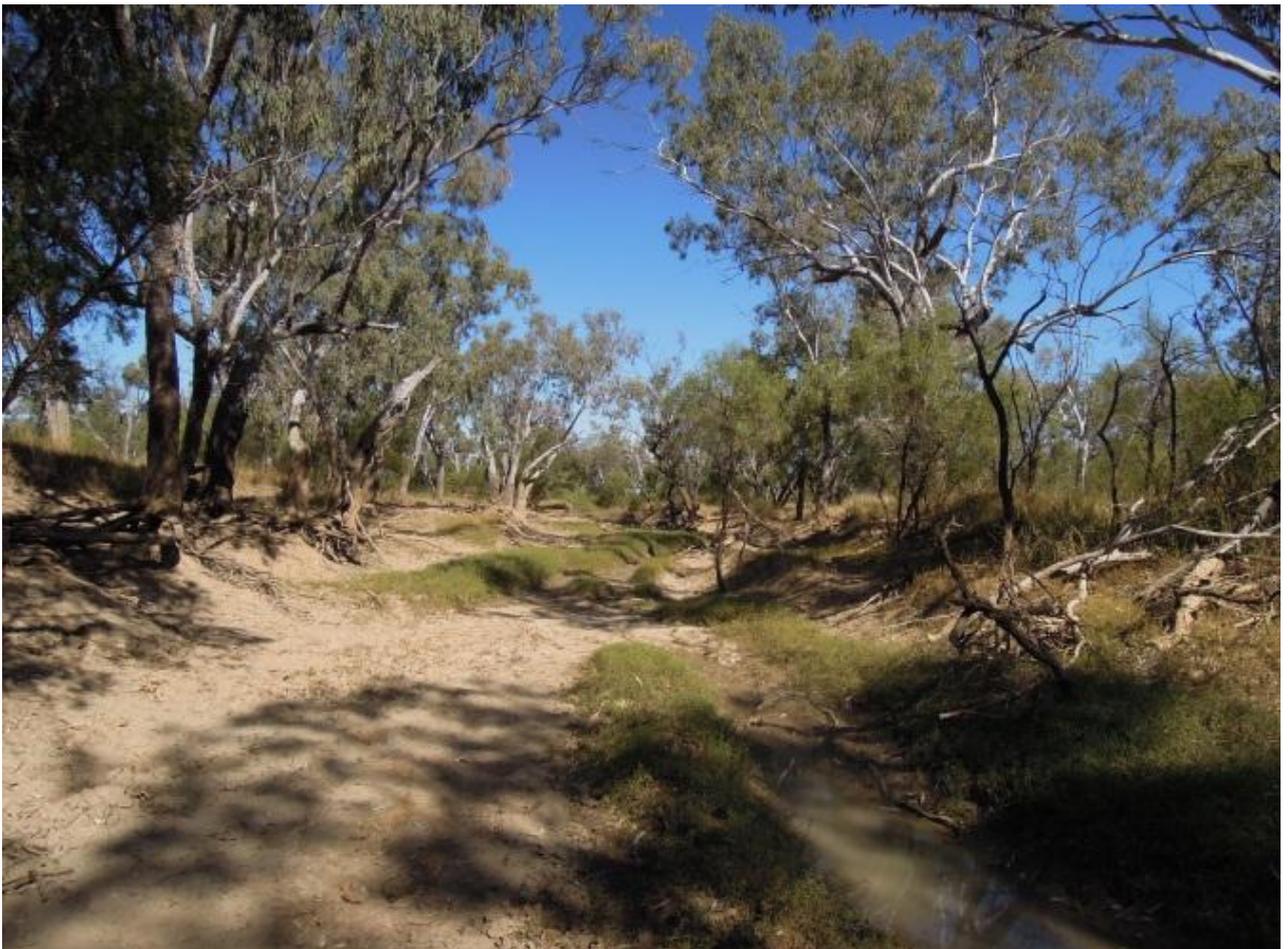
Photo: Belyando River (East Tributary)

Overview	Comment / Description
Stream Order Number (according to State Government mapping databases)	1
Area determination (according to the <i>Water Act 2000</i> based on identified exclusion criteria)	This crossing location fits the definition of a watercourse .

Riparian vegetation at this site is consistent with REs 11.3.25 and 11.3.37. Tree species present included *Eucalyptus coolabah* and *Eucalyptus camaldulensis*. Other species observed within the T2 and shrub layers included *Geijera parviflora*, *Terminalia oblongata* and *Acacia stenophylla*. The ground layer contained a mix of exotic and native grasses, including *Pennisetum ciliare*, *Dichanthium sericeum*, *Leptochloa digitata*, *Enteropogon acicularis* and *Bothriochloa ewartiana*

Some areas of severe erosion primarily caused by flooding and grazing pressure were observed. Materials deposited within the stream bed were comprised of sand, small gravel, clays and fine silts. Outside of the 'watercourse' the landscape appears highly erodible with a series of gullies and depressions evident.

Due to recent rainfall, the site contained pooled water, but, due to the seasonal nature of the 'watercourse', these pools would only be temporary and would not exist during extended periods of drier weather. The use of retained pools for long term survival of aquatic fauna species seems highly unlikely.
