**Carmichael Coal Mine and Rail Project
Supplementary Environmental Impact Statement**

Volume 4, Appendix C3h – Watercourse Determination Review

Water Act 2000 Watercourse Determination & Riverine Protection Permit Review

6396
22 March 2013
Adani Mining Pty Ltd

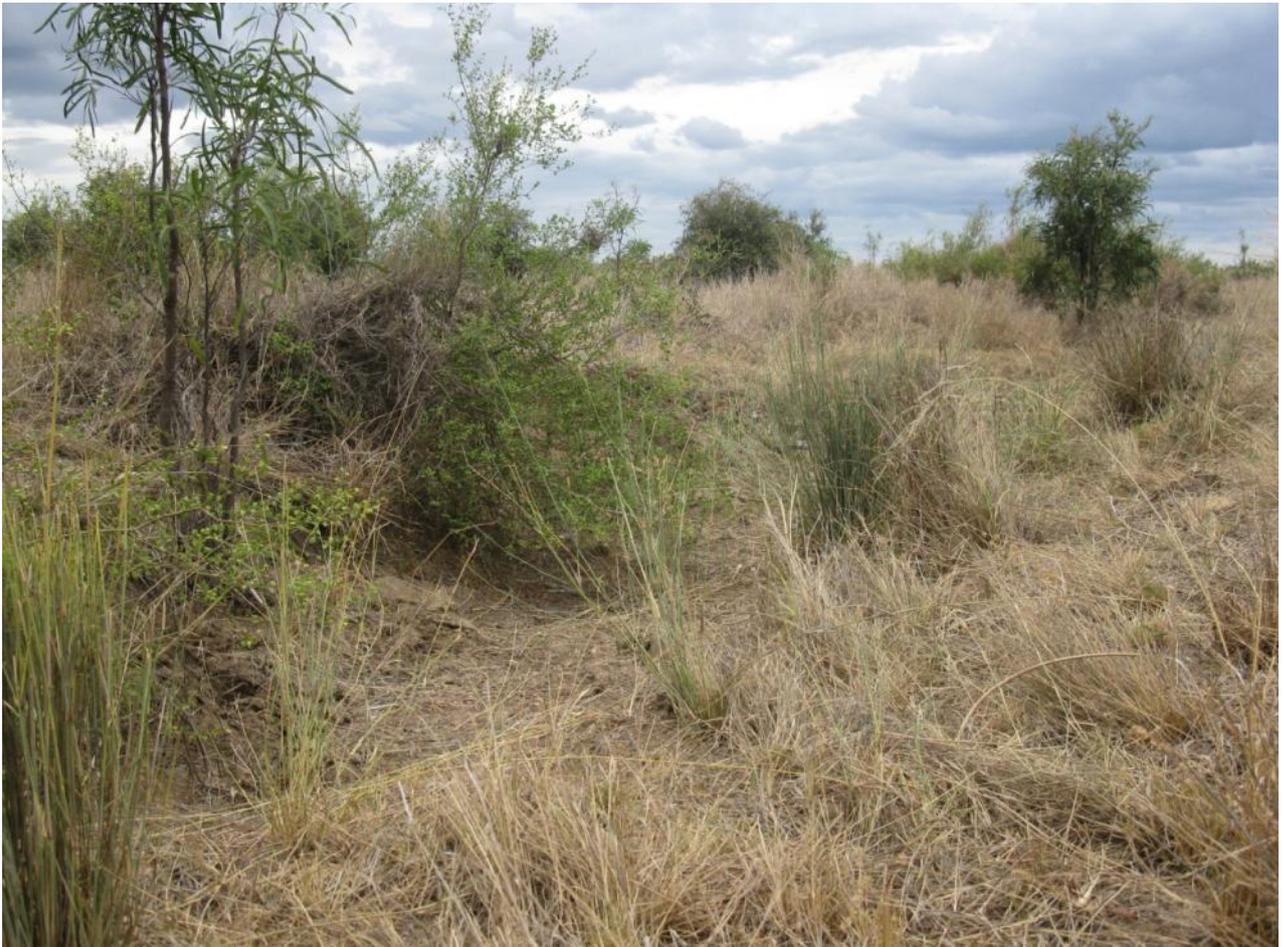
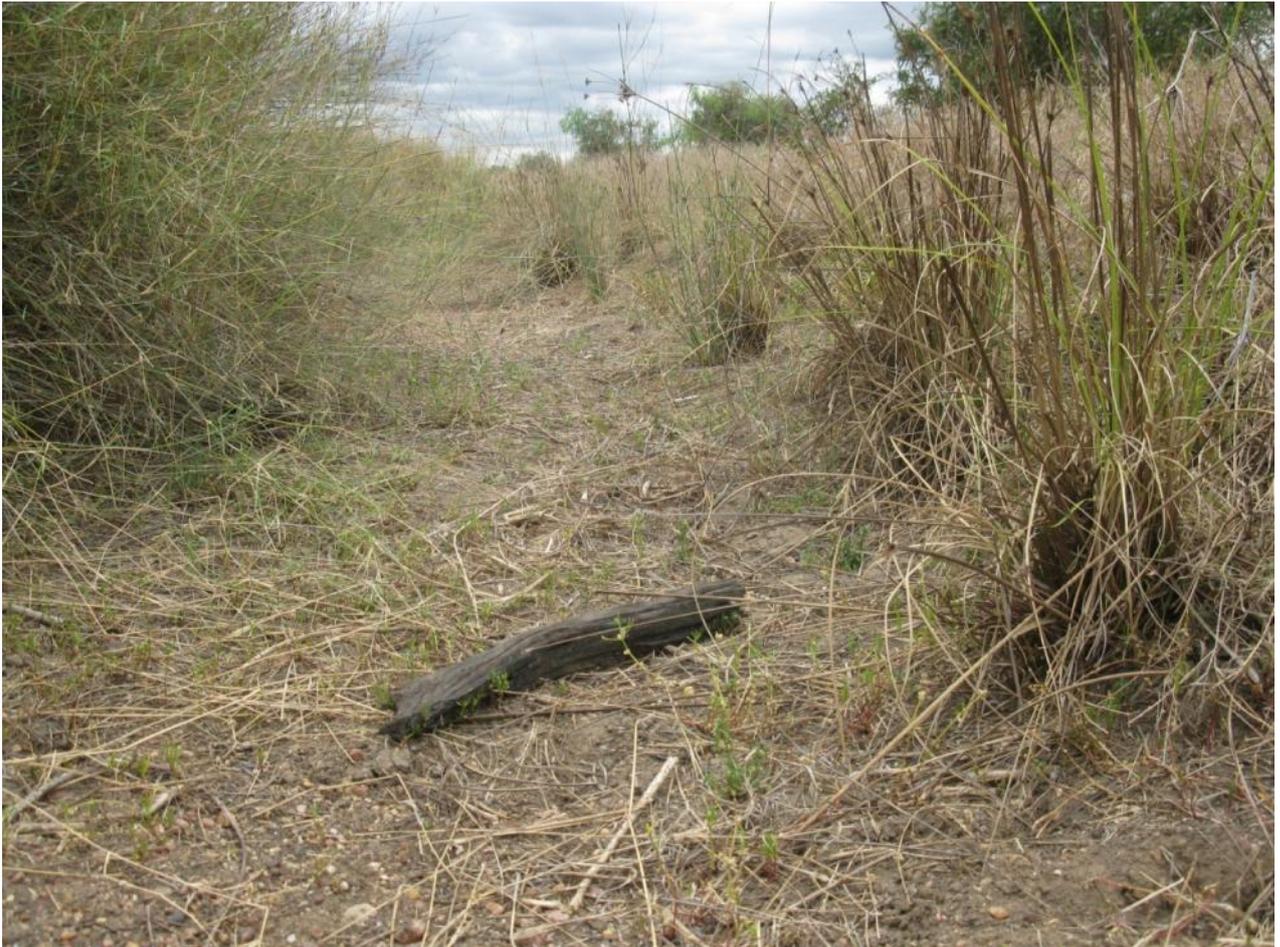
Photo: Unnamed Flow Path (Crossing 73)

Overview	Comment / Description
Stream Order Number (according to State Government mapping databases)	1
Area determination (according to the <i>Water Act 2000</i> based on identified exclusion criteria)	<p>This crossing location fits the definition of a drainage feature.</p> <ul style="list-style-type: none"> • Funnels immediate localised rainfall only. • Only flows for a short period following rainfall. • Lacks a true riverine environment.

The site does not meet the definition of a 'watercourse' and is best described as a 'drainage feature'.

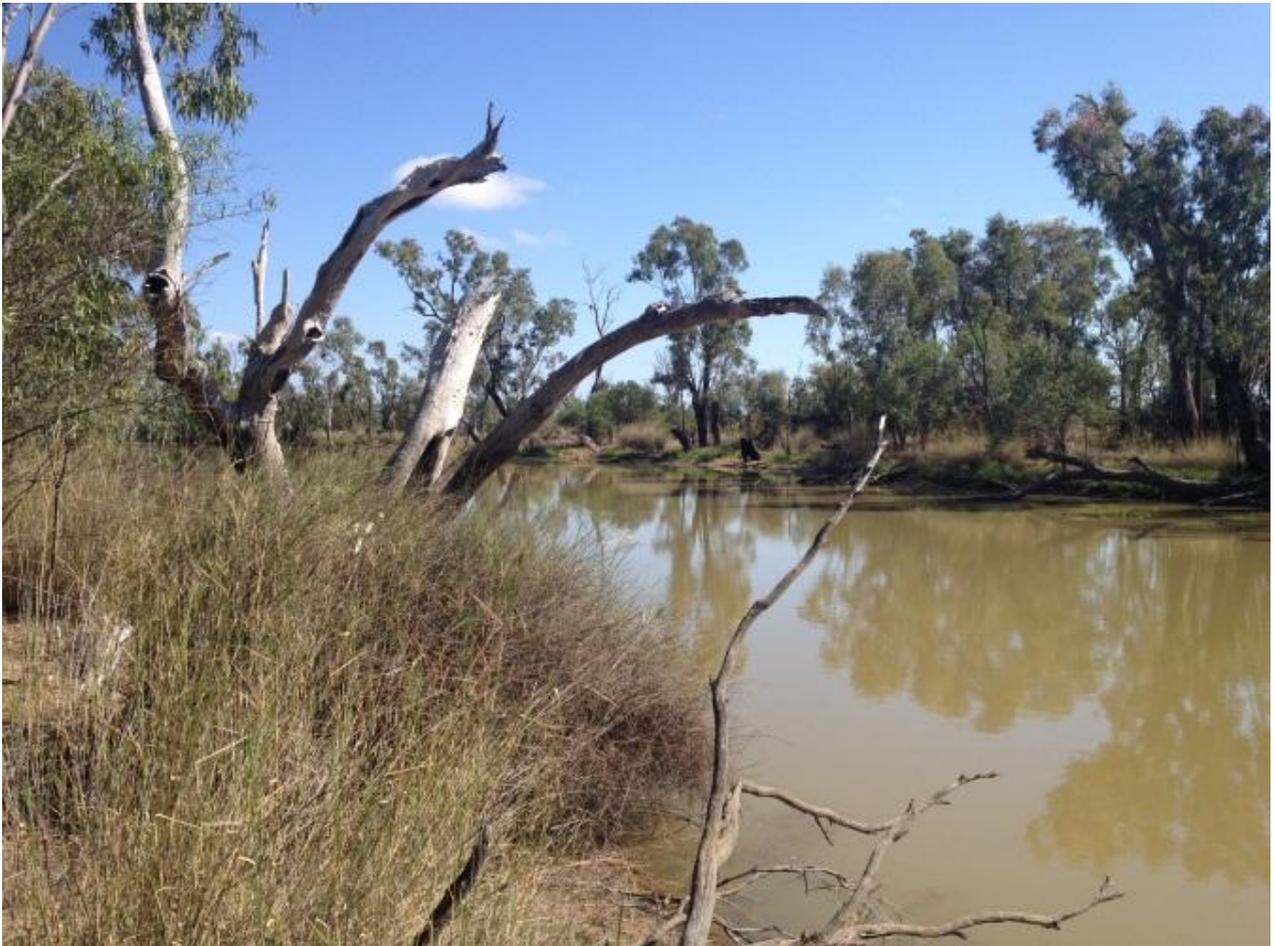
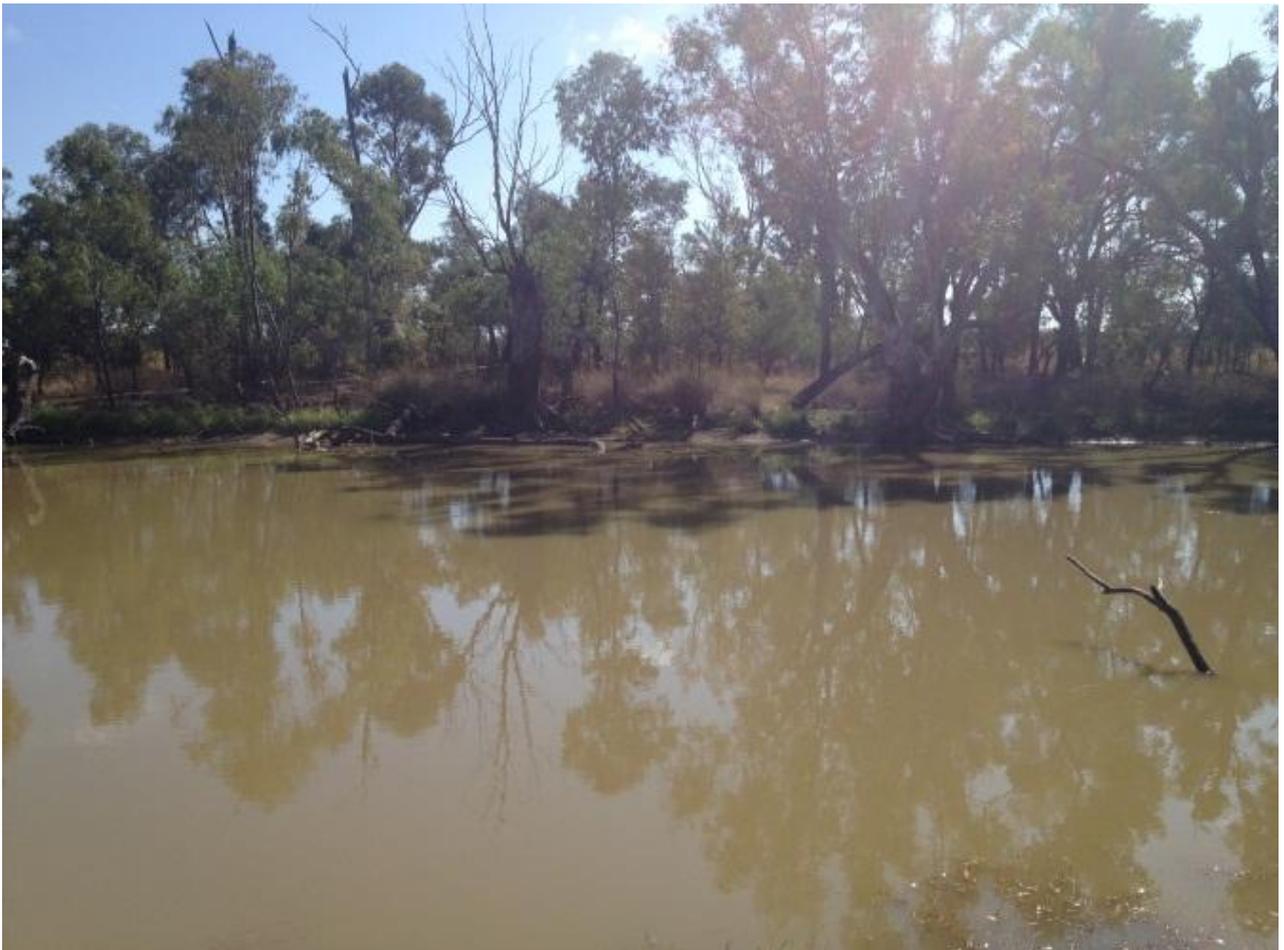
Photo: Water Body near Mistake Creek

Overview	Comment / Description
Stream Order Number (according to State Government mapping databases)	NA
Area determination (according to the <i>Water Act 2000</i> based on identified exclusion criteria)	This crossing location fits the definition of a watercourse .

Banks of the water body associated with the alignment at this site are stabilised with grasses and sedges interspersed with variable states of erosion due to cattle activity. Numerous habitat values were observed within the waterhole, including submerged logs and macrophytes.

The riparian vegetation at this site can be described as woodland to open-woodland with a grassy understorey. Vegetation was dominated by *Eucalyptus coolabah*, *Acacia cambagei* and *Acacia harpophylla*. Scattered tree or shrub species, such as *Eucalyptus populnea*, *Terminalia oblongata*, *Eremophila mitchellii* and *Atalaya hemiglauca*, were occasionally present. The ground layer was very sparse and dominants included *Muehlenbeckia florulenta*, *Paspalidium caespitosum*, *Bothriochloa ewartiana*, *Iseilema vaginiflorum*, *Eragrostis macrocarpa* and *Aristida latifolia*. *Leptochloa digitata* and *Muehlenbeckia florulenta* dominated the vegetation on the banks of the water body.

This relatively extensive water body meets the definition of a 'watercourse'.

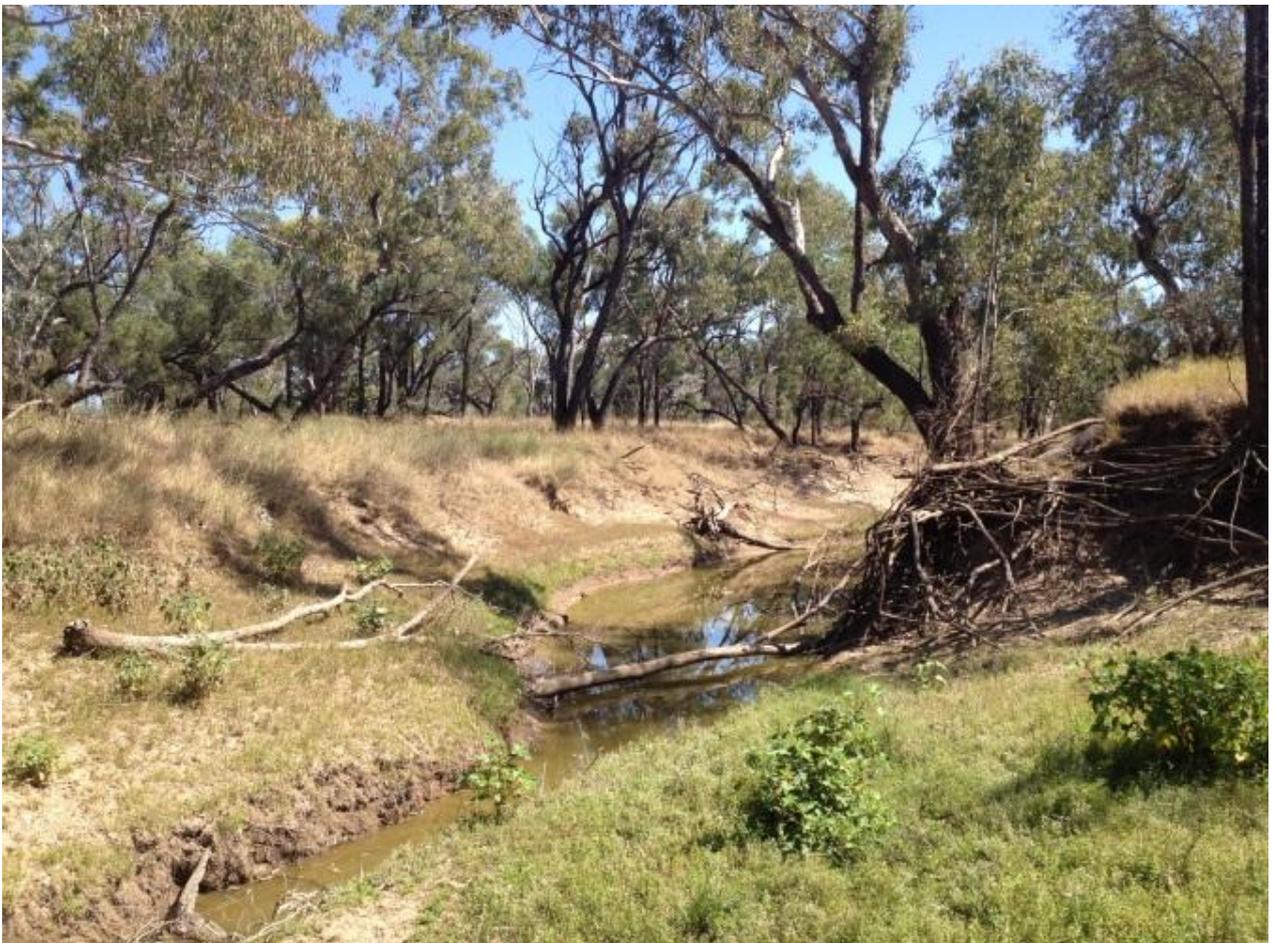
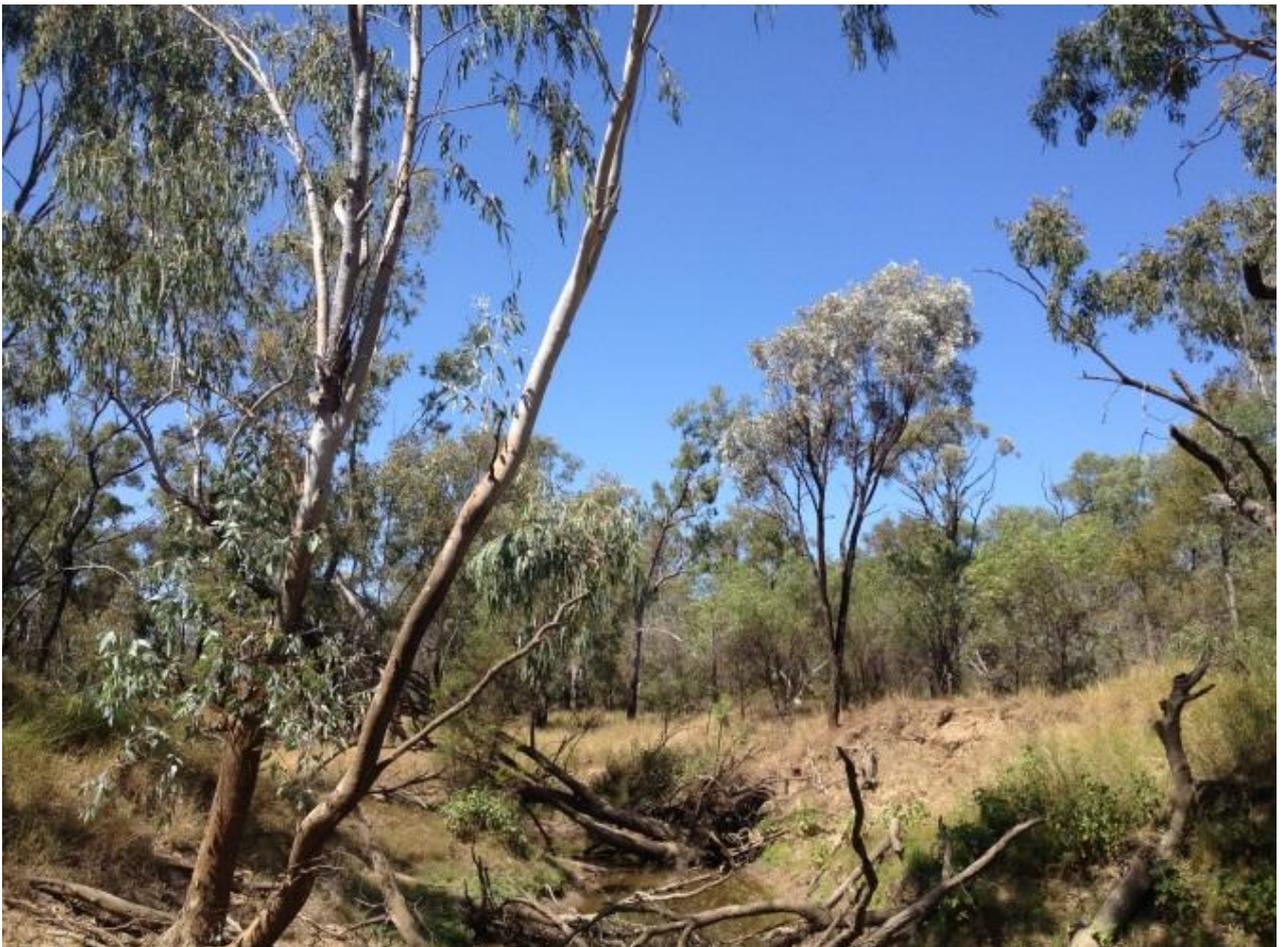
Photo: Mistake Creek Anabranch

Overview	Comment / Description
Stream Order Number (according to State Government mapping databases)	2
Area determination (according to the <i>Water Act 2000</i> based on identified exclusion criteria)	This crossing location fits the definition of a watercourse .

Riparian vegetation at this site is consistent with REs 11.3.25 and 11.3.37 and dominated by *Eucalyptus coolabah* and *Eucalyptus camaldulensis*. Other species observed within the T2 and shrub layers included *Geijera parviflora*, *Terminalia oblongata* and *Acacia stenophylla*. The ground layer contained a mix of exotic and native grasses, including *Pennisetum ciliare*, *Dichanthium sericeum*, *Leptochloa digitata*, *Enteropogon acicularis* and *Bothriochloa ewartiana*.

Stream bed materials were formed from sand, gravel, clay and silt materials. Sand formed the greatest percentage of the substrate within the stream bed. Temporary pools were observed in areas where timber, silt and sand materials had deposited from flood events preventing water deviation.

Observed severe bank erosion and slumping were predominantly caused by grazing and flood disturbances. Erosion has resulted in fallen trees and exposed roots for a number of trees within the assessment area.

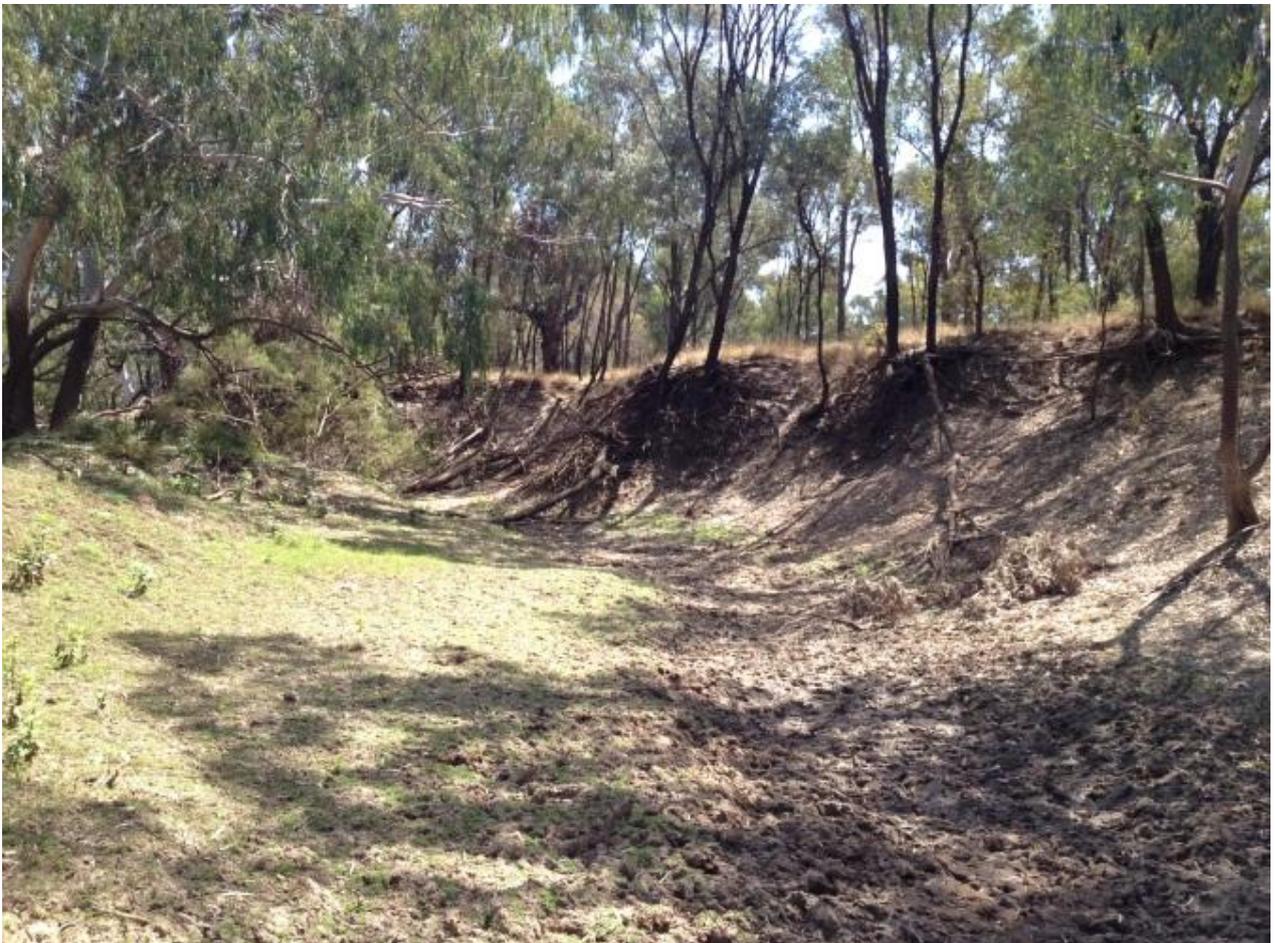
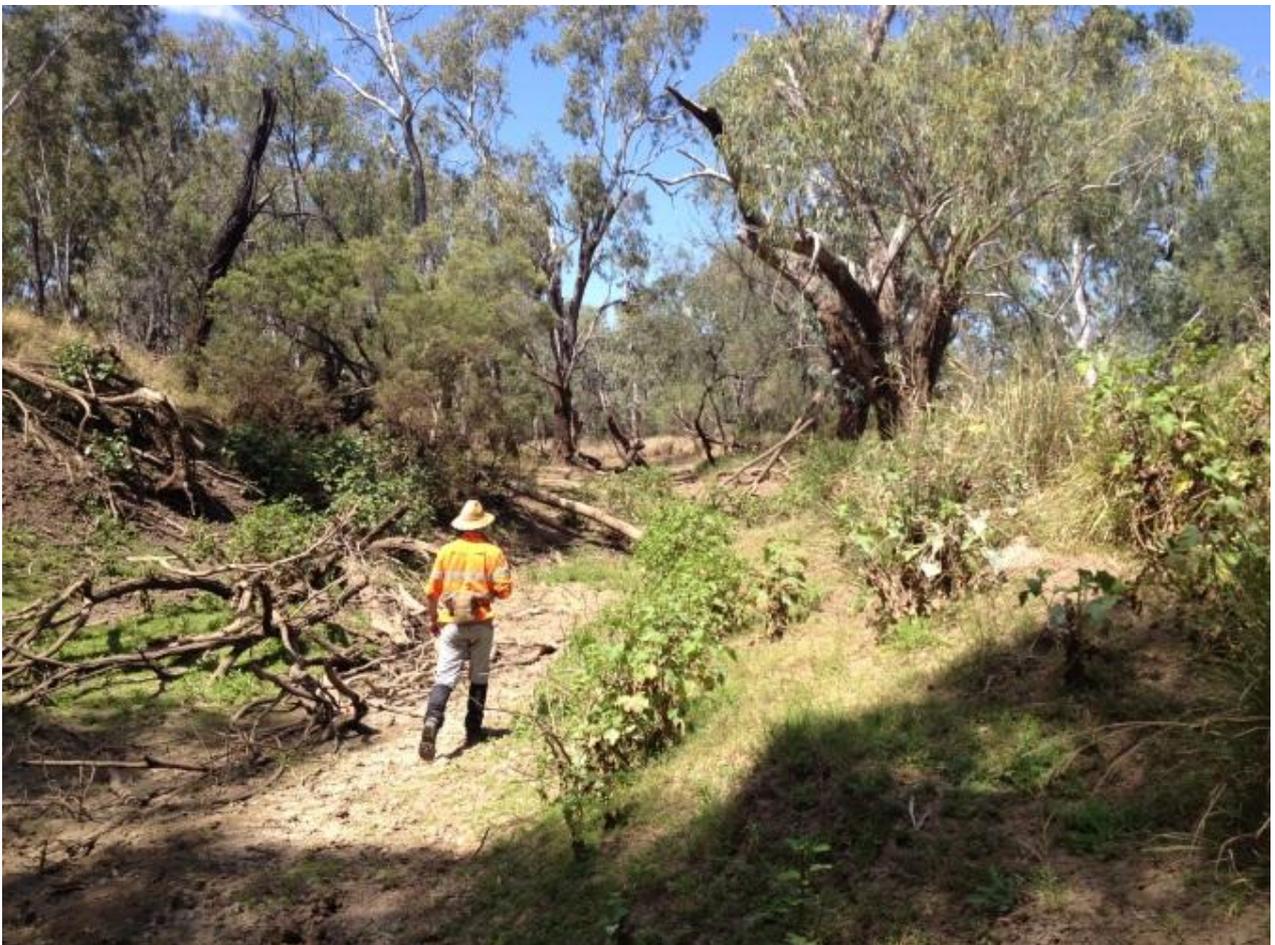
Photo: Mistake Creek

Overview	Comment / Description
Stream Order Number (according to State Government mapping databases)	6
Area determination (according to the <i>Water Act 2000</i> based on identified exclusion criteria)	This crossing location fits the definition of a watercourse .

The 'watercourse' bed was comprised of a combination of sands, gravel, clays and silts, with sand the dominant substrate observed within the 'watercourse'. Erosion and bank slumping were observed on the left and right banks predominantly caused by cattle accessing the watercourse and recent flood events.

Undercutting of riparian vegetation was observed in a number of locations resulting in exposed roots and fallen timber. Small turbid pools were observed within the 'watercourse' bed but the majority of the 'watercourse' contained no pooled or flowing water. *Cyperus* and *Juncus* species were only observed within soakage points along with the remains of freshwater molluscs, crustaceans and gastropods.

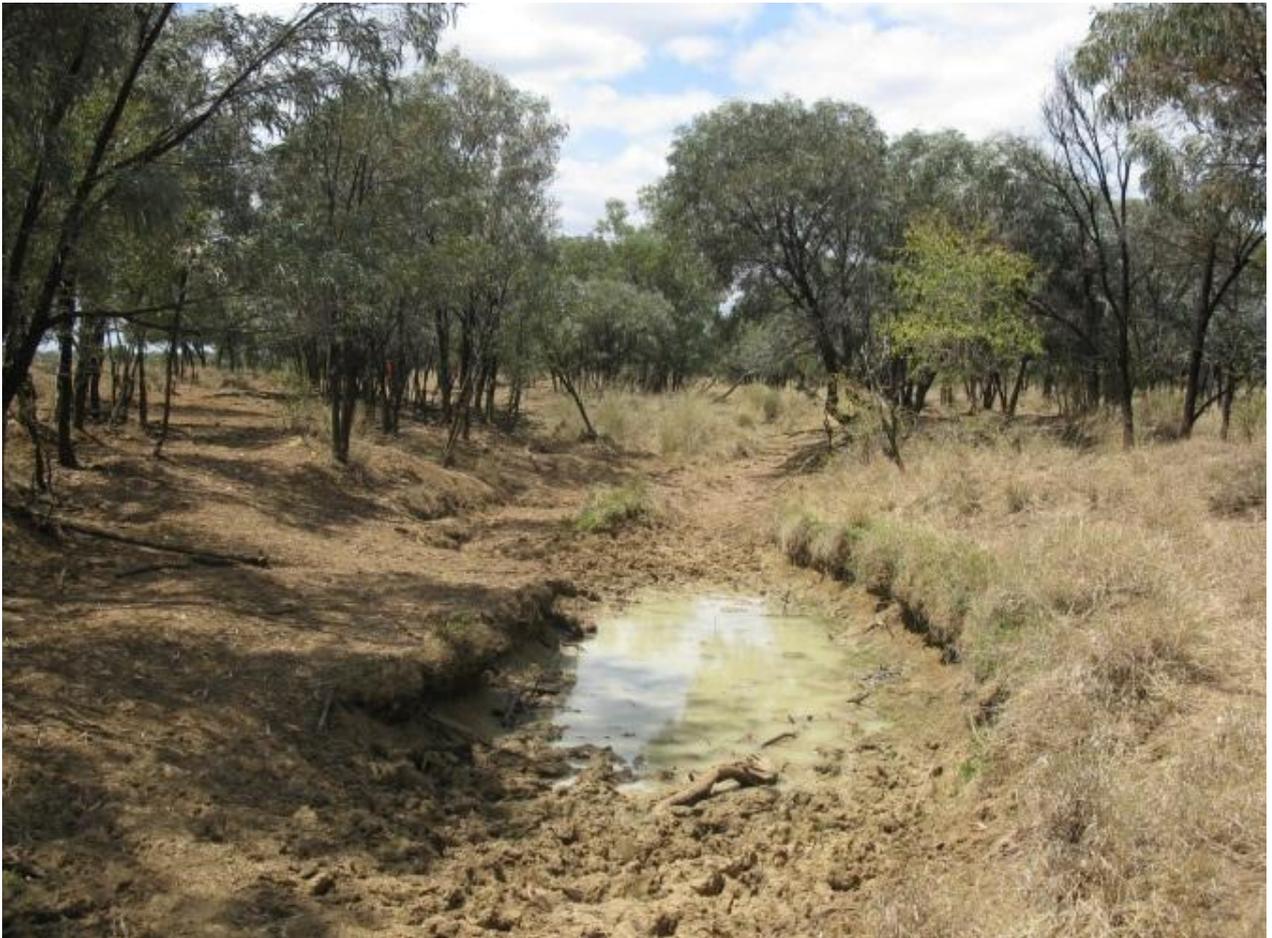
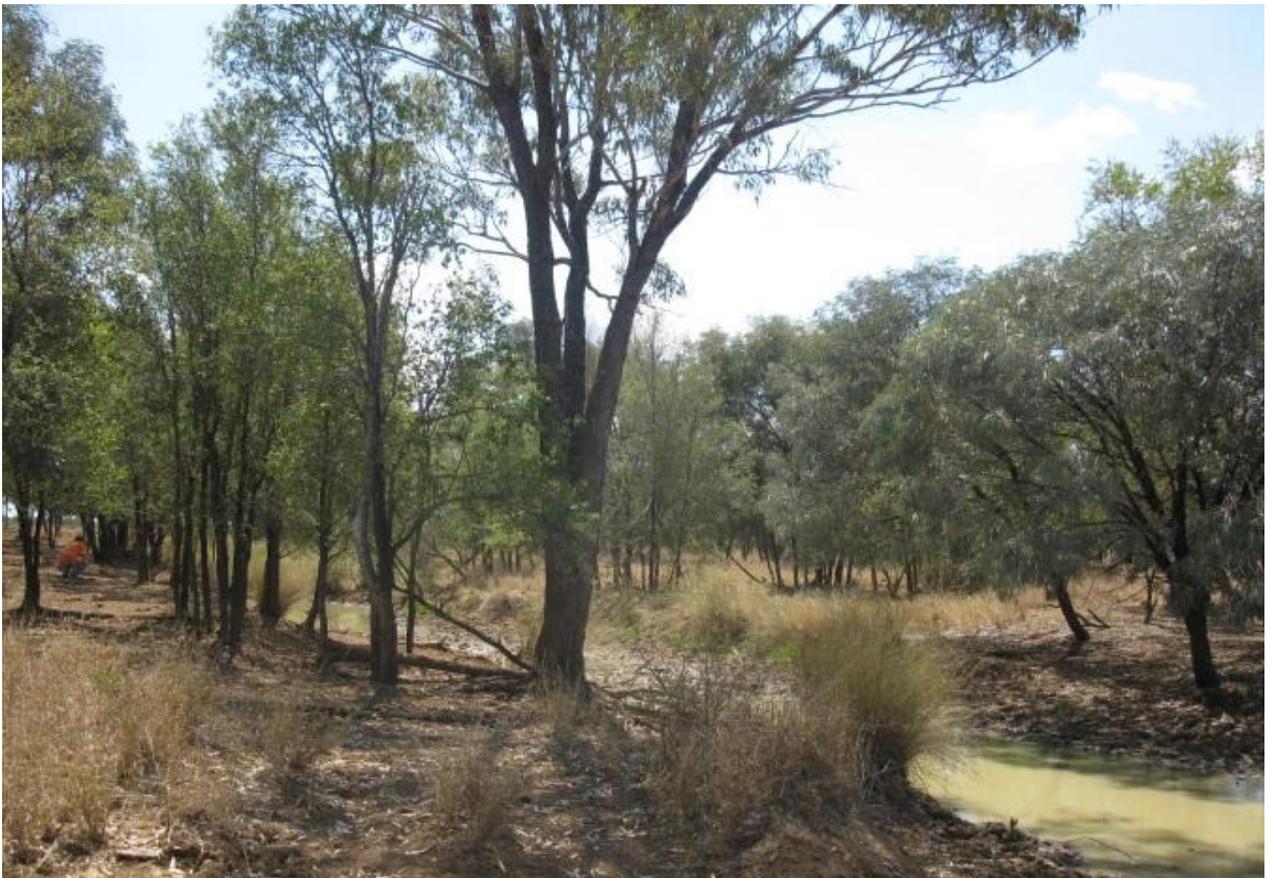
Photo: Gowrie Creek

Overview	Comment / Description
Stream Order Number (according to State Government mapping databases)	4
Area determination (according to the <i>Water Act 2000</i> based on identified exclusion criteria)	<p>This crossing location fits the definition of a drainage feature.</p> <ul style="list-style-type: none"> • Funnels immediate localised rainfall only. • Only flows for a short period following rainfall. • Lacks a true riverine environment.

No remnant or regrowth vegetation is associated with this 'drainage feature'. Adjoining tree species included *Acacia harpophylla*, *Acacia cambagei*, *Eucalyptus coolabah*, *Acacia salicina* and *Terminalia oblongata* up to 10 m in height. Shrub and ground layer species included *Citrus glauca*, *Carissa ovata*, *Lysiphillum carronii*, *Archidendropsis basaltica*, *Leptochloa digitata*, *Enteropogon acicularis*, *Pennisetum ciliare*, *Parthenium hysterophorus*, *Eriocereus martini* and *Aristida latifolia*.

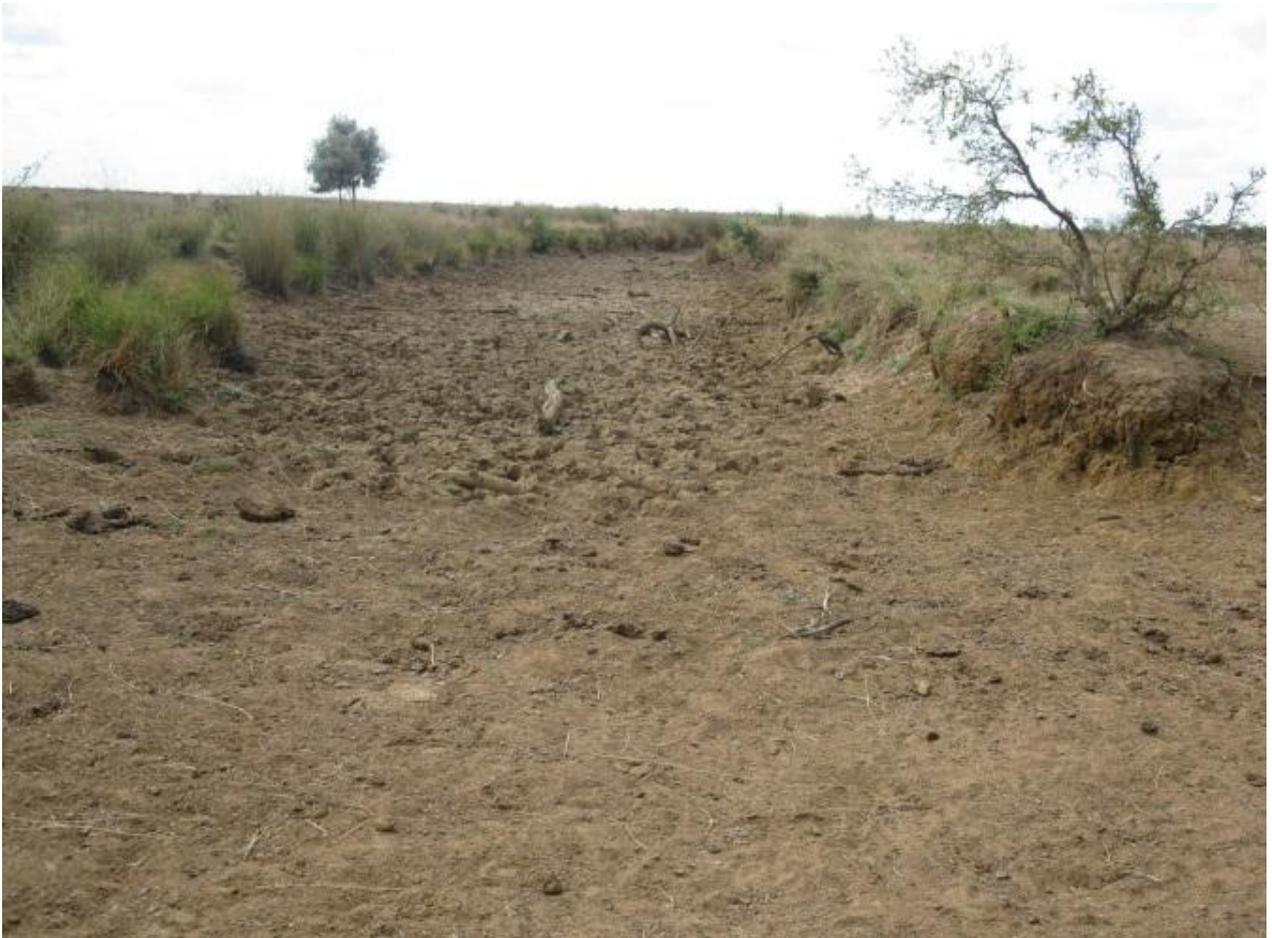
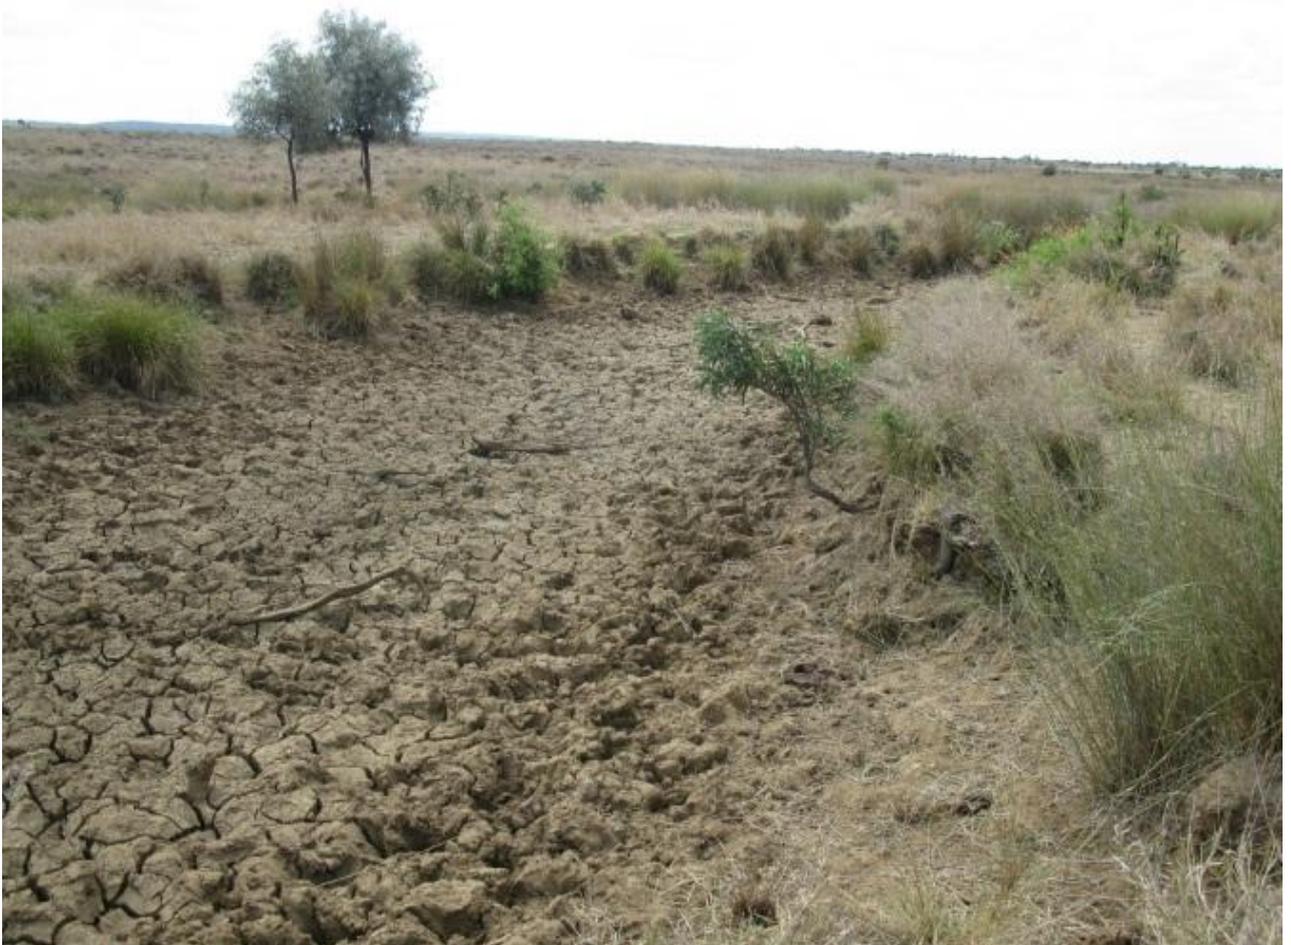
Photo: Gowrie Creek Tributary (Crossing 67)

Overview	Comment / Description
Stream Order Number (according to State Government mapping databases)	2
Area determination (according to the <i>Water Act 2000</i> based on identified exclusion criteria)	<p>This crossing location fits the definition of a drainage feature.</p> <ul style="list-style-type: none"> • Funnels immediate localised rainfall only. • Only flows for a short period following rainfall. • Lacks a true riverine environment.

This 'drainage feature' was completely dry during the survey and only appears to flow and contain water after periods of intense or continual rainfall. The substrate within the 'drainage feature' was comprised predominantly of cracking clays and silt materials.

The area was highly disturbed with very high levels of erosion and bank slumping throughout. The majority of the erosion was as a result of cattle grazing and watering.

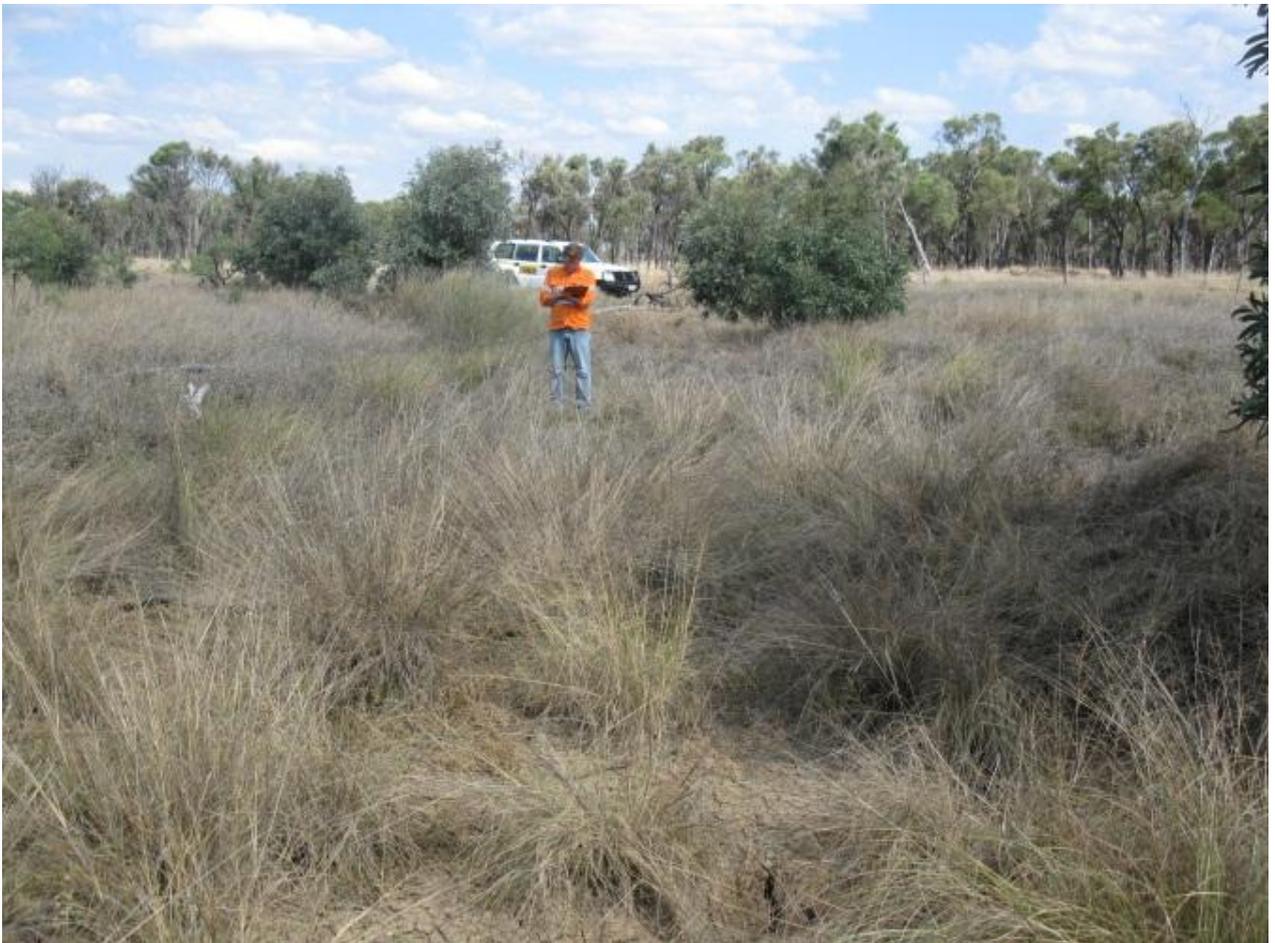
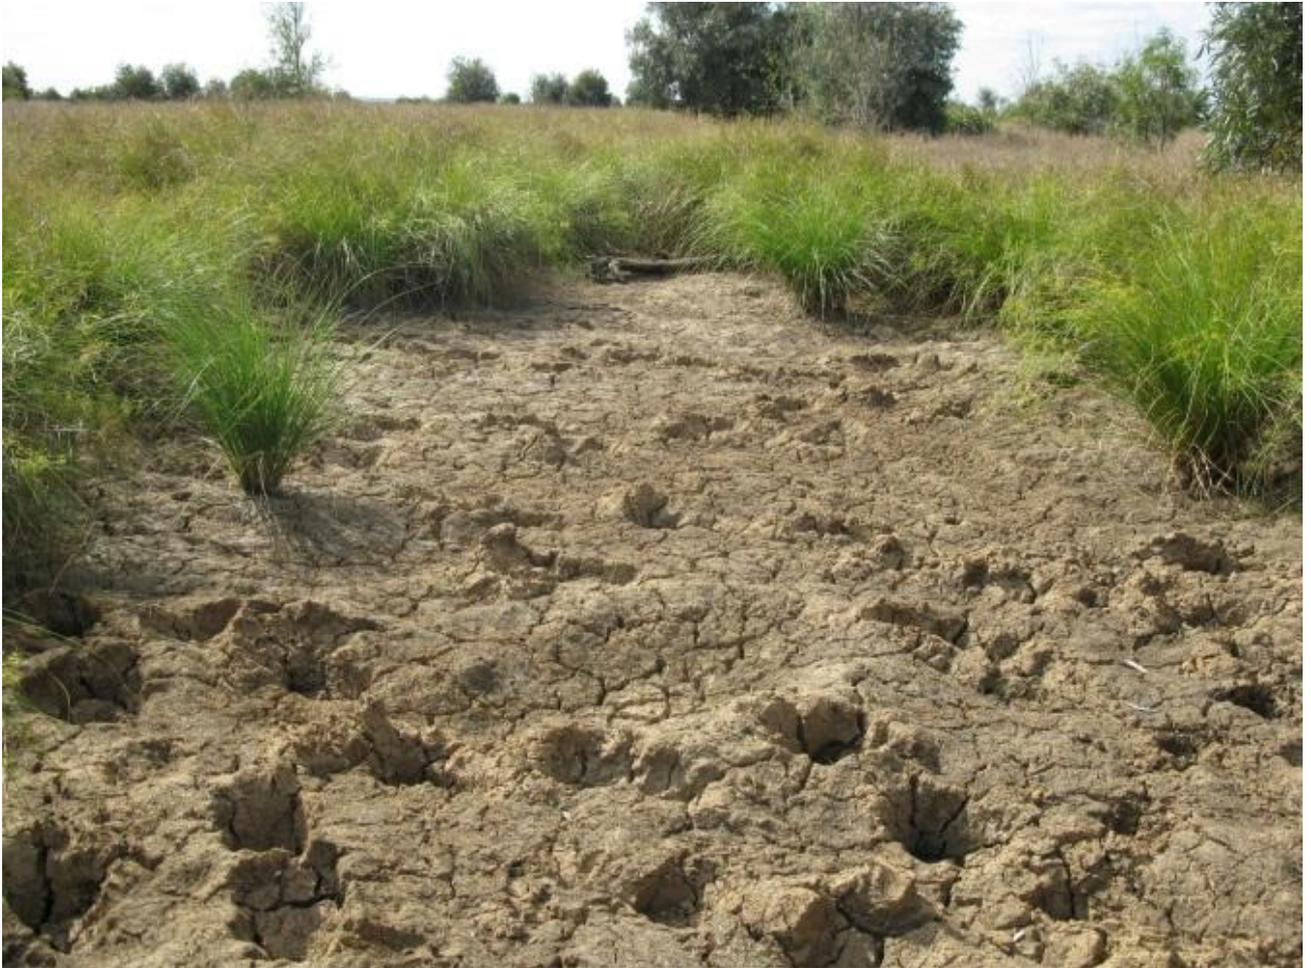
Photo: Gowrie Creek Tributary (Crossing 66)

Overview	Comment / Description
Stream Order Number (according to State Government mapping databases)	1
Area determination (according to the <i>Water Act 2000</i> based on identified exclusion criteria)	This crossing location does not contain any defined channel features and is not considered a 'watercourse' or 'drainage feature'.

The area has been historically cleared of all woody vegetation and is now dominated by the exotic fodder grass species *Pennisetum ciliare*. This location contains a number of shallow dry depressions, however, has no features consistent with a 'watercourse'.

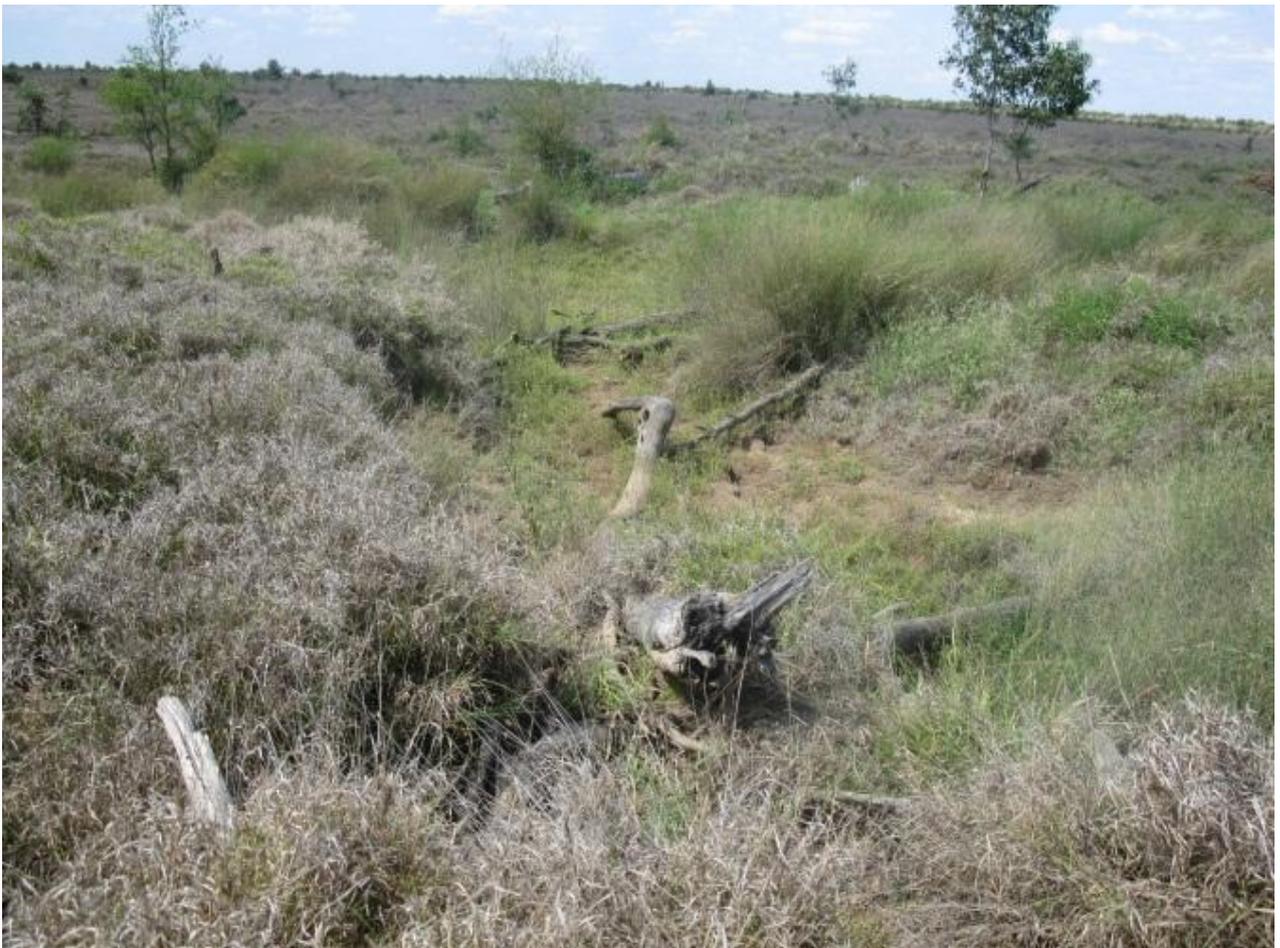
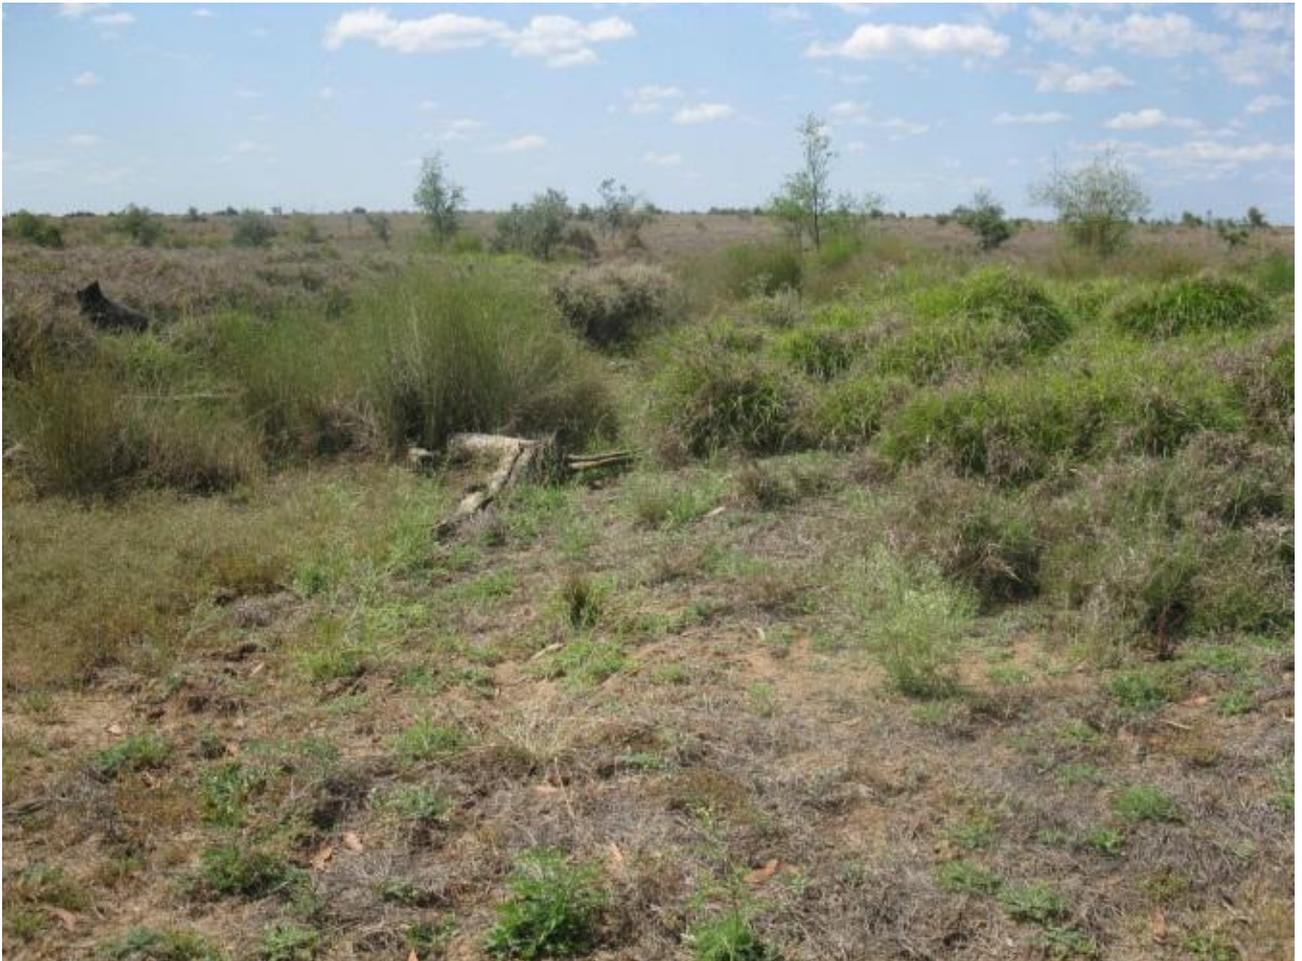
Photo: Gowrie Creek Tributaries (Crossings 64 & 63)

Overview	Comment / Description
Stream Order Number (according to State Government mapping databases)	1
Area determination (according to the <i>Water Act 2000</i> based on identified exclusion criteria)	This crossing location does not retain any defined channel features and is not considered a 'watercourse' or 'drainage feature'.

This location contains no features consistent with a 'watercourse'. Vegetation observed included relatively small scattered *Acacia harpophylla*, *Terminalia oblongata* and *Citrus glauca* less than 2 m in height. *Pennisetum ciliare*, *Parthenium hysterophorus*, *Capparis lasiantha*, *Carissa ovata*, *Leptochloa digitata*, *Aristida latifolia* and *Cyperus exaltatus* formed a dense ground layer. Weed species observed included *Parthenium hysterophorus*, *Pennisetum ciliare*, *Opuntia tomentosa*, *Eriocereus martini* and *Xanthium pungens*.
