**Carmichael Coal Mine and Rail Project
Supplementary Environmental Impact Statement**

Volume 4, Appendix C3h – Watercourse Determination Review

Water Act 2000 Watercourse Determination & Riverine Protection Permit Review

6396
22 March 2013
Adani Mining Pty Ltd

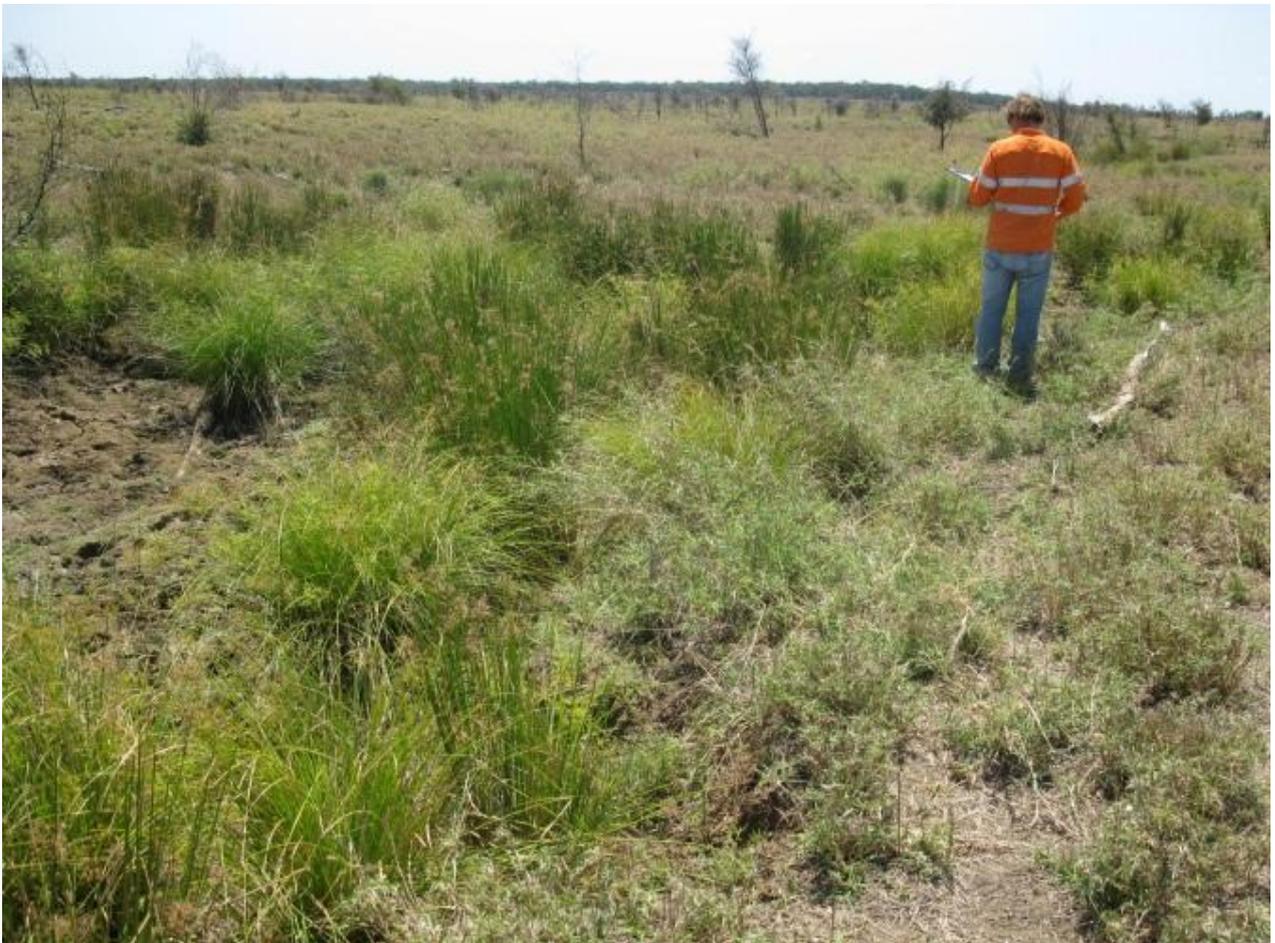
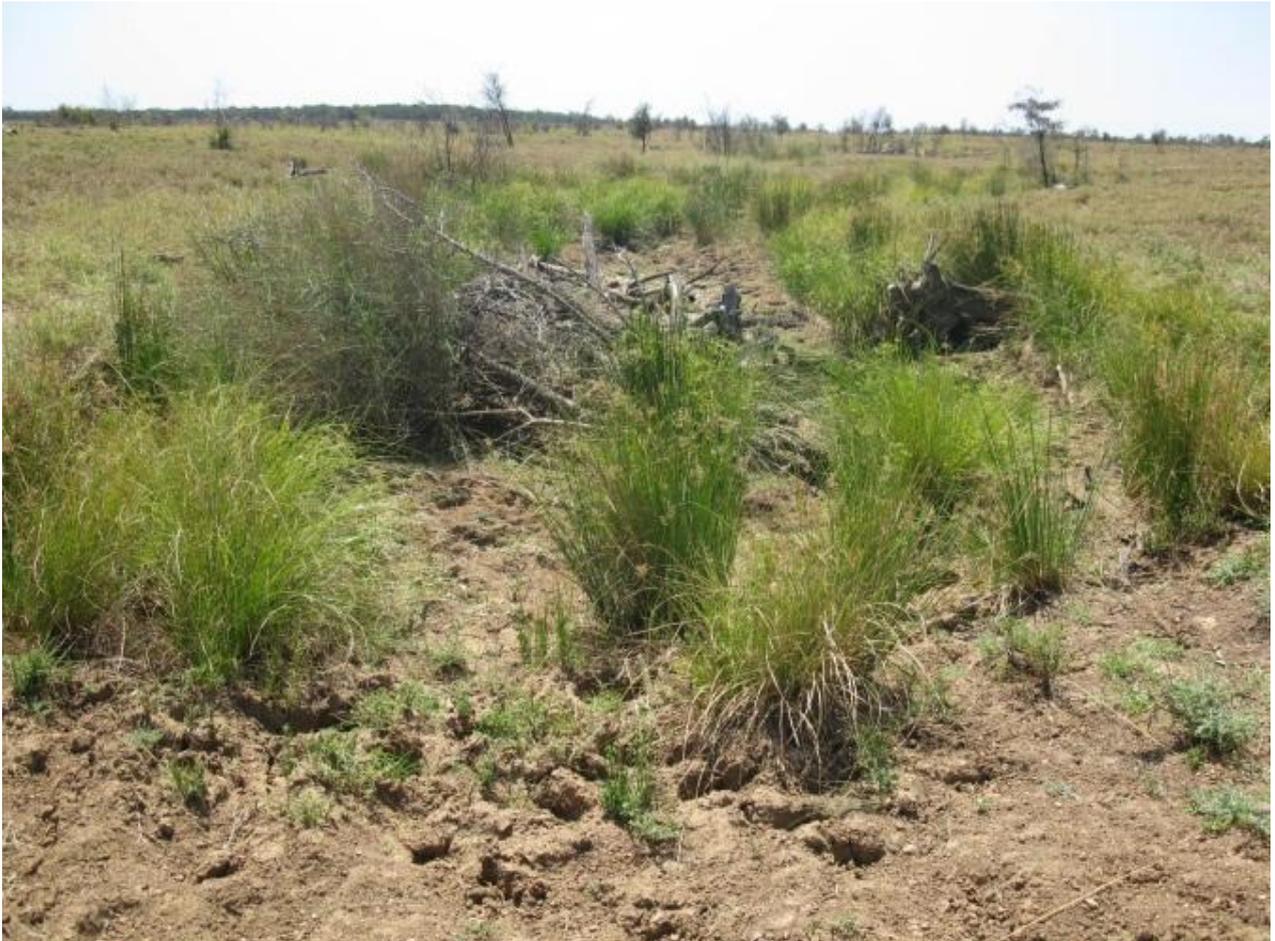
Photo: Unnamed Flow Path (Crossing 60)

Overview	Comment / Description
Stream Order Number (according to State Government mapping databases)	1
Area determination (according to the <i>Water Act 2000</i> based on identified exclusion criteria)	This crossing location does not contain any defined channel features and is not considered a 'watercourse' or 'drainage feature'.

This area is not a 'watercourse' or 'drainage feature'. Vegetation observed included relatively small scattered *Acacia harpophylla*, *Terminalia oblongata* and *Citrus glauca* less than 2 m in height. A dense ground layer containing *Pennisetum ciliare*, *Parthenium hysterophorus*, *Capparis lasiantha*, *Carissa ovata*, *Leptochloa digitata*, *Aristida latifolia* and *Cyperus exaltatus* was observed.

Observed weed species included *Parthenium hysterophorus*, *Pennisetum ciliare*, *Opuntia tomentosa* and *Eriocereus martini*.

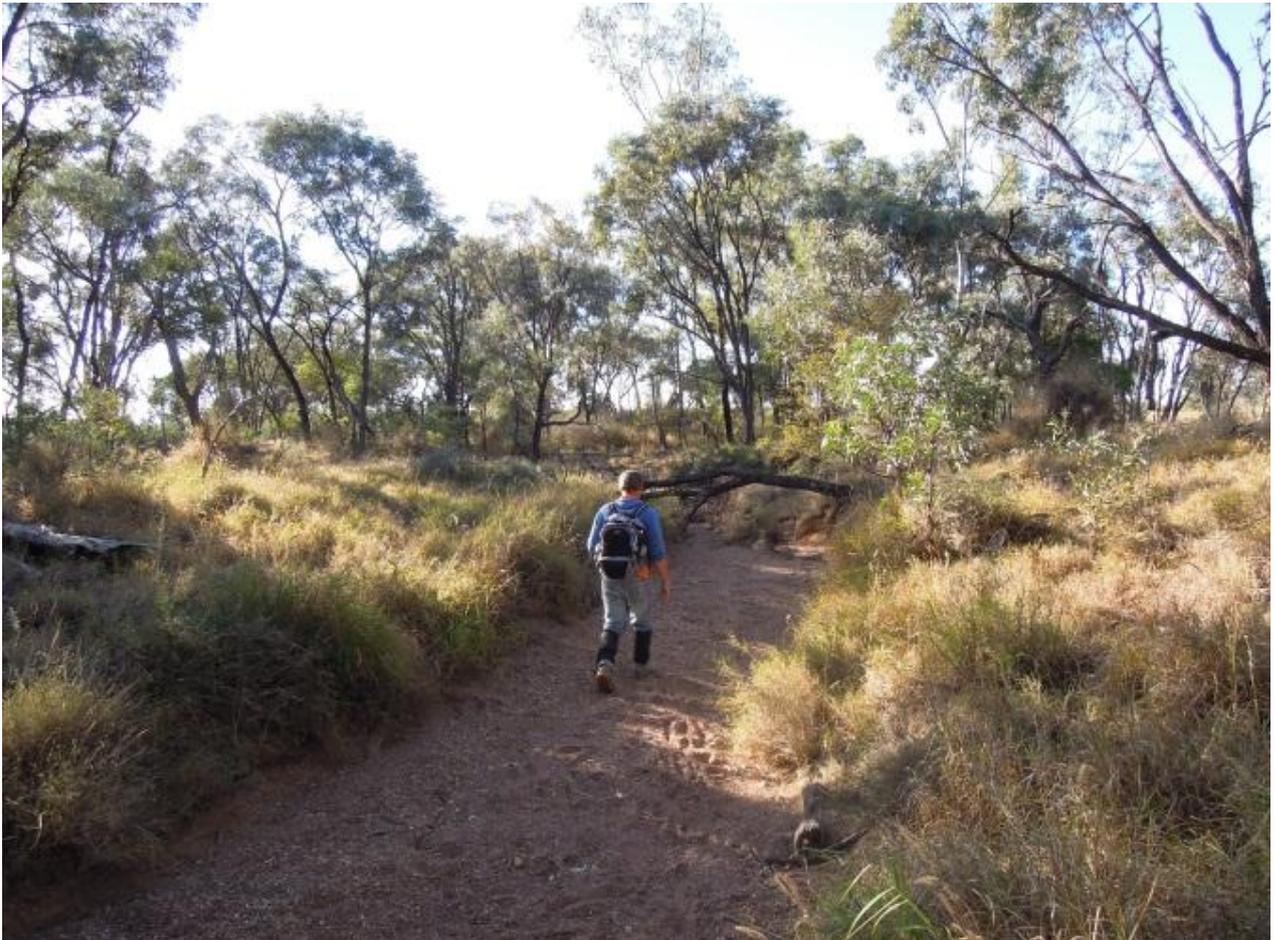
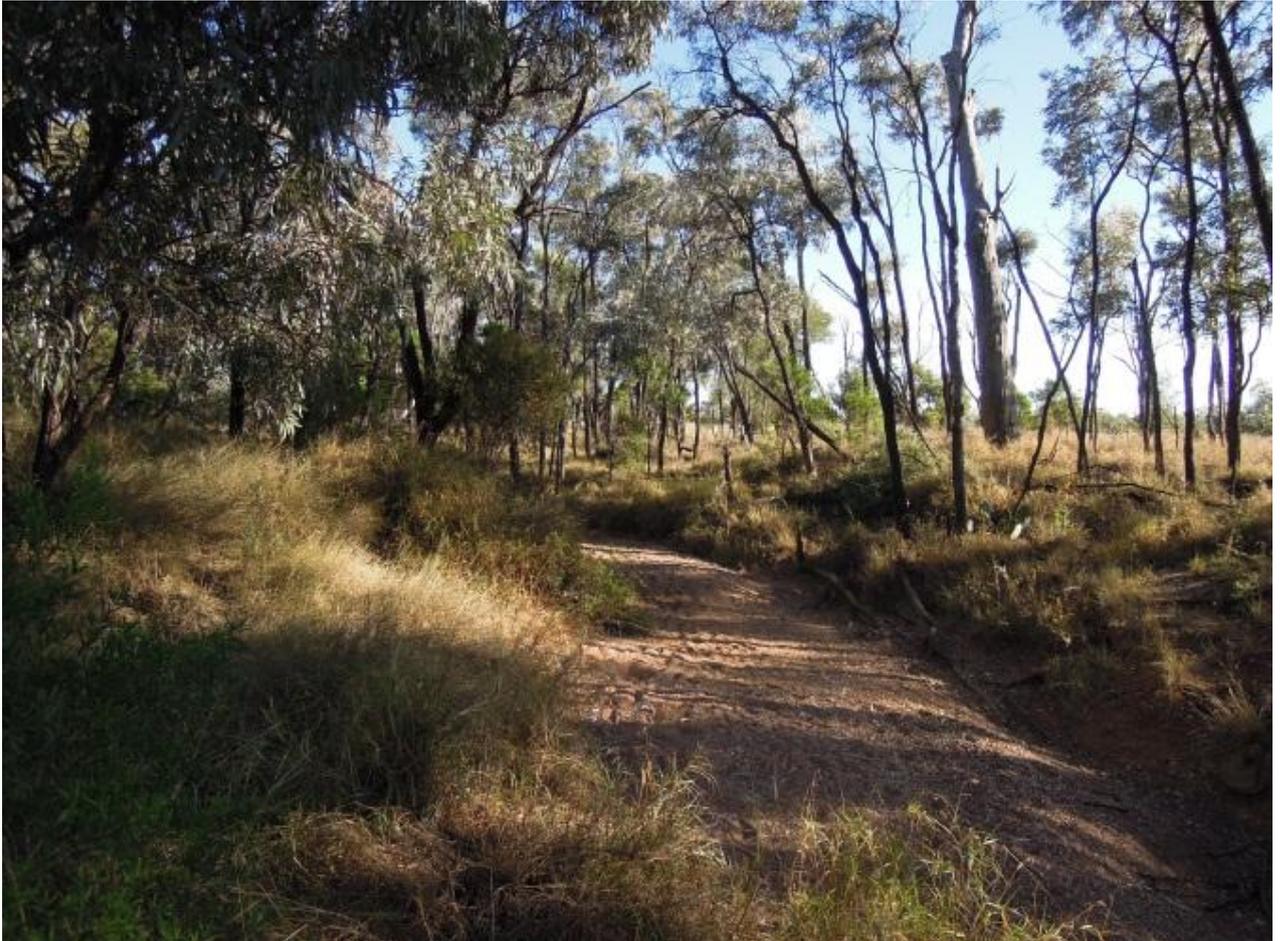
Photo: Unmapped Flow Path 1

Overview	Comment / Description
Stream Order Number (according to State Government mapping databases)	NA
Area determination (according to the <i>Water Act 2000</i> based on identified exclusion criteria)	<p>This crossing location fits the definition of a drainage feature.</p> <ul style="list-style-type: none"> • Funnels immediate localised rainfall only. • Only flows for a short period following rainfall. • Lacks a true riverine environment.

The vegetation at this site is dominated by *Acacia harpophylla* and *Acacia cambagei*. The shrub and ground layer was comprised of *Eremophila mitchellii*, *Carissa ovata*, *Citrus glauca*, *Bothriochloa bladhii*, *Bothriochloa ewartiana*, *Pennisetum ciliare*, *Dichanthium sericeum*, *Leptochloa digitata* and *Enteropogon acicularis*.

The depression is formed by the concentration of overland flow with the substrate comprised of sand and gravel with areas of fine sediment and silts. No pools or areas capable of holding water were observed within the alignment area.

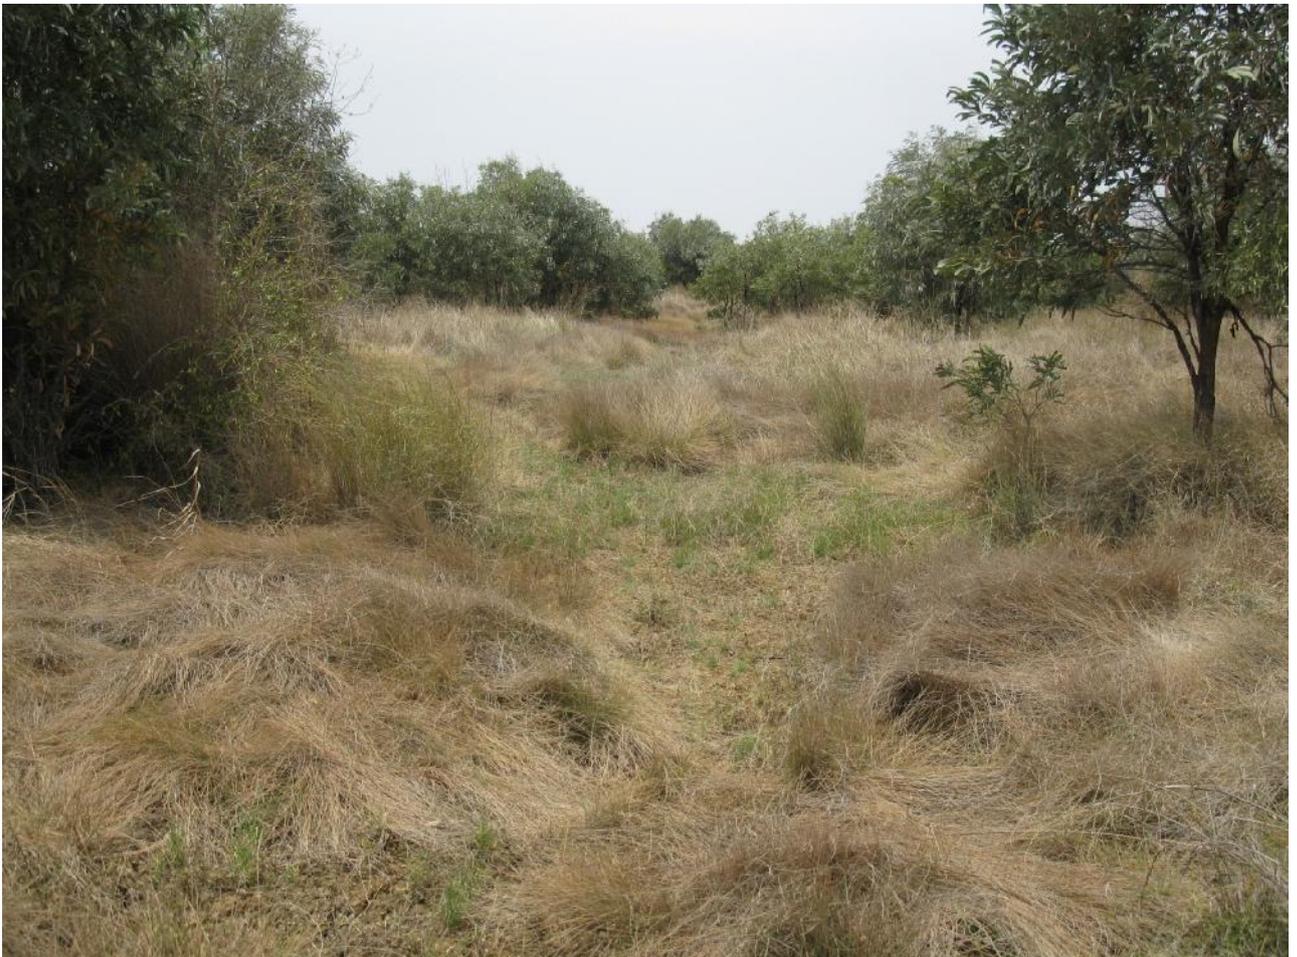
Photo: Unnamed Flow Path (Crossing 56)

Overview	Comment / Description
Stream Order Number (according to State Government mapping databases)	1
Area determination (according to the <i>Water Act 2000</i> based on identified exclusion criteria)	This crossing location is an open paddock with regrowth that does not contain any defined channel features and is not considered a 'watercourse' or 'drainage feature'. As such, no Field Determination is presented for this site.

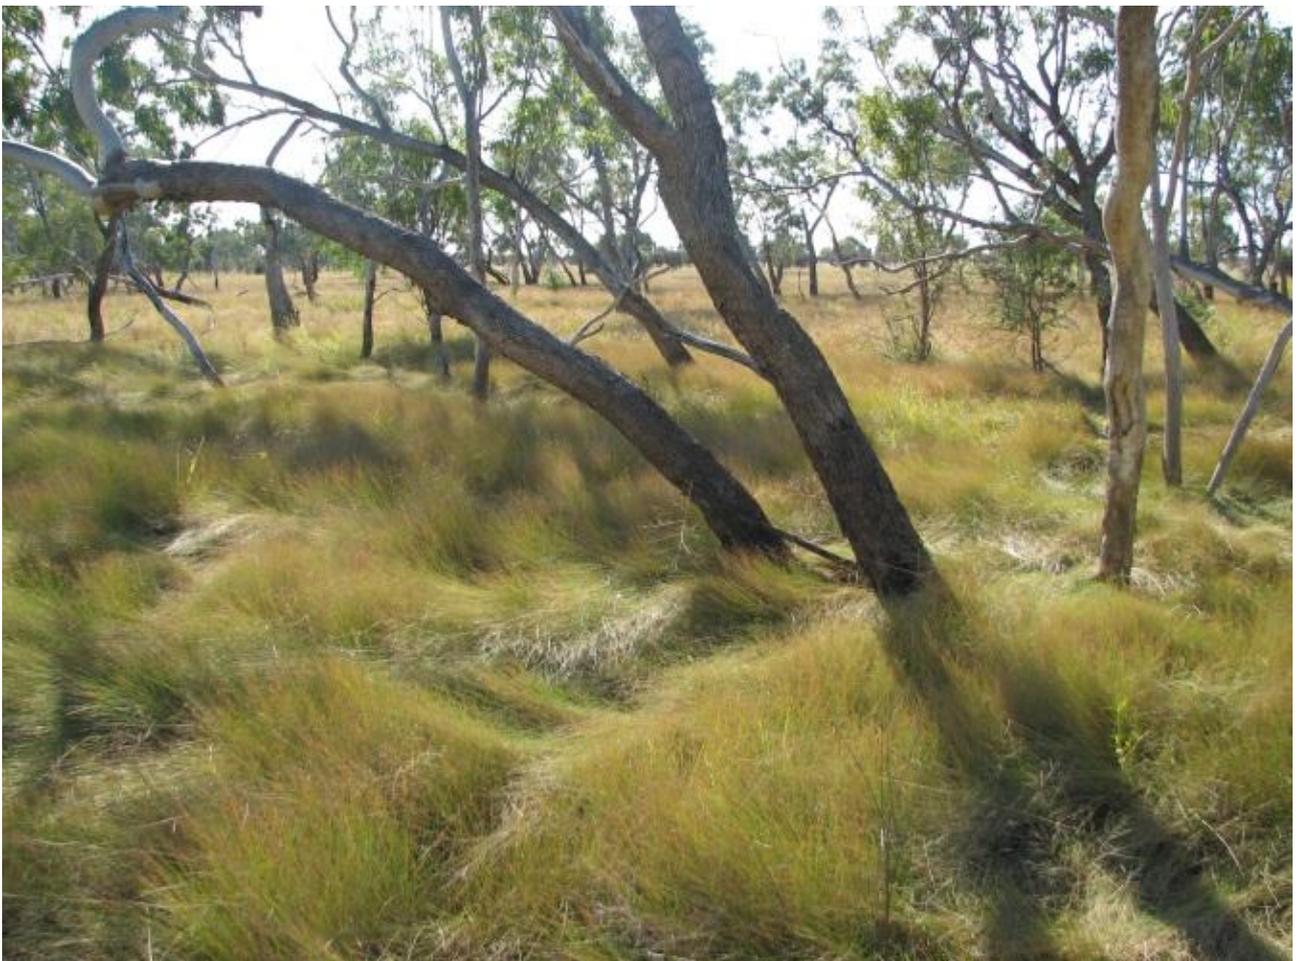
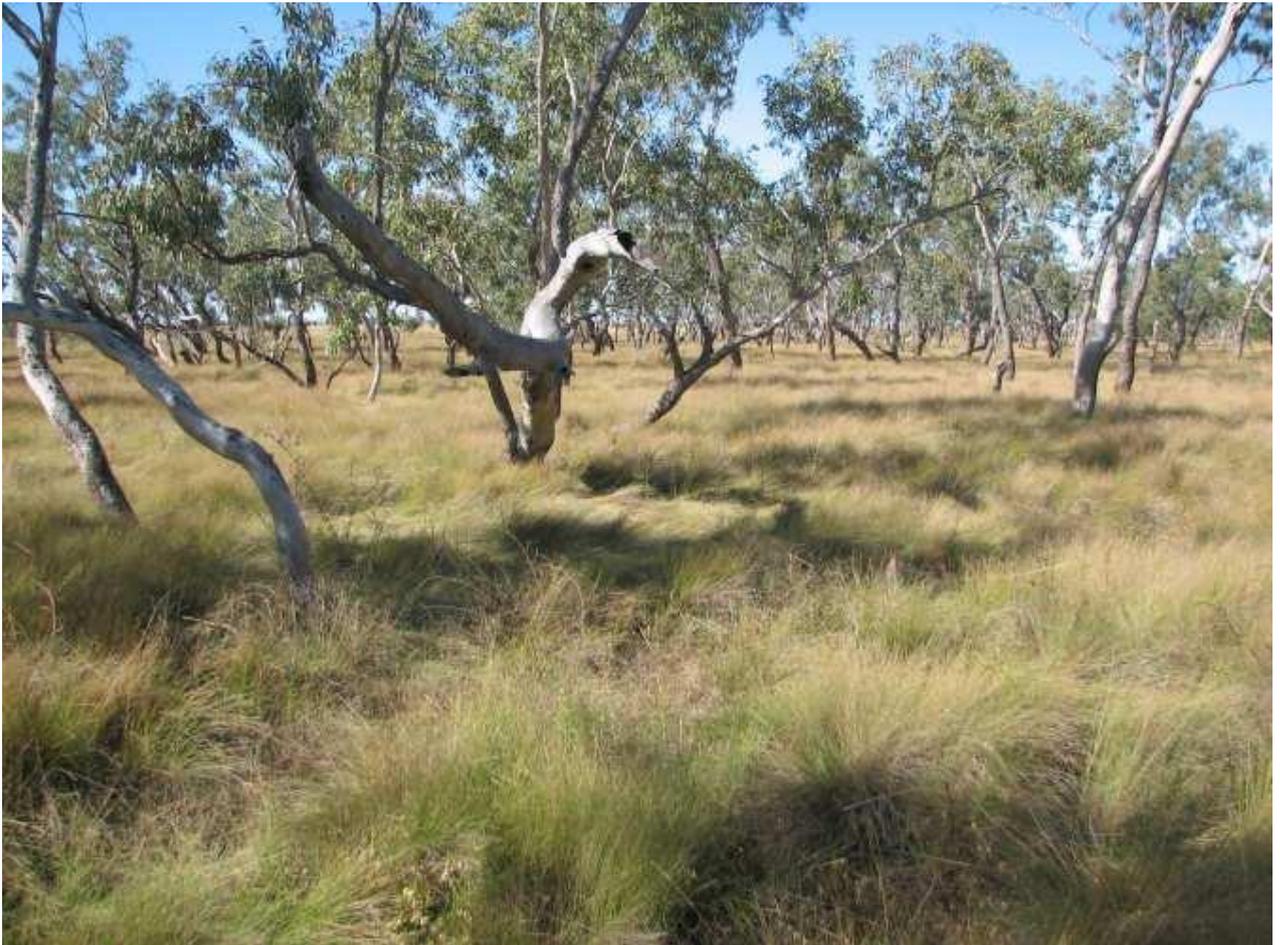
Photo: Logan Creek Tributary (Crossing 53)

Overview	Comment / Description
Stream Order Number (according to State Government mapping databases)	2
Area determination (according to the <i>Water Act 2000</i> based on identified exclusion criteria)	<p>This crossing location fits the definition of a drainage feature.</p> <ul style="list-style-type: none"> • Funnels immediate localised rainfall only. • Only flows for a short period following rainfall. • Lacks a true riverine environment.

This flow path runs from South to North and is surrounded by remnant vegetation. Areas adjoining the remnant vegetation have historically been cleared and are now dominated by exotic *Pennisetum ciliare*. The area contains no formalised 'watercourse' structure, with no obvious channels, beds or banks observed during the field survey.

No ponds, pools, riffles or bars were observed within the survey area, and no aquatic habitats were present. Vegetation observed included *Eucalyptus coolabah*, *Terminalia oblongata*, *Eucalyptus populnea*, *Eremophila bigoniiflora*, *Geijera parviflora* and *Citrus glauca*. The shrub layer would be considered very sparse with the ground layer within remnant vegetation dominated by native grasses.

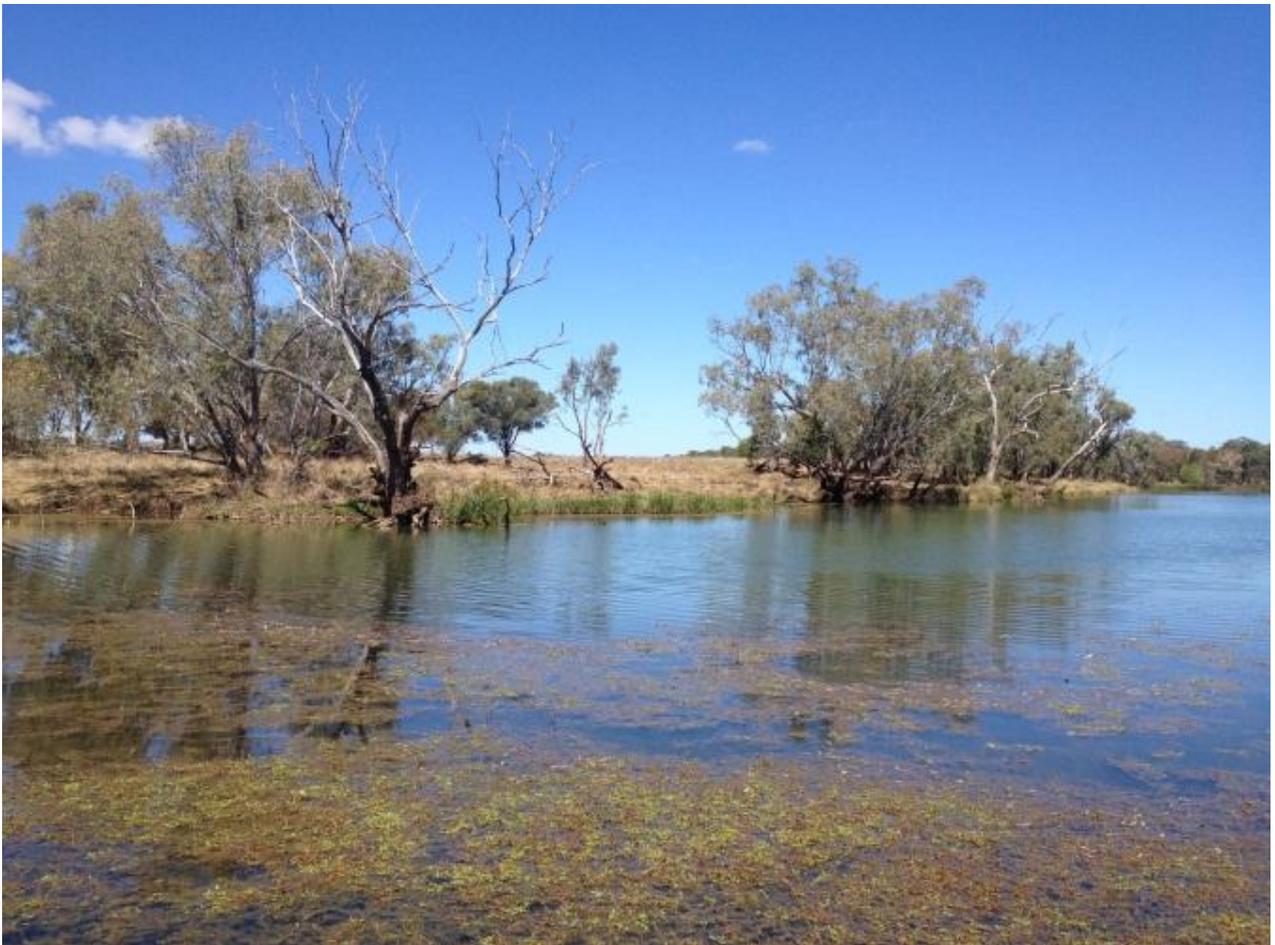
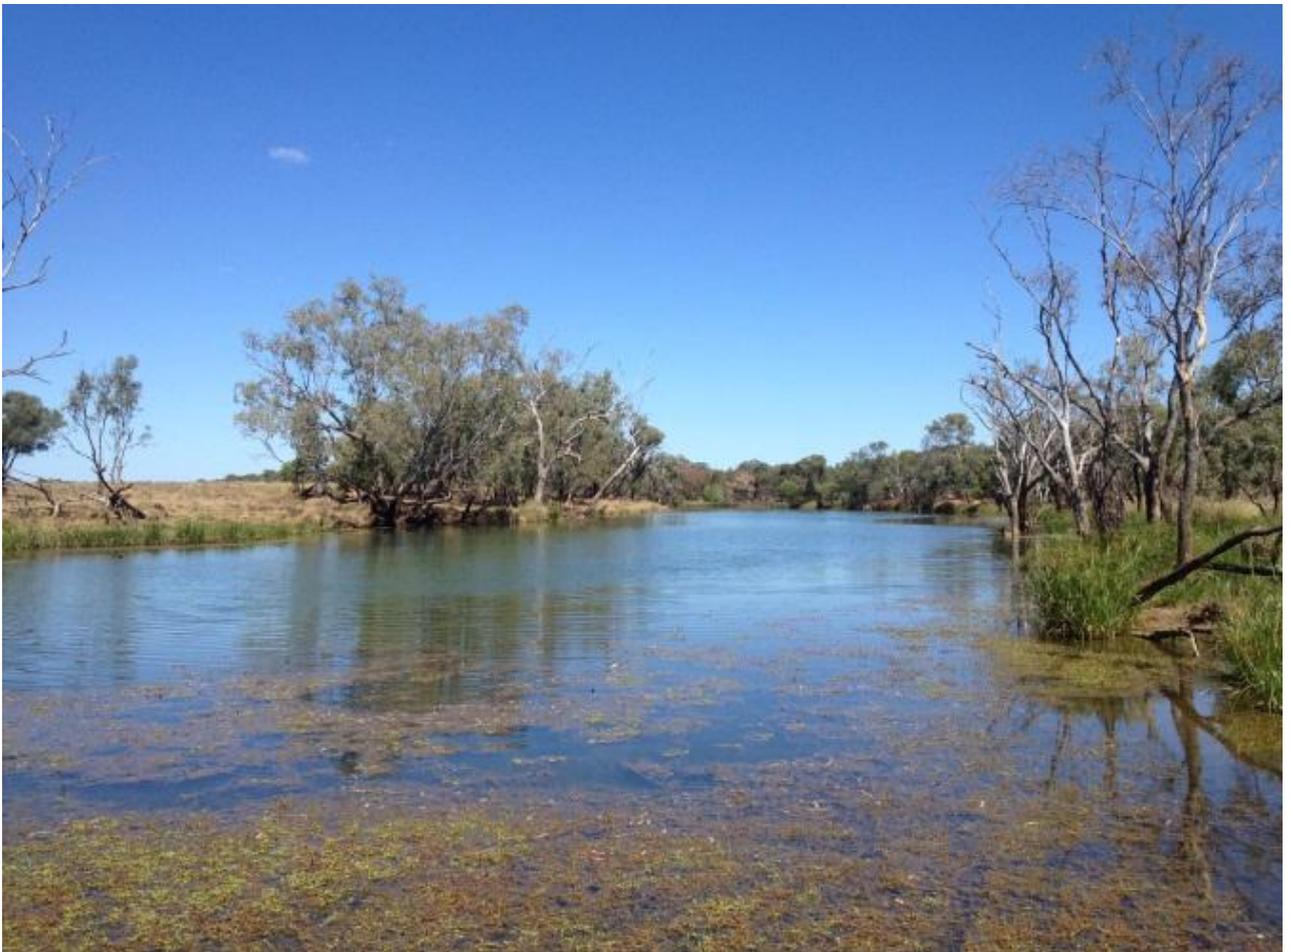
Photo: Logan Creek

Overview	Comment / Description
Stream Order Number (according to State Government mapping databases)	5
Area determination (according to the <i>Water Act 2000</i> based on identified exclusion criteria)	This crossing location fits the definition of a watercourse .

The riparian vegetation associated with this 'watercourse' is predominantly *Eucalyptus camaldulensis* and *Eucalyptus coolabah* with *Acacia cambagei* distant from the watercourse banks. Other species observed include *Geijera parviflora*, *Acacia salicina*, *Eremophila bigoniiflora*, *Eremophila mitchellii*, *Carissa ovata*, *Pennisetum ciliare*, *Parthenium hysterophorus*, *Terminalia oblongata*, *Dichanthium sericeum*, *Leptochloa digitata* and *Cyperus exaltatus*.

Substantial aquatic habitats in the form of submerged logs and macrophytes were present. Numerous avifauna were observed utilising this 'watercourse', including duck, cormorant, heron and ibis species.
