11. AQUATIC ECOLOGY

11.1. Aquatic Flora and Fauna

**EMU SWAMP DAM
SUPPLEMENTARY REPORT**

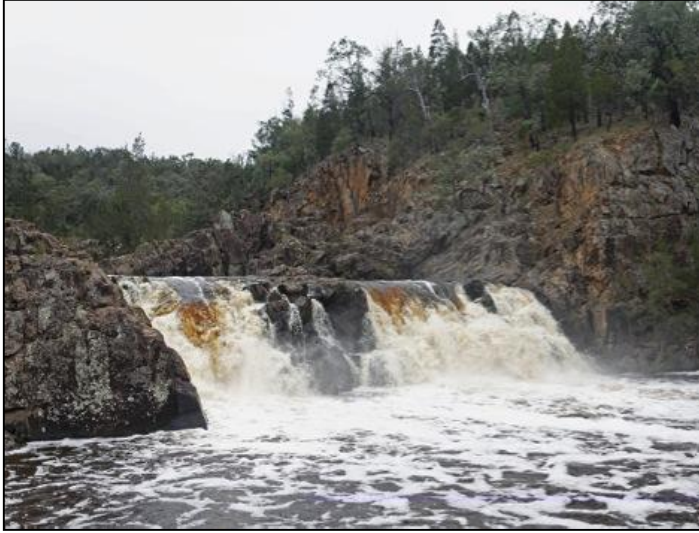
Figure 11.2 Nundubbermere Falls in high flow

The existing weirs, as identified throughout the area in the EIS, restrict fish passage in periods of low and moderate / average flow. That is, fish passage is currently restricted upstream of and within the proposed inundation area, and downstream of the proposed dam site, except in periods of high flow. Passage is less restricted at the weirs at 269.9 km AMTD and 270.6 km AMTD, where there are high flow by-passes that may be used by fish. Nundubbermere Falls, which is approximately 33 km downstream of the proposed dam site and approximately 2.5 m high, also represents a natural impediment to fish passage in the Severn River, particularly during low or moderate / average flow. It would also be difficult for fish to move upstream past these falls in high flow (Figure 11.2).

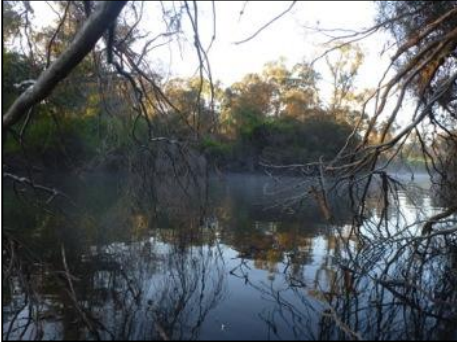
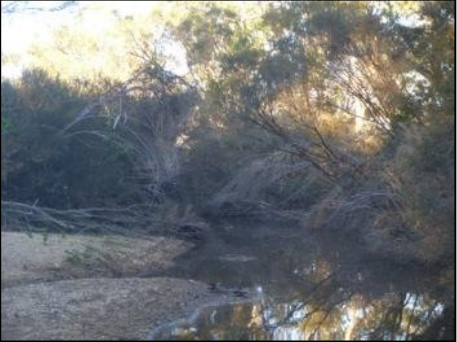
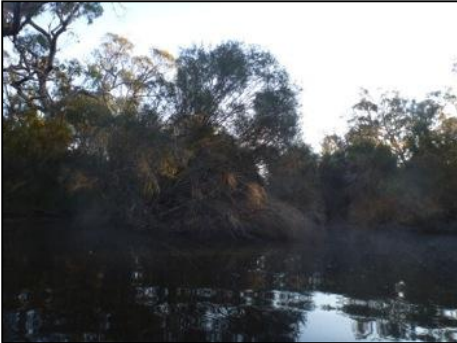
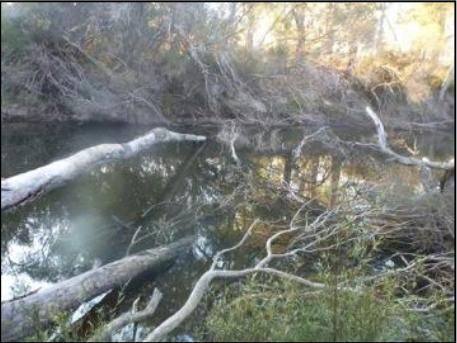
Site	Description	Photographs	
Upstream of the Proposed Dam Inundation area			
Site SRUS1	<p><i>General Description</i></p> <p>This site comprised a mildly sinuous and braided channel, with an average wetted width of 10 m and an average depth of 1.5 m. The right bank was sloping and low (0.2 m), and the left bank was steep to vertical and low (0.5 m). Both banks were stable. The riparian zone was ~3–5 m wide on each bank, with continuous vegetation dominated by casuarina and eucalypt trees and some shrubs. There was some shading of the river and trailing bank vegetation.</p> <p>In-stream habitat comprised shallow and deep pool, with scattered woody debris, detritus and tree roots. The bed substrate was dominated by sand, with some bedrock, gravel, boulders, cobbles and pebbles.</p> <p><i>Fish Passage</i></p> <p>There were no barriers to fish passage at this site.</p> <p><i>Suitability for Bell's Turtle</i></p> <p>This site was not assessed for turtles, but is considered unlikely to support Bell's turtles as there were few boulders.</p>

View downstream	View downstream of side channel

View upstream	Large woody debris

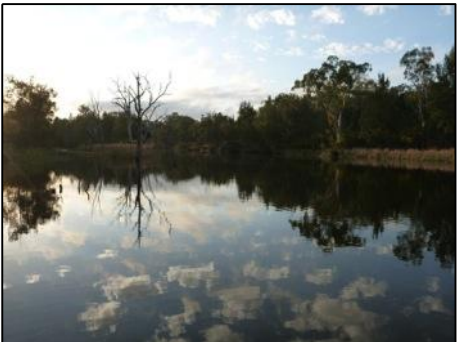
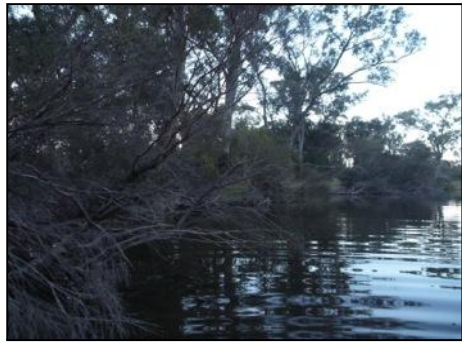
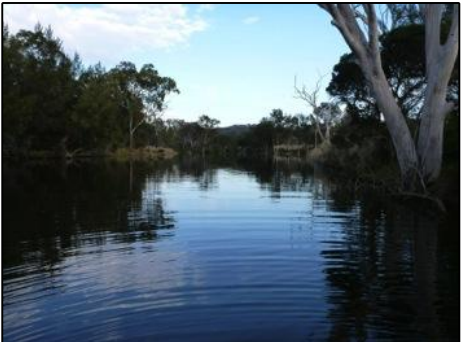
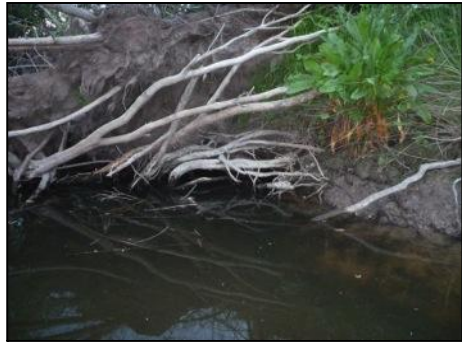
Site	Description	Photographs	
Site SRUS2	<p><i>General Description</i> This site comprised a mildly sinuous channel, with an average wetted width of 10 m and an average depth of 1 m. The left bank was sloping and low (0.5 m), and the right bank was steep and concave (0.8 m). Both banks were moderately stable. The riparian zone was ~1 m wide on each bank, with vegetation dominated by trees and grasses with some shrubs. Riparian vegetation was regularly spaced or in occasional clumps. There was little overhanging vegetation shading the river.</p> <p>In-stream habitat comprised shallow pool, with large woody debris, some detritus and isolated trailing bank vegetation. The bed substrate was dominated by cobbles and sand, with some pebbles and silt / clay.</p> <p><i>Fish Passage</i> There were no barriers to fish passage at this site.</p> <p><i>Suitability for Bell's Turtle</i> This site was not assessed for turtles, but is considered unlikely to support Bell's turtles as there were few boulders.</p>

View upstream	View of downstream left bank

View downstream	Tree roots overhanging into water

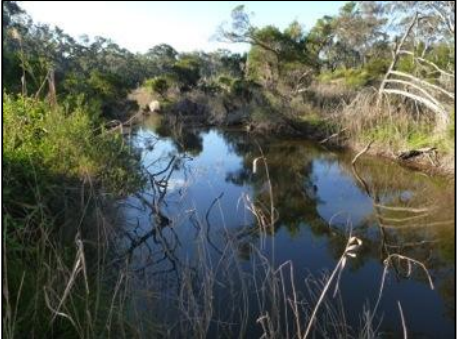
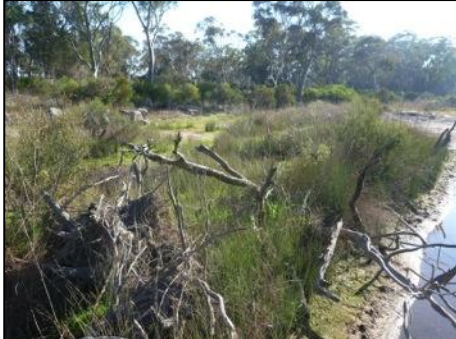
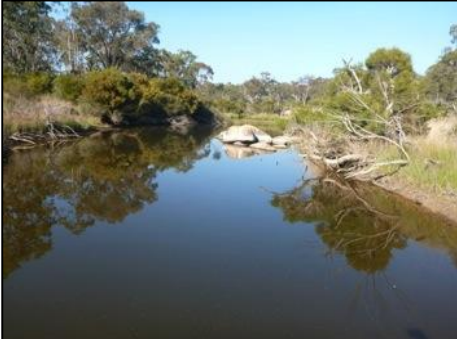
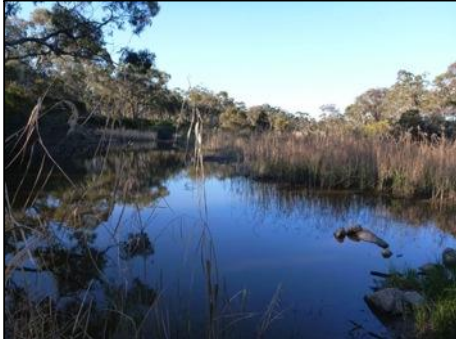
Site	Description	Photographs	
Site L	<p><i>General Description</i> This site comprised a mildly sinuous channel, with an average wetted width of 10 m and an average depth of 0.4 m. The banks were sloping and low (0.5 m), and stable. The riparian zone was ~20 m wide on each bank, with vegetation dominated by melaleuca and eucalypt trees and grasses with some shrubs. In-stream habitat comprised shallow pool and runs, with isolated woody debris, some detritus and beds of emergent aquatic plants. The bed substrate was dominated by bedrock and sand, with some gravel, boulders and pebbles.</p> <p><i>Fish Passage</i> Fish passage may be restricted at this site during periods of low flow due to sand deposits and bedrock constricting flow in some areas.</p> <p><i>Suitability for Bell's Turtle</i> This site was unlikely to be suitable for Bell's turtles as there were no undercut banks, little large woody debris and few boulders. No areas of potential nesting habitat were observed.</p>

View upstream	View of upstream right bank.

View downstream	Extensive reeds in shallow water

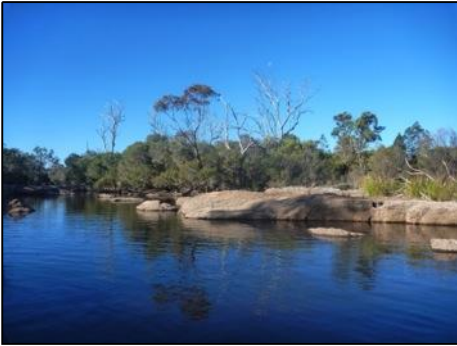
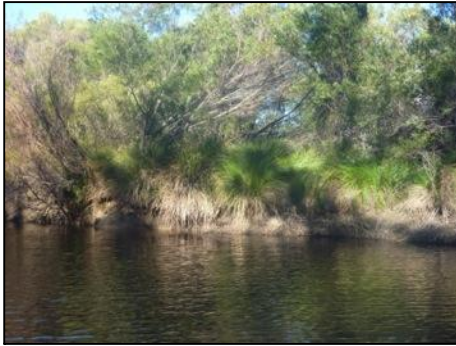
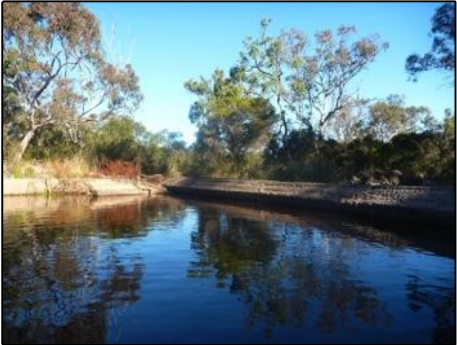
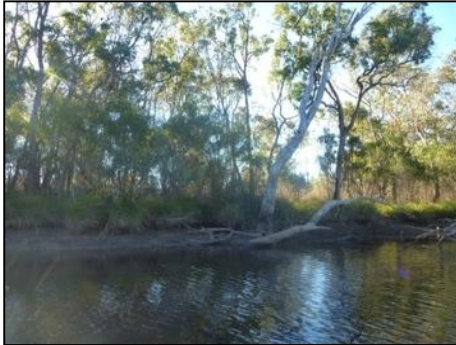
Site	Description	Photographs	
Site Fi	<p><i>General Description</i> This site comprised a weir pool with an average width of 12 m and an average depth of 1 m. The banks were steep and low (0.5 m), and moderately stable. The riparian zone was ~10 m on each bank, with vegetation dominated by melaleuca, callistemon and eucalypt trees, as well as shrubs and grasses. In-stream habitat included shallow and deep pools, scattered large woody debris, undercut banks, isolated emergent plants and some detritus. The bed substrate was dominated by sand and silt/ clay, with some bedrock, boulders, cobbles and pebbles.</p> <p><i>Fish Passage</i> A private weir at the downstream end of the reach would restrict fish passage except in high flow.</p> <p><i>Suitability for Bell's Turtle</i> This site is potentially suitable for Bell's turtles, but unlikely to support a stable population due to the downstream weir and anthropogenic disturbance upstream towards site L. No areas of potential nesting habitat were observed.</p>

View upstream from weir	Heavily vegetated bank

Weir	Overhanging vegetation and woody debris

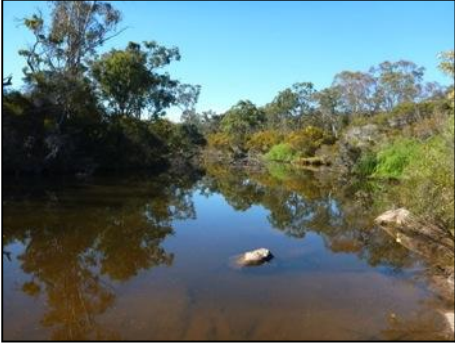
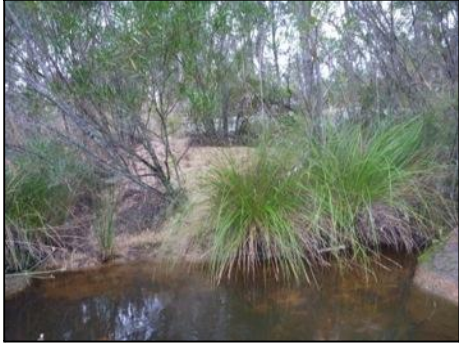
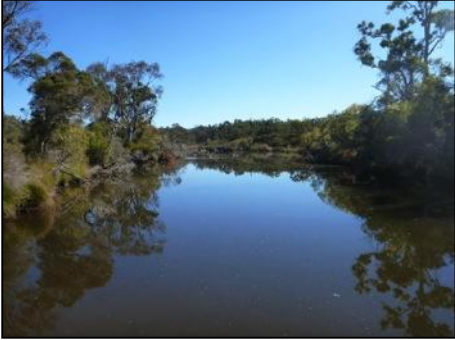
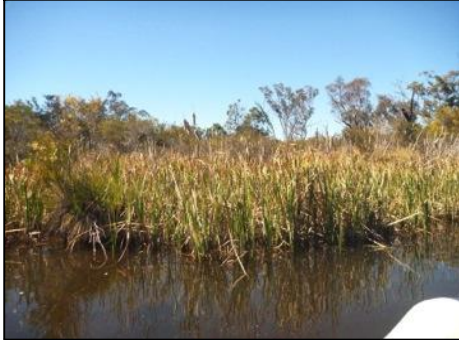
Site	Description	Photographs	
Within the Proposed Dam Inundation area			
Site 1	<p><i>General Description</i> This site comprised a weir pool with an average width of 20 m and an average depth of approximately 2 m. The banks were sloping on the left bank and steep on the right bank vertical, with an average height of 0.5 to 0.8 m. Both banks were stable.</p> <p>The riparian zone was ~5 m on each bank, with vegetation dominated by eucalypt trees, shrubs and grass.</p> <p>In-stream habitat included large woody debris, overhanging vegetation, boulders, and isolated areas of submerged and emergent aquatic plants. The bed substrate was dominated by bedrock and boulders, with some sand and silt / clay.</p> <p><i>Fish Passage</i> Fish passage within the reach surveyed was unrestricted, however there was a weir at the downstream end of the site that would restrict fish passage except during high flow events.</p> <p><i>Suitability for Bell's Turtle</i> Habitat at the upstream end of this site is potentially suitable for Bell's turtles.</p> <p>There were small isolated areas of suitable nesting habitat.</p>

View upstream	Sandy bank suitable for nesting

View downstream	Extensive <i>Typha orientalis</i> in channel

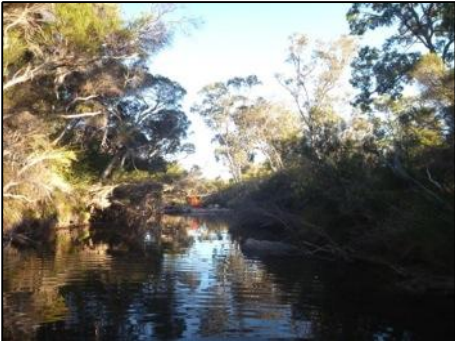
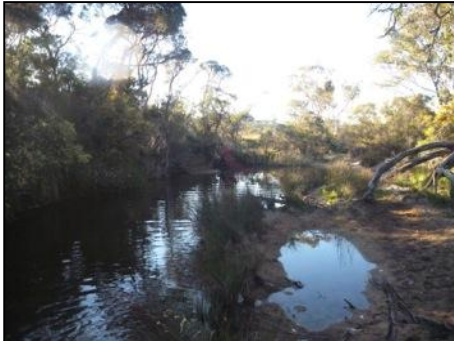
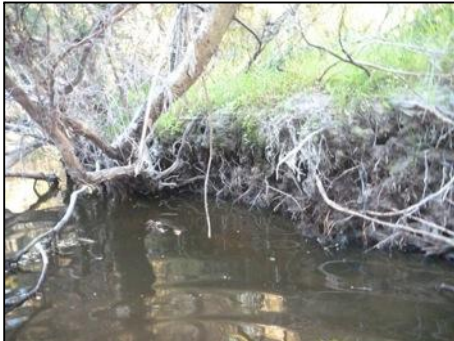
Site	Description	Photographs	
Site J	<p><i>General Description</i></p> <p>This site comprised a mildly sinuous channel with an average width of 5 m and an average depth of 1 m. The average bank full width was 20 m. The banks were sloping, low (0.5 m), and stable.</p> <p>The riparian zone was ~10 m wide on each bank. Melaleuca trees dominated riparian vegetation, with some shrubs and grasses.</p> <p>In-stream habitat included shallow and deep pools and shallow runs, with extensive woody debris, detritus, undercut banks and overhanging vegetation. The bed substrate was varied, with some bedrock, boulder, cobble, sand and silt / clay.</p>

<p><i>Fish Passage</i></p> <p>An upstream private weir restricted fish passage at this site. In low to moderate flow fish would not be able to pass the weir. Fish passage would be possible during high flow events.</p>

<p><i>Suitability for Bell's Turtle</i></p> <p>The habitat at this site is potentially suitable for Bell's turtles, and there were small isolated areas of potentially suitable nesting habitat.</p>

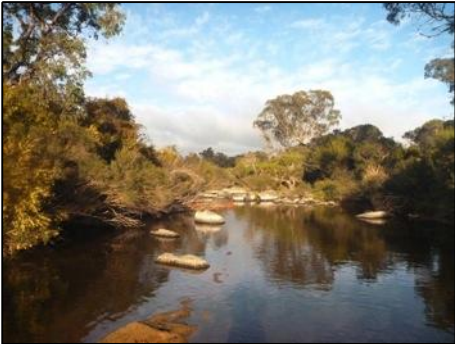
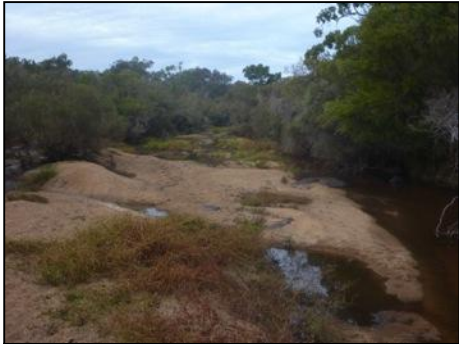
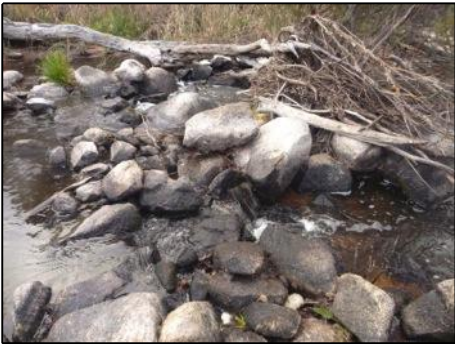
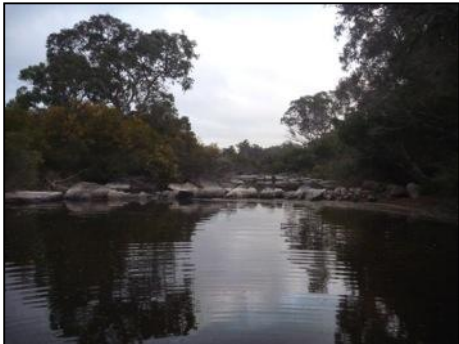
Site	Description	Photographs	
Site E	<p><i>General Description</i></p> <p>Site comprised an irregular channel, with an average width of 3 m and a maximum width of 10 m. A man made rock wall formed a pool in the middle of the site. The banks were sloping and low (0.5m). The banks were moderately stable.</p> <p>The riparian zone was ~5m wide on each bank. Melaleuca and eucalypt trees and shrubs dominated the riparian vegetation, with some grasses also abundant.</p> <p>In-stream habitat comprised shallow pools, runs and riffles, with sand bars. There was some detritus and little woody debris. There were isolated patches of emergent aquatic plants in-stream. The bed substrate was dominated by sand, with some bedrock and boulder.</p> <p>Overall disturbance was low.</p> <p><i>Fish Passage</i></p> <p>A man-made rock wall at this site would restrict fish passage for all fish during periods of low flow, and for large fish in periods of moderate / average flow. There would be no restrictions to fish passage during periods of high flow.</p> <p><i>Suitability for Bell's Turtle</i></p> <p>This site is unlikely to support a stable population of Bell's turtle due to the shallow water, which may dry during periods of low to no rain.</p> <p>There were small areas of sandy bank suitable for turtle nesting.</p>

View downstream	View downstream from upper end of reach

Small riffle at downstream end of reach	Man-made rock wall at site

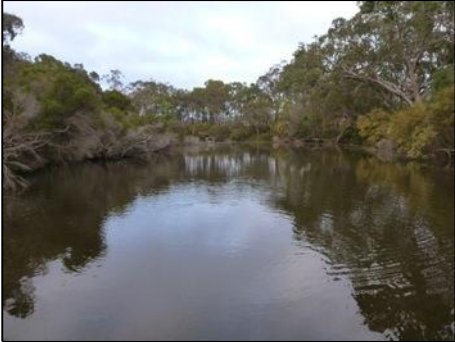
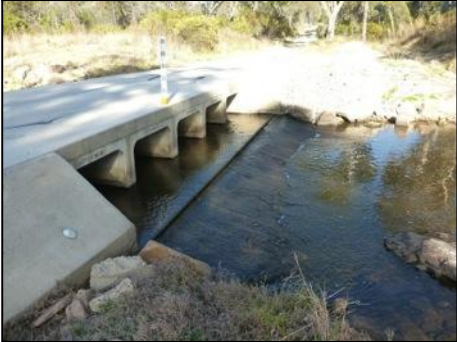
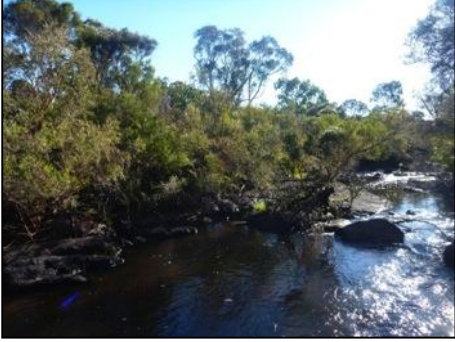
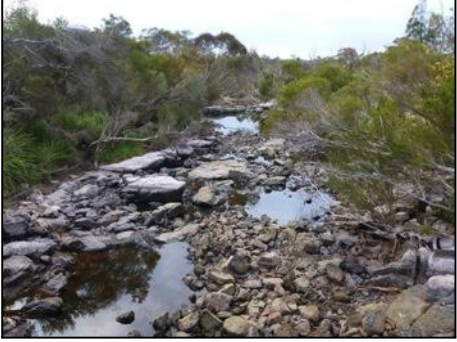
Site	Description	Photographs	
<p>Downstream of the Proposed Dam Site K</p>	<p><i>General Description</i> This site comprised an irregular channel with an average width of 15 m and an average depth of 1 m. There was a road crossing through the middle of this site and a weir at the downstream end. The banks were sloping to vertical, and low (0.5 m). Banks were undercut, but stable. The riparian zone was ~30 m wide on the left bank and ~20 m wide on the right bank. Melaleuca and eucalypt trees dominated riparian vegetation, with some shrubs and grasses. In-stream habitat included shallow and deep pools, runs and riffles, with some woody debris, detritus, undercut banks and overhanging vegetation. The bed substrate was dominated by bedrock and sand, with some boulders, cobble, pebble, gravel and silt / clay.</p> <p><i>Fish Passage</i> During periods of low flow fish passage at this site would be restricted by the culvert at the road crossing and bars in the channel. A private weir also restricts fish passage at the downstream end of this site in low to moderate / average flow.</p> <p><i>Suitability for Bell's Turtle</i> The habitat in the downstream end of this site is potentially suitable for Bell's turtles, and there were small isolated areas of potentially suitable nesting habitat. The upstream area is unlikely to support Bell's turtles.</p>

<p>View downstream in September</p>	<p>Culvert in middle of site</p>

<p>View upstream in May</p>	<p>View upstream in September</p>

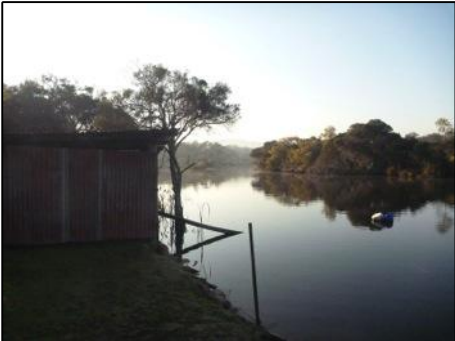
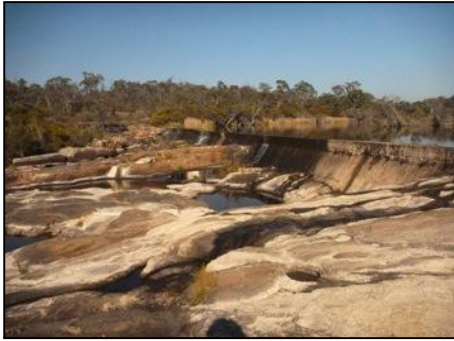
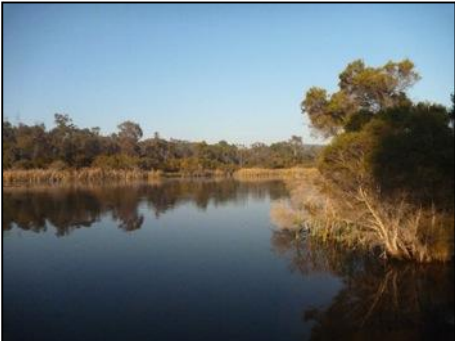
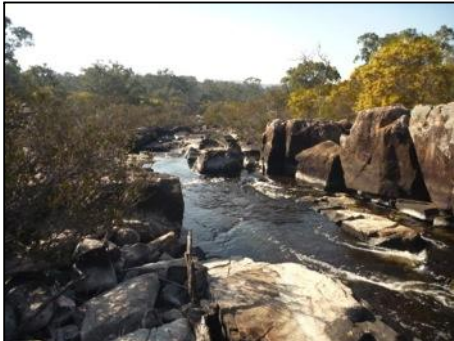
Site	Description	Photographs
Site C	<p><i>General Description</i></p> <p>This site comprised a large weir pool with an average width of 25 m and an average depth of more than 2 m.</p> <p>The banks were gently sloping, low (0.5 m high), and stable. The riparian zone was ~20 m on each bank, with vegetation dominated by eucalypt and callistemon trees, with shrubs and grasses.</p> <p>In-stream habitat consisted of a deep pool with isolated woody debris, scattered detritus and beds of submerged plants. Reeds lined the banks in many areas. The bed substrate was dominated by bedrock and boulders, with some gravel, sand and silt / clay.</p>

<p><i>Fish Passage</i></p> <p>Fish passage was unrestricted through the reach surveyed, but limited by a weir at the downstream end of the site. Fish passage is only possible at this site in high flow.</p>

<p><i>Suitability for Bell's Turtle</i></p> <p>Habitat at this site is unlikely to support a stable population of Bell's turtles. There was little large woody debris, trailing bank or overhanging vegetation, no undercut banks, and no flow. Suitable food sources (i.e. aquatic plants) were present. No areas of potential nesting habitat were observed.</p>

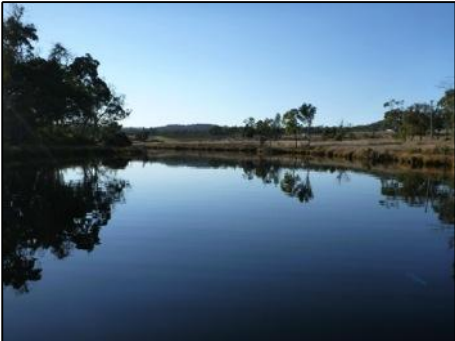
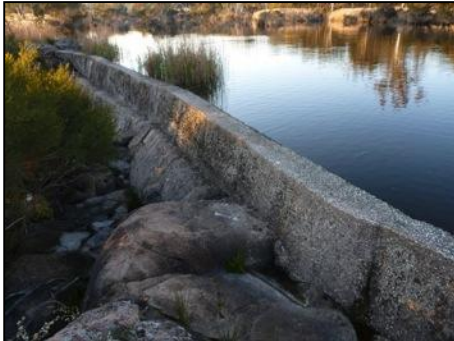
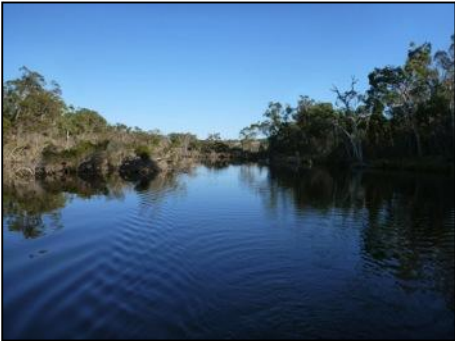
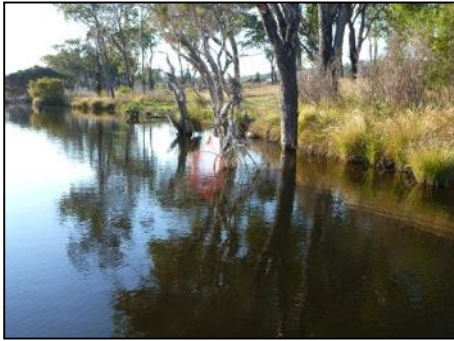
Site	Description	Photographs	
Site A	<p><i>General Description</i></p> <p>This site comprised a weir pool with an average width of 43 m, and a bank full width of approximately 70 m. The average depth was approximately 1 m. The banks were gently sloping, low (<1 m), and stable.</p> <p>The riparian zone was ~5 m on the left bank and ~10 m on the right bank. Grasses and discontinuous eucalypts and melaleucas dominated the riparian vegetation. There were areas of cleared on both banks for grazing and cropping.</p> <p>In-stream habitat consisted of a pool with no visible flow, large beds of ribbonweed and scattered woody debris. The bottom substrate was dominated by bedrock, gravel and silt/clay, with some boulder, sand, cobbles and pebbles.</p> <p><i>Fish Passage</i></p> <p>Fish passage at this site was restricted by a weir at the downstream end of the reach surveyed. Passage would only be possible past this weir in periods of high flow.</p> <p><i>Suitability for Bell's Turtle</i></p> <p>This site is unlikely to support Bell's turtles, unless in transit. There was little large woody debris or overhanging vegetation, few undercut banks or boulders, and no flow. Suitable food sources (e.g. ribbonweed) were present.</p> <p>No areas of potential nesting habitat were observed.</p>

View upstream	Weir at downstream end of reach

View downstream	Extensive reeds and grasses along bank

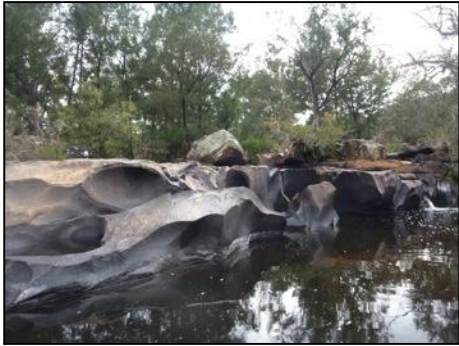
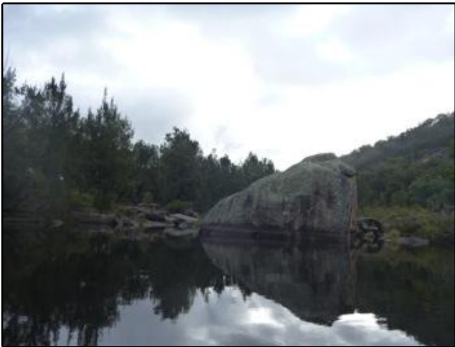
Site	Description	Photographs	
Site B	<p><i>General Description</i> This site comprised a wide irregular channel, with an average wetted width of 30 m (minimum 3 m and maximum 57 m). The average depth was approximately 1.2 m. The banks were low (0.5 m) and gently sloping to steep. The banks were stable, with no undercut areas.</p> <p>The riparian zone was ~15 m wide on each bank. Melaleuca, eucalypt and callistemon trees dominated the riparian vegetation, with some shrubs and grasses.</p> <p>In-stream habitat included shallow and deep pools with areas of shallow runs and cascades. There was abundant detritus, some algal growth, isolated woody debris and no submerged vegetation. The bed substrate was dominated by bedrock and boulders, with some finer sediments.</p> <p><i>Fish Passage</i> Upstream fish movement at this site may be restricted for some fish due to a bedrock shelf with a drop of approximately 0.8 m. Extensive bedrock through the site would restrict fish movement upstream and downstream during periods of low flow.</p> <p><i>Suitability for Bell's Turtle</i> Habitat at this site is potentially suitable for Bell's turtles, but large woody debris was limited and there were no overhanging banks. Overhanging and trailing bank vegetation was limited.</p> <p>There were some isolated areas of sand on the banks, suitable for nesting.</p>

View downstream	Bedrock shelf restricting flow

View upstream	Isolated area of sand on the bank

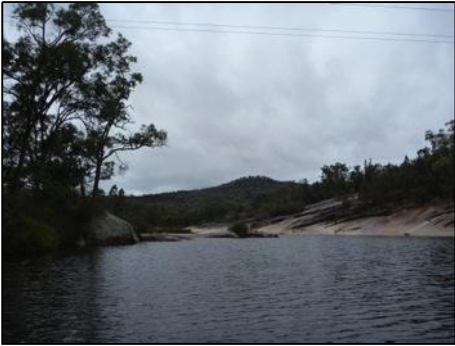
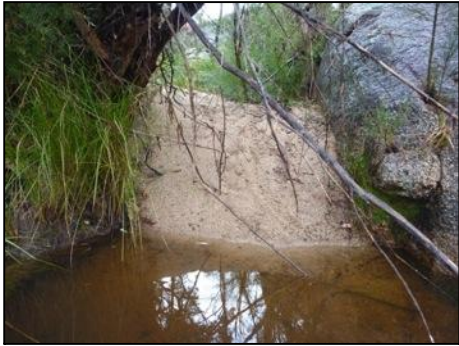
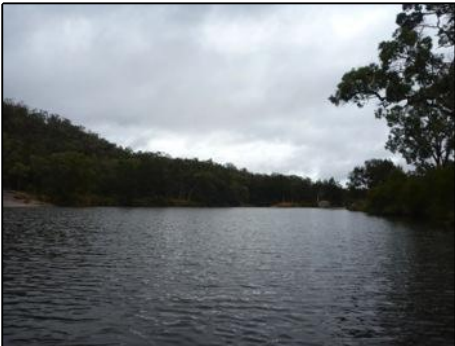
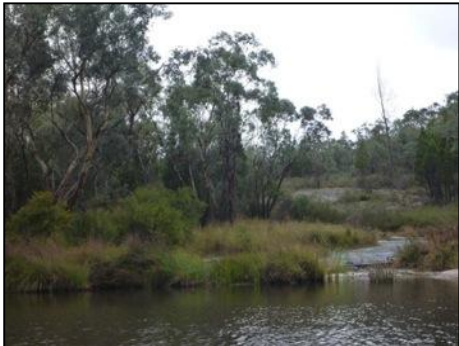
Site	Description	Photographs	
Site Di	<p><i>General Description</i></p> <p>This site comprised a large weir pool with an average width of 35 m and an average depth greater than 2 m. The banks were sloping and low (0.5 m), except in areas where exposed bedrock comprised the bank. Bank stability was high.</p> <p>The riparian zone was ~10 m on each bank. Eucalypt, melaleuca and casuarina trees dominated the riparian vegetation, with some shrubs and grasses. There were small areas of cleared vegetation on each bank.</p> <p>In-stream habitat deep and shallow pools and cascades. There were isolated areas of floating and submerged aquatic plants, scattered woody debris and some detritus. The bed substrate varied, with bedrock, boulders, cobble, gravel and sand all present.</p> <p><i>Fish Passage</i></p> <p>Fish passage at this site was restricted by a weir at the downstream end of the reach surveyed. Passage upstream would only be possible past this weir in periods of high flow.</p> <p><i>Suitability for Bell's Turtle</i></p> <p>Habitat at the upstream end of this site, above the cascade is potentially suitable for Bell's turtles, but the weir pool is less suitable.</p> <p>There were a few small, isolated areas of sand on the banks, suitable for nesting.</p>

View upstream	Woody debris

View downstream	Typical bank

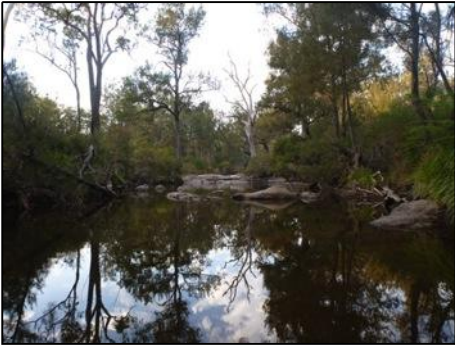
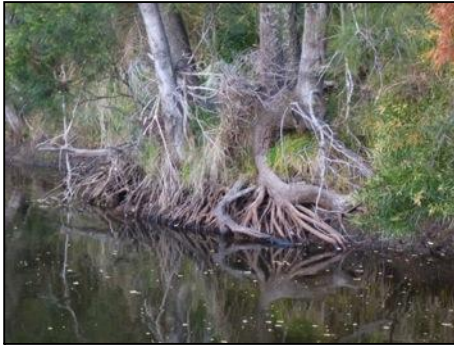
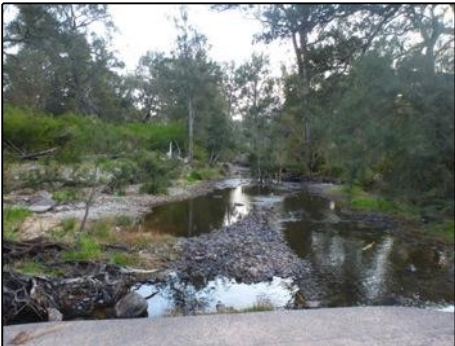
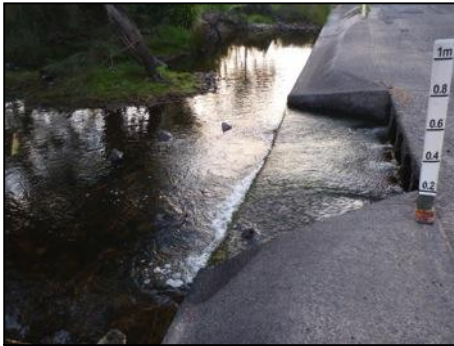
Site	Description	Photographs
Site Dii	<p><i>General Description</i></p> <p>Site comprised an irregular channel, with an average wetted width of 4 m and a bank full width of 15 m. The average water depth was 0.5 m. The banks were gently sloping to vertical and low (0.5 m). The banks were moderately stable.</p> <p>The riparian zone was ~5 m on the left bank and ~10 m on the right bank. Melaleuca and casuarina trees and shrubs dominated the riparian vegetation.</p> <p>In-stream habitat comprised shallow and deep pools, with runs and undercut banks. There was scattered large and small woody debris, and no in-stream aquatic vegetation. The bed substrate was dominated by boulders, cobble and pebble, with some bedrock, gravel, sand and silt / clay.</p> <p>A road crossing with a culvert was in the centre of this site.</p> <p><i>Fish Passage</i></p> <p>During periods of low flow fish passage at this site would be restricted by the road culvert and gravel bars. There is also a private weir approximately 700 m upstream of the reach surveyed that restricts fish passage in low to moderate / average flow.</p> <p><i>Suitability for Bell's Turtle</i></p> <p>Upstream of the road crossing is suitable for Bell's turtles, but downstream is shallow and likely to dry out in periods of low or no rain.</p> <p>No areas of potential nesting habitat were observed.</p>	<div data-bbox="1003 261 1456 608">

<p data-bbox="1003 639 1137 663">View upstream</p> </div> <div data-bbox="1532 261 1984 608">

<p data-bbox="1532 639 1704 663">Tree roots on bank</p> </div> <div data-bbox="1003 762 1456 1109">

<p data-bbox="1003 1141 1167 1165">View downstream</p> </div> <div data-bbox="1532 762 1984 1109">

<p data-bbox="1532 1141 1648 1165">Culvert at site</p> </div>

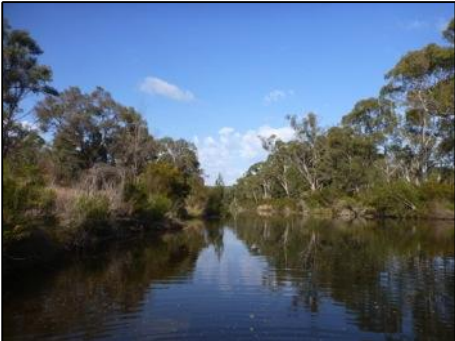
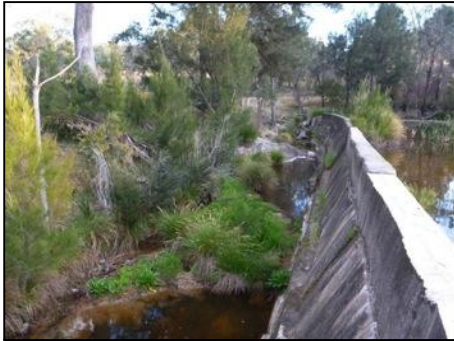
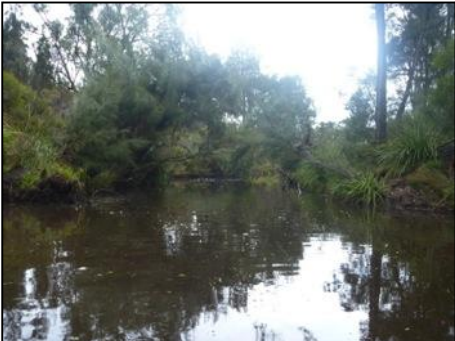
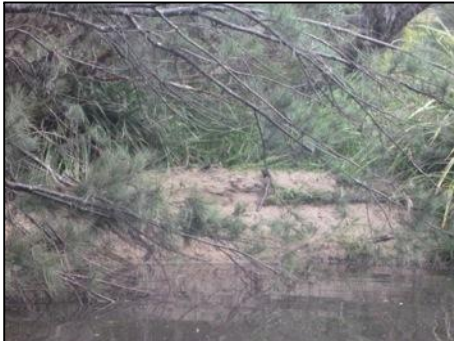
Site	Description	Photographs	
Site G	<p><i>General Description</i></p> <p>This site comprised a weir pool with an average width of 18 m and an average depth of more than 2 m. The banks were sloping to steep and an average height of 1 m. Both banks were stable.</p> <p>The riparian zone was approximately 3 m on the left bank and 10 m on the right bank. Eucalypt and casuarina trees and shrubs dominated the riparian vegetation, with some grasses.</p> <p>In-stream habitat was a deep pool with some woody debris and detritus. There were no in-stream aquatic plants. The bed substrate was dominated by bedrock, with some boulders, cobble, sand and silt / clay.</p>

<p><i>Fish Passage</i></p> <p>Fish passage at this site was restricted by a private weir. Fish movement past the weir would only be possible during periods of high flow.</p>

<p><i>Suitability for Bell's Turtle</i></p> <p>Habitat at this site is potentially suitable for Bell's turtles, but large woody debris was limited and there were no overhanging banks. There were shallow flowing areas less than 1 km upstream.</p> <p>There were some isolated areas of sand on the banks, suitable for nesting.</p>

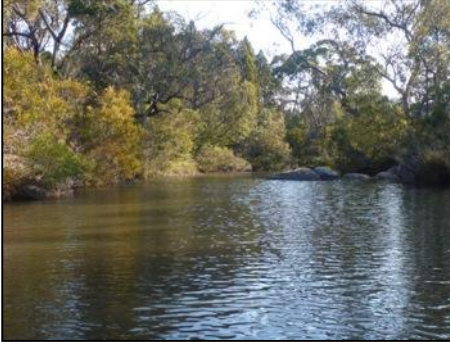
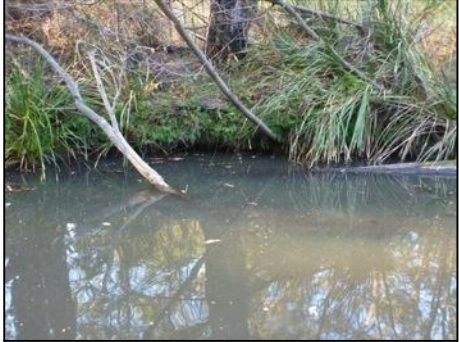
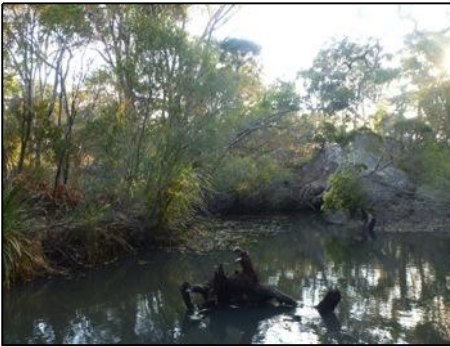
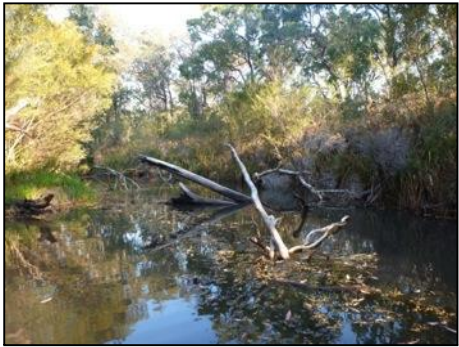
Site	Description	Photographs	
Reference Area			
<p>Site BRUS1</p>	<p><i>General Description</i> Site comprised a mildly sinuous channel, with an average width of 10 m and an average depth of 1.5 m. The channel was wide in the lower end of the reach and narrow at the upstream end. The banks were sloping to steep and low (0.3 to 0.5 m). Bank stability was high.</p> <p>The riparian zone was ~5 m wide on each bank. Eucalypt and casuarina trees dominated the riparian vegetation, with some shrubs. This site was in a national park, so riparian vegetation was largely undisturbed.</p> <p>In-stream habitat comprised deep pools with lots of large woody debris, large boulders, trailing bank vegetation and submerged aquatic plants (i.e. red milfoil). The bed substrate was dominated by sand, bedrock and boulders, with some cobbles.</p> <p><i>Fish Passage</i> This site was not assessed for fish, but there were no restrictions to fish passage. Fish passage downstream may be limited by Anderson's Weir (approximately 5 km downstream of the site).</p> <p><i>Suitability for Bell's Turtle</i> This site supports Bell's turtles.</p>

View downstream	Typical bank habitat

View upstream	Woody debris where turtle was basking
