Emu Swamp Supplementary Environmental Impact Statement –

Aquatic Ecology Assessment 2013

**Sinclair Knight Merz on behalf of Southern Downs
Regional Council**

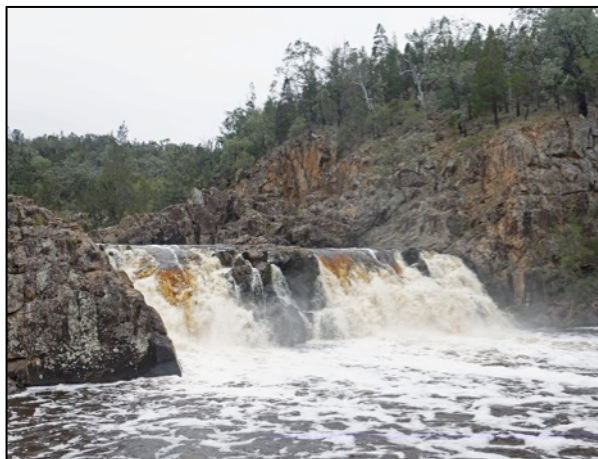
Figure 4.2

Nundubbermere Falls in high flow⁸

The downstream end of site K was also in the upstream extent of a weir pool. These weirs, along with other weirs identified throughout the area in the EIS, restrict fish passage in periods of low and moderate / average flow. That is, fish passage is currently restricted upstream of and within the proposed full supply level, and downstream of the proposed dam site, except in periods of high flow. Nundubbermere Falls, which is approximately 33 km downstream of the proposed dam site and approximately 2.5 m high, also represents a natural impediment to fish passage in the Severn River, particularly during low or moderate / average flow (Figure 4.2).

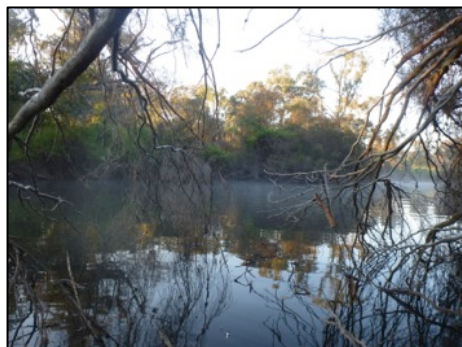
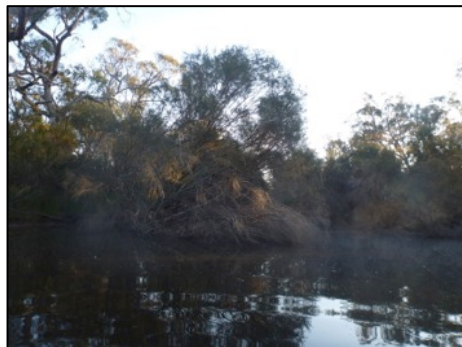
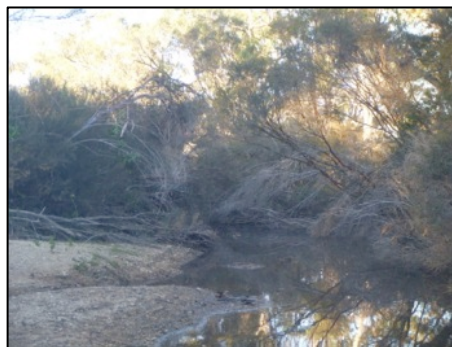
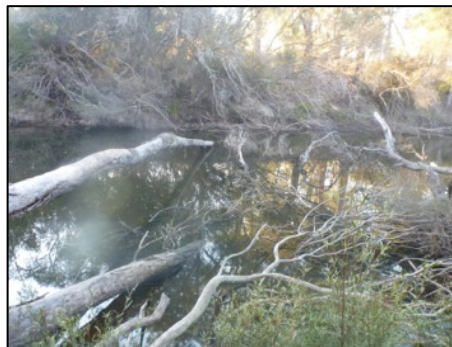
Site	Description	Photographs	
Upstream of the Proposed Dam Full Supply Level			
Site SRUS1	<p>General Description</p> <p>This site comprised a mildly sinuous and braided channel, with an average wetted width of 10 m and an average depth of 1.5 m.</p> <p>The right bank was sloping and low (0.2 m), and the left bank was steep to vertical and low (0.5 m). Both banks were stable. The riparian zone was ~3–5 m wide on each bank, with continuous vegetation dominated by casuarina and eucalypt trees and some shrubs. There was some shading of the river and trailing bank vegetation.</p> <p>In-stream habitat comprised shallow and deep pool, with scattered woody debris, detritus and tree roots. The bed substrate was dominated by sand, with some bedrock, gravel, boulders, cobbles and pebbles.</p> <p>Fish Passage</p> <p>There were no barriers to fish passage at this site.</p>

<p>View downstream</p>

<p>View upstream</p>

<p>View downstream of side channel</p>

<p>Large woody debris</p>

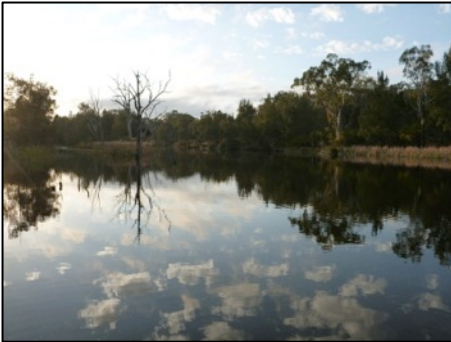
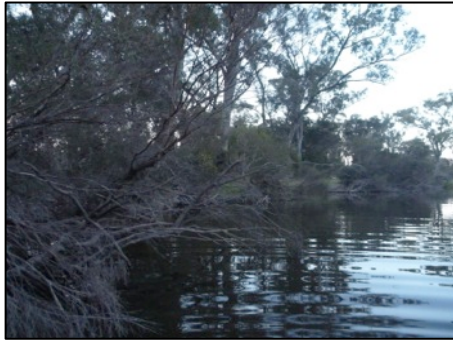
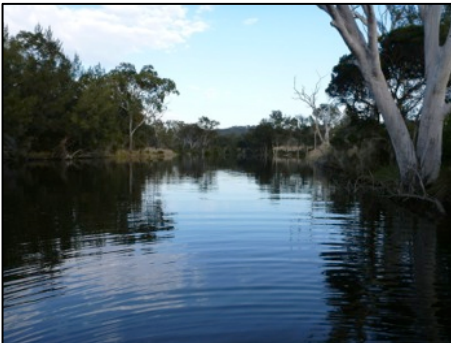
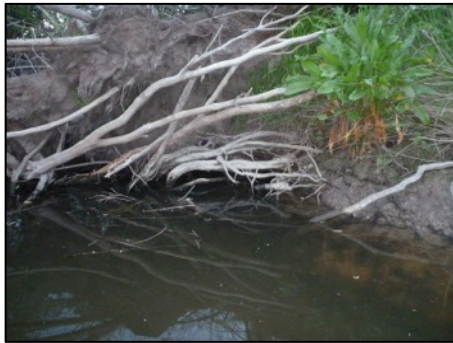
Site	Description	Photographs	
Site SRUS2	<p>General Description</p> <p>This site comprised a mildly sinuous channel, with an average wetted width of 10 m and an average depth of 1 m.</p> <p>The left bank was sloping and low (0.5 m), and the right bank was steep and concave (0.8 m). Both banks were moderately stable. The riparian zone was ~1 m wide on each bank, with vegetation dominated by trees and grasses with some shrubs. Riparian vegetation was regularly spaced or in occasional clumps. There was little overhanging vegetation shading the river.</p> <p>In-stream habitat comprised shallow pool, with large woody debris, some detritus and isolated trailing bank vegetation. The bed substrate was dominated by cobbles and sand, with some pebbles and silt / clay.</p>

<p>View upstream</p>

<p>View of downstream left bank</p>
	<p>Fish Passage</p> <p>There were no barriers to fish passage at this site.</p>

<p>View downstream</p>

<p>Tree roots overhanging into water</p>

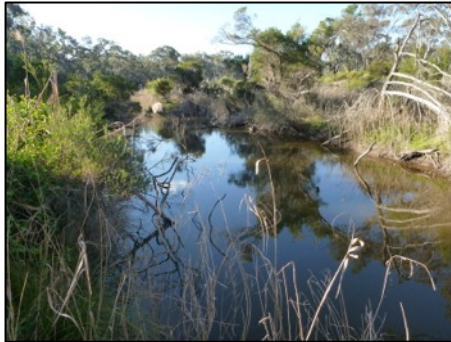
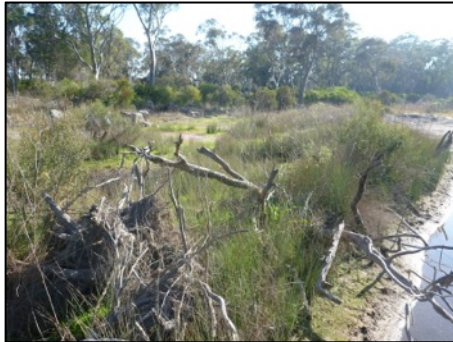
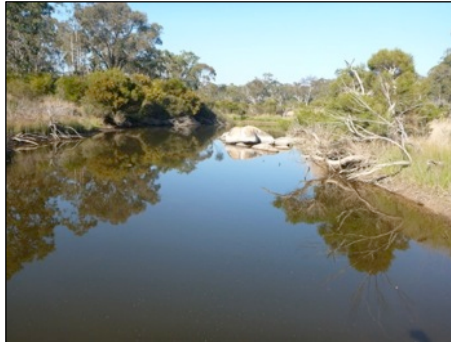
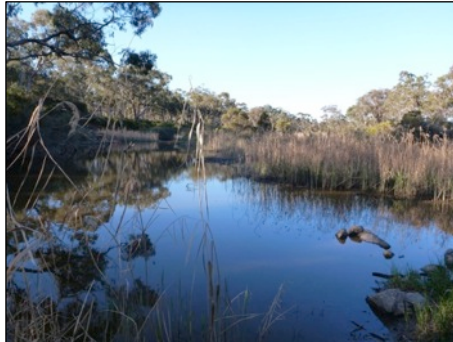
Site	Description	Photographs	
Site L	<p>General Description</p> <p>This site comprised a mildly sinuous channel, with an average wetted width of 10 m and an average depth of 0.4 m.</p> <p>The banks were sloping and low (0.5 m), and stable. The riparian zone was ~20 m wide on each bank, with vegetation dominated by melaleuca and eucalypt trees and grasses with some shrubs.</p> <p>In-stream habitat comprised shallow pool and runs, with isolated woody debris, some detritus and beds of emergent aquatic plants. The bed substrate was dominated by bedrock and sand, with some gravel, boulders and pebbles.</p> <p>Fish Passage</p> <p>Fish passage may be restricted at this site during periods of low flow due to sand deposits and bedrock constricting flow in some areas.</p>

<p>View upstream</p>

<p>View of upstream right bank.</p>

<p>View downstream</p>

<p>Extensive reeds in shallow water</p>

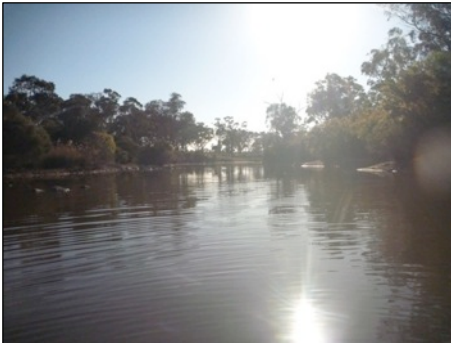
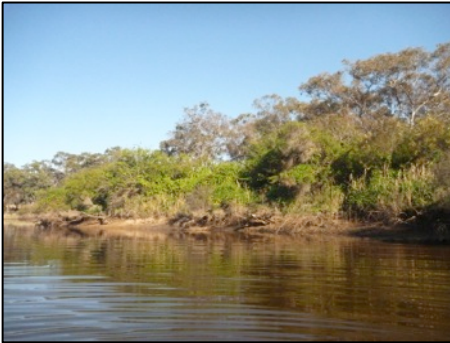
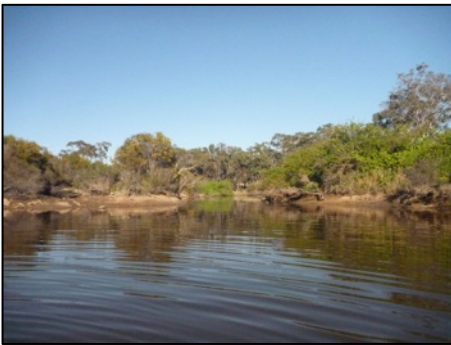
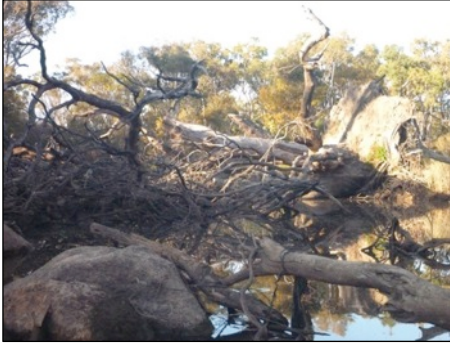
Site	Description	Photographs	
Site Fii	<p>General Description</p> <p>This site comprised a mildly sinuous channel, with an average wetted width of 6 m and a bank full width of ~25 m. The average depth was 1 m.</p> <p>The banks were sloping and low (0.5 m), and moderately stable. There was some minor bank erosion. The riparian zone was ~10 m wide on each bank, with vegetation dominated by shrubs and melaleuca and eucalypt trees.</p> <p>In-stream habitat comprised a shallow pool, with scattered woody debris, emergent plants, and detritus. The bed substrate was dominated by sand, with some bedrock, boulders, cobble and pebbles.</p> <p>Fish Passage</p> <p>Fish passage was unrestricted within the reach surveyed, but a private weir upstream of the reach would restrict passage except in high flow.</p>

<p>View upstream</p>

<p>View of downstream right bank</p>

<p>View downstream</p>

<p>Extensive woody debris</p>

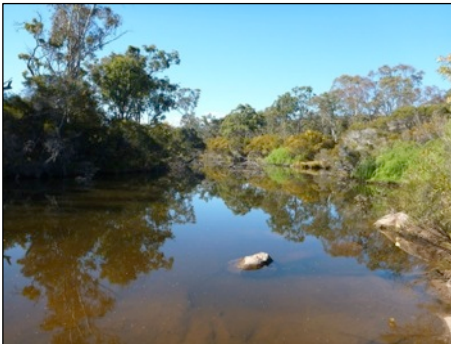
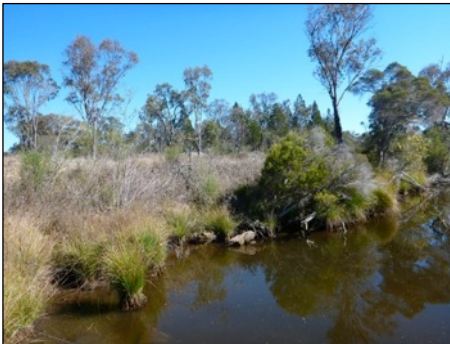
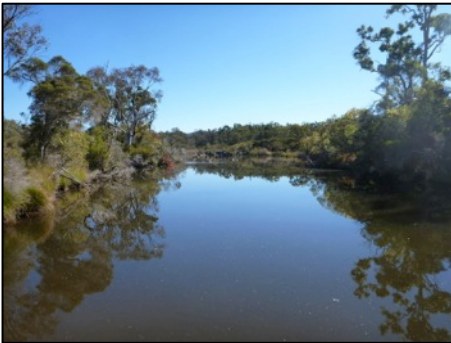
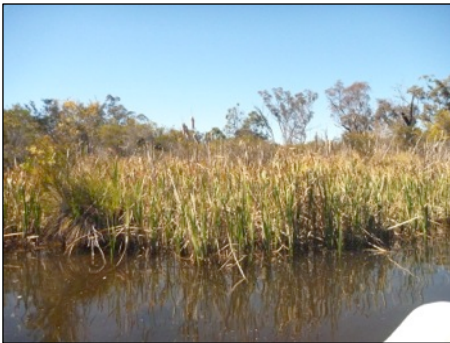
Site	Description	Photographs
Within the Proposed Dam Full Supply Level		
Site I	<p>General Description</p> <p>This site comprised a weir pool with an average width of 20 m and an average depth of approximately 2 m. The banks were sloping on the left bank and steep on the right bank vertical, with an average height of 0.5 to 0.8 m. Both banks were stable.</p> <p>The riparian zone was ~5 m on each bank, with vegetation dominated by eucalypt trees, shrubs and grass.</p> <p>In-stream habitat included large woody debris, overhanging vegetation, boulders, and isolated areas of submerged and emergent aquatic plants. The bed substrate was dominated by bedrock and boulders, with some sand and silt / clay.</p> <p>Fish Passage</p> <p>Fish passage within the reach surveyed was unrestricted, however there was a weir at the downstream end of the site that would restrict fish passage except during high flow events.</p>

<p>View upstream</p>

<p>View of downstream left bank</p>

<p>View downstream</p>

<p>Extensive <i>Typha orientalis</i> in channel</p>

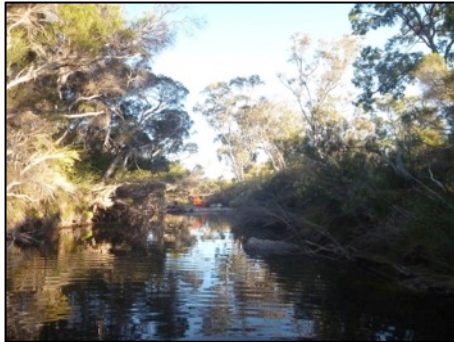
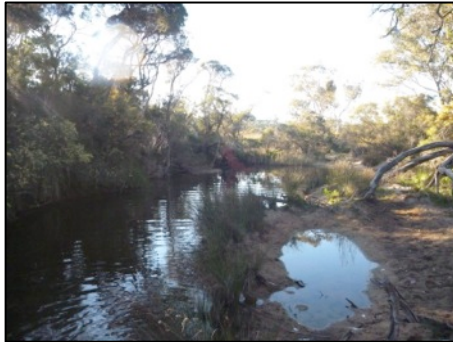
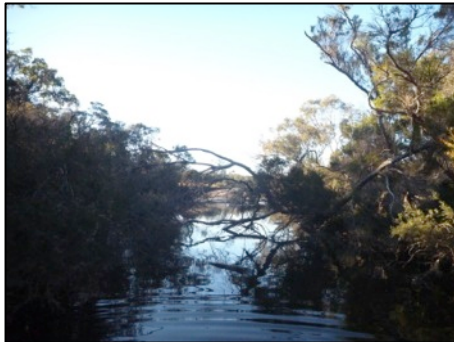
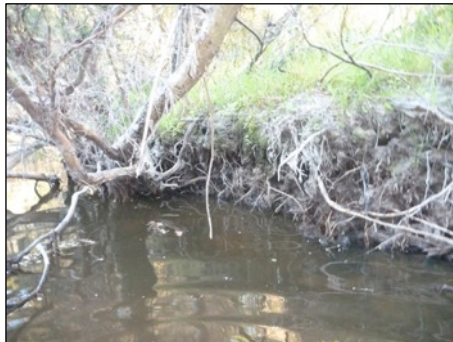
Site	Description	Photographs	
Site J	<p>General Description</p> <p>This site comprised a mildly sinuous channel with an average width of 5 m and an average depth of 1 m. The average bank full width was 20 m. The banks were sloping, low (0.5 m), and stable.</p> <p>The riparian zone was ~10 m wide on each bank. Melaleuca trees dominated riparian vegetation, with some shrubs and grasses.</p> <p>In-stream habitat included shallow and deep pools and shallow runs, with extensive woody debris, detritus, undercut banks and overhanging vegetation. The bed substrate was varied, with some bedrock, boulder, cobble, sand and silt / clay.</p>

View downstream	View upstream in side channel
	<p>Fish Passage</p> <p>Fish passage at this site was restricted by a private weir upstream. In low to moderate flow fish would not be able to pass the weir. Fish passage would be possible during high flow events.</p>

View upstream	Scoured bank and woody debris

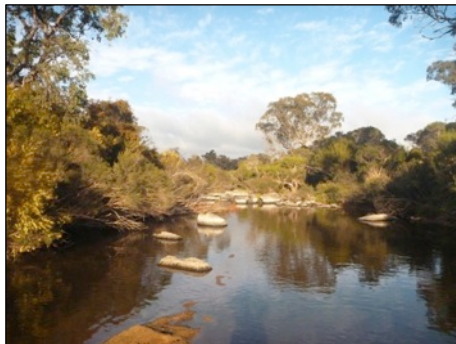
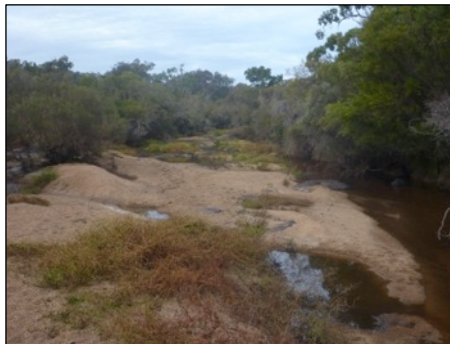
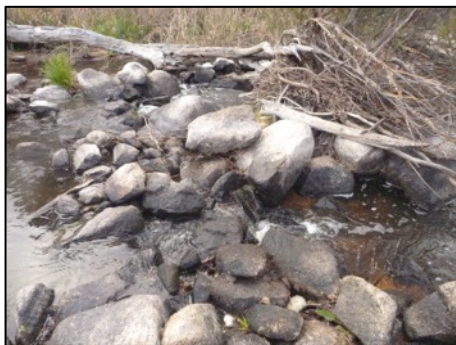
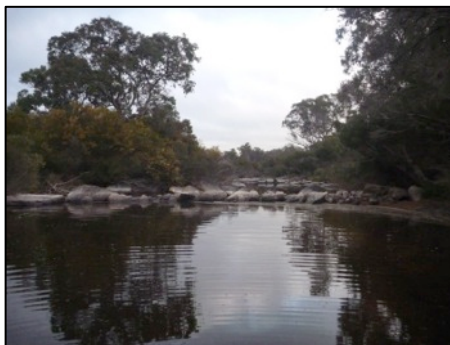
Site	Description	Photographs	
Site E	General Description <p>Site comprised an irregular channel, with an average width of 3 m and a maximum width of 10 m. A man made rock wall formed a pool in the middle of the site. The banks were sloping and low (0.5m). The banks were moderately stable.</p> <p>The riparian zone was ~5m wide on each bank. Melaleuca and eucalypt trees and shrubs dominated the riparian vegetation, with some grasses also abundant.</p> <p>In-stream habitat comprised shallow pools, runs and riffles, with sand bars. There was some detritus and little woody debris. There were isolated patches of emergent aquatic plants in-stream. The bed substrate was dominated by sand, with some bedrock and boulder.</p> <p>Overall disturbance was low.</p>

View downstream	View downstream from upper end of reach
	Fish Passage <p>A man-made rock wall at this site would restrict fish passage for all fish during periods of low flow, and for large fish in periods of moderate / average flow. There would be no restrictions to fish passage during periods of high flow.</p>

Small riffle at downstream end of reach	Man-made rock wall at site

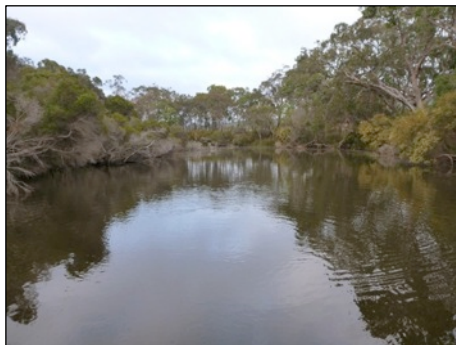
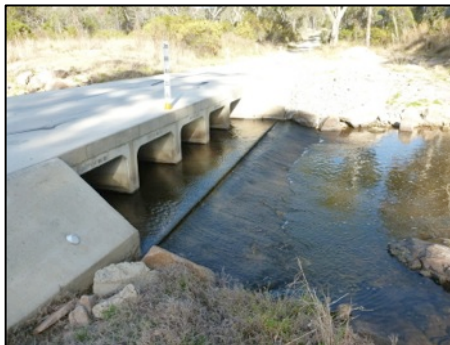
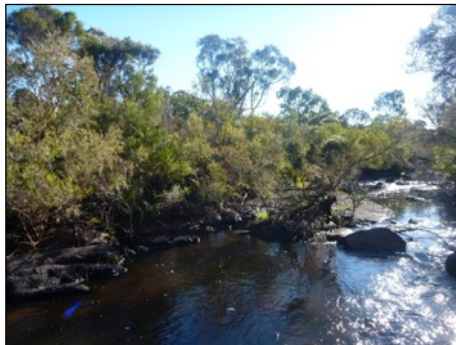
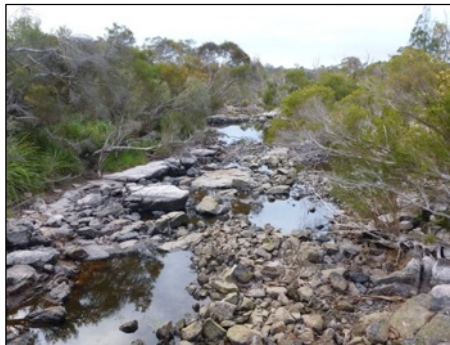
Site	Description	Photographs	
Downstream of the Proposed Dam			
Site K	<p>General Description</p> <p>This site comprised an irregular channel with an average width of 15 m and an average depth of 1 m. There was a road crossing through the middle of this site and a weir at the downstream end. The banks were sloping to vertical, and low (0.5 m). Banks were undercut, but stable. The riparian zone was ~30 m wide on the left bank and ~20 m wide on the right bank. Melaleuca and eucalypt trees dominated riparian vegetation, with some shrubs and grasses.</p> <p>In-stream habitat included shallow and deep pools, runs and riffles, with some woody debris, detritus, undercut banks and overhanging vegetation. The bed substrate was dominated by bedrock and sand, with some boulders, cobble, pebble, gravel and silt / clay.</p> <p>Fish Passage</p> <p>During periods of low flow fish passage at this site would be restricted by the culvert at the road crossing and bars in the channel. A private weir also restricts fish passage at the downstream end of this site in low to moderate / average flow.</p>

View downstream in September	Culvert in middle of site

View upstream in May	View upstream in September

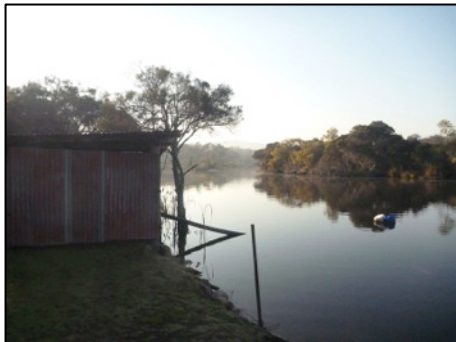
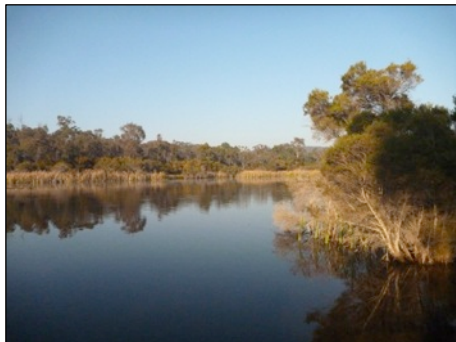
Site	Description	Photographs	
Site C	General Description

<p>This site comprised a large weir pool with an average width of 25 m and an average depth of more than 2 m.</p> <p>The banks were gently sloping, low (0.5 m high), and stable. The riparian zone was ~20 m on each bank, with vegetation dominated by eucalypt and callistemon trees, with shrubs and grasses.</p> <p>In-stream habitat consisted of a deep pool with isolated woody debris, scattered detritus and beds of submerged plants. Reeds lined the banks in many areas. The bed substrate was dominated by bedrock and boulders, with some gravel, sand and silt / clay.</p>	View downstream	Weir at downstream end of reach
	Fish Passage

<p>Fish passage was unrestricted through the reach surveyed, but limited by a weir at the downstream end of the site. Fish passage is only possible at this site in high flow.</p>	View upstream	Downstream of weir

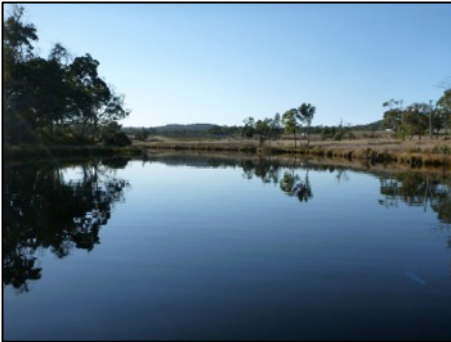
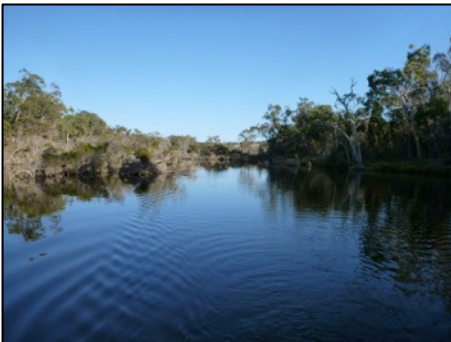
Site	Description	Photographs	
Site A	<p>General Description</p> <p>This site comprised a weir pool with an average width of 43 m, and a bank full width of approximately 70 m. The average depth was approximately 1 m. The banks were gently sloping, low (<1 m), and stable.</p> <p>The riparian zone was ~5 m on the left bank and ~10 m on the right bank. Grasses and discontinuous eucalypts and melaleucas dominated the riparian vegetation. There were areas of cleared on both banks for grazing and cropping.</p> <p>In-stream habitat consisted of a pool with no visible flow, large beds of ribbonweed and scattered woody debris. The bottom substrate was dominated by bedrock, gravel and silt / clay, with some boulder, sand, cobbles and pebbles.</p>

View upstream	Weir at downstream end of reach
	<p>Fish Passage</p> <p>Fish passage at this site was restricted by a weir at the downstream end of the reach surveyed. Passage would only be possible past this weir in periods of high flow.</p>

View downstream	Extensive reeds and grasses along bank

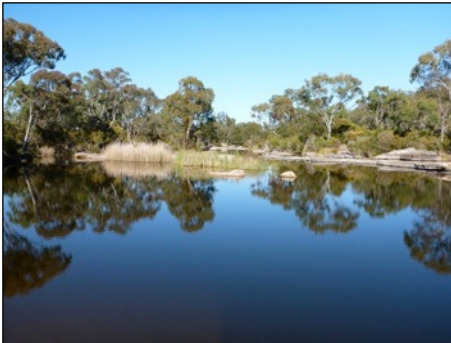
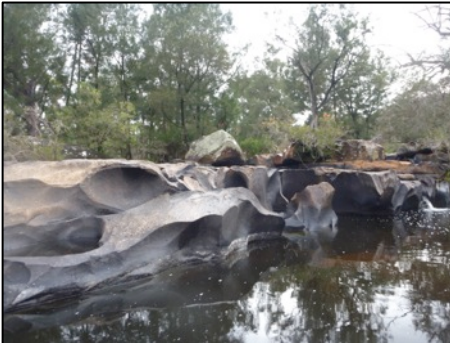
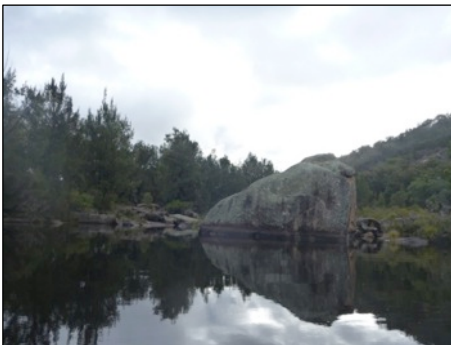
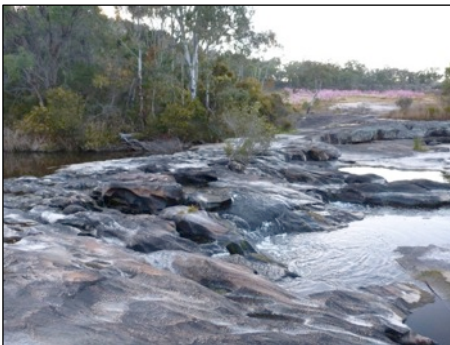
Site	Description	Photographs	
Site B	<p>General Description</p> <p>This site comprised a wide irregular channel, with an average wetted width of 30 m (minimum 3 m and maximum 57 m). The average depth was approximately 1.2 m. The banks were low (0.5 m) and gently sloping to steep. The banks were stable, with no undercut areas.</p> <p>The riparian zone was ~15 m wide on each bank. Melaleuca, eucalypt and callistemon trees dominated the riparian vegetation, with some shrubs and grasses.</p> <p>In-stream habitat included shallow and deep pools with areas of shallow runs and cascades. There was abundant detritus, some algal growth, isolated woody debris and no submerged vegetation. The bed substrate was dominated by bedrock and boulders, with some finer sediments.</p>

View downstream	Bedrock shelf restricting flow
	<p>Fish Passage</p> <p>Upstream fish movement at this site may be restricted for some fish due to a bedrock shelf with a drop of approximately 0.8 m. Extensive bedrock through the site would restrict fish movement upstream and downstream during periods of low flow.</p>

View upstream	Extensive bedrock at site

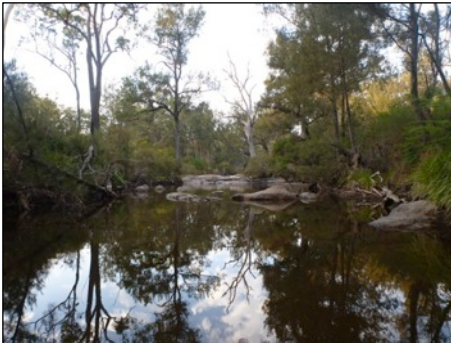
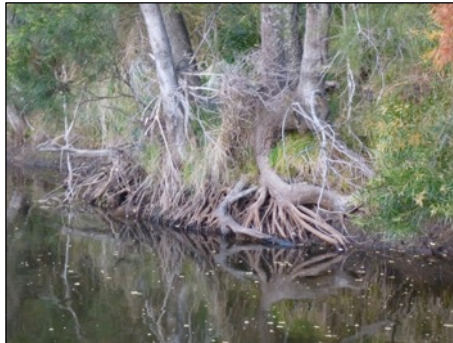
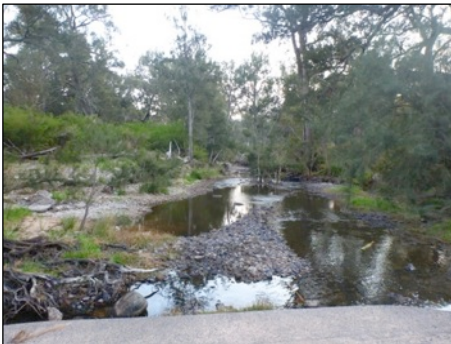
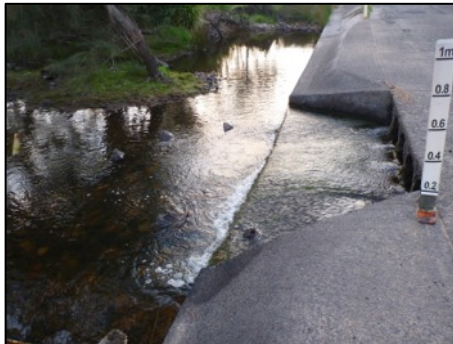
Site	Description	Photographs
Site Dii	<p>General Description</p> <p>Site comprised a irregular channel, with an average wetted width of 4 m and a bank full width of 15 m. The average water depth was 0.5 m. The banks were gently sloping to vertical and low (0.5 m). The banks were moderately stable.</p> <p>The riparian zone was ~5 m on the left bank and ~10 m on the right bank. Melaleuca and casuarina trees and shrubs dominated the riparian vegetation.</p> <p>In-stream habitat comprised shallow and deep pools, with runs and undercut banks. There was scattered large and small woody debris, and no in-stream aquatic vegetation. The bed substrate was dominated by boulders, cobble and pebble, with some bedrock, gravel, sand and silt / clay.</p> <p>A road crossing with a culvert was in the centre of this site.</p> <p>Fish Passage</p> <p>During periods of low flow fish passage at this site would be restricted by the road culvert and gravel bars. There is also a private weir approximately 700 m upstream of the reach surveyed that restricts fish passage in low to moderate / average flow.</p>

<p>View upstream</p>

<p>Tree roots on bank</p>

<p>View downstream</p>

<p>Culvert at site</p>

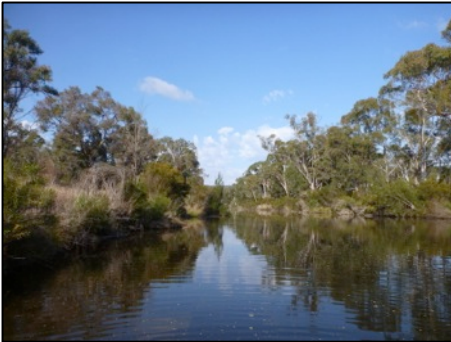
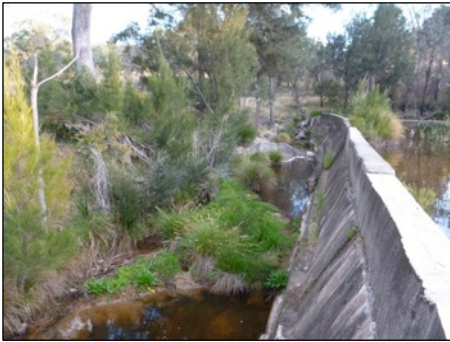
View downstream	Weir at downstream end of reach
	<p>Fish Passage</p> <p>Fish passage at this site was restricted by a private weir. Fish movement past the weir would only be possible during periods of high flow.</p>

Site	Description	Photographs	
Site G	<p>General Description</p> <p>This site comprised a weir pool with an average width of 18 m and an average depth of more than 2 m. The banks were sloping to steep and an average height of 1 m. Both banks were stable.</p> <p>The riparian zone was approximately 3 m on the left bank and 10 m on the right bank. Eucalypt and casuarina trees and shrubs dominated the riparian vegetation, with some grasses.</p> <p>In-stream habitat was a deep pool with some woody debris and detritus. There were no in-stream aquatic plants. The bed substrate was dominated by bedrock, with some boulders, cobble, sand and silt / clay.</p>

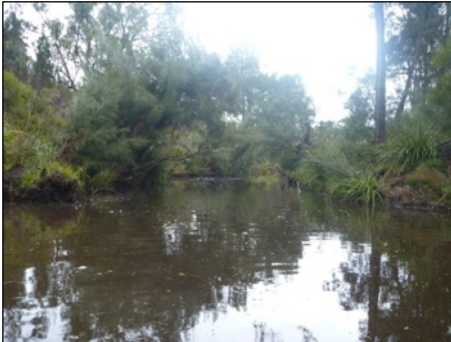
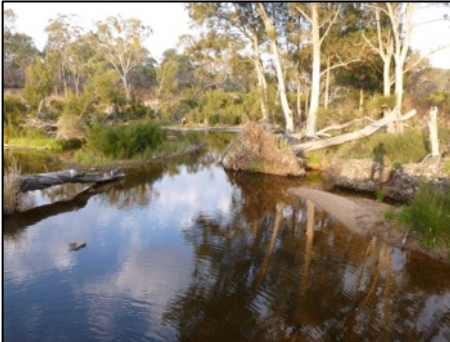
View upstream	Woody debris downstream of weir

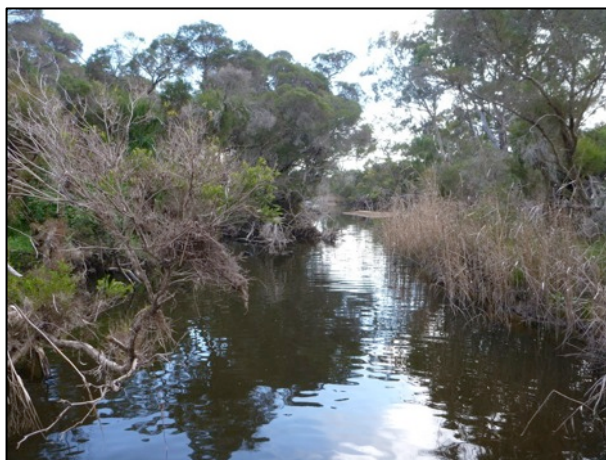
Figure 5.1

Common reed at site K

- common reed (Figure 5.1)
- common rush (Figure 5.2), and
- broad leaved cumbungi (Figure 5.3).

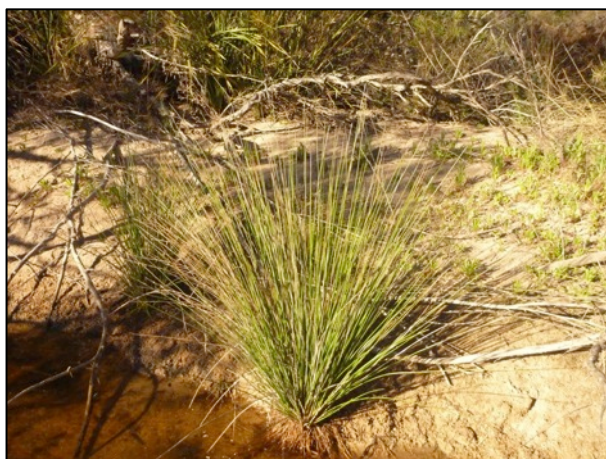
Figure 5.2

Common rush at site J

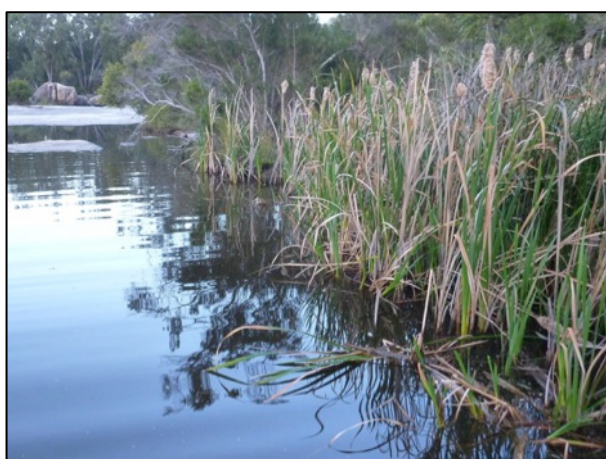
Figure 5.3

Broad leaved cumbungi at site B

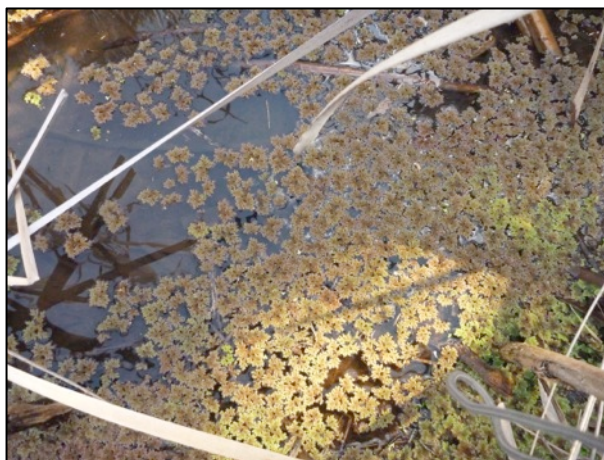
Figure 5.4

Red azolla at site C

There was one floating species, red azolla, at site C (Figure 5.4), and two submerged species:

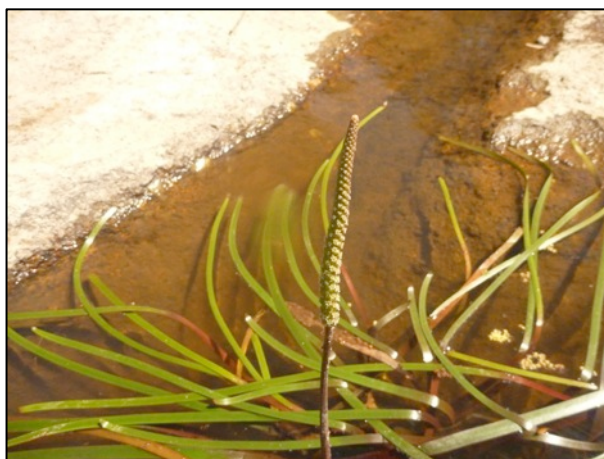
Figure 5.5

Ribbonweed at site B

- ribbonweed, at sites L, C, A, B and G (Figure 5.6), and
- water milfoil, at site L.

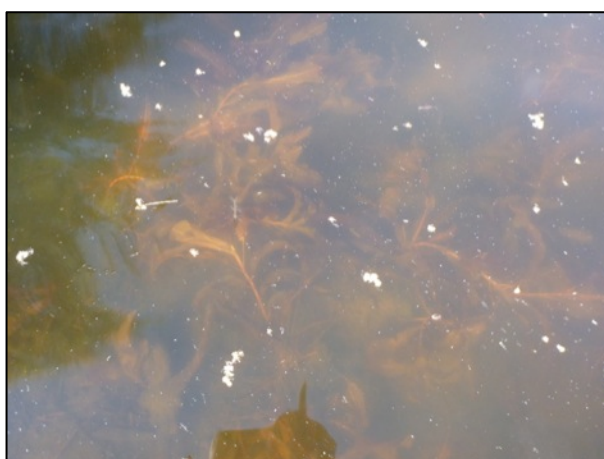
Figure 5.6

Water milfoil at site G

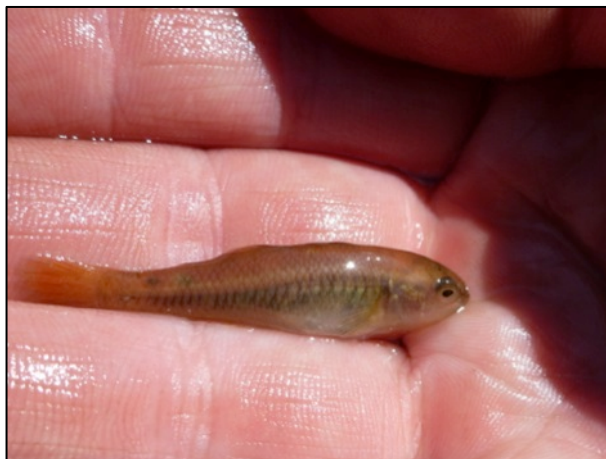
Figure 6.1

Carp gudgeon at site A

A total of five species of fish were caught in the survey: three native species and two exotic species (Table 6.1). No species listed under the EPBC Act or NCWR were caught. Carp gudgeons were the most widespread and abundant fish species during the survey (Figure 6.1). Mosquitofish, which are a noxious pest, were also abundant at site J, within the proposed dam full supply level.
