Emu Swamp Supplementary Environmental Impact Statement –

Turtle Survey 2013

**Sinclair Knight Merz on behalf of Southern Downs
Regional Council**

frc reference: 130402

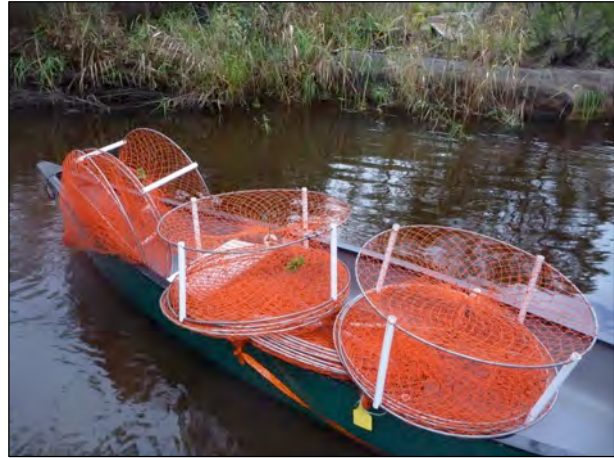
Figure 3.1

Turtle traps ready to be set from the canoe.

Turtle surveys were conducted as per the recommendations in the 2011 Survey Guidelines for Australia's Threatened Reptiles for Bell's turtles (SEWPAC 2011), where possible. Explanations for any deviations from the Survey Guidelines are provided in Table 3.4. At each site, five custom-made turtle traps (cathedral traps designed to replicate the traps used by EHP's turtle group, and that allow turtles to surface and breathe) were baited with meat (heart) and set at each site for between six and ten hours.

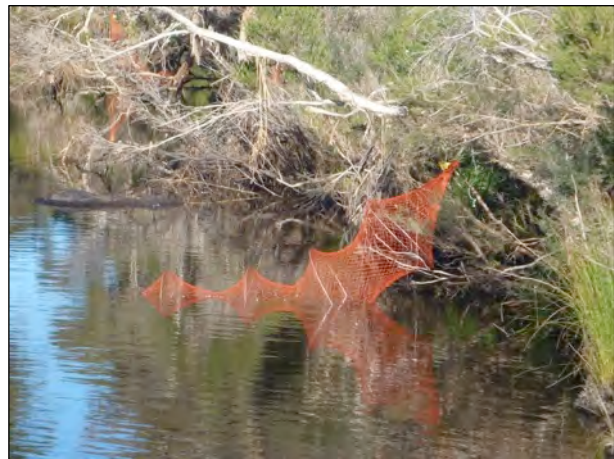
Figure 3.2

Turtle trap set at site K.

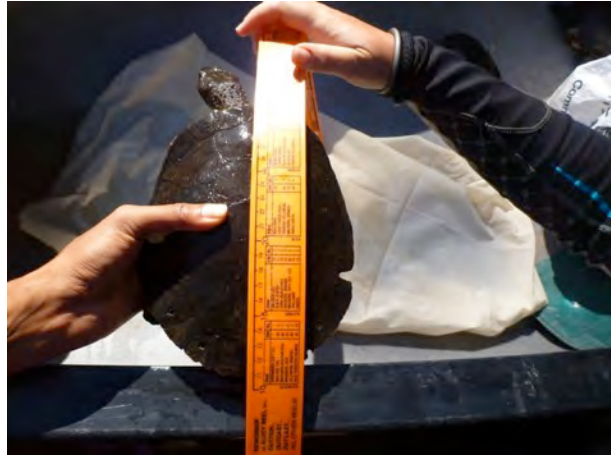
Figure 4.2

Bell's turtle being measured.

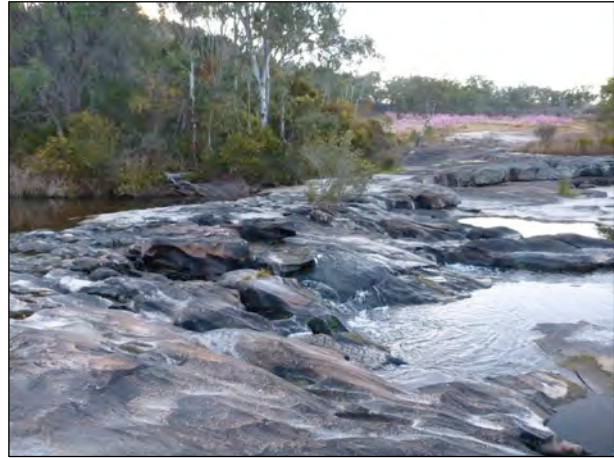
Figure 4.6

Substantial bedrock at site B.

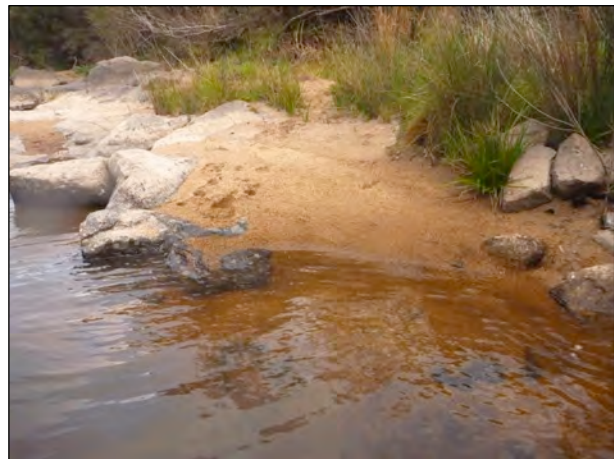
Figure 4.7

Sand bank suitable for nesting at site E.

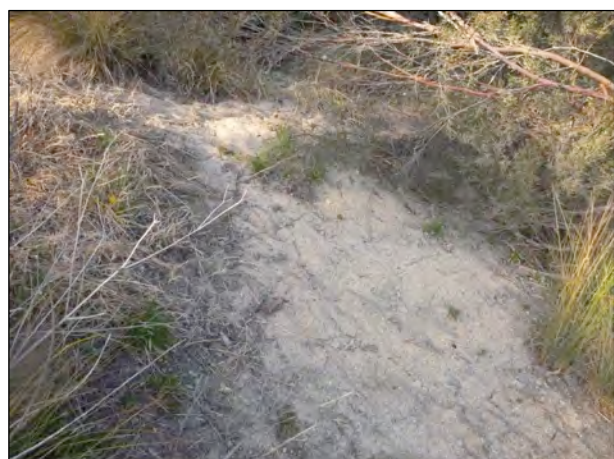
Figure 4.8

Small area of suitable nesting habitat at site Fii.

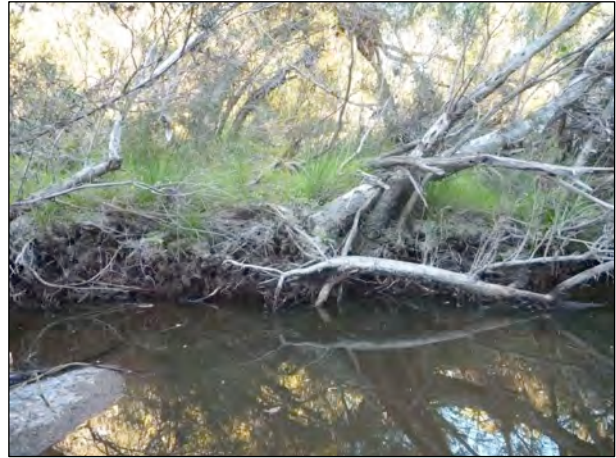
Figure 4.9

Woody debris and overhanging bank at site J.

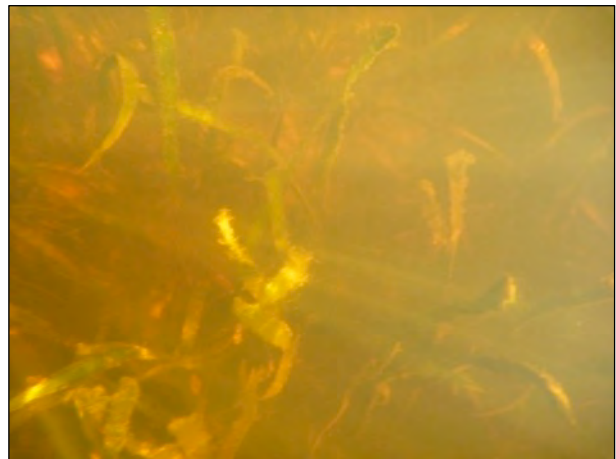
Figure 4.10

Submerged ribbonweed at site A.
