Gateway Upgrade Project

17. Aquatic Biology

17.1 Introduction

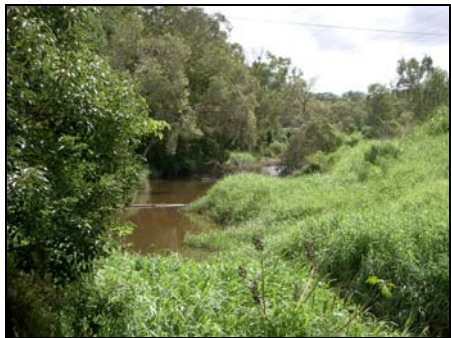
Location	Description	Photograph
Mt Gravatt-Capalaba Road to Cleveland Branch Rail Line		
Bulimba Creek 1 Bulimba Creek adjacent to the Gateway Motorway and Mt Gravatt – Capalaba Rd, Mackenzie. (west of Motorway at CH5300)	Bulimba Creek here is freshwater, with abundant instream macrophytes (<i>Potamogeton pectinatus</i>), relatively deep pools and riffles. The channel varies between approx. 1 and 10m wide and 1.5m deep. Sediments are coarse sand and gravel. The waterline is densely fringed with smartweed (<i>Persicaria attenuata</i>). The upper eastern bank is highly degraded, and lined with dense para grass (<i>Urochloa mutica</i>), the western bank is composed of remnant rainforest and sclerophyll trees.

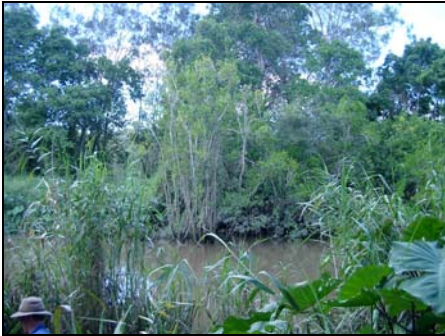
Location	Description	Photograph
<p>Bulimba Creek 2</p> <p>Bulimba Creek upstream of Minnippi Parklands, Belmont (west of Motorway at CH11900)</p>	<p>Bulimba Creek here is mildly brackish and tidally influenced, becoming fresher in summer months. The channel is approx. 9m in width, and up to approx. 3m in depth. Sediments are fine silts. There is some weed invasion of the banks by species such as lantana (<i>Lantana camara</i>) and camphor laurel (<i>Camphora cinnamomum</i>). The riparian zone includes mangroves, including the milky mangrove (<i>Excoecaria agallocha</i>); and blue taro (<i>Xanthosoma violaceum</i>).</p>

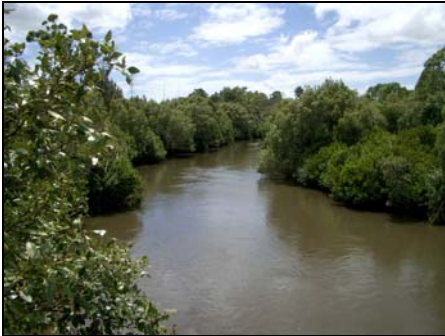
<p>Bulimba Creek 3</p> <p>Bulimba Creek at the Gateway Motorway, Murarie (10m downstream of Motorway at CH14800)</p>	<p>At the Gateway Motorway, Bulimba Creek is strongly estuarine, but dominated by freshwater after heavy rainfall. The channel is approx. 10m wide, and up to 3.5m deep. Sediments are fine silts. The banks are relatively stable, with invasion of some weeds such as broadleaf pepper tree (<i>Schinus terebinthifolius</i>). The banks are dominated by the grey mangrove (<i>Avicennia marina</i>).</p>

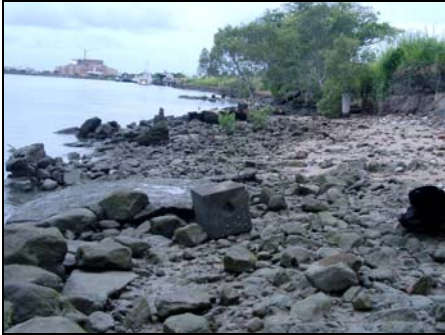
<p>Cleveland Branch Rail Line to Pinkenba Rail Line</p>		
<p>Brisbane River</p> <p>Brisbane River at the Gateway Bridge, Eagle Farm</p>	<p>The Brisbane River's banks are highly degraded, in some places with severe erosion. The southern bank consists of rock and rubble, the northern bank fine silty sands and some rocks. There are some scattered grey mangroves in the vicinity of the alignment.</p>

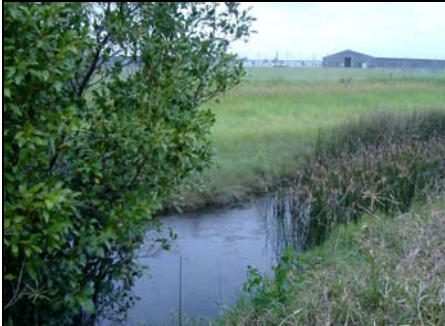
<p>Pinkenba Rail Line to Nudgee Road</p>		
<p>Lomandra Drive</p> <p>Drainage system adjacent to Lomandra Drive, Brisbane Airport (100m east of proposed deviation Motorway at approximate CH19550)</p>	<p>There are a number of small drainage channels in the vicinity of Lomandra Drive that may be affected. These drains are typically narrow (up to 2m wide and 1m deep) and lined with mangroves. Some of the drainage channels have freshwater sections, lined with bulrush (<i>Typha</i> spp.), common reed (<i>Phragmites australis</i>) and sedges.</p>

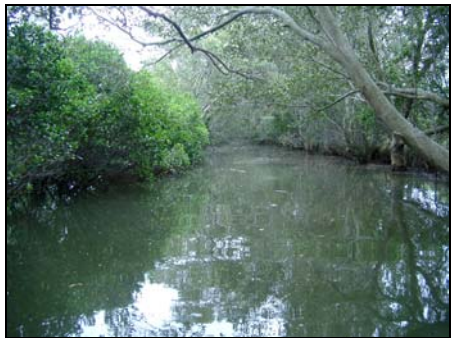
Location	Description	Photograph
<p>The Brisbane Airport</p> <p>The wetlands of the Brisbane Airport precinct, including Schultz Canal (CH21500 to 22950)</p>	<p>The wetlands of the Brisbane Airport are dominated by grey and river mangroves (<i>Aegiceras corniculatum</i>), and often grow in association with marine couch (<i>Sporobolus virginicus</i>) and sea blite (<i>Suaeda australis</i>). Many of the wetlands are highly degraded due to low tidal flushing.</p>

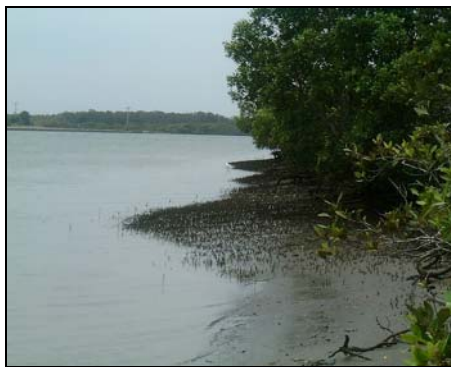
<p>Kedron Brook Floodway and Tributaries</p>	<p>At the Gateway Upgrade alignment the Kedron Brook Floodway is approximately 30m wide, and 4m deep. Sediments are sandy silts. Grey mangrove dominates the riparian fringes of the Floodway, river mangrove grow lower on the bank. There are also occasional red mangrove (<i>Rhizophora stylosa</i>). Saltmarsh plants such as sea blite grow in the understorey marine couch grows on the upper bank, above the erosion scarp (which is up to 1.5m in height).</p>

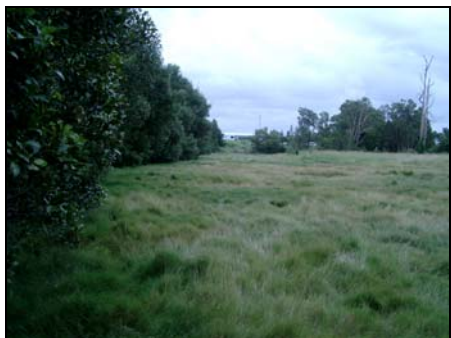
<p>Kedron Brook Wetlands</p> <p>Wetlands to the west of Kedron Brook Floodway and east of the Gateway Motorway.</p>	<p>The wetlands here are a matrix of saltmarsh dominated by marine couch sea blight and sea purslane (<i>Sesuvium portulacastrum</i>), small mangrove-lined channels, brackish sedgeland and stands of paperbark (<i>Melaleuca quinquenervia</i>) and swamp oak (<i>Casuarina glauca</i>).</p>

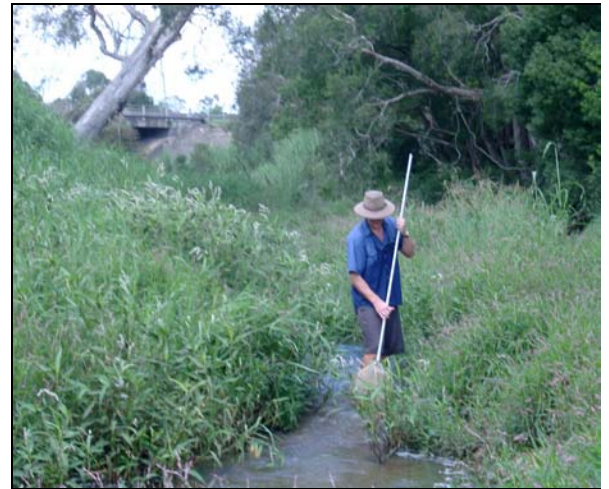
Photo 17.1

Dense *Persicaria* grows along the waters' edge at Bulimba Creek 1, at Mackenzie

In places at Bulimba Creek 1 the banks are highly eroded, and contain a high proportion of invasive weed species. The eastern bank in particular is highly degraded and covered with para grass (*Urochloa mutica*). The western bank supports remnant rainforest vegetation. Within the streambed, smartweed (*Persicaria attenuata*) forms a dense shrubbery (refer Photo 17.1).

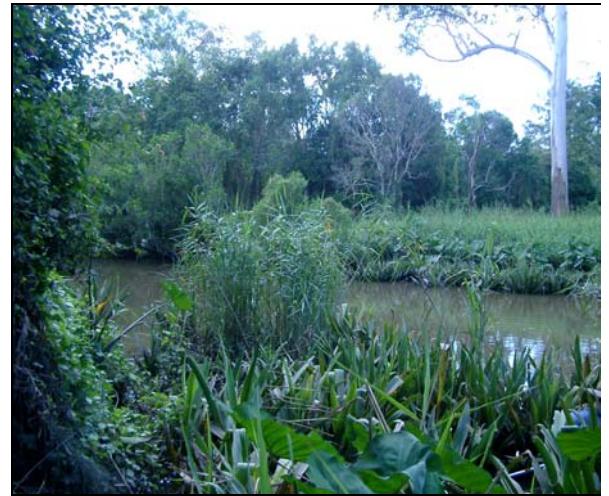
Photo 17.2

Mangrove lilies and blue taro grow along the low water mark of Bulimba Creek at Belmont

Mangrove lilies (*Crinum pedunculatum*), common reed (*Phragmites australis*) and blue taro (*Xanthosoma violaceum*) line the low water mark (refer Photo 17.2). Mangrove fern (*Acrostichum speciosum*) grows in sheltered backwaters. Weed species encroach on the banks where mangroves are absent. Flow at this site is moderately fast, and mildly tidal (tidal waters extend approximately 4km upstream).

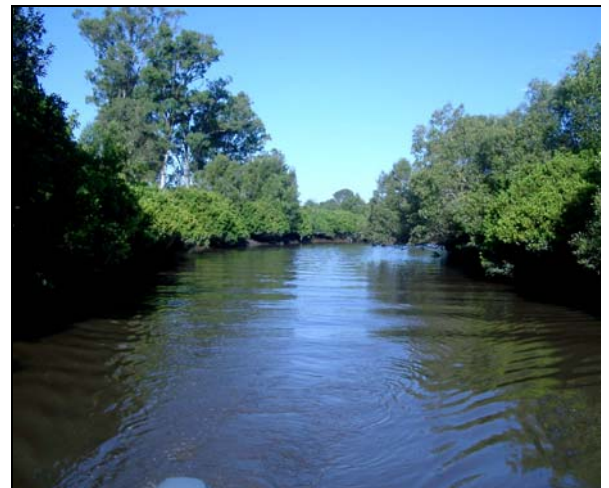
The banks of Bulimba Creek at Murarrie are fringed by dense grey and river mangrove

Mangrove communities in Bulimba Creek at the Gateway Motorway crossing (Bulimba Creek 3), are dominated by grey (*Avicennia marina*) and river (*Aegiceras corniculatum*) mangrove (refer Photo 17.3 and 17.4). Along the creek grey mangroves reach approximately 7m in height, whilst river mangroves are commonly 4m in height. Mangrove lilies grow in some areas. Mangroves are the only form of marine plants present at Bulimba Creek crossing at Murarrie (refer Photo 17.4). A number of terrestrial weed species encroach on the upper bank, such as Easter Cassia (*Senna pendula* var. *glabrata*) and broad-leaf pepper tree (*Schinus terebinthifolius*). Flow at this site is strongly tidal and at the time of sampling, highly affected by freshwater inflow.

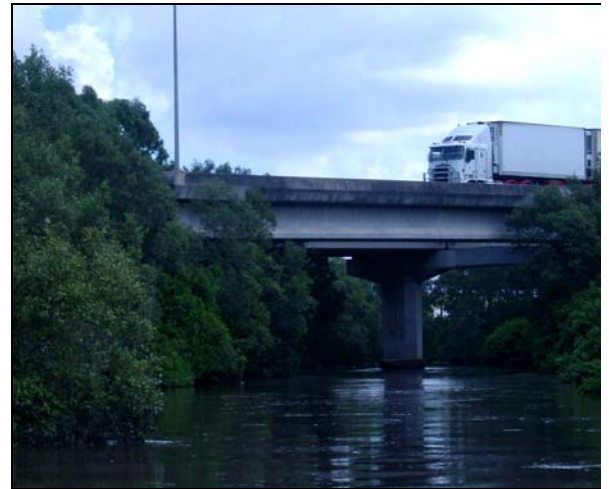
Photo 17.4

The Gateway Motorway crossing of
Bulimba Creek at Murarrie

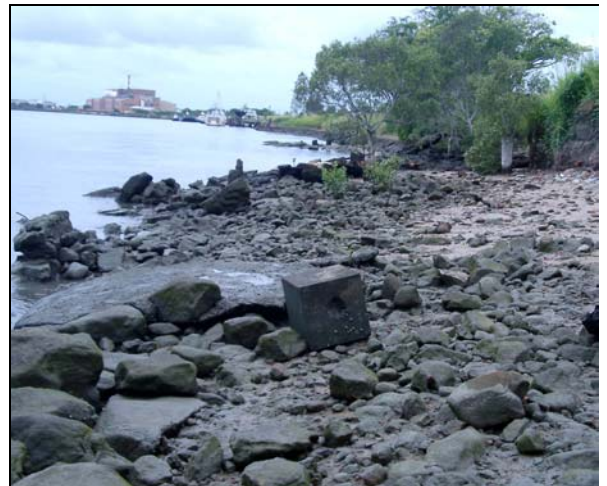
Photo 17.5

The southern bank of the Brisbane River near the Gateway Bridge

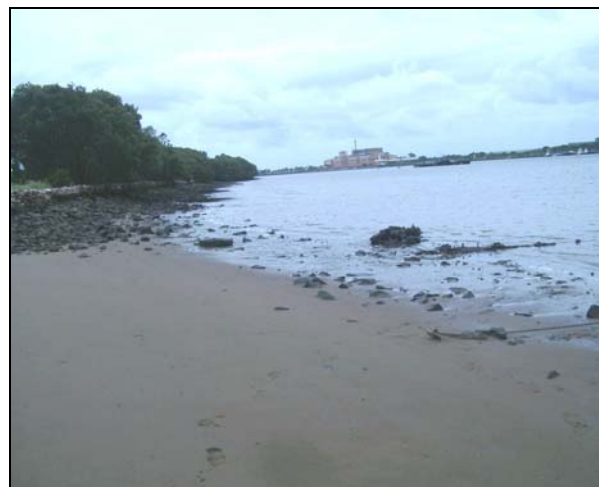
Photo 17.6

The northern bank of the Brisbane River near the Gateway Bridge

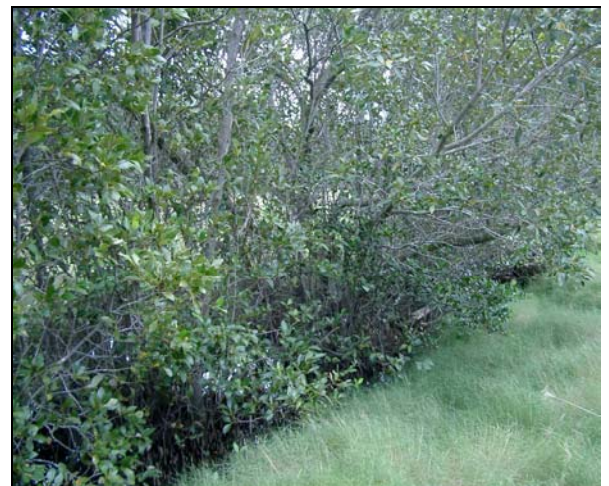
Photo 17.7

The alignment skirts a narrow mangrove channel and associated marine couch meadows in the southern part of the Brisbane Airport

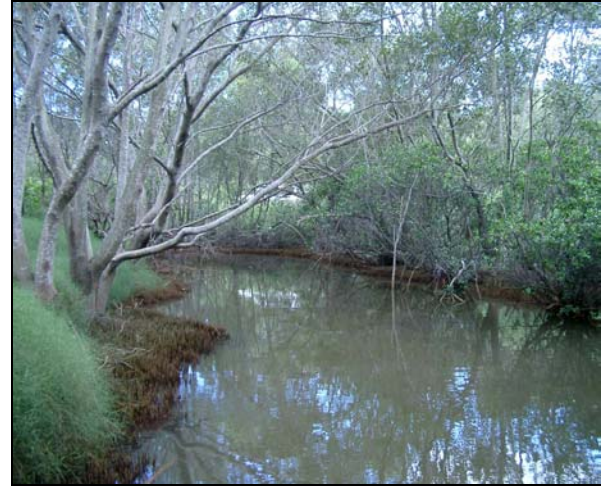
Photo 17.8

Schultz Canal is approximately 5m wide at the alignment

Further north, the alignment transects Schultz Canal. At this point the canal is approximately 5m wide, and lined with grey mangroves up to 7m. Lower on the bank there are river mangroves (*Aegiceras corniculatum*) to 3m (refer Photo 17.8). Schulz Canal is relatively well flushed in the downstream sections, however upstream of the proposed alignment, a service road without culverts crosses the road and blocks water passage.

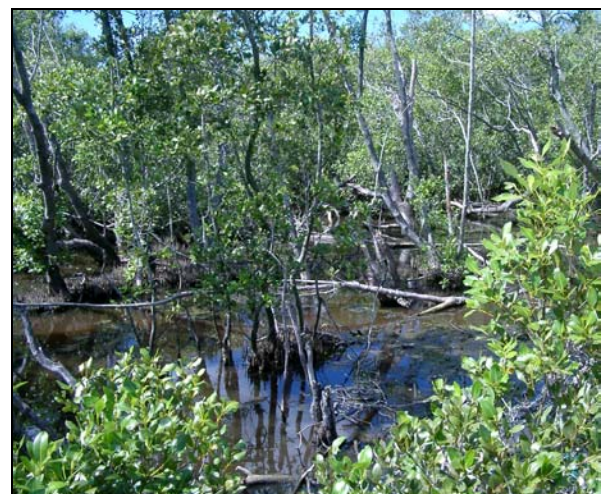
Photo 17.9

There are poorly flushed grey mangrove wetlands between Schultz Canal and Kedron Brook Floodway

The mangrove wetlands of the airport precinct near Kedron Brook Floodway are commonly shallow (less than 0.5m), and poorly flushed (refer Figure 17.5 and Photo 17.9). Sediments are dark and anoxic. In some areas, ponded water and anoxic sediments have seemingly caused mangrove dieback. Grey mangroves are the dominant species, although occasional milky and river mangroves grow within these wetlands. Mangrove stands are typically bordered by marine couch, although the other saltmarsh species recorded in the area also occasionally grow in association with mangrove communities.

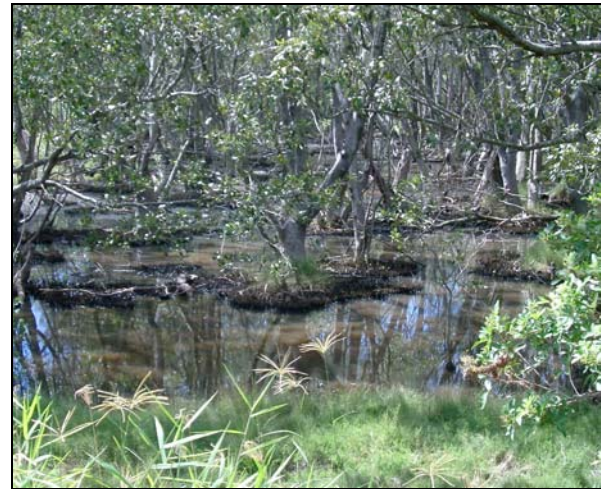
Photo 17.10

Wetlands of the airport are typically shallow (less than 0.5m) and bordered by marine couch

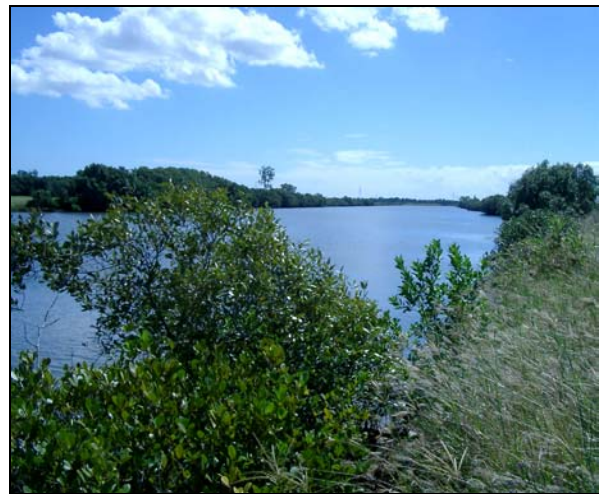
Terrestrial grasses grow on the upper bank of the Kedron Brook Floodway

The floodway is approximately 30m wide and 4m deep. It is well flushed, and strongly tidal. The banks are degraded in sections, with an erosion scarp up to 1.5m along parts of the eastern bank, and invasion of terrestrial weeds that grow on the upper bank (refer Photo 17.11 and 17.12). Along most of the east and west bank, there are grey mangrove to 5m and river mangrove to 2m (refer Photo 17.13). Sea blite and sea purslane grow in the understorey, whilst marine couch grows on the upper bank (often along the edge of the erosion scarp). Terrestrial grasses and weeds grow landward of the marine couch (refer Figure 17.4c).

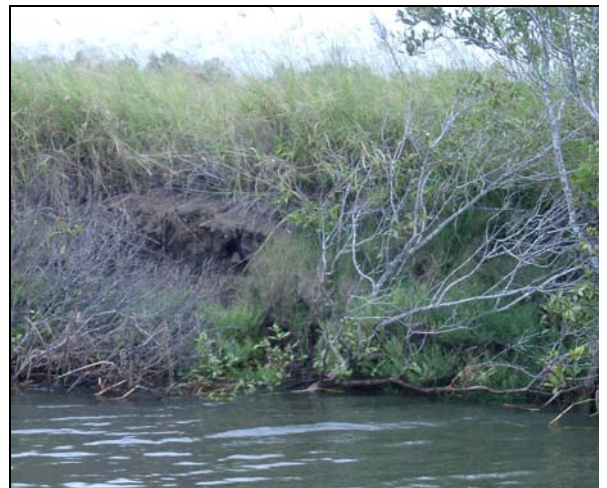
Photo 17.12

Some sections of the Kedron Brook Floodway's eastern bank are highly eroded

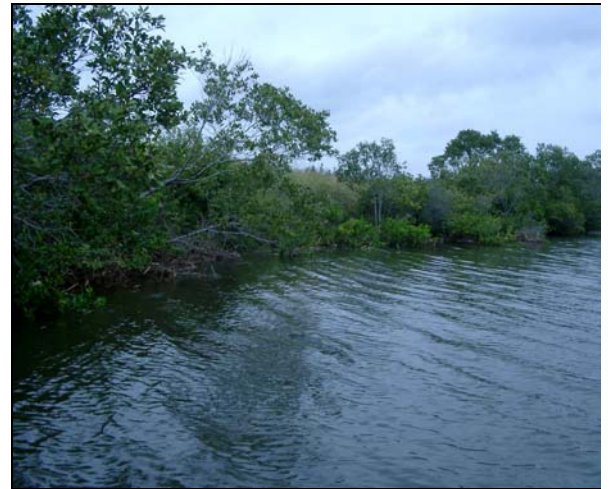
Photo 17.13

Mangrove communities of river and grey mangrove line much of the bank

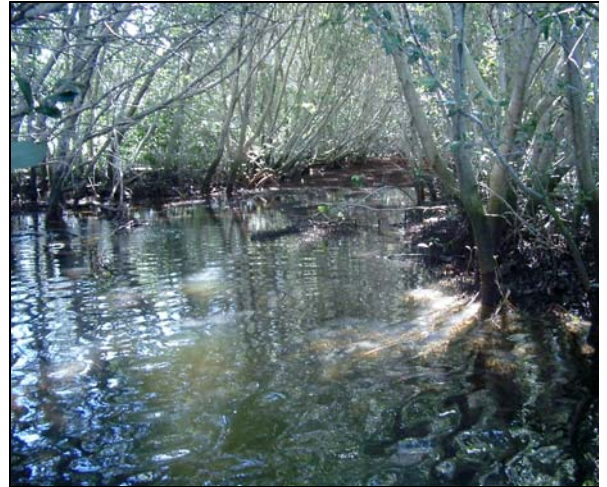
Photo 17.14

The tributary of Kedron Brook Floodway that is crossed by the Gateway Upgrade alignment

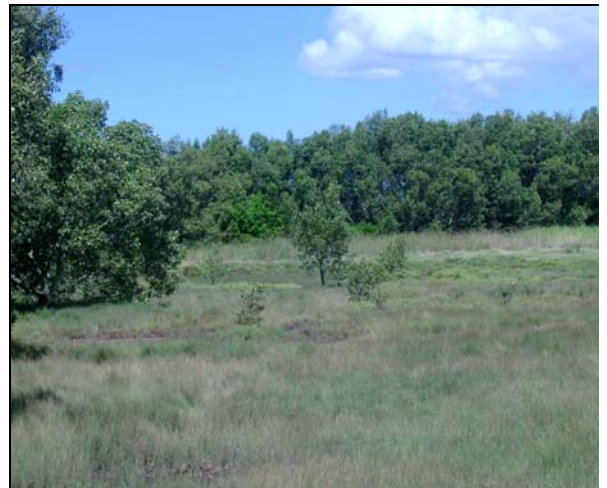
Photo 17.15

Extensive marine couch meadows grow between the Kedron Brook Floodway and the southern part of the tributary

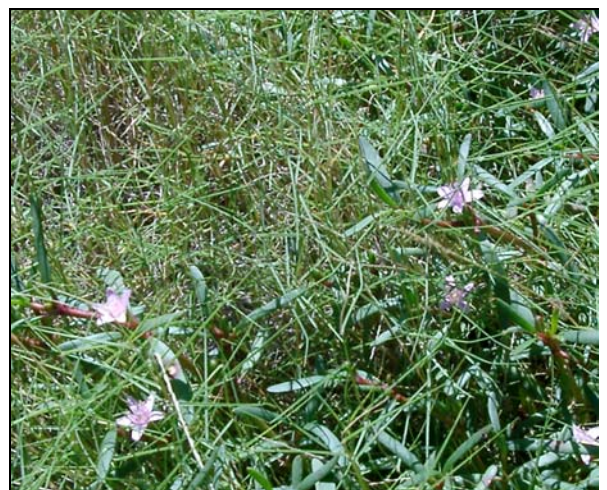
Photo 17.16

Sea purslane (*Sesuvium portulacastrum*) grows amongst marine couch (*Sporobolus virginicus*) adjacent to the Kedron Brook Floodway tributary

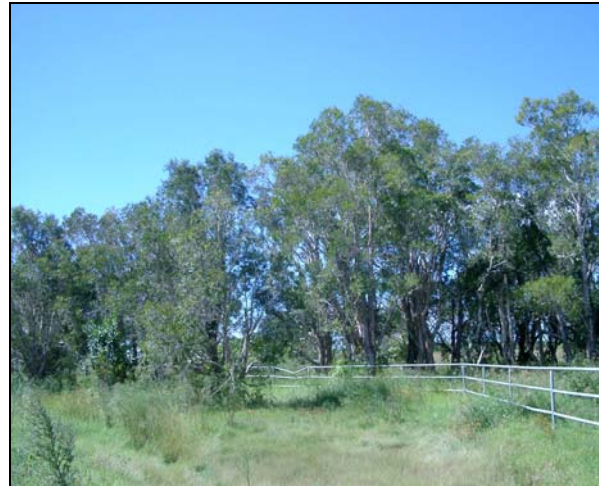
Photo 17.17

Paperbark stands grow north and south of the tributary of Kedron Brook Floodway

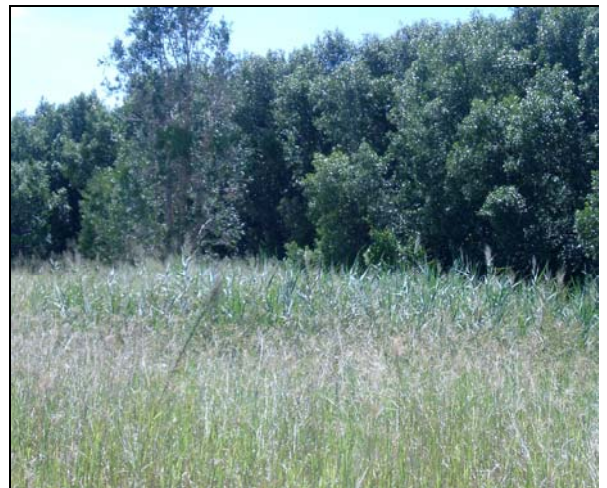
Photo 17.18

Common reed grows south of the tributary creek

Scattered saltmarsh, mangrove channels and freshwater sedgelands grow adjacent to the existing Gateway Motorway at the proposed overpass/on-ramp that meets the Gateway Upgrade alignment. Marine couch grows in association with the tributary of Kedron Brook Floodway (refer Photo 17.15 and 17.16 and Figure 17.4c). Paperbark (*Melaleuca quinquenervia*) to approx. 12m grows in two stands – one north of the tributary, the other south (refer Photo 17.17). Common reed (*Phragmites australis*) grows landward of the southern bank of the creek (refer Photo 17.18).

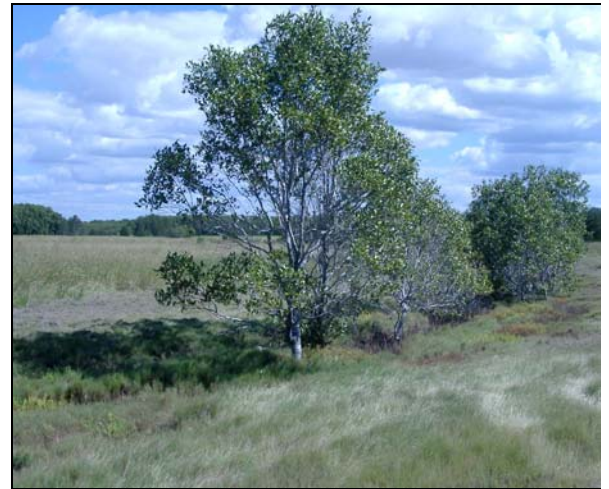
Photo 17.19

There are small mangrove channels approximately 80m south of the Gateway Motorway

Rank grasses and bushland weeds grow in a dense thicket to 50m south of the Gateway Motorway. Occasional small mangrove channels grow further south, with marine couch, sea blite and sea purslane (refer Photo 17.19). There are also patches of bare claypan. Sedges (*Schoenoplectus* sp. and *Schoenoplectus validus*) grow in waterlogged sections with marine couch (refer Photo 17.20).

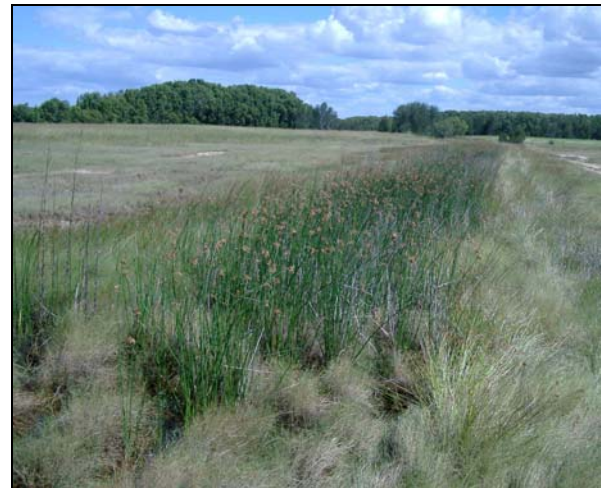
Photo 17.20

Schoenoplectus sedges and marine couch grow in low lying lands south of the Gateway Motorway, north of Kedron Brook Floodway
