# Gateway Upgrade Project

## 18. Cultural Heritage

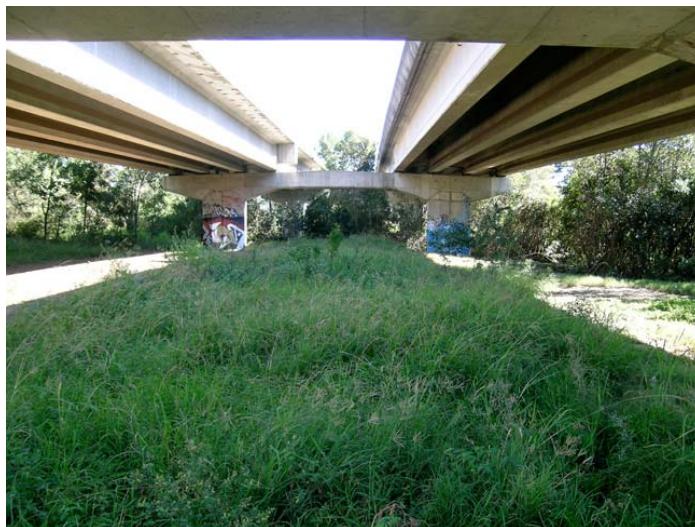
**Photo 18.1 Area under Gateway Motorway adjacent to Bulimba Creek**

The northern bank of the creek has been heavily impacted as the result of a long history of industrial development. Similarly, much of the visible area in the vicinity of the southern bank exhibits evidence of substantial quantities of imported soil, gravel and refuse. Much of the area has been cleared with only small pockets of remnant vegetation along the creek bank. This vegetation includes remnants of original vegetation types including various mangrove types such as the river mangrove as well as several types of eucalypts and melaleuca (refer Photos 18.1 to 18.3).

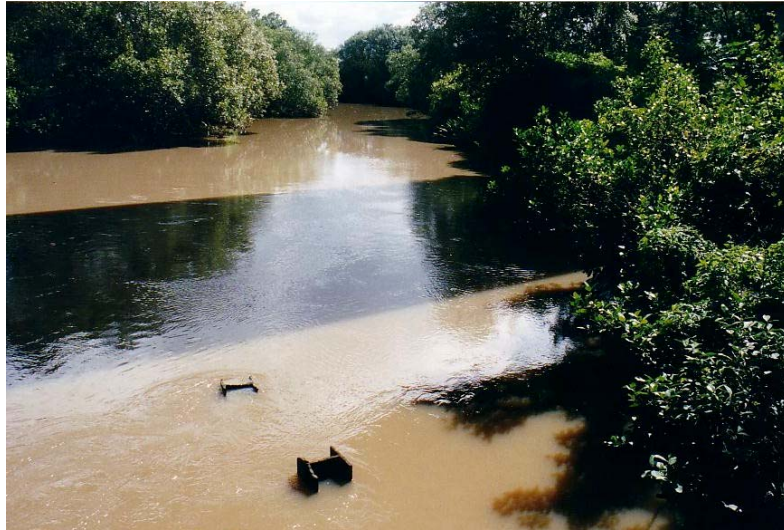
**Photo 18.4** Remnant metal 'I-beam' girders in Bulimba Creek

Two closely associated vertical metal 'I-beam' girders were noted protruding above the present water level adjacent to the southern bank of Bulimba Creek at SA 2 (refer Photo 18.4).

This remnant metalwork may be related to former industrial structures located along Bulimba Creek, and other urban creek/drainage systems in this industrialised area of Brisbane; it is unlikely to be of cultural heritage significance.

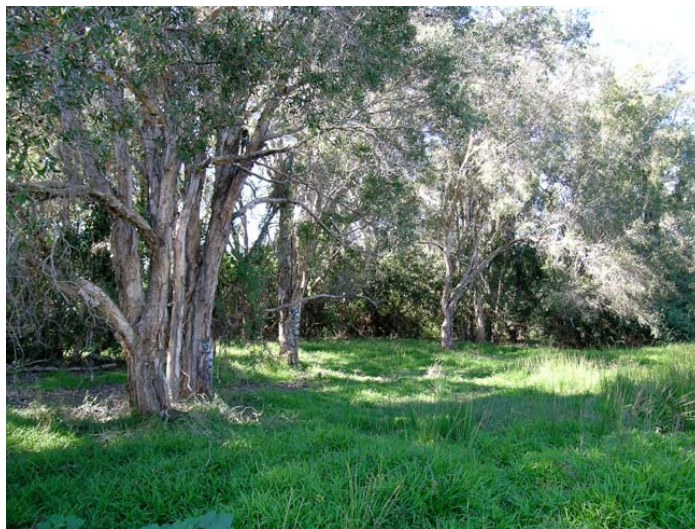
Photo 18.5 Remnant melaleuca forest located in SA 3

Other remnant pockets of vegetation include several pockets of relatively high integrity melaleuca wetlands; a smaller one beside the eastern side of the Motorway in the vicinity of the emergency breakdown bay (CH14500) and a larger remnant located on the western side between the Motorway and Murarrie Road (CH 14100 to 14600) (refer Photos 18.5 and 18.6). These wetland remnants included several types of eucalypt including scribbly gum (*Eucalyptus racemosa*), casuarinas including the common *Casuarina equisetifolia*, several types of melaleuca (such as *Melaleuca quinquenervia*), swampbox (*Lophostemon suaveolens*) and smaller vegetation varieties including soft twig rush (*Baumea rubiginosa*), grey sedge (*Lepironia articulata*) and slender knotweed (*Persicaria decipiens*).

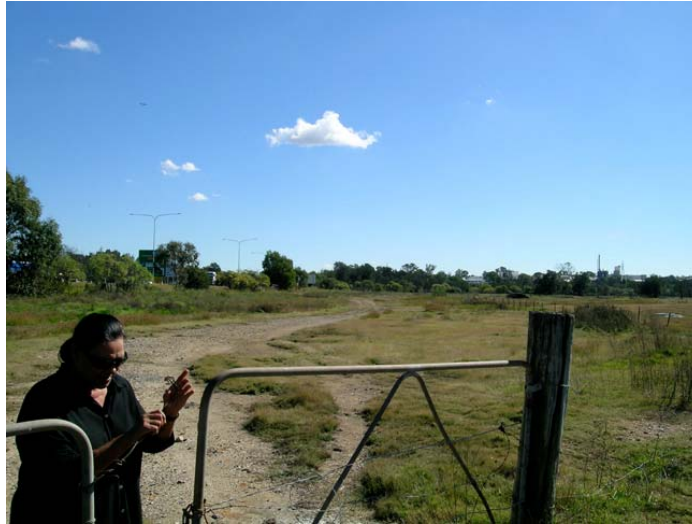
**Photo 18.7 View north towards remnant melaleuca swamp**

The remainder of the survey area consisted of low lying, damp areas of cleared land covered in a variety of native and introduced grasses, with occasional small pockets of regrowth casuarinas. This landscape type would appear to be the result of the clearing of existing wetland forests to make way for pastoral land. Unlike the eastern perimeter of the SA 3, ground surface visibility levels in the remainder of these areas was extremely poor to non existent due to the variety of native and introduced grasses and ground covers present in the area (refer Photos 18.7 and 18.8).

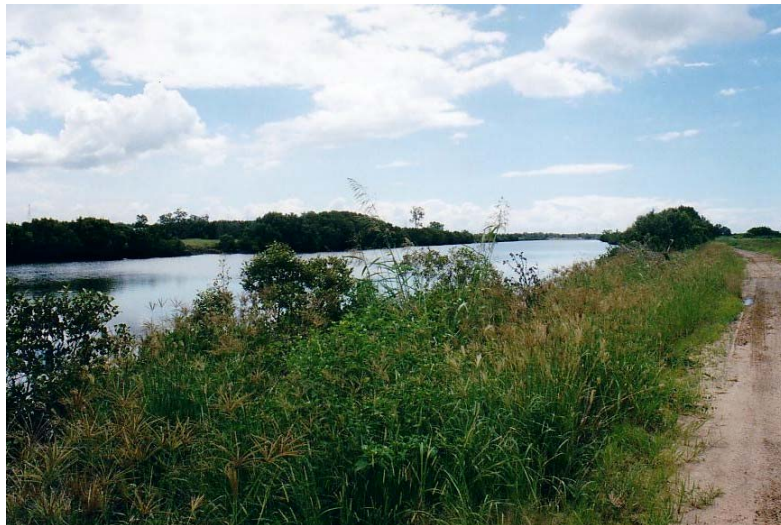
**Photo 18.9 Example of vegetation in SA 1**

The northern boundary of SA 1 included both northern and southern banks of the Kedron Brook Floodway with associated swamp and mangrove environments (refer Photo 18.9). This was a cleared, open swampy area with relatively good ground surface visibility (35-55%), but with abundant signs of development/disturbance. SA 1 also included the north bank of the Kedron Brook Floodway, however this area could not be safely accessed at the time of the field survey.

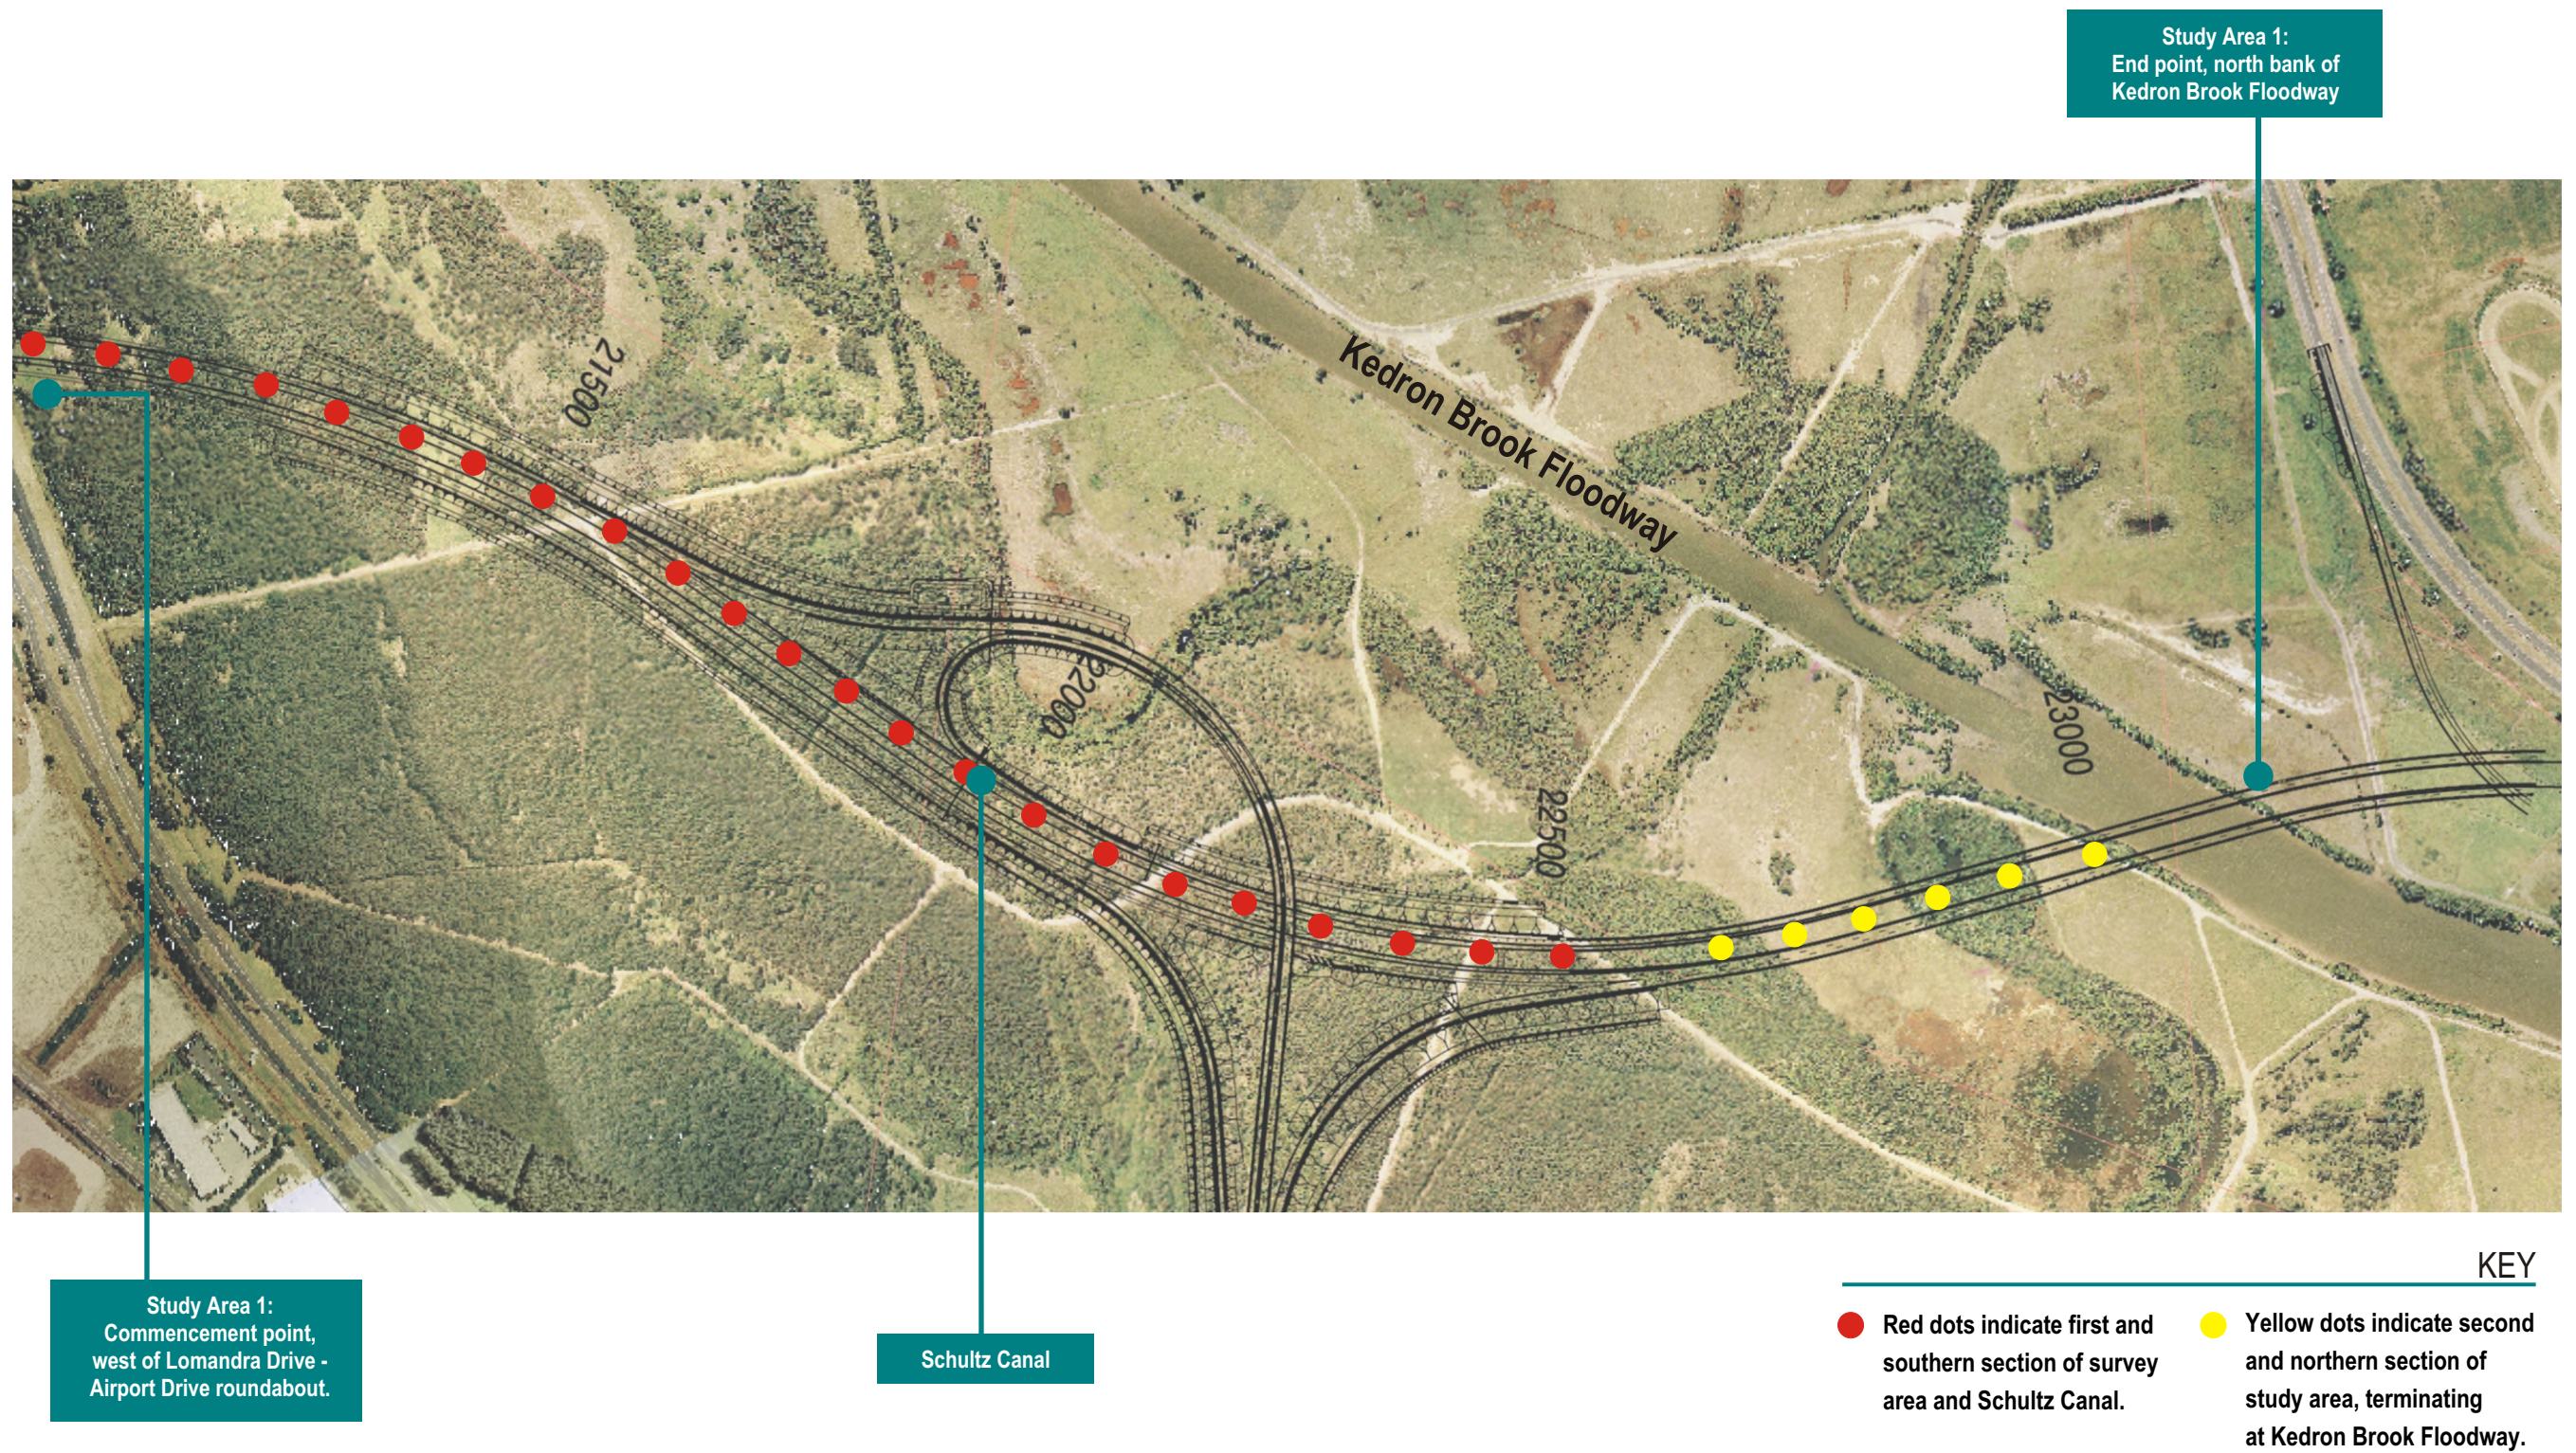
**FIGURE 18.3**  
**Cultural Heritage Survey Area 1**  
Airport Drive Precinct to Kedron Brook Floodway

Survey Area 1 (SA 1) is located within this land section of the GUP. The area consists of a 75m wide by 2km long linear corridor spanning various portions of cleared vacant land (Lot 1 on RP844114 and Lot 3 on SP110569) on and immediately adjacent to Brisbane Airport land. For ease of presentation SA 1 has been divided into the southern (Section 1) and northern (Section 2) sections (refer Figure 18.3).
