# FINAL REPORT

## Gladstone LNG Gas Transmission Pipeline – Surface water EIS

This report provides an assessment of the water resources of the Gladstone Liquefied Natural Gas (GLNG) project's gas transmission pipeline component. This assessment has been undertaken in the context of environmental values as defined by the *Environmental Protection (Water) Policy 1997*. The value of these resources to the community and the environment is discussed in terms of current legislation, water quality, regional hydrology, existing conditions of onsite drainage and flow regimes in the study area watercourses, including flooding aspects. Potential impacts from development activities on the environmental values are discussed and mitigation measures detailed to demonstrate appropriate management. Table 1-1 lists the sections of this report that address the Gladstone LNG Terms of Reference.

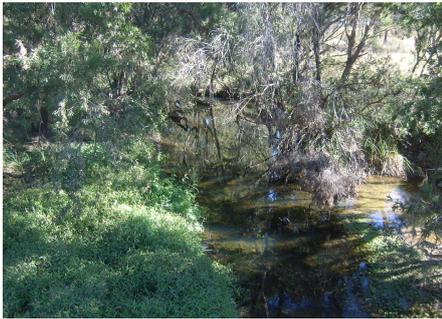
Photo: Looking Upstream

**Channel Banks:** Both left and right banks appear stable, with no evidence of erosion or bank failure at the assessment location. The low grade slopes are concave in shape and vegetated with grass and a scatter of small trees.

**Water Quality:** No apparent odour or oils were present. The trickling water was reasonably clear; light brown in colour with algae growth.

**Floodplain:** Grazed woodland.

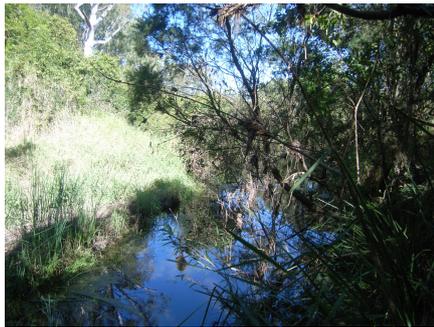
Photo: Looking Upstream

<b>Location No.</b>	<b>2</b>
<b>Location Name</b>	<b>Calliope River</b>
<b>Easting:</b>	293,174
<b>Northing:</b>	7,341,808
<b>Site Description:</b> <i>The Calliope River is located to the south west of Gladstone. The undulating stream bed results in both flowing and ponded water surfaces. The low flow channel bed has dense algal growth whilst the main channel bed has dense grass and shrub cover. The assessment was undertaken at a nearby road crossing of the watercourse as the pipeline crossing was inaccessible.</i>	
<b>Channel Depth:</b>	1.5m/10m
<b>Channel Width:</b>	1.5m/5m/100m
<b>Floodplain Slope:</b>	L 1:11, R 1:4
<b>Bank Slope:</b>	LB 1:13, RB 1:45
<b>Channel Banks:</b> Both left and right banks appear stable, with little evidence of erosion or bank failure at the site location. The low grade slopes are concave in shape and are grassed with a scatter of small trees.	
<b>Substrate Type:</b> The bed substrate is of low compaction with a moderate availability of interstitial spaces. The predominate particle size is a fine silt.

<b>Channel Bed:</b> The multistage channel has a low flow channel approximately 1.5m wide and a medium flow channel of approximately 5m and an upper channel that then extends approximately 100m. The low flow channel has an undulating silt bed surface, whilst the two upper beds are covered in grasses and small trees. Both lower and upper beds appear stable with no signs or erosion or deposition.	
<b>Water Quality:</b> No apparent odour or oils were present. The trickling water was reasonably clear; light brown in colour with algae growth.	
<b>Floodplain:</b> Grazed woodland.

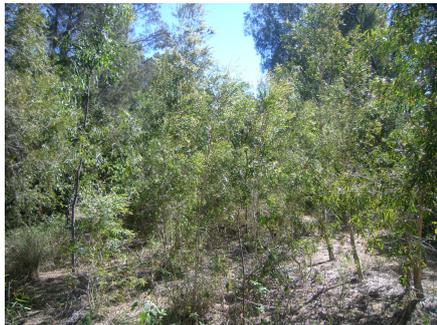
Photo: Looking Upstream

<b>LNG transmission pipeline – Surface Water Assessment</b>	
<b>Location No.</b>	<b>3</b>
<b>Location Name</b>	<b>Bell Creek</b>
<u>Easting:</u>	266,550
<u>Northing:</u>	7,326,278
<u>Site Description:</u> <i>Bell Creek is located to the south west of Gladstone. The flat bottom ephemeral stream is heavily vegetated with mature larger trees, dense scrubs on the banks and juvenile trees on the flat sandy bed.</i>	
<u>Channel Depth:</u>	2m
<u>Channel Width:</u>	10m
<u>Floodplain Slope:</u>	L 1:1, R 1:1
<u>Bank Slope:</u>	LB 1:1, RB 1:2.5
<u>Channel Banks:</u> Both left and right banks appear stable, with no evidence of erosion or bank failure. Although hard to determine under the dense vegetation, the bank slopes appear steep yet concave in shape.	
<u>Substrate Type:</u> The bed substrate is of low compaction with a high availability of interstitial spaces. The predominate particle size is a sand with some finer silts and coarser small gravels.

<u>Channel Bed:</u> The two stage channel has a low flow channel approximately 10m wide and a medium flow channel is approximately a further 10m wide. Both the low and medium flow channels have a reasonably flat surface dense with juvenile tree vegetation. Both lower and upper beds appear stable with no signs or erosion or deposition.	
<u>Water Quality:</u> No water present, no assessment undertaken	
<u>Floodplain:</u> Grazed pasture.

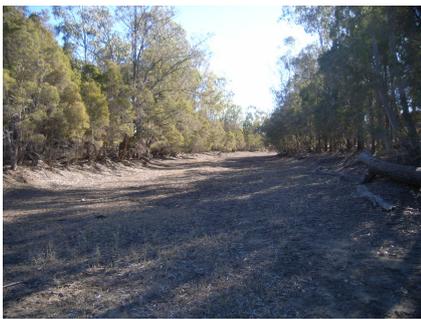
Photo: Looking Upstream

**Channel Banks:** Both left and right banks appear stable, with little evidence of erosion or bank failure. The banks are stepped in shape with moderately steep lower banks and low slope on the upper levels.

**Water Quality:** No water present, no assessment undertaken

**Floodplain:** Grazed pasture.

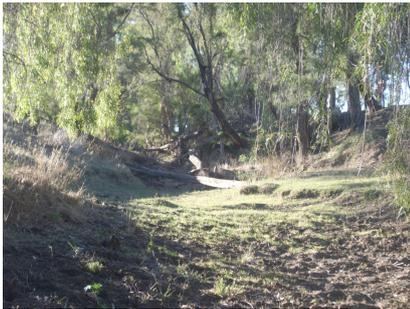
Photo: Looking Downstream

<b>LNG transmission pipeline – Surface Water Assessment</b>	
<b>Location No.</b>	<b>5</b>
<b>Location Name</b>	<b>Kroombit Creek</b>
<b>Easting:</b>	237,171
<b>Northing:</b>	7,311,399
<b>Site Description:</b> <i>Kroombit Creek is located to the north of Biloela. The ephemeral stream is an irregular U shaped channel with an undulating bed and large wooden debris deposits. There are signs of both bed and bank erosion from flow and erosion from livestock.</i>	
<b>Channel Depth:</b>	3m
<b>Channel Width:</b>	7m
<b>Floodplain Slope:</b>	L 1:90, R 1:45
<b>Bank Slope:</b>	LB 1:3.7, RB 1:3.7
<b>Channel Banks:</b> Both left and right banks are moderately eroded, with short sparse grass on lower areas and trees on upper banks. The banks are convex in shape with a low slope.	
<b>Substrate Type:</b> The bed substrate is of low compaction with a low availability of interstitial spaces. The pre-dominant particle size is a silt with some fine sands.

<b>Channel Bed:</b> The irregular U shaped channel has an eroded, undulating and silty sandy, bed which is sparsely grassed.	
<b>Water Quality:</b> No water present, no assessment undertaken	
<b>Floodplain:</b> Grazed pasture.

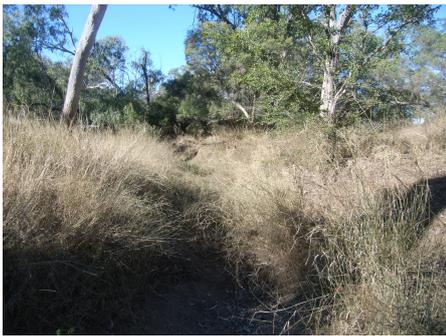
Photo: Looking Upstream

<b>LNG transmission pipeline – Surface Water Assessment</b>	
<b>Location No.</b>	<b>6</b>
<b>Location Name</b>	<b>Banana Creek</b>
<b>Easting:</b>	201,414
<b>Northing:</b>	7,300,296
<b>Site Description:</b> <i>Banana Creek is located to the north of the small town of Banana. The dry irregular stream has a sandy bed, low flow channel and grassy upper channel.</i>	
<b>Channel Depth:</b>	2m
<b>Channel Width:</b>	2m
<b>Floodplain Slope:</b>	L 1:50, R 1:40
<b>Bank Slope:</b>	LB 1:2.5, RB 1:7.5
<b>Channel Banks:</b> Both left and right banks appear moderately unstable, with 30 – 60% of bank reaches with evidence of erosion. The banks are stepped, convex in shape and steep in nature. The flat steps of the bank are vegetated with long grass and a scatter of smaller trees.	
<b>Substrate Type:</b> The bed substrate is of low compaction with a high percentage of fines making it predominately matrix dominated. The predominate particle size is a sand with some finer silts and coarser small gravels.

<b>Channel Bed:</b> The multistage channel has a low flow channel approximately 2m wide with a shallow flat sandy bed. The banks are then stepped with long grass and a scattering of small tree vegetation. There is a moderate build up of fine sediments at obstructions and bars.	
<b>Water Quality:</b> No water present, no assessment undertaken	
<b>Floodplain:</b> Grazed pasture.

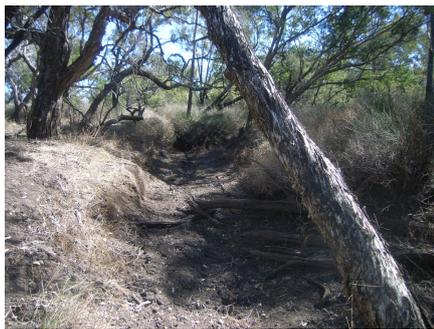
Photo: Looking Upstream

**Water Quality:** No water present, no assessment undertaken

**Floodplain:** Grazed pasture.

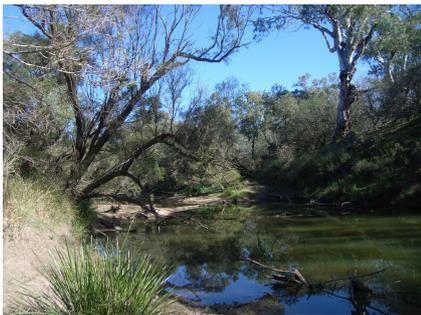
Photo: Looking Upstream

<b>Channel Bed:</b> The multistage channel has a low flow channel approximately 4m wide with a shallow reasonably flat silty clay bed. There is several log jams and rotting debris. The channel sinuosity is fair with bends increasing the stream length by 1 to 2 times.	
<b>Water Quality:</b> The stagnant water appeared to have no sediment, water oils or odour. It is slightly turbid in nature and light brown in colour. A slight algae growth near the bed of the watercourse was noted.

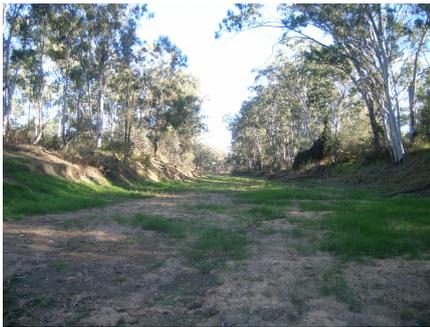
Photo: Looking Upstream

<b>LNG transmission pipeline – Surface Water Assessment</b>	
<b>Location No.</b>	<b>9</b>
<b>Location Name</b>	<b>Mimosa Creek</b>
<b>Easting:</b>	778,391
<b>Northing:</b>	7,291,707
<b>Site Description:</b> <i>Mimosa Creek is located to the north west of the small town of Banana. The flat ‘U’ shaped channel has a flat sandy bed with grassed and tree lined banks.</i>	
<b>Channel Depth:</b>	<i>6m</i>
<b>Channel Width:</b>	<i>20m</i>
<b>Floodplain Slope:</b>	<i>LB 1:55, RB 1:76</i>
<b>Bank Slope:</b>	<i>LB 1:5, RB 1:2</i>
<b>Channel Banks:</b> Both left and right banks appear stable, with only localised erosion. The right bank is convex in shape and moderately steep, whilst the left bank is stepped and has only a low slope angle. The flat sloped banks are vegetated with long grass and a scatter of tall mature trees.	
<b>Substrate Type:</b> The bed substrate is of low compaction with a high percentage of fines making it predominately matrix dominated. The predominate particle size is a sand with some finer silts.

<b>Channel Bed:</b> The flat ‘U’ shaped channel has a wide flat sandy bed with a scattering of short grass. Areas of bed erosion have filled with stagnant water. There is a moderate build up of fine sediments at obstructions and bars.	
<b>Water Quality:</b> The stagnant water appeared to have no sediment or water oils or odour. It is slightly turbid in nature and light brown in colour.	
<b>Floodplain:</b> Grazed bushland.

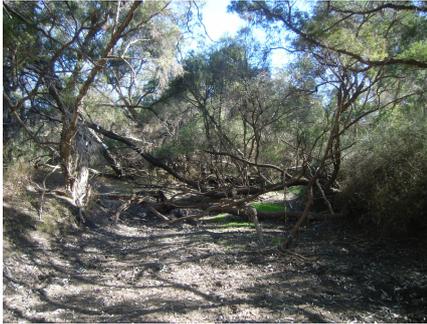
Photo: Looking Upstream

<b>LNG transmission pipeline – Surface Water Assessment</b>	
<b>Location No.</b>	<b>11</b>
<b>Location Name</b>	<b>Zamia Creek</b>
<u>Easting:</u>	755,085
<u>Northing:</u>	7,285,320
<u>Site Description:</u> <i>The ephemeral Zamia Creek has a flat ‘U’ shaped channel blocked with tree debris and leaf litter. The survey was undertaken close to the roadway, with the crossing location being inaccessible. Therefore the same field information has been used for all 4 Zamia Creek crossing locations.</i>	
<u>Channel Depth:</u>	1.3m
<u>Channel Width:</u>	5m
<u>Floodplain Slope:</u>	L 1:124, R 1:64
<u>Bank Slope:</u>	LB 1.3:1, RB 1.3:1
<u>Channel Banks:</u> Both left and right banks appear stable, with only localised erosion. Additionally both banks are concave in shape and moderately steep. The bank slopes are bare of vegetation, whilst the top of bank have a combination of long grass and small yet mature trees.

<u>Substrate Type:</u> The bed substrate is of moderate compaction with a high percentage of fines. The predominate particle size is a clay.	
<u>Channel Bed:</u> The flat ‘U’ shaped channel has a wide flat silty clay bed. The dry bed surface is cracking from the dry weather. The bed is moderately eroded from livestock. The channel sinuosity increases the stream length by 1 to 2 times.	
<u>Water Quality:</u> No water present, no assessment undertaken.	
<u>Floodplain:</u> Grazed pasture.

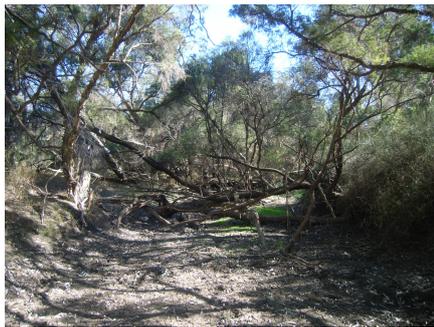
Photo: Looking Upstream

**Channel Bed:** The flat ‘U’ shaped channel has a wide flat silty clay bed. The dry bed surface is cracking from the dry weather. The bed is moderately eroded which is predominately from livestock. The channel sinuosity increases the stream length by 1 to 2 times.

**Water Quality:** No water present, no assessment undertaken.

**Floodplain:** Grazed pasture.

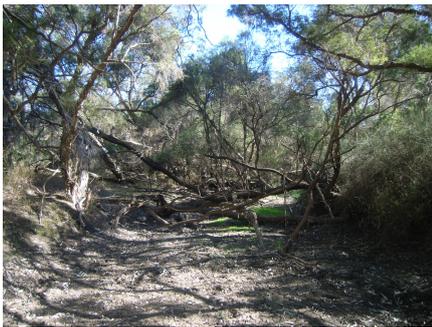
Photo: Looking Upstream

**Channel Bed:** The flat ‘U’ shaped channel has a wide flat silty clay bed. The dry bed surface is cracking from the dry weather. The bed is moderately eroded from livestock. The channel sinuosity increases the stream length by 1 to 2 times.

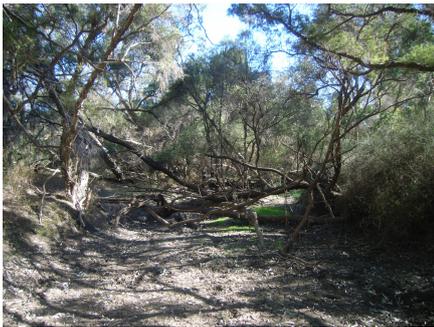
Photo: Looking Upstream

<b>LNG transmission pipeline – Surface Water Assessment</b>	
<b>Location No.</b>	<b>14</b>
<b>Location Name</b>	<b>Zamia Creek</b>
<b>Easting:</b>	741,373
<b>Northing:</b>	7,281,409
<b>Site Description:</b> <i>The ephemeral Zamia Creek has a flat ‘U’ shaped channel with tree debris and leaf litter. The survey was undertaken close to the roadway, with the crossing location being inaccessible. Therefore the same field information has been used for all 4 Zamia Creek crossing locations.</i>	
<b>Channel Depth:</b>	1.3m
<b>Channel Width:</b>	5m
<b>Floodplain Slope:</b>	L 1:45, R 1:50
<b>Bank Slope:</b>	LB 1.3:1, RB 1.3:1
<b>Channel Banks:</b> Both left and right banks appear stable, with only localised erosion. Additionally both banks are concave in shape moderately steep. The bank slopes are bare of vegetation, whilst the top of bank have a combination of long grass and small yet mature trees.	
<b>Substrate Type:</b> The bed substrate is of moderate compaction with a high percentage of fines. The predominate particle size is a clay.

<b>Channel Bed:</b> The flat ‘U’ shaped channel has a wide flat silty clay bed. The dry bed surface is cracking from the dry weather. The bed is moderately eroded from livestock. The channel sinuosity increases the stream length by 1 to 2 times.	
<b>Water Quality:</b> No water present, no assessment undertaken.	
<b>Floodplain:</b> Grazed pasture.

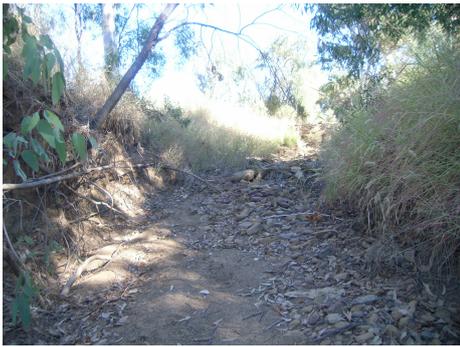
<u>Channel Bed:</u> The deepened 'U' shaped channel has a narrow flat sandy bed with leaf debris upstream of the assessment location and cobbles downstream. The bed appears to be moderately eroded potentially from the nearby roadway runoff.	
<u>Water Quality:</u> There was no water present. No assessment was undertaken.	
<u>Floodplain:</u> Grazed pasture.

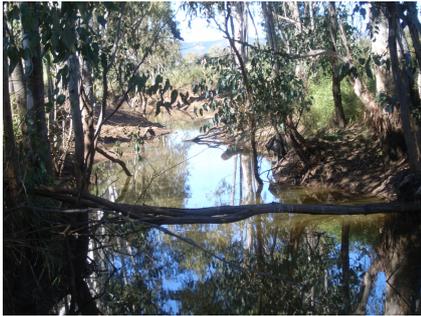
Photo: Looking Upstream

<b>Location No.</b>	<b>19</b>
<b>Location Name</b>	<b>Arcadia Creek</b>
<u>Easting:</u>	673,988
<u>Northing:</u>	7,225,119
<u>Site Description:</u> <i>Arcadia Creek is located within the Arcadia Valley, the location of the proposed pipeline crossing could not be accessed, and a roadside location was alternatively adopted. The small watercourse on the day of survey had approximately 0.25m deep, pooling water.</i>	
<u>Channel Depth:</u>	2.5m
<u>Channel Width:</u>	3m
<u>Floodplain Slope:</u>	L 1:25, R 1:65
<u>Bank Slope:</u>	LB 2.5:2, RB 2.5:2
<u>Channel Banks:</u> Both left and right banks appear unstable, with severe erosion frequently located along both straight reaches and bends. The left bank was concave in shape whilst the right bank is convex. Small trees vegetate the lower banks, whilst long grass is located on the upper banks.	
<u>Substrate Type:</u> The bed substrate is of moderate compaction with a high percentage of fines. The pre-dominate particle size is a silt.

<u>Channel Bed:</u> The 'U' shaped channel has a muddy bed. The bed appears stable at the survey location. The channel sinuosity is moderate and adds 2 to 3 times in length.	
<u>Water Quality:</u> There was a slight oily sheen to the water however no sediment or water odours were detected. The water was slightly turbid and light brown in colour.	
<u>Floodplain:</u> Grazed pasture.

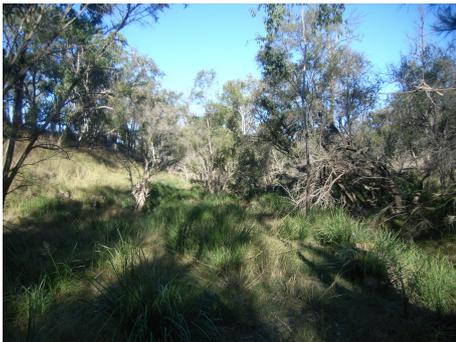
Photo: Looking Downstream

**Water Quality:** No water present, no assessment undertaken.

**Floodplain:** Woodland.

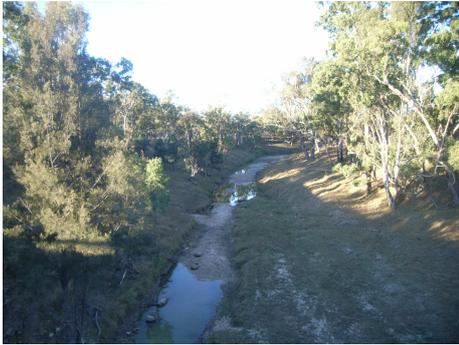
Photo: Looking Downstream

<b>LNG transmission pipeline – Surface Water Assessment</b>	
<b>Location No.</b>	<b>21</b>
<b>Location Name</b>	<b>Sardine Creek</b>
<b>Easting:</b>	662,934
<b>Northing:</b>	7,187,955
<b>Site Description:</b> <i>This site of Sardine Creek was inaccessible; the assessment was alternatively undertaken at the road crossing further downstream. At the assessment location water was ponded within the low flow channel; the downstream upper bed was grassed, whilst upstream the channel showed signs of severe deposition.</i>	
<b>Channel Depth:</b>	50m
<b>Channel Width:</b>	12m
<b>Floodplain Slope:</b>	L 1:2, R 1:8
<b>Bank Slope:</b>	LB 1:2, RB 1:2
<b>Channel Banks:</b> Both left and right banks appear stable, heavily vegetated with long grass and a scatter of small to medium sized trees. Both left and right banks are concave in shape and are of moderately to low steepness.	
<b>Substrate Type:</b> The bed substrate is of moderate compaction with a moderate percentage of fines. The pre-dominate particle size is a silty sands, gravels are also common downstream.

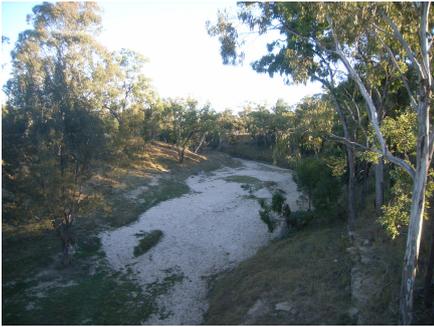
Photo: Looking Upstream

<b>Channel Bed:</b> The multi staged channel has a sandy low flow bed and short grassy surface on the upper channel bed. Particularly upstream, there is extensive build up of fine sediments. The channel sinuosity is fair and adds 1 to 2 times in length.	
<b>Water Quality:</b> Water was slightly turbid and light brown in colour.	
<b>Floodplain:</b> Grazed woodland.

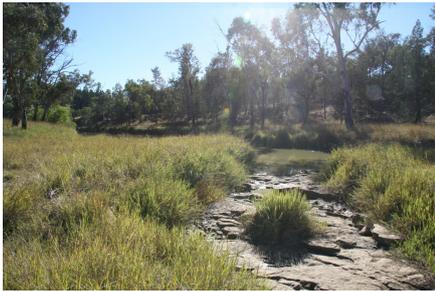
Photo: Looking Upstream

<b>Location No.</b>	<b>23</b>
<b>Location Name</b>	<b>Baffle Creek</b>
<b>Easting:</b>	681,796
<b>Northing:</b>	7,168,177
<b>Site Description:</b> <i>The assessment for this site was undertaken near Bilba Road. Here the watercourse had a two-staged channel, with ponded water over bedrock in the low flow channel and long grass on the upper bed.</i>	
<b>Channel Depth:</b>	6m
<b>Channel Width:</b>	100m
<b>Floodplain Slope:</b>	L 1:2, R 1:8
<b>Bank Slope:</b>	LB 1:10, RB 1:10
<b>Channel Banks:</b> Both left and right banks appear stable, heavily vegetated with long grass and a scatter of small trees. The right bank is concave in shape whilst the left bank is convex.	
<b>Substrate Type:</b> The channel substrate is of moderate compaction with a moderate percentage of fines. The surface of the channel is predominately bedrock. Fine silts are distributed within the cracks of rock and are moderately compacted.

<b>Channel Bed:</b> The multi staged channel, has a low flow channel surface of bedrock and dense long grass vegetating the upper channel bed. There are no signs of erosion.	
<b>Water Quality:</b> Water present is pooled and stagnant, turbid and light brown in colour. There is also algae growth on the bedrock surface.	
<b>Floodplain:</b> Woodland

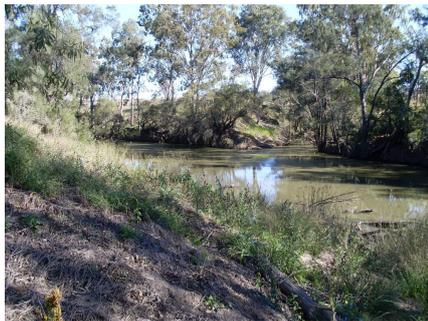
Photo: Looking Downstream

<b>Location No.</b>	<b>24</b>
<b>Location Name</b>	<b>Hutton Creek</b>
<u>Easting:</u>	692,823
<u>Northing:</u>	7,152,538
<u>Site Description:</u> <i>The Hutton River is located at the southern extent of the pipeline in the Fariview gas field. The watercourse had a depth of approximately 1m of slow moving water at the time of survey. The channel is constricted with large wooden debris and vegetated bars.</i>	
<u>Channel Depth:</u>	14m
<u>Channel Width:</u>	34m
<u>Floodplain Slope:</u>	L 1:7.5, R 6.5
<u>Bank Slope:</u>	LB 3:2, RB 3:2
<u>Channel Banks:</u> Both left and right banks appear stable, heavily vegetated with long grass and a scatter of small to medium sized trees. The left bank is stepped, whilst the right bank is concave in shape and the banks have low and moderately steepness respectively.	
<u>Substrate Type:</u> The bed substrate is of low compaction with a well rounded sediment. The pre-dominate particle size is a silty clay, with occasional gravels.

<u>Channel Bed:</u> The flatten U shaped channel shows signs of severe deposition with extensive build up of fine sediment forming bars along the channel bed. The channel sinuosity is good and adds 2 to 3 times in length.	
<u>Water Quality:</u> Water is slightly turbid and green in colour with high algal growth present. Neither oils nor odours were visual detected.	
<u>Floodplain:</u> Woodland.
